# McFetridge Lane & Awaiti Place stormwater remediation

Ecological impact assessment  
Prepared for Tauranga City Council

9 June 2021

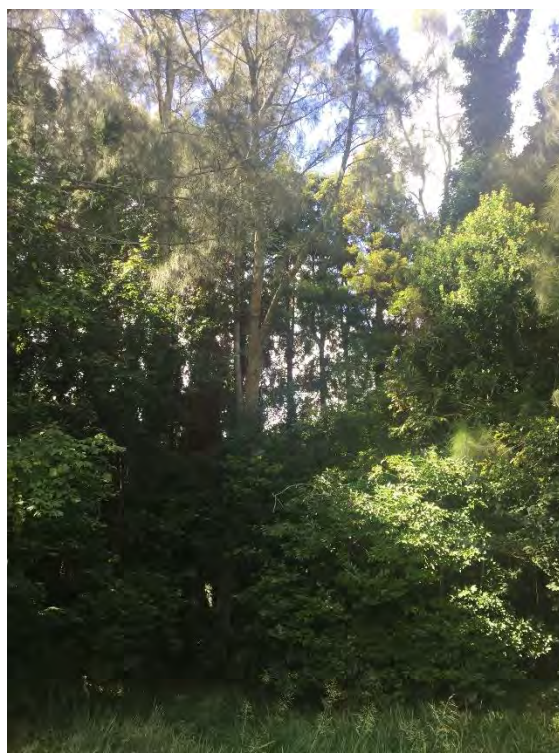
Image 1: Mix of native and exotic species growing in the riparian margin of the McFetridge stormwater wetland.

Images 1 and 2 show some of the vegetation surrounding the stormwater devices at both sites.

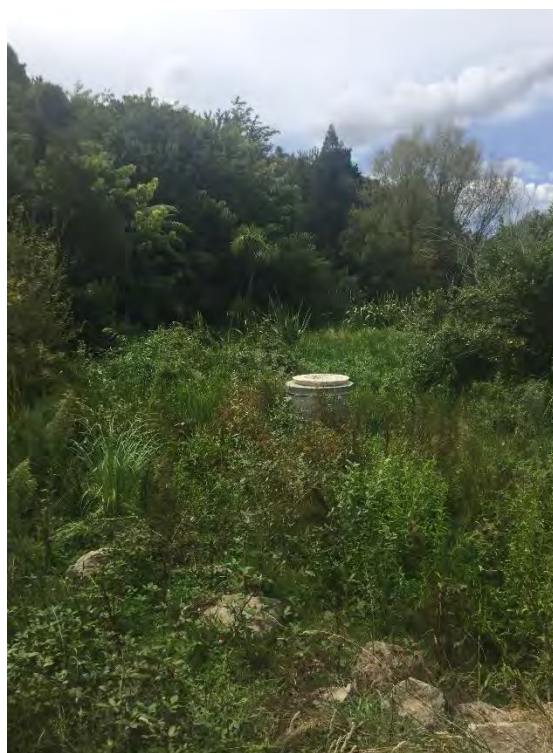
Image 2: Mix of native and exotic species growing in the riparian margin towards the upstream extent (and stream habitat) of the Awaiti Place stormwater pond.

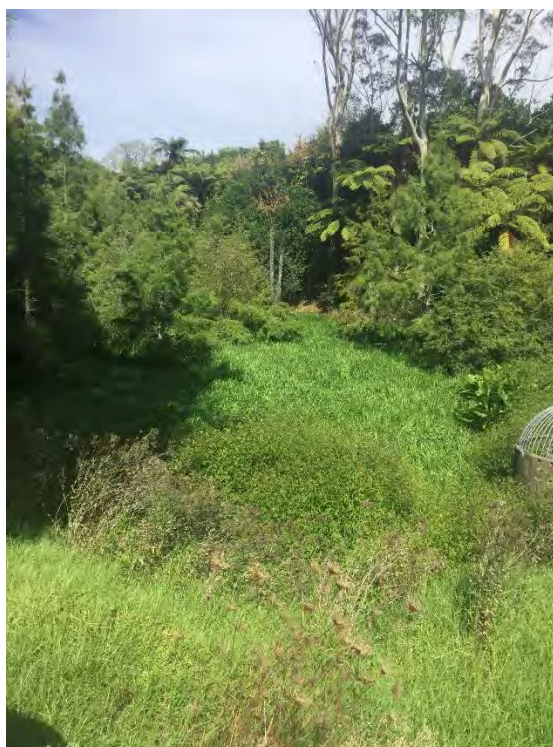
Image 3: Downstream end of the McFetridge Lane stormwater wetland.

A raised concrete outlet was located at the downstream end of the stormwater wetland. Water entered the outlet and flowed through a culvert beneath McFetridge Lane before following an open channel further north. The raised outlet had created a narrow stormwater wetland approximately 350m in length with a width varying between 10m to 40m. Stream habitat was present upstream of the stormwater wetland, but there was no obvious channel through the wetland area.

The stormwater wetland was almost completely covered in dense reed sweetgrass (*Glyceria maxims*). Other wetland species present were restricted to the stormwater wetland margins and were sporadic. These included flax (*Phormium tenax*), cabbage tree, blackberry, arum lily, willow, and several other exotic trees. Images 3 and 4 show the stormwater wetland.

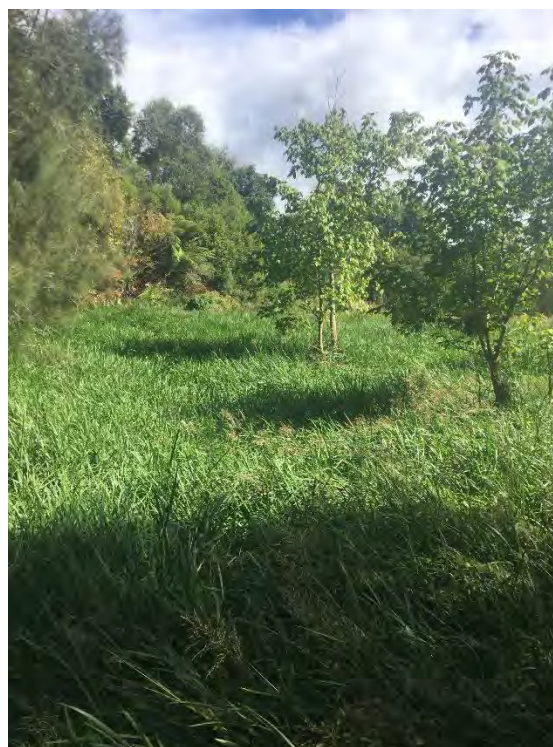
Image 4: Dense swards of reed sweet grass growing throughout the McFetridge Lane stormwater wetland.

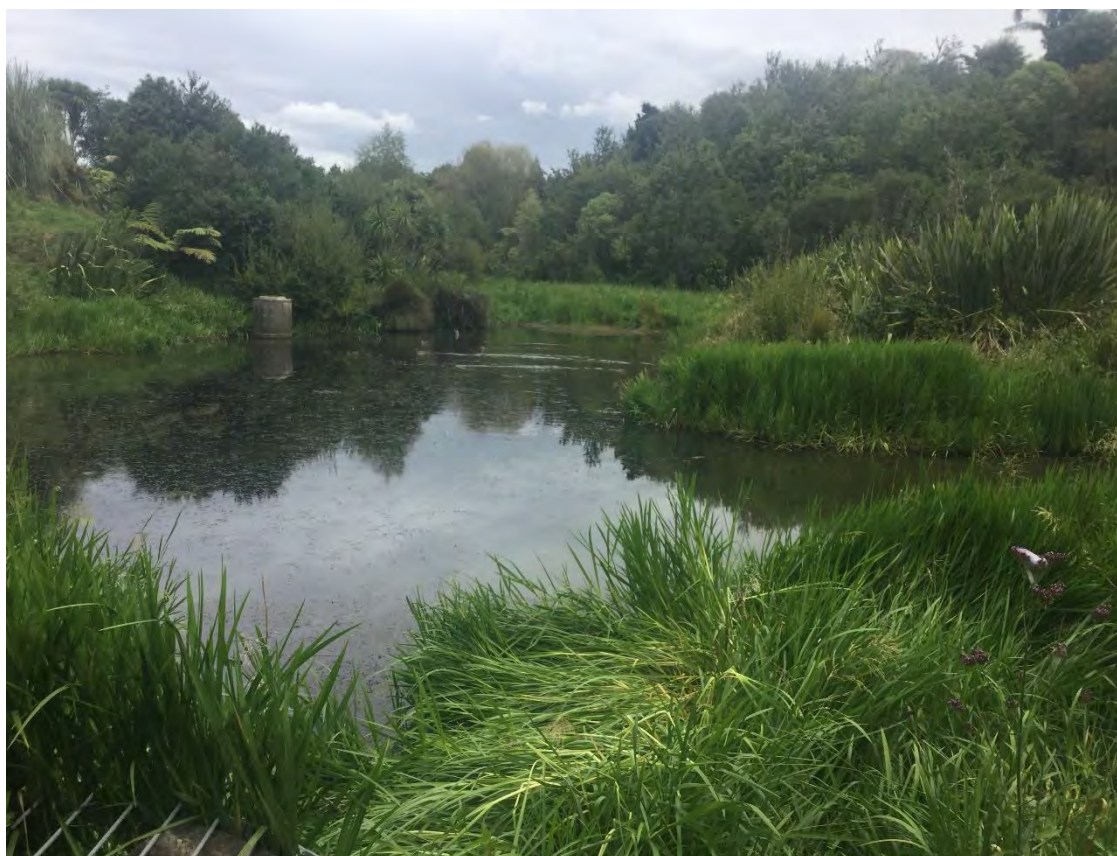
*Image 5: Awaiti Place stormwater pond.*

The stormwater feature was comprised of mostly open water and featured aquatic pest plants (thought to be Canadian pondweed (*Elodea canadensis*) and curly pondweed (*Potamogeton crispus*)), that became more dense towards the centre of the pond. Reed sweetgrass formed dense swards around the edge of the pond with other common sedges (*Carex* sp.) and rushes (*Juncus* sp.) also present. Image 5 shows the stormwater pond.

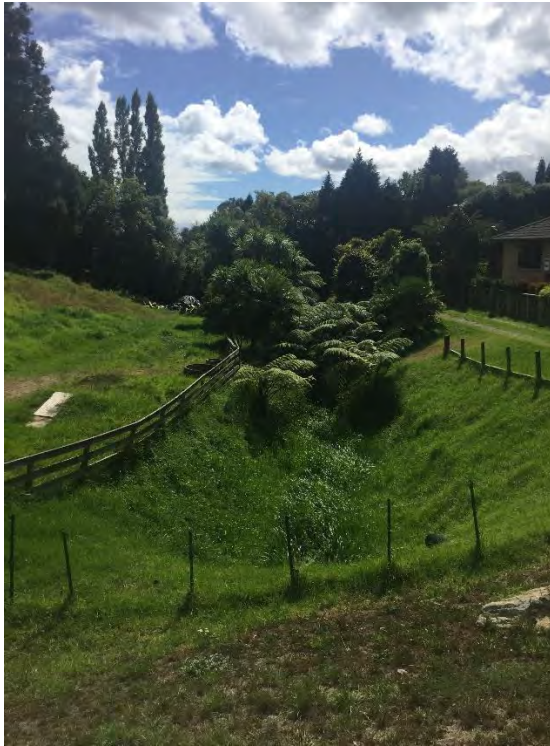
*Image 6: Stream channel immediately downstream of McFetridge Lane.*

Images 6 and 7 showed the stream flowing downstream of McFetridge Lane and adjacent to Awaiti Place. Images 8 and 9 show the open channel between Poike Road and Harrisfield Drive.

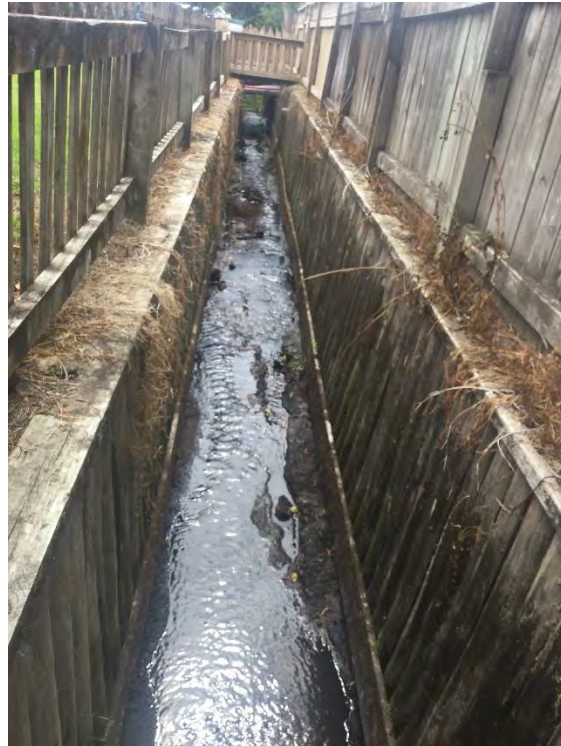
*Image 7: Stream channel flowing adjacent to Awaiti Place.*

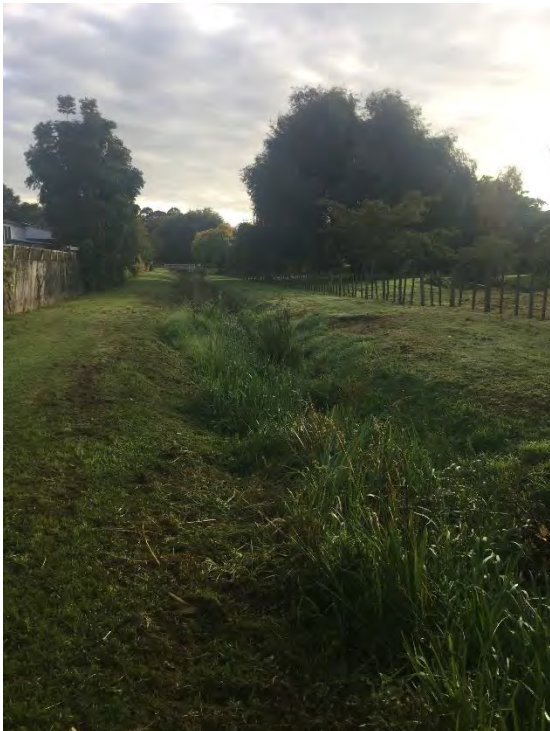
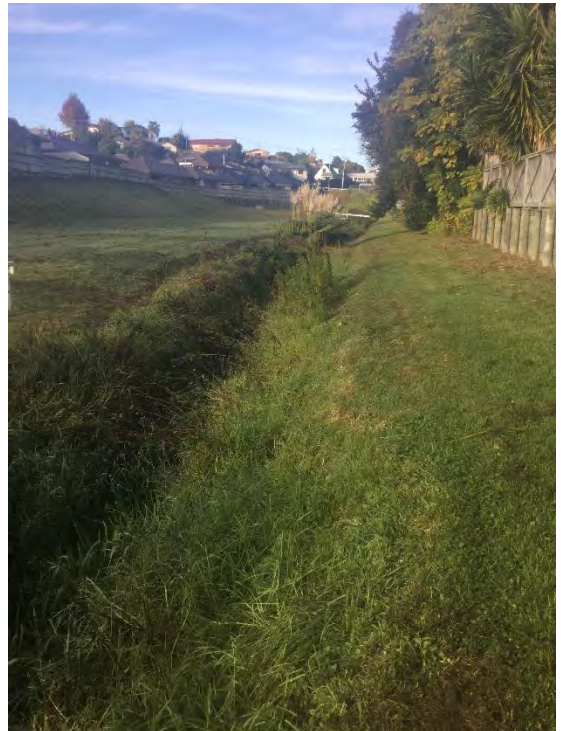
*Image 8 and 9: Stream channel flowing north between Poike Road and Harrisfield Drive.*

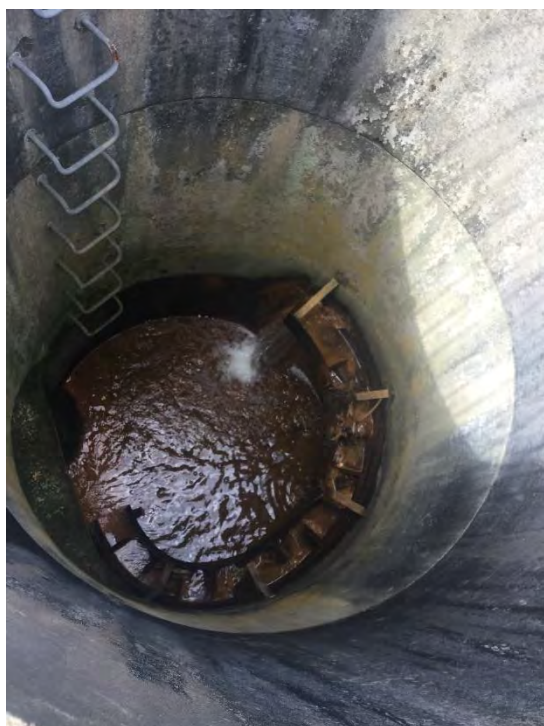
Image 11: Inlet / outlet structure of McFetridge stormwater wetland. Note the fish ladder.

Although the McFetridge Lane and Awaiti Place stormwater devices both contained fish ladders, these will provide a partial barrier to fish passage for species which are not adept swimmers / climbers, particularly as both fish ladders / ramps appeared to have had minimal maintenance (Images 8 and 9). The network of culverts downstream of the stormwater pond/ wetland may also pose a barrier(s) to fish passage. The online stormwater devices can also be a barrier to fish passage, particularly if there are periods of high temperature, low dissolved oxygen and / or proliferation of pest fish species.

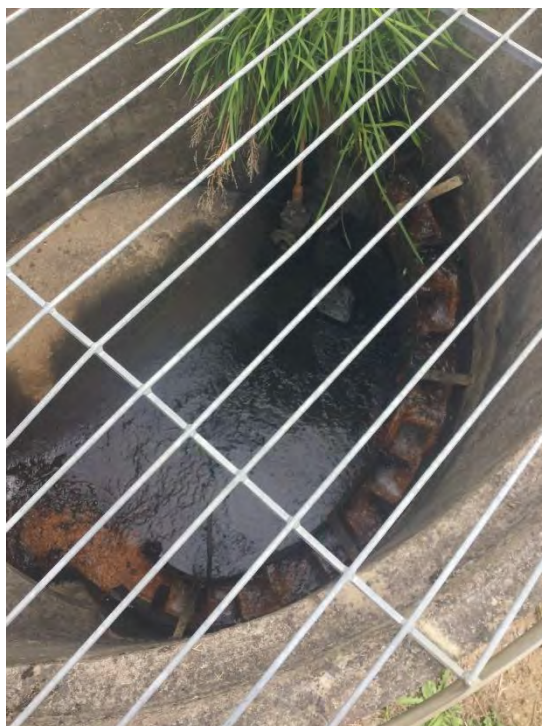
Image 12: Inlet / outlet structure of Awaiti stormwater pond. Note the fish ladder.

The existing riser at the stormwater pond will be replaced including the fish ladder. The new riser will be similar in height to what is currently on site and will mean the new fish ladder will also be similar in height and extent to the existing structure.

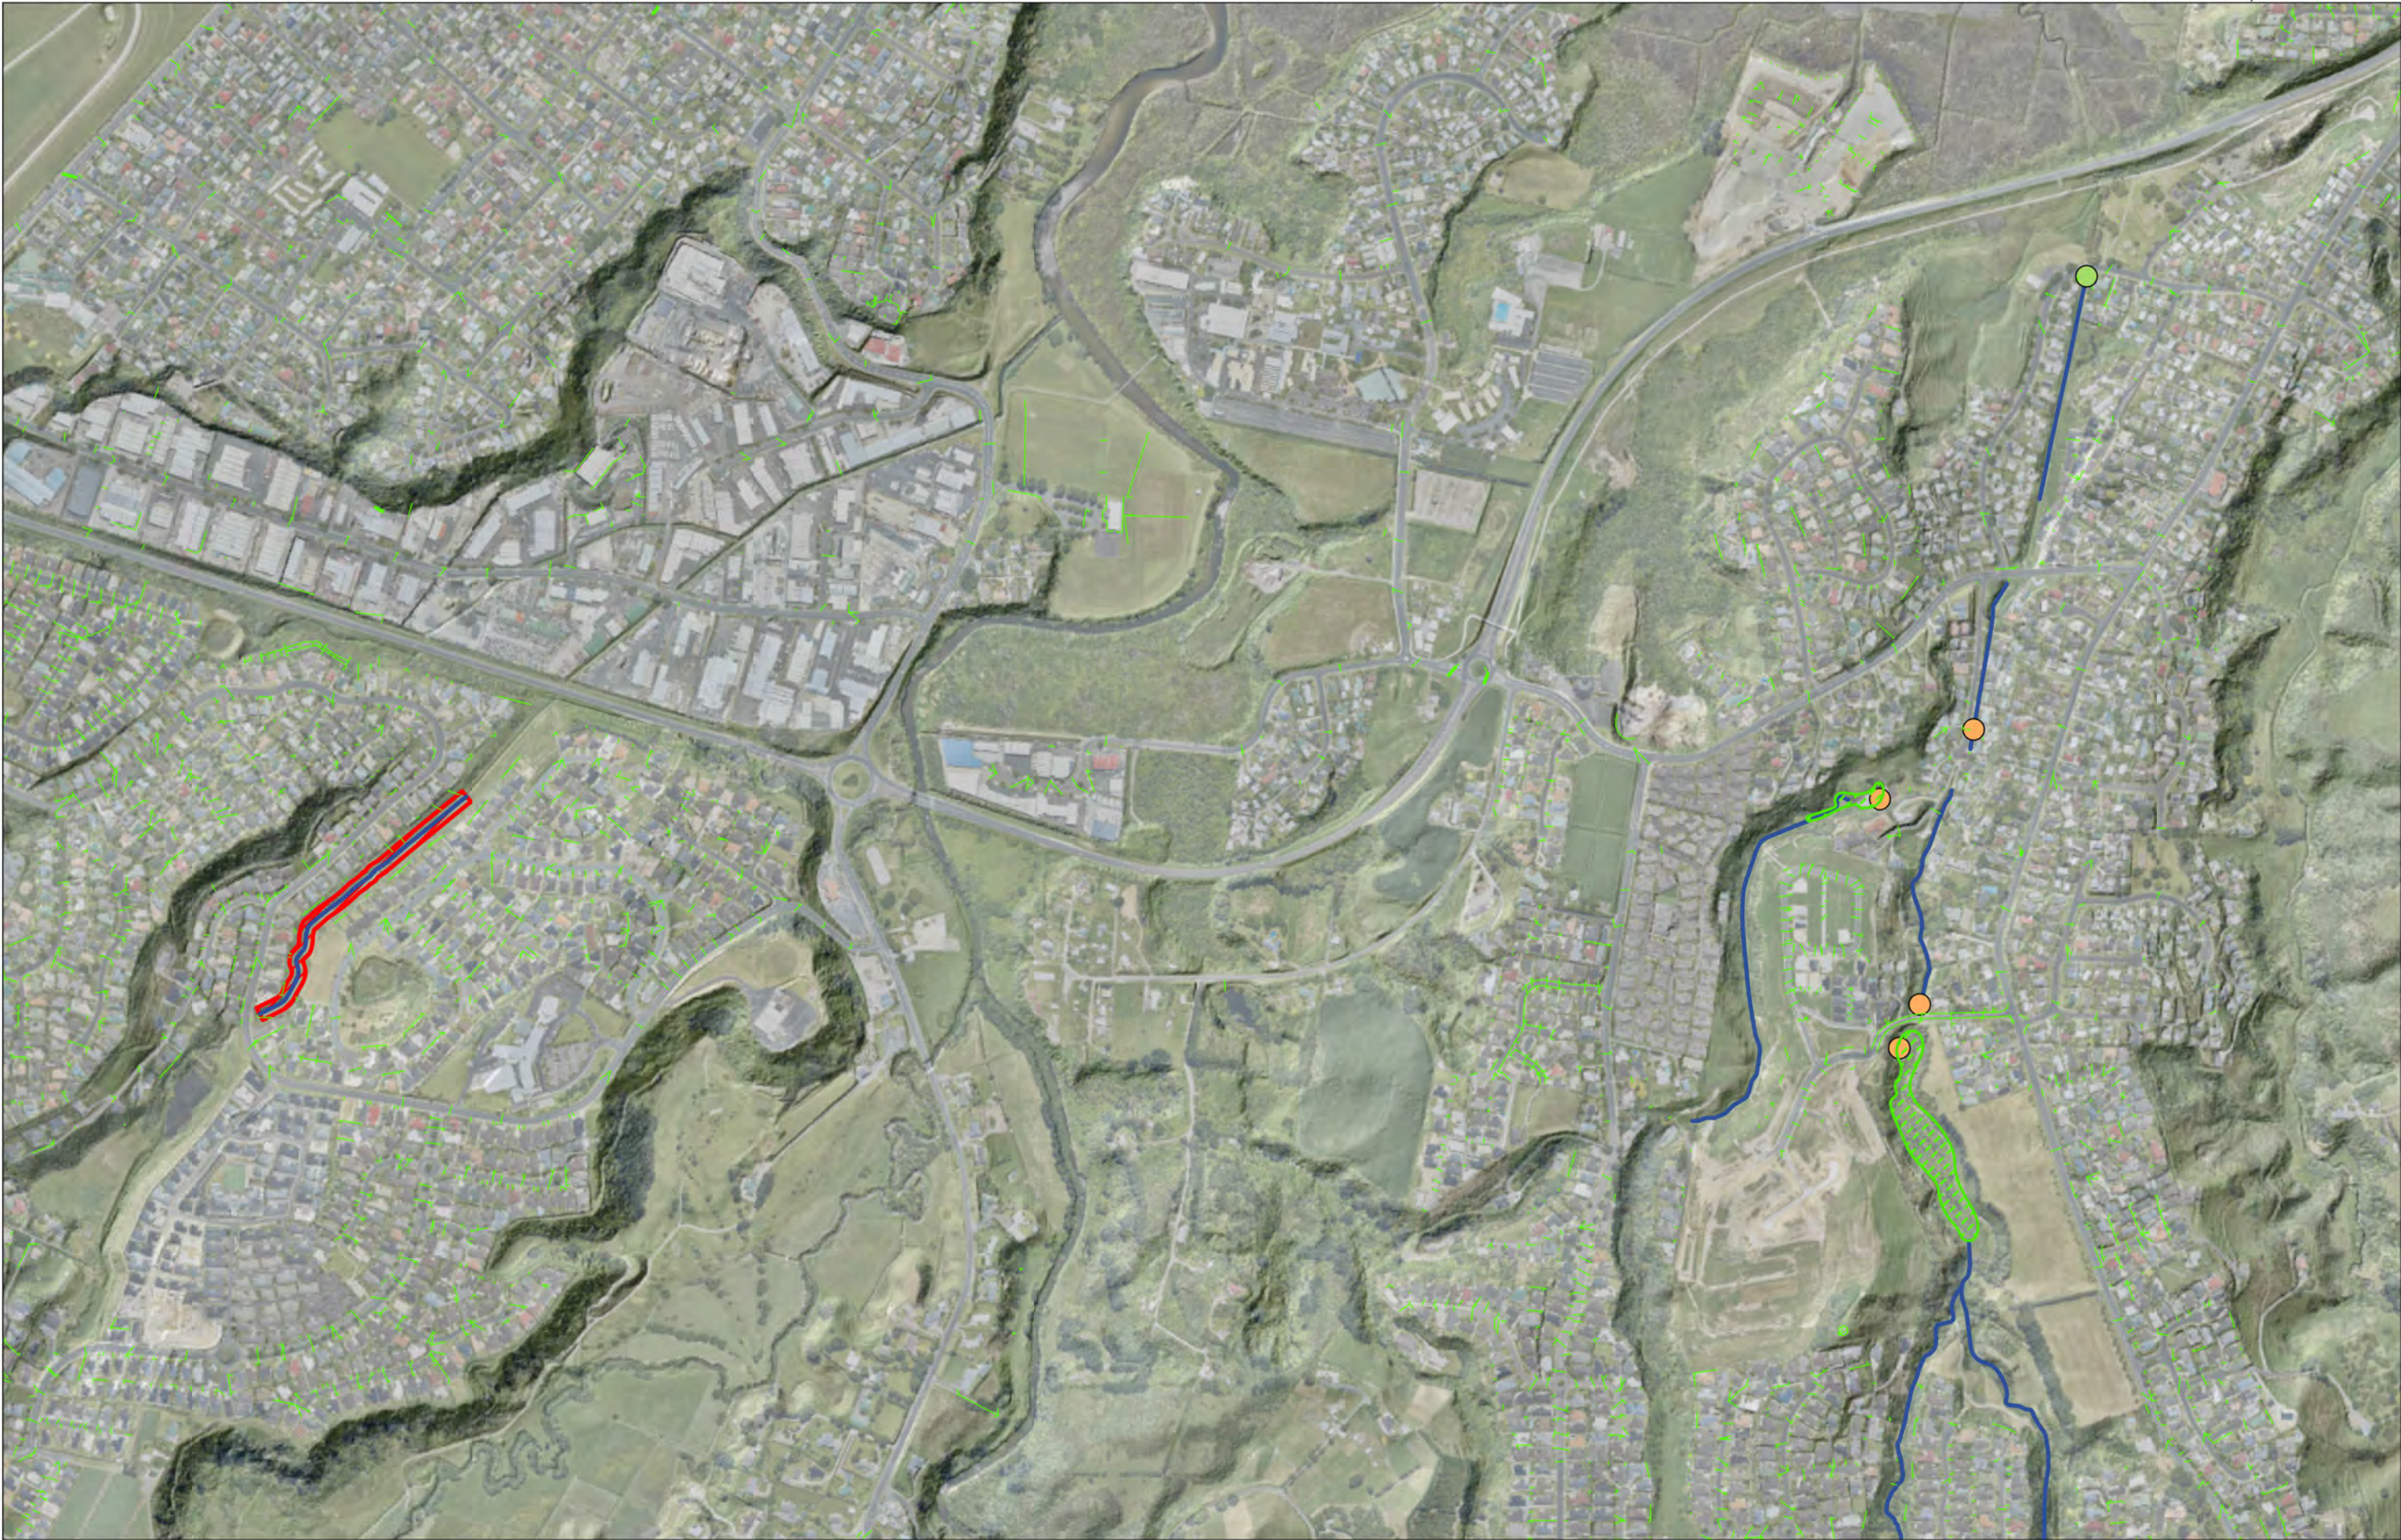
## Appendix 1: Figure 1

heavy metal concentrations. Figure 1, Appendix 1, shows the locations of the spot water quality measurements and sediment quality samples.

Macroinvertebrate samples were collected downstream of Awaiti stormwater pond and McFetridge stormwater wetland. Sample locations are shown on Figure 1, Appendix 1. The samples were collected using a 500-micron net following Protocol C2 (Stark *et al.* 2001), preserved in ethanol and analysed according to Protocol P1: coded abundance. Soft-bottom macroinvertebrate indices (MCI-sb and QMCI-sb) were calculated for both samples (Stark & Maxted 2007) as well as species richness and number of EPT<sup>2</sup> taxa.
