Bathing and shellfish surveillance monitoring report 2010/2011

Bay of Plenty Regional Council Environmental Publication 2011/13 October 2011

Environmental Publication 2011/13

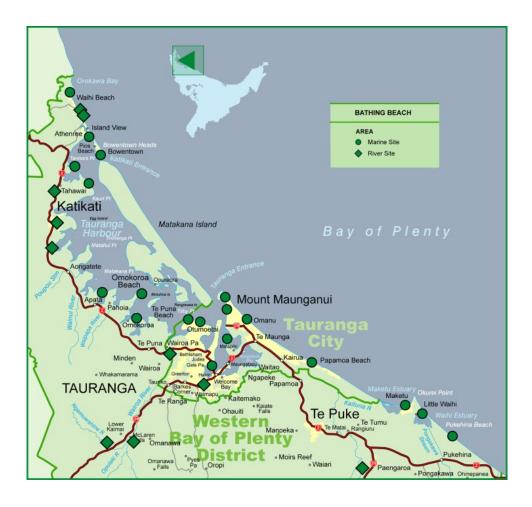
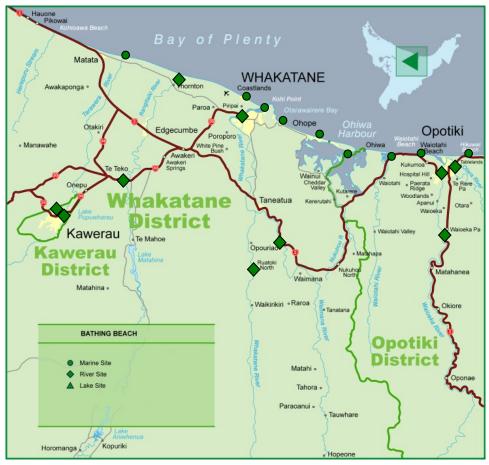
Figure 1 Bathing surveillance sites

The bathing surveillance monitoring sites are shown in the maps that follow (Figure 1).
