Kopurererua

Sub-Catchment Action Plan 2012

The Kopurererua Sub-Catchment Action Plan is one of a series about the sub-catchments surrounding Tauranga Harbour. This action plan provides an analysis of the current land management issues, a summary of the available physical resources in the Kopurererua sub-catchment, and planned action for land and resource use in the sub-catchment.

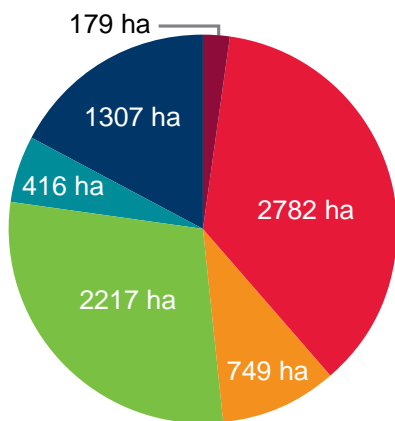
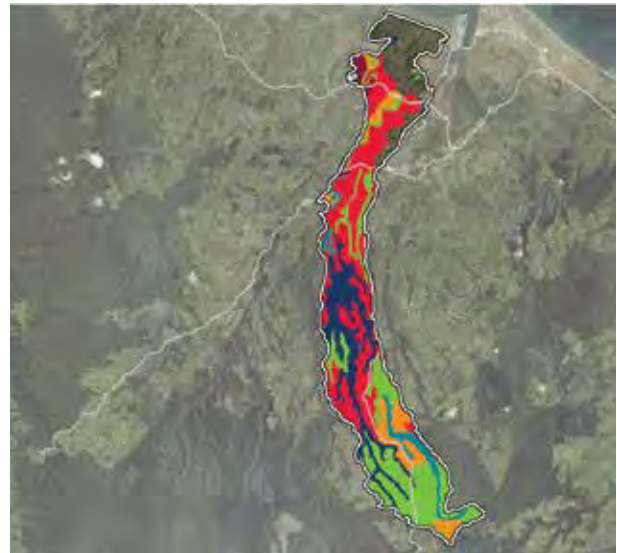
Land use capability classification in the Kopurererua sub-catchment

The majority of land in this sub-catchment is highly productive Land Use Capability (LUC) Class 3 – undulating to rolling landscapes - found throughout the middle and lower sub-catchment. Moderately erodible LUC Class 6 and 7 lands – rolling to steep landscapes - are in the middle and upper catchment. Highly erodible LUC Class 8 – very steep gully sides - is primarily in the middle catchment.

LUC Class	LUC Units	Percent
2	2e 1, 2s 1	2
3	3e 1, 3e 2, 3e 8, 3w 1	31
4	4e 1, 4e 2, 4e 9	8
6	6e 2, 6s 3, 6e 4, 6e 11, 6w 1	25
7	7e 1, 7e 2	5
8	8e 4, 8w 1	15

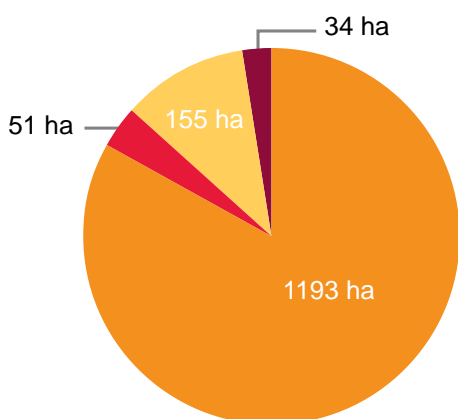
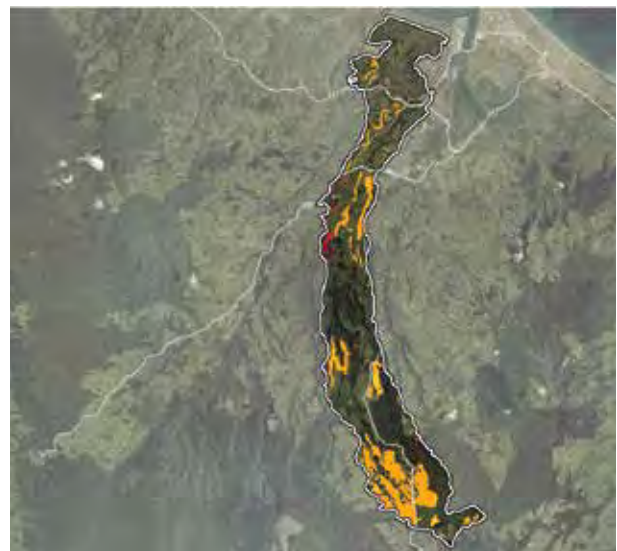
Erosion risk in the Kopurererua sub-catchment

A high proportion of Land Use Capability Class 6 land in the Kopurererua sub-catchment is medium-risk, erosion-prone land due to pastoral land use.

Land Use	Risk	Percent
Pasture	Medium	13
Pasture	High	1
Exotic forest	Medium	2
Exotic forest	High	0.4

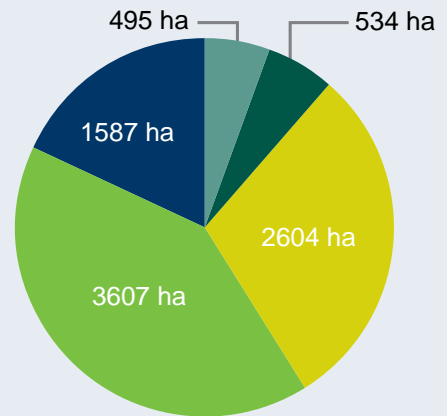
Land cover in the Kopurererua sub-catchment

Vegetation	Percent
Exotic	6
Horticulture	6
Indigenous	29
Pasture	41
Urban	18

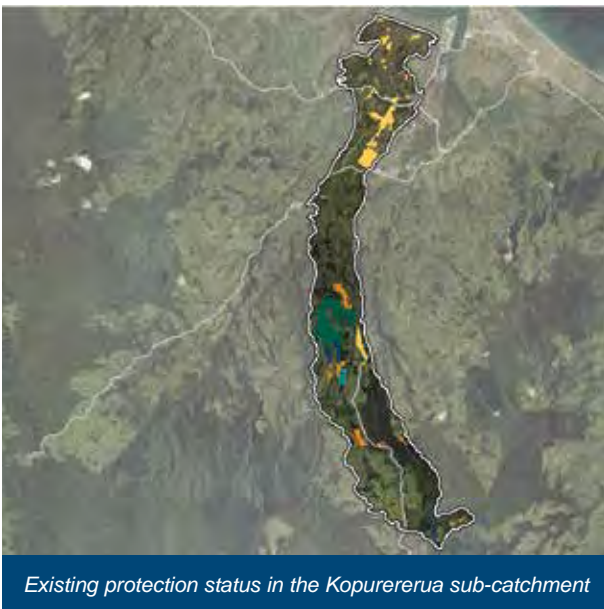
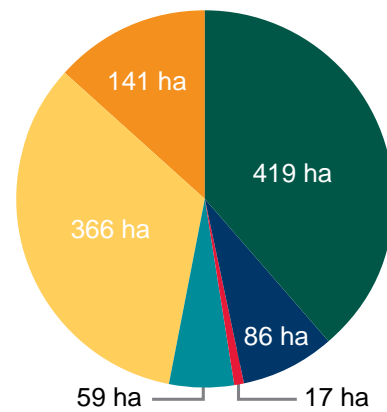
Existing protection status in the Kopurererua sub-catchment

Class	Percent
DOC	5
BOPRC Covenant	1
Māori	0.1
QEII	1
District Reserve	4
WBOPDC Covenant	2
