## Waiau Sub-Catchment Action Plan 2012

The Waiau Sub-Catchment Action Plan is one of a series about the sub-catchments surrounding Tauranga Harbour. This action plan provides an analysis of the current land management issues, a summary of the available physical resources in the Waiau sub-catchment, and planned action for land and resource use of the sub-catchment.

Published October 2012

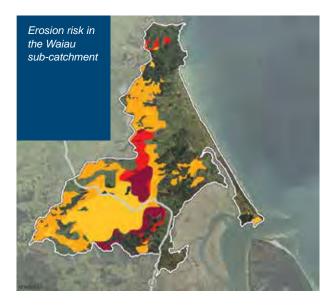
## Erosion risk in the Waiau sub-catchment

A high proportion of Land Use Capability Classes 6 & 7 land in the Waiau sub-catchment is medium to high risk erosion-prone land due to pastoral land use. Forestry located on this class of land has a medium to high risk of erosion during the post-harvest phase.

Land Use	Risk	Percent		
Pasture	Medium	19		
Pasture	High	4		
Exotic forest	Medium	16		
Exotic forest	High	5

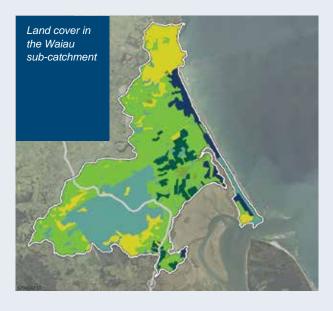
#### Land cover in the Waiau sub-catchment

A large proportion of the sub-catchment land cover is pasture and exotic forest. A significant area of the subcatchments' land cover is indigenous forest land found primarily north of Waihi Beach and south of Mt Hikurangi.
