6e Coast Care in action

Exploring management and action for coastal conservation

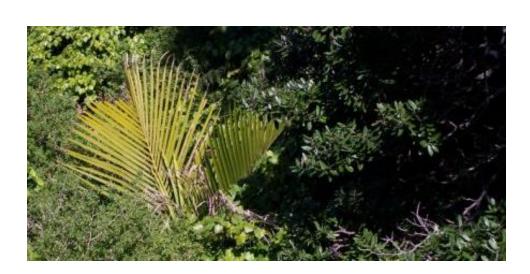
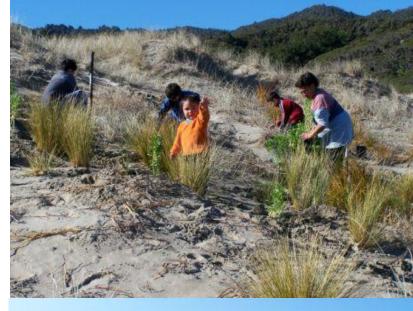
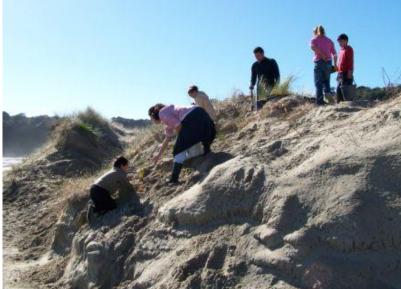
- Right: Oruaiti Coast Care
 Group planting pingao and
 kōwhangatara to repair the
 dunes at Oruaiti.
- Below: A rare sight nikau on the dunes at Oruaiti.

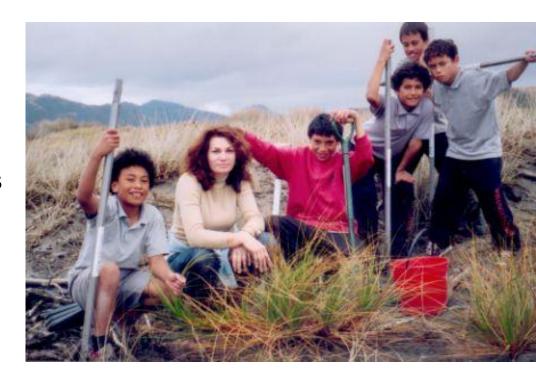
- Heavy crow bars are needed to make planting holes on this hard gravel beach.
- But these "tough" conditions don't worry the plants, as demonstrated by the exceptional growth of the two year old pingao plant in the foreground.

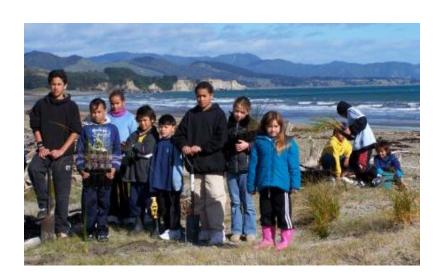
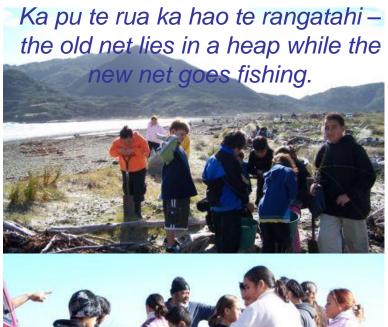
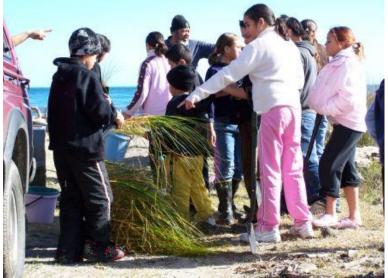
Dune plants are growing well on this shingle beach, even though people thought dune plants wouldn't grow on shingle!
