Values and decision making case study – Pukehina

Case study: The Pukehina story

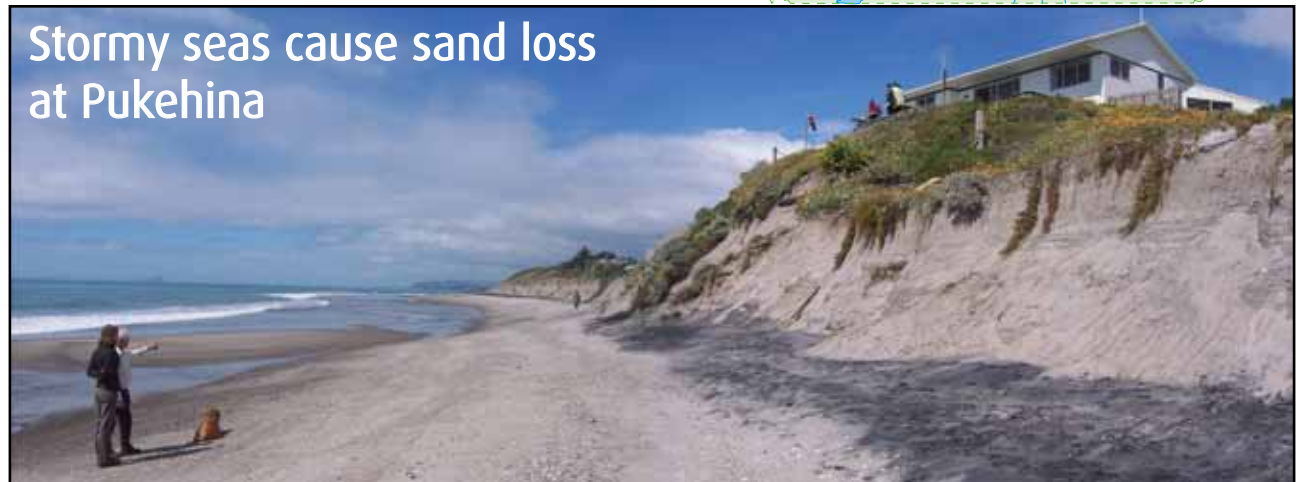
Stormy seas cause sand loss at Pukehina

On 18 September 2005 a combination of low barometric pressure, high King tides and a strong easterly swell caused dune erosion that left many Pukehina beachfront residents very concerned. Some houses have been built too close to the beach at Pukehina and during these heavy seas the unnaturally steep dunes retreated as far back as private property boundaries. Many Pukehina residents remember another similar

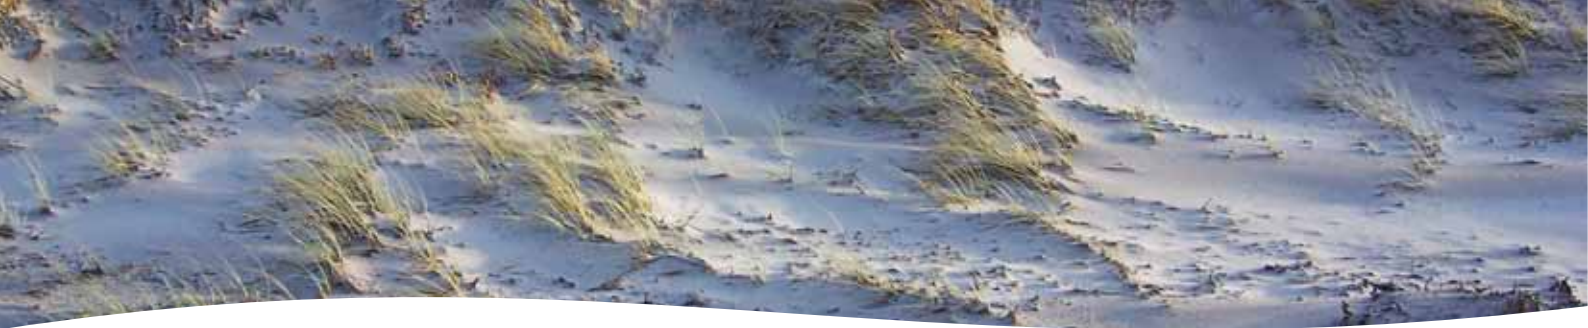
September 2005: 3 weeks after the initial storm damage.

Below - Picture 4: The transformation of dunes in front of housing with the planting of natives.

Before and after Pukehina Beach

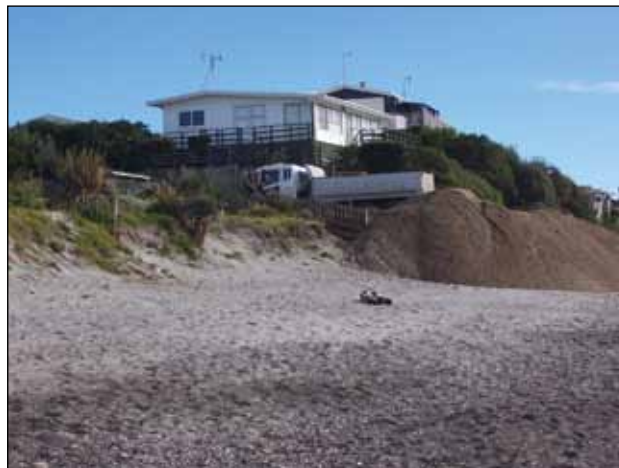
July 2006: Residents paid for sand trucked in from the Pongakawa Canal which was spread in front of their properties.

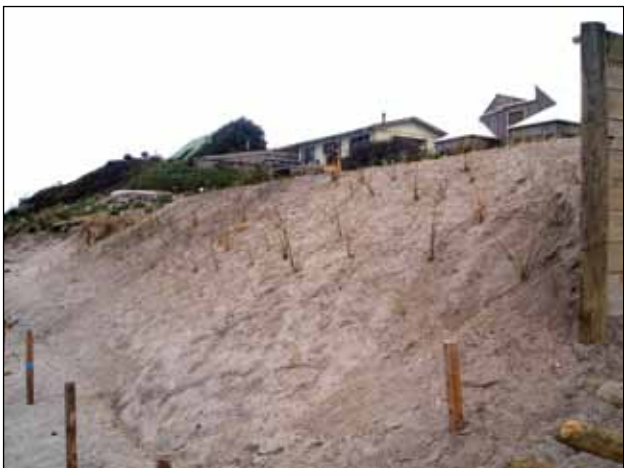
July 2006: Residents fence off the new plantings to keep feet out!

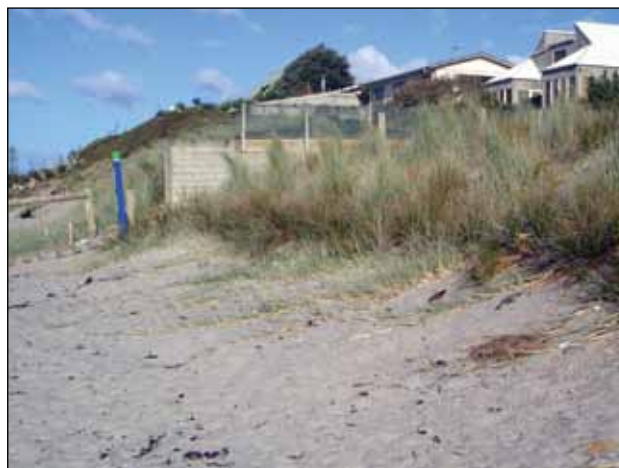
May 2007: New runners are ready to trap the next lot of blown sand and increase the width of the dune!

I guess you could say, to add insult to injury, the dune was then planted up by locals who wanted to have gardens in front of their houses. The plants they put onto the dunes (in their gardens) can't cope with the normal cut and fill (erosion) processes on the coast. (Picture 4 shows what can be done with beach restoration and the replanting of native dune plants).
