## 6j Coastal protection management options

Exploring management and action for coastal conservation

# Ohiwa Coast Care

# Papamoa East Coast Care

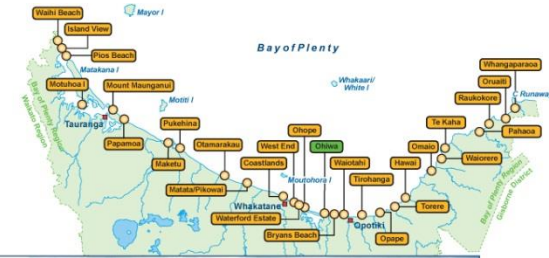
Ohiwa 1976 - Gazetted as 'Stock Reserve' in 1906

Dunes are a dynamic natural system of balance. However the balance was tipped to favour erosion by changing weather patterns, in combination with the almost **total** removal of the native "sand binding" plants.

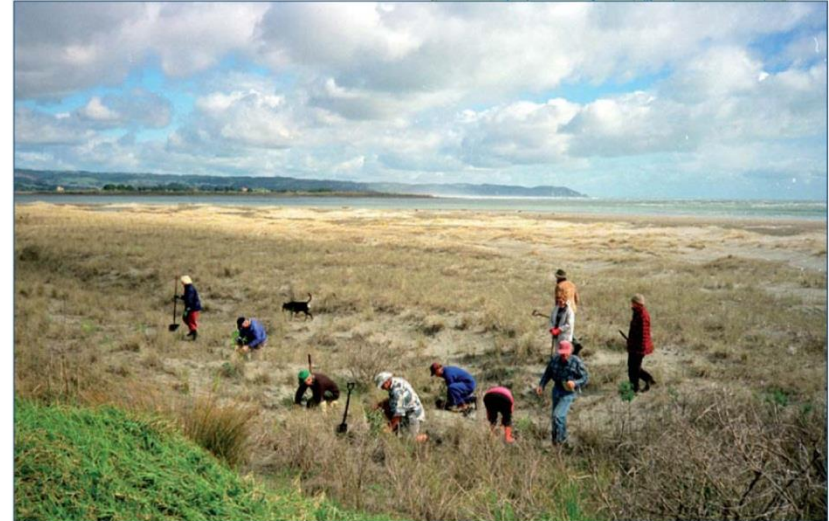
Ohiwa 1996

Wave action returned the sand during calm weather and due to changing weather cycles. This sand was then trapped and stored by native dune plants to rebuild the restored dune system.

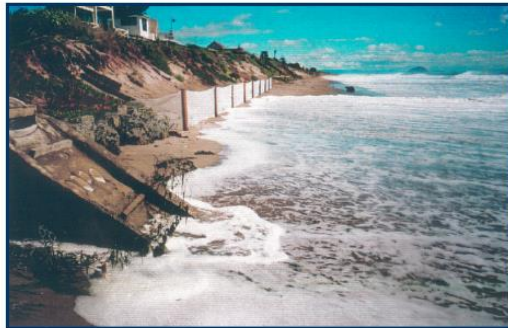
**August 1998.**

Saltwater susceptible plants fall over the edge as sand is removed by storm surge. Concrete and rubble has been dropped on the slope in a vain attempt to stem the erosion.

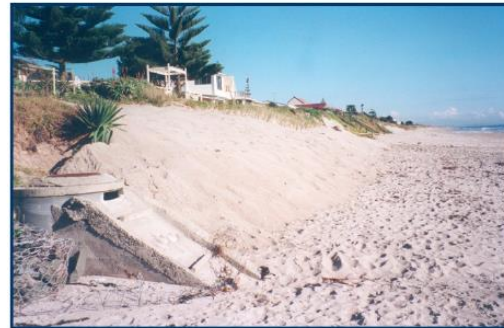
**May 2000.**

During the frequent autumn abundance of sand on beaches, a small quantity was moved up, under strict control by authorities, to reshape the dune front. This sand was planted with spinifex and pingao immediately to stabilise it.

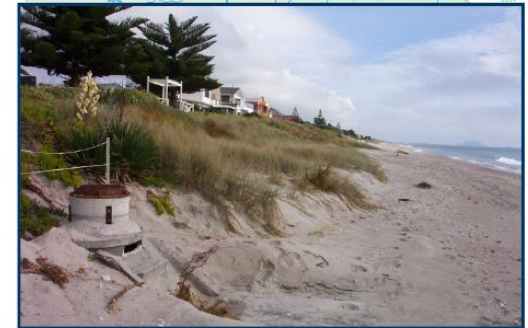
**May 2004.**

Just four years later, the plants are successfully restoring front dune function. This photo was taken after the impact of 10m waves from Cyclone Ivy. Note the buildup of sand relative to the storm water drain.

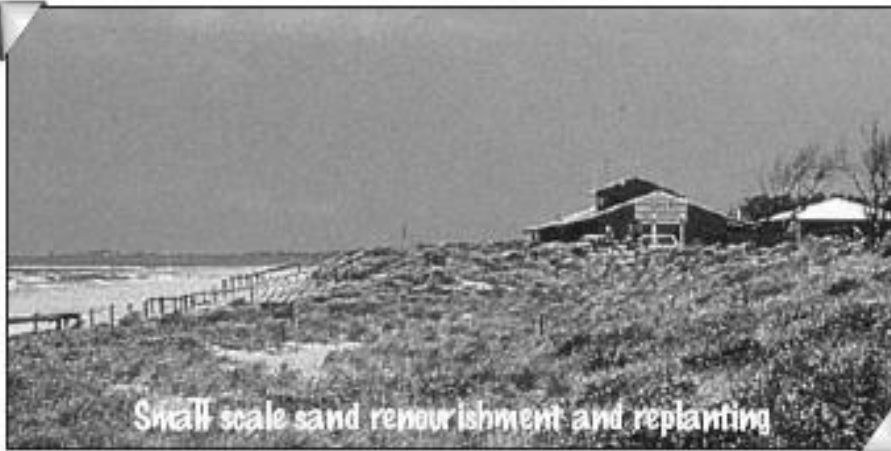
**1994**

Small scale sand nourishment and replanting

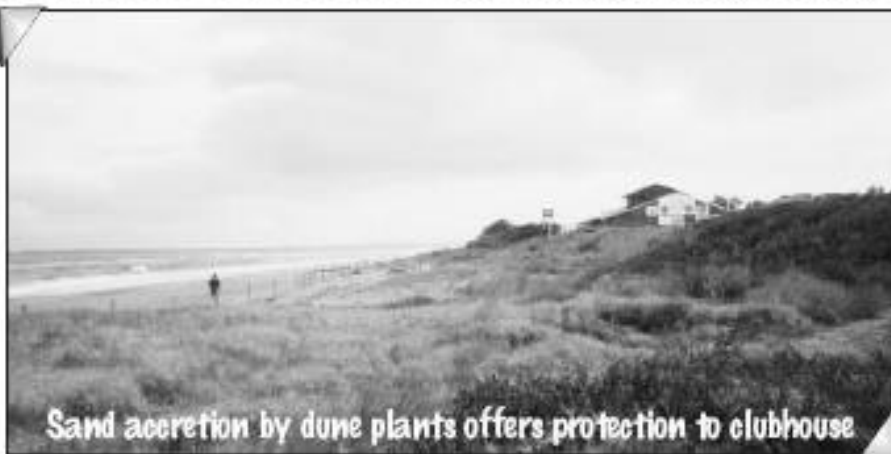
**1998**

Sand accretion by dune plants offers protection to clubhouse

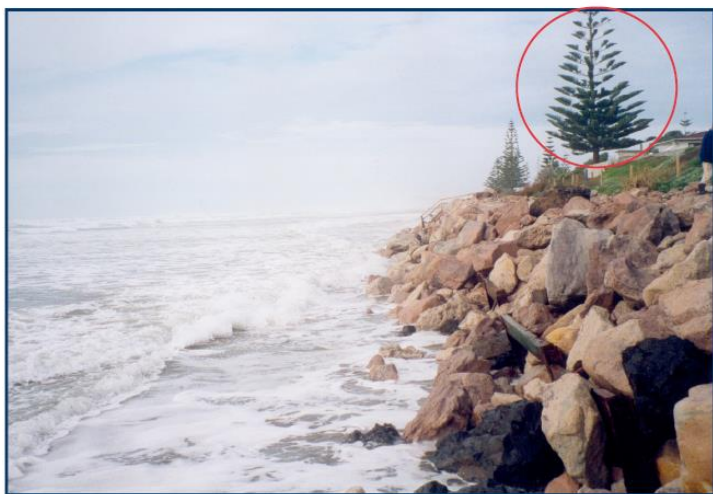
## Waves Smashing Into Rocks At The Loop

Turbulence resulting from wave impact has stripped sand off the beach, lowered the level of the beach, which allows waves to reach close to the houses. This situation can not improve unless functional dunes are re-established.

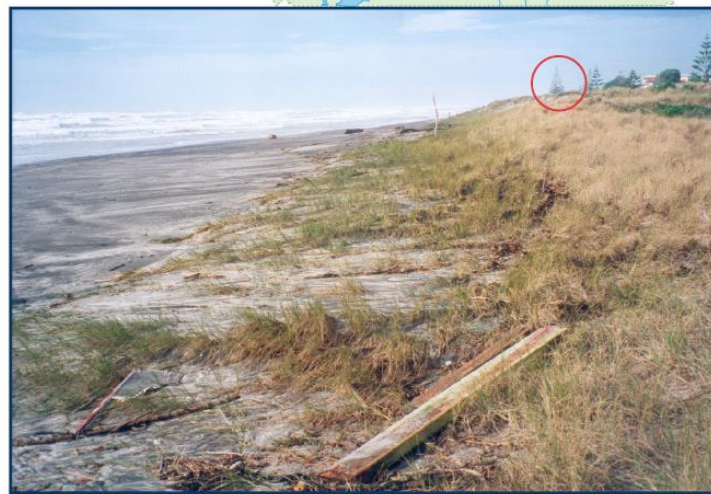
## Affected But Secure Foredune

Native dune plants have resisted wave attack and minimised erosion. Note how wide the beach is at exactly the same tide time as Photo 1. Natural dune function is providing a stable and safe beach that is self-sustaining.

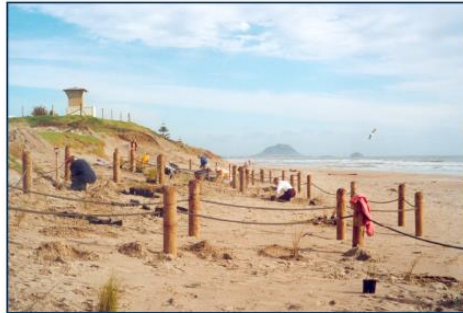
**August 2000**  
Coast Care BOP members designed, installed and planted leaf shaped plots to create multiple access points, blocking access on occasion.

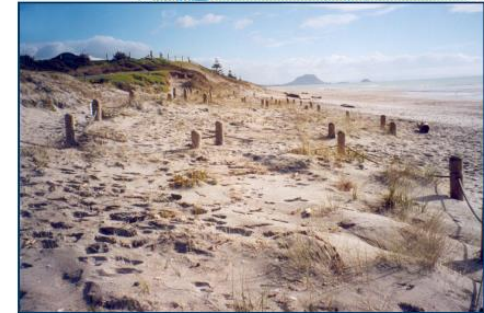
**June 2002**  
The "weather bomb" struck and the spinifex and pingao trapped vast quantities of sand. The bollards and ropes had to be raised to renew effectiveness.

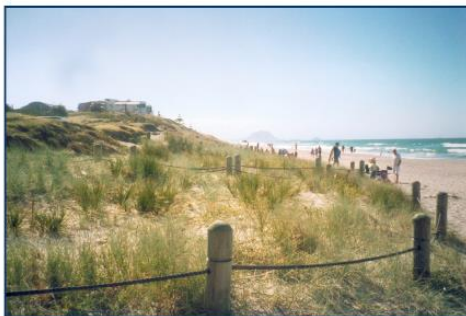
**31 December 2002**  
Just six months later, the plants have emerged completely, ready to trap more sand in the next storm event.

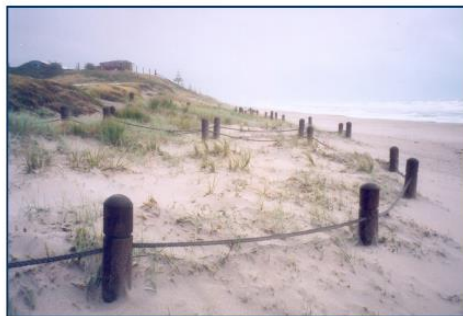
**9 January 2003**  
Nine days later it happened again.

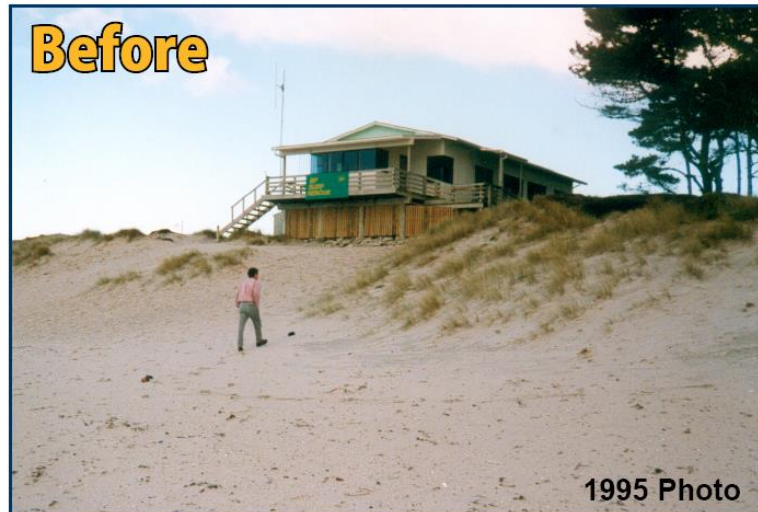
Wind erosion was threatening the stability of the Papamoa Surf Rescue Base (see the broken concrete at the front of the building, placed to reduce wind erosion of the foundations).

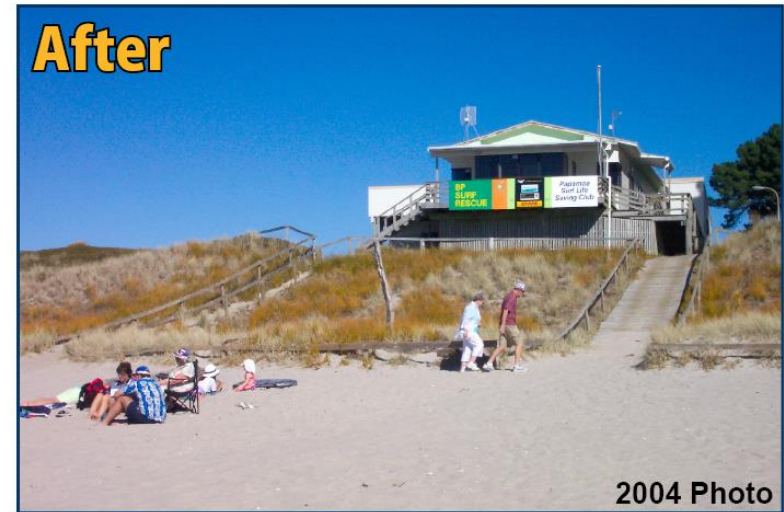
Planting native species and subsequent natural dune rebuilding have increased the stability of this important building, and created a wider beach for people to enjoy.

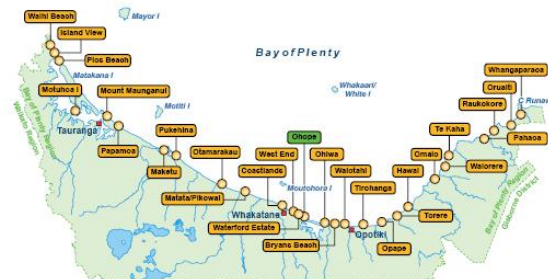
### Dune Front

A storm water drain (by peg in middle of photo) was lowering beach level, which promoted wave attack on the dune front slope.

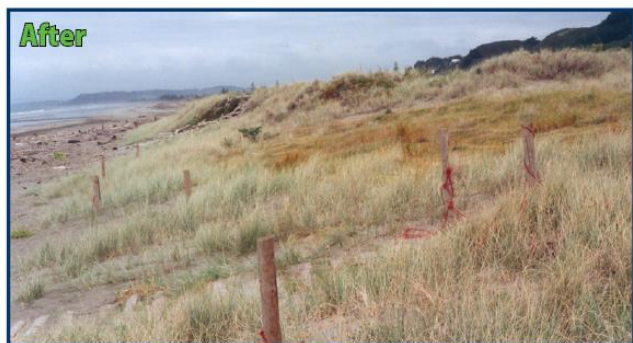
Whakatane District Council removed the storm water drain and formed a drainage swale behind the dune. Excess sand from the swale was used to fill in the embayment. Ohope Coast Care members planted the sand with functional dune plants.

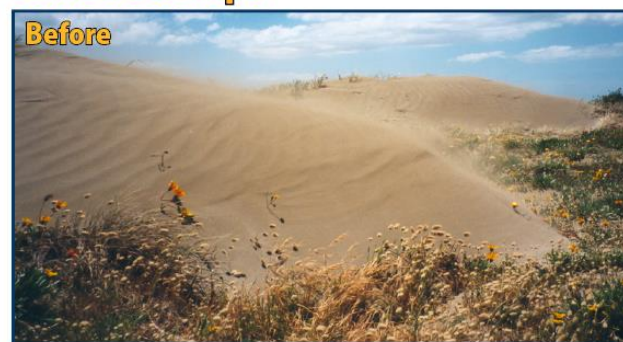
The eroded front slope encouraged wind erosion of sand over the crest, to be deposited on the backslope. This untethered sand was smothering daisies and weeds, and blowing towards the road and houses.

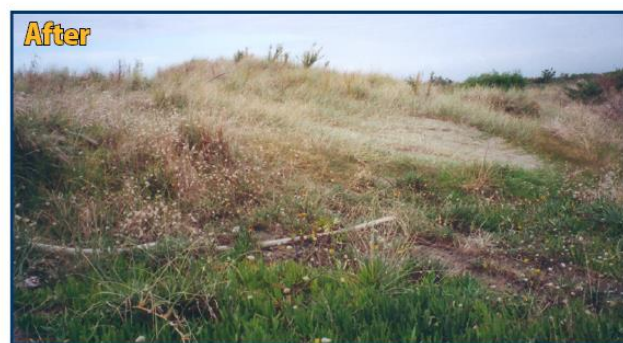
The wind deposited sand was also planted with functional dune plants by Ohope Coast Care, to result in a functional and stable dune.
