Beach management case study – Ōhiwa

Case study: Ōhiwa Beach

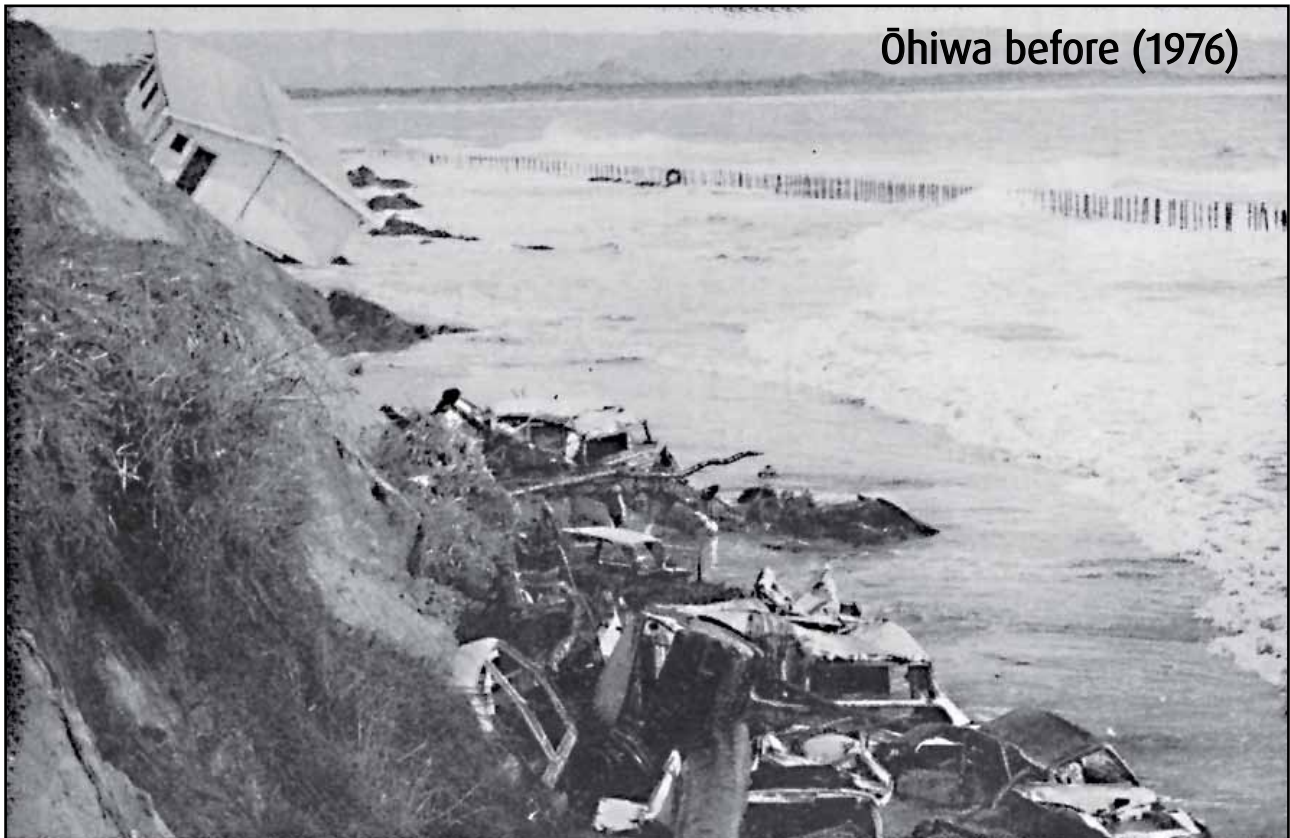
Ōhiwa before (1976)

NOTE: This dune area was gazetted as a stock reserve in 1906 and grazed heavily. Some areas have been used as hay paddocks. The area was infested with lupins for some years before this erosion episode occurred.

The accompanying photo (Ref. Soil and Water Magazine December 1976) of Ōhiwa Spit looking westward was taken in April 1976, and clearly illustrates the disastrous effects of the severe coastal erosion taking place at the spit.

"In an effort to curb the erosion, the Poverty Bay Catchment Board put in rail and brush protection in the summer of 1970, two metres seaward of what were then the sand dunes. As the photograph shows, this protection was completely unsuccessful. The erosion, a combination of tidal and wave action, outflanked the protection and the dunes have since been destroyed.

The house is one of the two that fell down the cliffs because of the combination of high spring tides and strong on-shore wind in Easter of 1976.

Car bodies were thrown over the cliffs in a further attempt to halt what is basically a natural erosive process". This method of 'protectant' is described by Mr Jeremy Gibb, geologist with the Ministry of Works and Development's water and soil division, as being "completely ineffective", because the cars simply sink down into the sand.

Ōhiwa Spit is eroding at a rate of approximately eight metres a year – this is a very high rate of erosion by NZ standards. Mr Gibb estimates that the short life expectancy of the spit is probably only between 40 and 70 years.

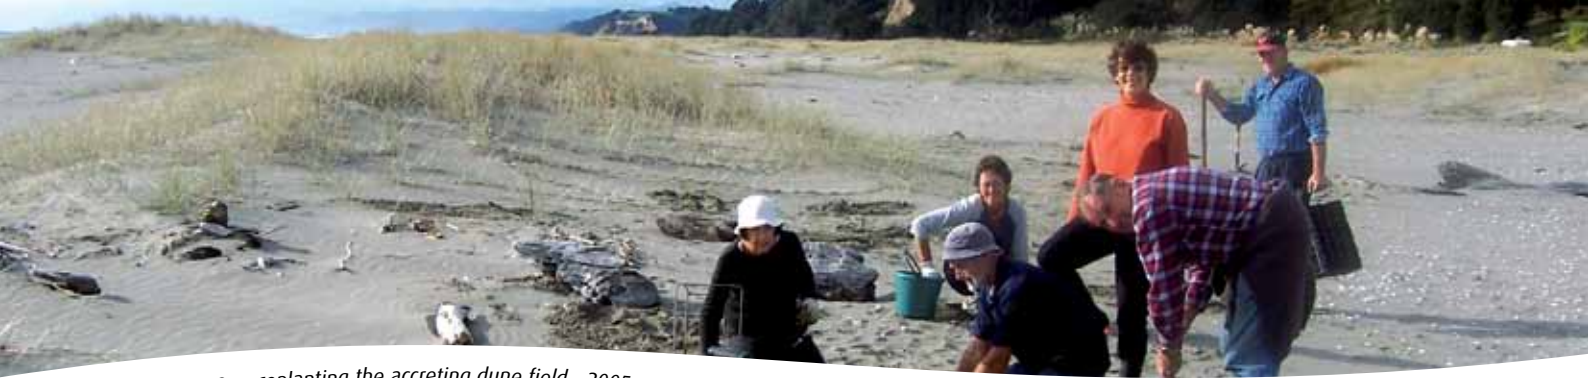
Ōhiwa Beach Coast Care replanting the accreting dune field - 2005.

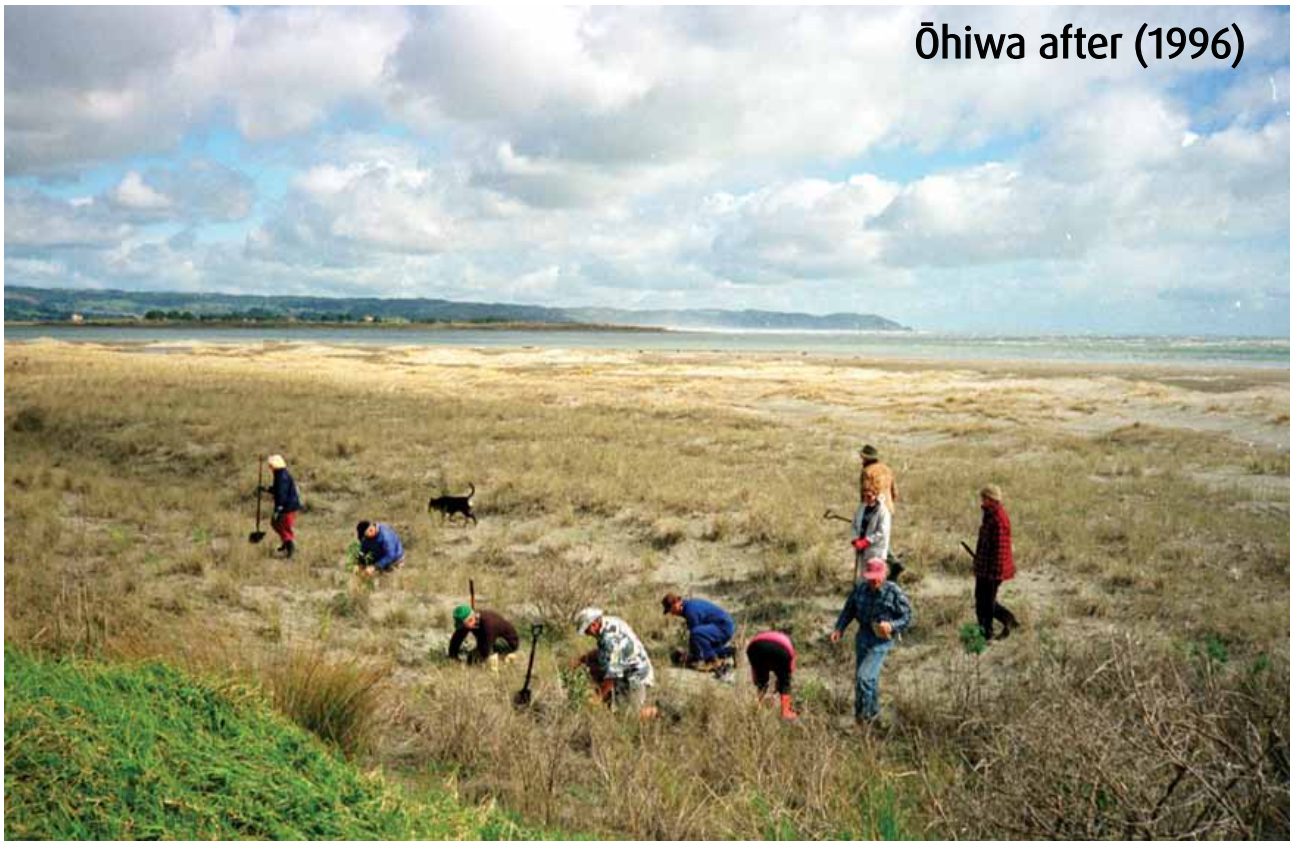
Ōhiwa after (1996)

After the 1976 erosion phase, sand returned to this beach (during the normal "Fill" sequence of the "Cut & Fill" cycle). It was trapped by native spinifex. The cars and trucks pictured in the 1976 photo still lie beneath the people planting above. Grazing stopped in 1988 and dune restoration began. This dune and beach system was over 235m wide (2012), helped by the good restoration work of the local Coast Care group pictured in the top photo.
