Papamoa East Coast Care

- Motiti Road, the Storm Water Drain
- Dune Reshaping Trial

Solving Problems by Restoring Dunes Motiti Road, Papamoa East

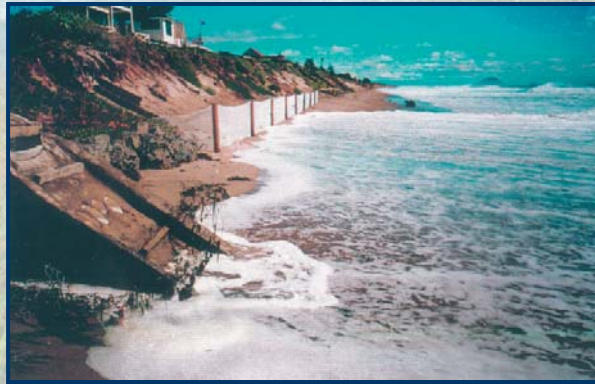
August 1998.
Salt-tolerant garden plants fall over the edge as sand is removed by storm surge. Concrete and rubble has been dropped on the slope in a vain attempt to stem the erosion.

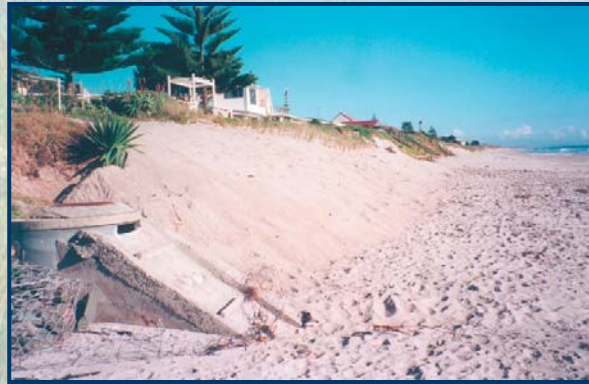
May 2000.
During the frequent autumn abundance of sand on beaches, a small quantity was moved up, under strict control by authorities, to reshape the dune front. This sand was planted with spinifex and pingao immediately to stabilise it.

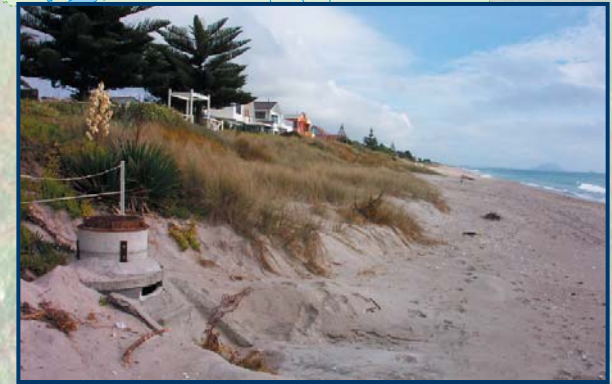
May 2004.
Just four years later, the plants are successfully restoring front dune function. This photo was taken after the impact of 10m waves from Cyclone Ivy. Note the buildup of sand relative to the storm water drain.

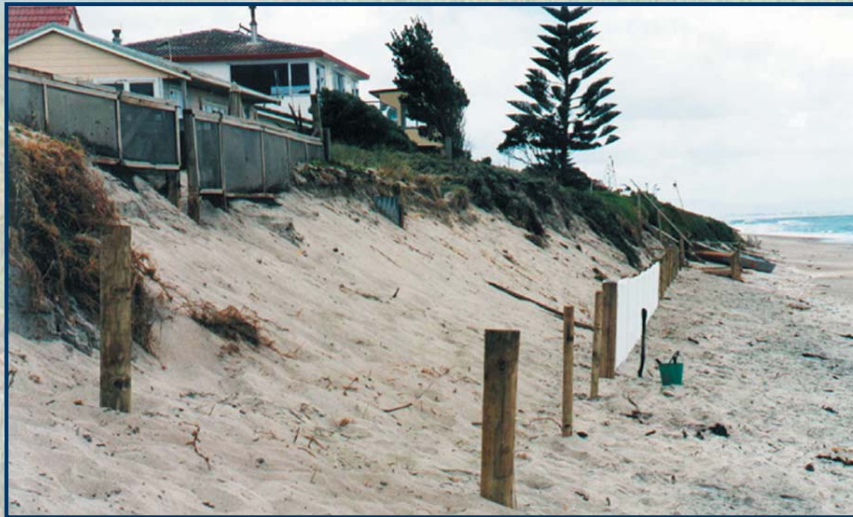
June 1997

Dune front erosion had been problematic for decades. In 1978 the BOP Catchment Commission advised residents there were no simple or cheap answers to address their erosion concerns at Papamoa East.

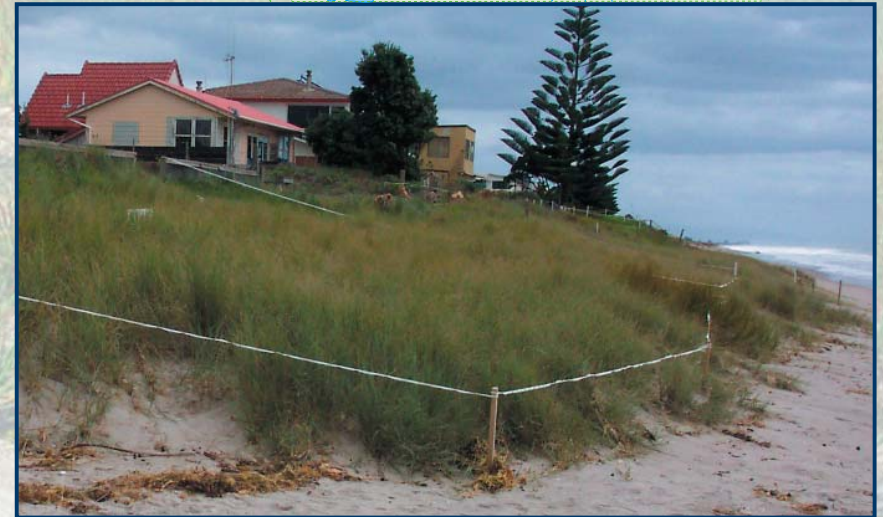
March 2004

Inexpensive planting of native dune species has re-created an accreting front dune, by Papamoa Coast Care helping to solve the erosion problems. This photo was taken the day after the impact of 10m waves from Cyclone Ivy.
