# Dune management in Ohope Maraetotara Reserve

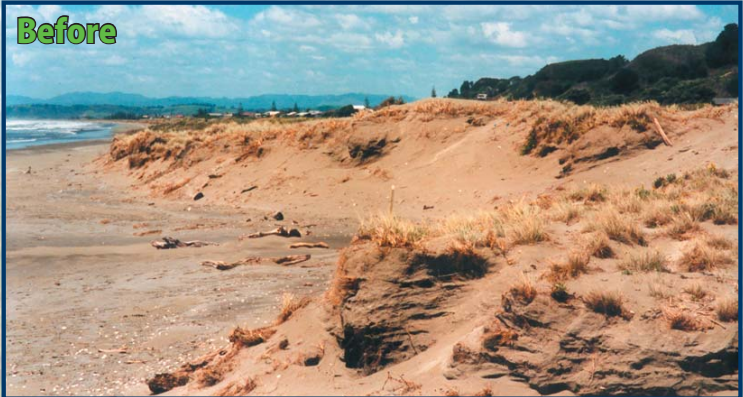
**Before**  
A storm water drain (by peg in middle of photo) was lowering beach level, which promoted wave attack on the dune front slope.

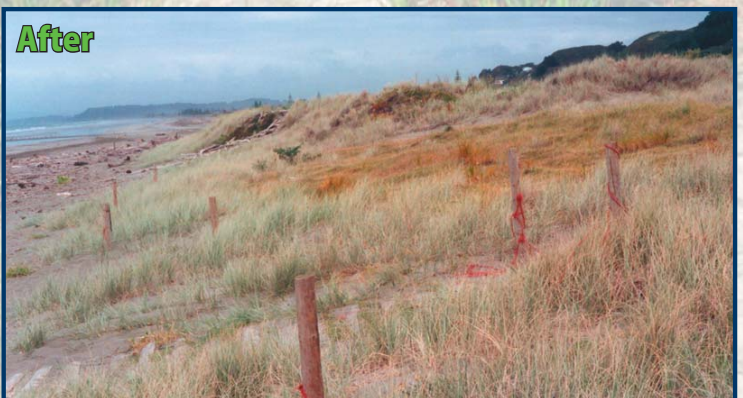
**After**  
Whakatane District Council removed the storm water drain and formed a drainage swale behind the dune. Excess sand from the swale was used to fill in the embayment. Ohope Coast Care members planted the sand with functional dune plants.

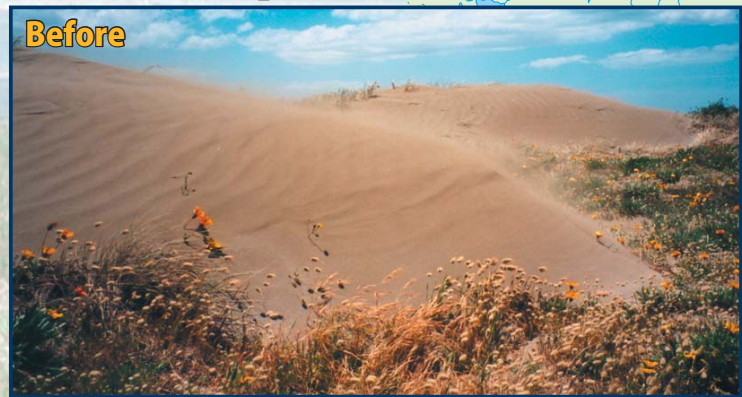
**Before**  
The eroded front slope encouraged wind erosion of sand over the crest, to be deposited on the backslope. This untethered sand was smothering daisies and weeds, and blowing towards the road and houses.

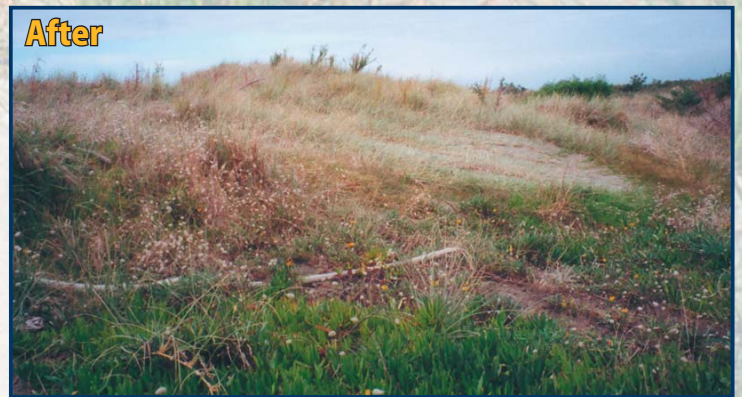
**After**  
The wind deposited sand was also planted with functional dune plants by Ohope Coast Care, to result in a functional and stable dune.
