Papamoa Domain Coastal Protection

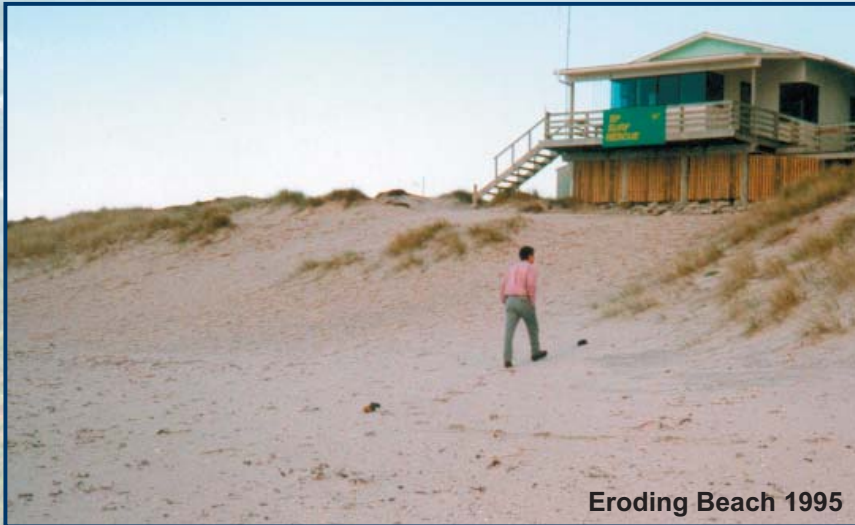
Eroding Beach 1995

Planting of native dune species in 1995 and 1996, and redirecting casual pedestrians has reversed earlier, ongoing erosion problems. Sand supplied by natural processes is being accumulated by the colonising dune plants (i.e. spinifex & pingao), burying fences, dramatically improving the dune buffer, and beach width.

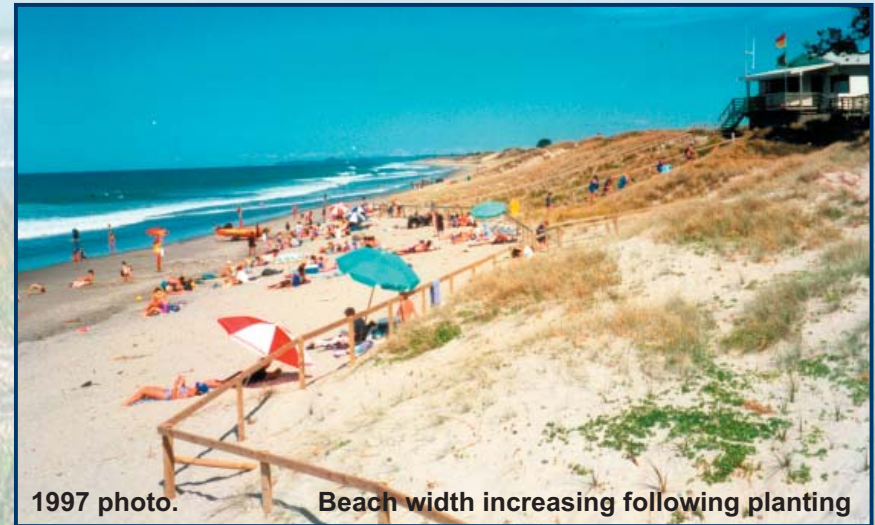
1997 photo. Beach width increasing following planting

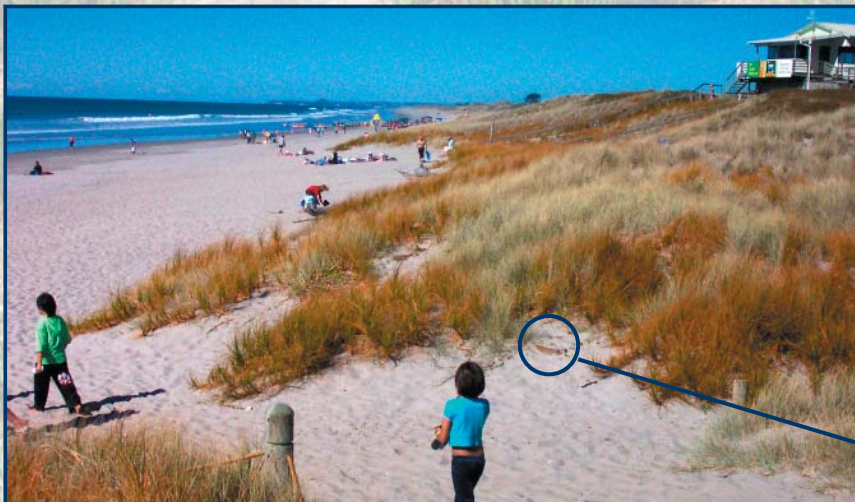
Remnant of fence rail. The rest of the fence has been buried by accumulated sand.
