NERMN Estuarine Water Quality

Prepared by John McIntosh, Manager Environmental Investigations

Environment Bay of Plenty
Environmental Publication 2003/09
June 2003

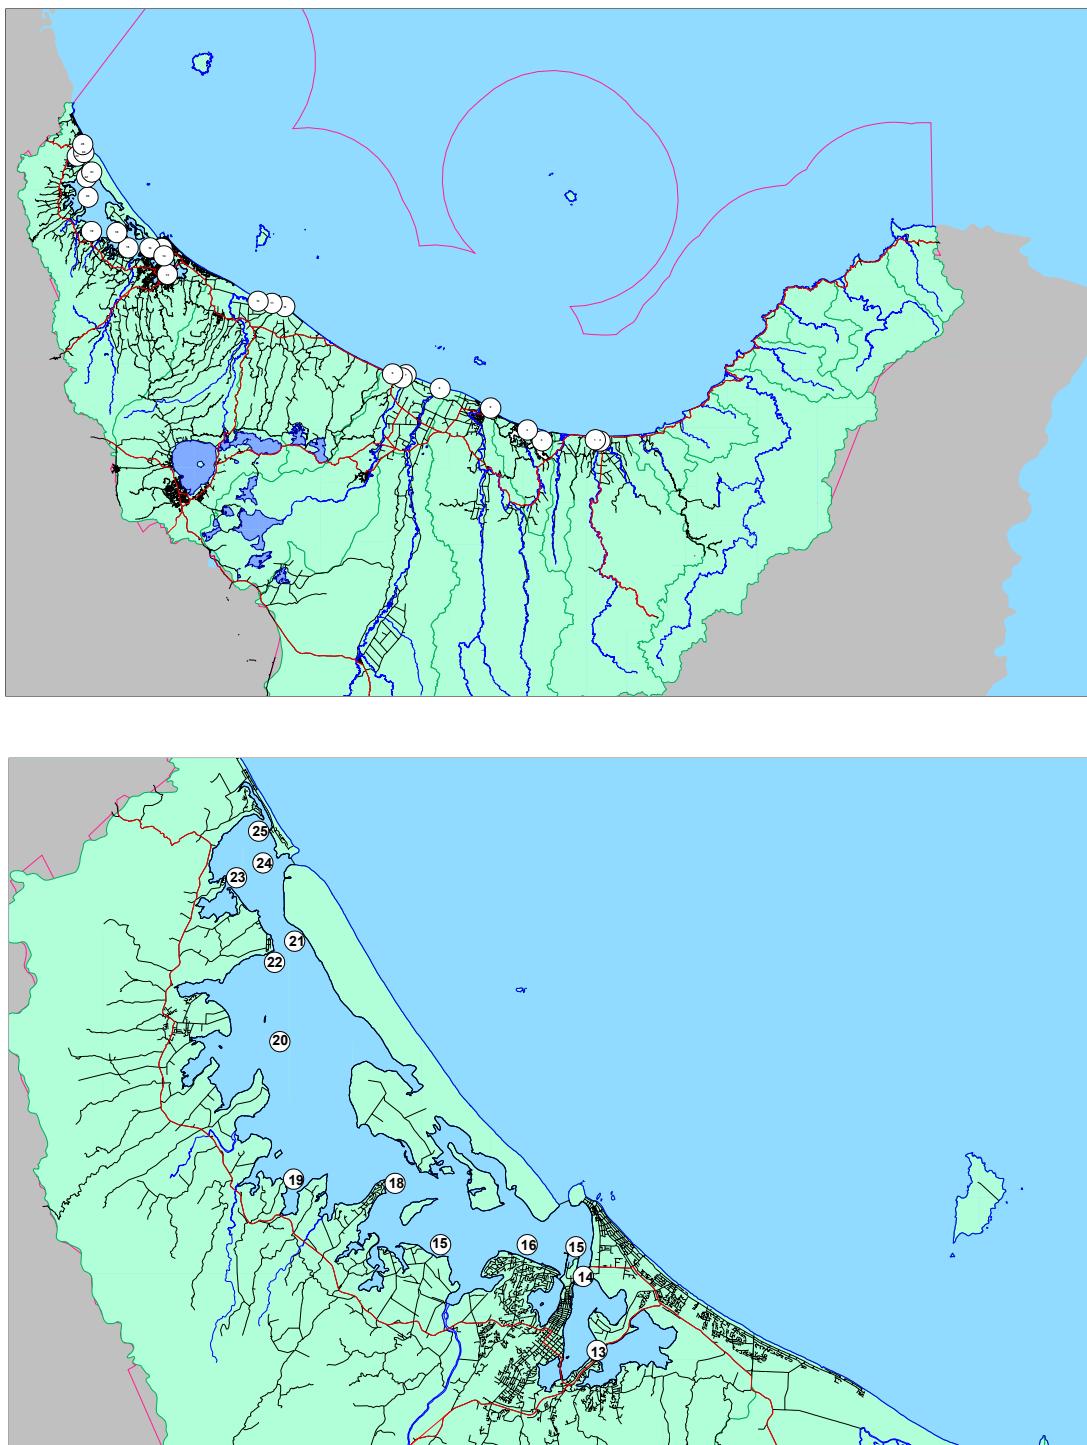
Figure 1 General location map (Upper) and Tauranga Harbour locational map (Lower).

The sites are sampled every two months over the high tide period. The sites reported here are listed in Table 1. LABSTAR is the laboratory database which contains all the analytical data. The site number refers to the locational details on the following figures in this report.

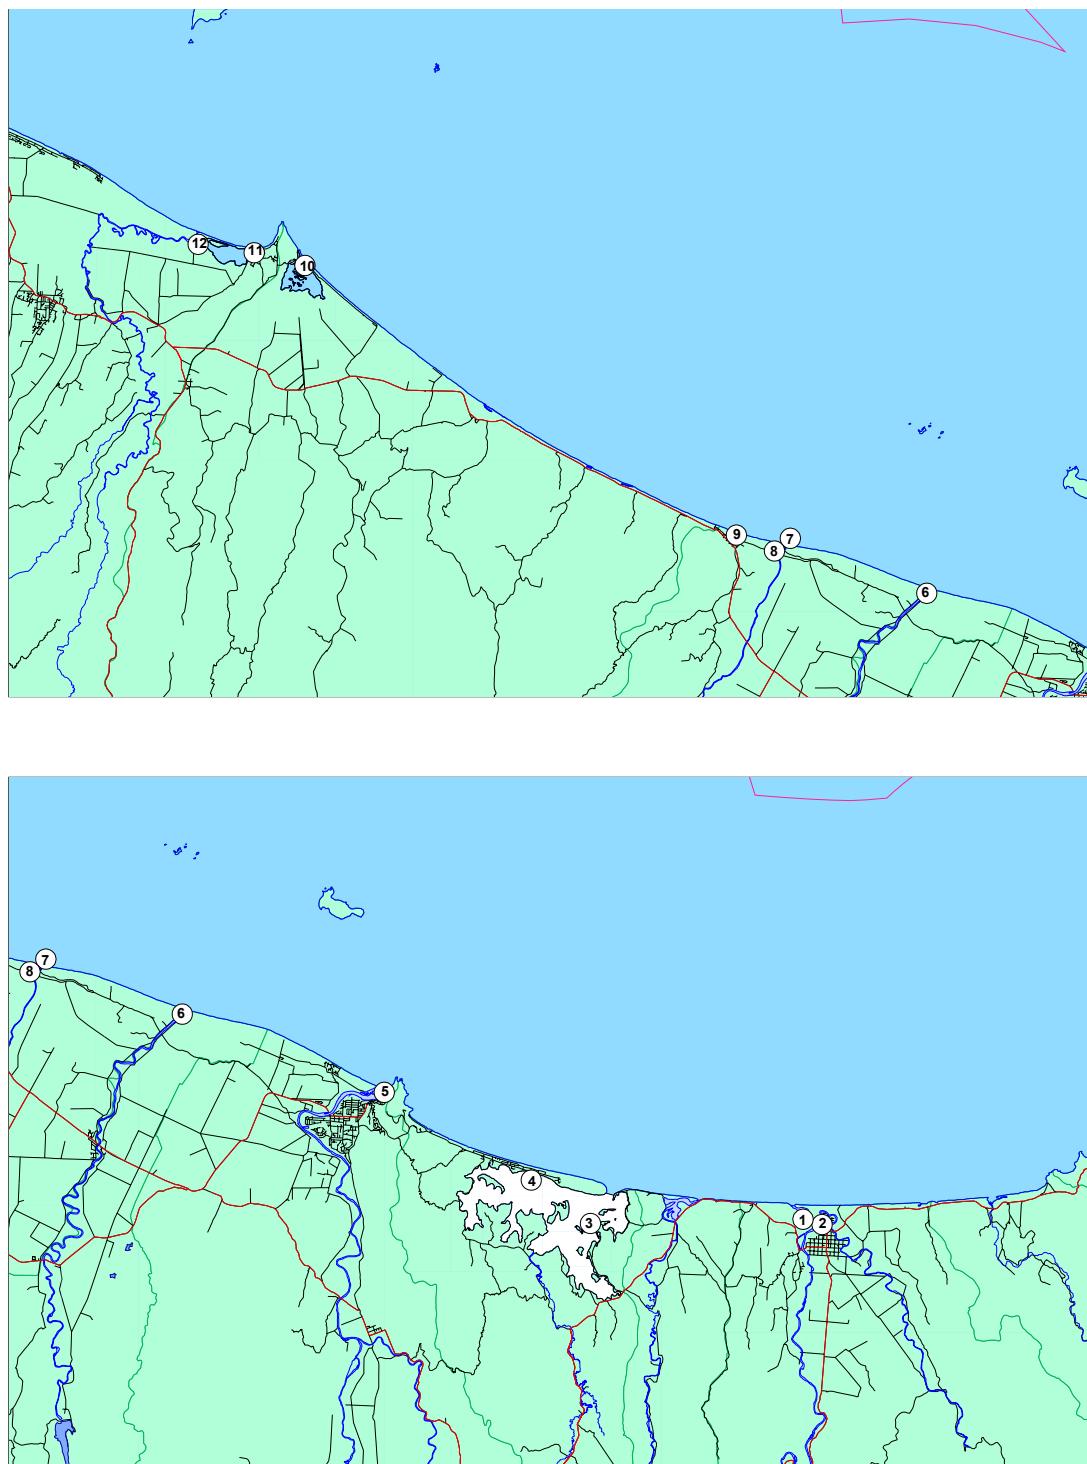
Figure 2 *Location map from the Kaituna River to the Rangitaiki River (Upper) and from Whakatane to Opotiki (Lower).*

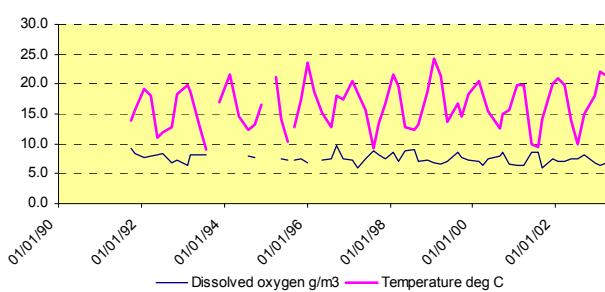
Maungatapu Bridge, Tauranga Harbour

The Tauranga Harbour sites are predominantly saline. At Maungatapu Bridge the data shows the influence of dilution with fresh water. This dilution would include the Waimapu Stream pushed up the Maungatapu channel by the incoming tide as well as the freshwater inputs from the Welcome Bay inflows. The Pahoia site also demonstrates the freshwater influence of the Wainui River.

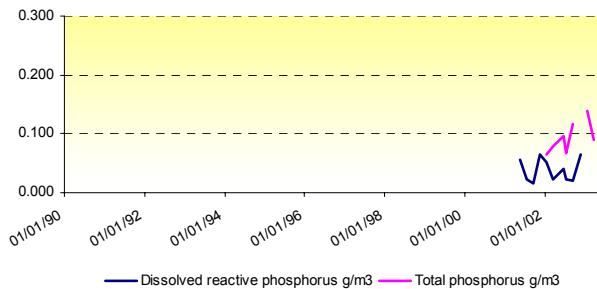
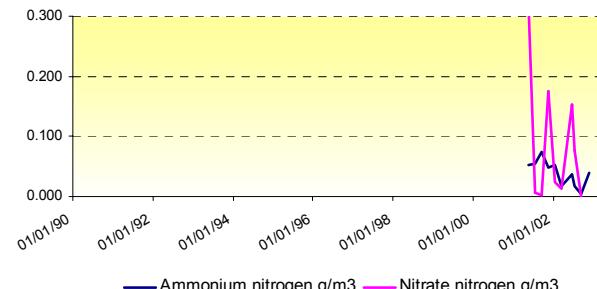
Matata Lagoon, control structure

Matata Lagoon has the highest nutrient levels reflecting its freshwater status and the low flushing rate.

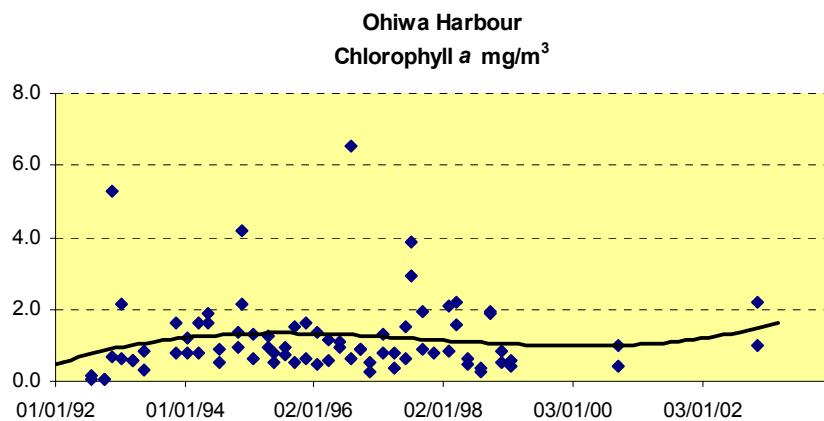
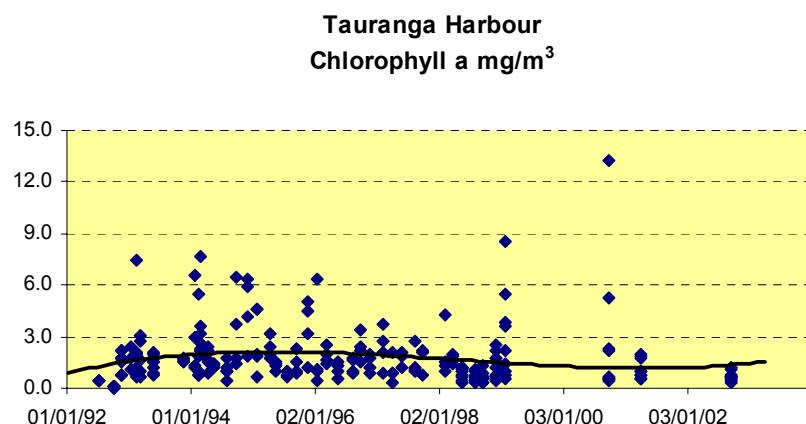
Chlorophyll a data has been plotted for all the sites in each of Ohiwa Harbour and Tauranga Harbour, to examine for any trends in harbour productivity. No trend is apparent but Tauranga Harbour demonstrates a slightly higher chlorophyll a level and higher individual spikes at certain locations. Median chlorophyll a for Tauranga Harbour is 1.3 mg/m³ and for Ohiwa Harbour 0.9 mg/m³.
