**The ecological condition of the Rotorua
Lakes using LakeSPI**

**NIWA Client Report: HAM2008-149
September 2008**

NIWA Project: BOP07208

Prepared for

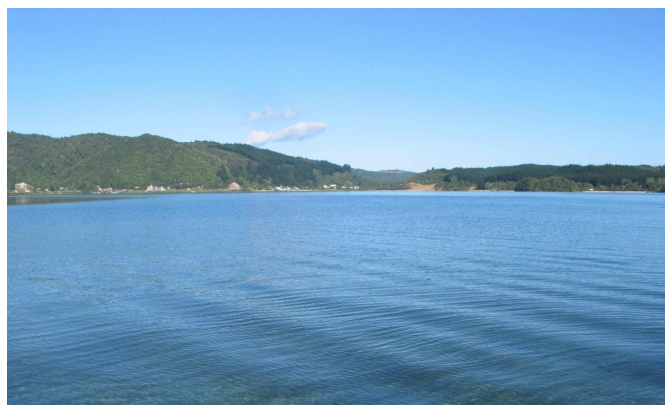
Table 4: LakeSPI results for Lake Rotoma. LakeSPI Indices expressed as a percentage of lake maximum potential.

State	Year	LakeSPI Index (%)	Native Condition Index (%)	Invasive Condition Index (%)
Pristine		94	90	0
	1973	69	63	19
	1988	54	57	41
Historical data	2001	52	54	44
	2005	52	58	51
Present day	2008	48	53	54

In 1973 Lake Rotoma had a high LakeSPI score, which reflected the early stage of *Lagarosiphon* invasion and the extensive high cover charophyte meadows in this lake. By 1988 the Invasive Condition Index had more than doubled, which in turn reduced both the Native Condition Index and LakeSPI score for this lake. The following 20 years from 1988 to 2008 have shown a more gradual increase in the Invasive Condition Index, but with minimal change to the Native Condition Index or LakeSPI score. This lake presently has the second highest Native Condition Index after Lake Rotomahana and one of the lowest Invasive Condition Index scores for any of the lakes, which contributes to its high LakeSPI ranking.

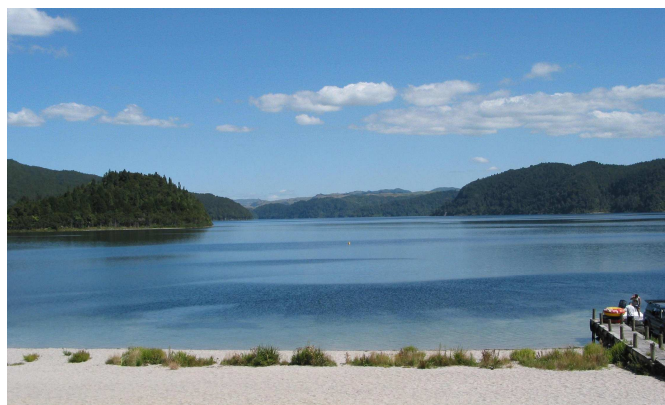
Table 5: LakeSPI results for Lake Okataina. LakeSPI Indices expressed as a percentage of lake maximum potential.

State	Year	LakeSPI Index (%)	Native Condition Index (%)	Invasive Condition Index (%)
Pristine		94	90	0
	1981	51	57	53
Historical data	1988	47	53	57
	2005	44	51	65
Present day	2008	48	54	58

LakeSPI scores for Lake Okataina have been reasonably stable with only minor fluctuations in LakeSPI condition over the last 27 years from 1981 to 2008. Care must be taken in interpreting these results since Lake Okataina has no outlet, and water levels can vary by several metres. Although lake level changes tend to be quite slow, they can still affect the available habitat for submerged vegetation in shallow water and the corresponding adjustments in the maximum depth of charophyte colonisation may respond more slowly.

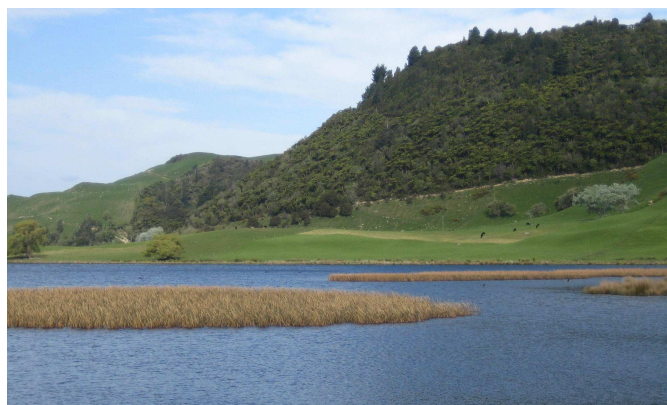
State	Year	LakeSPI Index (%)	Native Condition Index (%)	Invasive Condition Index (%)
Pristine		94	90	0
	1980	40	49	67
Historical data	1988	44	53	66
	2001	41	50	70
	2003	34	42	77
Present day	2006	34	39	76

Lake Okareka has recorded a 10% decrease in the LakeSPI Index over the last 18 years, from 1988 to 2006, resulting from a decline in the quality of native plant communities present, indicated by the Native Condition Index, and an increase in the Invasive Condition Index over the same time frame.

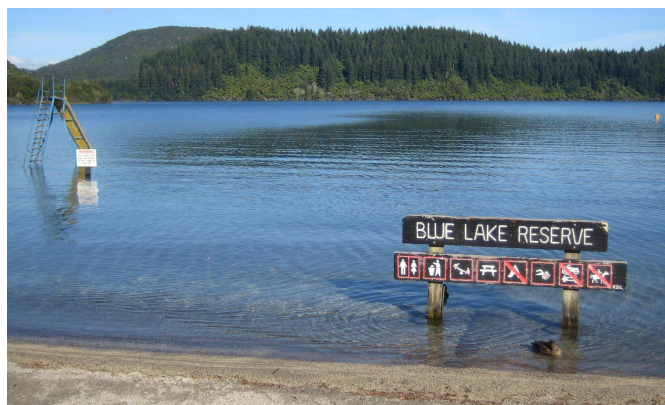
State	Year	LakeSPI Index (%)	Native Condition Index (%)	Invasive Condition Index (%)
Pristine		94	90	0
	1970	70	77	33
Historical data	1988	63	75	47
	2005	46	45	50
Present day	2008	32	28	63

The LakeSPI Index shows a reduction of 31% over the last 20 years indicating that the condition of Lake Tikitapu has deteriorated faster than any of the 12 Rotorua Lakes over this same period from 1988 to 2008. Unlike the other lakes this decline is not due to the impact from new invasive species but from a significant decline in the quality and extent of native plant communities present. The mean maximum depth of native plant growth at LakeSPI survey sites has declined from 12.4m in 2005 to only 8.8m resulting in a 47% decline in the ‘Native Condition Index’ over the last 3 years. This notable reduction in native condition is most likely related to water quality, in particular water clarity near the maximum depth limit of vegetation growth. The presence of a sustained turbid water layer with high chlorophyll *a* levels has been reported above the thermocline (David Hamilton, Waikato University, pers comm.). The increase in Invasive Condition scores over this same time frame has occurred not on account of any new invasive plant introductions but due to the existing invasive vegetation now having a greater relative impact on overall vegetation status.

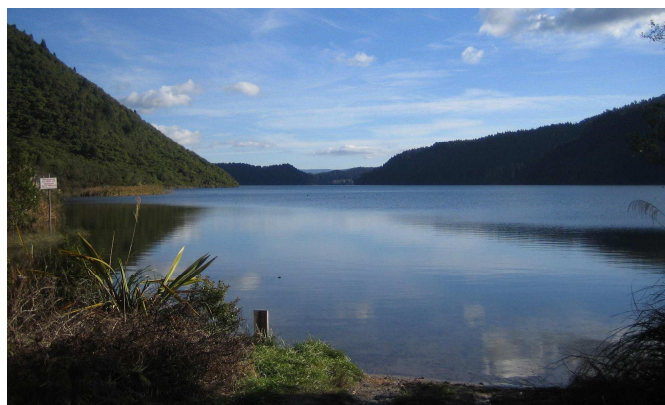
Table 9: LakeSPI results for Lake Rotokakahi. LakeSPI Indices expressed as a percentage of lake maximum potential.

State	Year	LakeSPI Index (%)	Native Condition Index (%)	Invasive Condition Index (%)
Pristine		94	90	0
Historical data	1988	52	61	53
	2005	35	36	71
Present day	2008	31	32	71

Lake Rotokakahi has undergone the second largest decline behind Lake Tikitapu shown for any of the 12 lakes over the same 20 year time period. The LakeSPI Index has decreased by 21% from 1988 to 2008, while the Native Condition Index has almost halved with a 29% reduction largely due to a decline in charophyte meadows. This has occurred even though there has been no change in the dominant invasive species in this lake *Elodea canadensis*, although the relative impact of invasive presence on overall submerged vegetation has increased. The declining condition of Lake Rotokakahi, like Tikitapu, is not due to invasive weeds but rather a decline in native condition presumably due to a reduction in water quality. Additional observations support this in Rotokakahi, with filamentous algae prevalent on submerged vegetation and blue-green algal mats often covering sediments beyond the maximum depth of plant growth. These are good indicators of poor lake health. Nutrient inputs are likely to be entering this lake from the predominantly farmland catchment as well as from sediment nutrient release during summer stratification. Recent logging in the catchment appears to have further increased lake turbidity since the last LakeSPI 2008 survey. A decline in oxygen content in deeper water has been

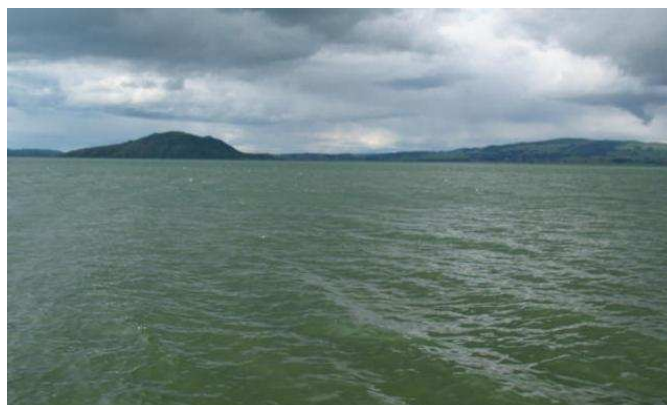
Table 11: LakeSPI results for Lake Rotorua. LakeSPI Indices expressed as a percentage of lake maximum potential.

State	Year	LakeSPI Index (%)	Native Condition Index (%)	Invasive Condition Index (%)
Pristine		94	90	0
	1982	27	23	68
Historical data	1988	18	21	90
	2001	22	17	74
	2003	22	21	77
Present day	2006	22	21	78

Lake Rotorua has a low LakeSPI Index placing it in the bottom group of 5 lakes categorised as being in ‘poor’ condition. The LakeSPI scores and Native Condition Index have not changed much over the 24 years from 1982 to 2006. The variable Invasive Condition Index over this same period was attributable to the ‘boom & bust’ of *Egeria*, which was first recorded in this lake in July 1983 and by 1988 had established weed beds around most of the lake resulting in a peak Invasive Condition Index of 90%. In 1988 it was estimated that *Egeria* comprised more than 80% of the vegetation in the lake with an area of 440 ha. In the early 1990s *Egeria* underwent a major decline and has never recovered, which is reflected in the Invasive Condition Index from 2001 declining from the 1988 peak.

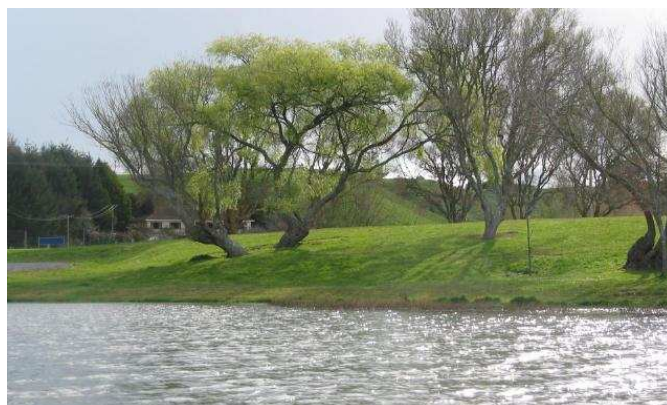
Table 12: LakeSPI results for Lake Okaro. LakeSPI Indices expressed as a percentage of lake maximum potential.

State	Year	LakeSPI Index (%)	Native Condition Index (%)	Invasive Condition Index (%)
Pristine		94	89	0
Historical data	1982	31	29	67
	2003	19	6	76
Present day	2006	19	6	52

Elodea is the only invasive species reported in this lake. It is possible other invasive species have been introduced but were not able to establish or thrive. The hypereutrophic nature of this lake presents an unfavourable habitat for submerged vegetation. This is reflected in the highly variable cover and depth range of *Elodea*, both seasonally and annually. It is also likely to explain root lyses (root death and detachment) in *Elodea* beds from periods of oxygen stress and anoxia. On several occasions we have observed rooted shallow water *Elodea* beds, while at around 2m depth and deeper all of the *Elodea* appears as non-rooted ‘drift’. This may well coincide with periods of shallow stratification with severe anoxia below the thermocline resulting in root death and shoot detachment.

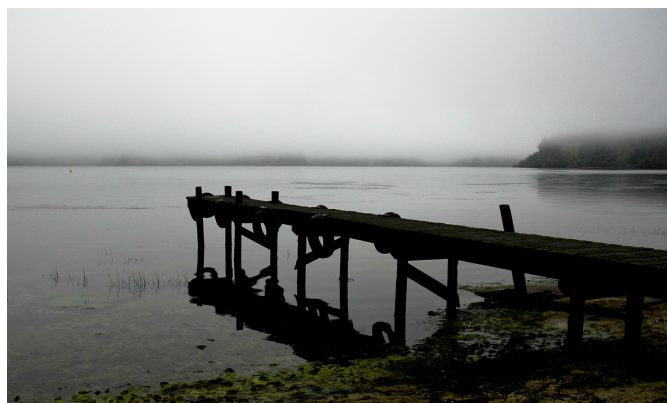
Table 13: LakeSPI results for Lake Rotoehu. LakeSPI Indices expressed as a percentage of lake maximum potential.

State	Year	LakeSPI Index (%)	Native Condition Index (%)	Invasive Condition Index (%)
Pristine		89	88	0
	1988	33	33	73
Historical data	2003	34	34	64
	2006	22	32	82
Present day	2008	18	26	85

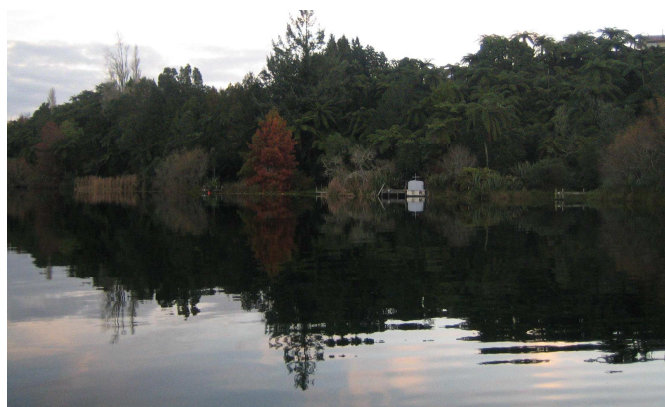
Table 14: LakeSPI results for Lake Rotoiti. LakeSPI Indices expressed as a percentage of lake maximum potential.

State	Year	LakeSPI Index (%)	Native Condition Index (%)	Invasive Condition Index (%)
Pristine		94	90	0
	1981	26	33	82
Historical data	1988	26	33	85
	2001	20	24	90
	2003	18	22	90
Present day	2006	18	18	90

Lake Rotoiti has consistently had one of the highest Invasive Condition Index scores and during the most recent 2006 survey it continued to have the lowest LakeSPI Index so far recorded for any of the 12 lakes in this region. It is interesting to note the similarity of LakeSPI scores, Native Condition Index and Invasive Condition Index between Lakes Rotoiti (18, 18, 90) and Rotorua (22, 21, 78), 2006 surveys. Lake Rotoiti has a complex morphometry with areas along the northern shoreline that are too steep to support submerged vegetation making them unsuitable for LakeSPI. The western end of Rotoiti has been predominantly influenced from Lake Rotorua inflows and there has been a progressive decline in submerged vegetation in several arms of Lake Rotoiti such as Okawa Bay, Wairau Bay and Te Weta Bay. Sheltered areas with low water quality are now often dominated by loose filamentous algae, attached benthic blue-green algal mats and planktonic blue-green algal blooms. The LakeSPI scores indicate poor water quality in this lake.
