LAKE ROTORUA AND LAKE ROTOITI

Report on the Technical Issues and Effects to be Considered in the Application for Resource Consents

Prepared by B R Titchmarsh, Manager Technical Services

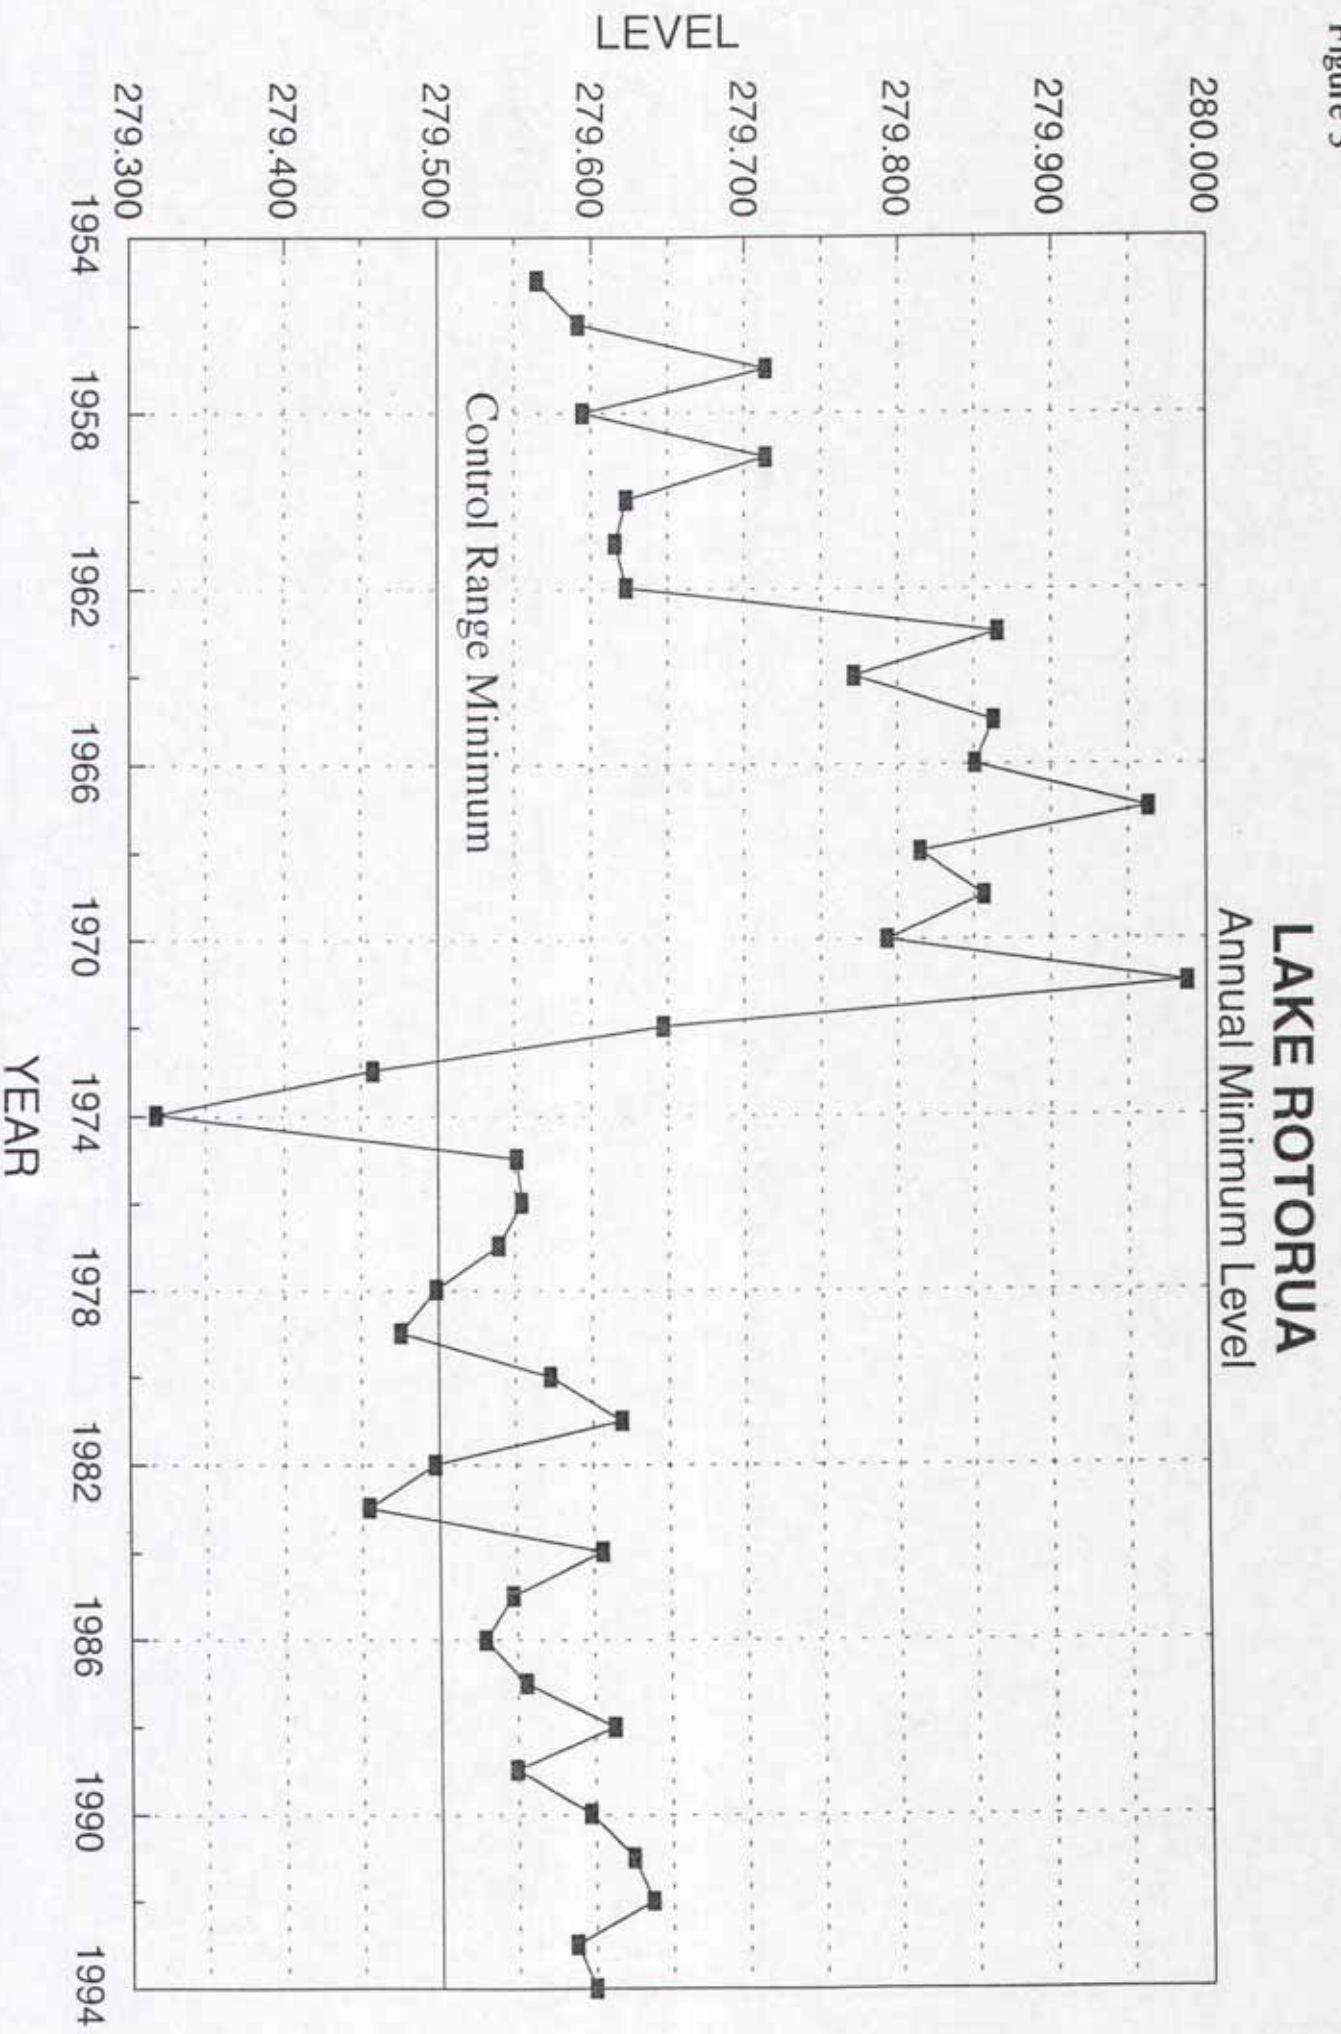
Figure 3

From Tables 1 and 2 and Figures 3, 4 and 5 it can be clearly seen that prior to the channel enlargement works of 1972 and 1973 that the lake level was generally high for long periods of time. Following those enlargement works lake levels generally dropped until the construction of the Ohau Channel structure in September 1989.

Tables 1 and 2 indicate that since the structure has been in place the lake level has been maintained at acceptable levels with the maximum of 280.11m being exceeded only 1.2% of the time. The lake level has also been maintained between 279.70 and 279.90 for just under 50% of the time.

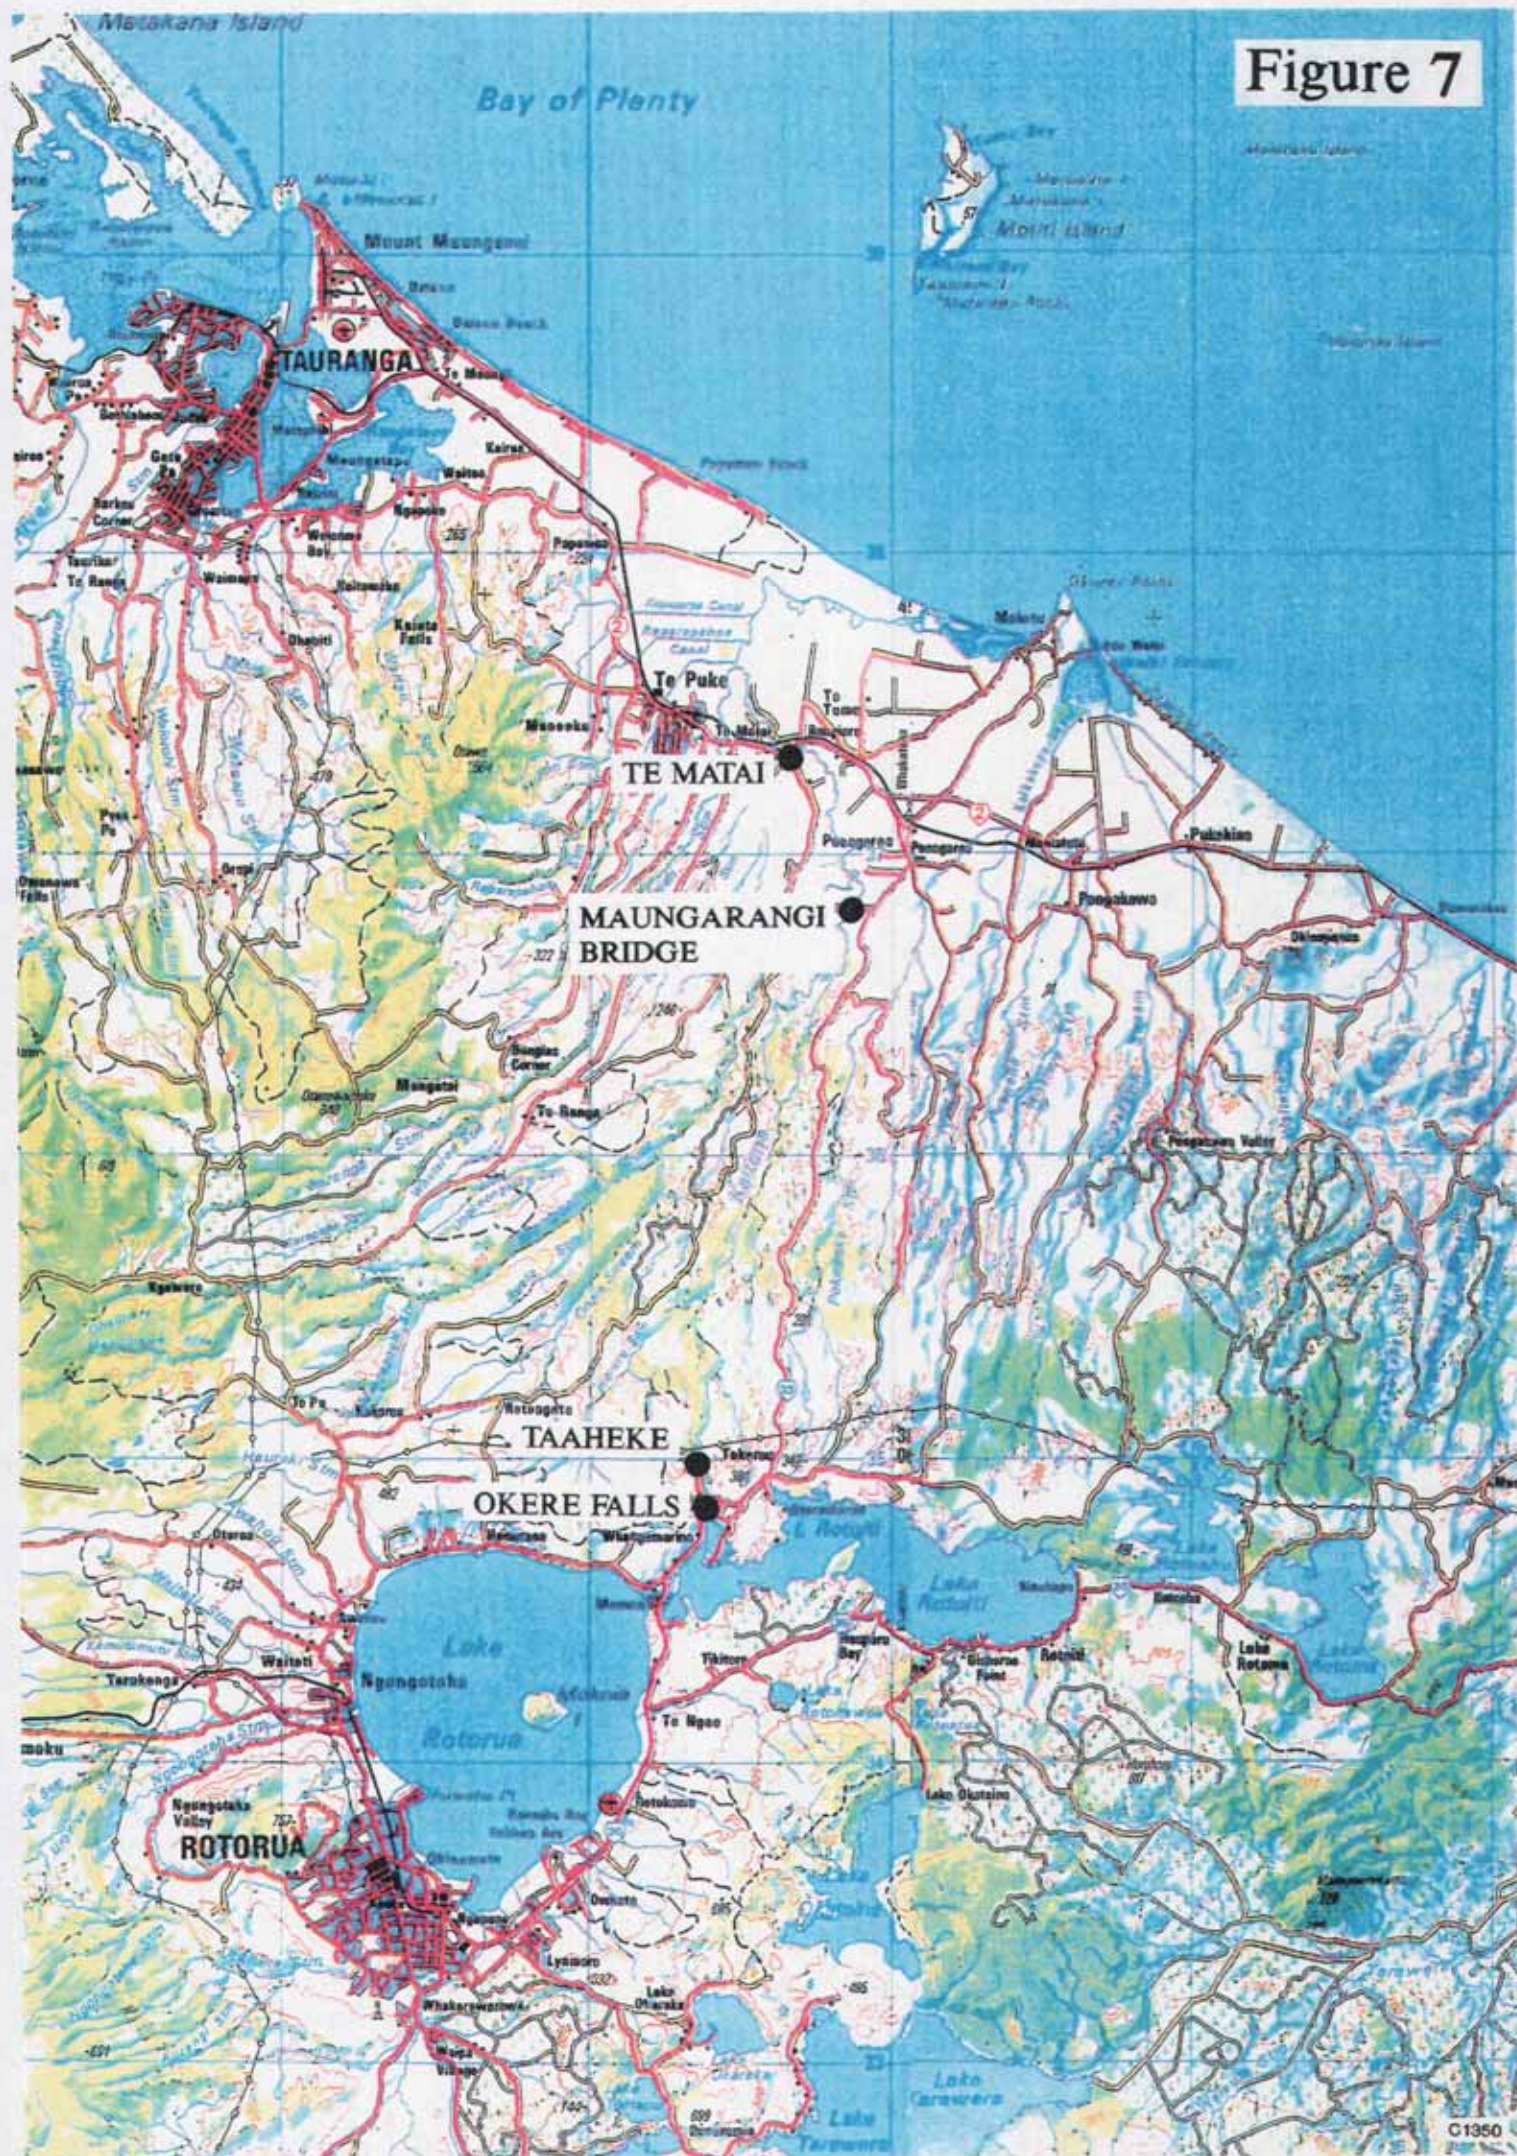
Environment B.O.P and its predecessor the Catchment Board has been responsible for the operation of the gates and controlling the flows for the last 10 years and during this time has developed a good understanding of the ability to control lake levels and flows from Lake Rotoiti. Figure 7 shows the location of the control gates and other main features of the river

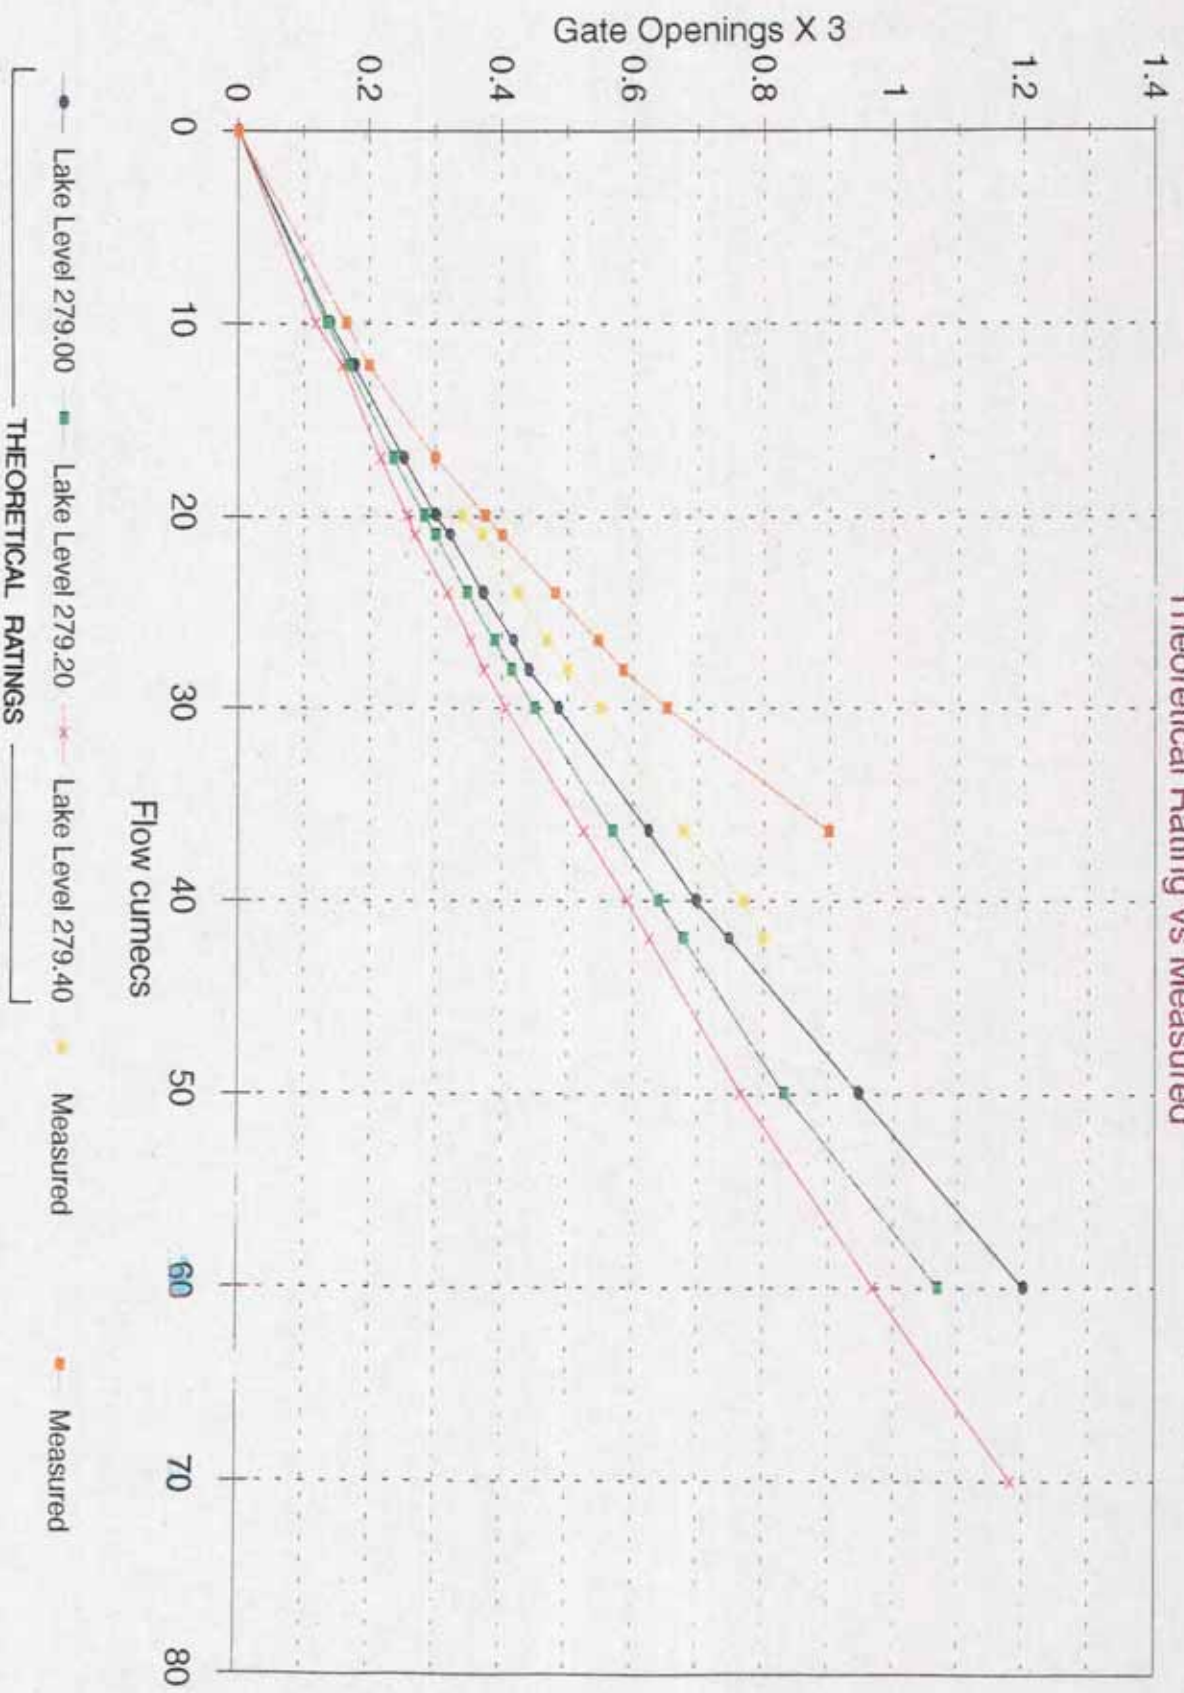
Figure 11

OKERE FALLS GATES

Theoretical Rating vs Measured

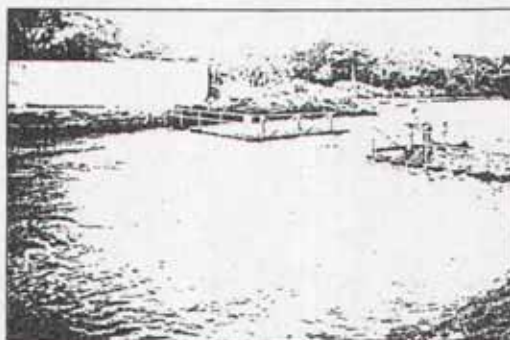
THE Ohau Channel control structure.
