Bay of Plenty Region July 2004 and December 2004 Flood Events

FINAL CLAIM from Environment Bay of Plenty for Government Assistance towards Response Costs and Costs of Reinstatement of Damaged River and Drainage Scheme Infrastructural Assets

July and December 2004 Flood Response and Recovery Works

Final Claim to Ministry of Civil Defence and Emergency Management

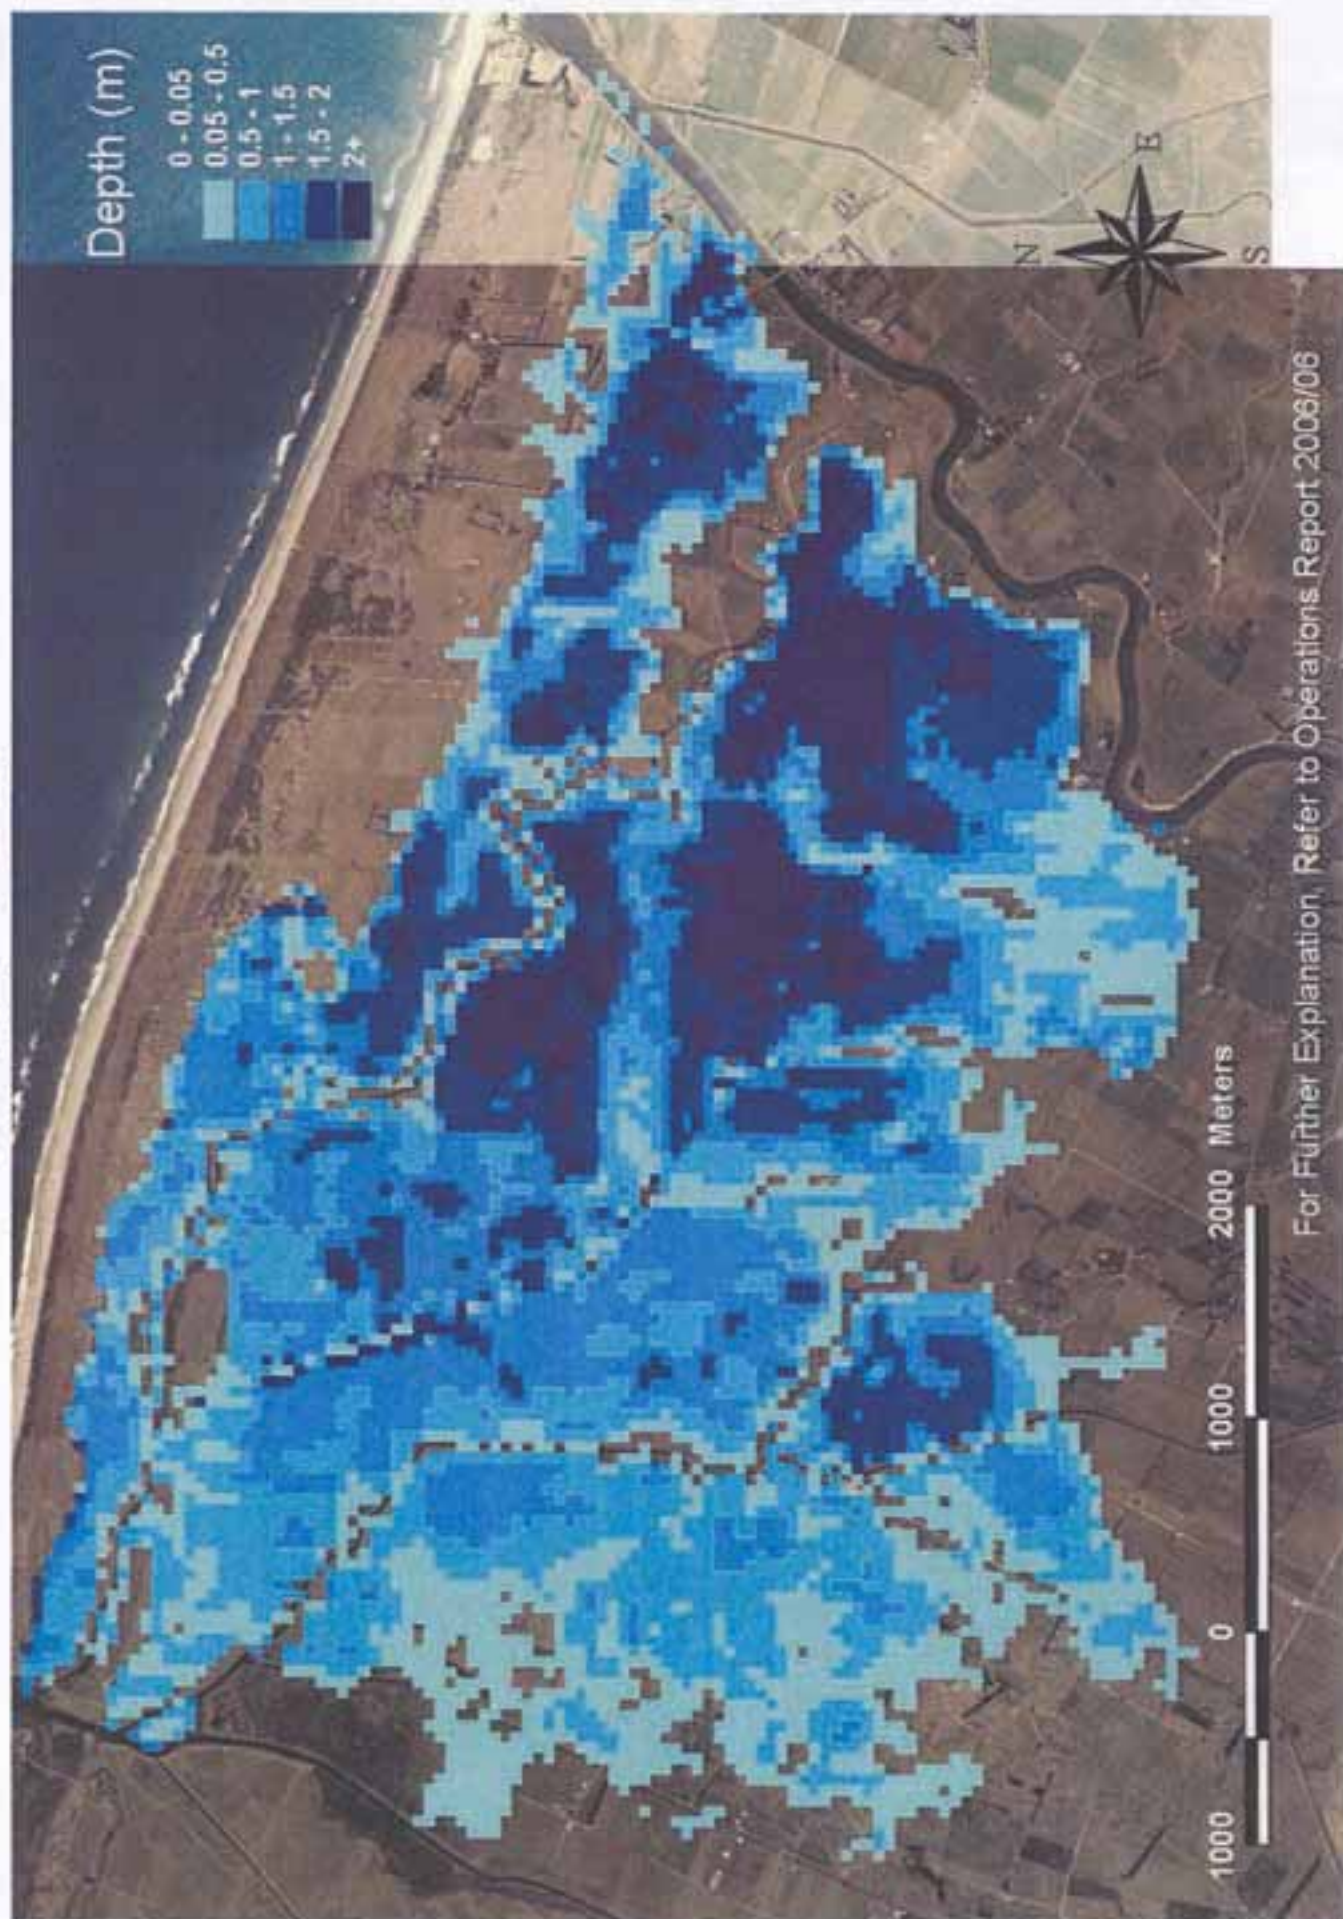
Inundation from a breach at Laws Bend, Rangitaiki River 1% AEP Flood
