Natural Environment Regional Monitoring Network River and Stream Channel Monitoring Programme 2000/2001 and 2001/2002

Environment Bay of Plenty
Environmental Publication 2003/16
August 2003

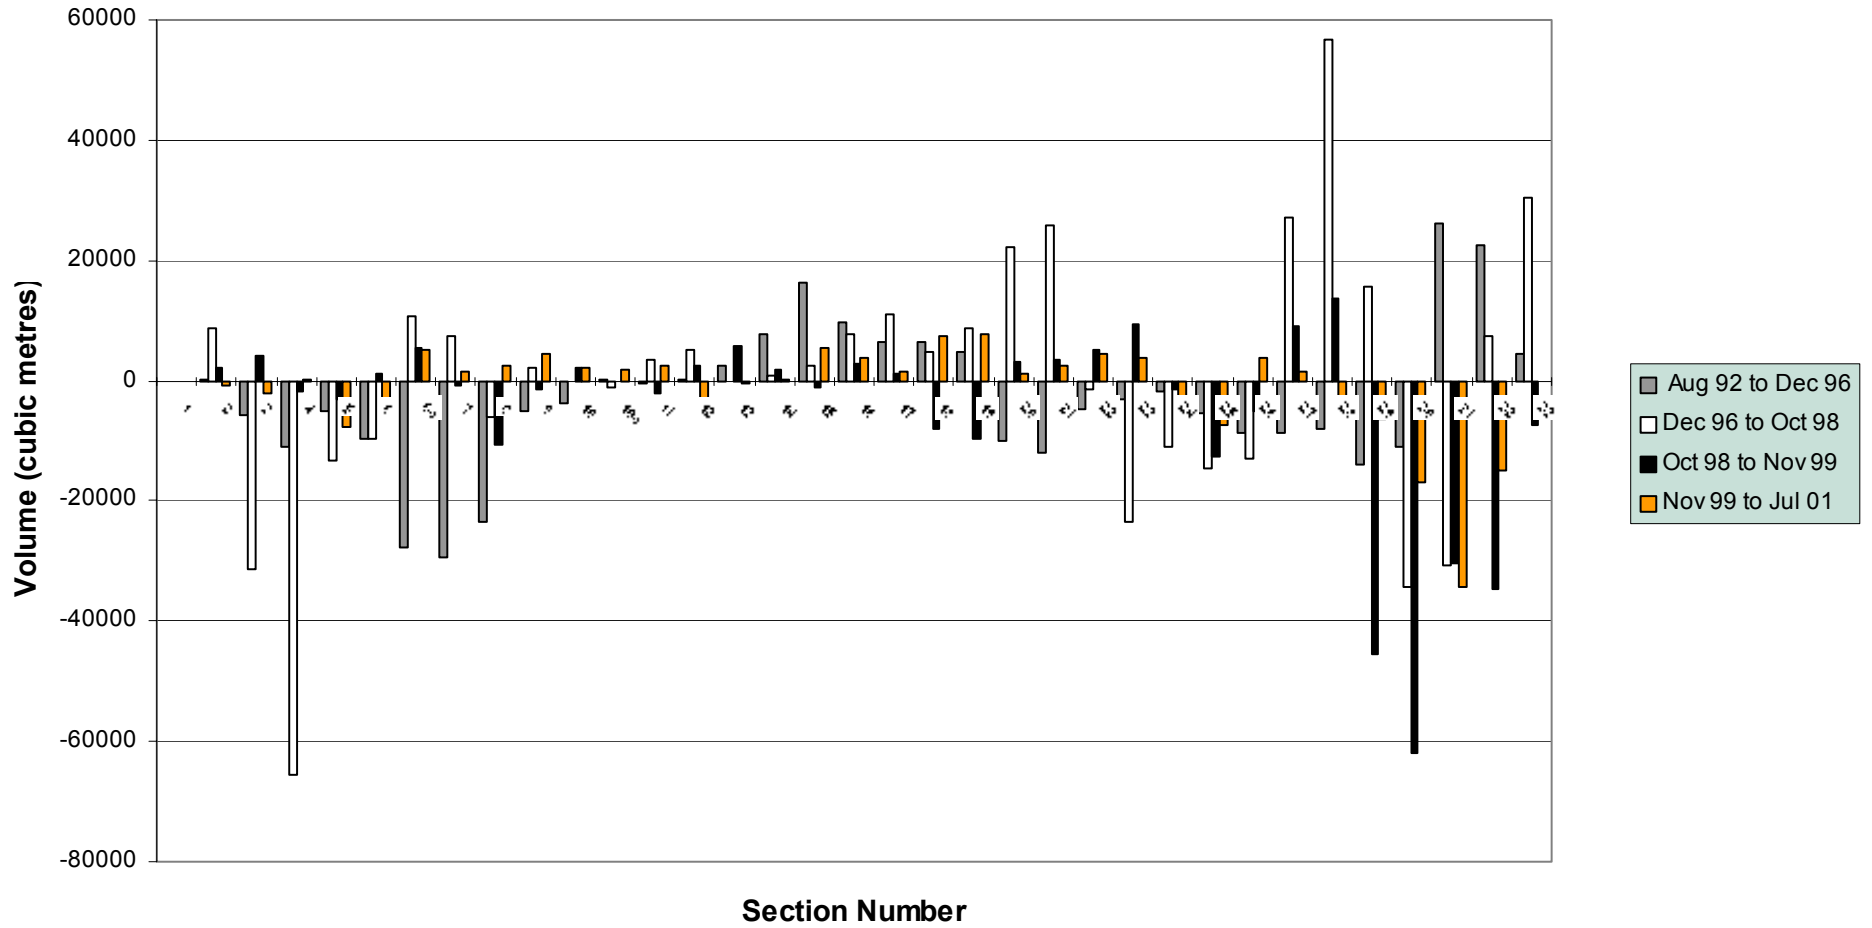
Waimana River Volume Changes - Active channel

The analysis of the 2001 survey shows that a total volume of **47,000m³** has been lost in the active channel since the previous survey in 1999. Again, losses are centred around cross-sections 27 to 32 where a total volume of 78,500m³ was lost. Bed levels have dropped in this reach too, and bank erosion seems to be an ongoing process. An estimated volume of 212,500m³ was eroded from the banks in this reach. 12,000m³ were lost at cross-sections 23 to 25, and 16,000m³ were lost just above the confluence into the Whakatane River at cross-sections 1 to 6 with the river degrading in this lower reach. Bank erosion is also observed at cross-sections 18 and 24. Rising river levels and the highest volume gains were observed between cross-sections 17 and 19.

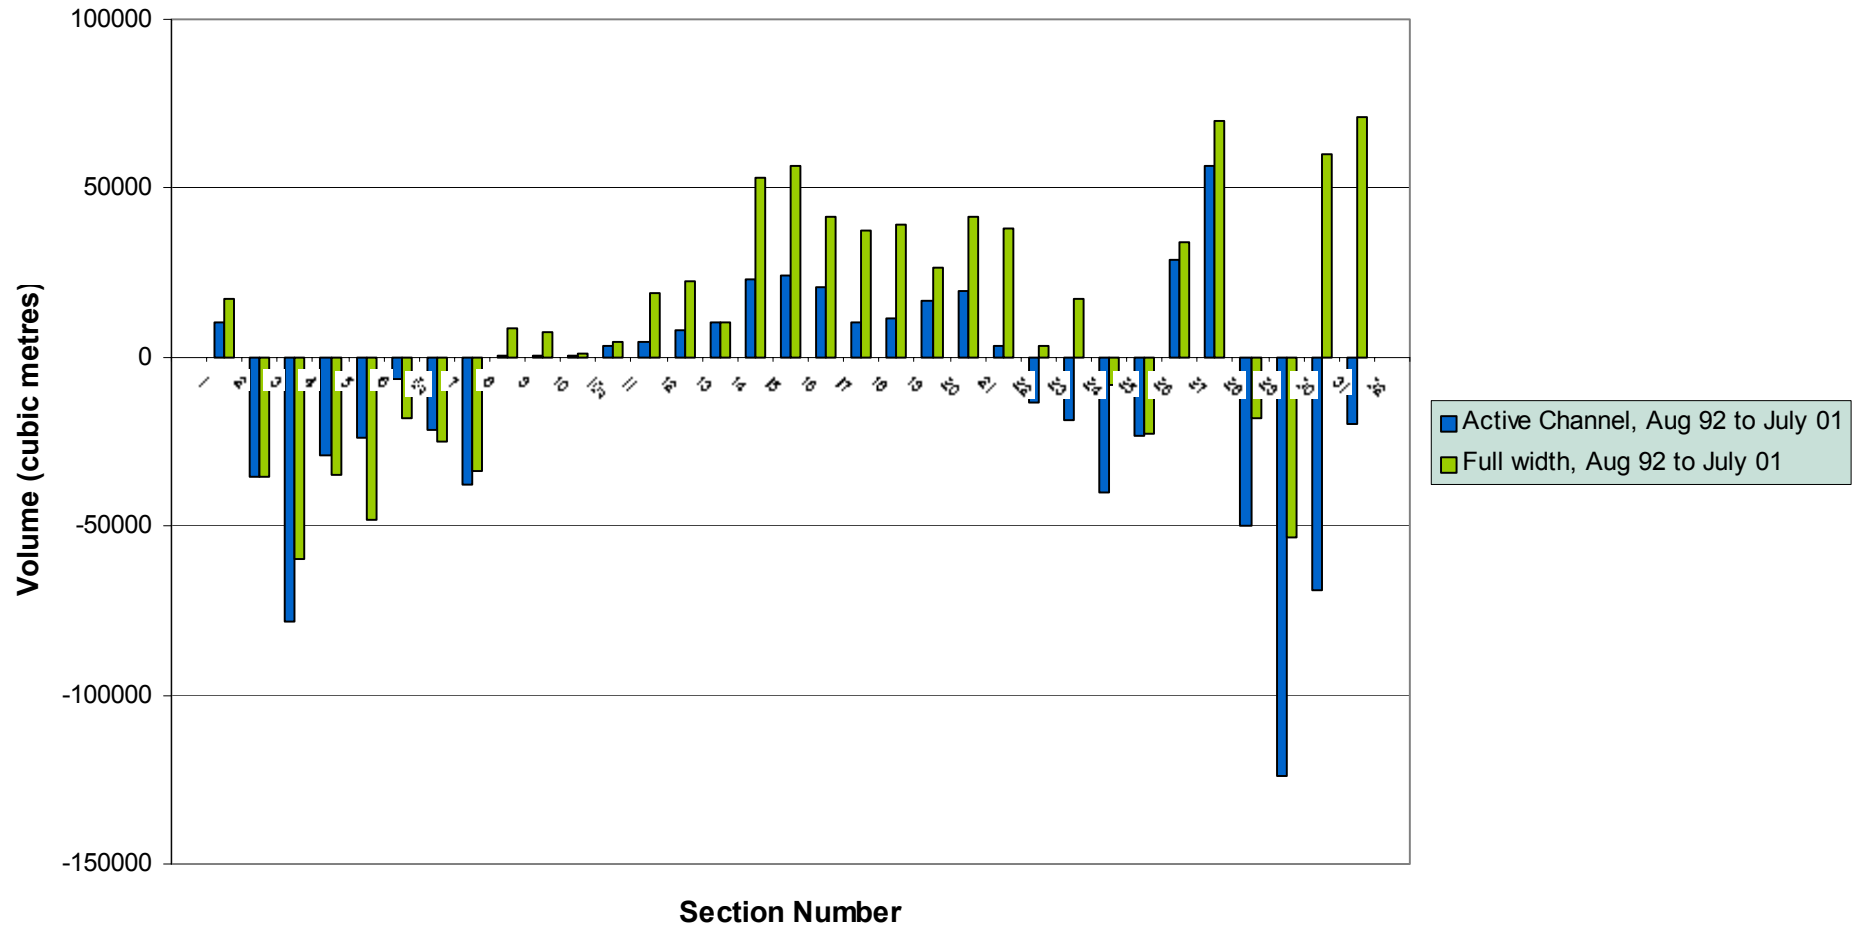
Waimana River Volume Changes

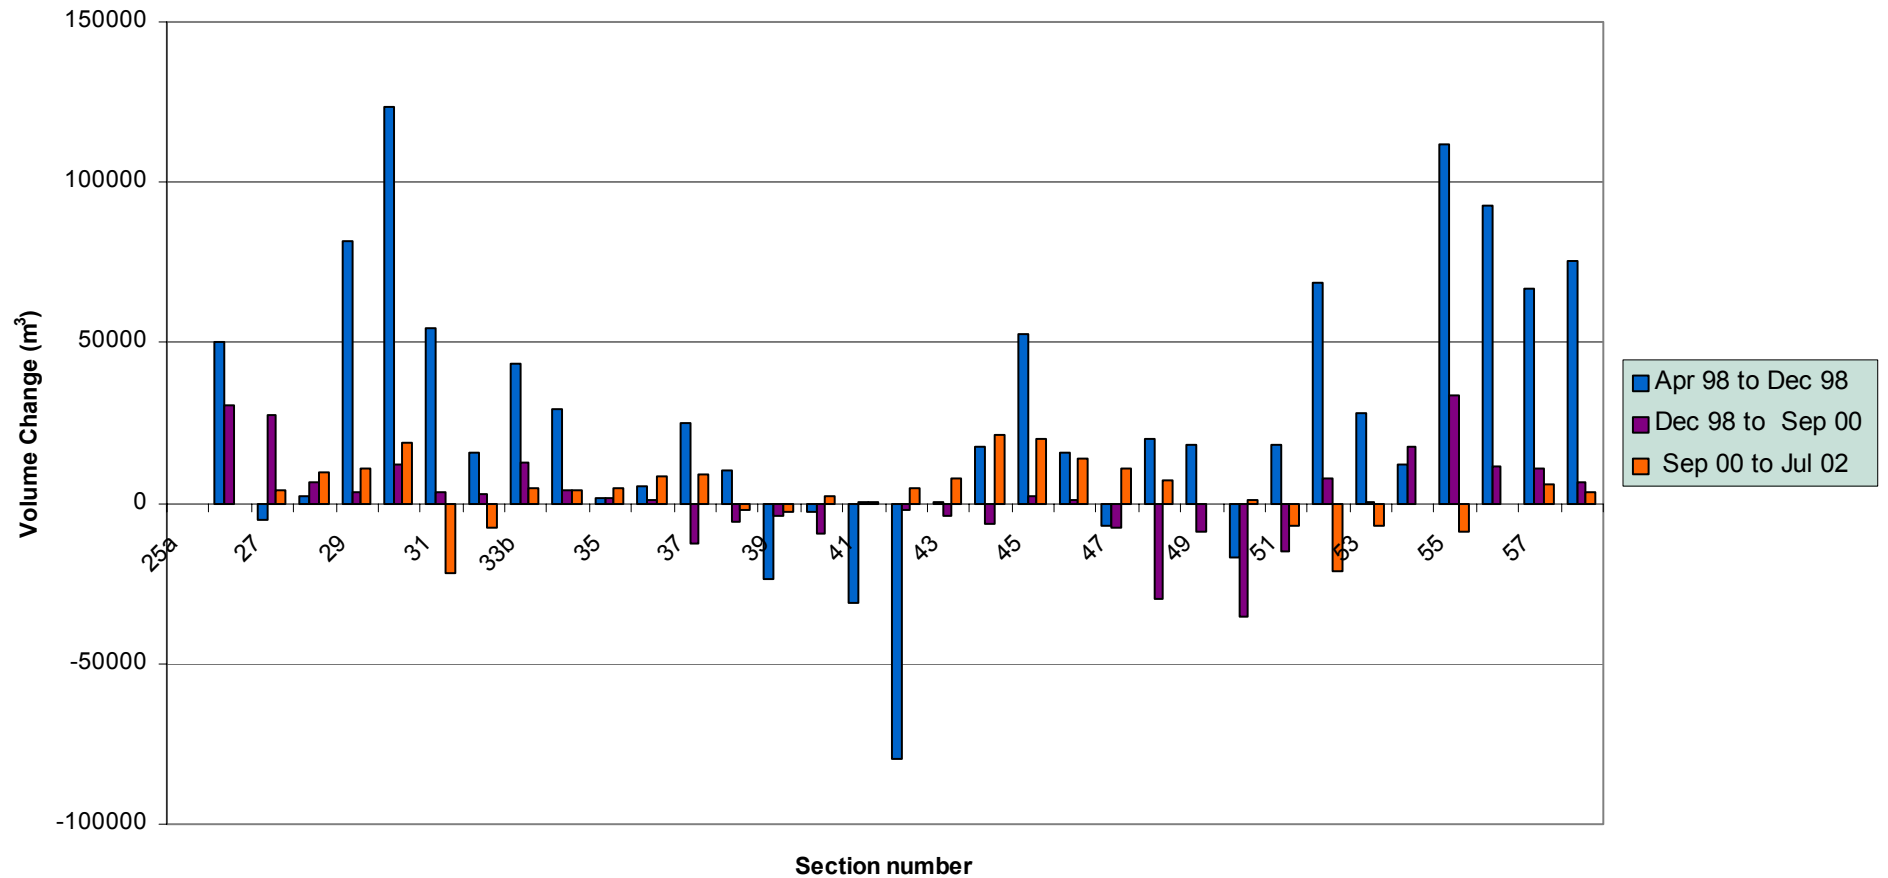
Whakatane River (above Pekatahi bridge) Volume changes - Full width

The 2002 survey shows that since the 2000 survey there has been again a **volume gain of 92,000m³** within the full floodplain width of the river. The largest volume gains are around cross-sections 44 and 45 with 21,200m³ and 20,000m³ respectively. Volume losses were observed at cross-section 31, where a shingle pit on the right floodplain affects the volume calculations, 32, 38, 39, and 51 to 56. Bed levels have dropped in the reach of cross-sections 51 to 57 (except at cross-sections 54), and have risen at cross-sections 47 and 48. Bank erosion has occurred at the right bank of cross-section 53 and 54.

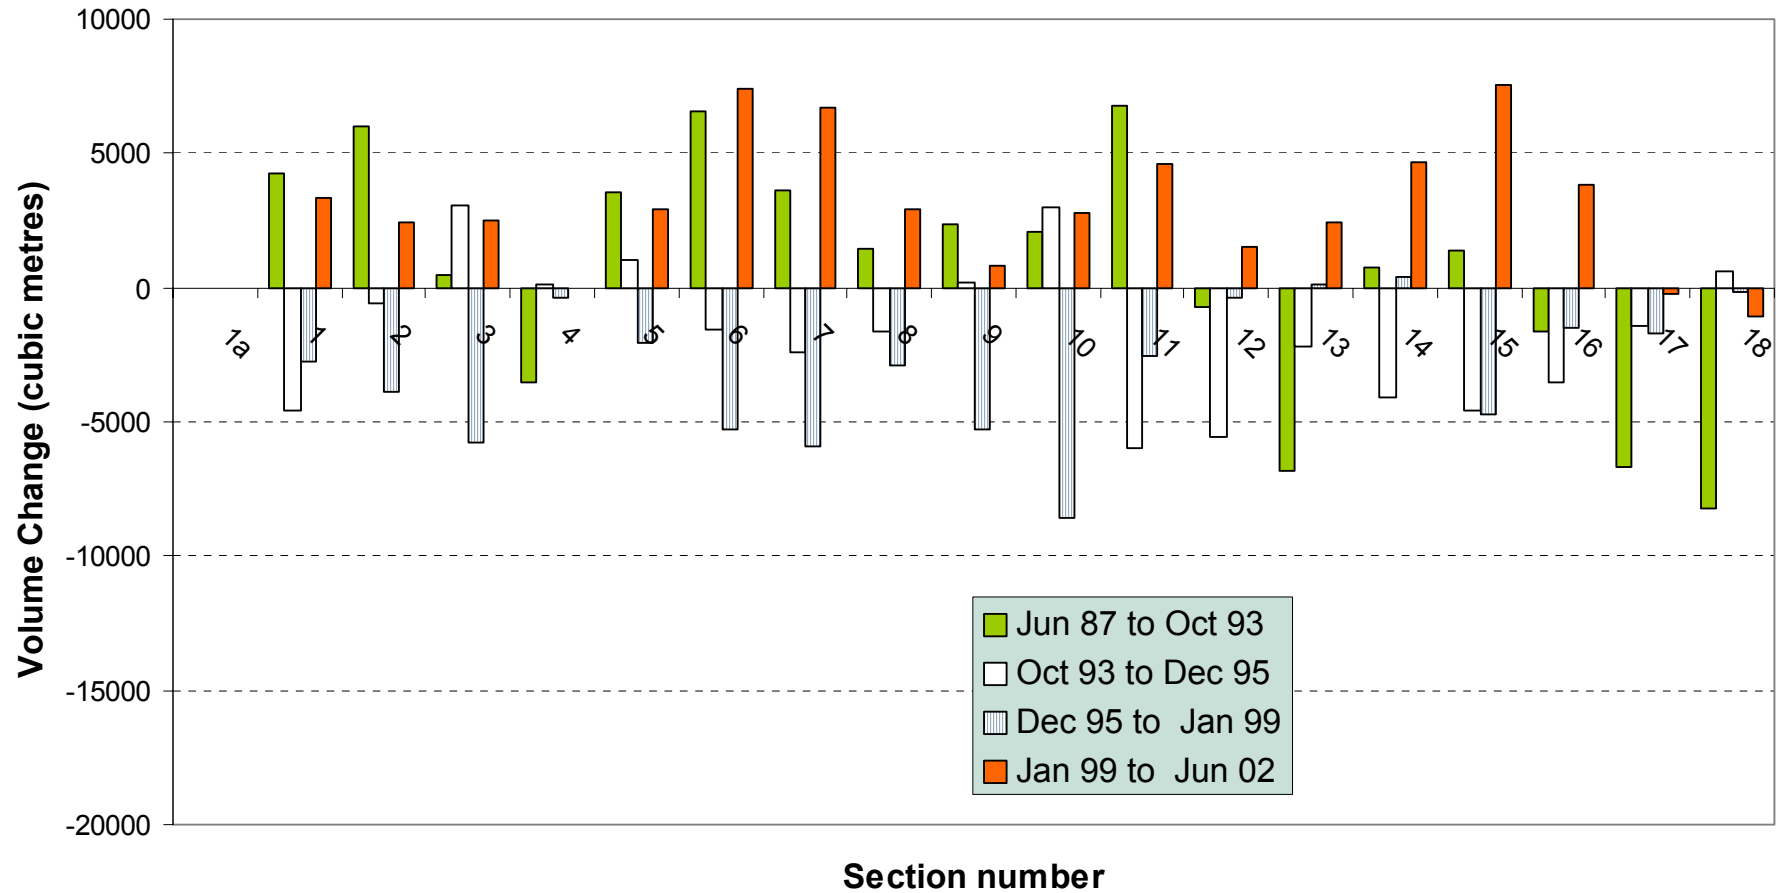
Rangitaiki River Volume Changes below Te Teko

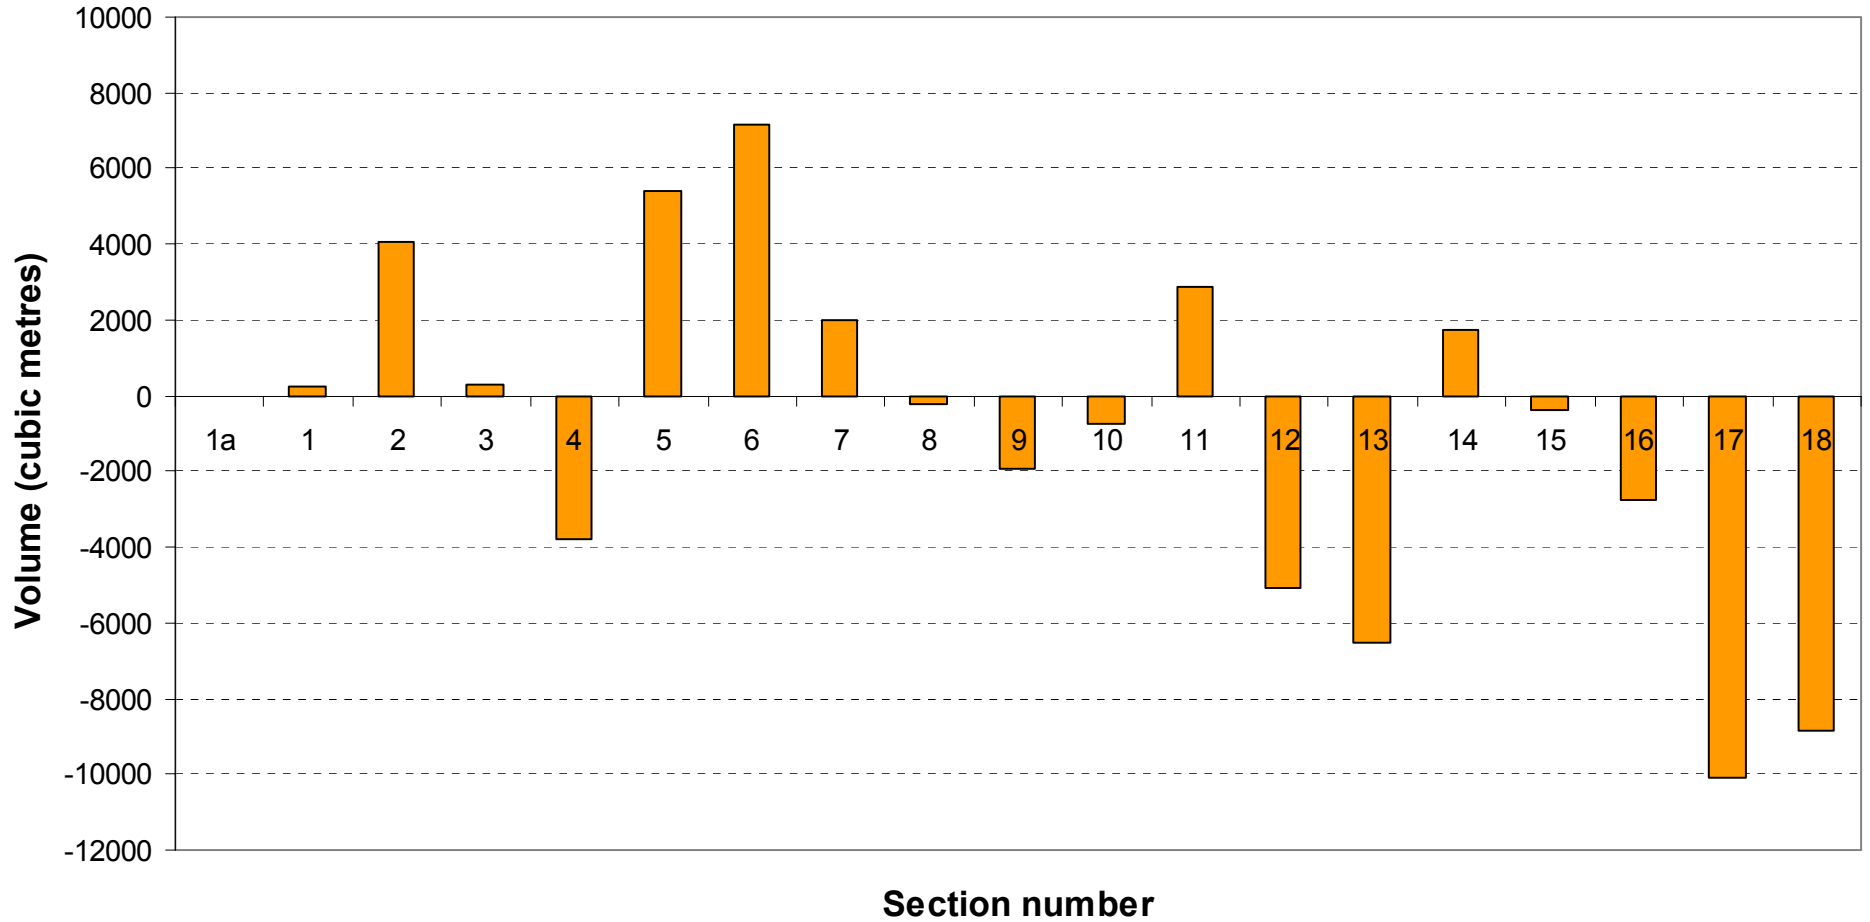
Rangitaiki River Total (1987 to 2002) Volume Changes below Te Teko

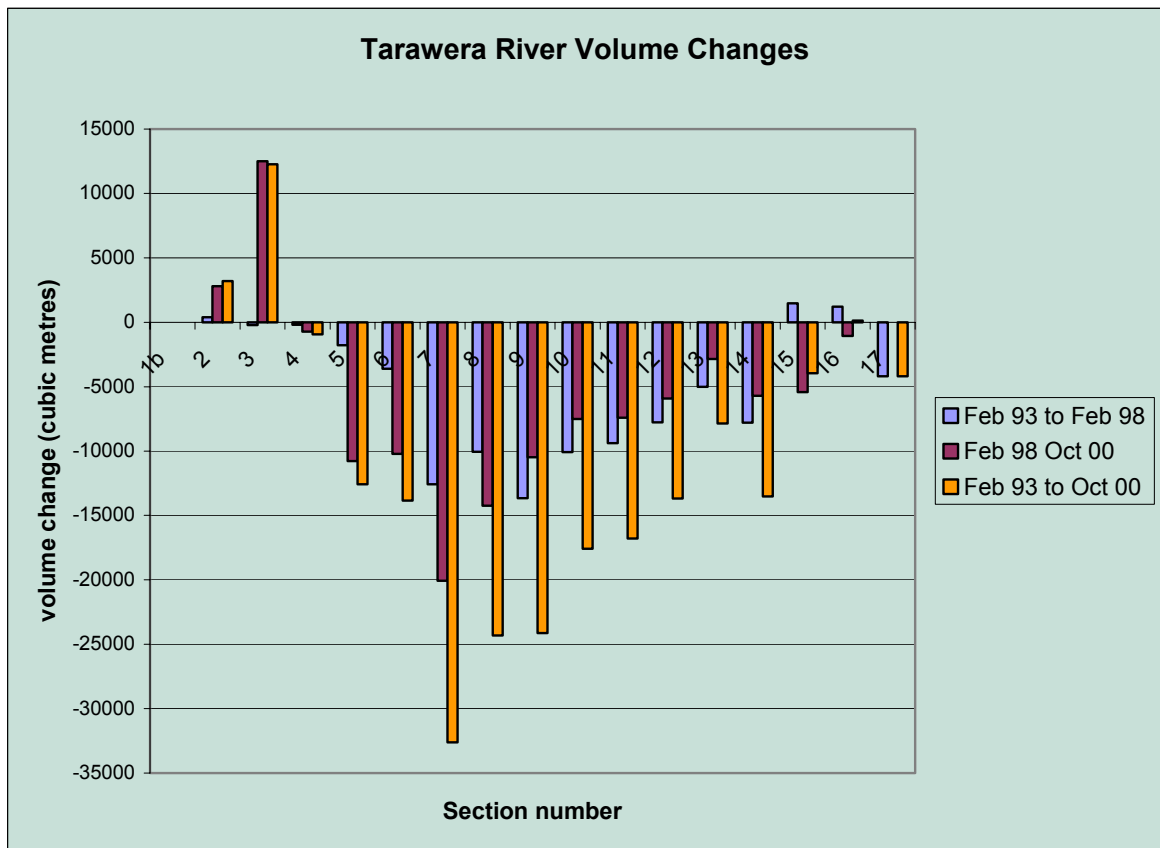
**Tarawera River - Volume changes
Surveys 1993, (1996), 1998, 2000**

The 2000 survey shows a volume loss of 87,000m³ since 1998. With the volume loss of 83,000m³ between 1993 and 1998, this adds up to a total loss of 170,000m³ since 1993. The trend of dropping minimum bed levels which was observed from the 1998 survey is continuing at most of the cross-sections, particularly at cross-sections 5 to 8 where bed levels have dropped by up to 1 metre since 1993.
