Bathing Surveillance Grading Report 2008

Prepared by Paul Scholes
Environment Bay of Plenty
Environmental Publication 2008/12

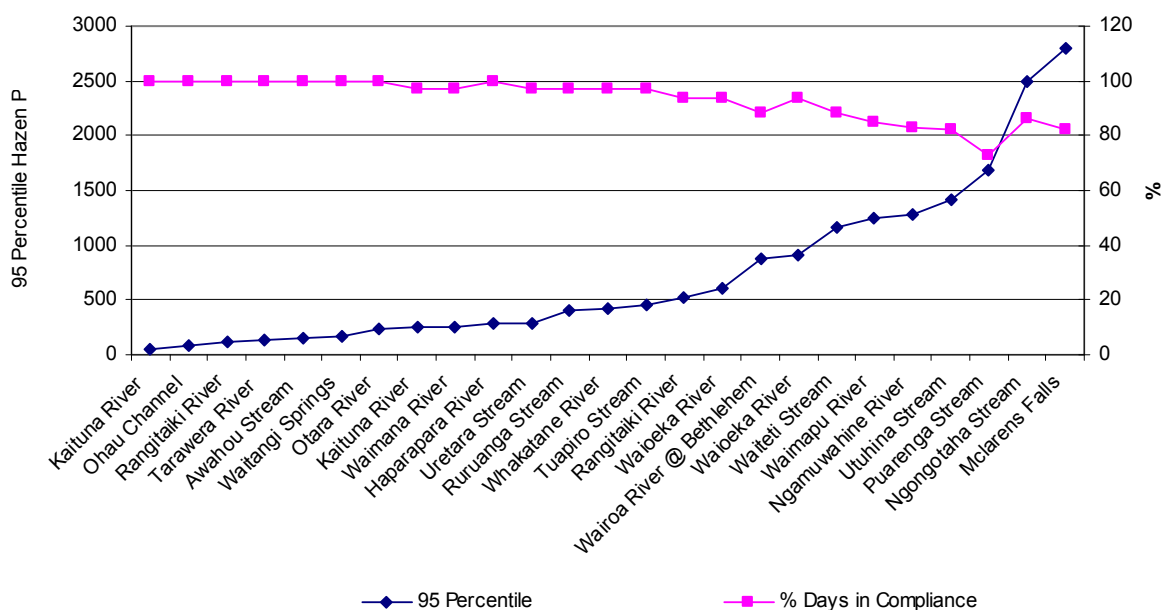
Figure 2 95 Percentiles and Percentage Days in Compliance, River sites, 2003 to 2008.

Percentage days in compliance has a good correlation with the Hazen 'P' 95 percentile (used for the MAC category) for all sites except the open coastal sites and lake sites (estuarine sites: $r=-0.866$, $p<0.01$, $n=16$; river sites: $r=-0.952$, $p=0.01$, $n=24$; lake sites: $r=-0.487$, $p<0.05$, $n=21$). This relationship is illustrated in Figure 2 for the river sites monitored in the Bay of Plenty. Two sites do not follow the trend of increasing percentile to decreasing percentage days in compliance, these are the Ngongotaha Stream and the Wairoa River at McLaren Falls. Both waterways have consistently elevated results affecting the Hazen percentile with some non-compliance days.

The percentage days in compliance (monitored days below the red alert guideline) are given in Tables 4 to 6. Percentage days in compliance is another indicator of risk to recreational water users, where a low percentage (e.g. <90%) indicates a risk to users. Caution must be used when interpreting this indicator, as rainfall can generate high results.

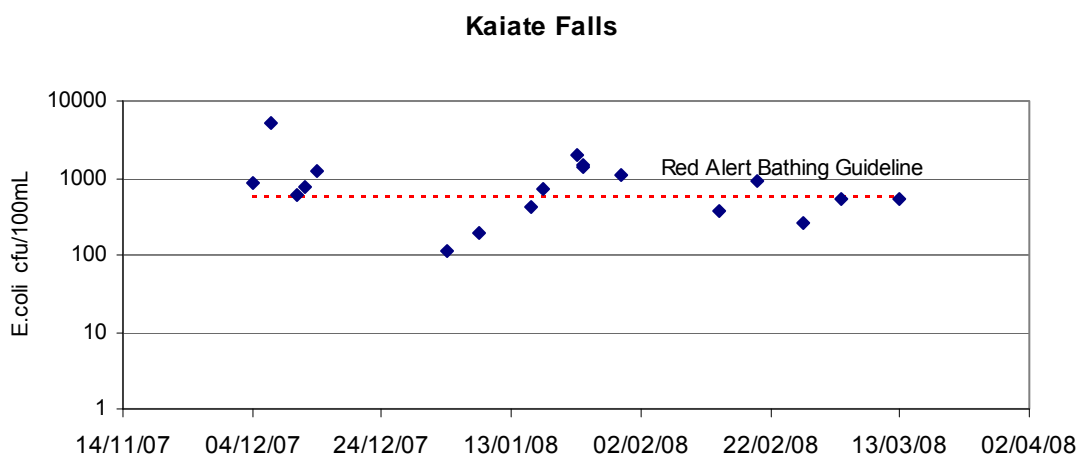
Figure 3 *E. coli* concentrations, Kaiate Falls.

Summer surveillance monitoring found similar high concentrations at times (Figure 3) which resulted in Toi Te Ora Public Health issuing a health warning in December of 2007. Warning signs were duly erected and the catchment above the falls was surveyed.

Kaiate Falls is a popular recreational area in the Welcome Bay area of Tauranga. Kaiate Stream passes through a series of rock pools and water falls before passing into the Waitao Valley. The area was included in the Environment Bay of Plenty bathing surveillance programme through monitoring work being carried out by the Te Awa O Waitao Joint Steering Group in 2007. The group in liaison with NIWA had consistently found *E.coli* levels from the Kaiate Falls area above the red alert mode given in the MfE/MoH Guidelines.

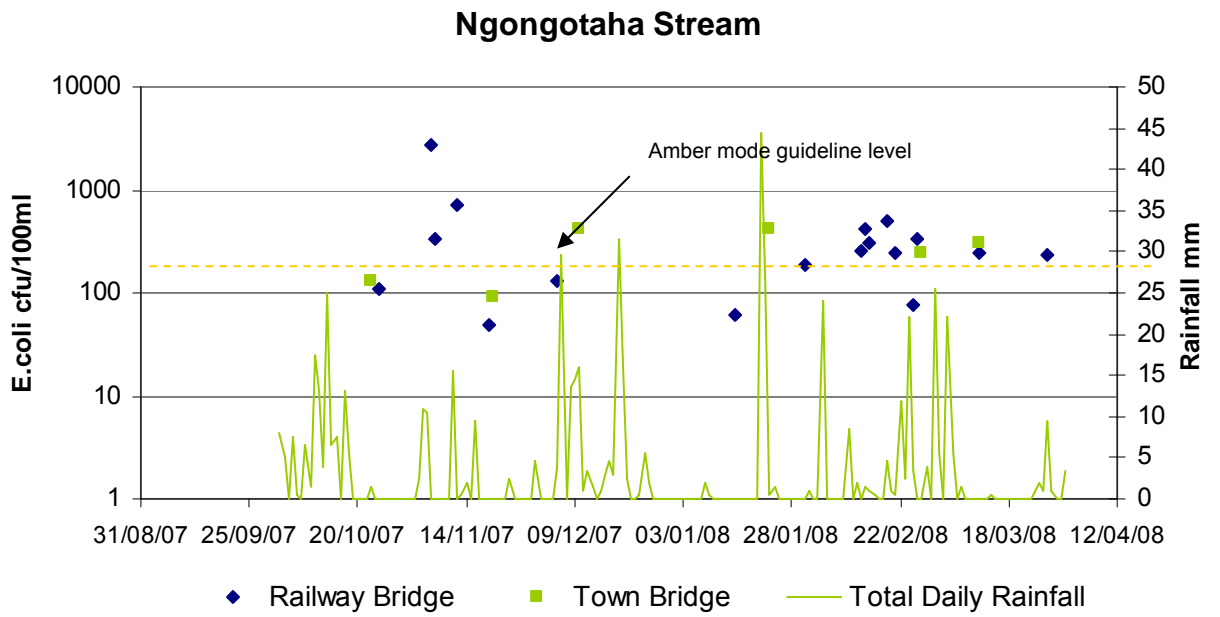
Figure 5 *E. coli* concentrations (cfu/100ml), Ngongotaha Stream.

The Ngongotaha Stream site monitored at Railway Bridge has on several occasions displayed *E.coli* concentrations above the amber mode bathing guideline level (Figure 5) for the past two summer seasons. Often elevated concentrations have been associated with rainfall events, but not always.

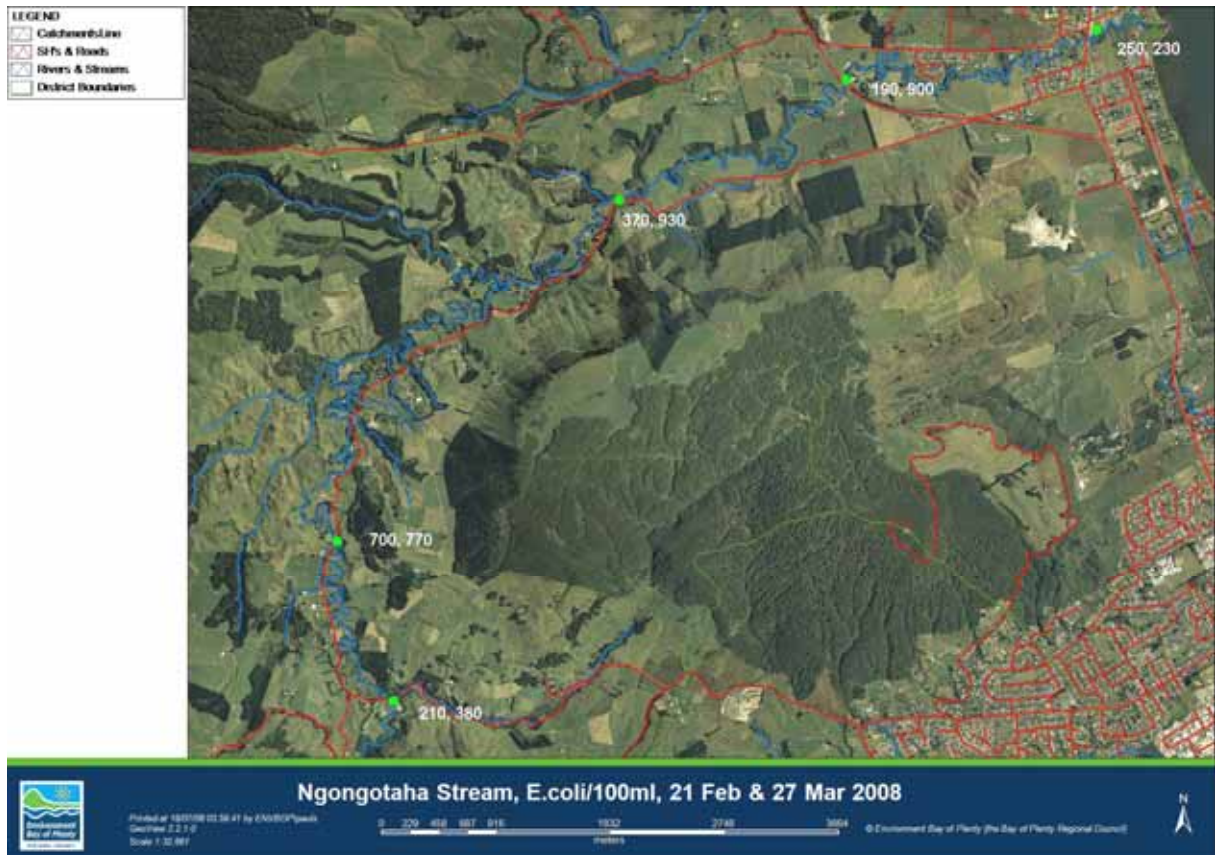
Figure 6 *E. coli* concentrations, Ngongotaha Stream.

A small catchment survey was undertaken in early 2008 to ascertain if elevated results were also occurring higher up in the catchment. Figure 6 shows that some faecal contamination is detected near the headwaters of the stream but this increases downstream below a wildlife park containing a variety of ponds. *E.coli* levels are variable further down with the higher results (>900 *E.coli*/100ml) being found after a rain event that occurred on 27 March 2008. However, this has not impacted the regular sampling site results at the Railway Bridge, but this may be due to variability in the water or dilution from urban stormwater.

The only discharge consents in the catchment are for onsite wastewater treatment systems, a jet boat operation and various stormwater discharges within the urban area. There is potential for an increase in urban development to have added to the stormwater loading to the stream, however it would seem that faecal contamination is occurring much higher up in the catchment. As most of the catchment is a mixture of pastoral lands and forestry with the lower catchment urbanised, there are a range of sources that are potentially contributing to contamination.
