# Recreational Waters Surveillance Report 2014/15

Bay of Plenty Regional Council  
Environmental Publication 2015/06

August 2015

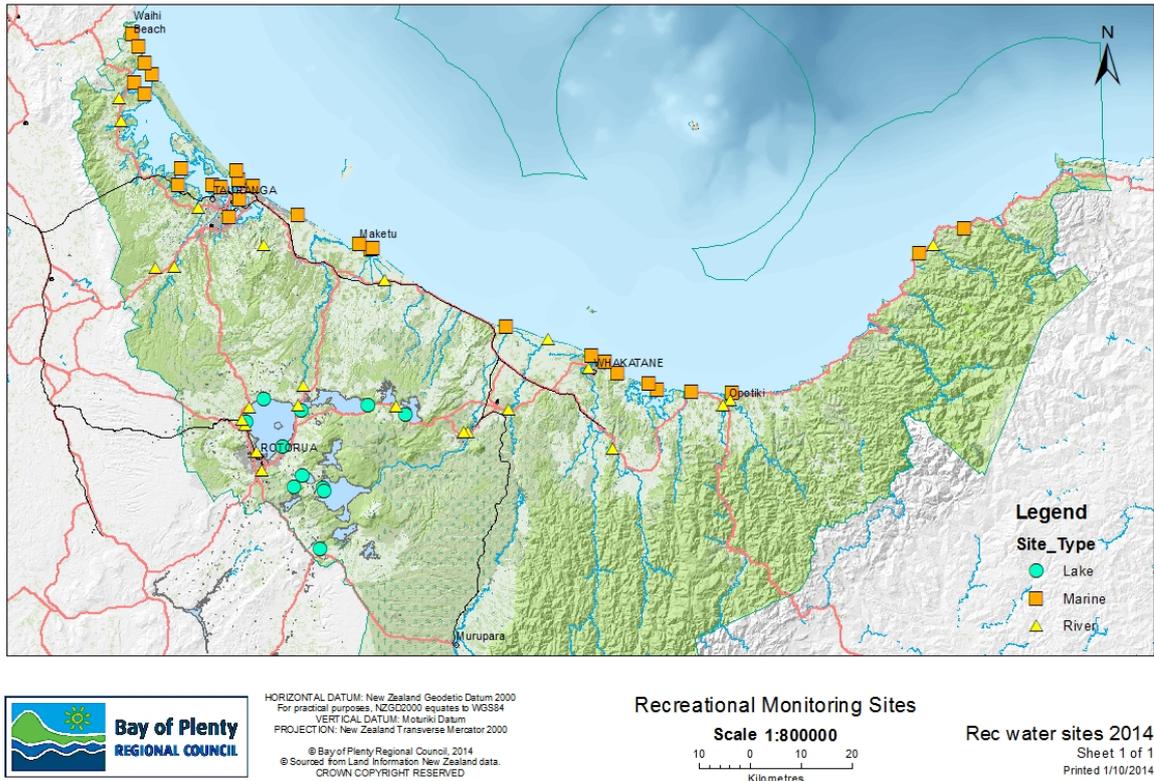
Figure 1.1 Bathing surveillance sites for the 2014/15 season, Bay of Plenty

The bathing surveillance monitoring sites are shown in the map that follows (Figure 1.1).

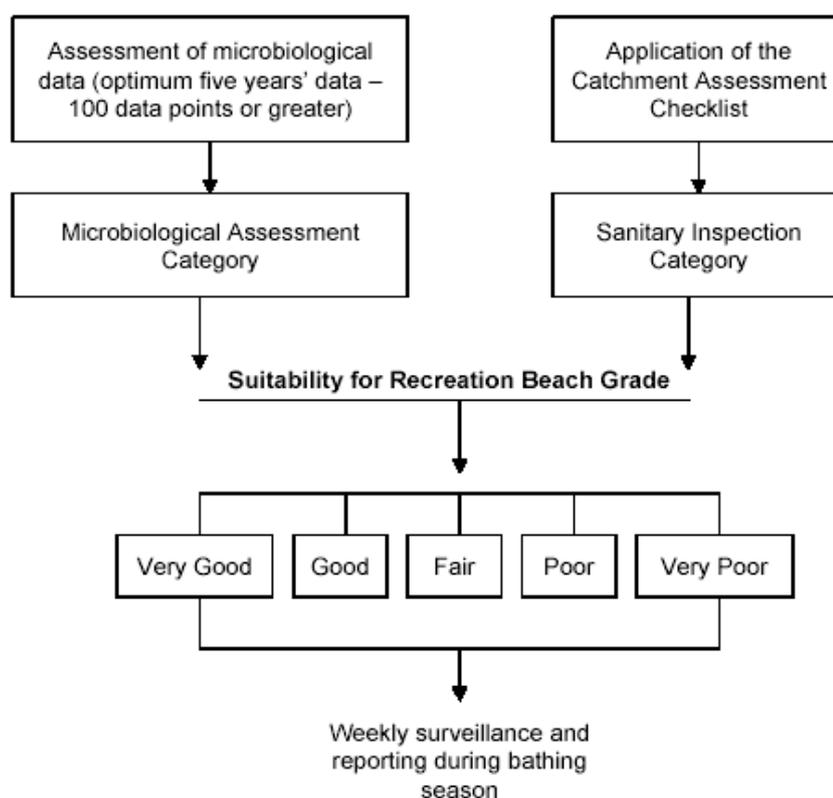
Figure 2.1 Components used to grade a beach (from MfE and MoH, 2003)

These two combined give an overall Suitability for Recreation Grade (SFRG) (Figure 2.1), which describes the general condition of a site at any given time, based on both risk and indicator bacteria counts. The five grades in the SFRG range from 'Very Good' to 'Very Poor'. Grades help determine whether ongoing monitoring is required, and provide the basis for telling people whether or not water is suitable for recreational use from a public health perspective. If there is an incompatibility between the SIC and the MAC, (this may be due to limited data) then a 'Follow Up' grade is given.

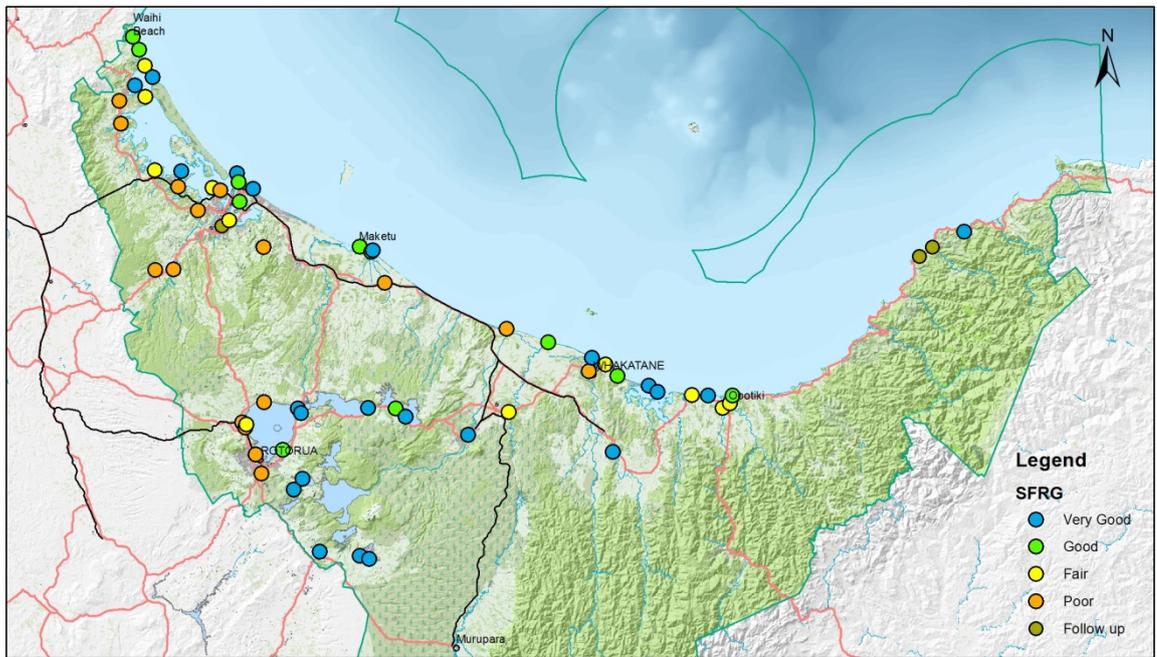
Figure 3.1 Suitability for Recreation Grades, 2014/15

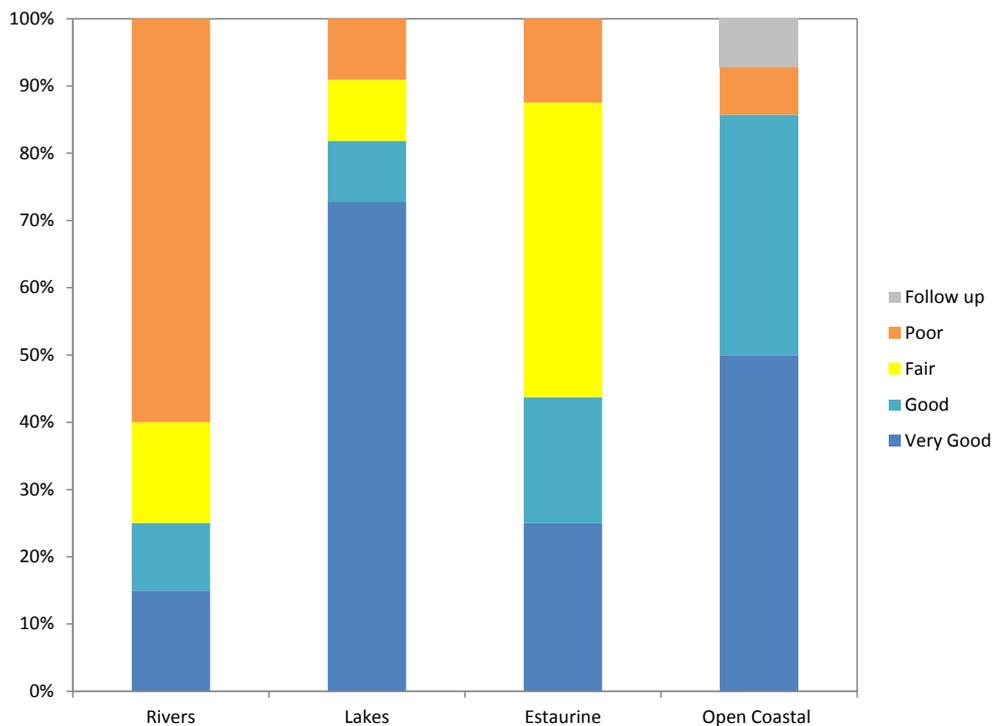
Figure 3.2 Comparison of the 2014/15 results for the Suitability for Recreation Grade (SFRG)

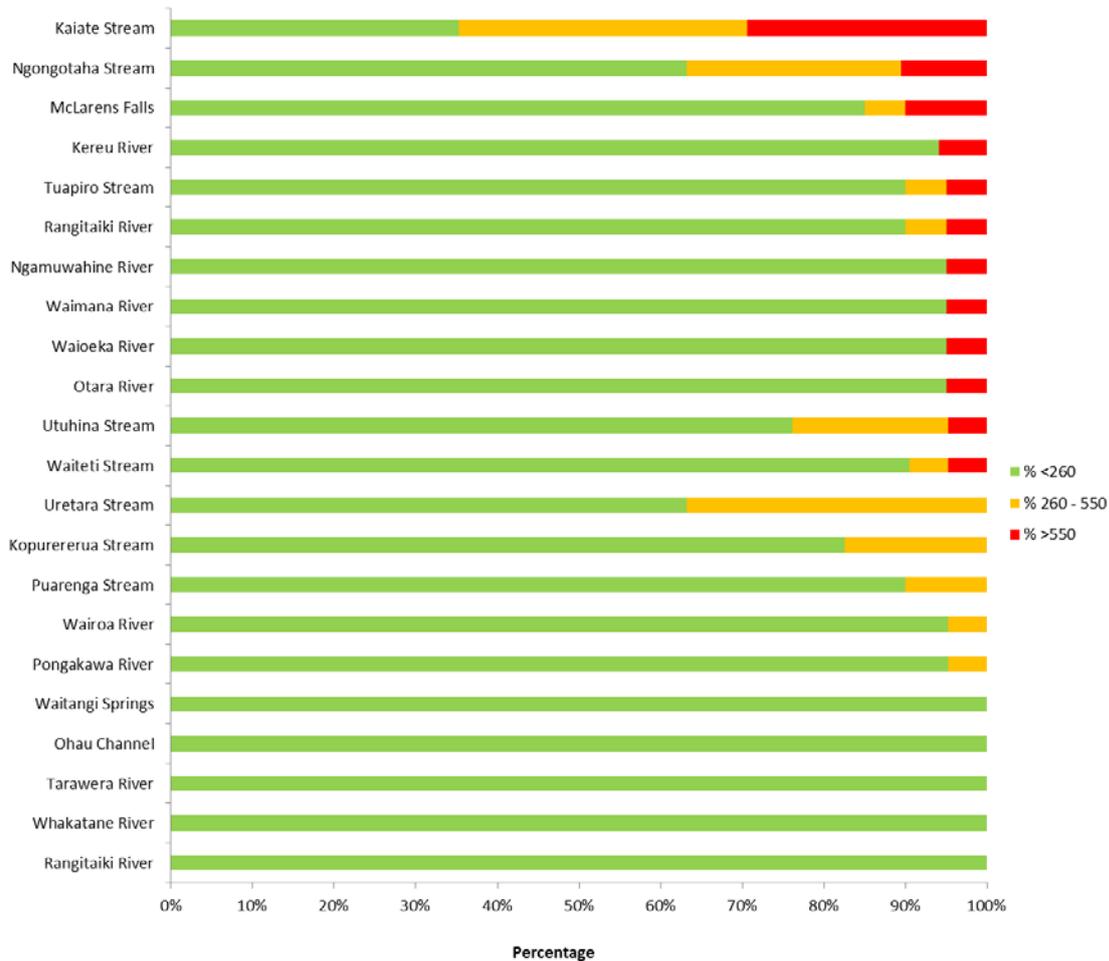
Figure 3.2 River and stream E.coli levels compared against each of the modes in the NZ Microbiological Water Quality Guidelines (MfE/MoH 2003), 2014/2015 bathing season

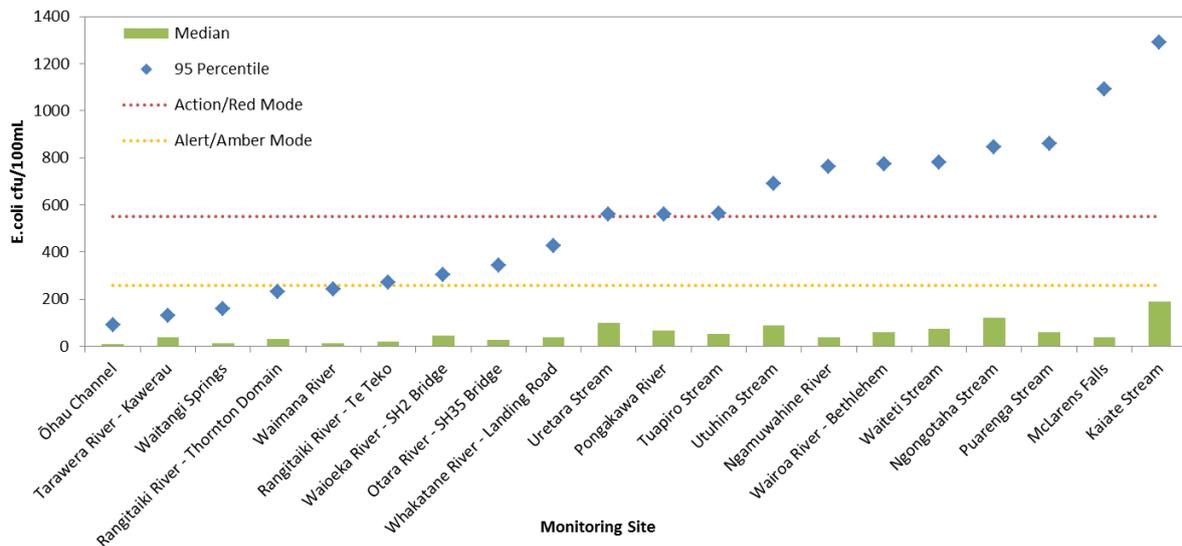
Figure 3.3 Ninety five-percentile and median *E.coli* concentrations, river and stream sites over the past five years. Note that Kereu River and Kopurererua Stream results have been excluded, as they are new sites as of 2014/15

Figure 3.3 shows that 12 sites' 95 percentile data are higher than the Red/Action Mode guideline. These can be classed as the highest priority sites for investigation and action, however, exceedances over the 95<sup>th</sup> percentile guideline predominantly occur with events that generate surface runoff, when swimming is less likely to occur. Median values are also plotted in Figure 3.3 and this gives a measure of the average risk of infection to water uses (particularly primary contact). No median values were over the Orange/Alert Mode, indicating that on average, all rivers over the 2014/15 season were suitable for swimming.

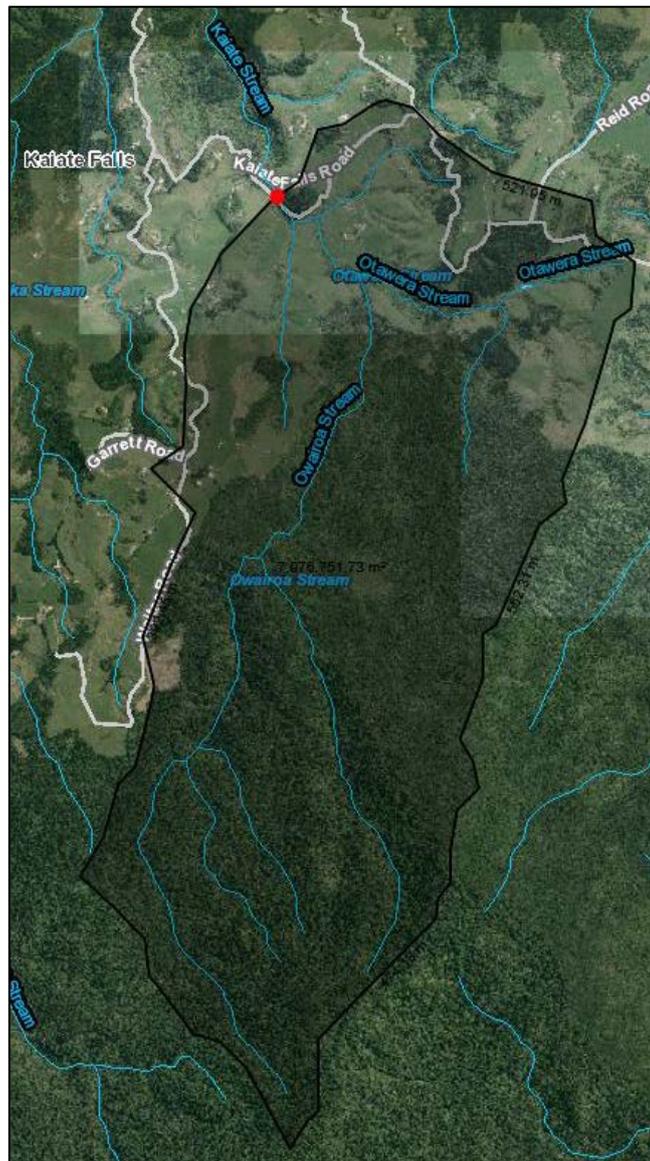
Figure 3.4 Map showing the Kaiate Stream monitoring location at Kaiate Falls Road Bridge (red marker), the catchment (shaded area), and tributaries

The catchment above Kaiate Falls Road Bridge covers an area of approximately 798 ha, where 543 ha (68%) is covered in native vegetation, while the remaining 255 ha (32%) is used for predominately for pastoral farm land, mostly cattle. The Kaiate Stream at the monitoring location is a third-order stream, and its main tributaries are the second-order Owairoa Stream and the second-order Otawera Stream. The Owairoa drains a large proportion of the native bush area, while the Otawera drains both native bush and farmland (Figure 3.4).

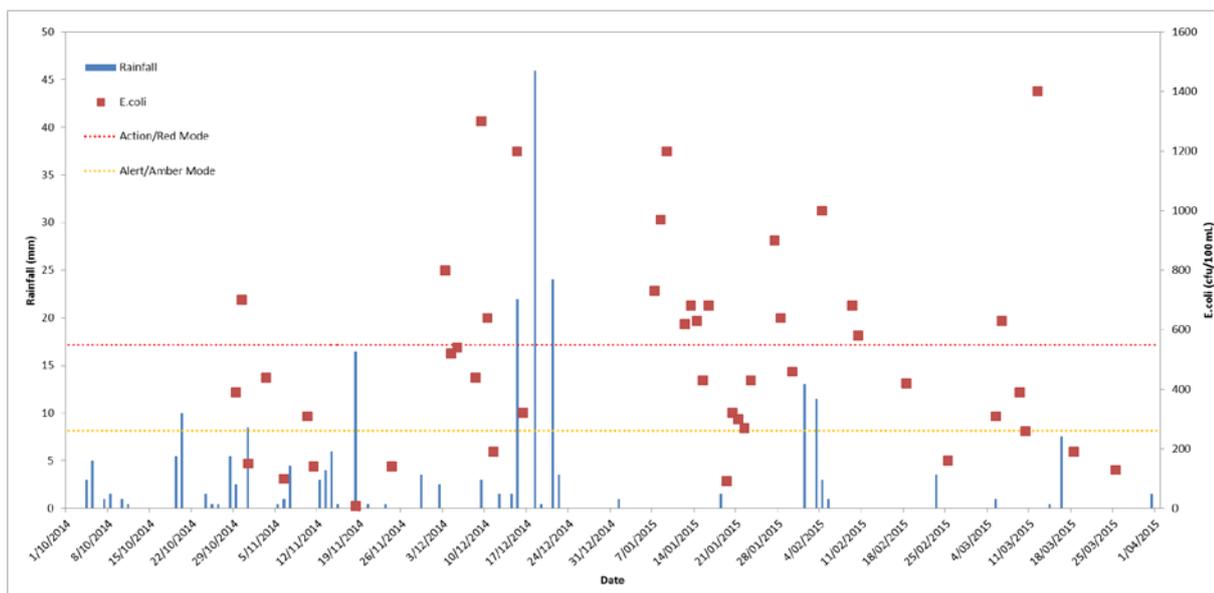
Figure 3.5 Graph of *E.coli* values and rainfall at Waimapu over the 2014/15 bathing season, with respect to the New Zealand Microbiological Water Quality Guidelines (MfE/MoH, 2003)

Throughout the 2014/15 season, Kaiate Stream samples have consistently exceeded guideline values, with extreme values occurring sporadically (Figure 3.5). Although the 95 percentile decreased slightly to 1290 cfu/100 mL, 29% of samples were above the Action/Red Mode guideline, which is a significant increase in comparison to the previous season. As the 2014/15 rainfall totals were similar to that of the previous seasons, the apparent increase in *E.coli* concentration may indicate changes within the catchment.

Rainfall events recorded at Waimapu are also shown in Figure 3.5. *E.coli* concentrations appear to decrease after the relatively large December 2014 rainfall events. However, no significant relationship exists between *E.coli* levels in Kaiate Stream and rainfall at Waimapu, perhaps due to the local spatial variation of rainfall. A rain gauge and a hydrometric instrument at Kaiate Stream would be useful to determine if a relationship exists.

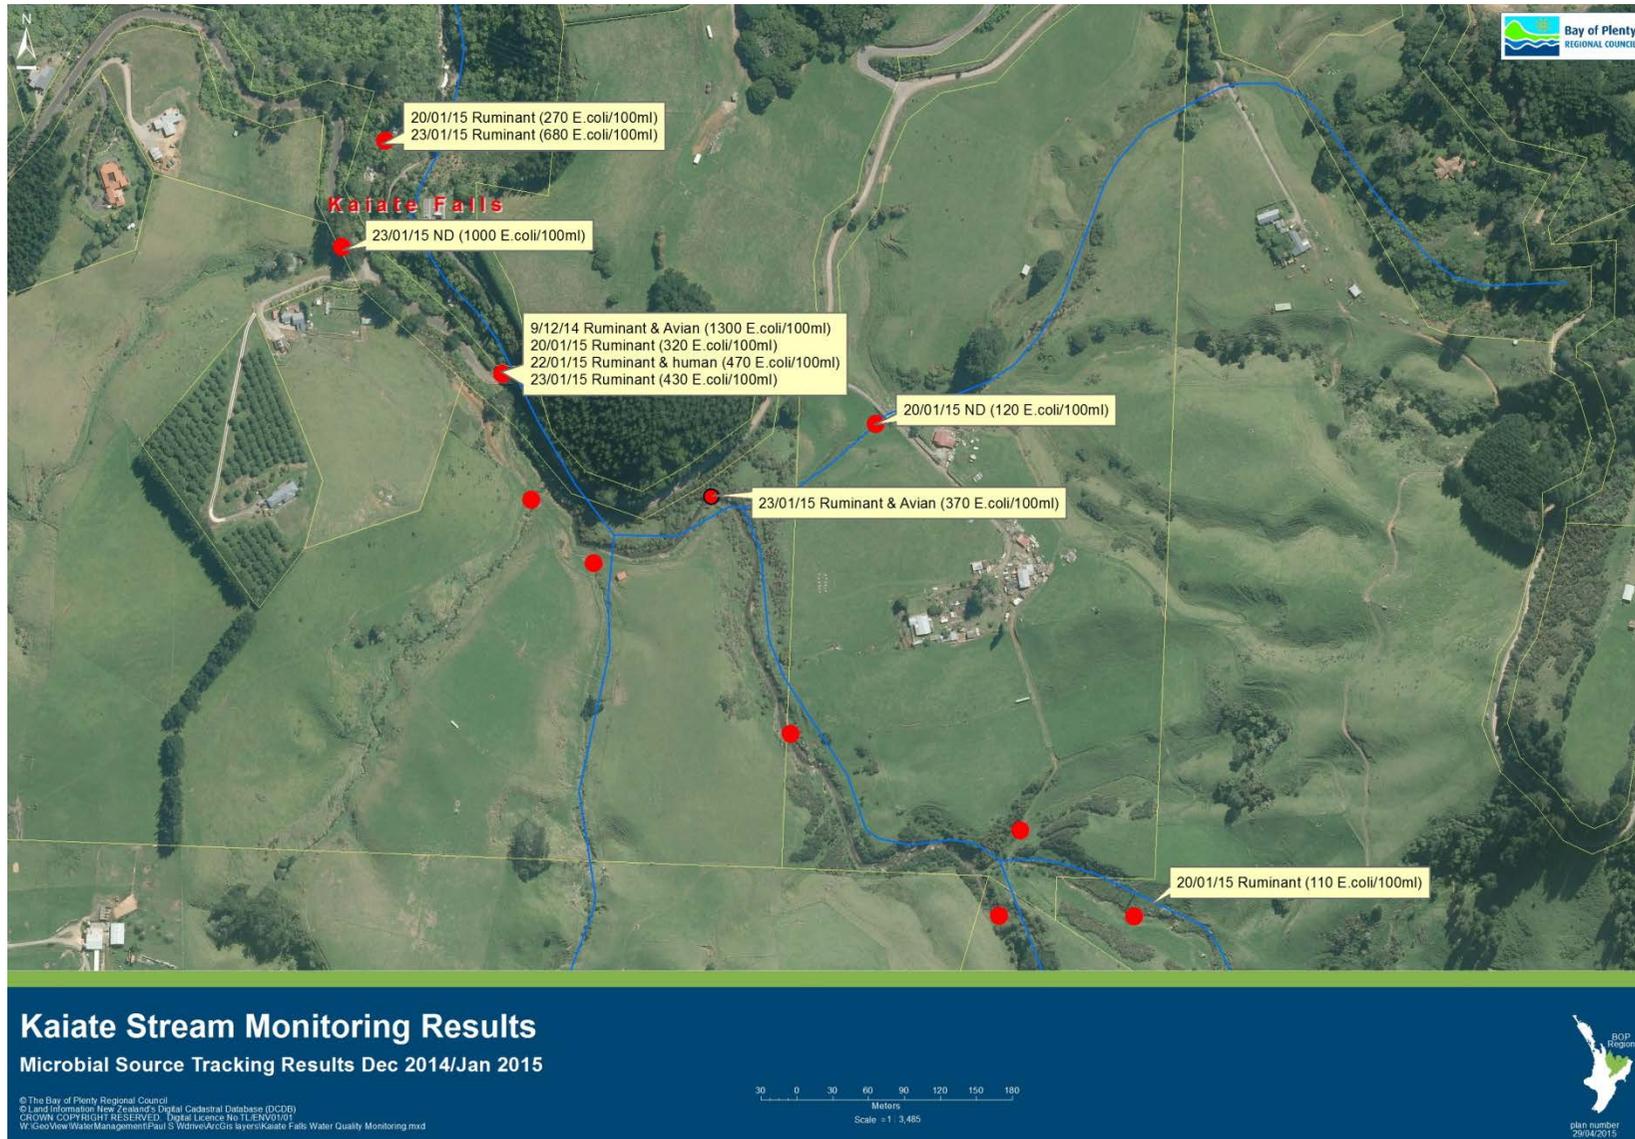
Figure 3.6 Kaiate Stream Microbial Source Tracking results, 2014/15. The site containing four results is Kaiate Falls Road Bridge

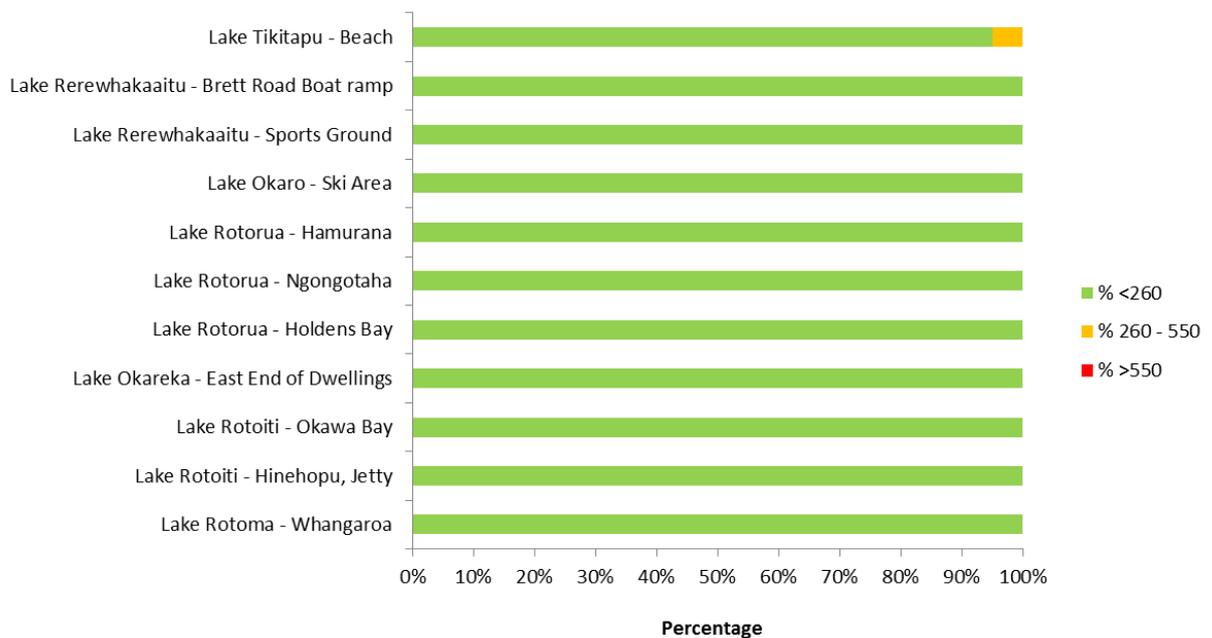
Figure 3.7 Lake *E.coli* levels compared against each of the modes in the NZ Microbiological Water Quality Guidelines (MfE/MoH 2003), 2014/2015 bathing season

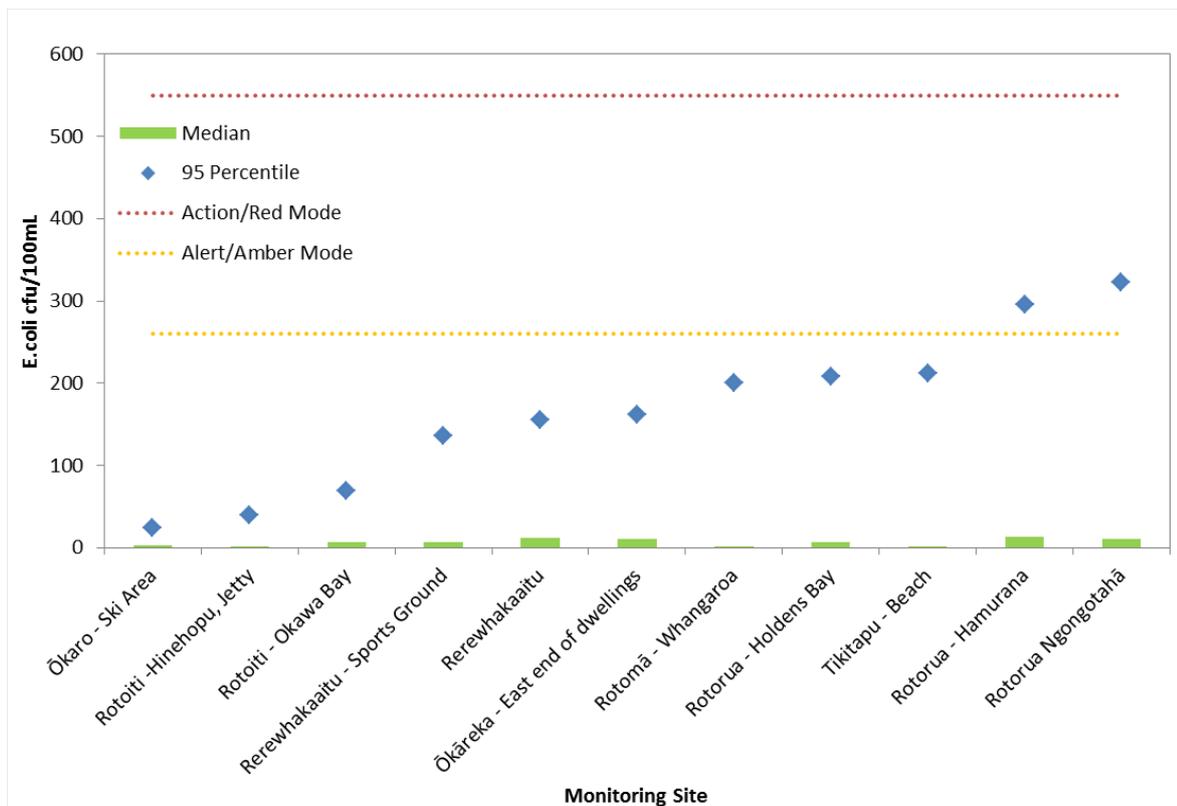
Figure 3.8 Ninety five-percentile and median results of *E.coli* concentrations, lake sites over the past five years

The median *E.coli* concentrations for lake sites were all below 15cfu/100 mL indicating a low level of faecal contamination overall (Figure 3.8). Lake Rotorua at Hamurana had the highest median *E.coli* concentrations of lake sites (13.5 cfu/100 mL), although the site did not reach the Orange/Alert Mode.

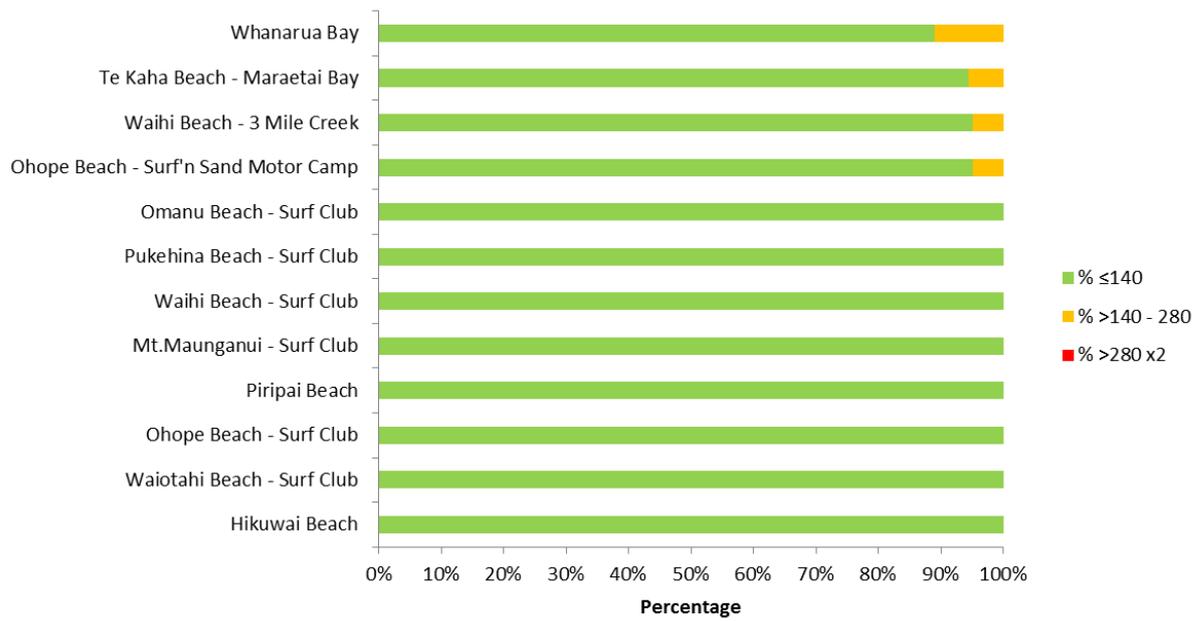
Figure 3.9 Coastal marine enterococci levels compared against each of the modes in the NZ Microbiological Water Quality Guidelines (MfE/MoH 2003), 2014/2015 bathing season.

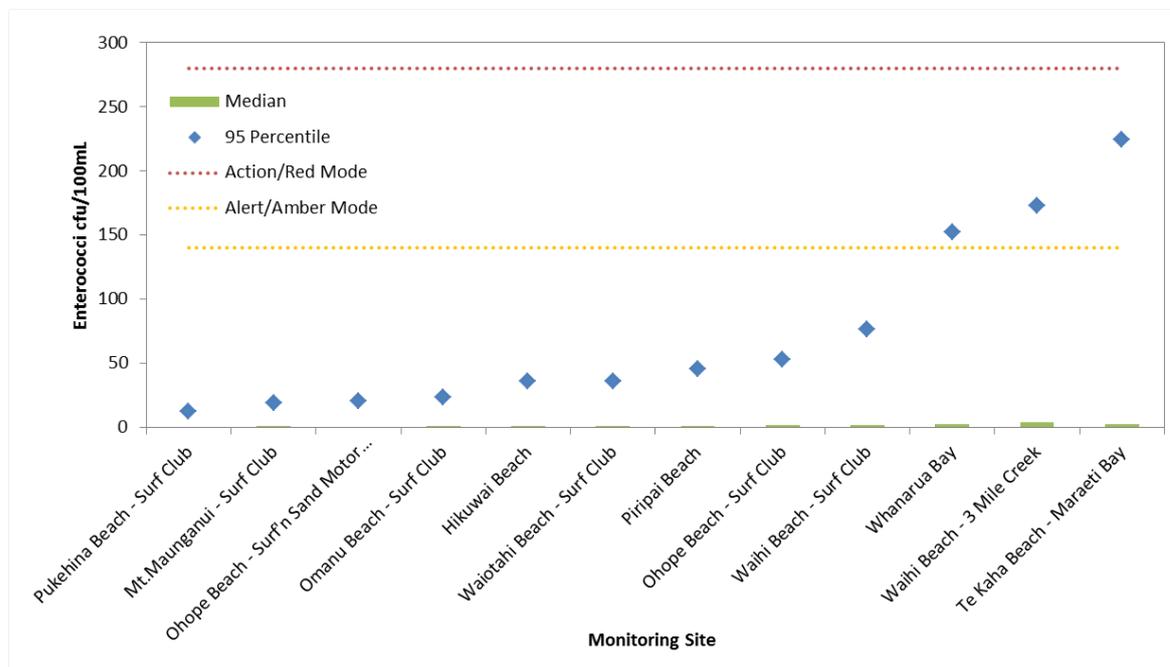
Figure 3.10 Ninety five-percentile and median results of enterococci concentrations, coastal marine sites over the past five years

All 12 open coastal sites had median enterococci concentrations below 5 cfu/100 ml in both 2014/2015 and the last five years. This indicates overall a low level of enterococci indicator bacteria contamination for marine coastal waters in the Bay of Plenty (Figure 3.10).

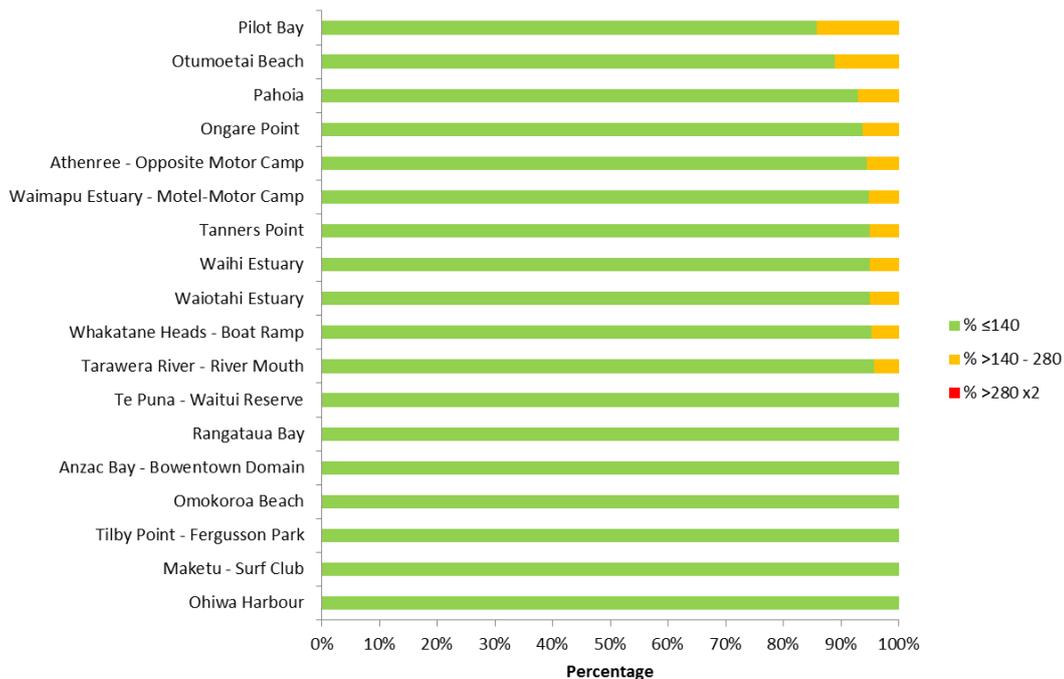
Figure 3.11 Estuarine marine enterococci levels compared against each of the modes in the New Zealand Microbiological Water Quality Guidelines (MfE/MoH 2003), 2014/2015 bathing season

Eleven of the 18 estuarine sites reached the Orange/Alert Mode during the 2014/15 season (Figure 3.11), with no sites reaching Red/Action Mode. Median enterococci concentrations were generally well below the Orange/Alert Mode, with the highest median level of 39 cfu/100 mL at Tarawera River Estuary (Figure 3.12).

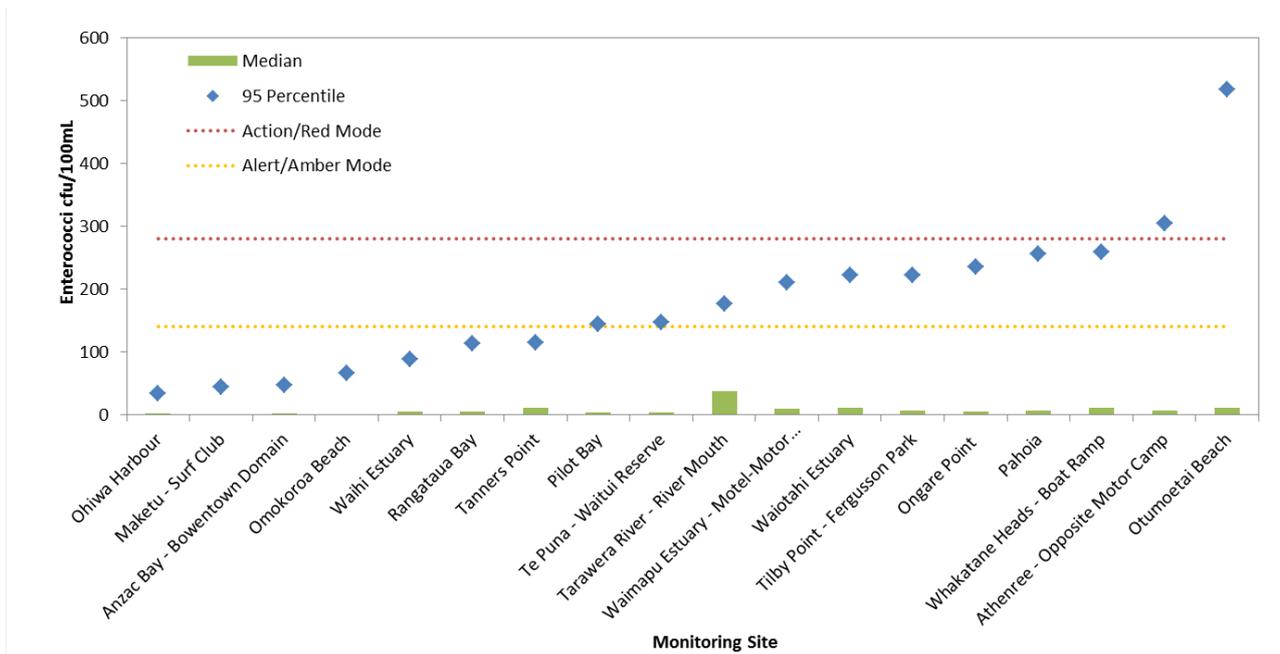
Figure 3.9 *Ninety five-percentile and median results of enterococci concentrations, estuarine marine sites over the past five years*

Athenree and Otumoetai were the only sites with 95<sup>th</sup> percentiles over the Red/Action mode over the last five years (Figure 3.12). This indicates a greater than five percent risk of contact with infectious organisms. The source of bacteria load at Athenree is unclear as the sewerage system, for the community is reticulated. However, the Waiiau Stream enters the harbour nearby and may contribute to the bacteria load, particularly during times of flood. Otumoetai is influenced by the Wairoa River which can also have elevated bacterial levels when in flood. This site can also be influenced by sewage overflows which occur on occasion.

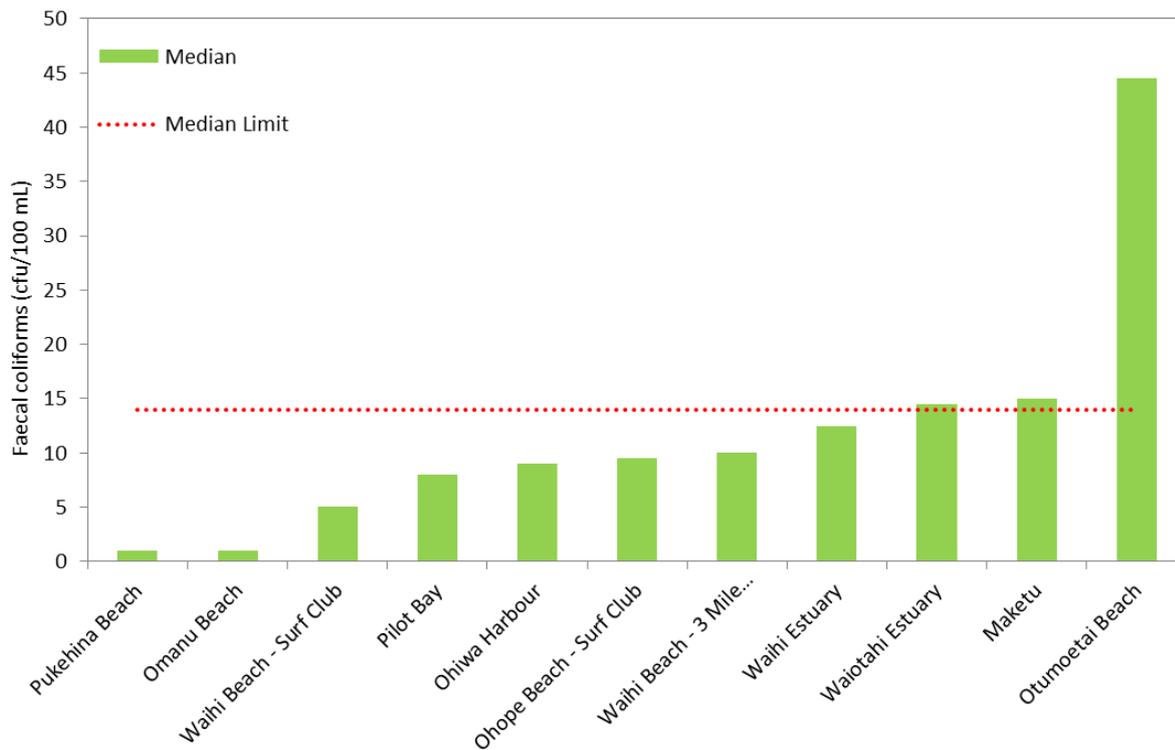
Figure 4.1 Median faecal coliform concentrations at several shellfish gathering locations, with the 14 cfu/100 mL MPN limit from the New Zealand Microbiological Water Quality Guidelines (MfE/MoH 2003)

Results for the FC sampling over the 2014/15 bathing season are presented in Figure 4.1. The median faecal coliform concentrations were found to be over the MoH safe consumption guideline of 14 MPN/100 mL at Waiotahi Estuary, Maketū and Otumoetai Beach. Figure 4.2 shows the percentage of samples with FC concentrations above 43 cfu/100 mL, with reference to the 10% limit. It reveals that Otumoetai, Waiotahi Estuary, Waihi Estuary, Pilot Bay, and Maketū all exceed the guideline. Most other sites were within safe consumption limits. Every sample taken at Pukehina Beach, Ōmanu Beach, and Waihi Beach at the Surf Club had FC concentrations below 43 cfu/100 mL.

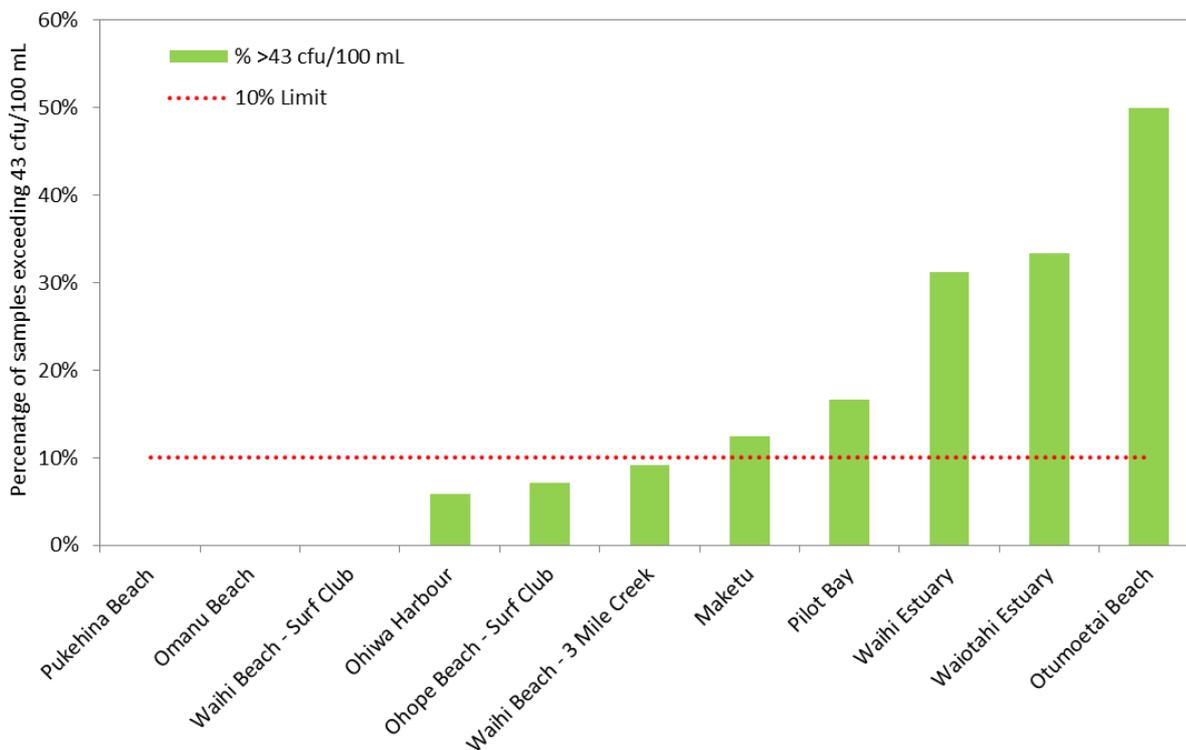
Figure 4.2 Percentage of samples exceeding the limit of 43 cfu/100 mL stipulated by the NZ Microbiological Water Quality Guidelines (MfE/MoH 2003) for the 11 marine sites

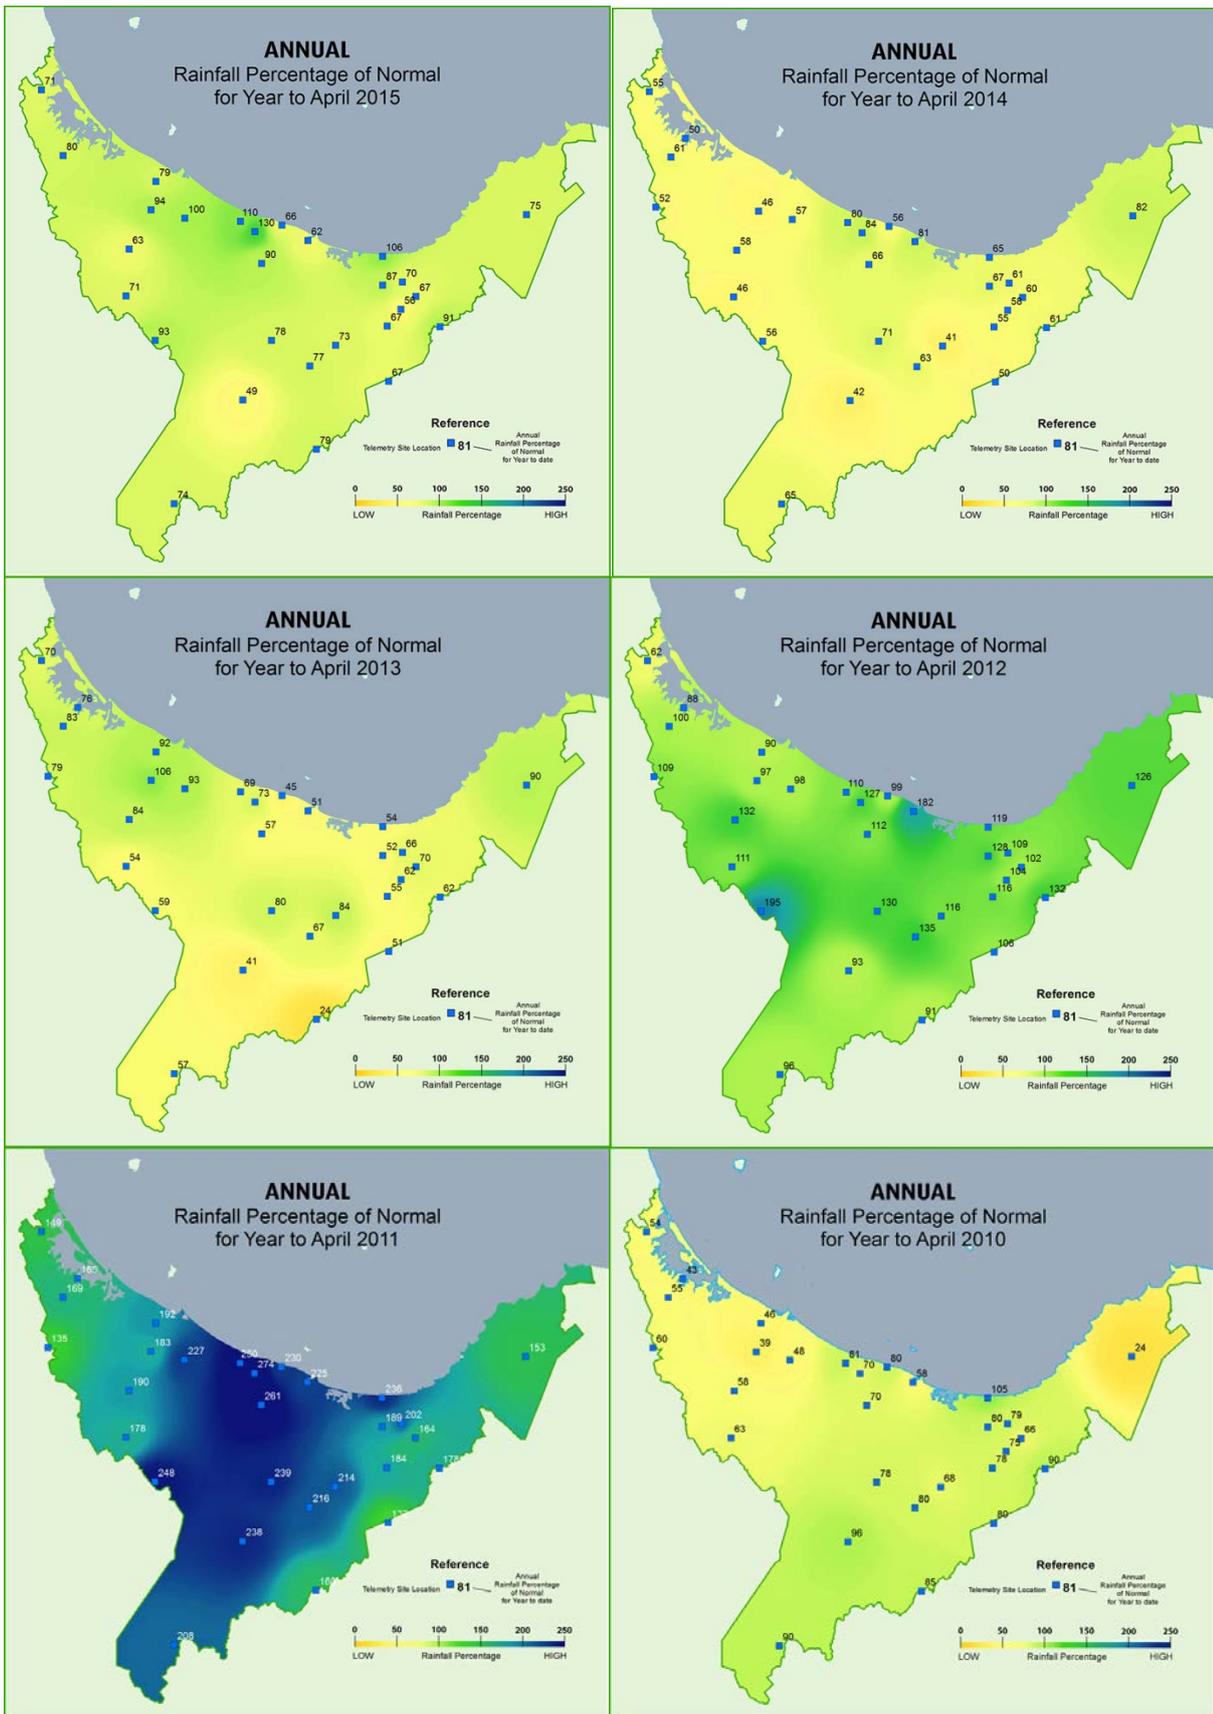
Figure 5.1 Annual rainfall percentage of normal for years 2010 to 2015

The 2014/15 season for the rivers in this relatively dry summer (see Figure 5.1) showed that 11.0% of samples reached the Orange/Alert Mode and 7.0% reached the Red/Action Mode. Of the total samples (1251) analysed for indicator bacteria, only 3.0% activated the Orange/Alert Mode and 2.5% the Red/Action Mode.
