NERMN River and Stream Channel Monitoring Programme - 2002/03, 2003/04, 2004/05 and 2005/06

Environment Bay of Plenty
Environmental Publication 2006/15
September 2006

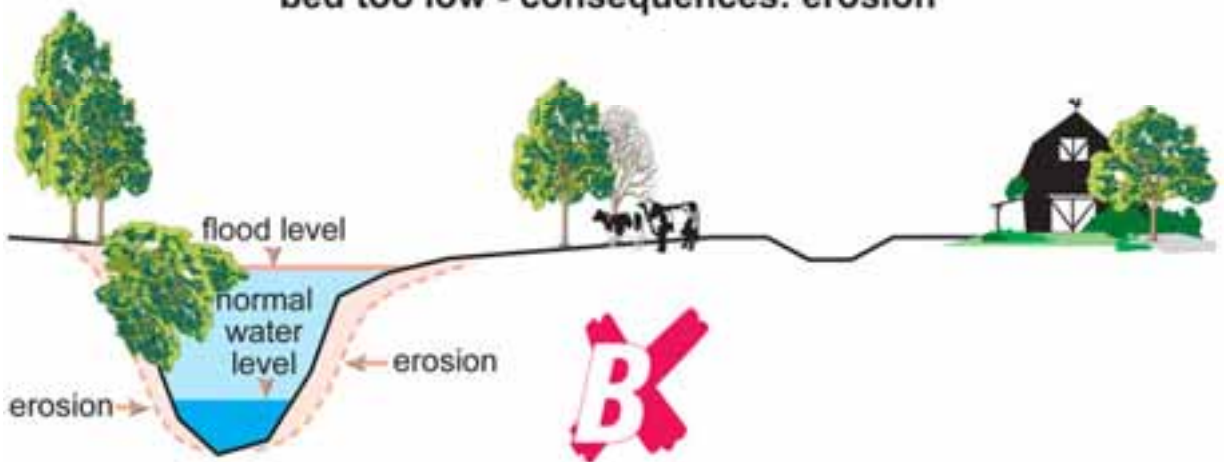
bed too low - consequences: erosion

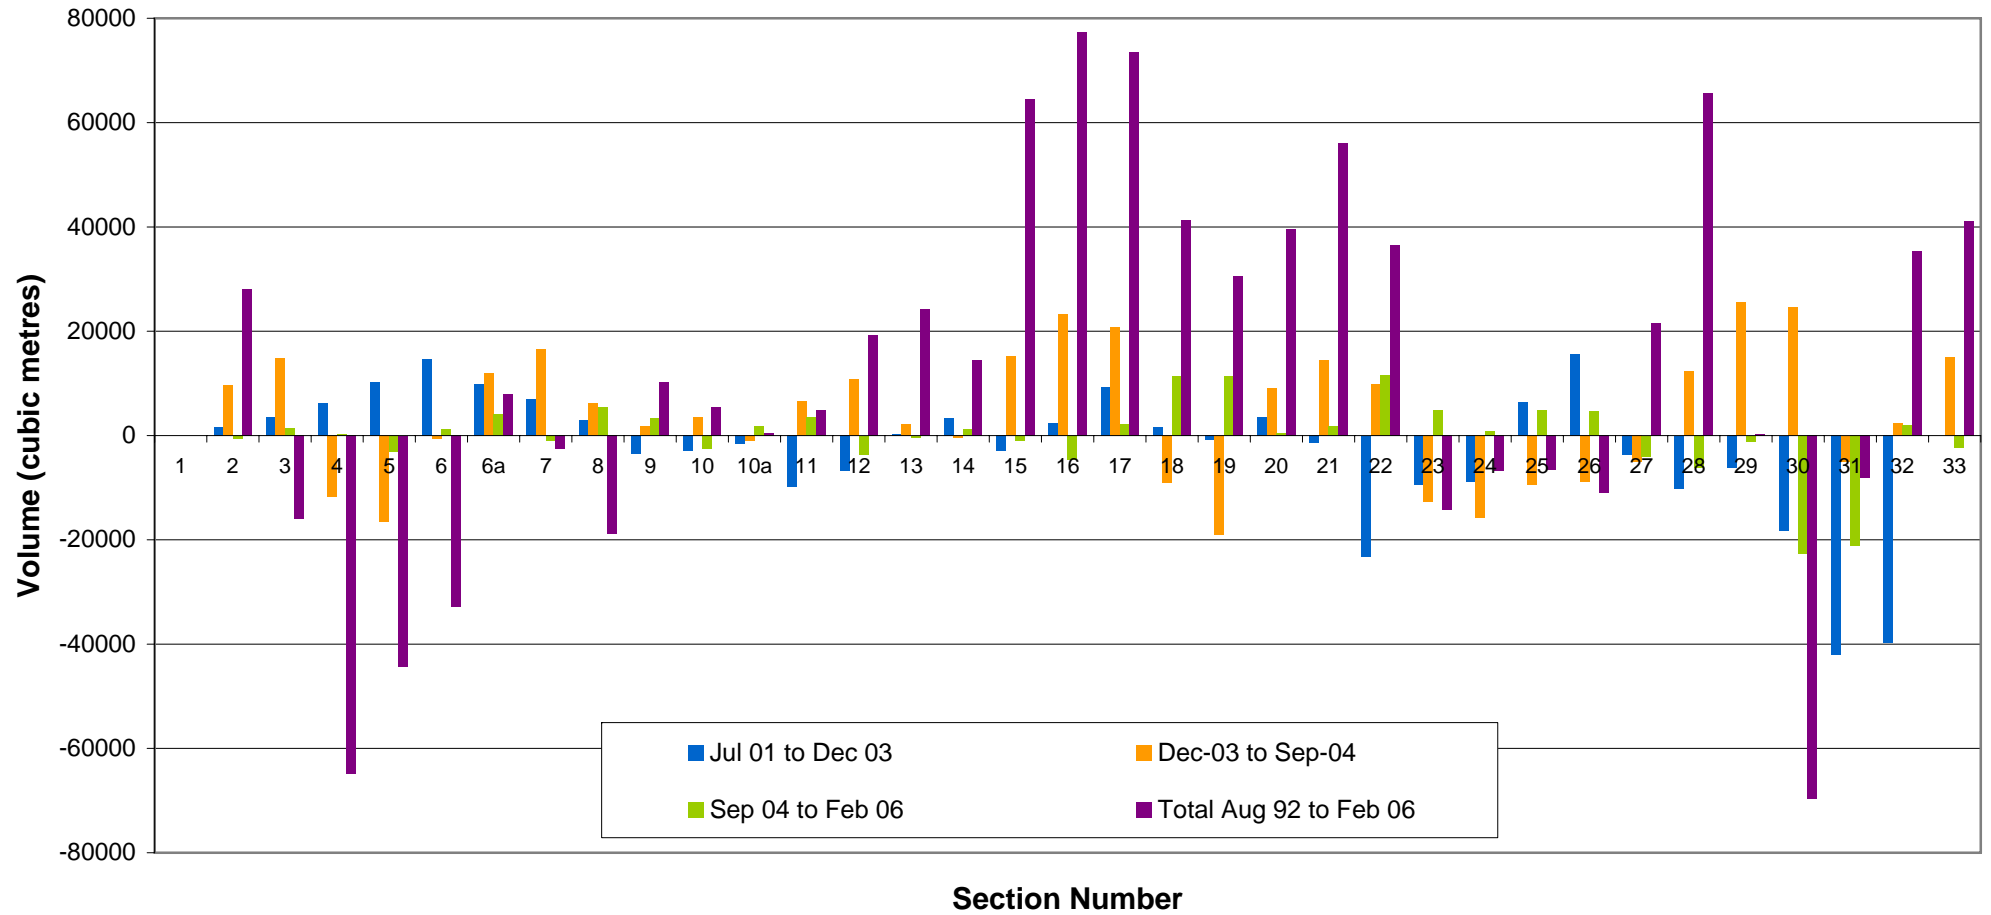
Waimana River Volume Changes - Full Width

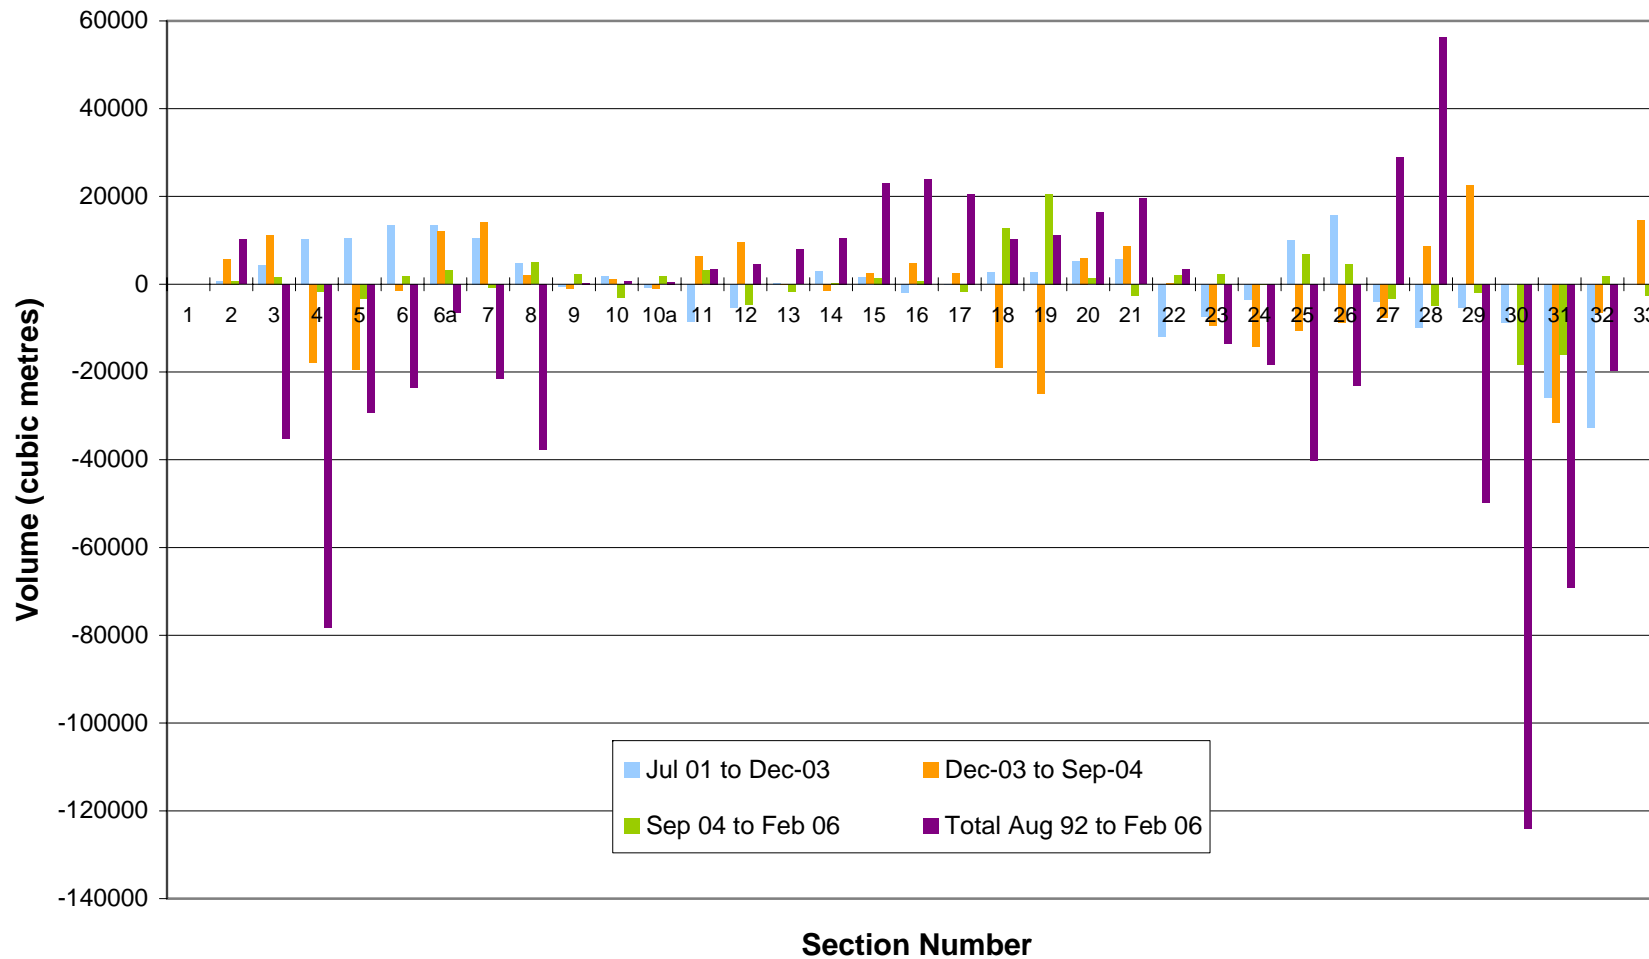
Waimana River Volume Changes - Active channel

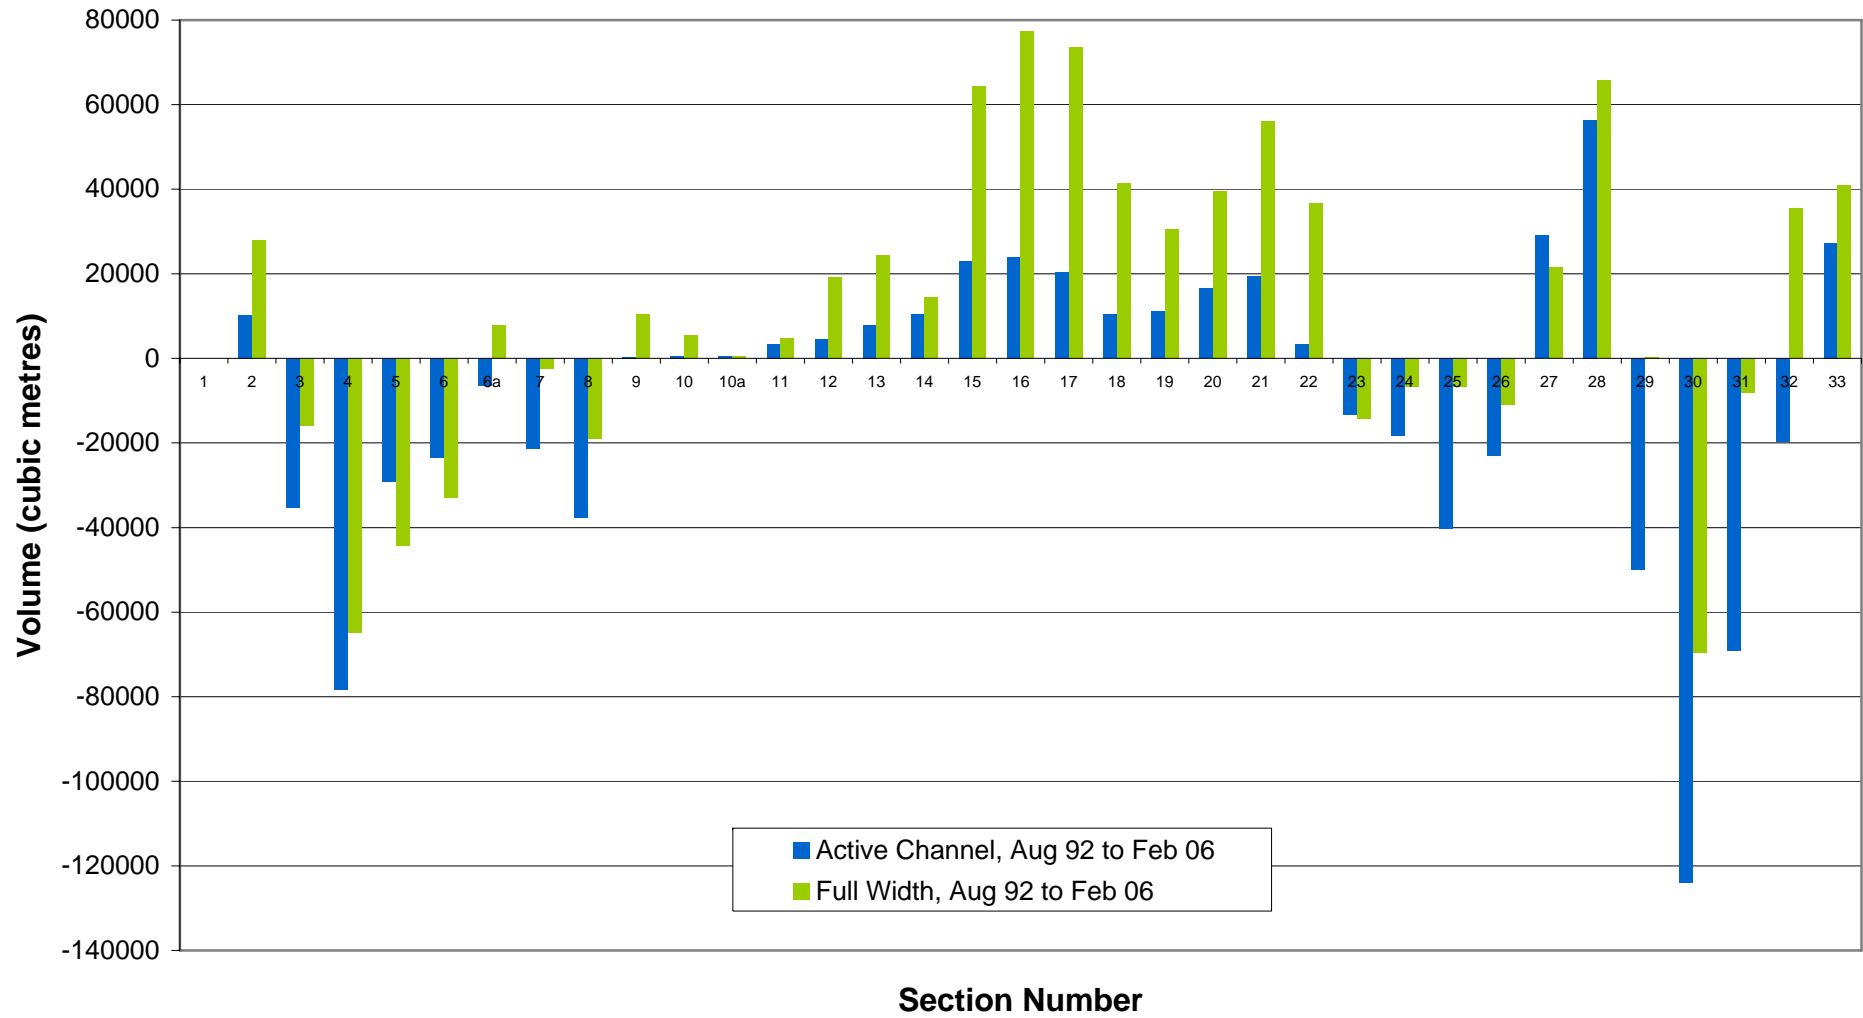
Waimana River Volume Changes

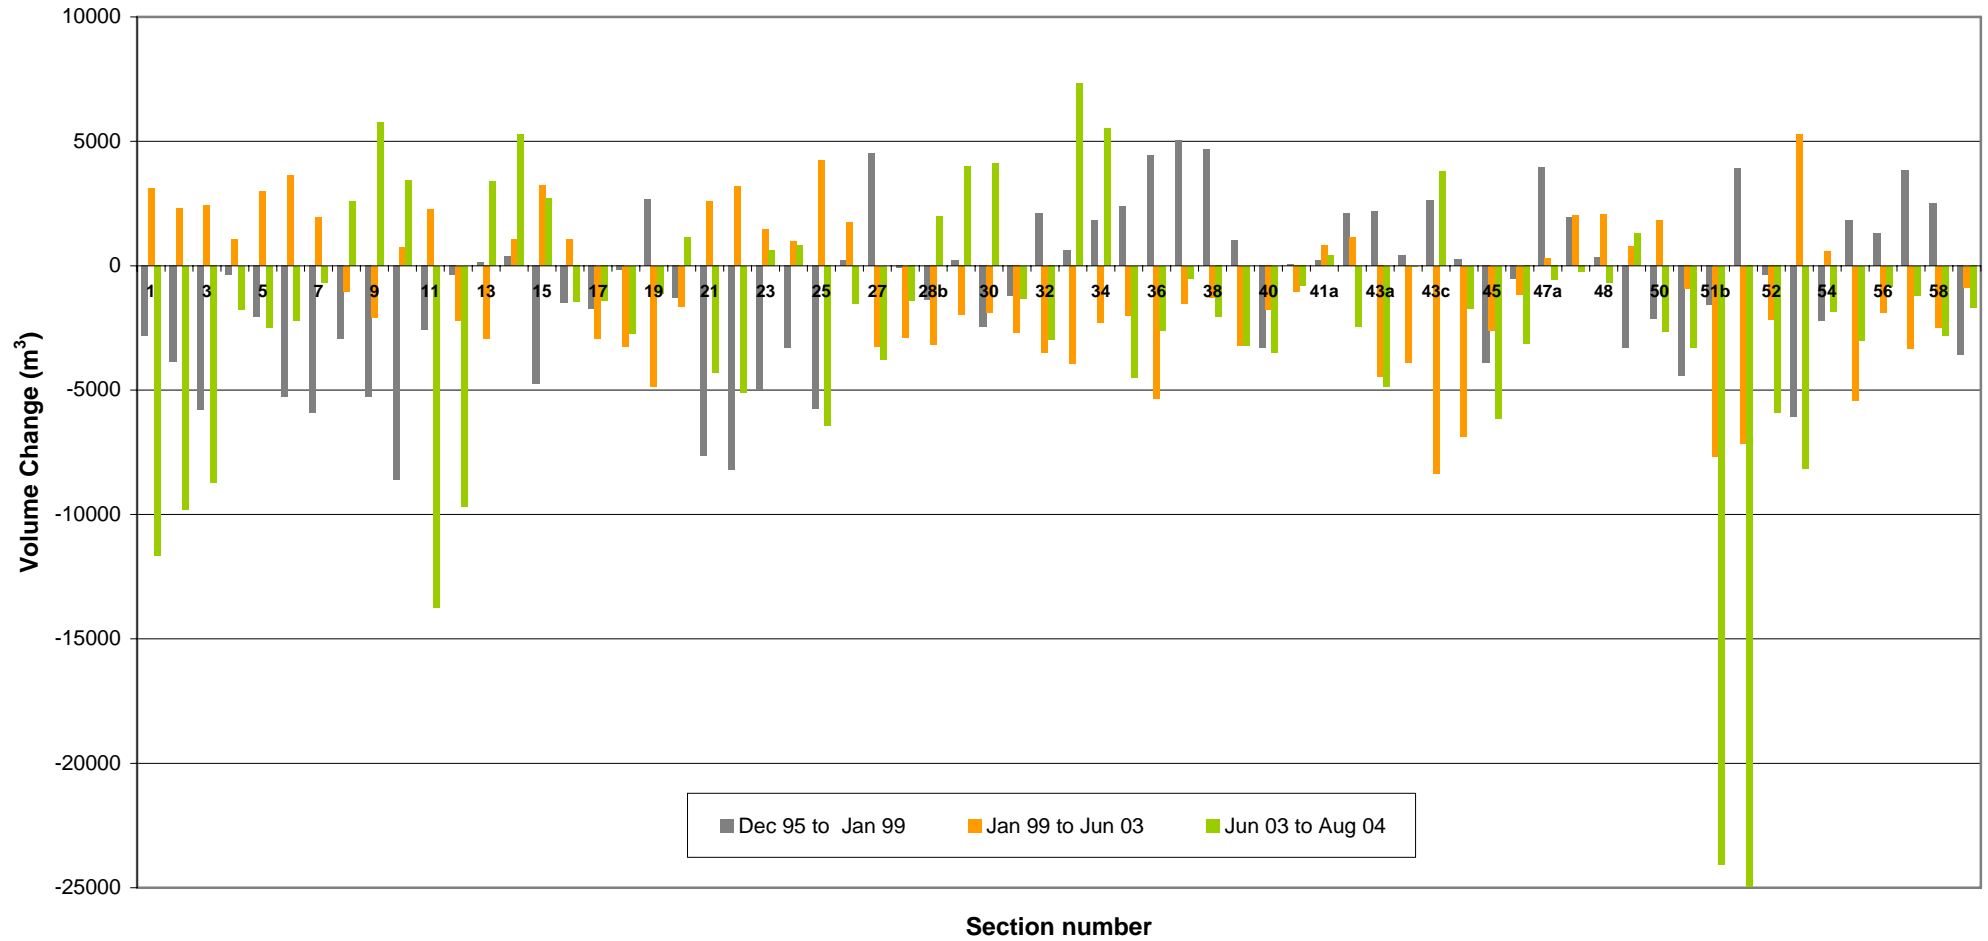
Rangitaiki River Volume Changes below Te Teko

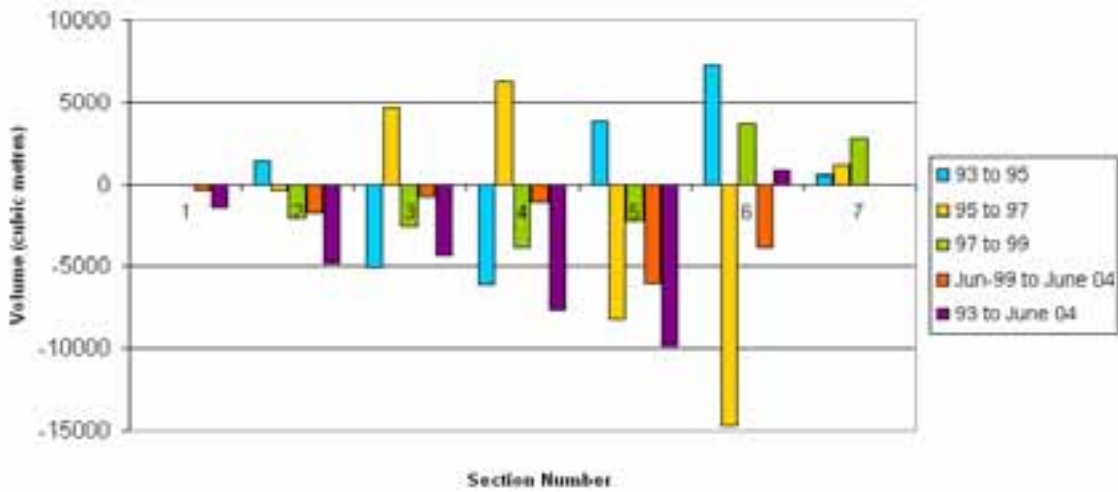
Ohutu Stream Volume Changes

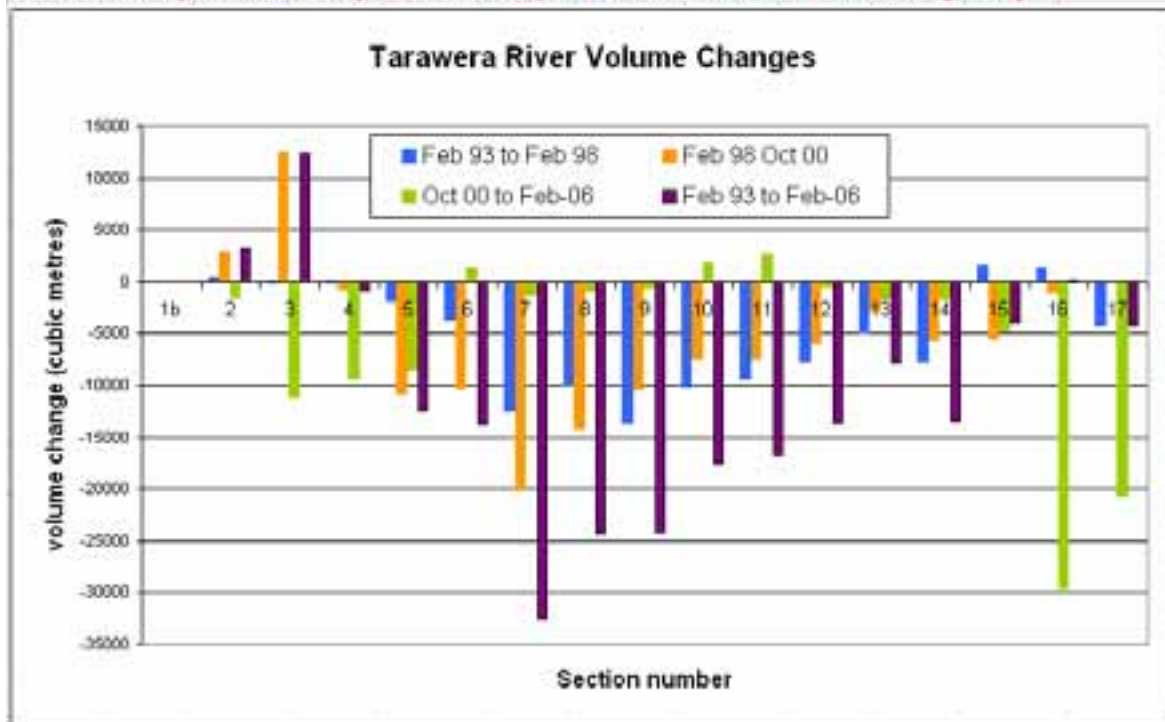
benchmarks re surveyed since 2000 survey ->> benchmarks approx. 200mm lower than before ->> volume change too high!!!!
