Transpower HAI–MTM A and B lines: archaeological assessment

**report to
Transpower**

Date: 13 July 2017

Reference: 16-0703

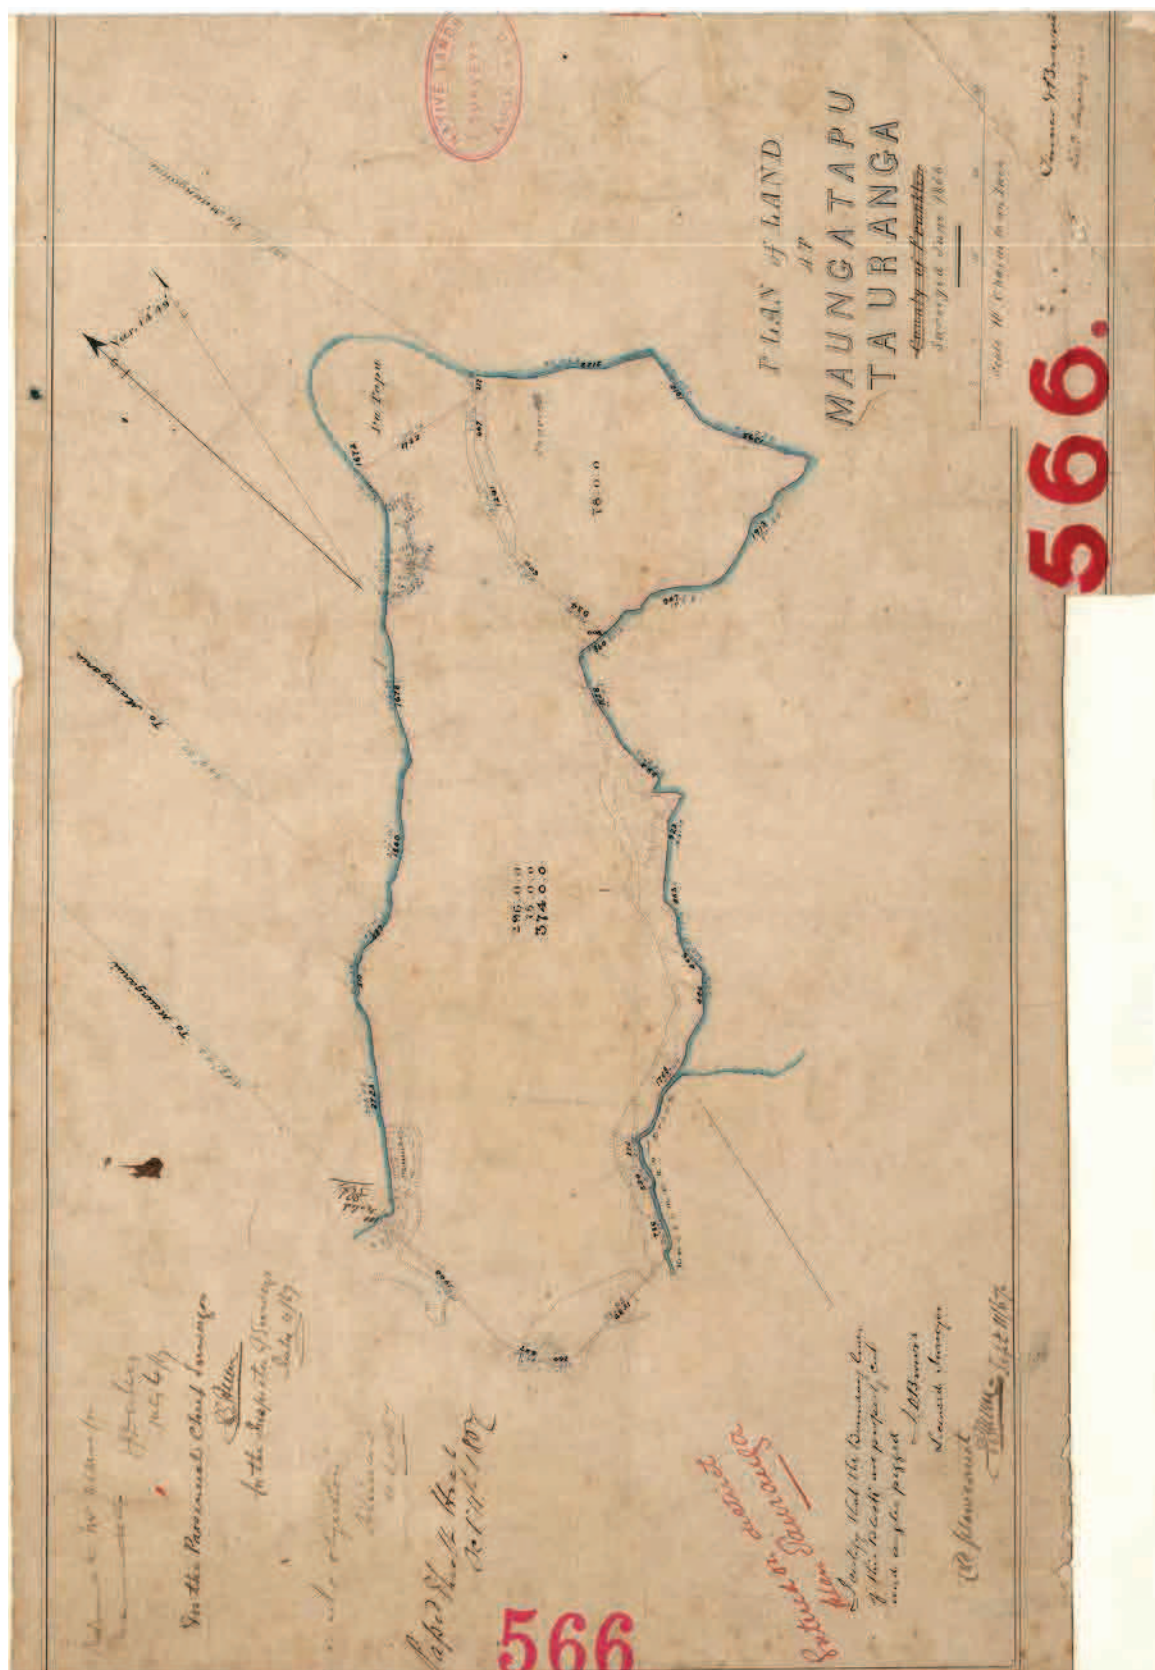
Figure 2. ML 566, drawn in 1866, showing Te Pa o te Ariki on the north east.

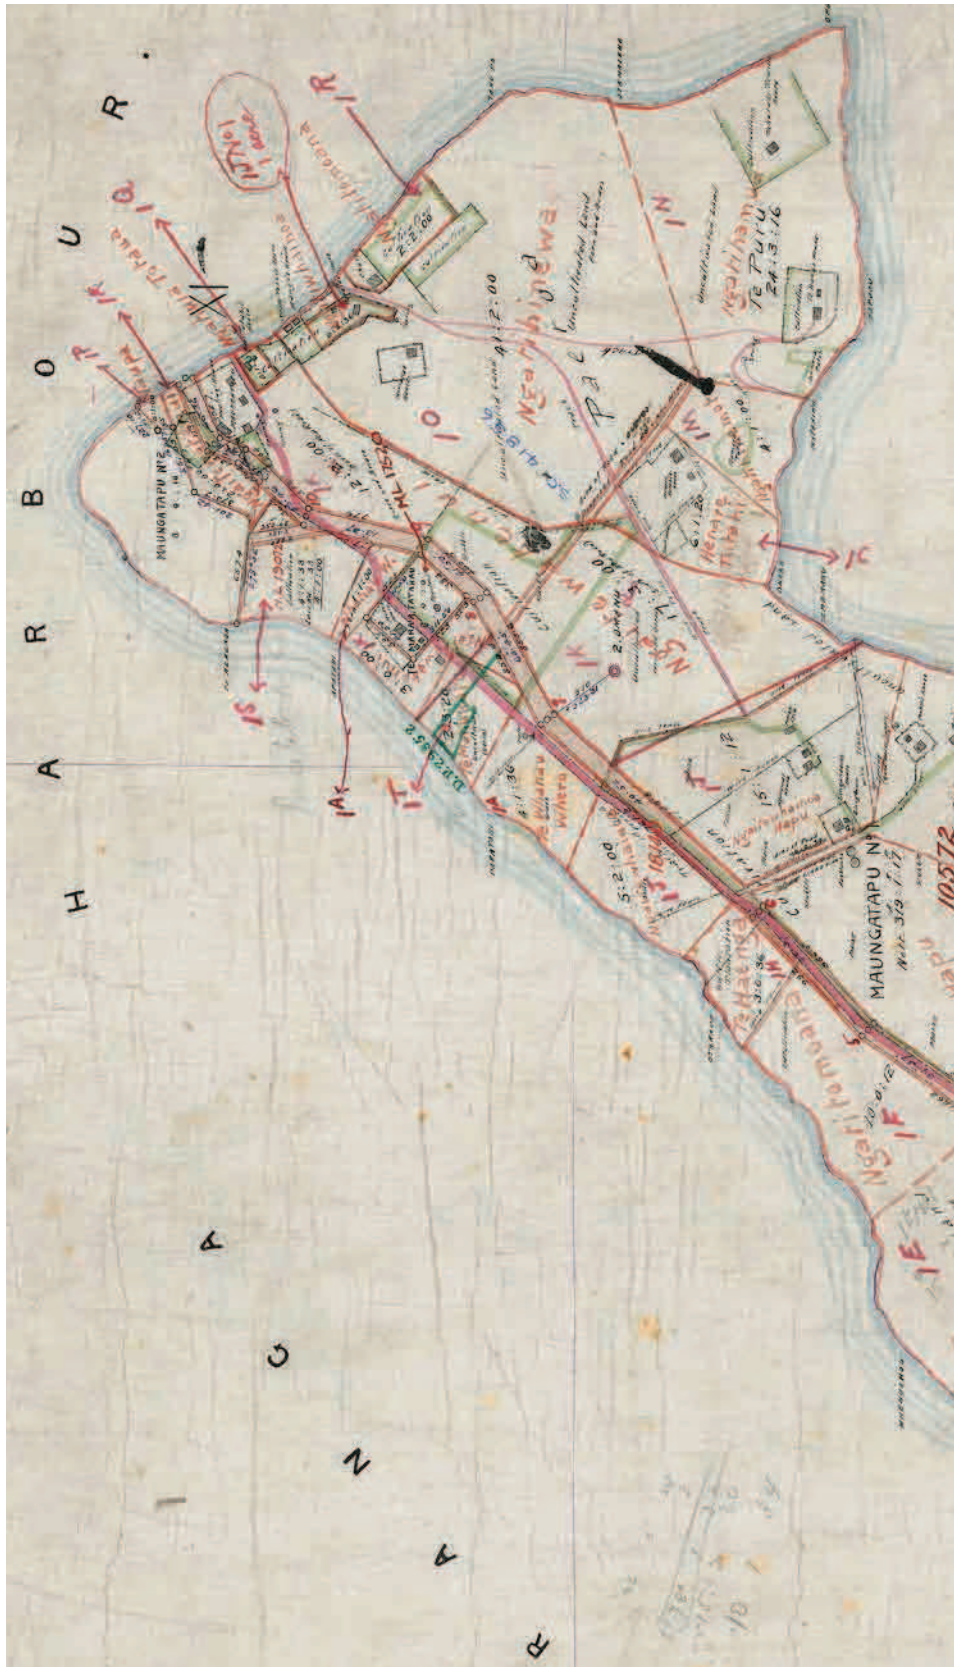
Figure 3. Detail of ML 5924-6, drawn in 1885, showing Te Pa o te Ariki (SRS U14/175).

Several European traders followed Tapsell to settle in villages around Tauranga Harbour. One of these villages was Maungatapu, where four Europeans were living by 1831 (Stokes 1980: 58). During the following decade sporadic European visits were interspersed with musket warfare. Maungatapu was visited again in 1852 by the H.M.S *Pandora*, which documented the pa surrounded by a stockade and deep trench, with many people living both on the pa and in houses surrounding it. In 1865 Tauranga's tribal land was confiscated by the Crown under the New Zealand Settlements Act 1863, after involvement in the Waikato Land Wars. Survey Plan ML 566, dated to 1866 shows Te Pa o te Ariki (Figure 2). The peninsula was surveyed again in 1885; ML 5924-6 shows the pa clearly identified as well as house sites and potentially an urupa is recorded (Figure 3). There is also a watercolour painted in 1863 of Maungatapu,

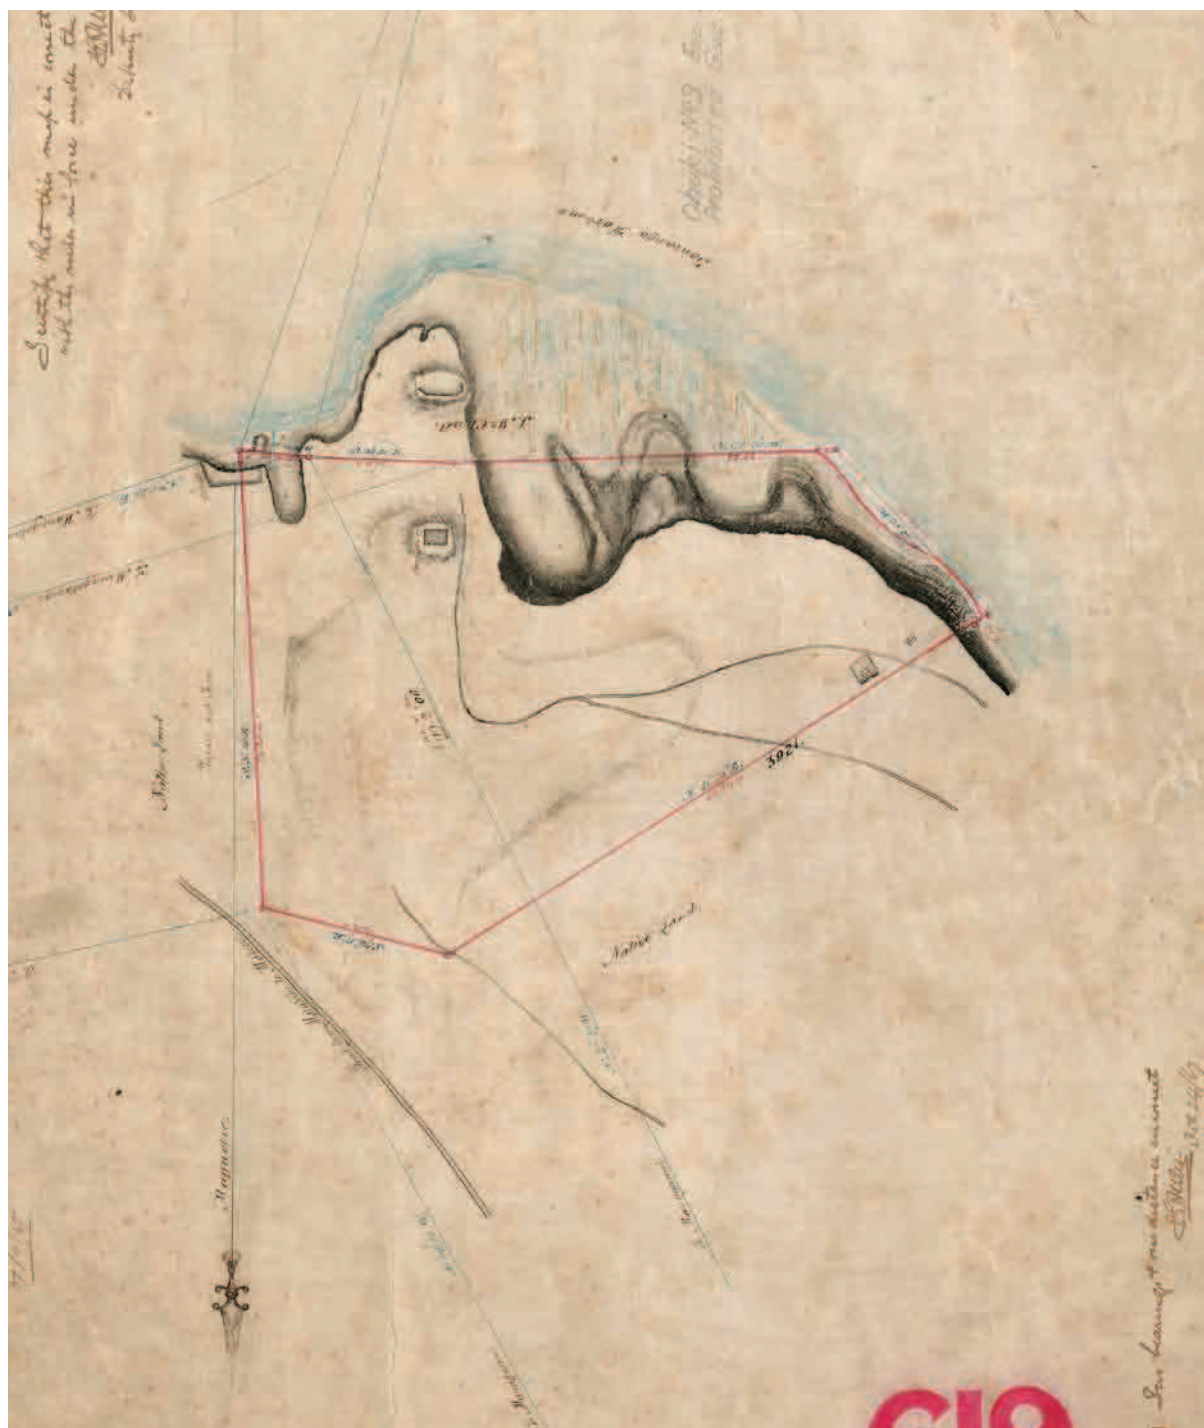
Figure 5. Detail of ML 619, drawn in 1867, showing U14/201 on the southern tip of the peninsula, and several other fortifications along the coastline (note north is to the left of the image).

Very little is recorded on European occupation of the Matapihi side of the harbour, other than a row boat ferry service established in 1873 between Matapihi and Te Papa (which was the centre of Tauranga Township at the time) (Bellamy 1982). Maungatapu remained a village settlement until the early 1900s, providing goods and services to Tauranga until the mid-1900s when Tauranga's residential expansion engulfed Maungatapu as a suburb. A survey plan of ML 619 shows the land hosting several fortified sites, drawn in 1867 (Figure 5). One of these is the coastal pa U14/201. Several other elevated sites are seen on the map which are currently unrecorded archaeologically.

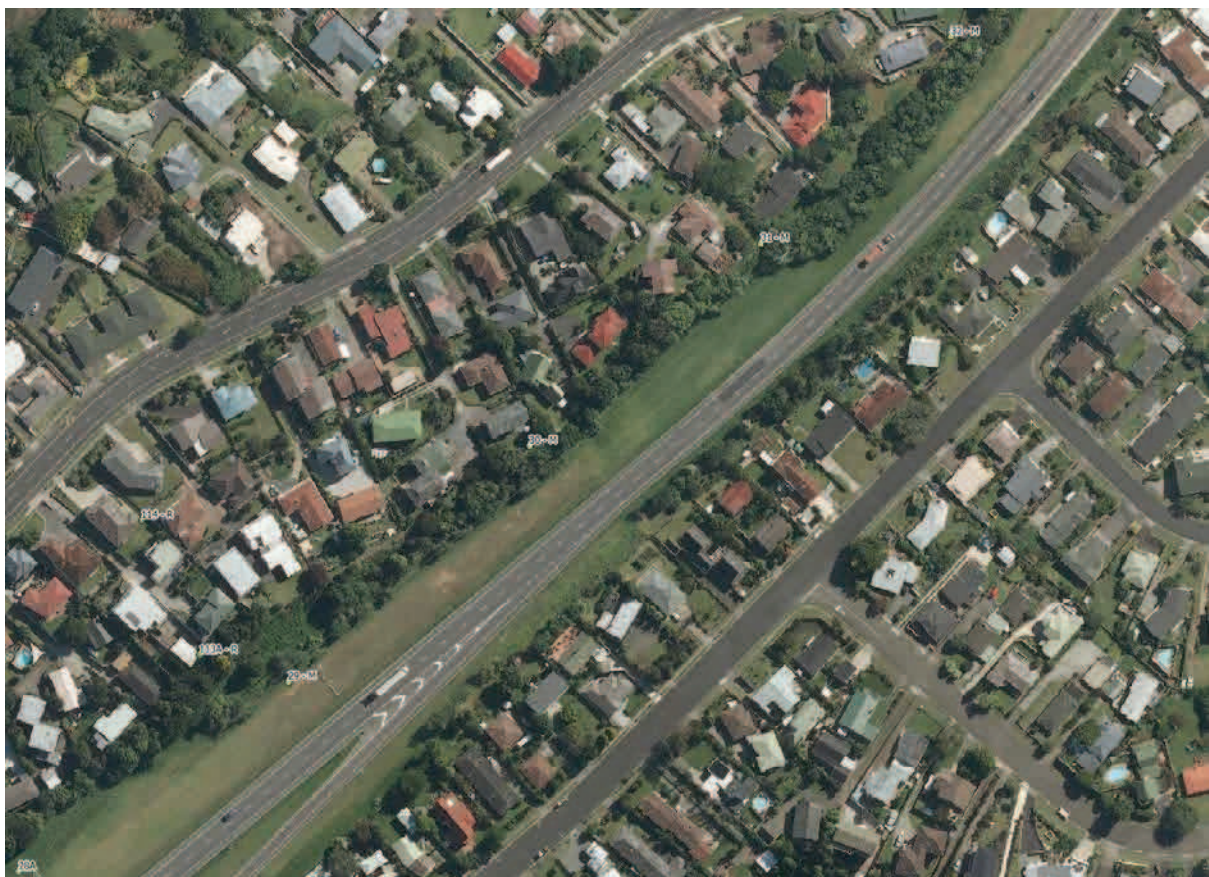
Poles 28–32 will be moved within a 5 m window to either side of their current location at the highway's western easement (Figure 6). There were no visual or probing indicators of archaeological material within the window of the works at these poles, most were within the dense overgrown bush on runs down a high and gently sloping rise southwest to northeast over approximately 800 meters.

Figure 6. Aerial photograph of the State Highway 29 west easement showing the locations of Poles 28–32.

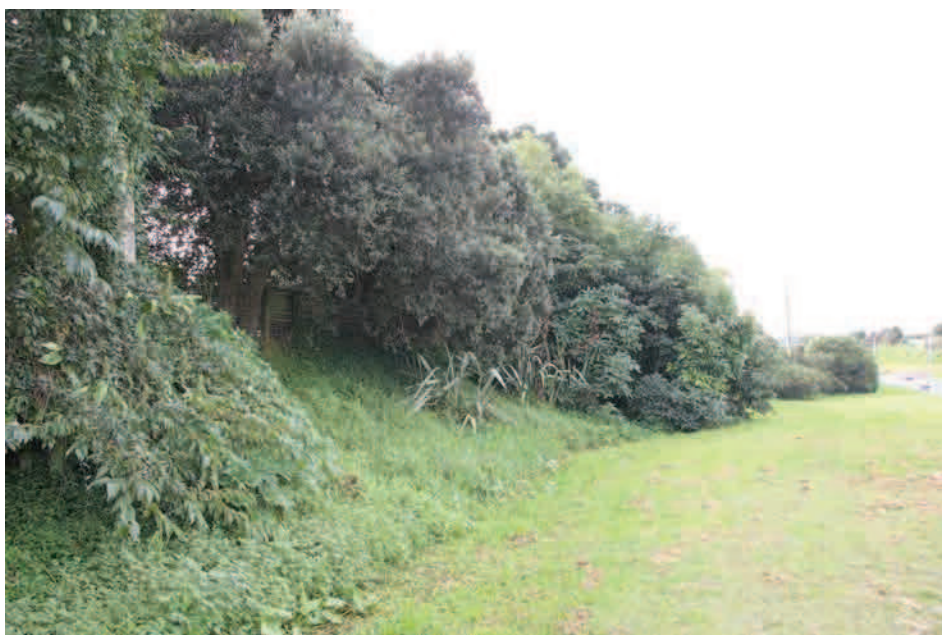
Figure 7. Pole 30 in the foreground to the left, showing the dense bush near the poles impacting the quality of the visual survey.

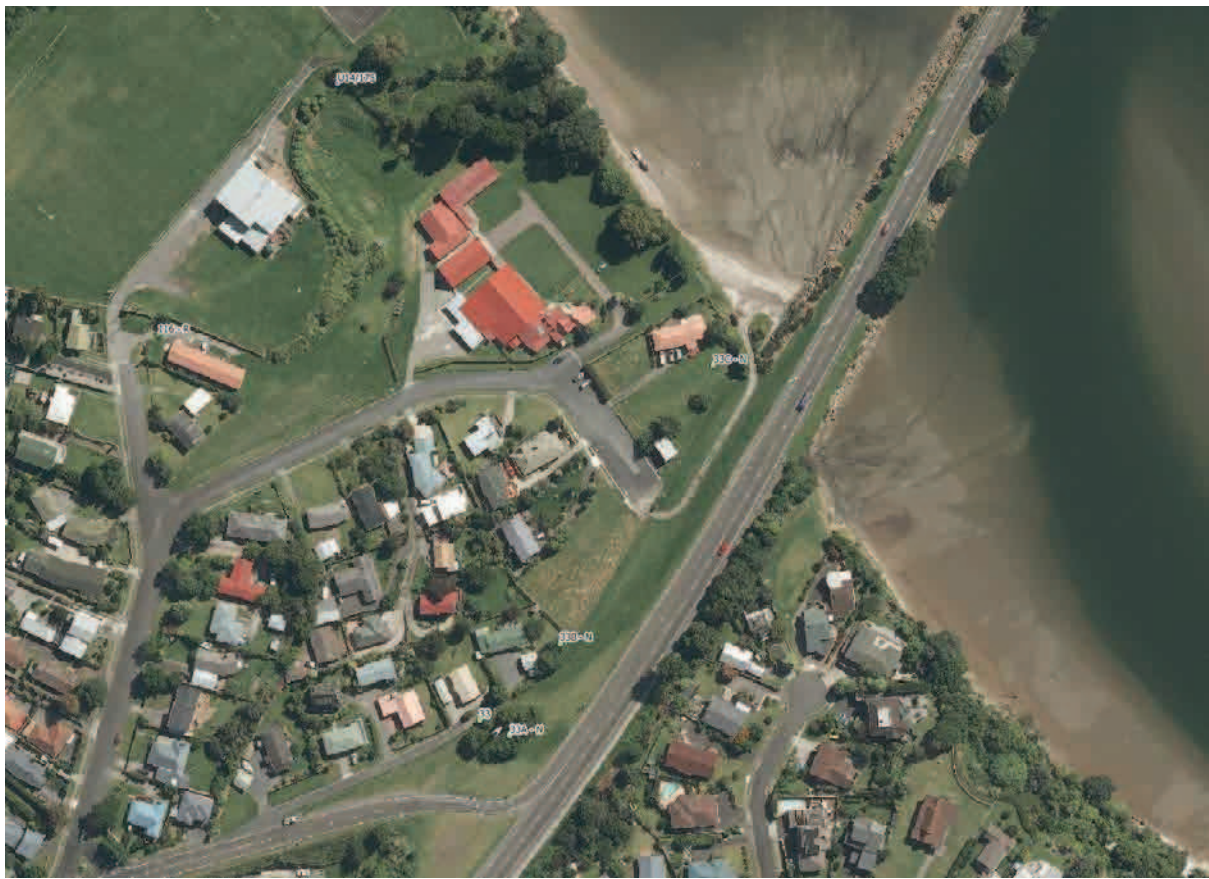
These new poles will be installed within the marked occupation area of Te Pa o te Ariki (U14/175), as shown after pre-European archaeological features were found during the investigations of earthworks at Wikitoria Pump Station (Mallows, 2011). The surveyed areas for the poles did not provide any visual or probing archaeological indicators during the site visit.

Figure 8. Aerial photograph of the State Highway 29 west easement with pole positions 33a–33c plotted and labelled.

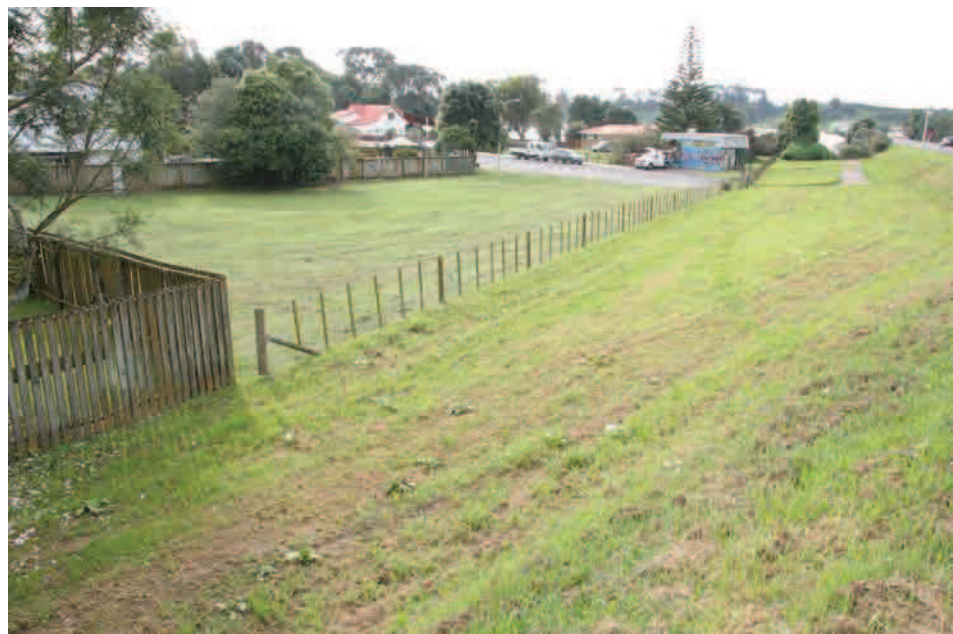
Figure 9. The area where 33B and 33C will be placed, facing north east, showing the likely lack of modification to the area. Wikitoria pump station is to the left of the photograph.

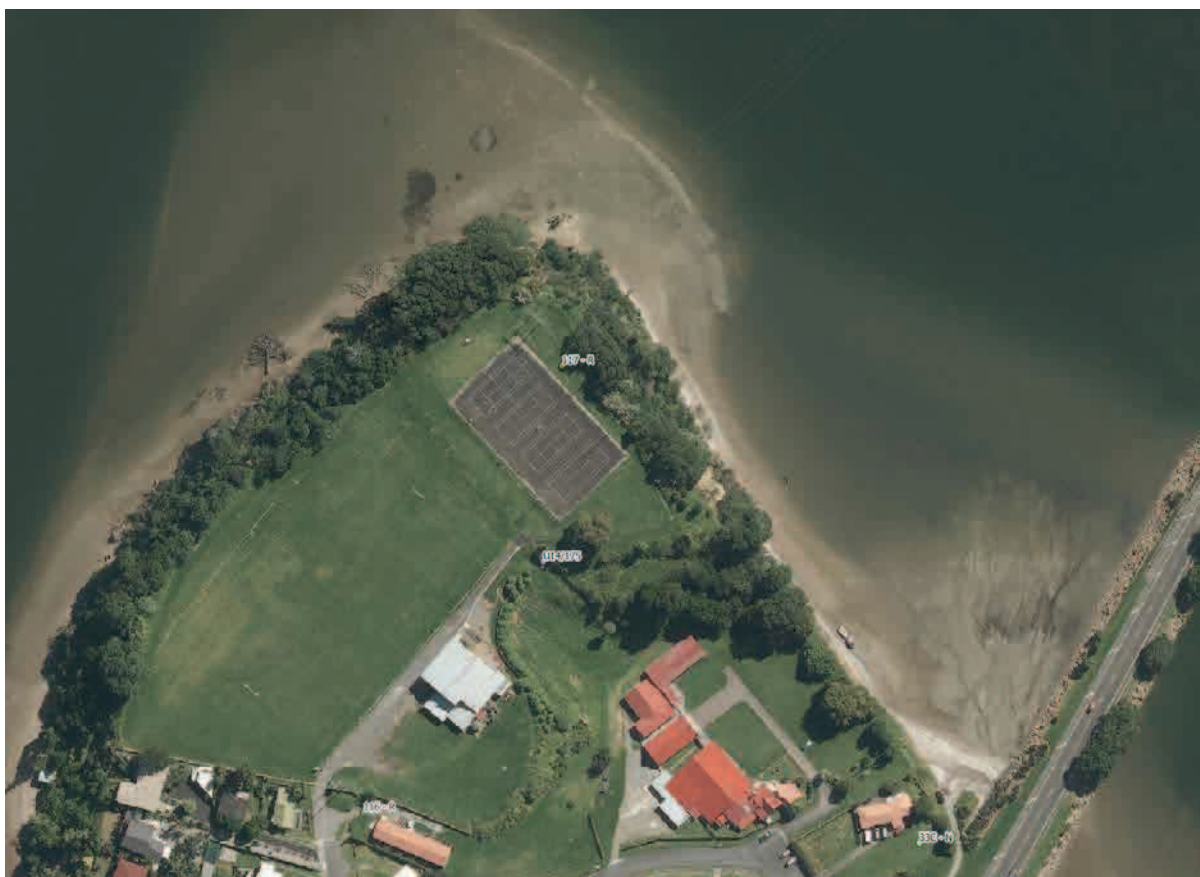
Poles 116 and 117 are both double-posted poles (pi poles) which are currently on the Ariki Sports field, which is also the location of Te Pa o te Ariki (U14/175) (Figure 10). Pole 116 is at the south eastern end of the high point on the park, before the slope runs east and south (Figure 11). The survey detected loosely packed midden 60 mm below the ground surface. Probing around Pole 117 did not detect any midden, and there were no exposed surfaces where subsurface features may have been visible, the grass near the poles were very overgrown (Figure 12). Pole 117 is fairly close to the cliff edge of the pa (approx. 15–25 m), and the surrounding land to both poles is very likely subsurface archaeological remains related to the pa. Both Poles 116 and 117 are to be removed.

Figure 10. Aerial photograph of Arika Park (Te Pa o te Ariki, SRS: U14/175) with pole positions 116–117 plotted and labelled.

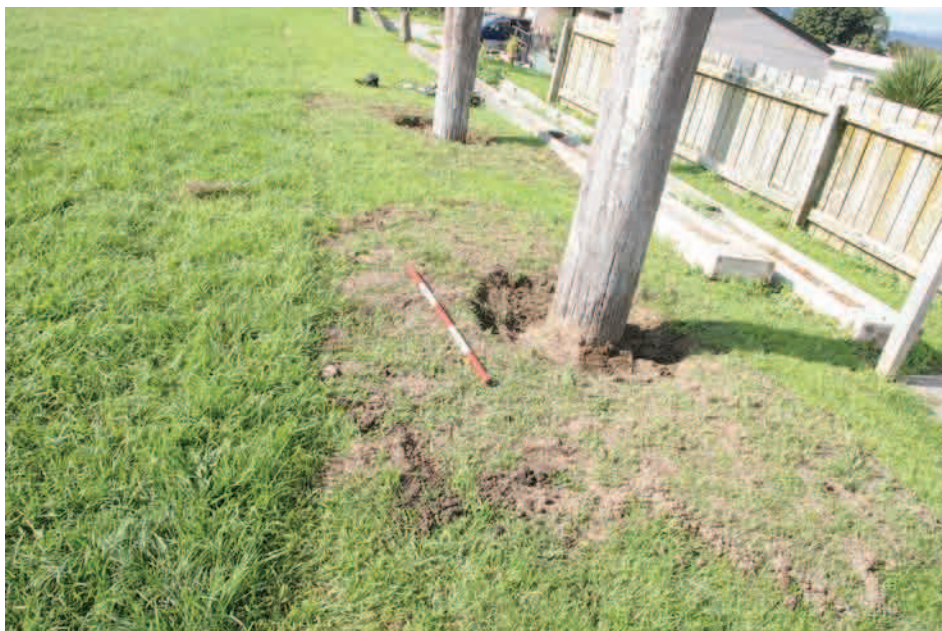
Figure 11. Pole 116 facing south east where the pole will be removed.

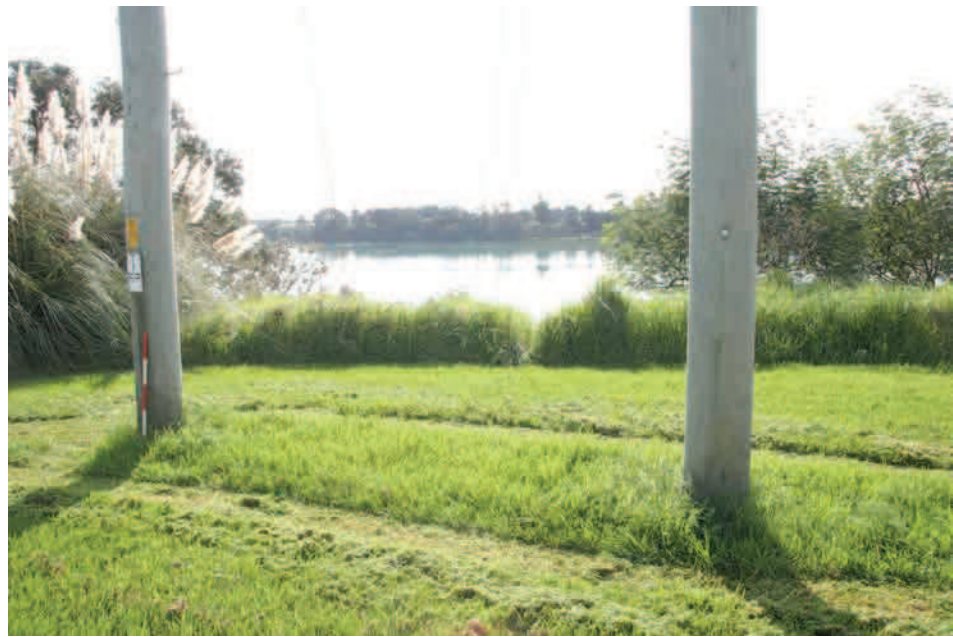
Figure 12. Pole 117 where the pole will be removed, facing north-west looking toward Matapihi.

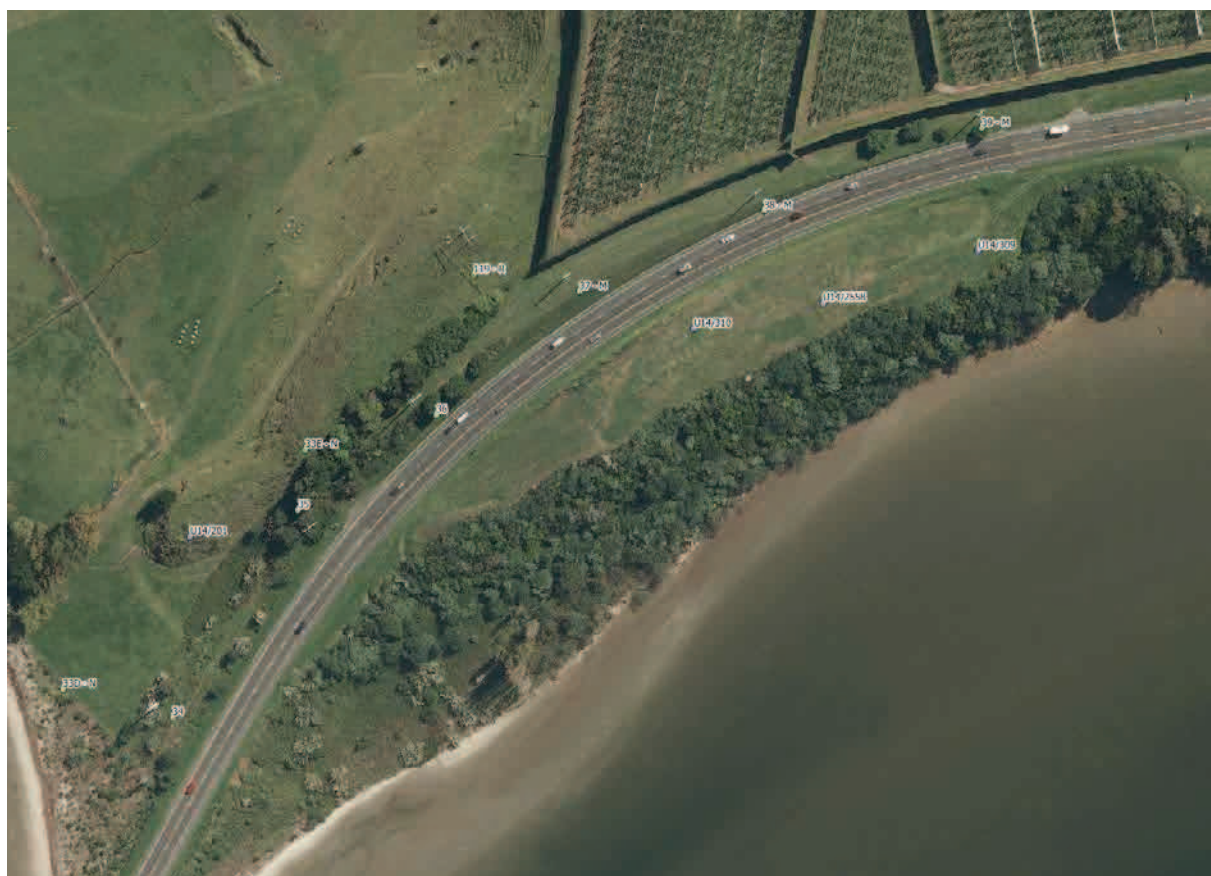
These poles all lie at the southern tip of Matapihi and are within the area that marks site U14/201, Te Ngaio, a pa on the south facing spur bisected by State Highway 29a (Figure 13). Poles 33D, 33E and 39 will be new poles, while Poles 37, 38 will be retained in existing location with no change to structures. Pole 119 is a double-posted pole with two stabilising strainers to south and north that will be removed.

Figure 13. (Aerial photograph of the south part of Matapihi peninsula (including site U14/201) with the pole positions 33d–119 plotted and labelled.

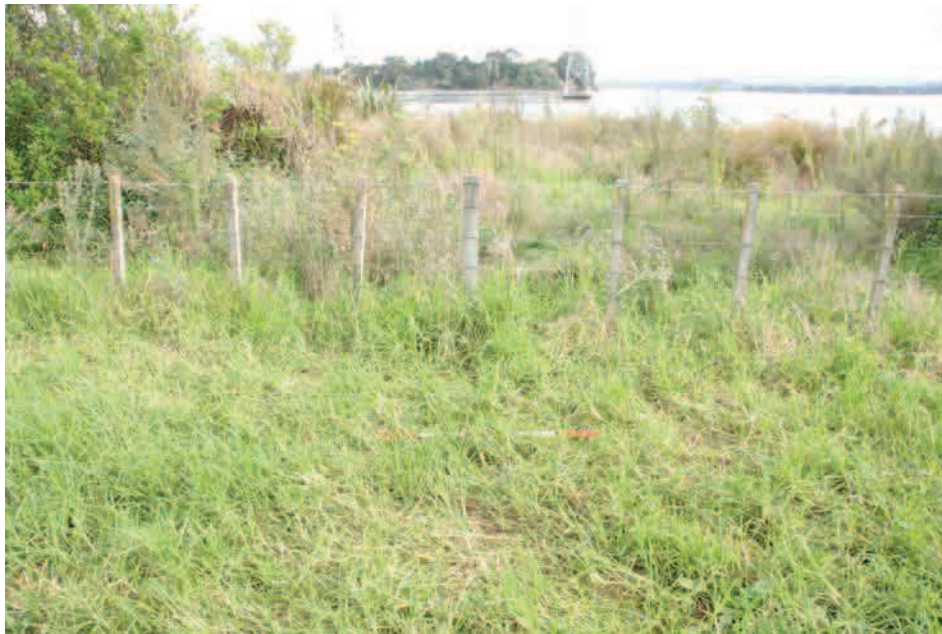
Figure 14. The overgrown vegetation at the point where Pole 33D will be installed..

Probing at 33D provided evidence of subsurface shell 70 mm below the ground surface, this may be a natural deposit considering its proximity to the coastline, however the presence of U14/201 nearby means this cannot be confirmed without archaeological excavation. There was no visual evidence of archaeology immediately near the position because the vegetation was dense and partly overgrown (Figure 14). The land is currently used for grazing stock and horses but the surface does not appear damaged.

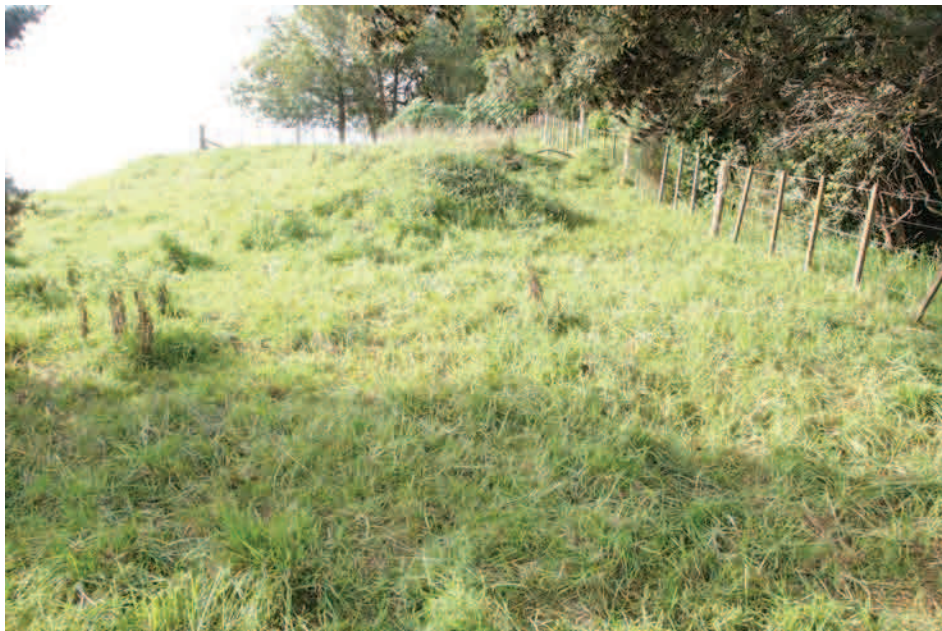
Figure 15. The area where Pole 33E will be installed

Surveying near 33E did not provide any evidence of subsurface or visual markers of archaeological remains. The pole is on a high point, approximately 30 m north to a series of ditch and bank complexes (Figure 15). The position commands clear views of the southern portion of the pa, Te Ngaio, and the harbour to west and east. The pole position is 10–15 m from archaeologi-

cal remains of the pa found during earthworks in 2005 (Cable 2005). The land is currently used for grazing stock and horses and shows surface damage from this.

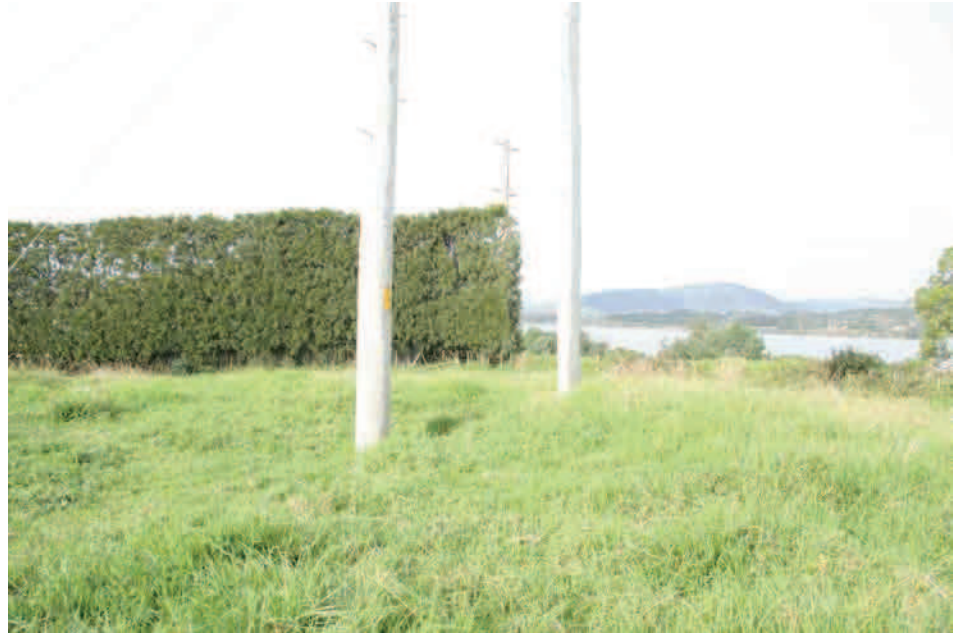
Figure 16. Pole 119.

Pole 119 lies further inland than 33E, at a flat high point 7–8 m east from a sharp drop from the ridgeline (Figure 13). There were no archaeological features found by probing or visual inspection. The pole position is 10–15 m from archaeological remains found related to the pa during highway easement earthworks in 2005 (Cable 2005) (Figure 16).

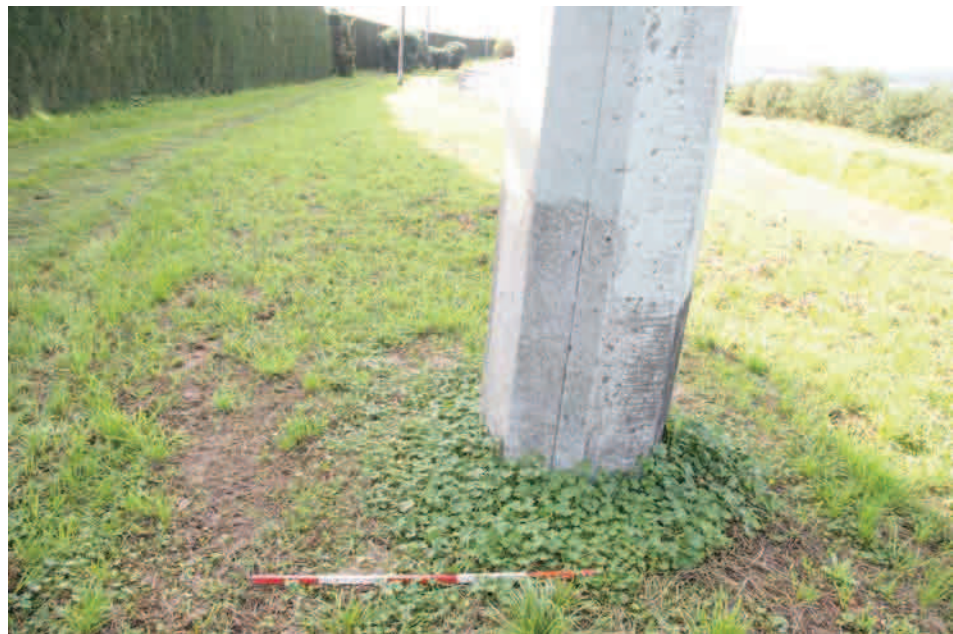
Figure 17. Poles 37, 38 and 39 facing northeast from Pole 37, showing the downhill, north eastern portion of the pa.

The locations for Poles 37–39 did not provide any visual or subsurface indicators of archaeological remains, although excavations in 2005 confirmed there is archaeological activity running across the ridge as far back as Pole 39 and probably further northeast up the highway easement. The land is in good condition; the only land use is the very occasional vehicle. The poles

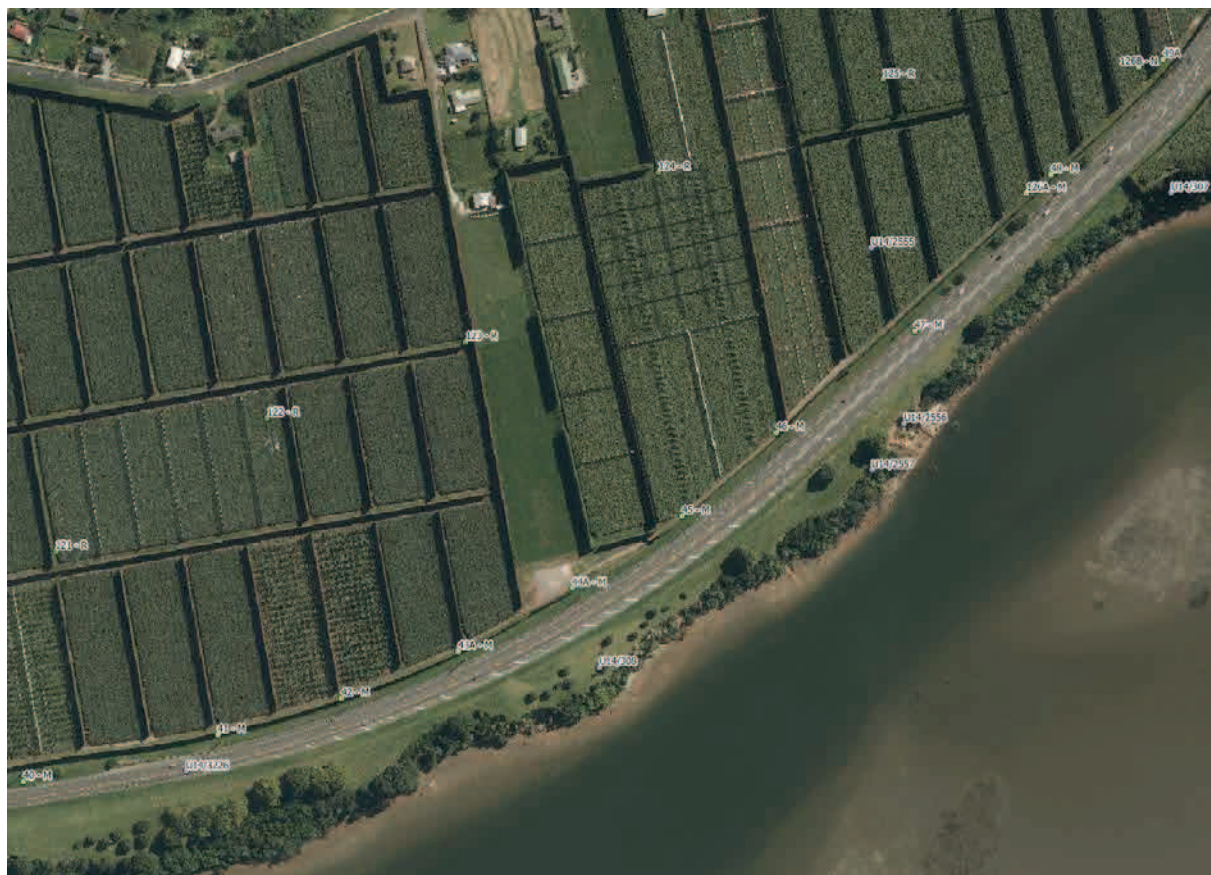
Most of existing poles will be retained and new poles installed between existing (within same general alignment) – please refer to the attached pole schedule appended to this report. They all run on the highway eastern easement and between 40–90 m of the current coastline of Rangataua Bay (Figure 18). Similar to Poles 37–39, the land is in very good condition. Pole 40 may lie on the peripheral parts of U14/201, however no visual or probing results indicated archaeological remains were present. Pole 41 is approximately 20 m northeast of archaeological site U14/3226, recorded post-earthworks as an exposed profile of post-holes, midden and rua-pits as part of the construction of the highway in 2004. Considering the proximity of Te Ngaio Pa (U14/201), and the series of midden and oven sites running up the nearby Rangataua Bay coastline, it is possible that Poles 40–49 may be on or close to unrecorded pre-European Maori archaeological remains.

Figure 18. Aerial photograph of the highway and labelled pole positions of poles 40–49 with nearby archaeological sites

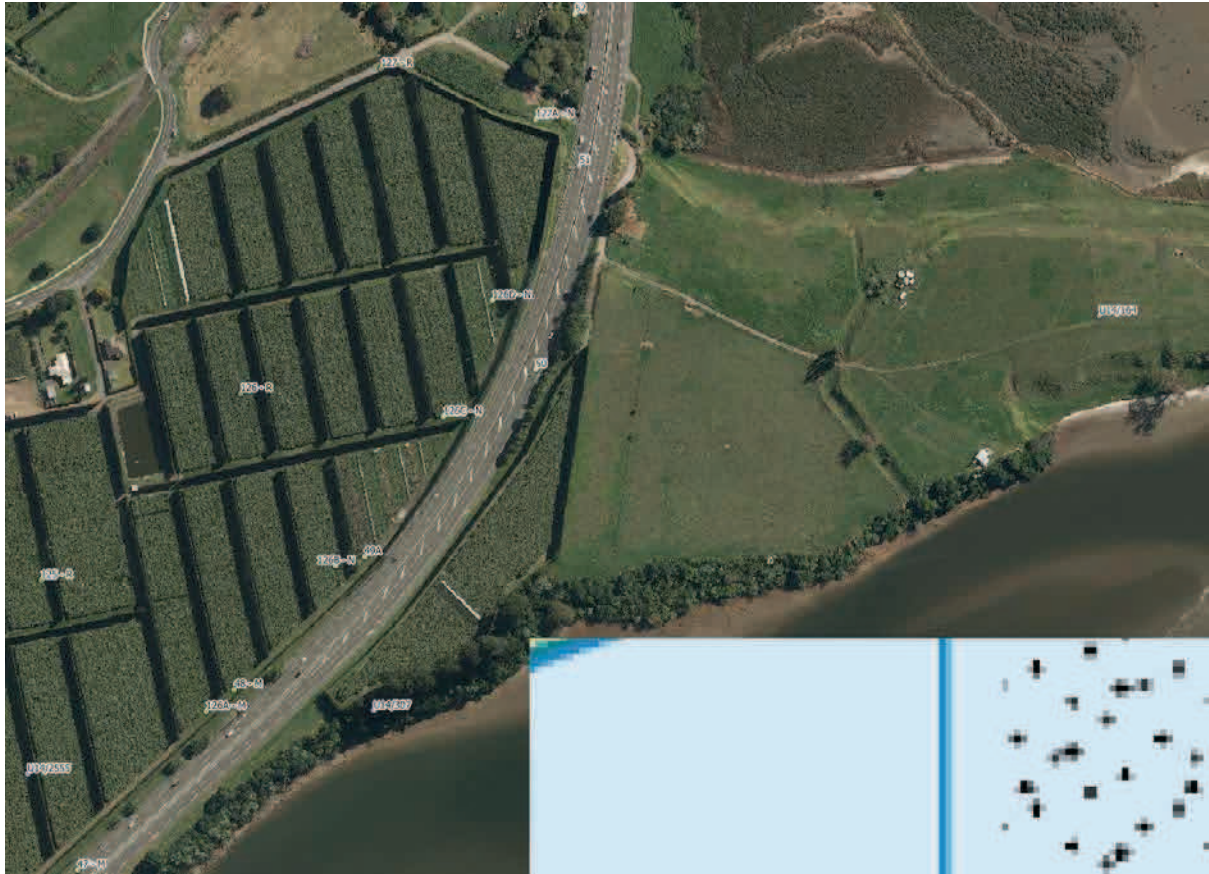
Figure 20. Aerial photograph of the land where the poles 126A–D will be installed with nearby archaeological sites.

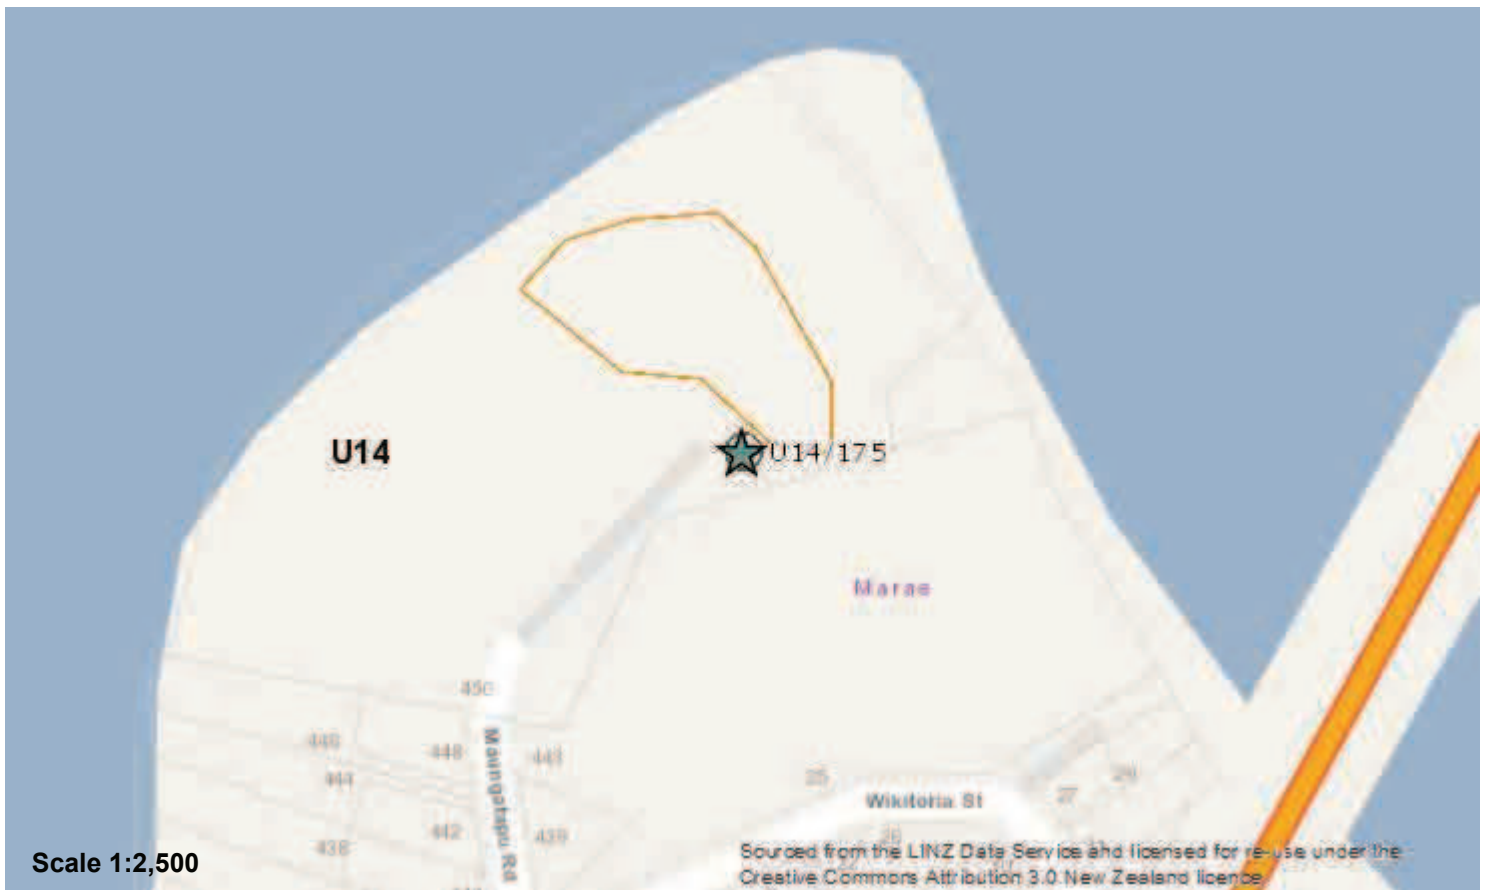
Photo is view of the pa/sports complex from the north. Note terracing above the marae (as indicated by the green arrow). Much of the site was damaged when the sports field complex was constructed (2002).

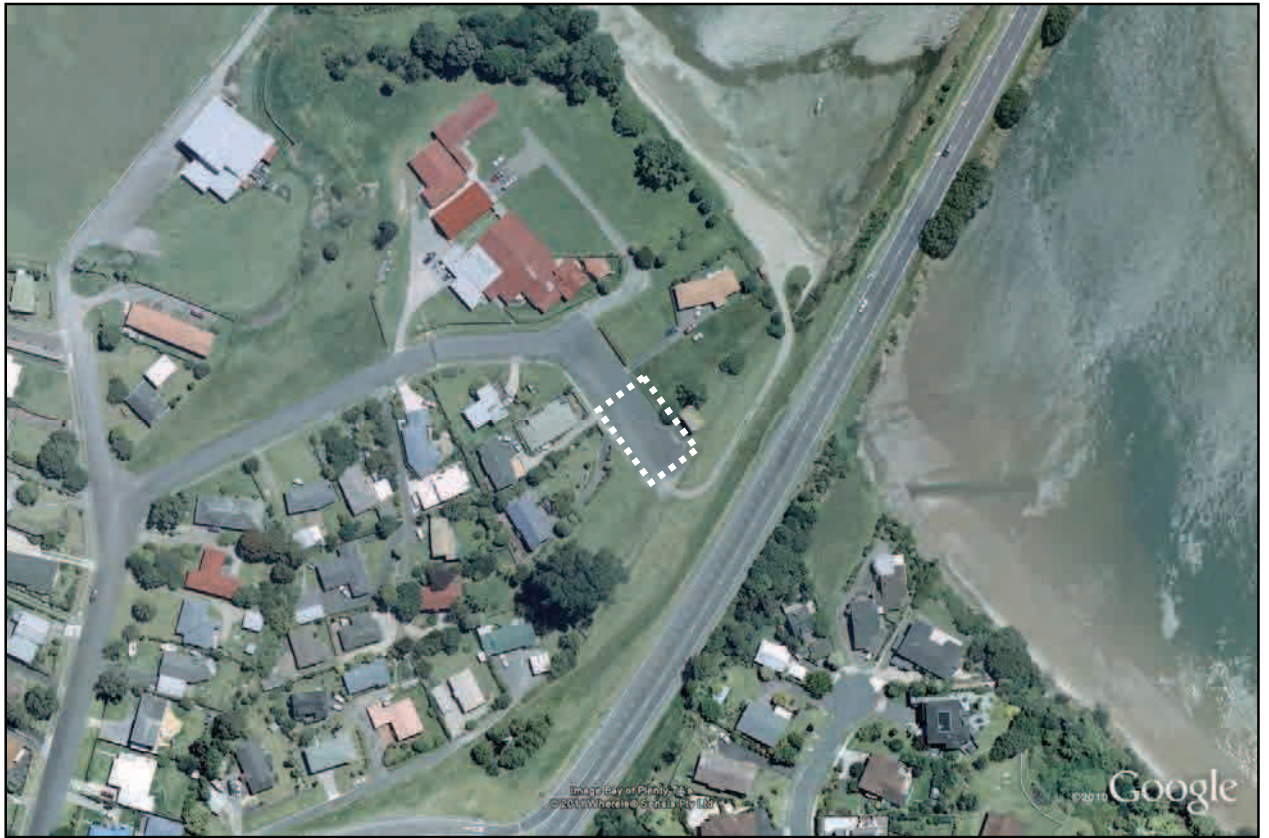
Location of area monitored under NZHPT Authority 2010/438 (highlighted by white dashed line). Image captured from Google Earth on the 3/3/11.

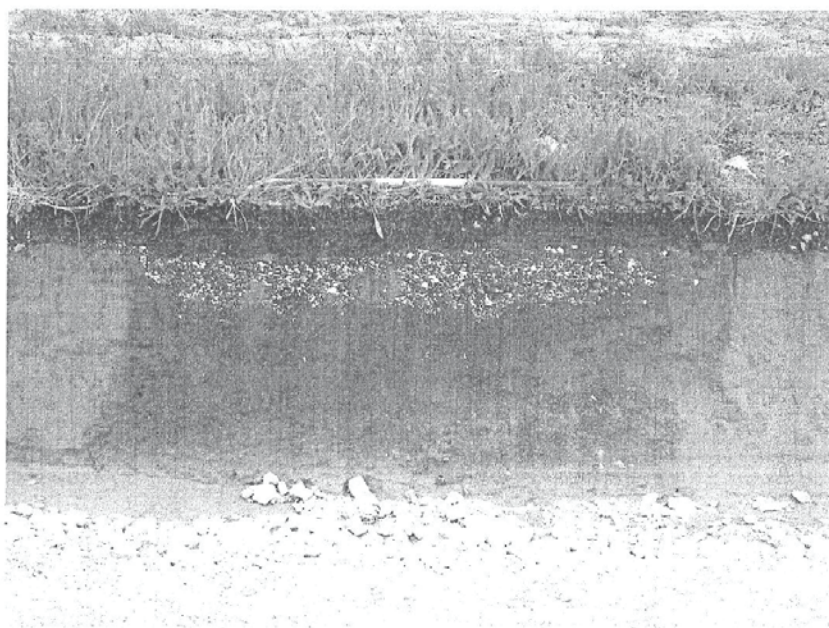
Figure 4: Feature photo of Pit 4

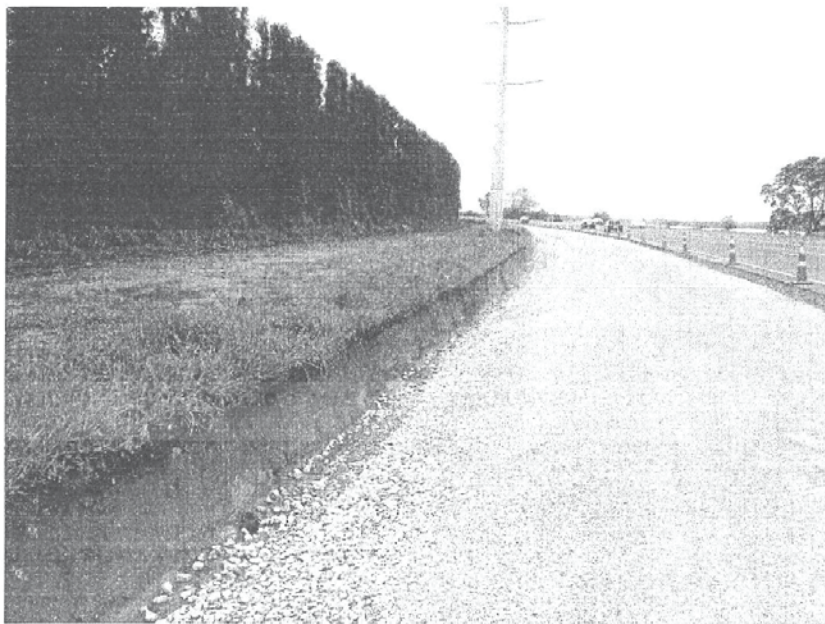
Figure 1: General picture of road cutting profile taken from the west

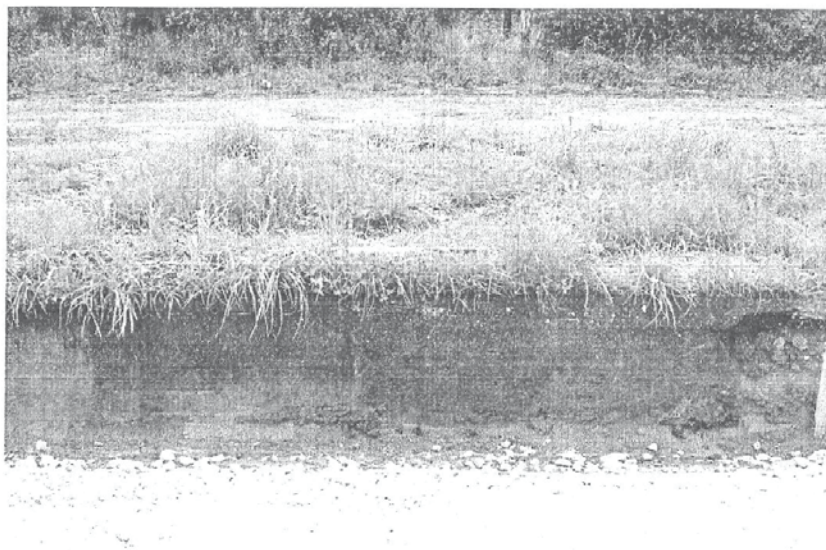
Figure 2: Feature photo of Pit 2
