Focus Catchments water quality update 2021

Bay of Plenty Regional Council
Environmental Publication 2021/10

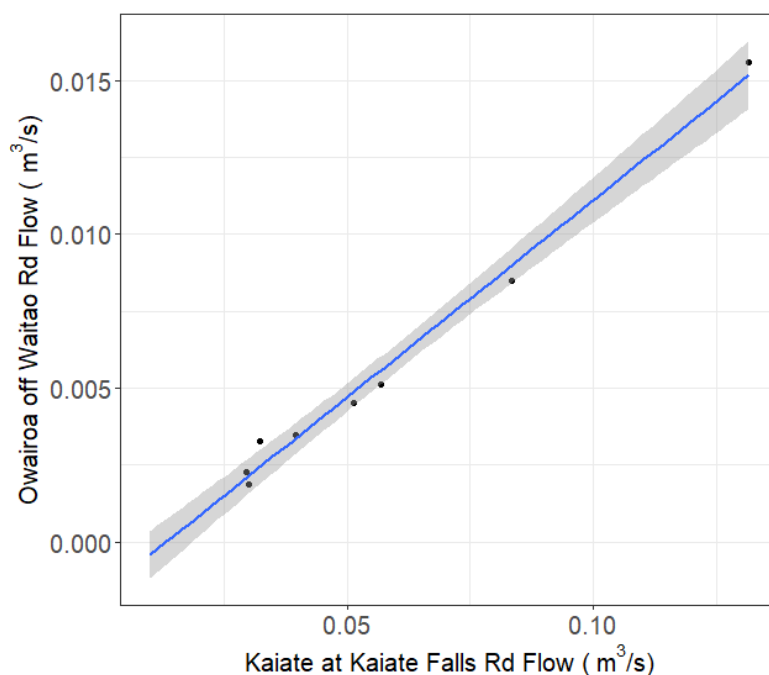
Figure 3.8 Relationship between flow at Owairoa off Waitao Road and Kaiate at Kaiate Falls Road.

Owairoa off Waitao Road only had three measured gaugings over the 2019/2020 sampling season. Mahon et al. (2020) compared using actual gaugings only, and synthetic flow gaugings for the load calculations. As there was minimal difference in the median load, results between the two methods, the synthetic flow gaugings were used to include more data. An additional five wading gaugings were measured over the 2020/2021 sampling season, providing eight gaugings in total to investigate a relationship with the continuously rated site. Figure 3.8 shows a strong linear relationship between Owairoa off Waitao Road and the continuously rated site at Kaiate at Kaiate Falls Road. This relationship is not vastly different to the relationship utilised in Mahon et al. (2020) ($y = 0.128x - 0.0017$ versus $y = 0.1131x - 0.0013$ for 2019/20 and 2020/21 respectively). However, loadings estimated in Mahon et al. (2020) are still updated in this report to reflect this new relationship.

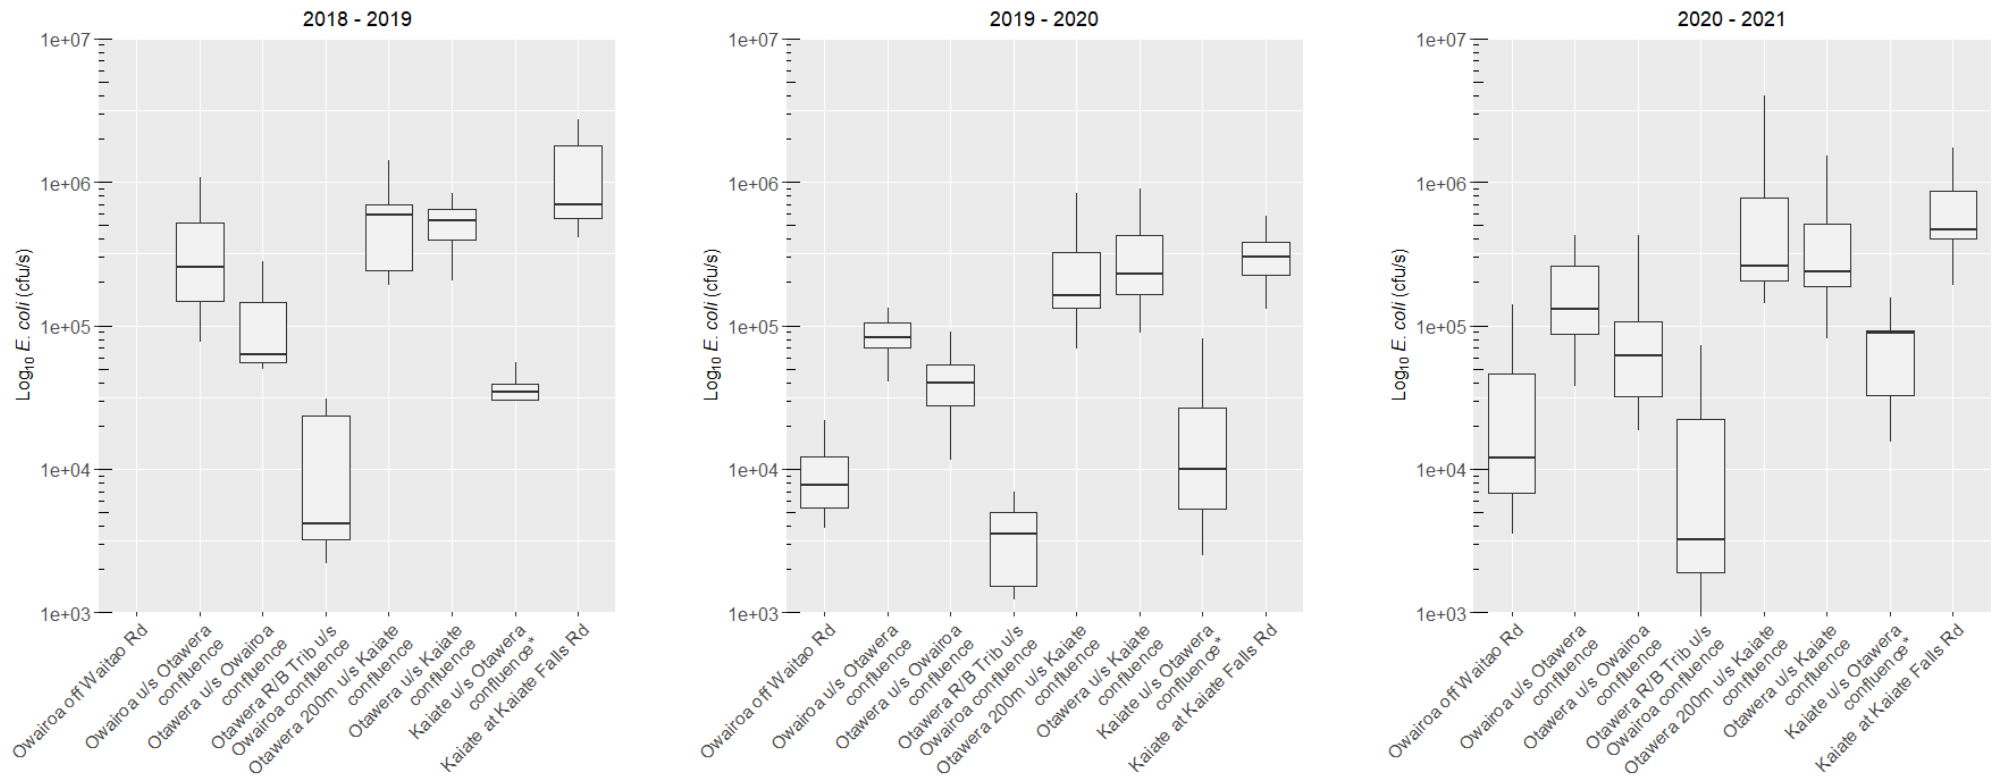
Figure 3.12 *E. coli* load for all sites sampled over the 2018/2019, 2019/2020 and 2020/2021 summers. Sites are arranged from upstream to downstream (left to right). Note log_{10} scale on y-axis. Sites with asterisks (*) are sites where only actual gauging data has been used due to the lack of flow relationship with the Kaiate at Kaiate Falls Road site.

A comparison of the three monitoring periods is shown in Figure 3.12. The three periods had differing climate conditions, where the 2018/2019 and 2020/2021 years had variable rainfall capturing some rain events, while the 2019/2020 period had very low rainfall and would be considered a baseflow monitoring season. The 2020/2021 monitoring period shows an increase in the contribution of load from the 'control' site (Owairoa off Waitao Road) compared to the 2019/2020 season. The contribution from Kaiate u/s Otawera confluence also increased over the 2020/2021 season in comparison to both previous seasons. This indicates an increase in faecal contamination from these two sites, which could be a result of a higher number of sample collection days during rainfall. Previously the Kaiate at Kaiate Falls Road site has been more or less equivalent to the loads estimated for the lower Otawera Stream. This season there has been an increase, which is likely a result of the increased input from the Kaiate Stream upstream of the Otawera confluence. Nonetheless, the results still consistently point to the Otawera Sub-catchment being the dominant source of faecal contamination, and within the Otawera Catchment the Owairoa Stream dominates.

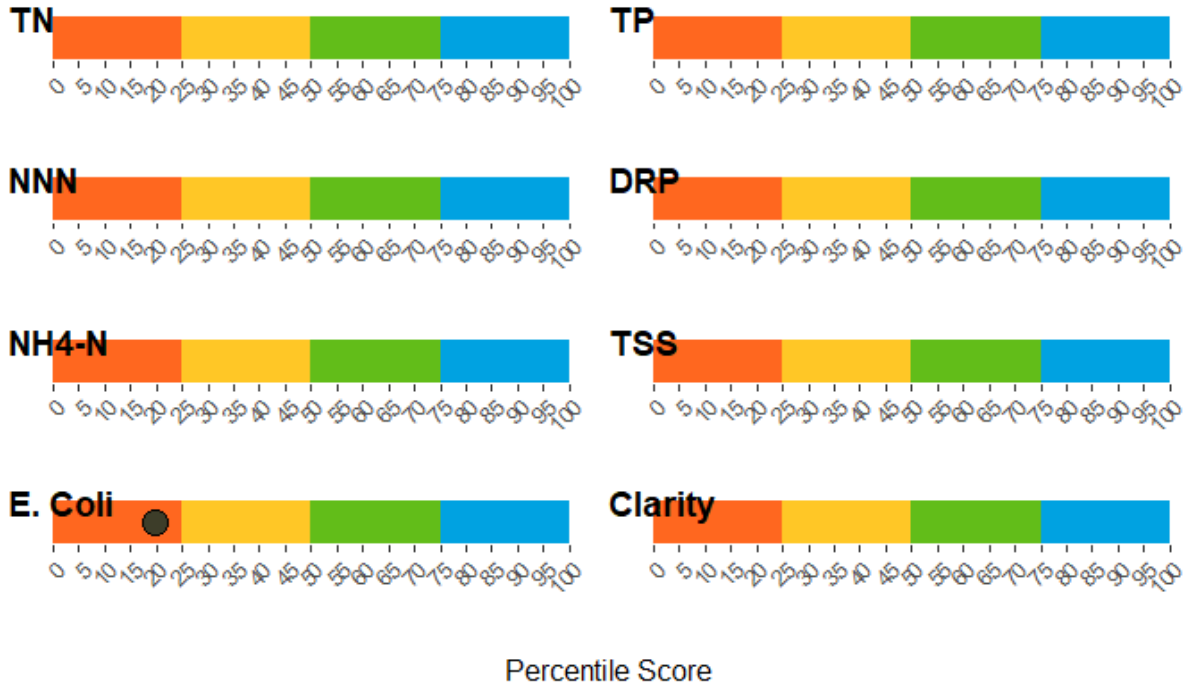
This figure compares median values for eight different measurements collected at the site, against the distribution of data from all sites in the Bay of Plenty region. The grey dot represents the site's percentile score (0% = worst, 100% = best), with each coloured segment representing 25% of the overall distribution. The segment colour scheme ranges from (worst 25% of sites) to blue (best 25% of sites).

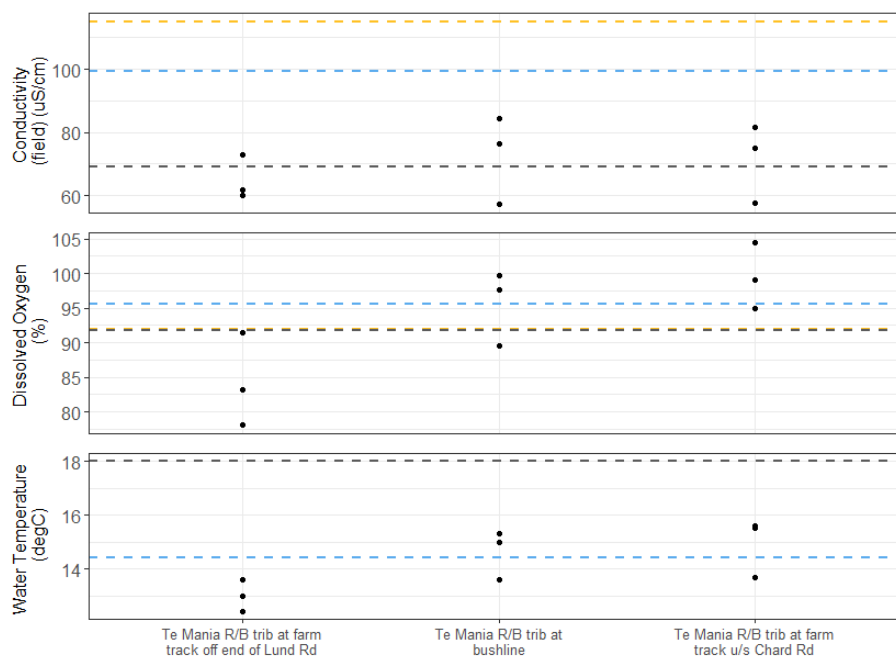
Figure 4.2 Conductivity, dissolved oxygen and water temperature results in the upper Te Mania Catchment, 2020. Comparative values shown are the ANZG DGV¹⁰ (yellow), the VA Gentle median¹¹ (blue), and the catchment median 2019/2020 (grey). Sites are ordered upstream to downstream (left to right).

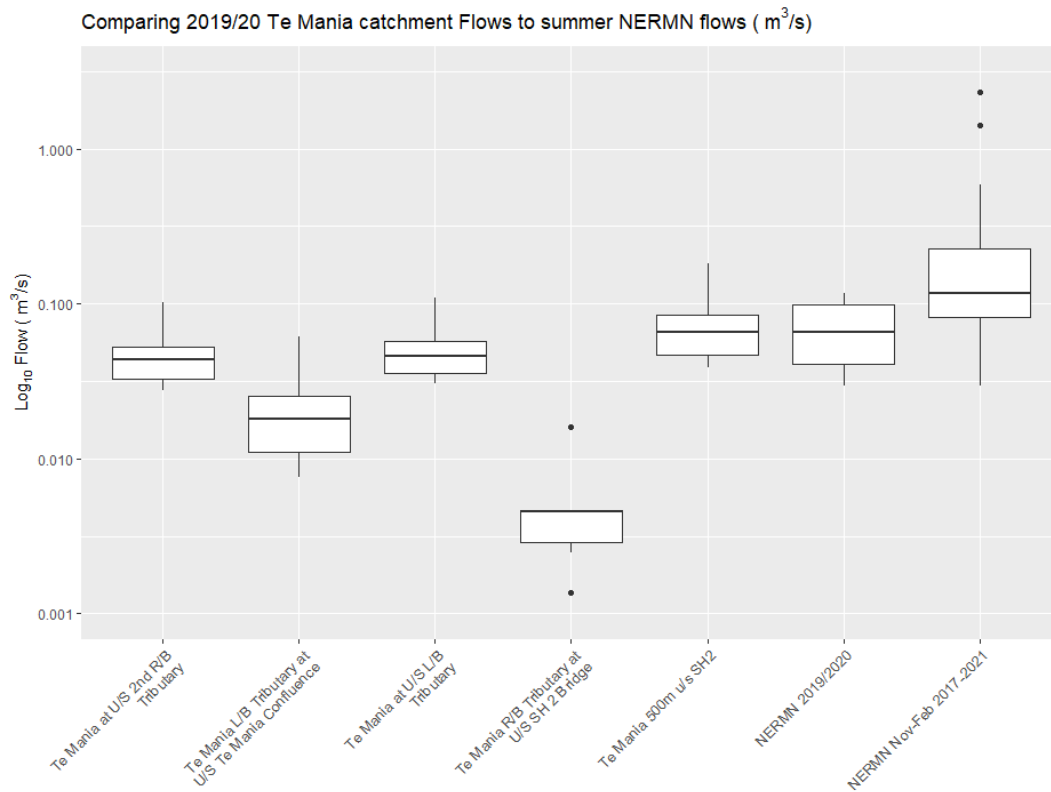
Figure 4.5 Comparison of flows in the Te Mania Catchment sites to the flows at the NERMN site over 2019/2020 and summer months 2017-2021.

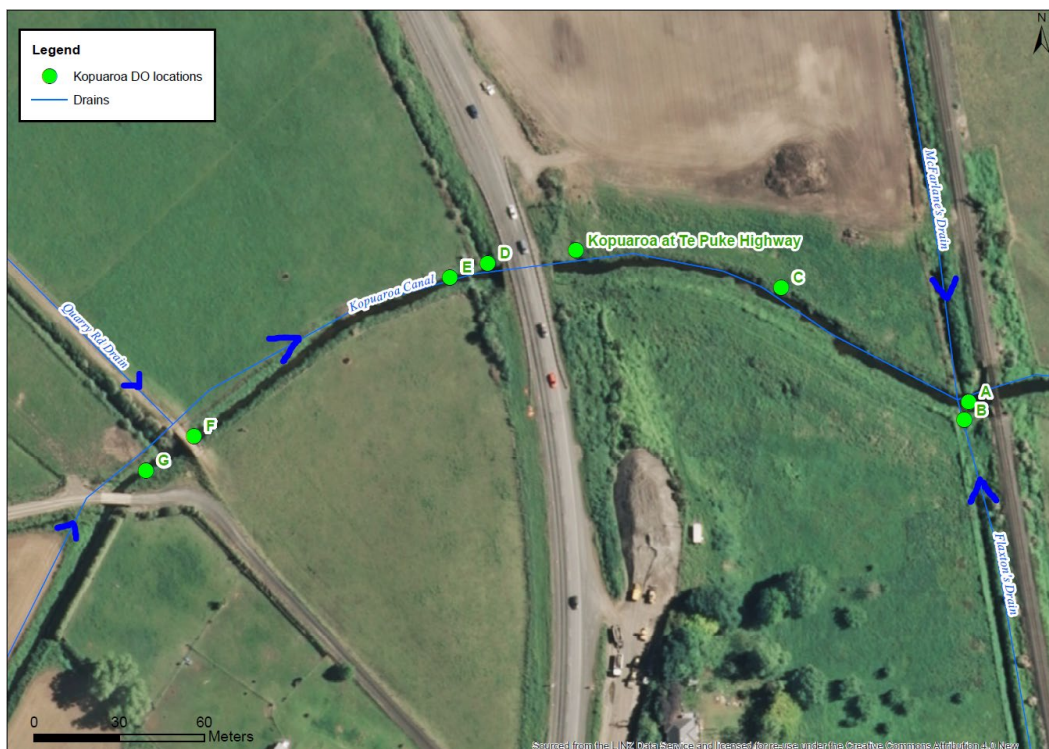
Figure 5.1 Locations for dissolved oxygen investigation in the Kopuaroa Canal, October 2020-March 2021. Location attributes are listed in Appendix C1. Arrows indicate direction of flow.
