Tauranga Harbour Coastal Hazards Study

Coastal Erosion Assessment

Prepared for
Bay of Plenty Regional Council

Prepared by
Tonkin & Taylor Ltd

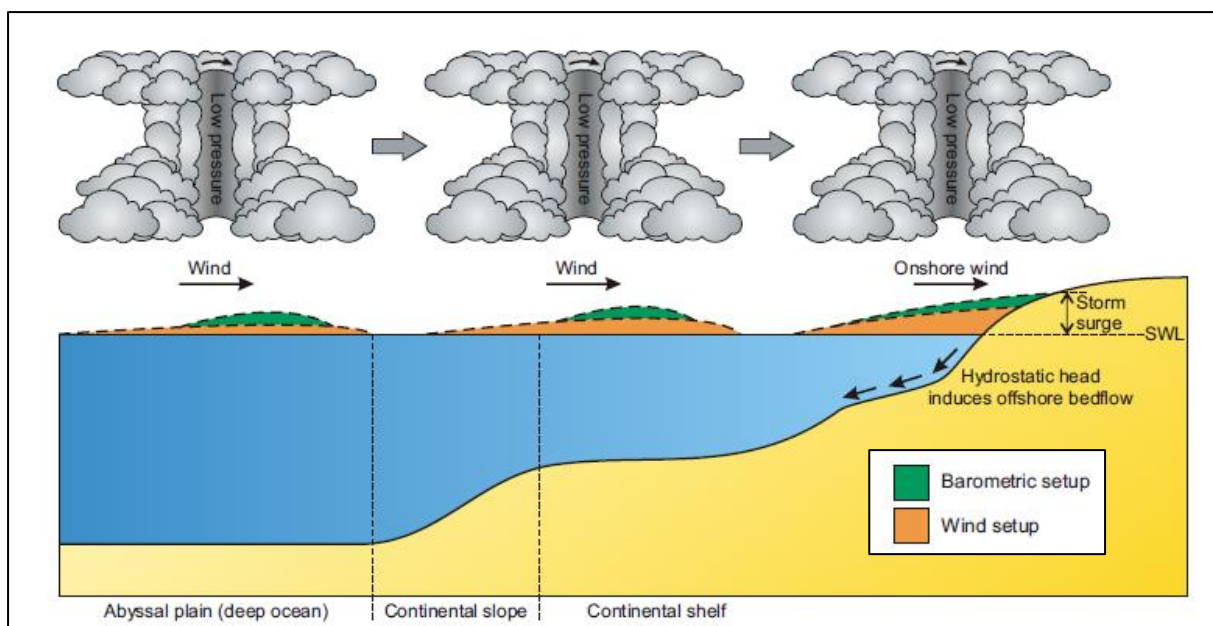
Figure 2-3 Processes causing storm surge (source: Shand, 2010).

Storm surge results from the combination of barometric setup from low atmospheric pressure and wind stress from winds blowing along or onshore which elevates the water level above the predicted tide (Figure 2-3). The combined elevation of the predicted tide and storm surge is known as the storm tide.

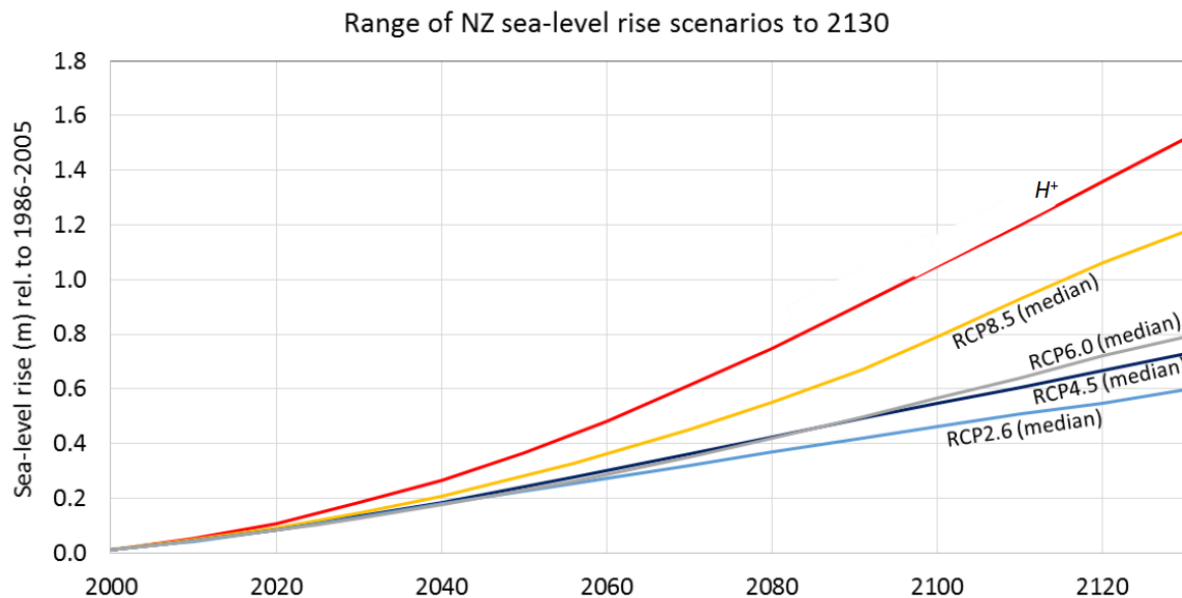
Figure 2-4 Range of sea level rise scenarios to 2130 (Stephens, 2017).

The Ministry for the Environment (2017) guideline recommends four sea level rise scenarios to cover a range of possible sea-level futures. The scenarios are based on the most recent IPCC report (IPCC, 2013) (Figure 2-4).

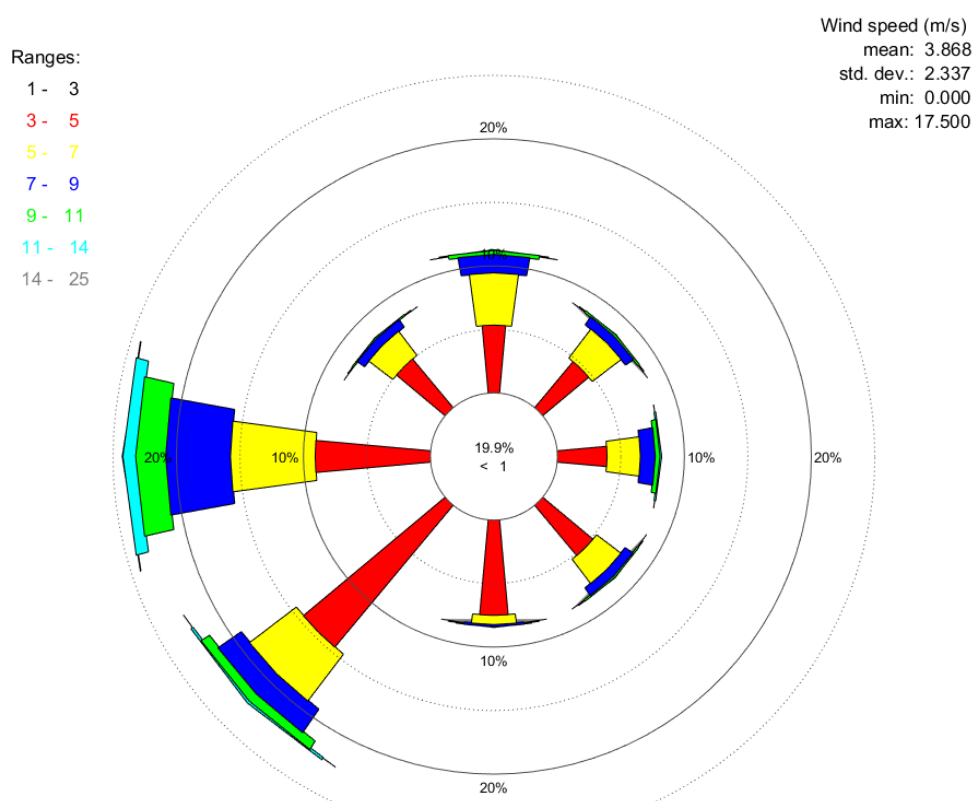
Figure 2-5 Wind rose for Tauranga Airport 1995 – 2016 (Source: MetService, 2018).

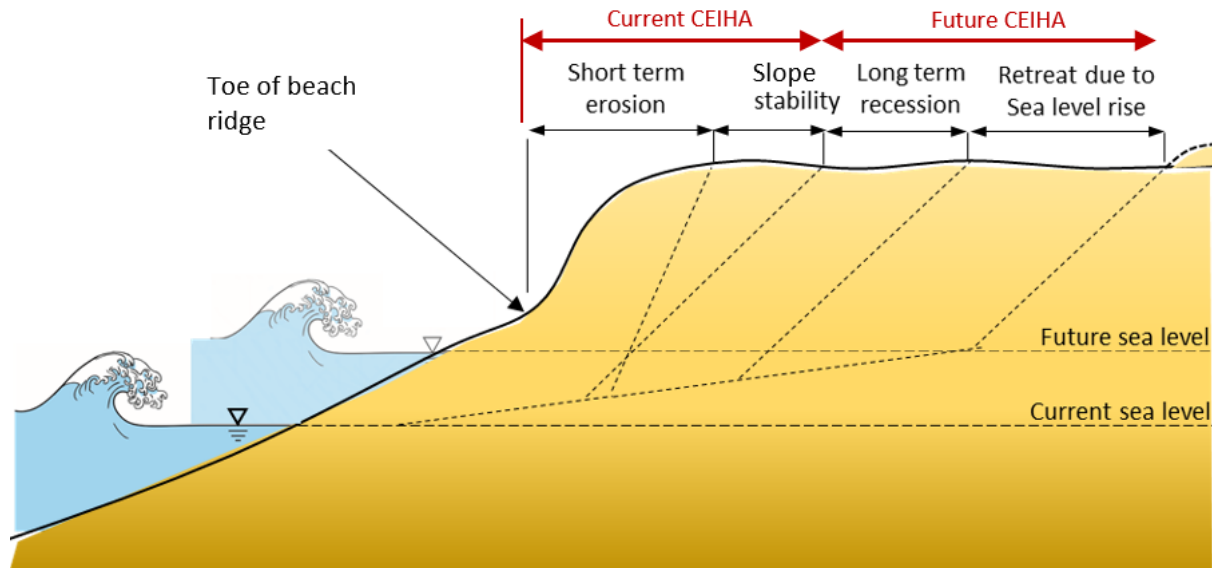
Figure 4-1 Definition sketch for the coastal erosion hazard area for an unconsolidated shoreline.

| SS | = | Slope stability allowance. This is the horizontal distance from the base of the eroded slope to the crest at a stable angle of repose (m) |

LT	=	Long term rate of horizontal coastline movement (m/yr)
T	=	Timeframe (years)
SLR	=	Horizontal coastline retreat due to the effects of increased mean sea level (m)

The CEIHA baseline to which values are referenced is the most recent beach ridge toe derived from site survey data or LiDAR. The cross over between the short term erosion and the slope stability represents the short term effect from talus material protecting the shoreline.

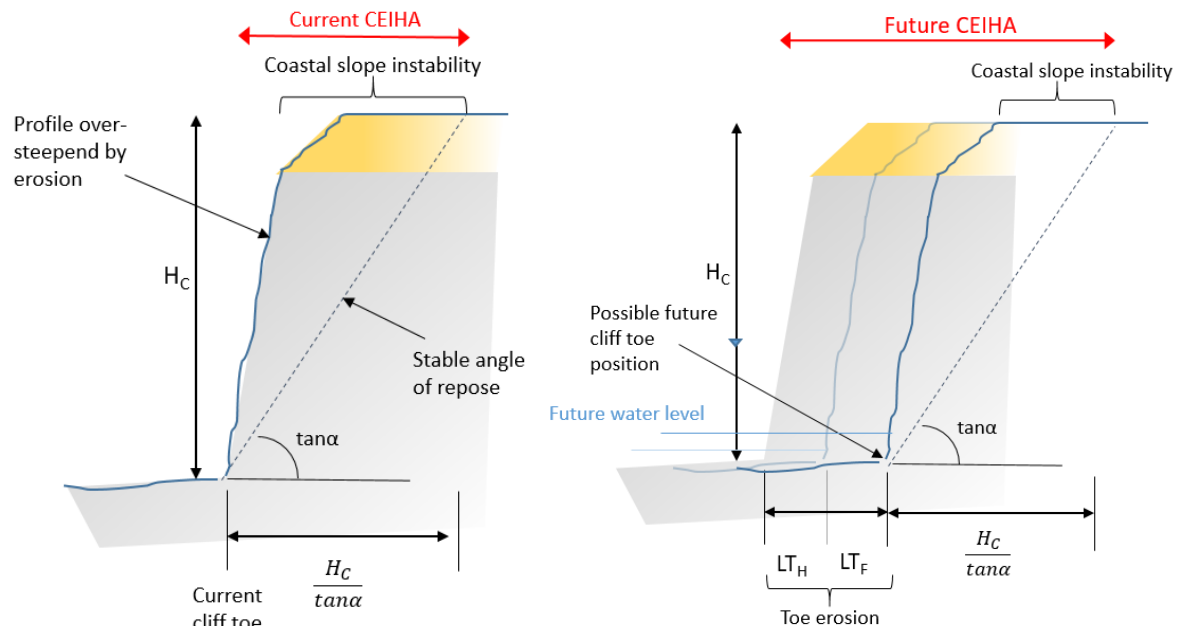
Figure 4-2 Definition sketch for consolidated shoreline.

The CEIHA_{Cliffs} baseline to which values are referenced is the most recent cliff toe location derived from LiDAR or site survey data.

Figure 4-2 shows that the current CEIHA distance is entirely dependent on the stable angle of repose. Therefore the current CEIHA for unconsolidated cliff and bank shorelines represents the land currently exposed to slope instability hazard.

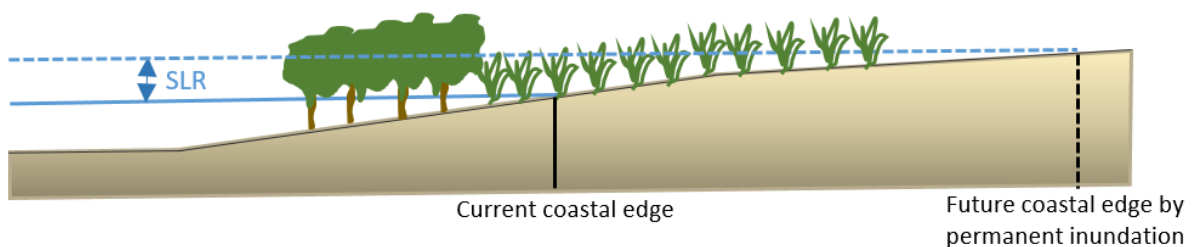
Figure 4-3 Effect of permanent inundation on coastal edge position in low-lying areas.

A shoreline is defined by the landward extent of typical marine processes such as tides and waves. In a sheltered estuarine environment this can be approximated by the mean high water spring (MHWS) position. The potential increase in future sea level may cause the shoreline to migrate landward as areas are permanently inundated by these processes (i.e. Figure 4-3). For the low-lying estuarine areas around Tauranga Harbour there is no evidence of shoreline erosion. However there is potential for the shoreline to migrate landward with permanent inundation from sea level rise assuming no change in morphology. For these shorelines we have used the future MHWS-7 output from Stephens (2019) to assess the permanent inundation hazard for low-lying estuarine areas.

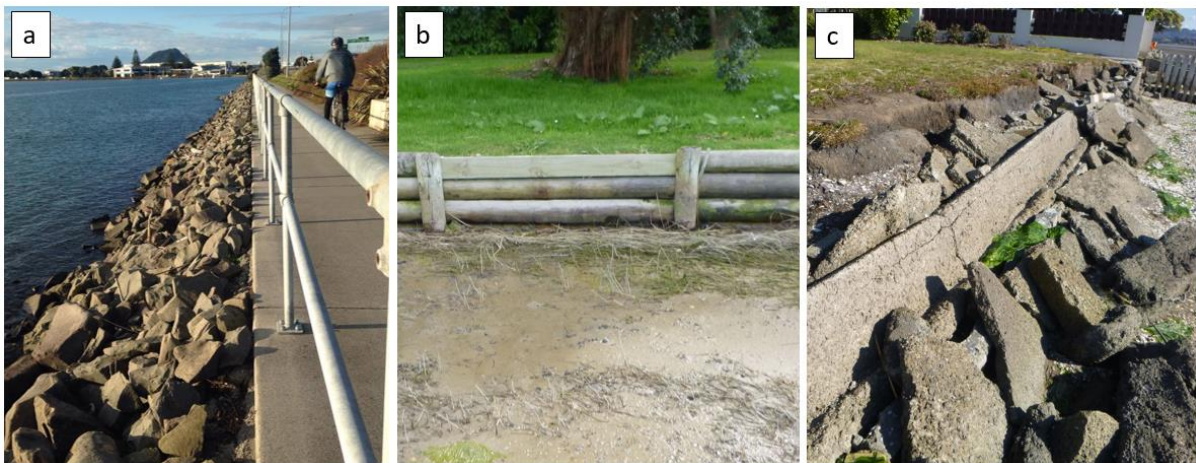
Figure 4-4 Example of the three types of protection structures around Tauranga Harbour (a) critical, (b) consented and (c) informal, non-consented structures.

- 1 Critical, consented structures (e.g. Figure 4-4A)
- 2 Non-critical, consented structures (e.g. Figure 4-4B)
- 3 Informal or non-consented structures (e.g. Figure 4-4C).

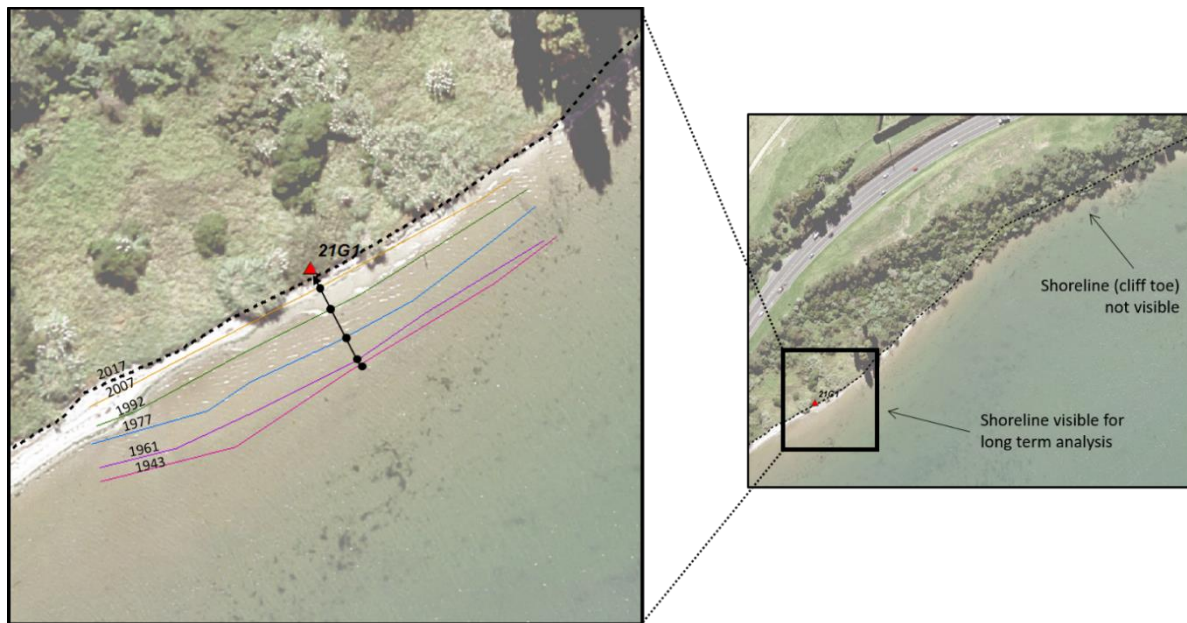
Figure 5-3 Example of single point shoreline position analysis for Cell 21G, Matapihi.

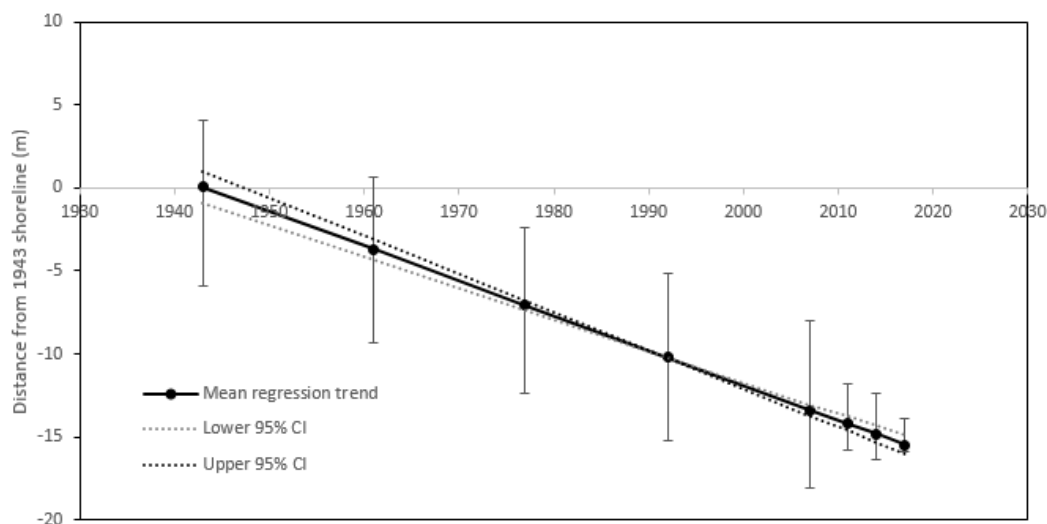
Figure 5-4 Example of linear regression analysis for the single point 21G (Matapihi) and upper and lower 95% confidence intervals. Error bars are based on estimated aerial photograph accuracy.

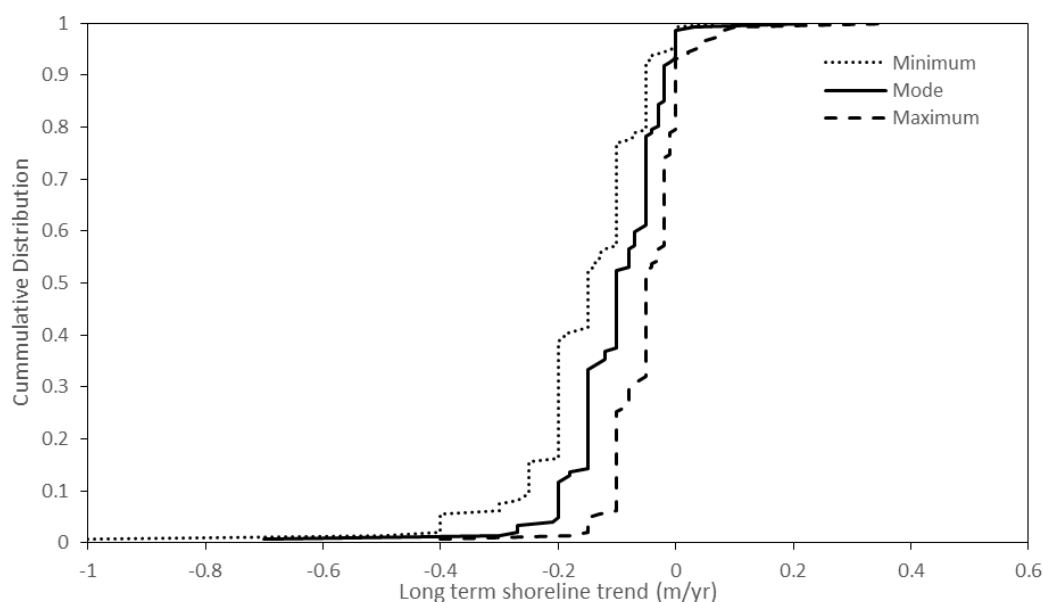
Figure 5-5 Cumulative distribution plot of the long term shoreline trends throughout Tauranga Harbour (negative values = erosion, positive values = accretion).

Long term shoreline trends throughout the Harbour range from -1 to +0.36 m/yr, with most shorelines showing a long term erosion rate of -0.1 m/yr (Figure 5-5). The majority of the sites have a measured long term erosion rate between -0.2 to -0.05 m/yr. This equates to -5 to -20 m of erosion over a 100 year timeframe.

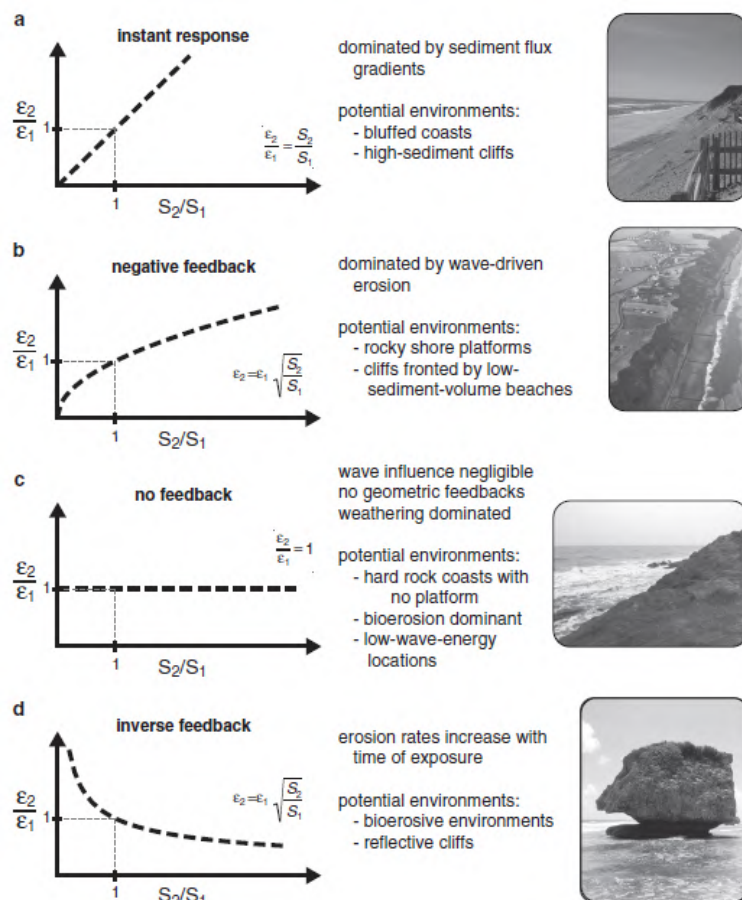
Figure 5-6 Possible modes of cliff response to SLR (adapted from Ashton et al., 2011)

An instantaneous response ($m = 1$) is where the rate of future recession is proportional to the increase in SLR. An instant response is typical of unconsolidated or weakly consolidated shorelines. No feedback ($m = 0$) indicates that wave influence is negligible and weathering dominates. The most likely response of consolidated shorelines is a negative/damped feedback system ($m = 0.5$), where rates of recession are slowed by development of a shore platform or fronting beach; i.e. Equation 5-5. Aston et al. (2011) also suggest an additional case of inverse feedback when $m < 0$ indicating a reduction in recession with increasing sea levels. They suggest this could occur when erosion is controlled by bio-erosion which may reduce with additional submergence. The approach suggested by Ashton et al. (2011) is conceptually plausible and has the potential to predict recession rates on a wide variety of rock types with further analysis.

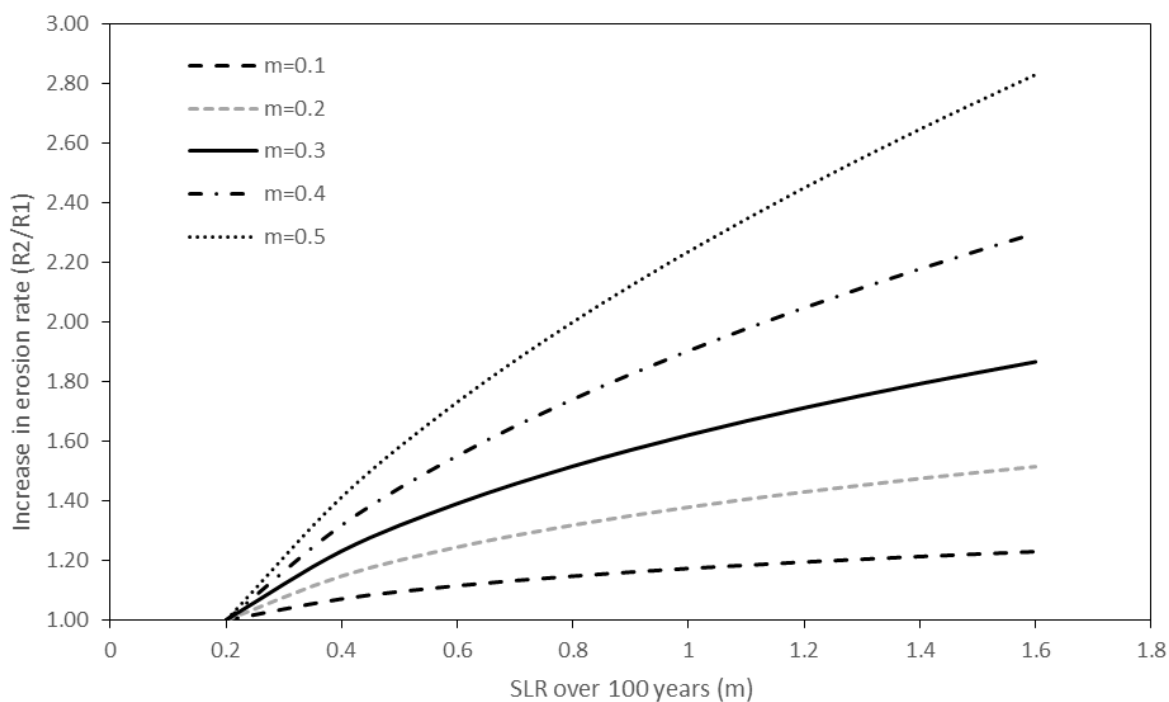
Figure 5-7 Increase in consolidated shoreline erosion rate with increasing SLR for different shoreline response factors.

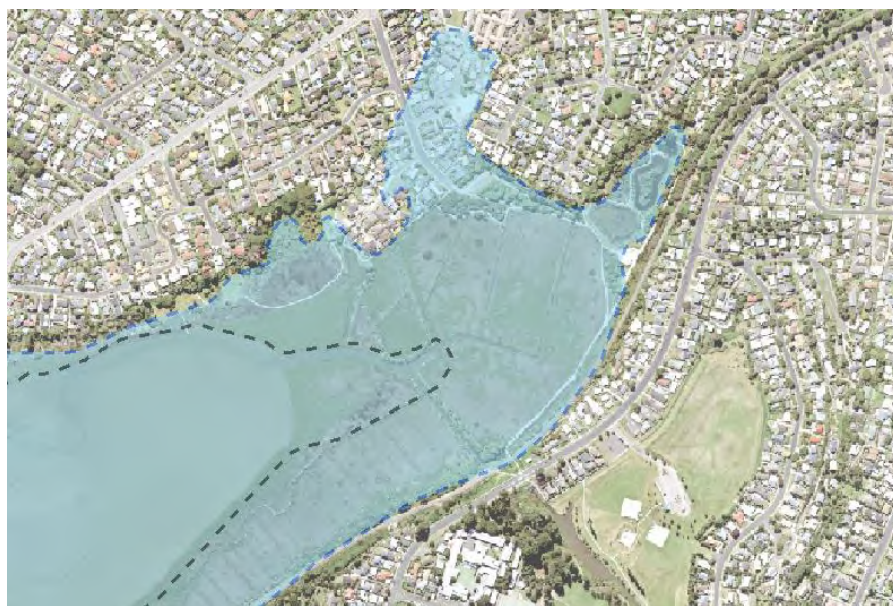
Figure 5-8 Example of how low-lying estuarine shorelines are likely to be translated landward with inundation from future SLR scenarios (black dashed line represents the current MHW, blue shading represents future MHW with 1.6 m SLR).

In low-lying estuarine environments, increased future sea level may result in tidal inundation of the backshore. While this is not technically erosion (loss of material), the net result is the same with the mean shoreline position being translated inland (Figure 5-8). This term has therefore been assessed separately in low-lying environments where recession by the Bruun Rule or cliff erosion methods are not applicable (refer description in 4.6.3).

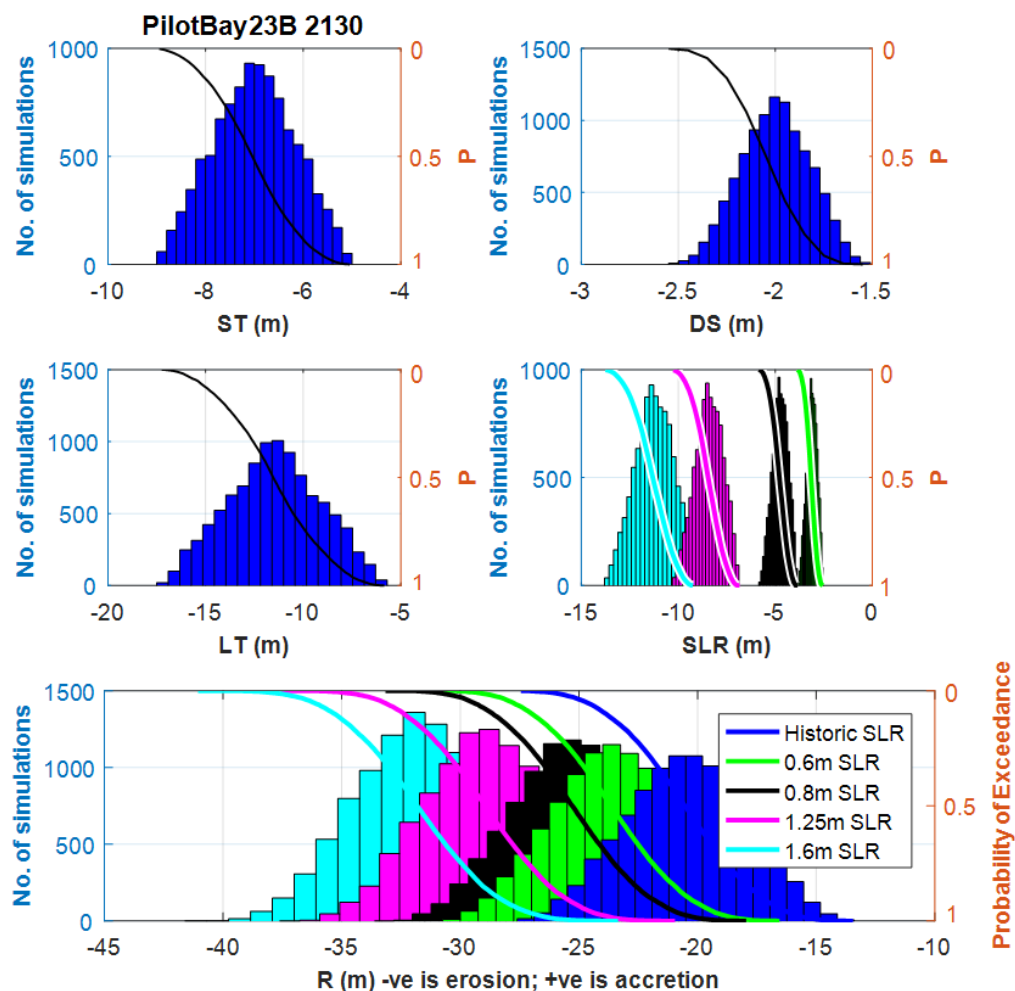
Figure 6-1 Example of histograms and cumulative distribution functions of parameter samples and resultant CEIHA distances for Cell 23B (Pilot Bay) in 2130.

The future timeframes include a range of SLR scenarios. The highest SLR scenario for the 100 year timeframe is 1.6 m. The projected erosion distance for this scenario ranges from -23 and -41 m. Under this scenario, there is a 50% chance of an erosion distance of -31 m ($P_{50\%}$).

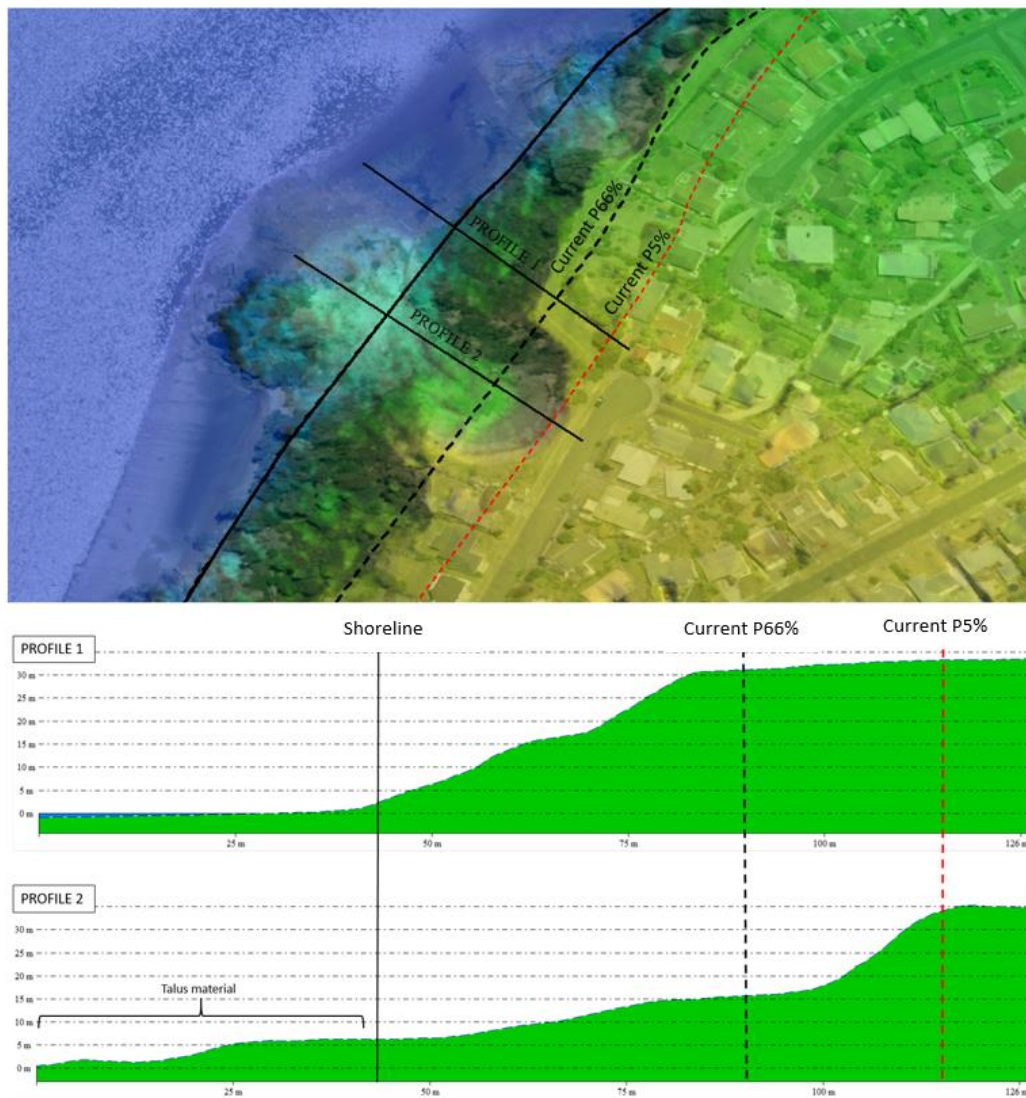
Figure 6-2 Example of existing slope profiles with current CEIHA (black dashed = P66%, red-dashed = P5%) for Cell 4B1 (Omokoroa).

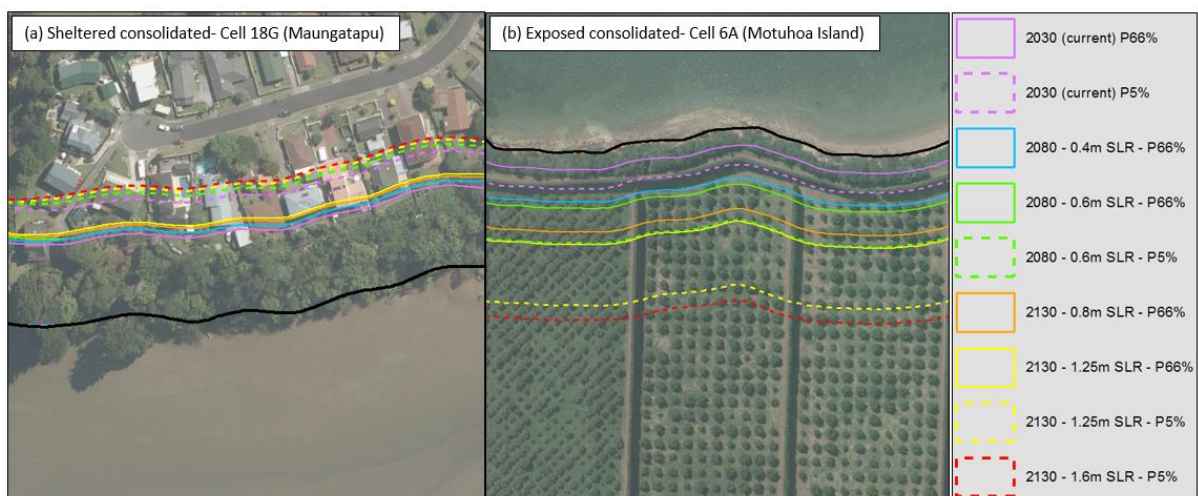
Figure 6-3 Comparison between (a) a sheltered cliff (Cell 18G) and (b) an exposed cliff (Cell 6A).

The exposed cliffs are more sensitive to changes in sea level rise compared to sheltered cliffs. As mentioned above, this is due to the effect of SLR allowing larger waves to reach the site in locations where the fetch is sufficient. For example, the 2130 CEIHA for the sheltered cliffs in Cell 18G only increases by ~2% with the increasing sea level rise scenarios (Figure 6-3). Whereas for an exposed cliff, such as Cell 6A, the CEIHA in 2130 increases by almost 50% with the increasing sea level rise scenarios (Figure 6-3).
