**Omokoroa Stage 3 Structure
Plan Area**

**Supplementary Level B Liquefaction
Assessment**

Prepared for
Bay of Plenty Regional Council

Prepared by
Tonkin & Taylor Ltd

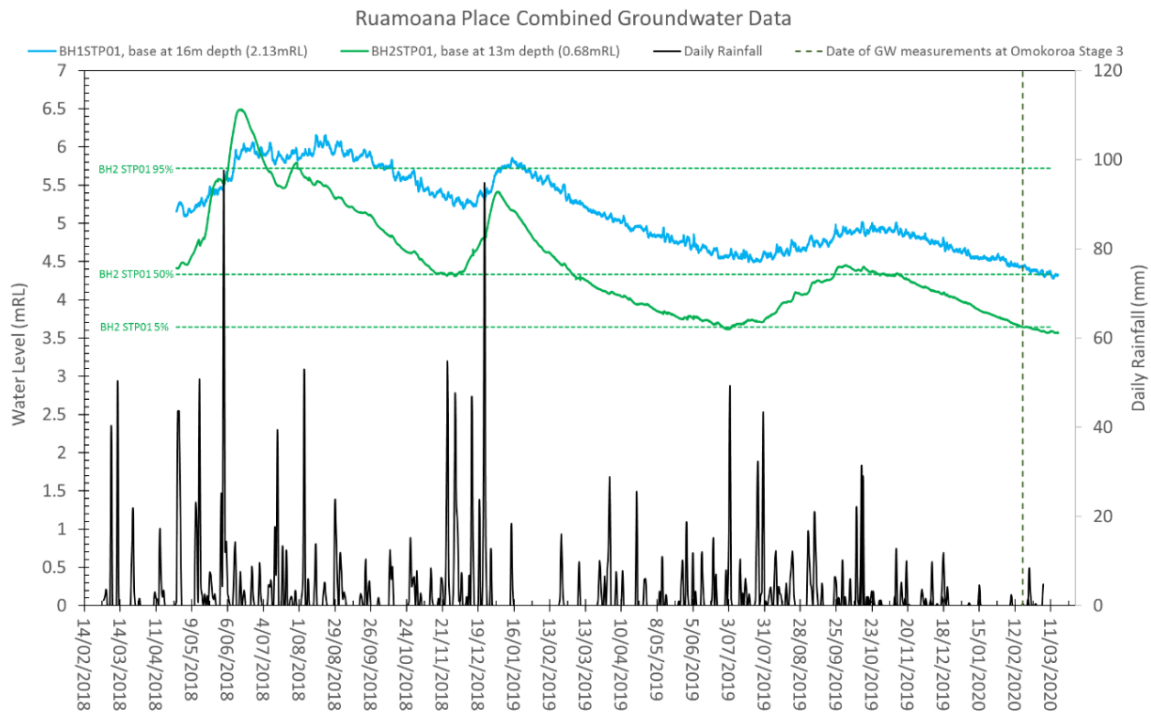
Figure 4.2: Ruamoana Place groundwater monitoring data and rainfall data

Figure 4.2 shows that seasonal fluctuations of between 2.0 and 3.0 m in groundwater level have been observed at Ruamoana Place. We note though that the difference between the 5th percentile and the median is around 0.7 m in these records.

Water levels at Ruamoana Place have been recorded in six standpipes, however we have conservatively selected the two records shown in Figure 4.2 as they exhibit the greatest seasonal fluctuations. Based on the records from these two standpipes we have estimated seasonal groundwater level maxima and minima within the study area.

Measurements of groundwater levels within the study area were obtained during summer months, i.e. when the groundwater level was likely to be close to its lowest point (5th percentile). Due to the potential variance between Ruamoana Place and the study area, the median groundwater level has been estimated as 1 m above the measurements obtained from the site on 18 February 2020. This provides median groundwater depth estimates of between 4 and 6 m bgl within the area of proposed development.
