Tühua (Mayor Island)

# SITE 70 Moutoki Island Oil Spill Management Plan

Oil Spill Management Plan

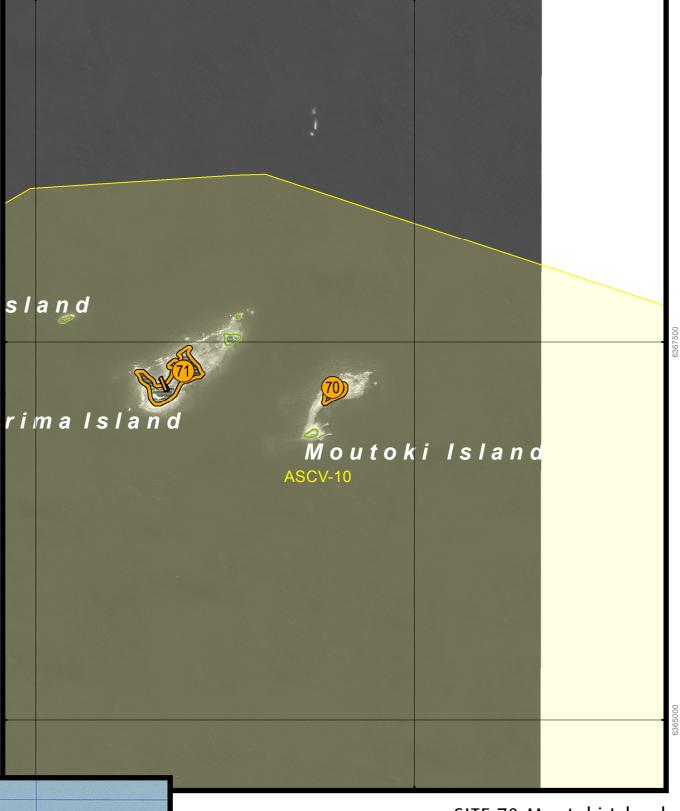
Moutoki Island lies approximately 9 km north of the Rangitaiki Rivermouth. The island is the second largest of the Rurima Rocks, with the largest, Rurima Island, lying about 1 km west. It is covered in Pohutukawa forest.

Foreshore type	Rocky reef and spit.		
	All shore segments have "habitat value" and "contact value".		
	All intertidal areas are identified in the Regional Coastal Plan as areas of significant conservation/ cultural value.		
Map sheets	NZ Topo 50 Chart Number		
	BD39 part BE39 Matatà	NZ542	
Segments	No segment assigned	•

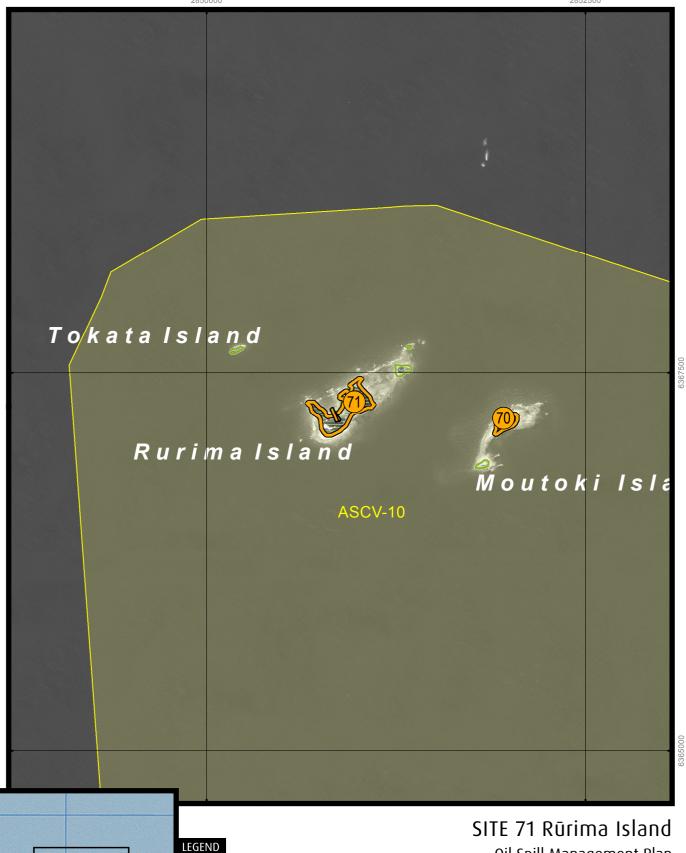
Rurima Island lies approximately 9 km north of the Rangitaiki Rivermouth. The island is the largest of the Rurima Rocks, with the smaller Moutoki and Tokata Islands lying about 1 km east and west respectively. Rurima Island is about 500 m long, with two bays and sandy beaches on the northwest side. A wide shallow reef, almost a lagoon, stretches north from the pohutukawa-covered island.

Foreshore type	Sandy beaches, rock pools, small dune system.		
	All shore segments have "habitat value" and "contact value".		
	All intertidal areas are identified in the Regional Coastal Plan as areas of significant conservation/ cultural value.		
Map sheets	NZ Topo 50 Chart Number		
	BD39 part BE39 Matatà	NZ542
