Site 65	Whangaparaoa River	Risk ranking: 3
<p>DESCRIPTION</p> <p>This site comprises bar built estuary with a mobile mouth. A sandbar encloses areas of significant saltmarsh and open water lagoon.</p>		
<p>Foreshore type</p>	<p>Lagoon, shorebird feeding areas, saltmarsh, open water in channel, exposed rocky foreshore.</p>	
<p>Map sheets</p>	<p>NZTopo 50 BD 43 Ruakokore</p>	<p>Chart Number NZ 542</p>
<p>Segments: EBOP-00360, EBOPR-00360</p>		
<p>At Risk Resources</p> <ul style="list-style-type: none"> • Numerous at risk and threatened bird species including: No New Zealand dotterels (tuturiwhatu) (as of 2011-11-05), banded dotterel (pohowera) (4-6 pairs) and pied cormorant (kāruhiruhi) colony nesting at river mouth in trees • Lagoon behind spit may be disconnected from river • Usually good outflow of water from the river • Saltmarsh vegetation along river • Saltmarsh vegetation in lagoon and tidal areas behind spit • Beach has pebble - cobble sized particles • Mussel gathering on exposed rocky outcrop east of spit • Several areas are identified in the Regional Coastal Plan as areas of significant conservation/cultural value • Cultural sites

SITE 65 Whangaparaoa River Oil Spill Mana

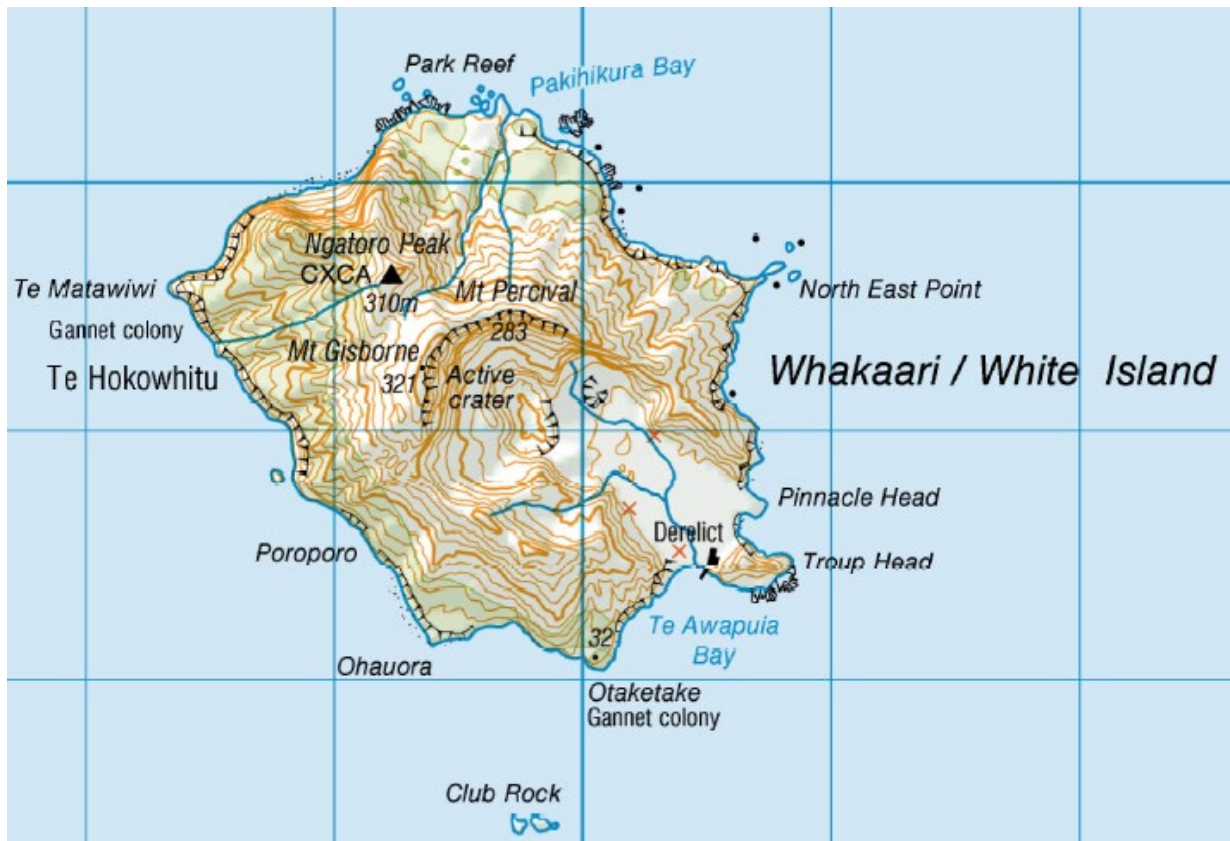
Access

The main landing is at Crater (Awapuia) Bay on the SSE coast where there is an old wharf. Around Troup Head to the east are two more small gravelly beaches where landings are straight forward during normal westerly seas. Other beaches exist on the northwest, southwest and east coasts but waves and swells normally make landings difficult and rock-fall hazards exist above them.

The main shoreline types are exposed bedrock cliffs and boulder beaches. There are possibly some bedrock platforms in places. There are several beaches mixed types which I have marked on the Google Earth image ex Island_White.pdf. The finest-grained beaches are those at the SSE "mouth" of the crater.
