Site 57	Waiaua Estuary	Risk ranking: 1
<p>DESCRIPTION</p> <p>This site comprises bar-built estuary with a highly mobile mouth. A sandbar encloses the areas of significant salt-marsh habitat.</p>		
<p>Foreshore type/environmental value</p>	<p>Lagoon, Shorebird feeding areas, Open water in channel, saltmarsh Fish spawning</p>	
<p>Map sheets</p>	<p>NZ Topo 50 BE 41 Ōpōtiki</p>	<p>Chart Number NZ 542</p>
<p>Segments: EBOP 00080, EBOP 00090</p>		
<p>At Risk Resources</p> <ul style="list-style-type: none"> • Sand spit has nesting New Zealand dotterels (tuturiwhatu) (12) and nesting oyster catchers • Feeding estuarine birds • Usually strong outflow of water from the river • Whitebaiting (spawning March-April) • Lagoon behind spit to east • Saltmarsh vegetation in lagoon • Bird sanctuary on ocean side of spit for shore nesting birds • Beach has gravel sized particles • Intertidal areas are identified in the Regional Coastal Plan as areas of significant conservation/cultural value • Cultural sites: Urupe in sand dunes on western side of mouth

SITE 57 Waiaua Estuary Oil Spill Management Plan

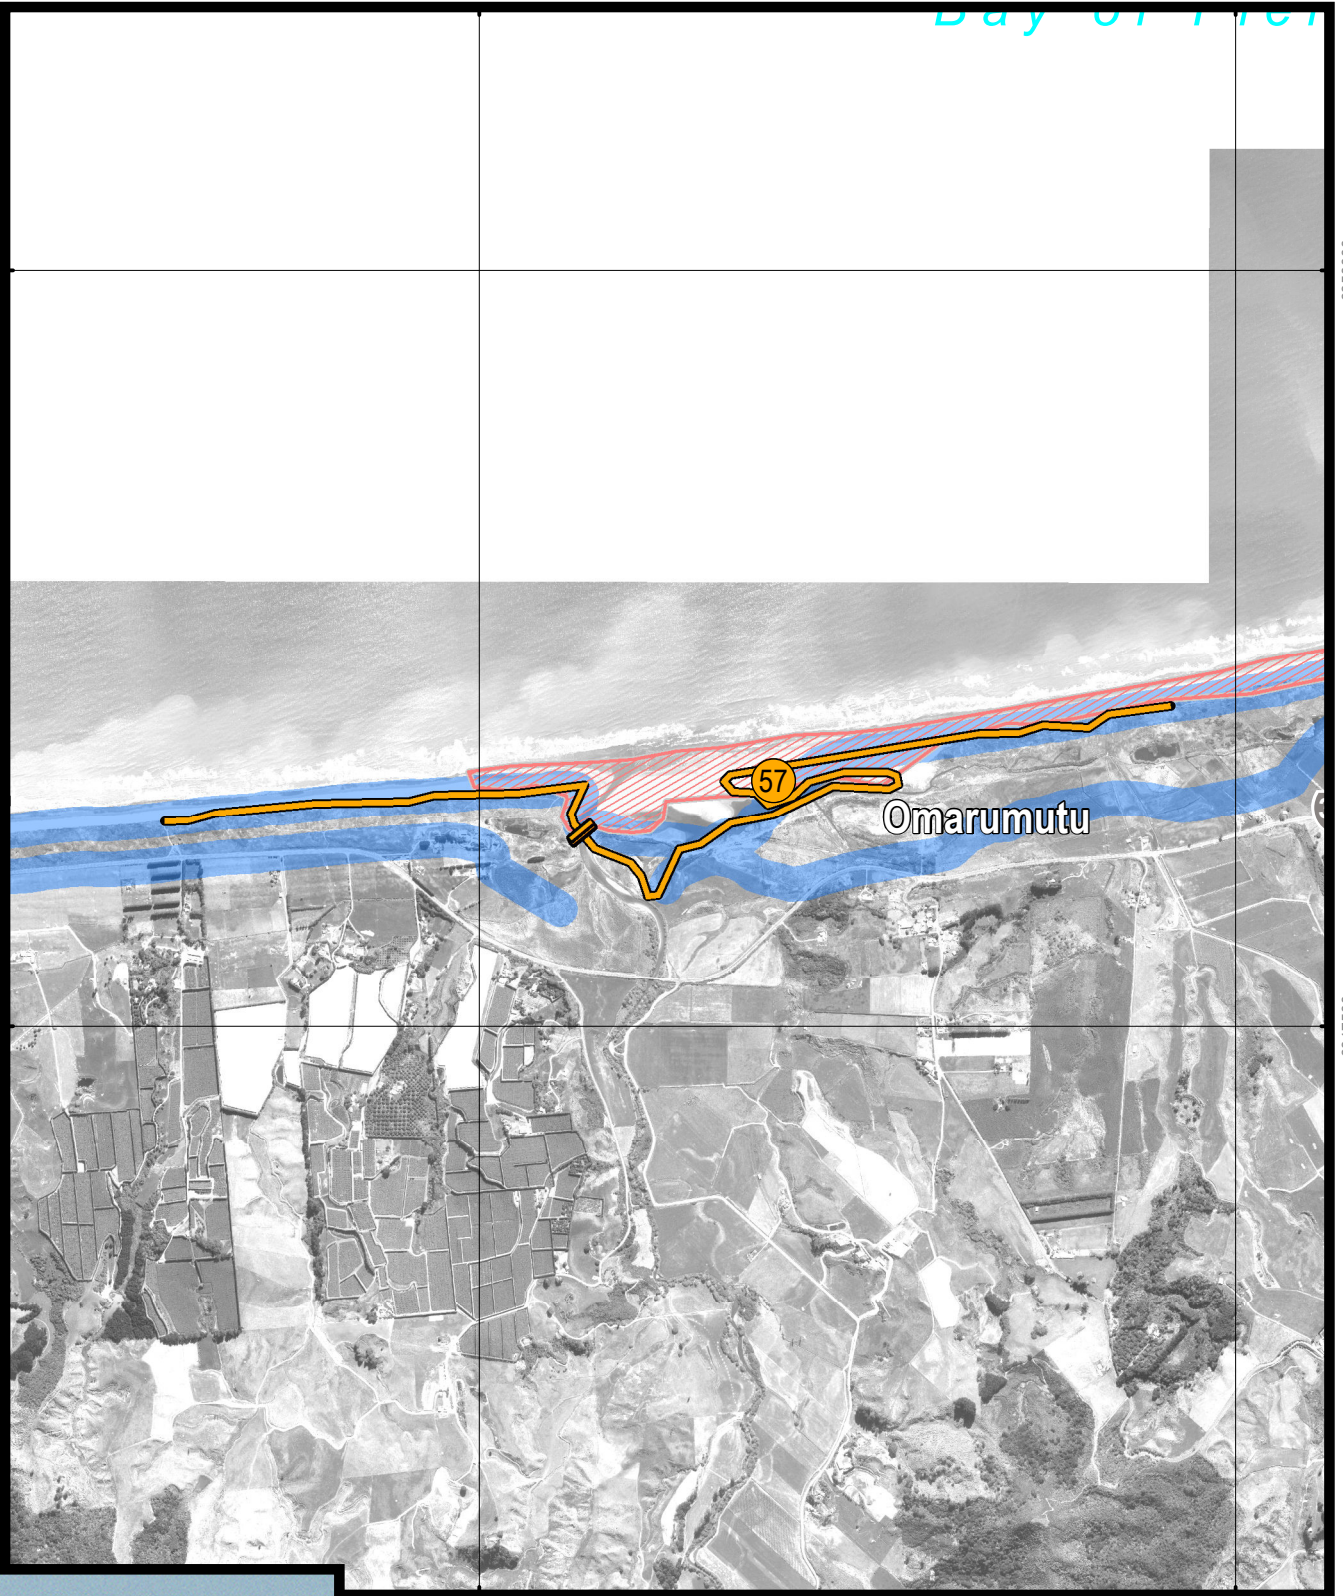
<p>Notes</p> <p>Oil that enters the low energy systems of this estuary will remain for some time. Oil will harm saltmarsh habitat and whitebait spawning areas.</p> <p>Actions</p> <ul style="list-style-type: none"> • Limit oil entering the eastern lagoon through protective barrier/booming • Capture oil on the north-western sandy intertidal and clean this area to limit the volume of oil in the estuary • Shoreline clean-up along the ocean beach on both sides of the mouth of the estuary • Notify wildlife team • Discuss pre-clean-up of intertidal debris - tidal range specific • Consider pre-emptive capture of New Zealand dotterel • Consider pre-emptive capture of wildlife generally • Activation of oiled wildlife response collection teams if required • Priority clean-up of spit entrances to limit remobilisation of oil into estuary (See STM for Sandy Beaches Shoreline Clean-up) 		
<p>Access</p> <p>Access to the entrance of the estuary is via SH 35: track access to the west; beach access from Opape to the east.</p>

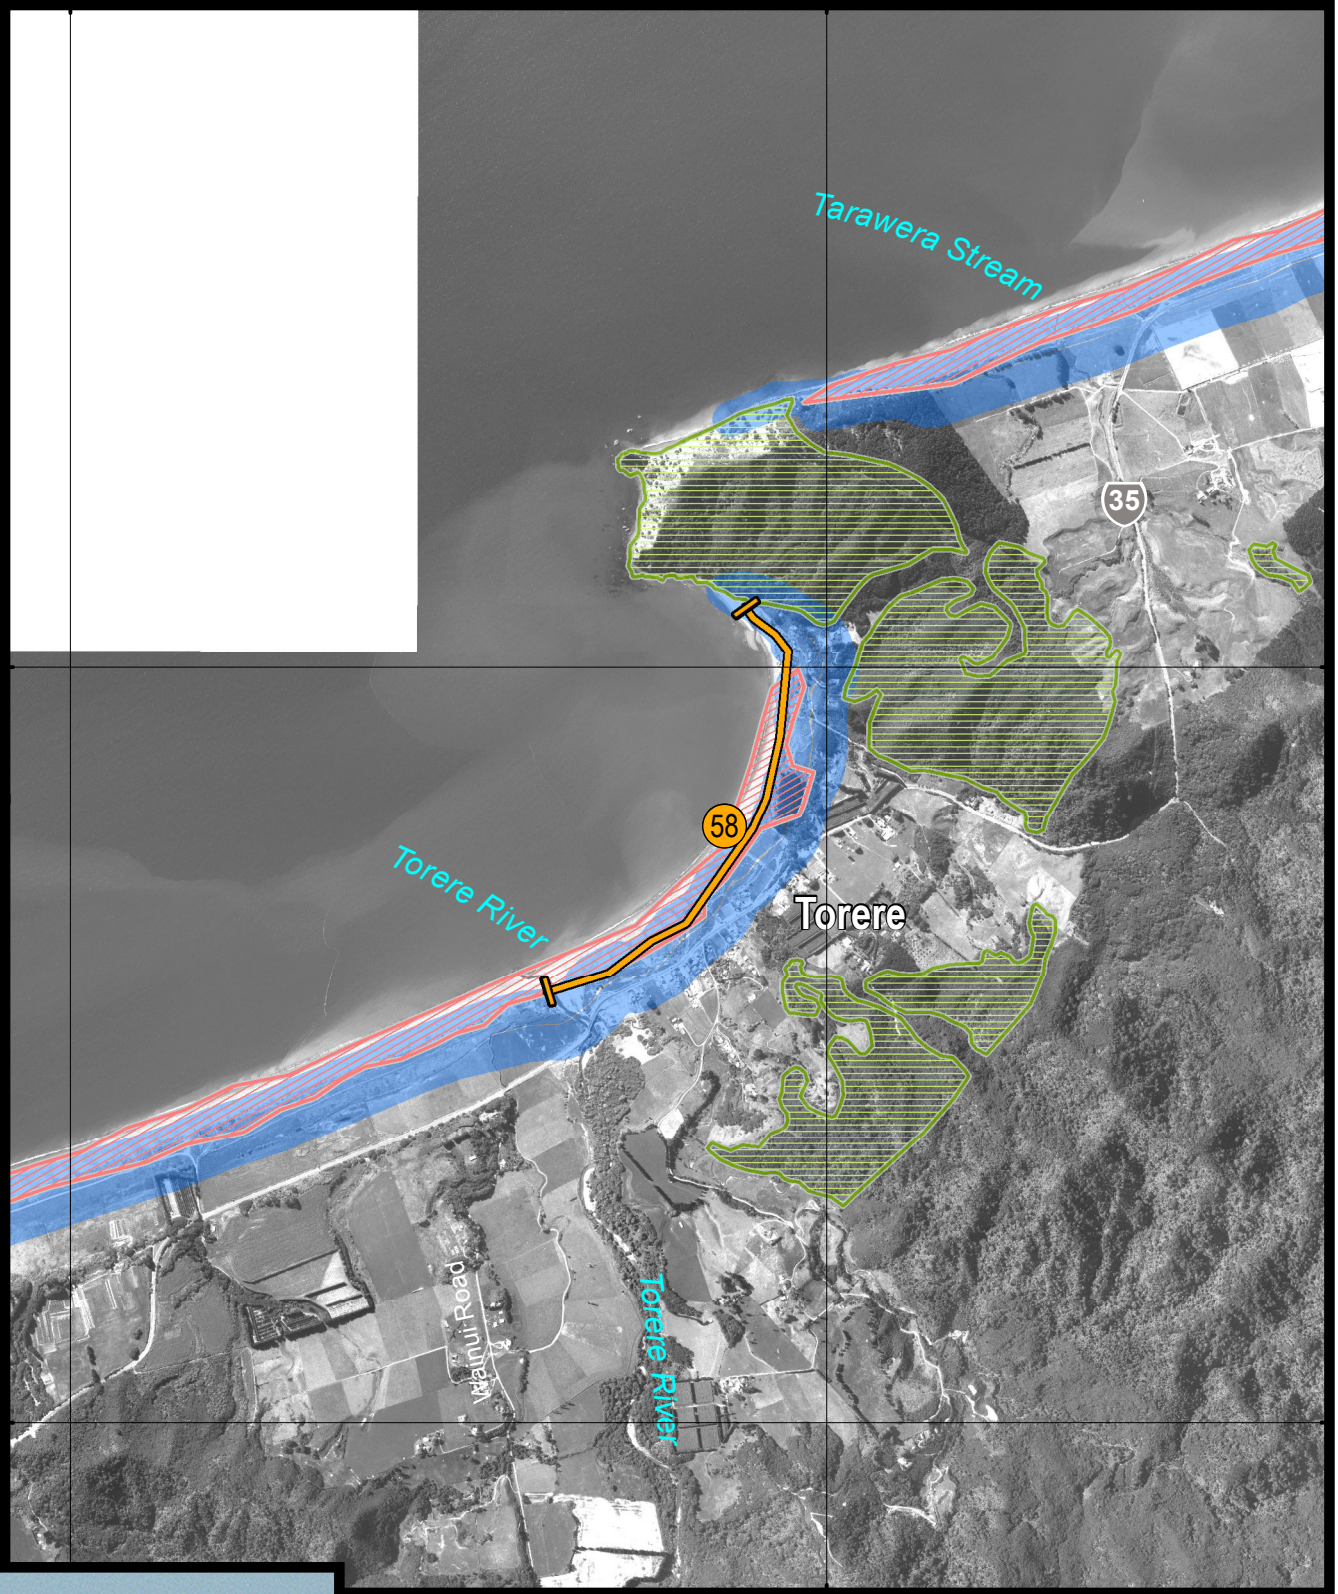
SITE 58 Waiti River & Torere Oil Spill Management Plan

Site 58	Waiiti River and Torere	Risk ranking: 3
<p>DESCRIPTION</p> <p>This site includes two river mouths, one either side of Torere township with water crossing the ocean beach into estuary at higher tidal states.</p> <p>1 To the south-west: Waiiti is a small river mouth usually cut off from the beach at low tide forming a small lagoon behind the spit.</p> <p>2 To the north-east: Torere lagoon exits at small river mouth at the eastern end of the beach, with the narrow lagoon extending west towards Torere.</p>		
Foreshore type	Steep pebble/cobble beach, Lagoon, riparian vegetation	
Map sheets	NZ Topo 50 BD 43 Ruakokore	Chart Number NZ 542
Segments: EBOP 00150		
<p>At Risk Resources</p> <p>1 Waiiti: Shore birds including New Zealand dotterel (tuturiwhatu)</p> <p>2 Torere lagoon: Amenity value</p> <p>Both Waiiti and Torere lagoon:</p> <ul style="list-style-type: none"> • Kahawai fishery • All intertidal areas are identified in the Regional Coastal Plan as areas of significant conservation/cultural value • Cultural sites: including kaimoana

<p>Notes</p> <p>Oil that enters the low energy systems of this estuary will remain for some time. Oil will harm intertidal habitat.</p> <p>Actions</p> <ul style="list-style-type: none"> • Consider entrance closure at incoming tides and release river water when required (feasibility dependent on river flow) • Consider collection and recovery near river mouth • Booming near each mouth to prevent oil entering connecting channel • Notify wildlife team • Discuss pre-clean-up of intertidal debris - tidal range specific • Consider pre-emptive capture of wildlife generally • Activation of oiled wildlife response collection team 		
<p>Access</p> <p>1 Waiiti River: Beach access is from state Highway 35 south-west of Tōrere township</p> <p>2 Torere Lagoon: Access road just north-east of Torere township</p>

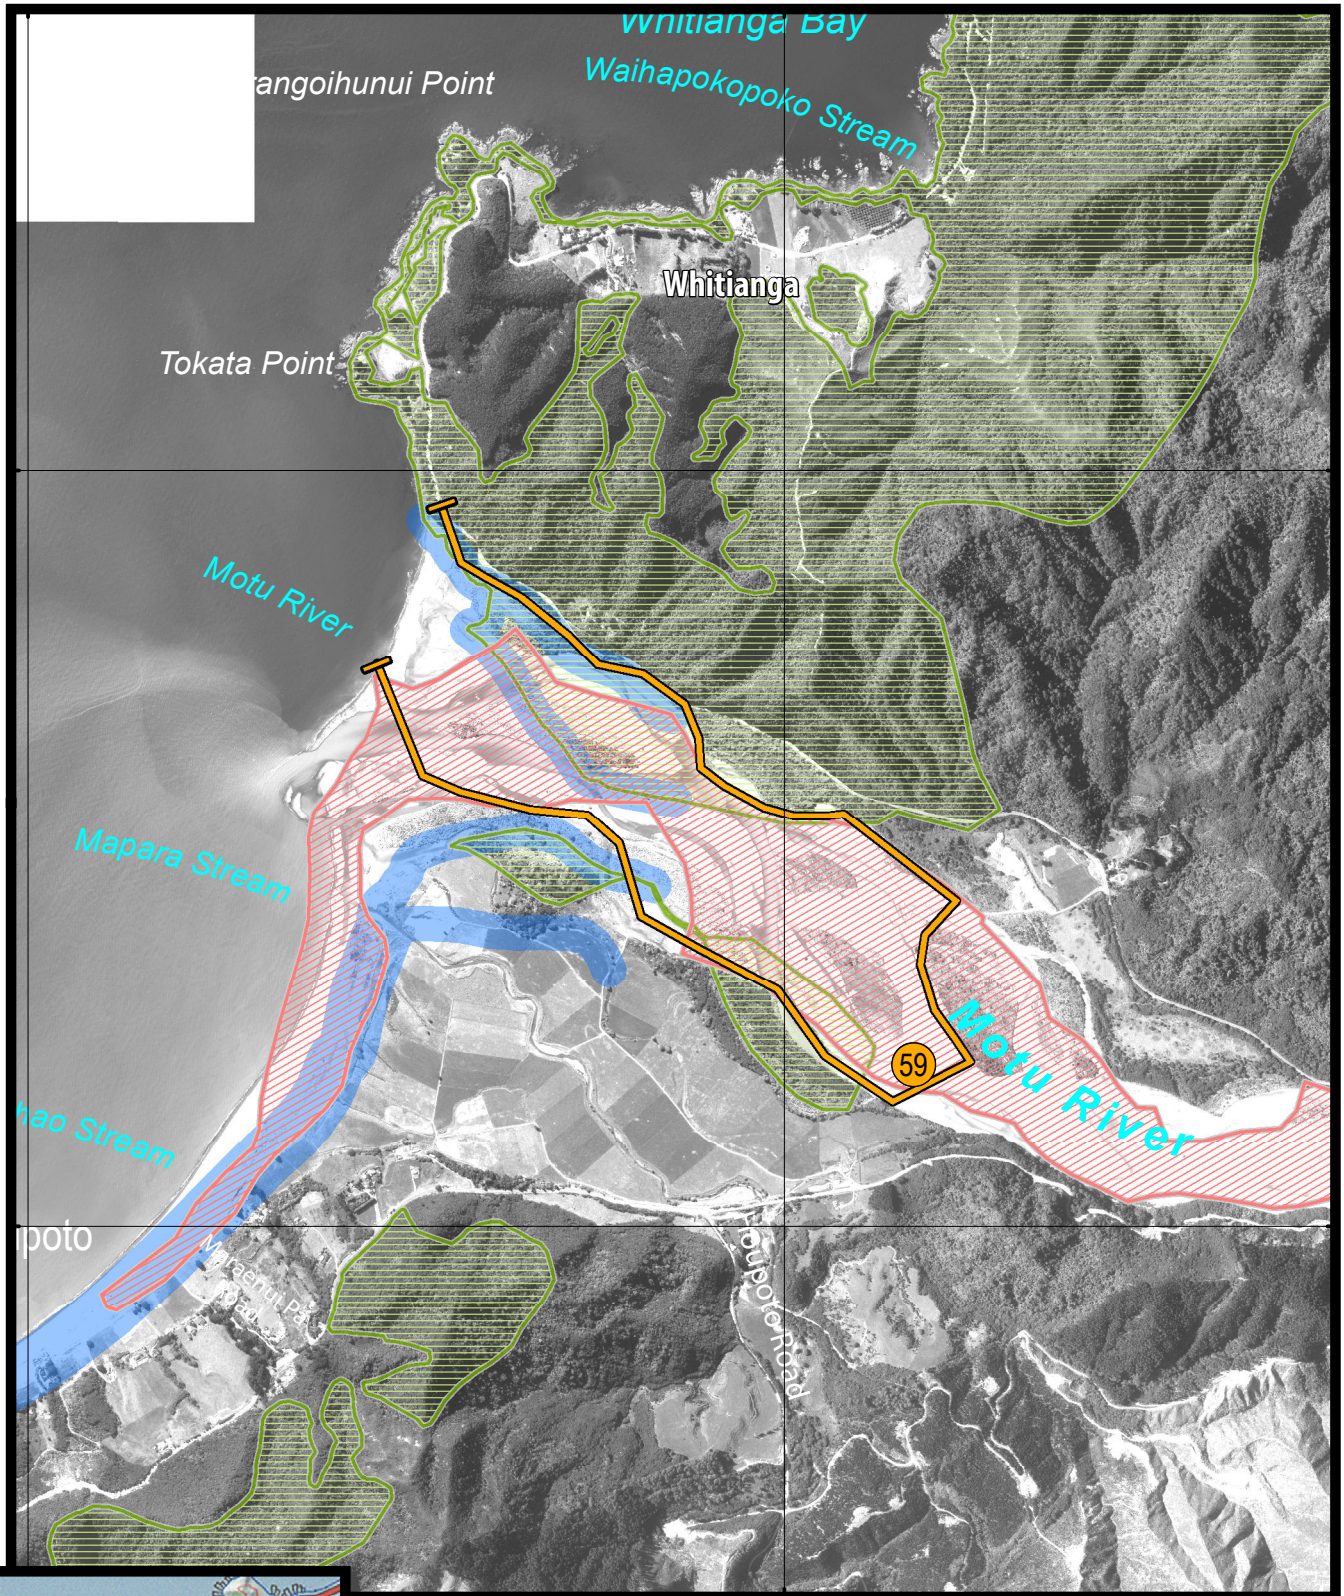
SITE 59 Motu River Oil Spill Management Plan

Site 59	Motu River	Risk ranking: 2
<p>DESCRIPTION</p> <p>Site of tidal braided river mouth. Highly active river mouth with sand bar enclosing lagoon and saltmarsh.</p>		
<p>Foreshore type/environmental value</p>	<p>River mouth, saltmarsh, Fishery, Lagoon. All shore segments have “habitat value”.</p>	
<p>Map sheets</p>	<p>NZ Topo 50 BE 42 Houputu</p>	<p>Chart Number NZ 542</p>
<p>Segments: EBOP R 00200</p>		
<p>At Risk Resources</p> <ul style="list-style-type: none"> • New Zealand dotterel (tuturiwhatu) (non 2011-11-05) • Some gulls, oystercatchers breeding on beach at mouth • Fish breeding location – nationally significant snapper spawning area and regionally significant kahawai fishery. The area extends seaward of Mean High Water Springs in a six nautical mile radius from Tokaroa Rock and along the coast from Haurere Point in the south to Ohae Point in the north • Kaimoana • All intertidal areas are identified in the Regional Coastal Plan as areas of significant conservation/cultural value <p>Cultural sites:</p> <ul style="list-style-type: none"> • Culturally significant kahawai fishery (December)

Access to beach areas and the Motu River Estuary is indicated on the topographical map, SH 35. Access to Motu Estuary from the east side of the Motu River is limited to walking down from the lookout. Access from the west side is via farmland or access track from turn off to marae. The nearest boat launching ramp is located at the Ōpōtiki Wharf.

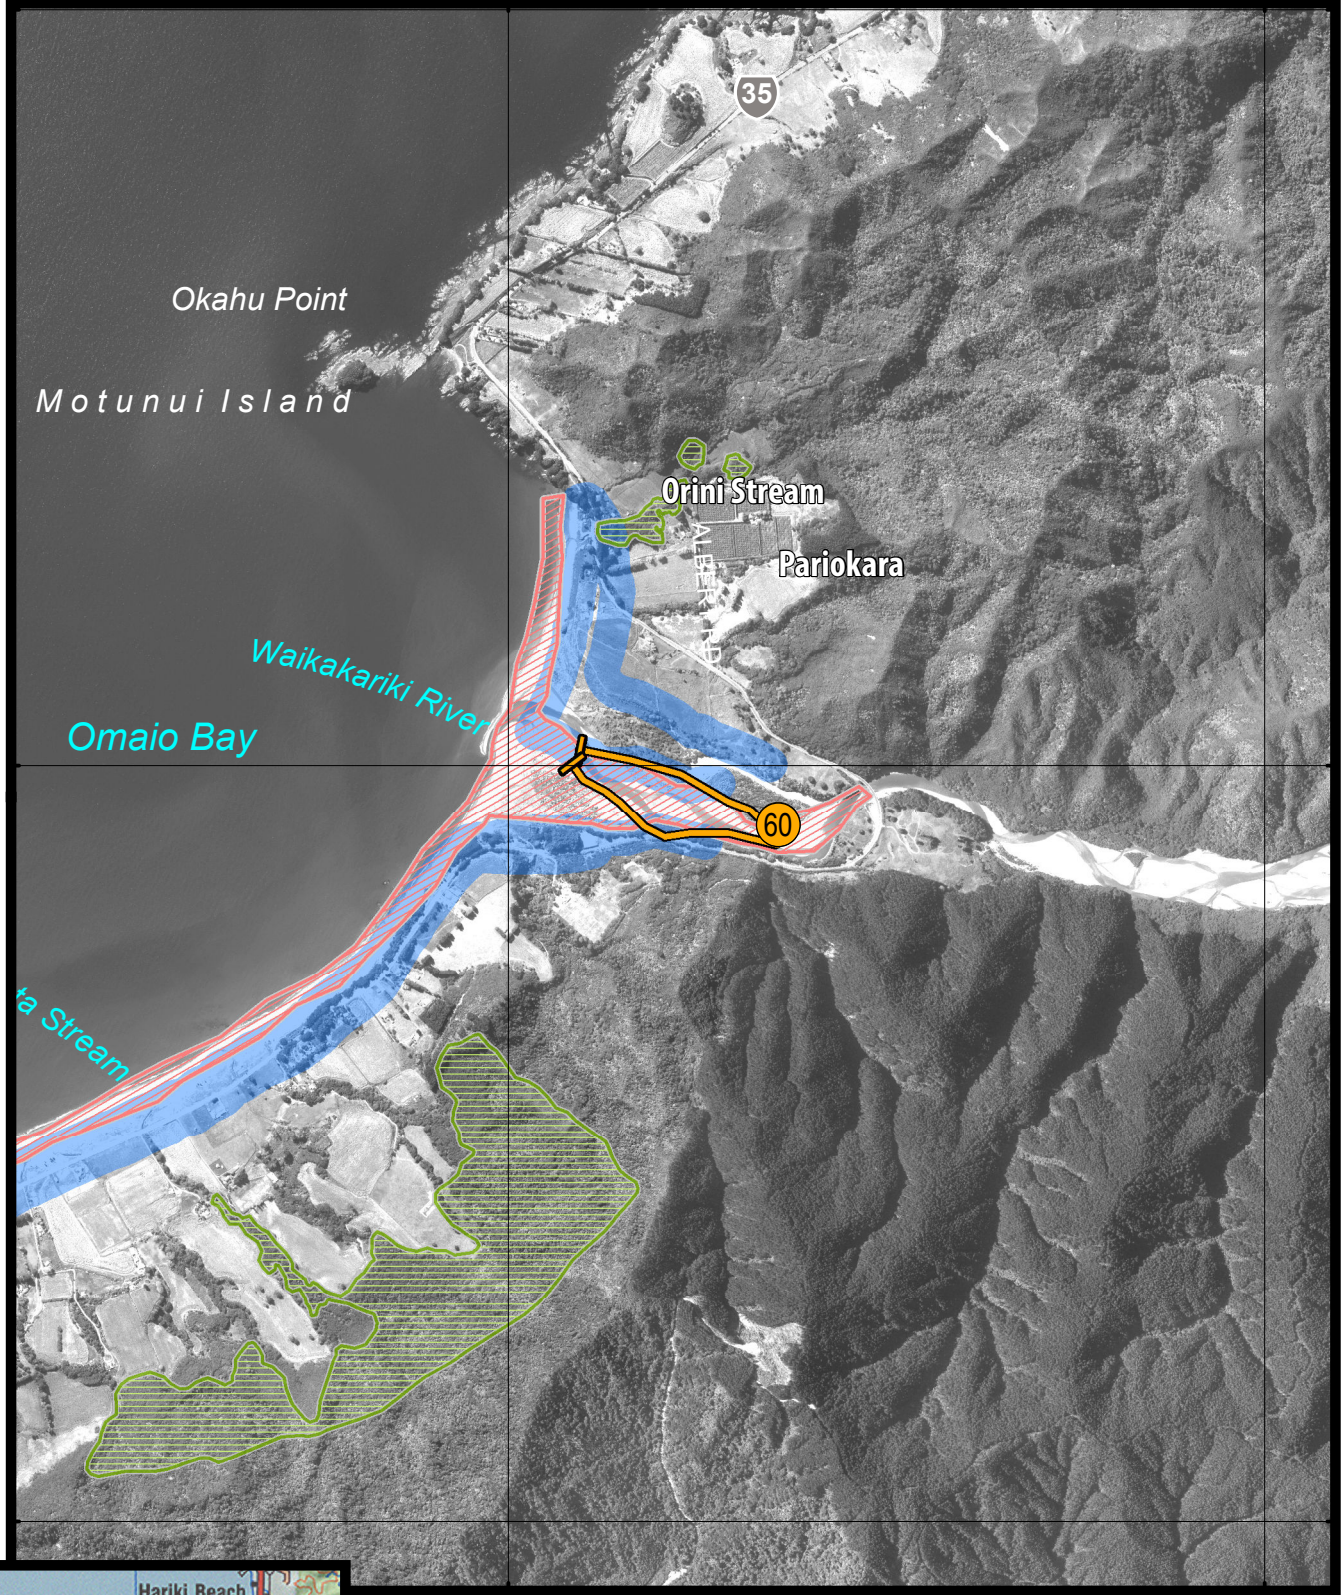
SITE 60 Haparapara Oil Spill Management Plan

Site 60	Haparapara	Risk ranking: 3
<p>DESCRIPTION</p> <p>Sandspit enclosed estuary located at northern end of beach in Omaio Bay. Haparapara River is generally a low flow river with a mobile entrance with a lagoon located to the south of entrance. Sandspits and beaches are pebble/cobble.</p>		
Foreshore type	Lagoon, Open water in channel, saltmarsh	
Map sheets	NZ Topo 50 BD 42 Te Kaha	Chart Number NZ 542
Segments: EBOP R 00230		
<p>At Risk Resources</p> <ul style="list-style-type: none"> • Shorebird feeding areas • Possible shell collecting sites • All intertidal areas are identified in the Regional Coastal Plan as areas of significant conservation/cultural value • Cultural sites 		
<p>Notes</p> <p>Oil that enters the low energy systems of this estuary will remain for some time. Oil will harm intertidal and sand flats habitat</p> <p>Actions</p> <ul style="list-style-type: none"> • Consider containment and recovery system as close as possible to the mouth, with deflection away from saltmarsh areas • OR bulldoze entrance closed at high tides and release river water when required to refresh water • Notify wildlife team • Discuss pre-cleanup of intertidal debris - tidal range specific • Consider pre-emptive capture of wildlife generally • Activation of oiled wildlife response collection teams if required

<p>Access</p> <p>State highway 35. Access possible from tracks to north and south of estuary</p>
