Site 13	Aongatete	Risk ranking: 2
DESCRIPTION Low energy, saltmarsh and mangrove. Aongatete Estuary contains large areas of representative mangrove stands, which are diverse in stature and density. These stands are contiguous with saltmarsh of high quality characteristic of Tauranga Harbour.		
Foreshore type/environmental value	Mangroves, sandy/muddy shores Habitat (intertidal) All shore segments have “habitat value” All intertidal areas are identified in the Regional Coastal Plan as areas of significant conservation/cultural value	
Map sheets	NZ Topo 50 BD 36 Lower Kaimai	Chart Number NZ 541
Segments	TAU-00480; 00470; 00490; 00491; 00461	
At Risk Resources <ul style="list-style-type: none">• Australasian bittern (matuku hūrepo) - nationally endangered, banded rail (kataitai), North Island fern bird (mātātā), pukeko, spotless crane (pūweto), white-faced heron (matuku-moana)• Whitebait (inanga)

SITE 13 Aongatete Oil Spill Management Plan

Oil Spill Management Plan

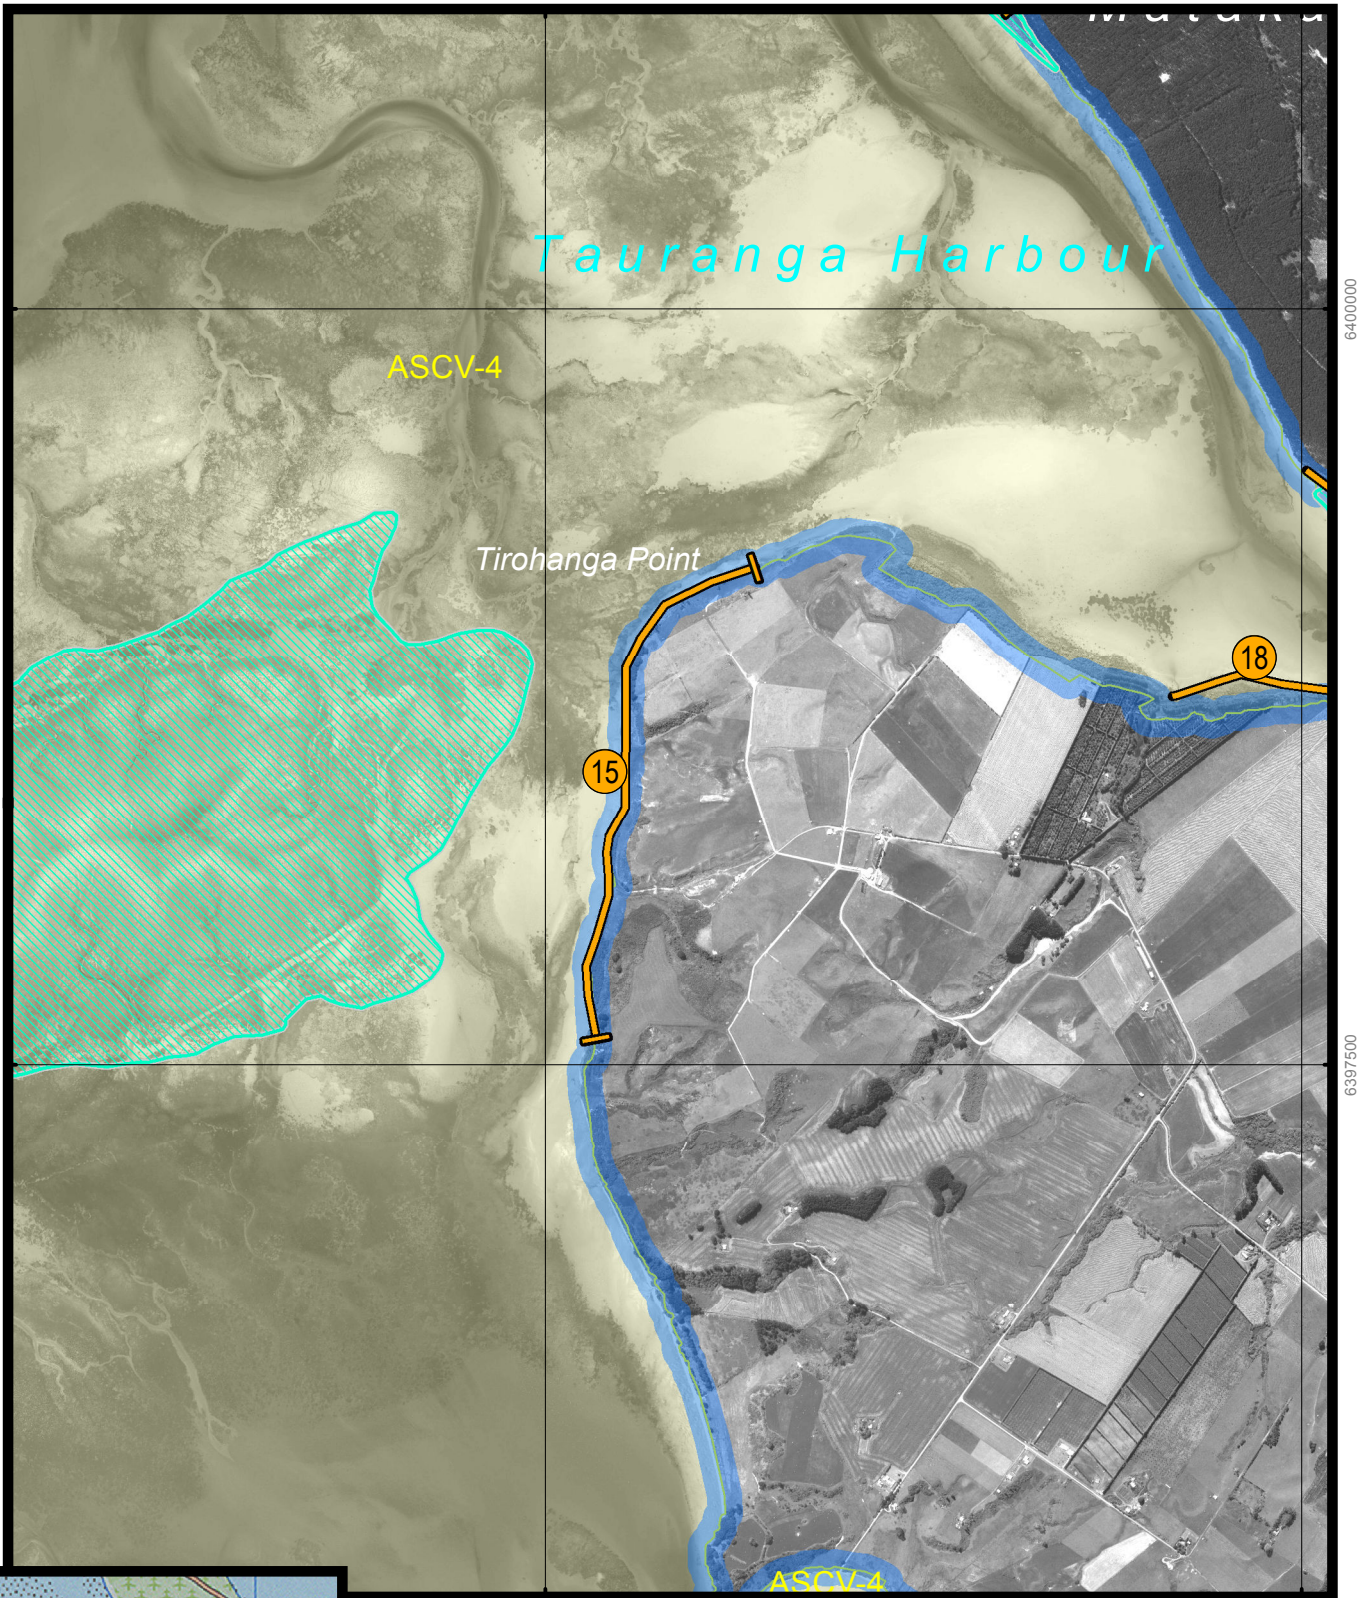
SITE 15 Central Mangroves

Site 15	Central Mangroves	Risk ranking: 3
DESCRIPTION Largest area of mangroves in harbour, with some manuka shrublands in centre. Situated in central middle of harbour on western side of Matakana Island. Moderate energy tidal flow.		
Foreshore type/environmental value	Sandy/muddy shores, riparian vegetation, transitional ecosystem (island in the making) All shore segments have “habitat value” All intertidal areas are identified in the Regional Coastal Plan as areas of significant conservation/ cultural value	
Map sheets	TOPO 50 BD36 Lower Kaimai	Chart Number NZ541
Segments	TAU-00830	
At Risk Resources <ul style="list-style-type: none">• Fernbird (kataitai), Banded Rail (kataitai)• Heron and shags• Canada goose and black swan nesting area• High value transitional ecosystem with fish spawning and invertebrate values• Cultural values: Mahinga kai		
Notes Where possible, oil should be prevented from entering the harbour

Most preferred	Least preferred	Feasibility
Containment and Recovery	High		Limited access and tidal
On water Recovery	High		Possible but only in channels
Dispersant Application	Low	Requires escalation to Tier 3 and MNZ approval	Water depth won't allow
Shoreline Clean-up	Medium		Limited access and time - tidal
Natural Recovery	Medium		On-going monitoring
