# Tauranga Harbour Coastal Hazards Study

## Coastal Erosion Assessment

Prepared for  
Bay of Plenty Regional Council

Prepared by  
Tonkin & Taylor Ltd

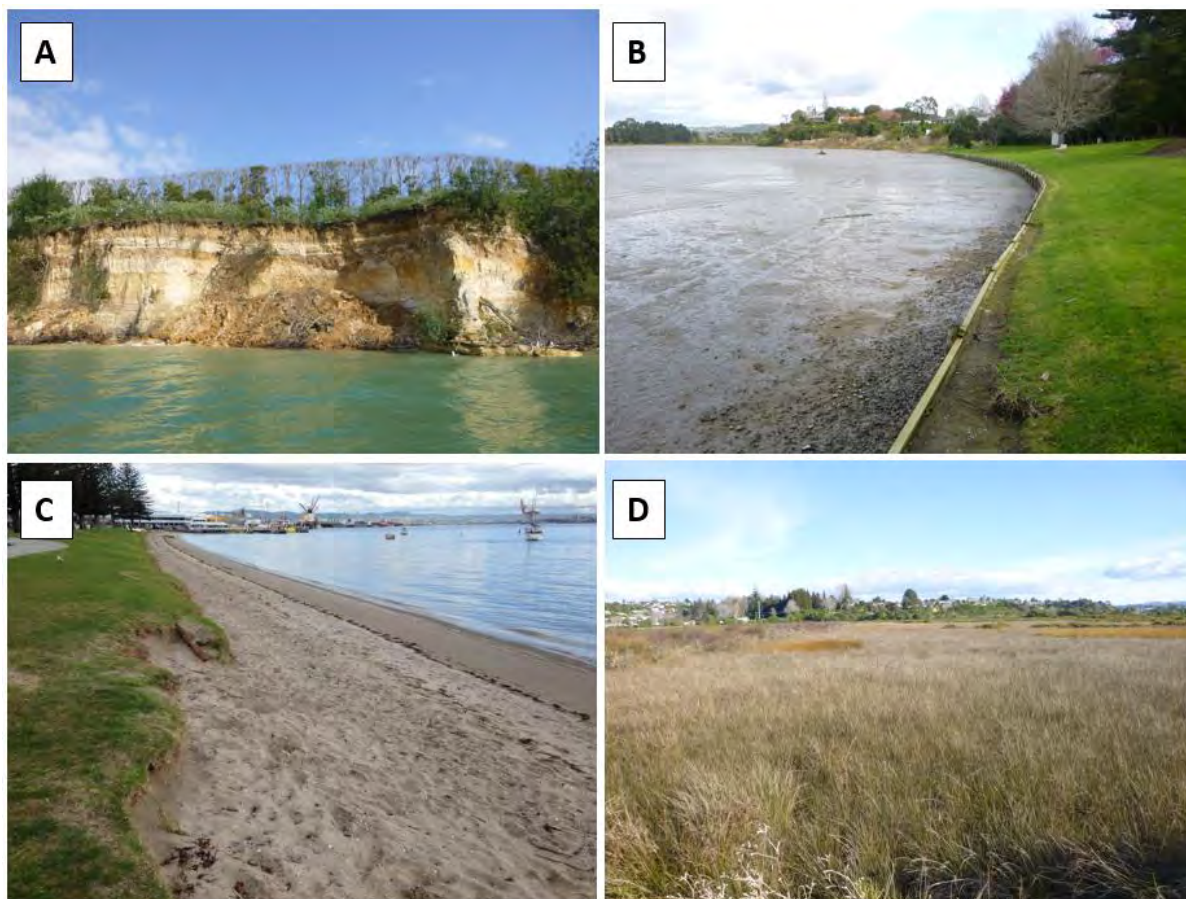
Figure 2-1 Examples of different shoreline morphology around Tauranga Harbour. (A) Consolidated cliffs, (B) consolidated bank, (C) unconsolidated beach ridge, (D) low-lying estuarine area.

Unlike the open coast, there are very few sand dune systems throughout the harbour. Most of the unconsolidated shorelines are characterised by beach ridges, backed by grass reserves. An example of an unconsolidated shoreline is Pilot Bay (Figure 2-1C).

The low-lying estuarine areas are characterised by non-eroding shorelines, typically fronted by salt marsh and mangroves. Such shorelines typically occur within the sheltered upper reaches of the harbour, for example, the Matua salt marsh (Figure 2-1D).

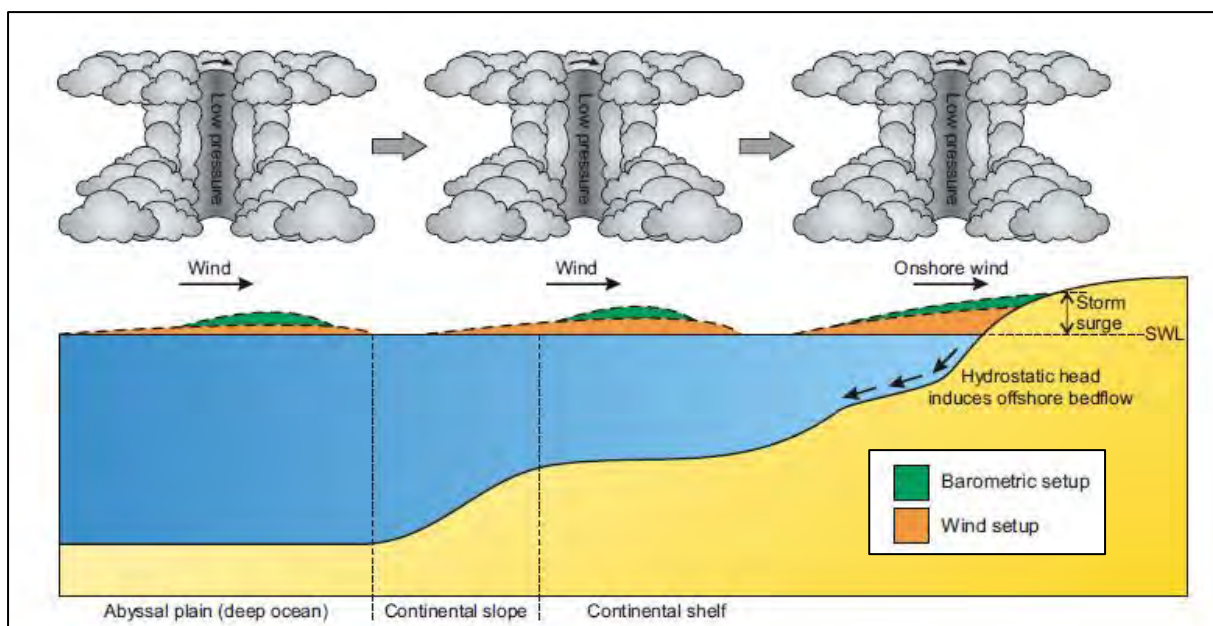
Figure 2-3 Processes causing storm surge (source: Shand, 2010).

Storm surge results from the combination of barometric setup from low atmospheric pressure and wind stress from winds blowing along or onshore which elevates the water level above the predicted tide (Figure 2-3). The combined elevation of the predicted tide and storm surge is known as the storm tide.

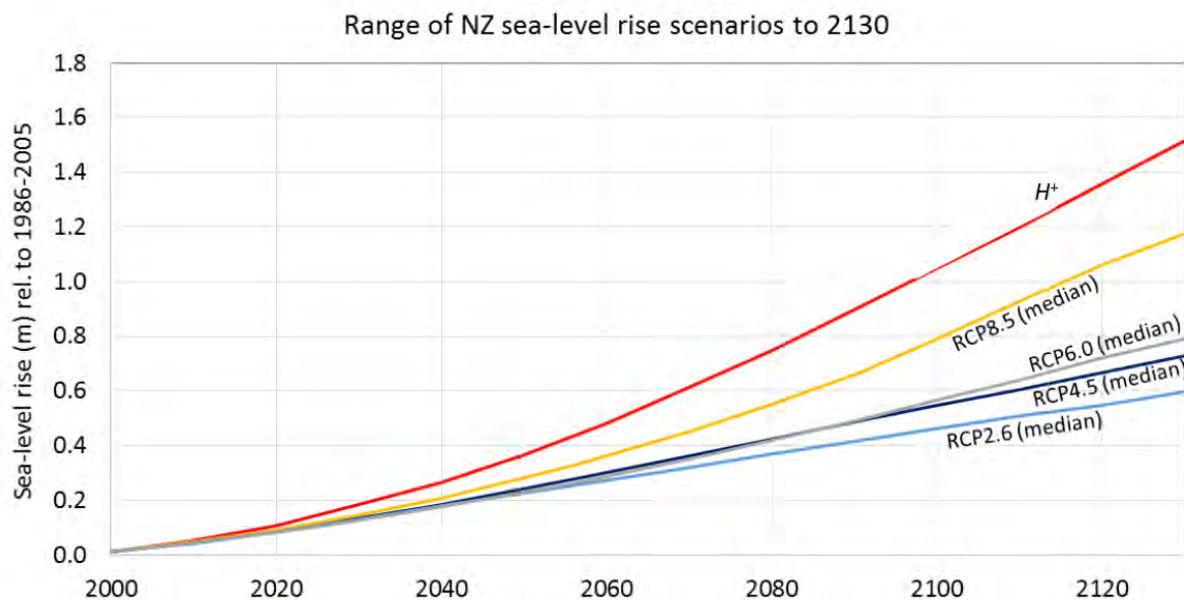
Figure 2-4 Range of sea level rise scenarios to 2130 (Stephens, 2017).

The Ministry for the Environment (2017) guideline recommends four sea level rise scenarios to cover a range of possible sea-level futures. The scenarios are based on the most recent IPCC report (IPCC, 2013) (Figure 2-4).

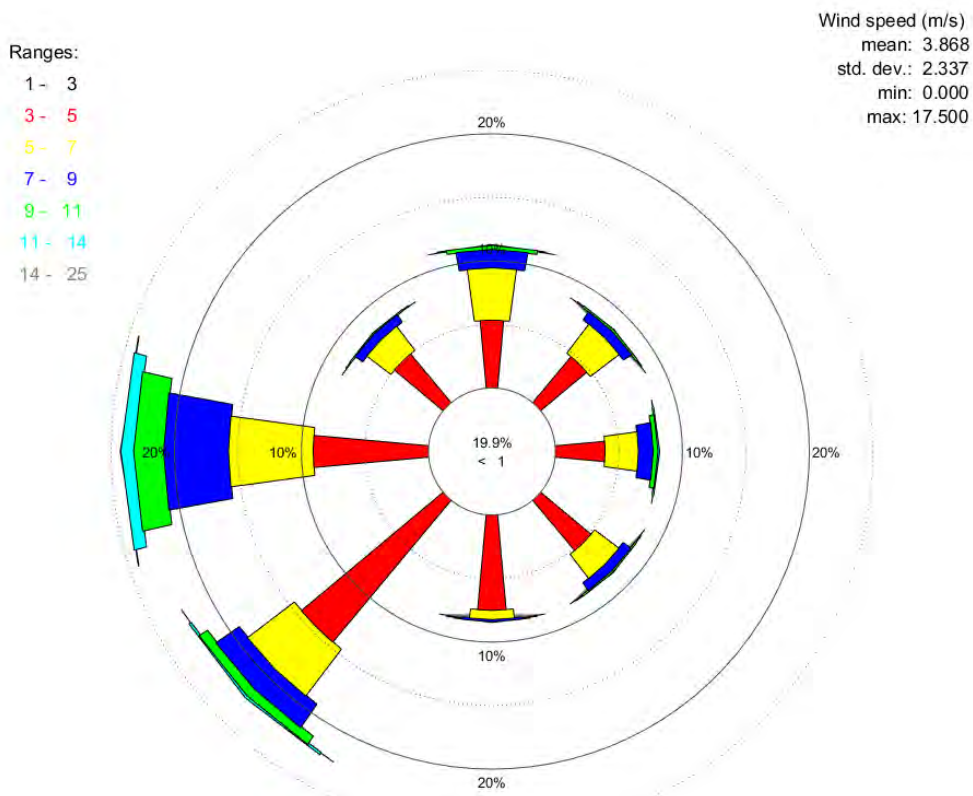
Figure 2-5 Wind rose for Tauranga Airport 1995 – 2016 (Source: MetService, 2018).

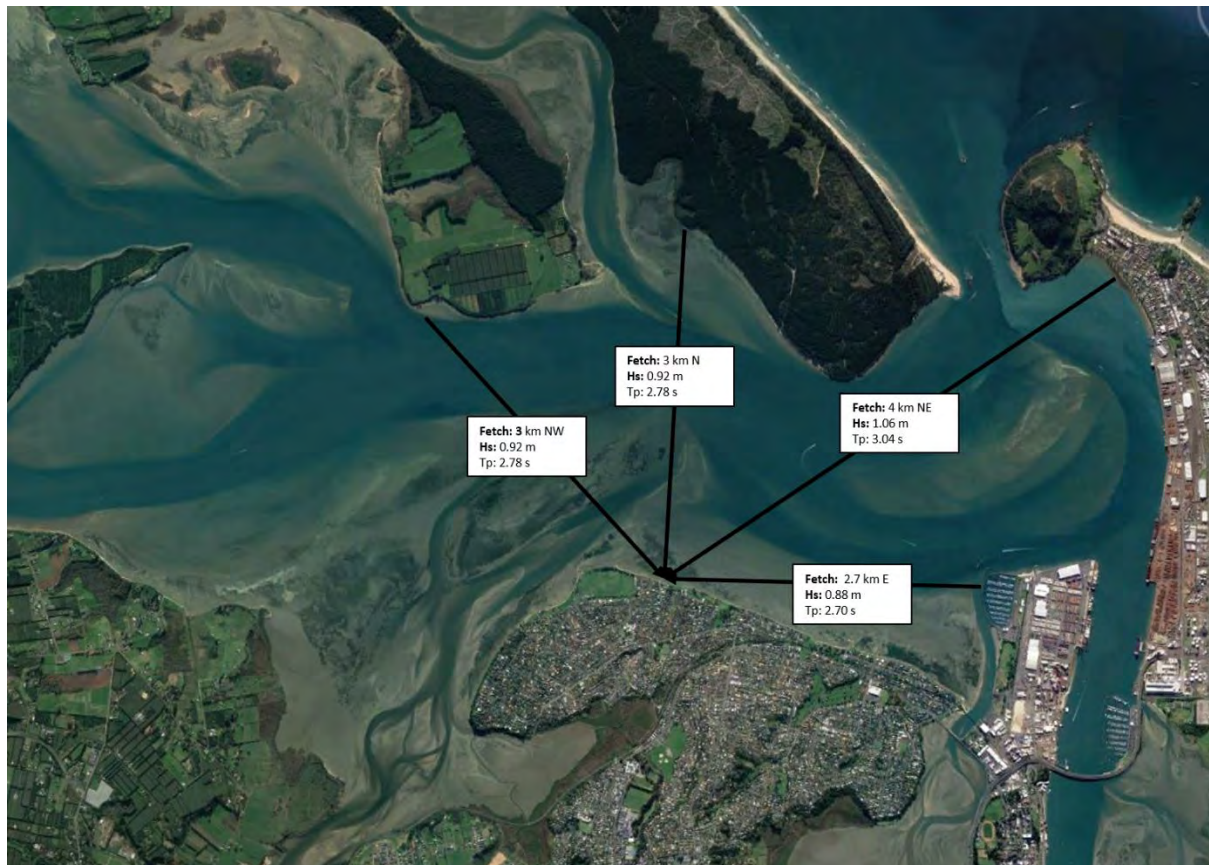
Figure 2-6 Example of fetch distances with corresponding fetch-limited wave heights for the western Otumoetai shoreline. Fetch-limited wave heights based on 23 m/s 1 hour duration wind speeds.

Figure 2-5 demonstrates the different fetch distances for the Otumoetai shoreline, where the maximum fetch-limited wave height at Otumoetai is 1.06 m, generated from the NE.

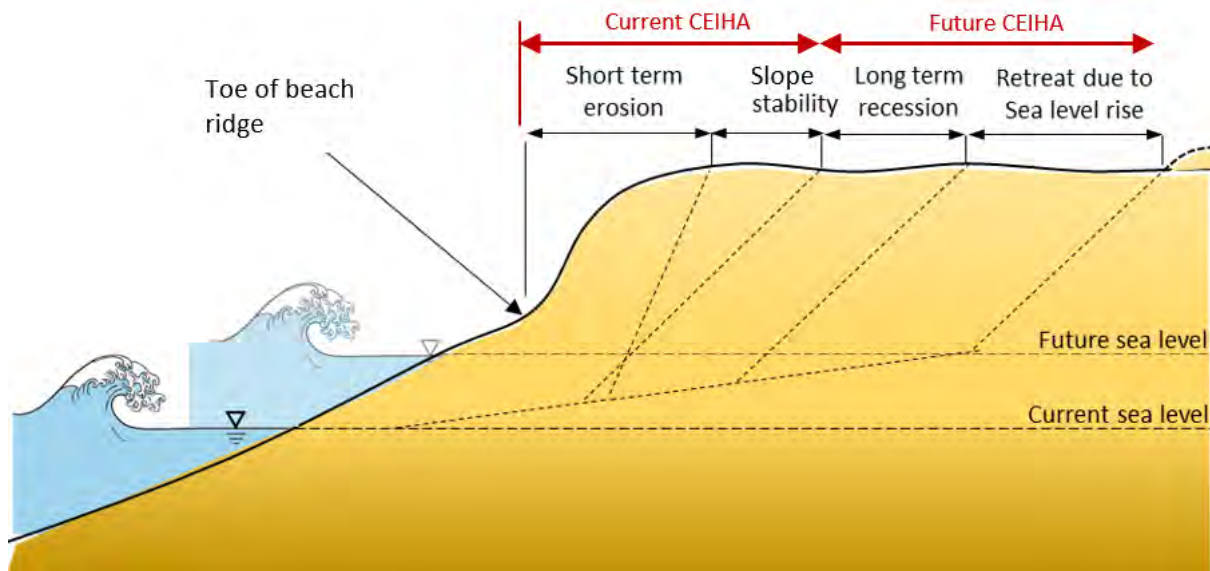
Figure 4-1 Definition sketch for the coastal erosion hazard area for an unconsolidated shoreline.

- ST = Short term changes in horizontal shoreline position related to storm erosion due to singular or a cluster of storms events or fluctuations in sediment supply and demand, beach rotation and cyclical changes in wave climate (m)
- SS = Slope stability allowance. This is the horizontal distance from the base of the eroded slope to the crest at a stable angle of repose (m)

LT	=	Long term rate of horizontal coastline movement (m/yr)
T	=	Timeframe (years)
SLR	=	Horizontal coastline retreat due to the effects of increased mean sea level (m)

The CEIHA baseline to which values are referenced is the most recent beach ridge toe derived from site survey data or LiDAR. The cross over between the short term erosion and the slope stability represents the short term effect from talus material protecting the shoreline.

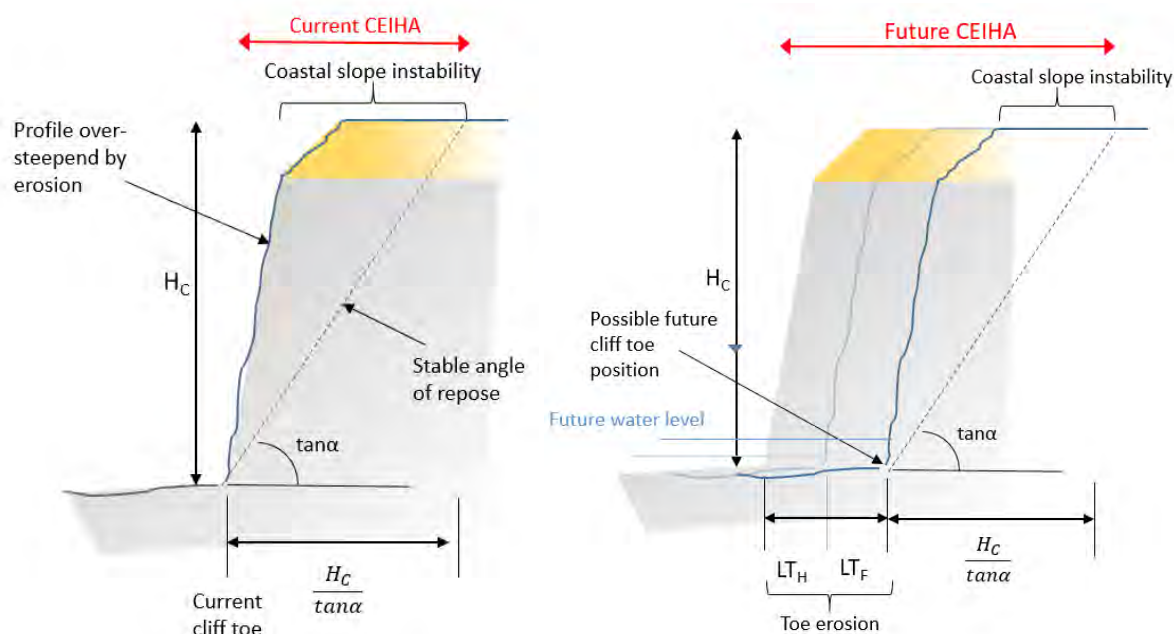
Figure 4-2 Definition sketch for consolidated shoreline.

Figure 4-2 shows that the current CEIHA distance is entirely dependent on the stable angle of repose. Therefore the current CEIHA for unconsolidated cliff and bank shorelines represents the land currently exposed to slope instability hazard.

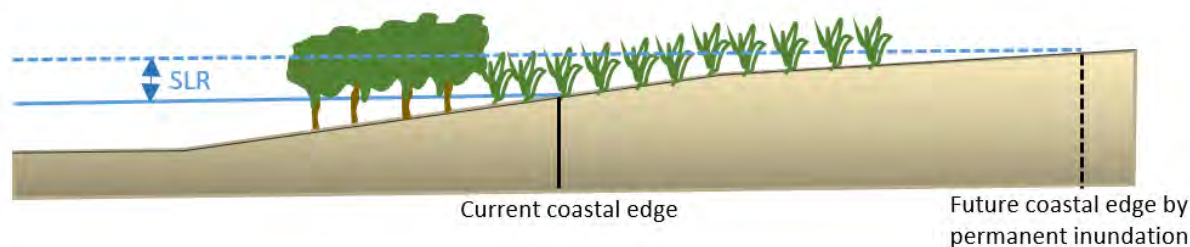
Figure 4-3 Effect of permanent inundation on coastal edge position in low-lying areas.

A shoreline is defined by the landward extent of typical marine processes such as tides and waves. In a sheltered estuarine environment this can be approximated by the mean high water spring (MHWS) position. The potential increase in future sea level may cause the shoreline to migrate landward as areas are permanently inundated by these processes (i.e. Figure 4-3). For the low-lying estuarine areas around Tauranga Harbour there is no evidence of shoreline erosion. However there is potential for the shoreline to migrate landward with permanent inundation from sea level rise assuming no change in morphology. For these shorelines we have used the future MHWS-7 output from Stephens (2019) to assess the permanent inundation hazard for low-lying estuarine areas.

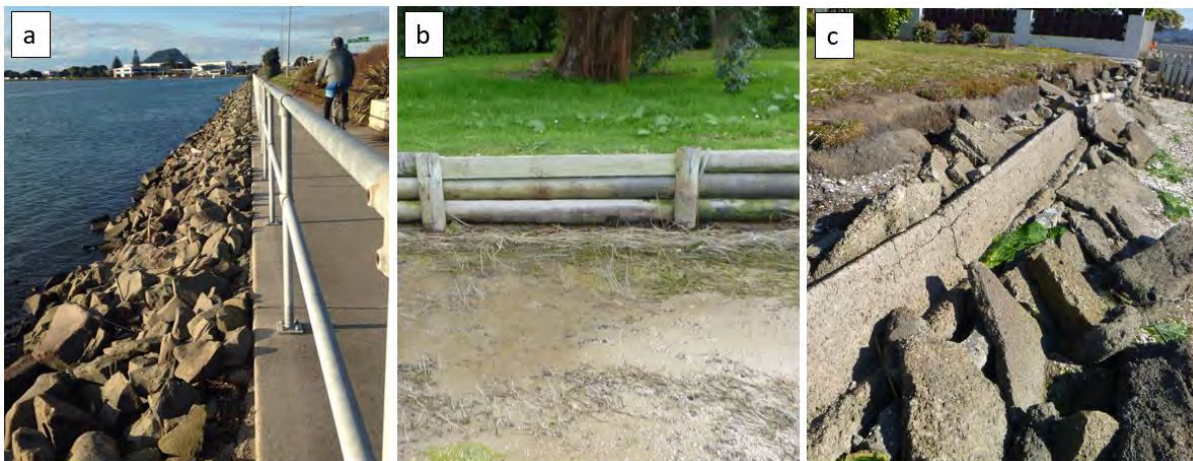
Figure 4-4 Example of the three types of protection structures around Tauranga Harbour (a) critical, (b) consented and (c) informal, non-consented structures.

- 1 Critical, consented structures (e.g. Figure 4-4A)
- 2 Non-critical, consented structures (e.g. Figure 4-4B)
- 3 Informal or non-consented structures (e.g. Figure 4-4C).

Critical consented structures are those which are protecting key public infrastructure and assets. These include state highways, port infrastructure, the central business district and water infrastructure such as treatment plants. Due to the high value of assets being protected, advice has been provided by the project partners that these will be maintained and upgraded as required. Based on this advice, there are four areas where critical structures have been identified across the harbour sites:

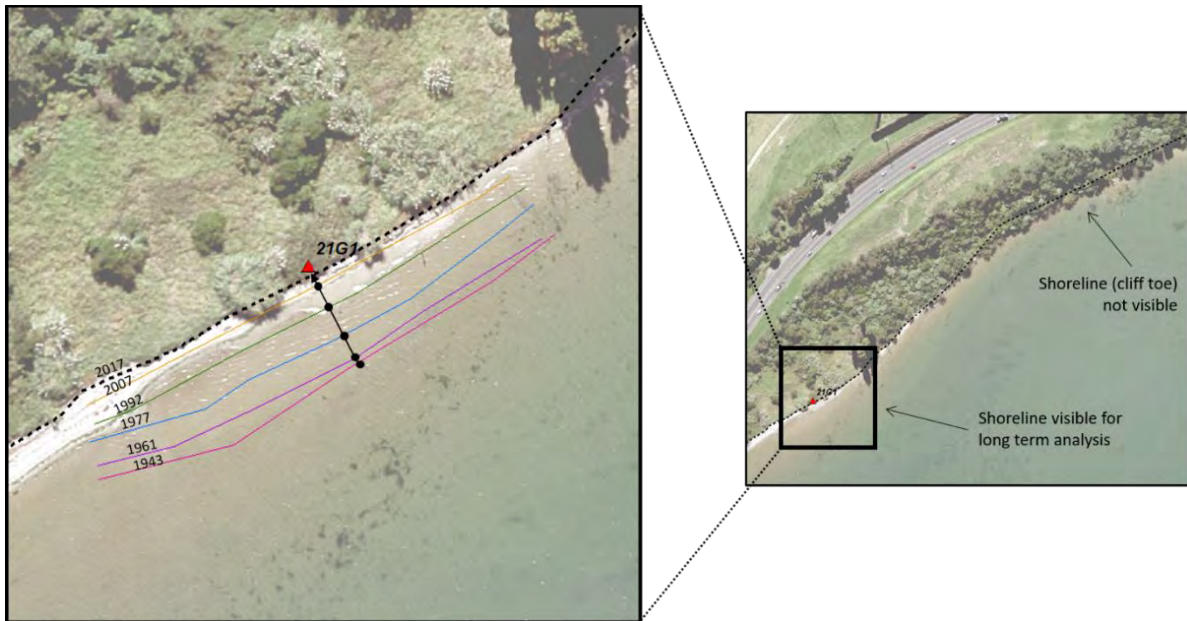
Figure 5-3 Example of single point shoreline position analysis for Cell 21G, Matapihi.

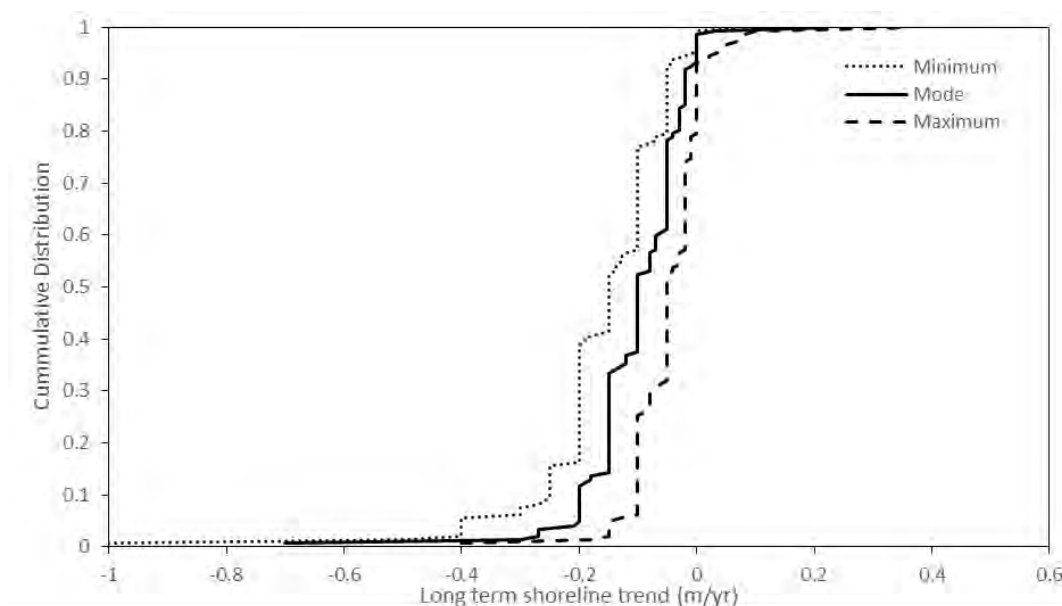
Figure 5-5 Cumulative distribution plot of the long term shoreline trends throughout Tauranga Harbour (negative values = erosion, positive values = accretion).

Long term shoreline trends throughout the Harbour range from -1 to +0.36 m/yr, with most shorelines showing a long term erosion rate of -0.1 m/yr (Figure 5-5). The majority of the sites have a measured long term erosion rate between -0.2 to -0.05 m/yr. This equates to -5 to -20 m of erosion over a 100 year timeframe.

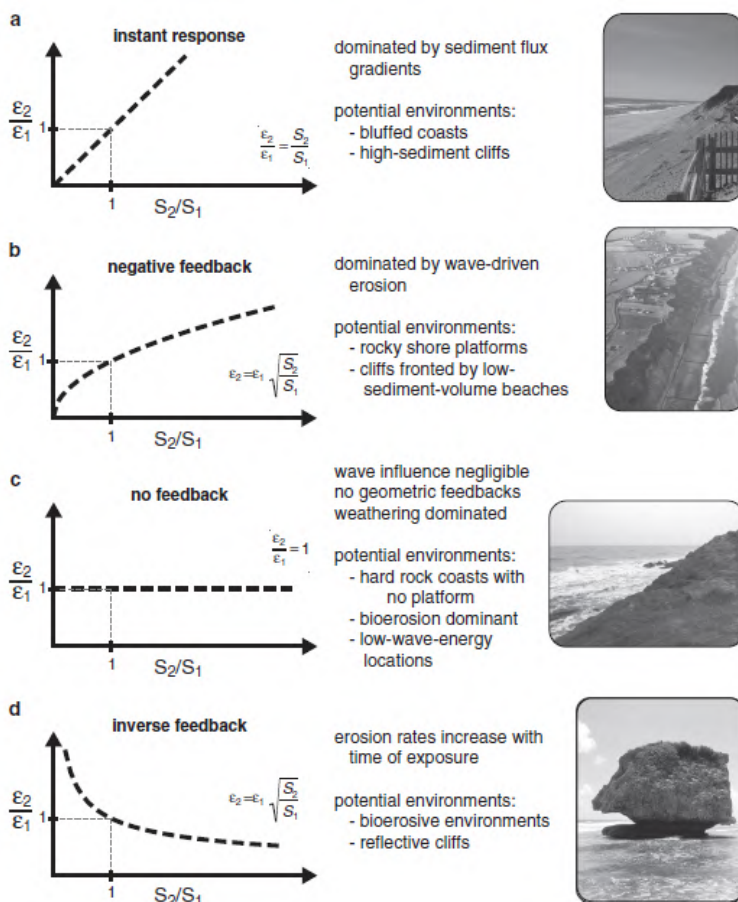
Figure 5-6 Possible modes of cliff response to SLR (adapted from Ashton et al., 2011)

An instantaneous response ( $m = 1$ ) is where the rate of future recession is proportional to the increase in SLR. An instant response is typical of unconsolidated or weakly consolidated shorelines. No feedback ( $m = 0$ ) indicates that wave influence is negligible and weathering dominates. The most likely response of consolidated shorelines is a negative/damped feedback system ( $m = 0.5$ ), where rates of recession are slowed by development of a shore platform or fronting beach; i.e. Equation 5-5. Aston et al. (2011) also suggest an additional case of inverse feedback when  $m < 0$  indicating a reduction in recession with increasing sea levels. They suggest this could occur when erosion is controlled by bio-erosion which may reduce with additional submergence. The approach suggested by Ashton et al. (2011) is conceptually plausible and has the potential to predict recession rates on a wide variety of rock types with further analysis.

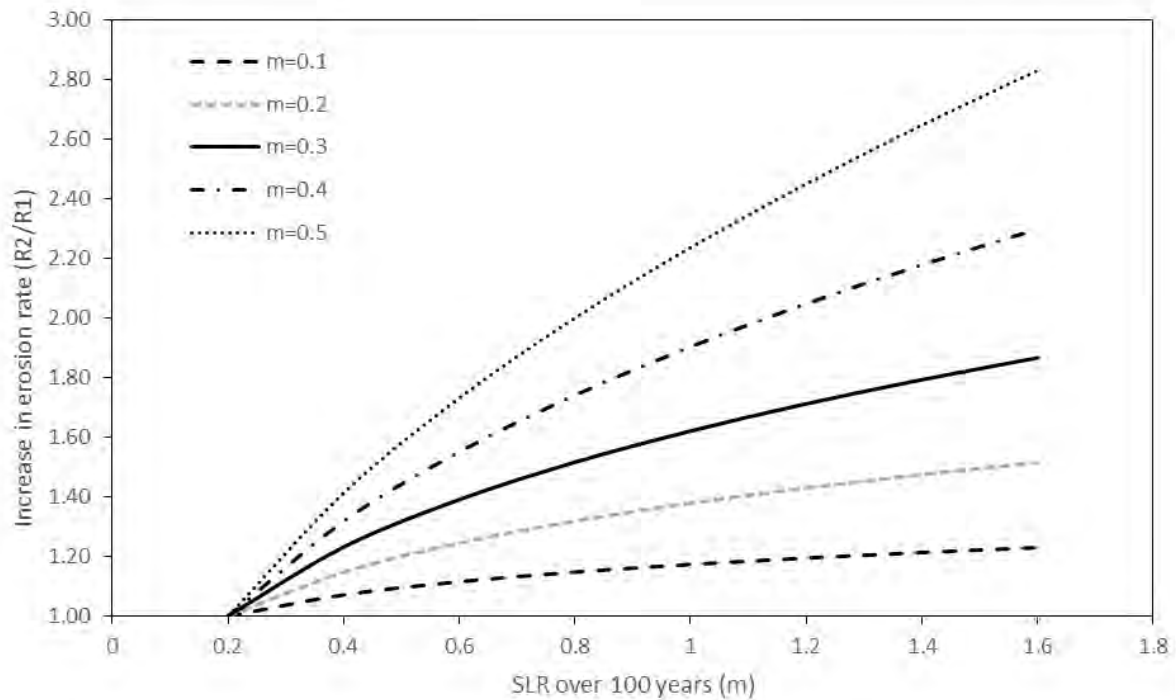
Figure 5-7 Increase in consolidated shoreline erosion rate with increasing SLR for different shoreline response factors.

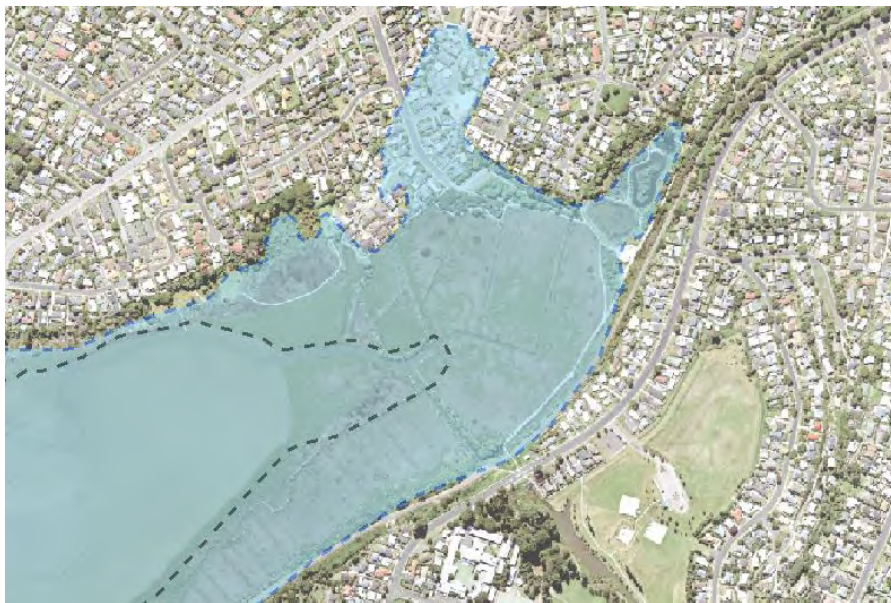
Figure 5-8 Example of how low-lying estuarine shorelines are likely to be translated landward with inundation from future SLR scenarios (black dashed line represents the current MHW, blue shading represents future MHW with 1.6 m SLR).

In low-lying estuarine environments, increased future sea level may result in tidal inundation of the backshore. While this is not technically erosion (loss of material), the net result is the same with the mean shoreline position being translated inland (Figure 5-8). This term has therefore been assessed separately in low-lying environments where recession by the Bruun Rule or cliff erosion methods are not applicable (refer description in 4.6.3).

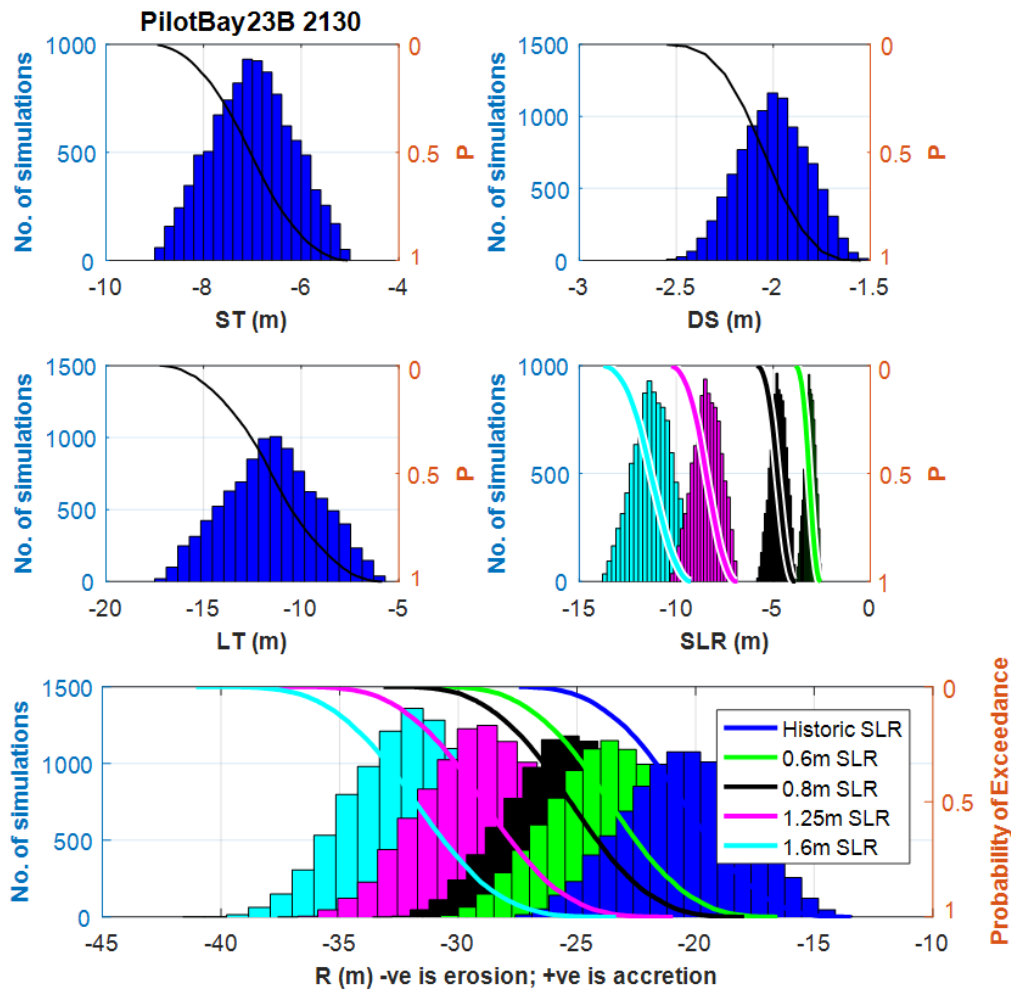
Figure 6-1 Example of histograms and cumulative distribution functions of parameter samples and resultant CEIHA distances for Cell 23B (Pilot Bay) in 2130.

The future timeframes include a range of SLR scenarios. The highest SLR scenario for the 100 year timeframe is 1.6 m. The projected erosion distance for this scenario ranges from -23 and -41 m. Under this scenario, there is a 50% chance of an erosion distance of -31 m (P<sub>66%</sub>).

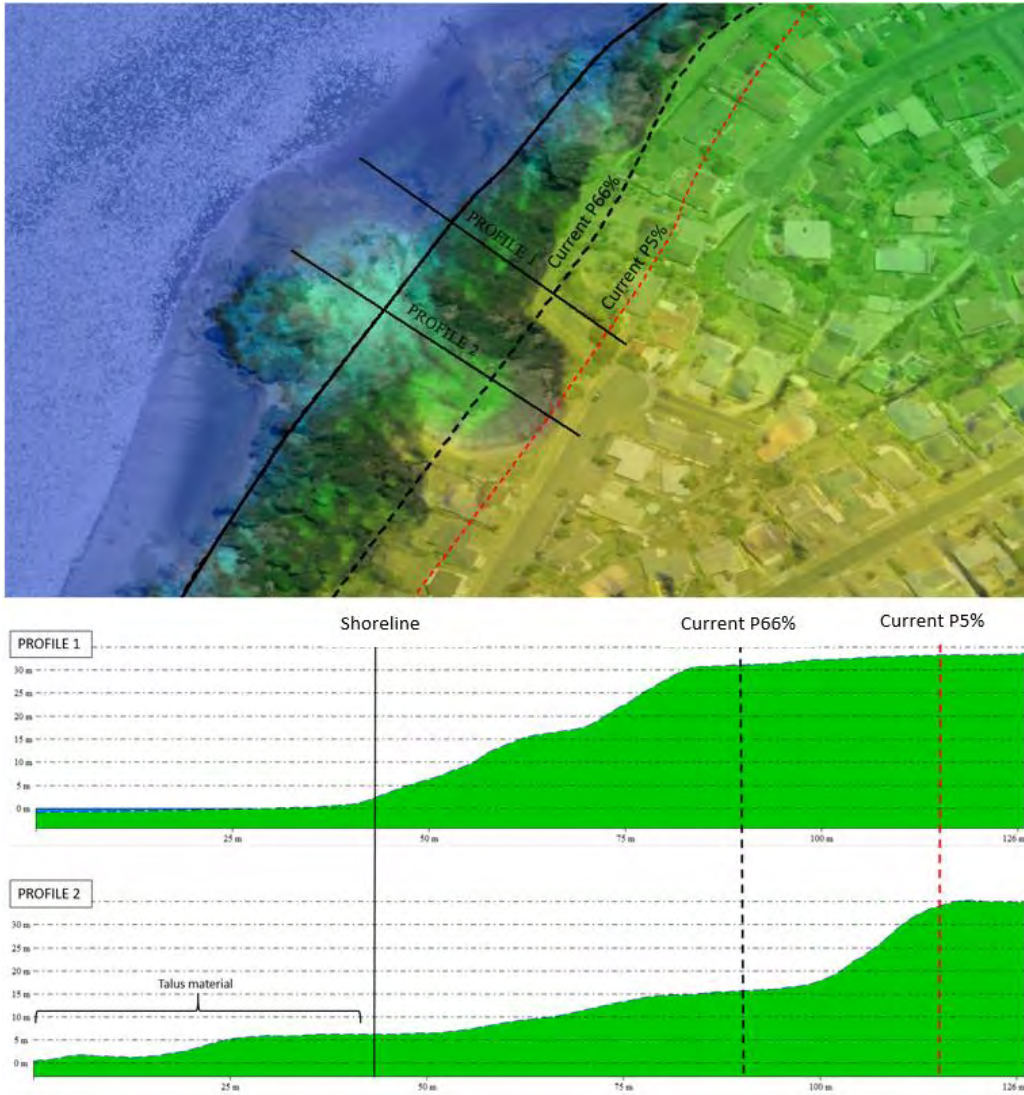
Figure 6-2 Example of existing slope profiles with current CEIHA (black dashed = P66%, red-dashed = P5%) for Cell 4B1 (Omokoroa).

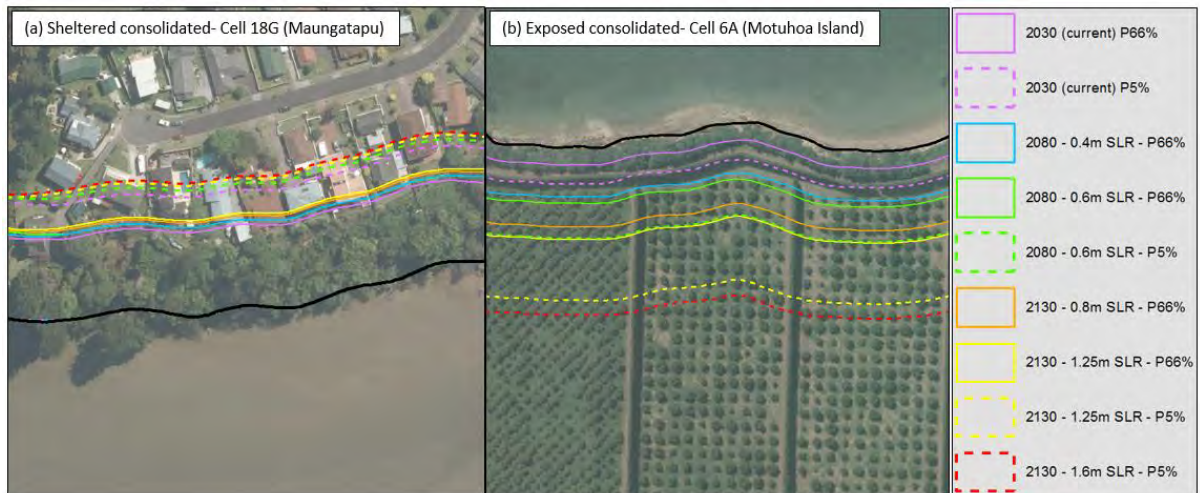
Figure 6-3 Comparison between (a) a sheltered cliff (Cell 18G) and (b) an exposed cliff (Cell 6A).

The exposed cliffs are more sensitive to changes in sea level rise compared to sheltered cliffs. As mentioned above, this is due to the effect of SLR allowing larger waves to reach the site in locations where the fetch is sufficient. For example, the 2130 CEIHA for the sheltered cliffs in Cell 18G only increases by ~2% with the increasing sea level rise scenarios (Figure 6-3). Whereas for an exposed cliff, such as Cell 6A, the CEIHA in 2130 increases by almost 50% with the increasing sea level rise scenarios (Figure 6-3).
