Ballance – Mt Maunganui

Environmental improvement

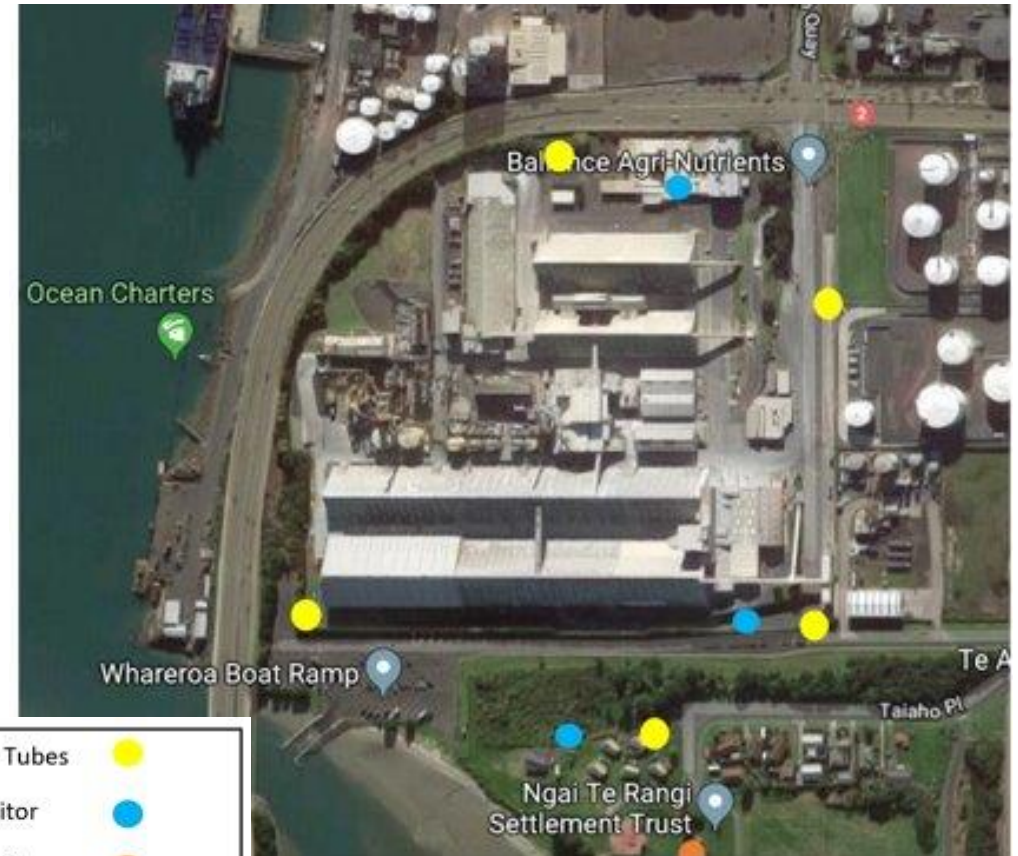
Dust Deposition Tubes	Yellow dot
PM10 AAQ Monitor	Blue dot
BOPRC AAQ monitor	Orange dot

Location	NE	NW	SE	SW	Marae
% Fert Dust of Total Dust	32.4	16.7	18.3	18.4	14.4

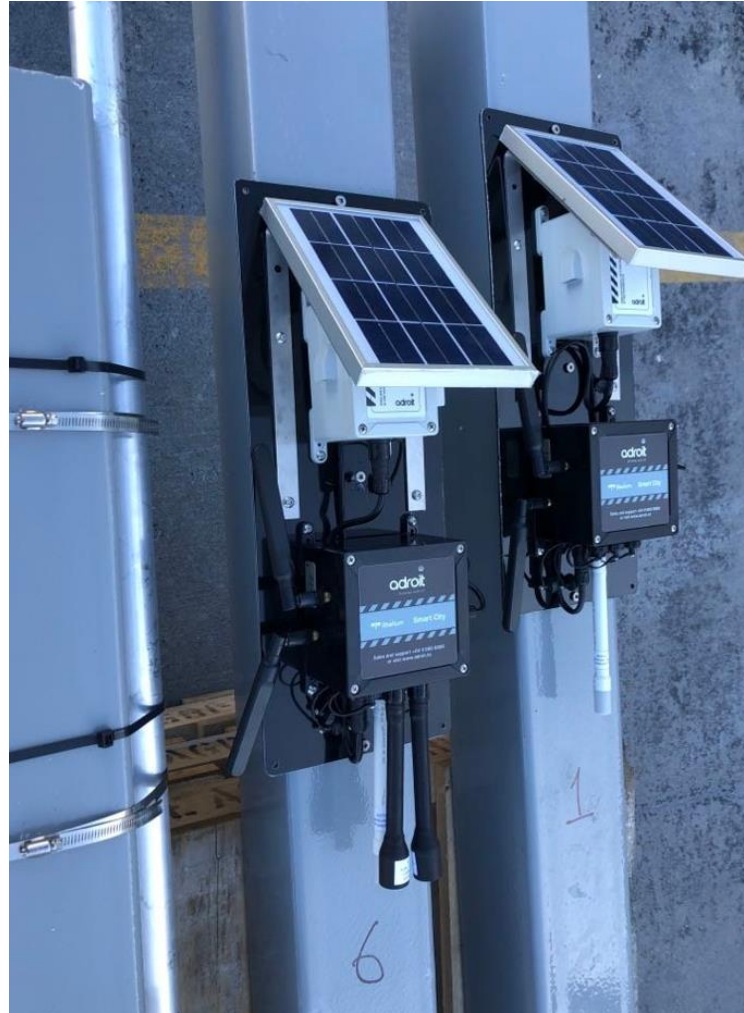
- Adroit units distributed on site
- Range of parameters being monitored
- Greater number of monitoring locations
- Co-location of some units with existing pm10 BAM units

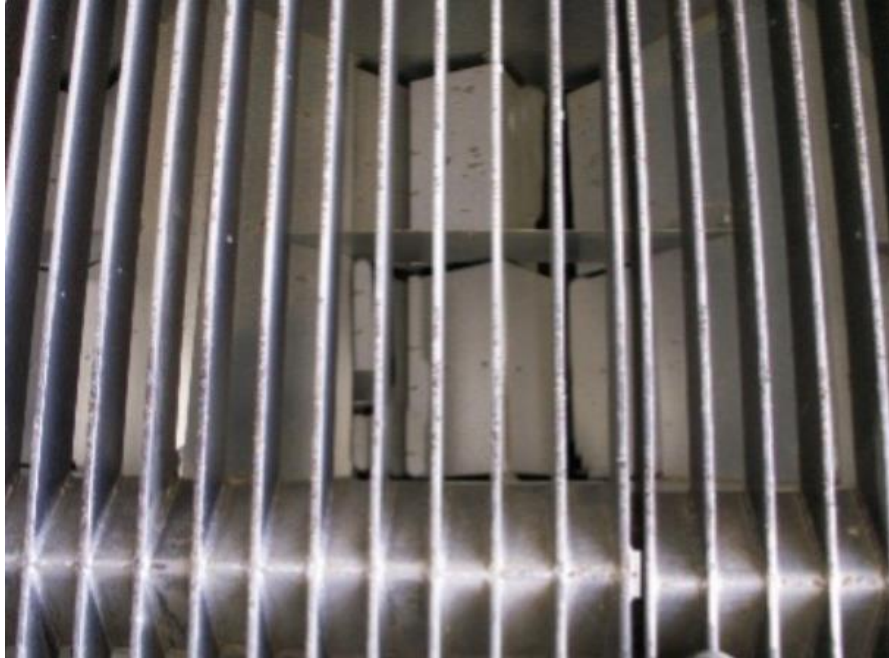
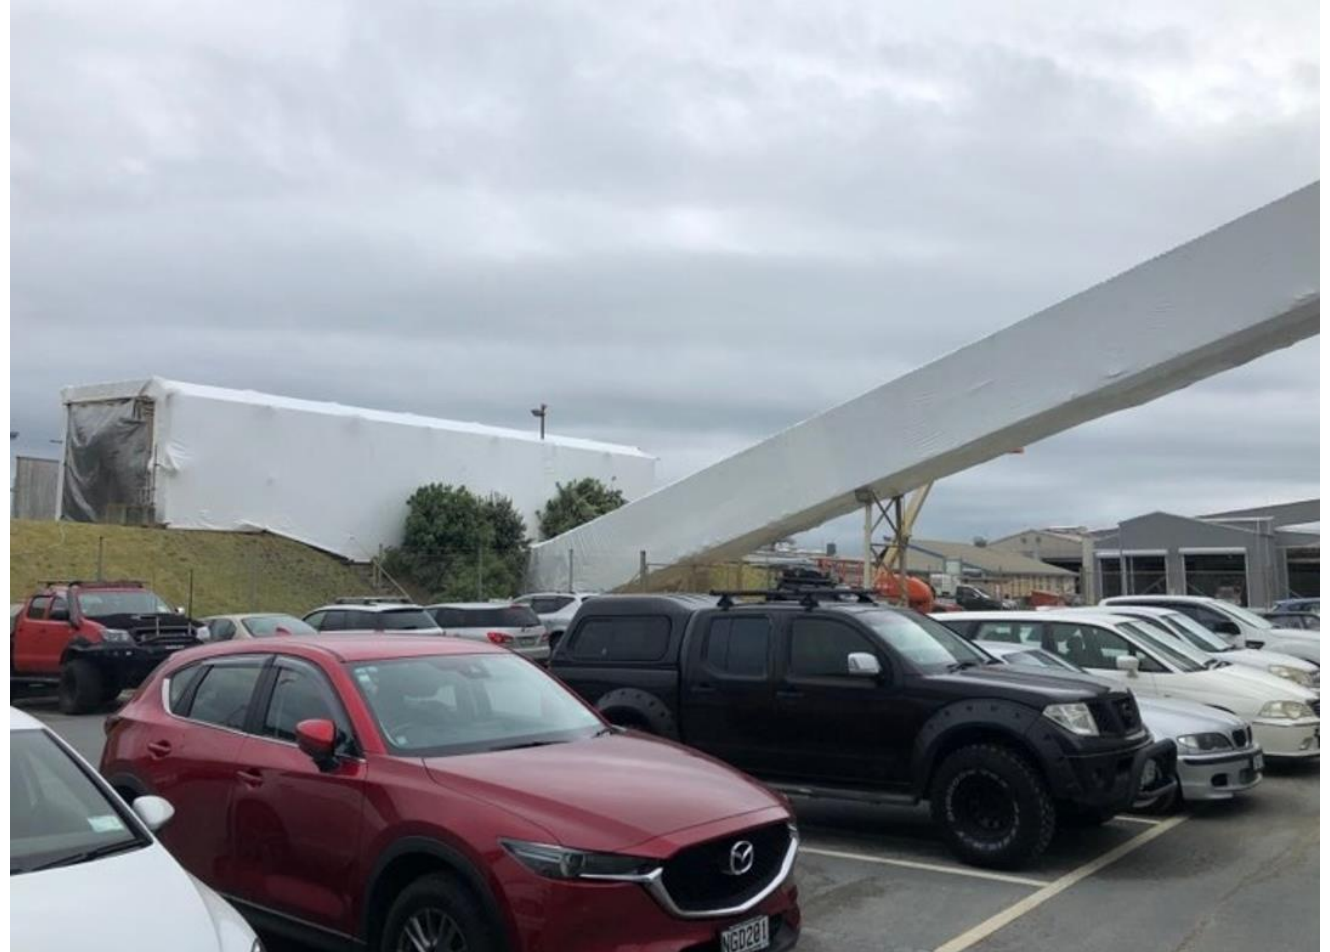
- Burnley baffles on intake grids to reduce dust during deliveries
- Temporary structures around intakes and conveyors to contain dust
- Tarps protecting roof cap vents in product store
