Annual Report 2019-2020

Kaituna River Re-Diversion and Te Awa o Ngatoroirangi/
Maketu Estuary Enhancement Project

Date: 30 August 2020

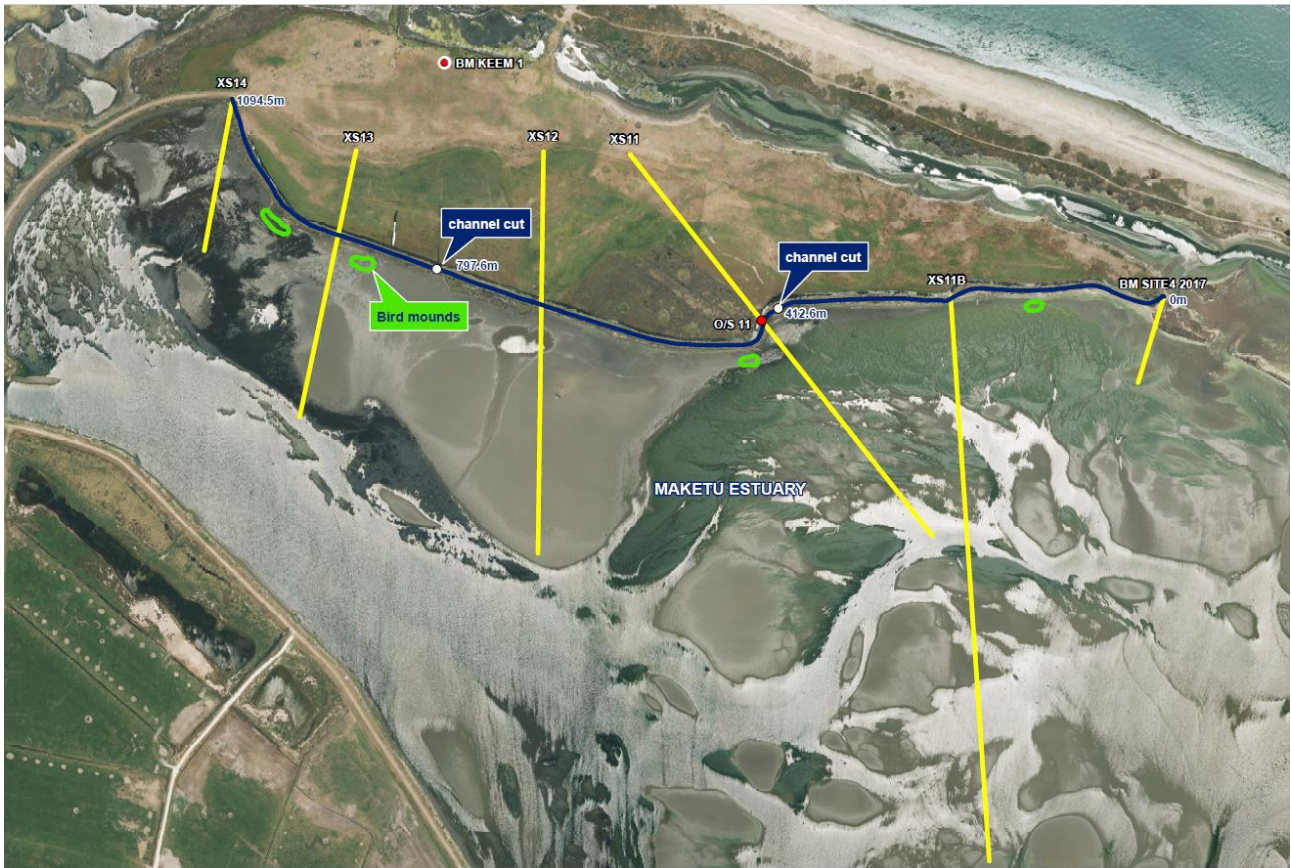
Figure 1 Papahikahawai Island survey locations

The location of the Papahikahawai transects are shown in Figure 1 along with the transect profiles in Figure 2 and 3. The 2020 monitoring results at Papahikahawai have been compared with 2016 to 2019 survey results.

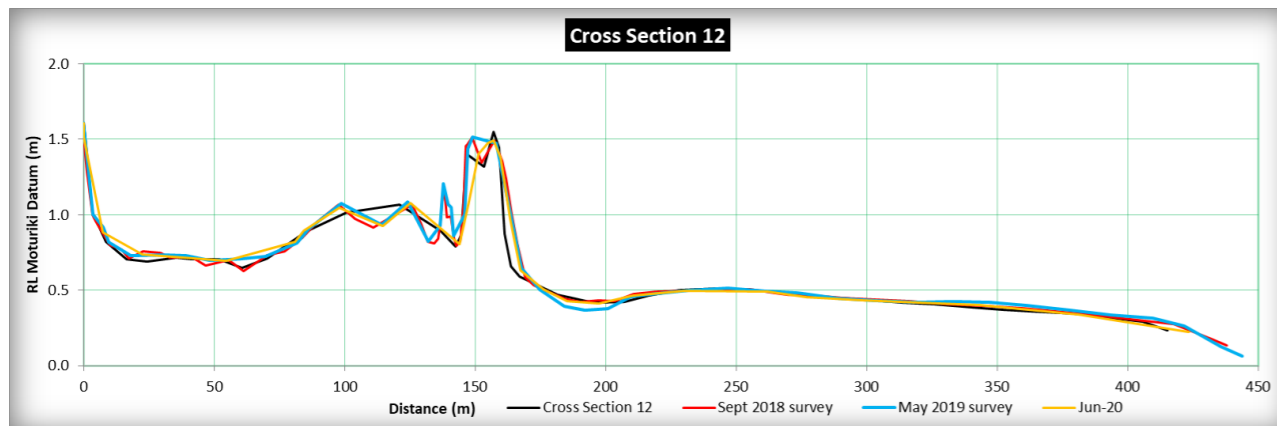
Figure 2 Papahikahawai Island Cross section monitoring results. Black line is the September 2016 survey, red line the September 2018 survey, blue line is the May 2019 survey and yellow line the June 2020 survey.

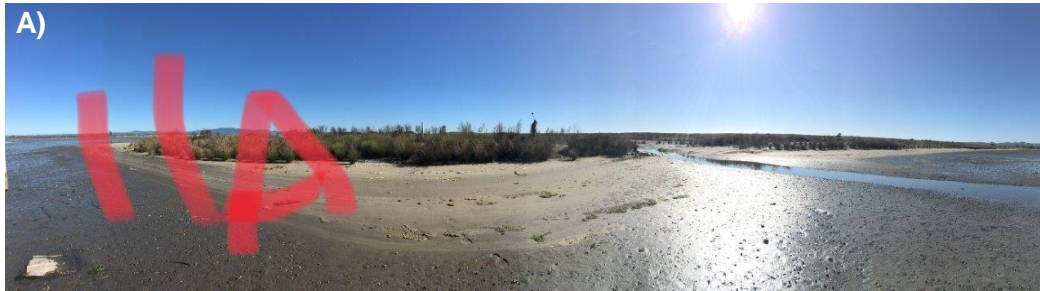
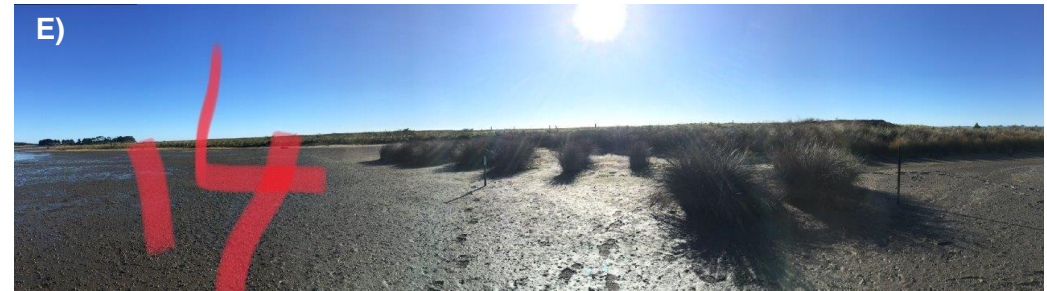
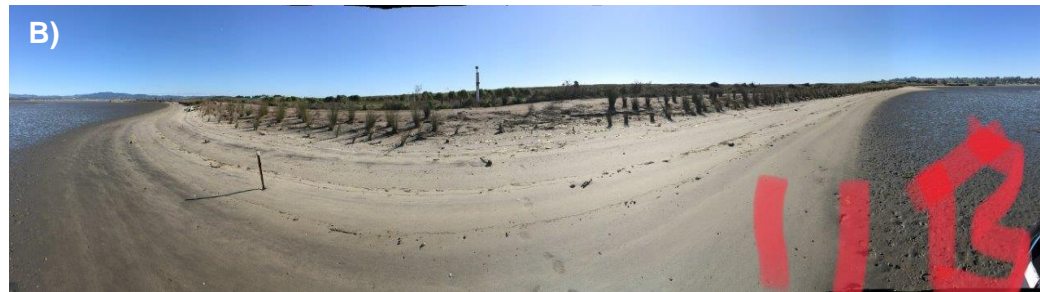
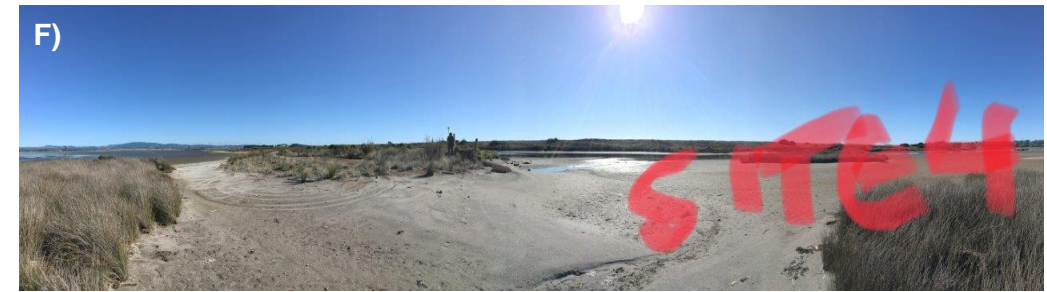
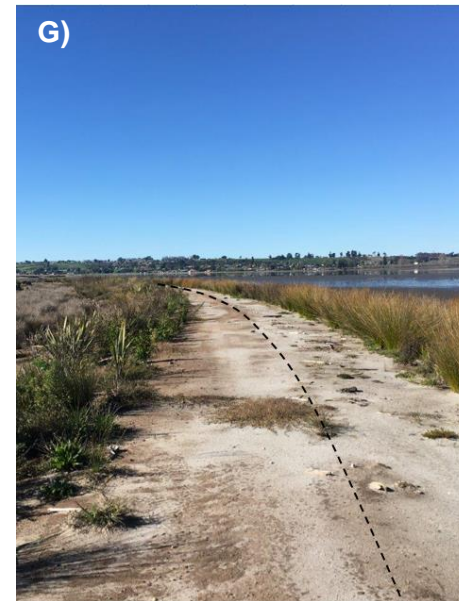
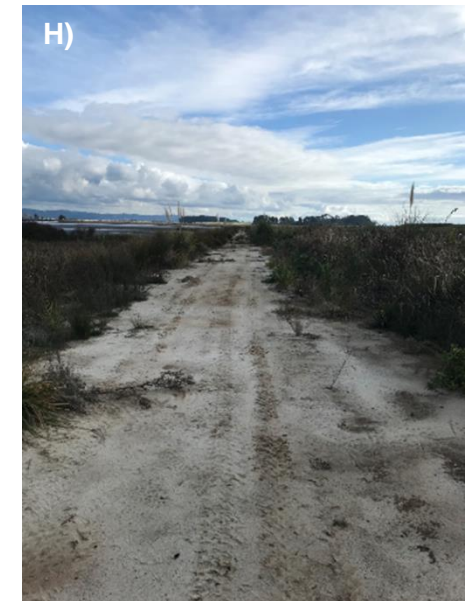
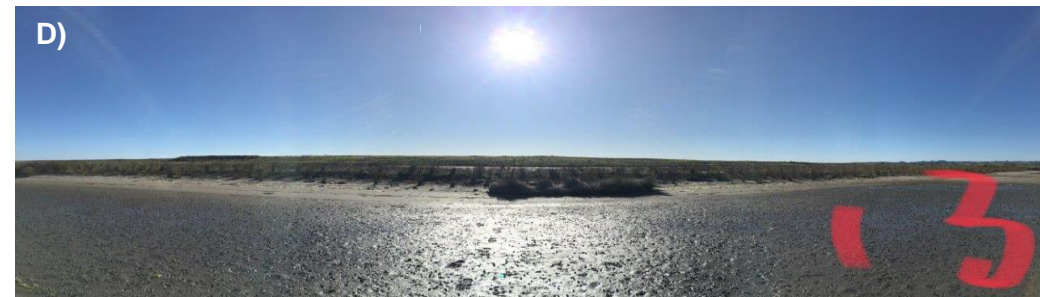
Figure 3 Papahikahawai Cross Sections from 2019: A) Site 11a, B) Site 11b, C) Site 12, D) Site 13, E) Site 14, F) Site 4; Papahikahawai Chenier Crest: G) 2019 H) 2020

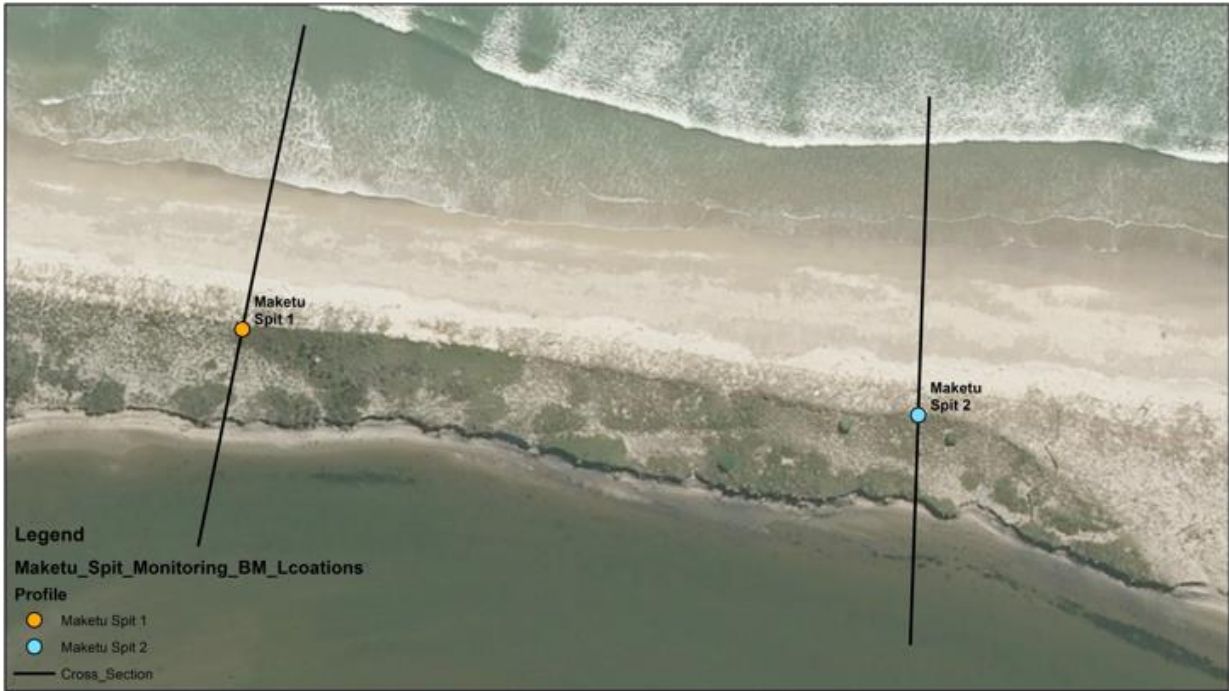
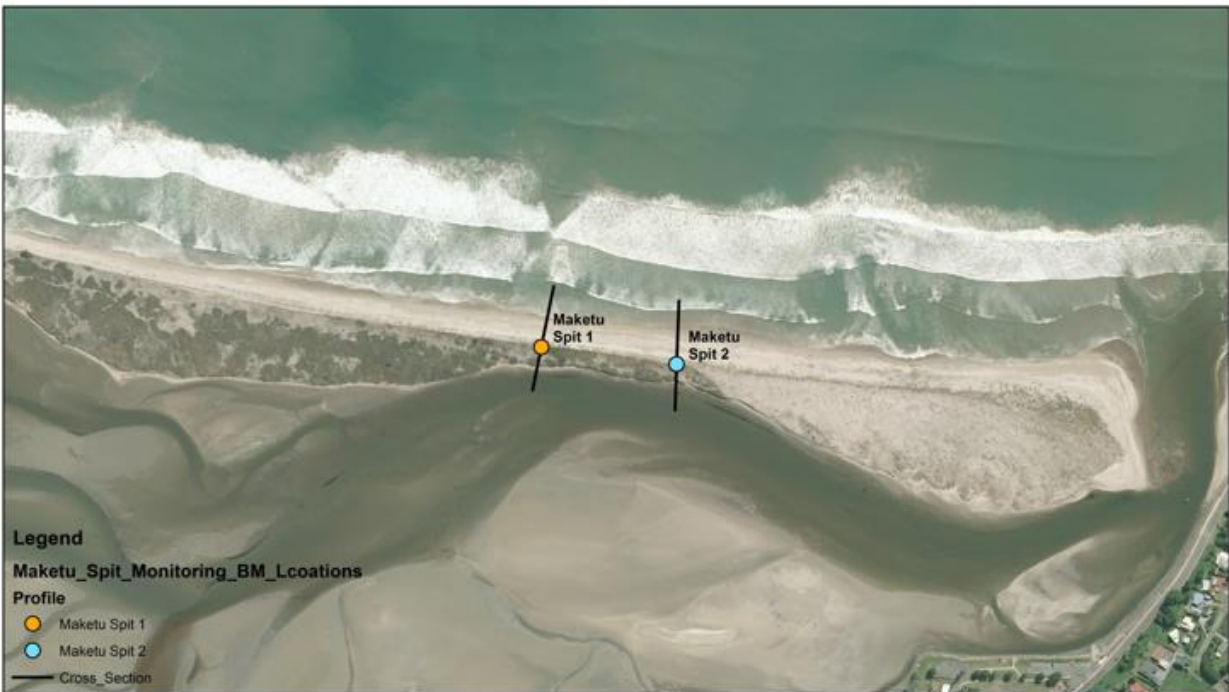
Figure 4 Maketu Spit Monitoring transects – Spit 1 and 2.

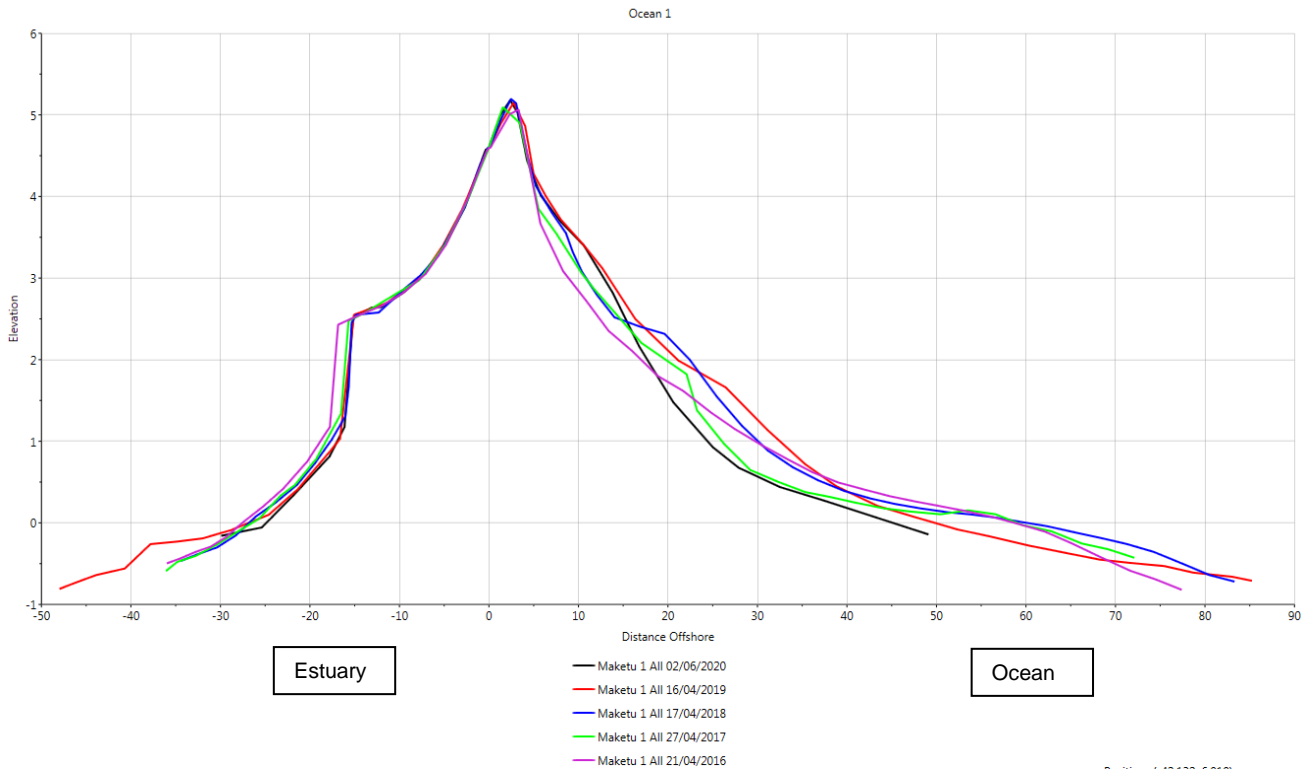
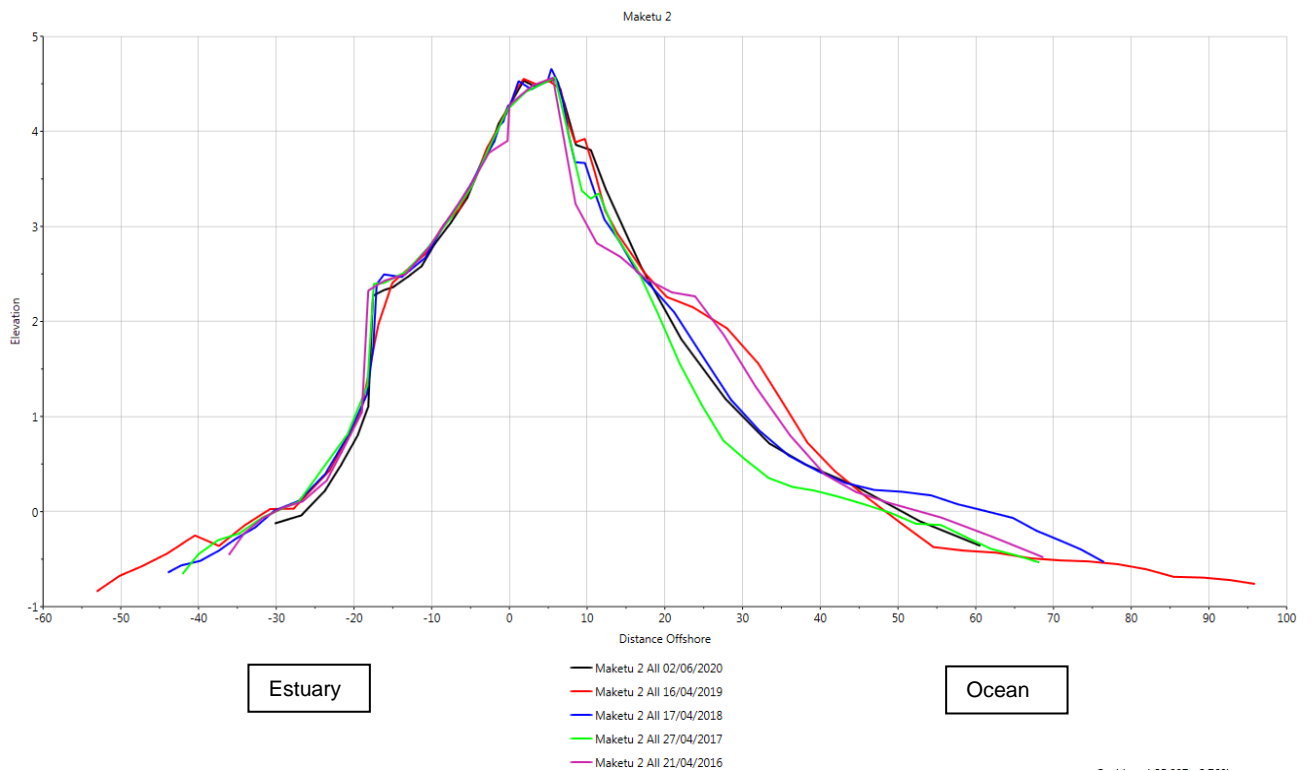
Figure 5 Maketu spit surveying results. Spit 1 (top), Spit 2 (bottom). The red line represents the 2016 results, the blue line represents 2017 results, the green line represents 2018 results, the purple line represents 2019 results and the black line represents the 2020 results.

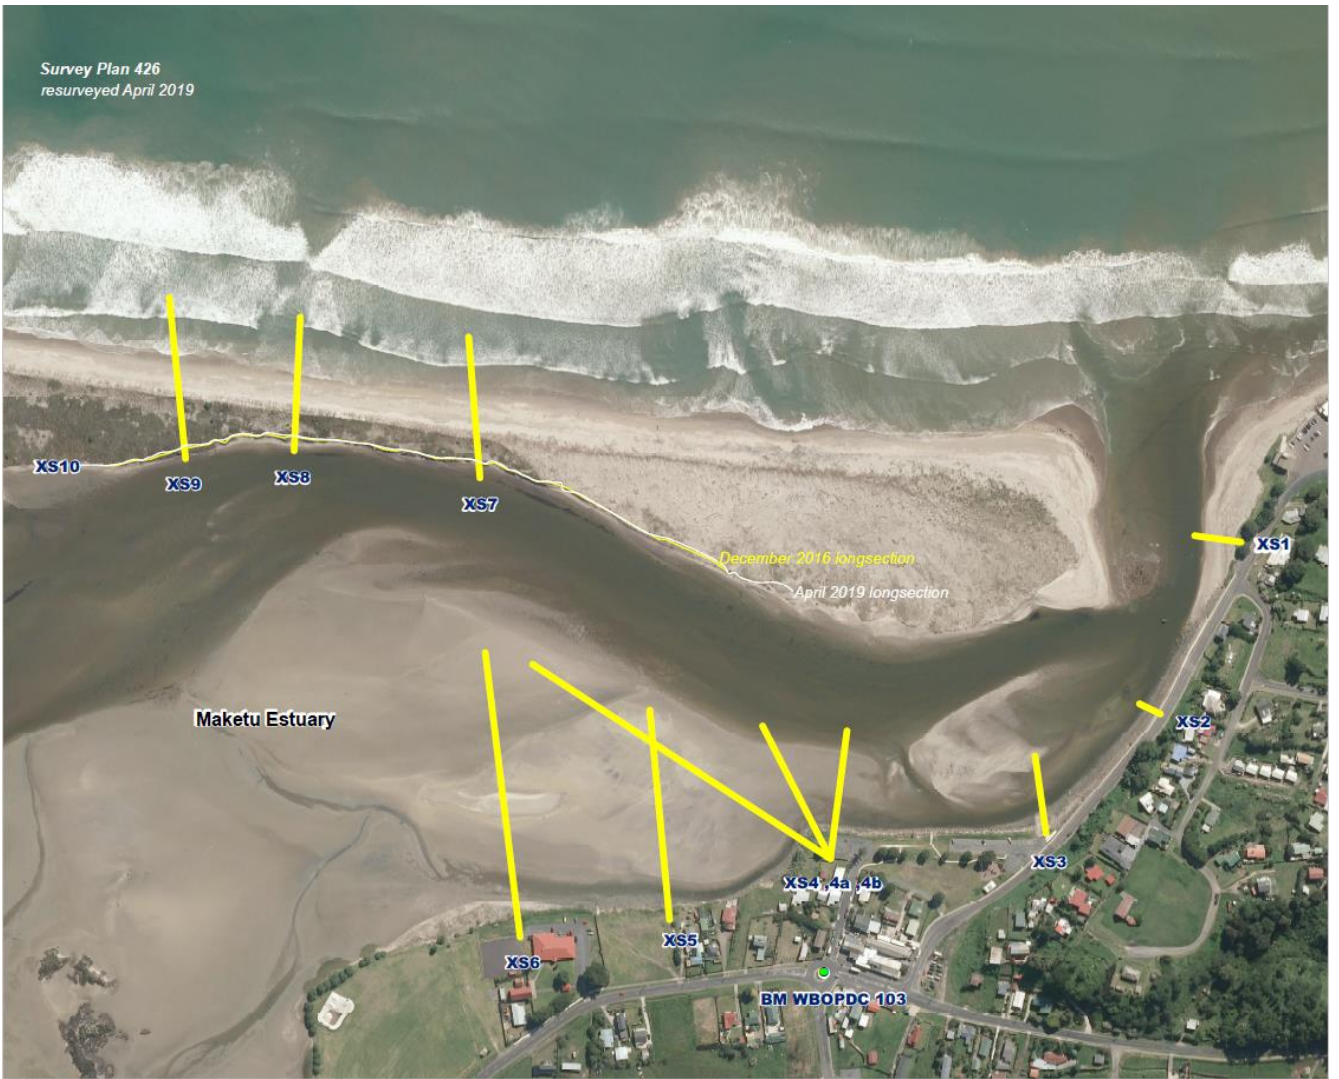
Figure 6 Survey Locations at Beach Road and Maketu township, including Maketu boat ramp, the Spit monitoring locations and the Dune Toe.

The location of the Maketu transects is shown in Figure 6 along with the transect profiles in Figure 7. The 2020 monitoring results have been compared with 2016 to 2019 survey results.

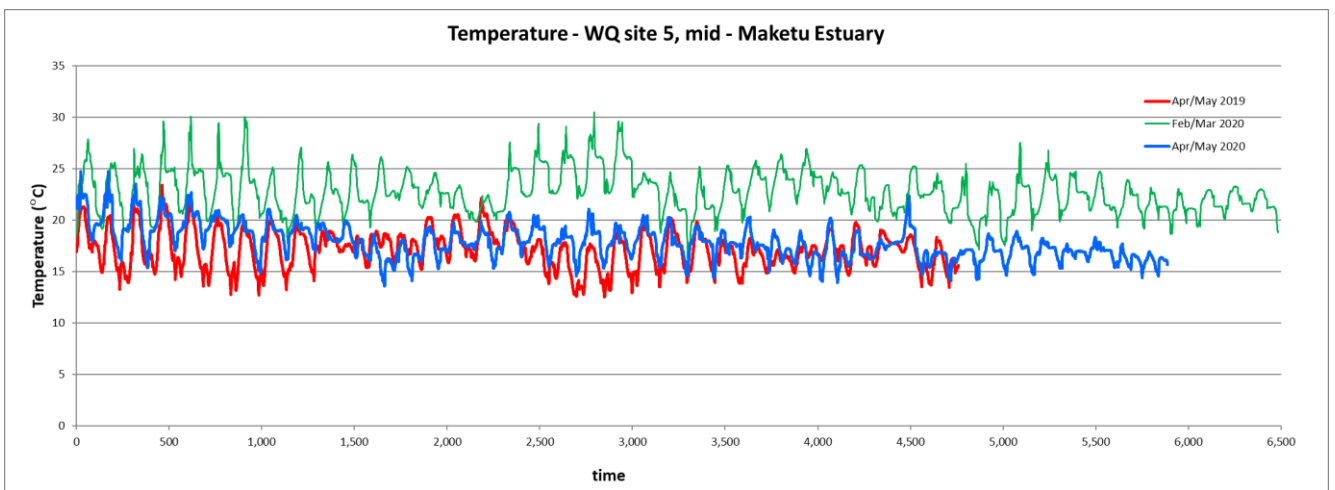
Figure 13 Temperature levels (°C) recorded for short periods at the WQ 5 site in the upper mid area of Maketū Estuary in 2019 and 2020.

Changes to temperature levels at the mid estuary WQ 5 and Causeway 2 site in Papahikahawai Creek are shown in Figures 12 and 13 below. In 2019 temperature levels from both sites were much lower compared to the 2020 measurements after the re-diversion of the Kaituna River. At the Papahikahawai Creek site the maximum temperature recorded was 31.6°C in 2020 compared to 21.6 °C in 2019. After the re-diversion flows increased from 150,000 to 400,000 m³ (about 1,600 on time axis), temperature levels dropped for a brief period of time at both sites. High temperatures in this part of the estuary are not unknown given the shallow water particularly at low tide.

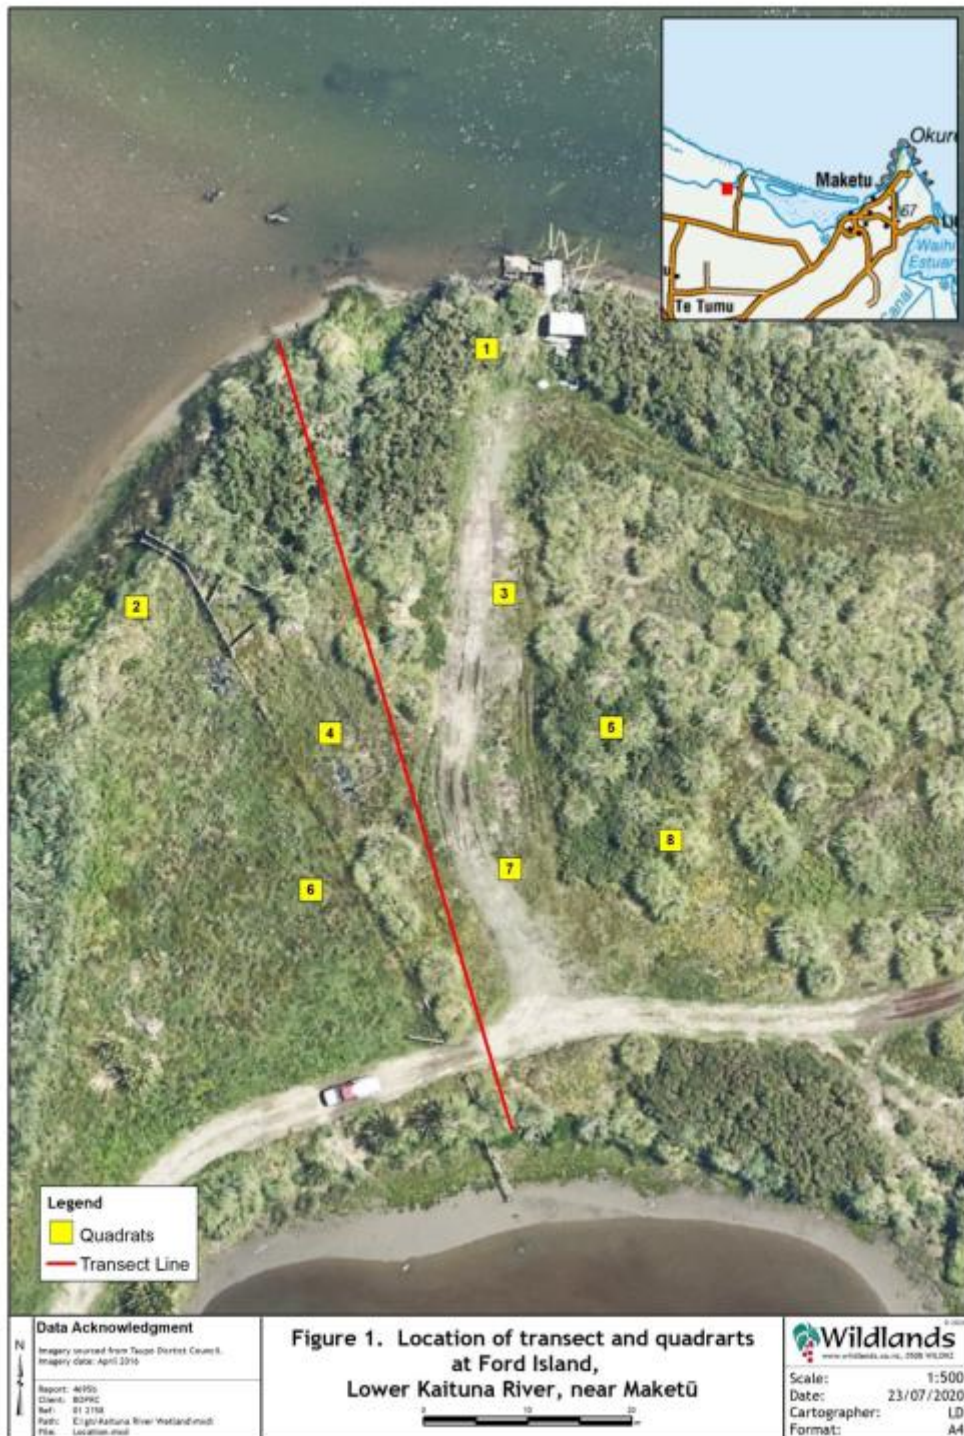
Figure 13 Report).

Locations of transect line 9 (map replicated from the Wildlands 2020 Ford Island

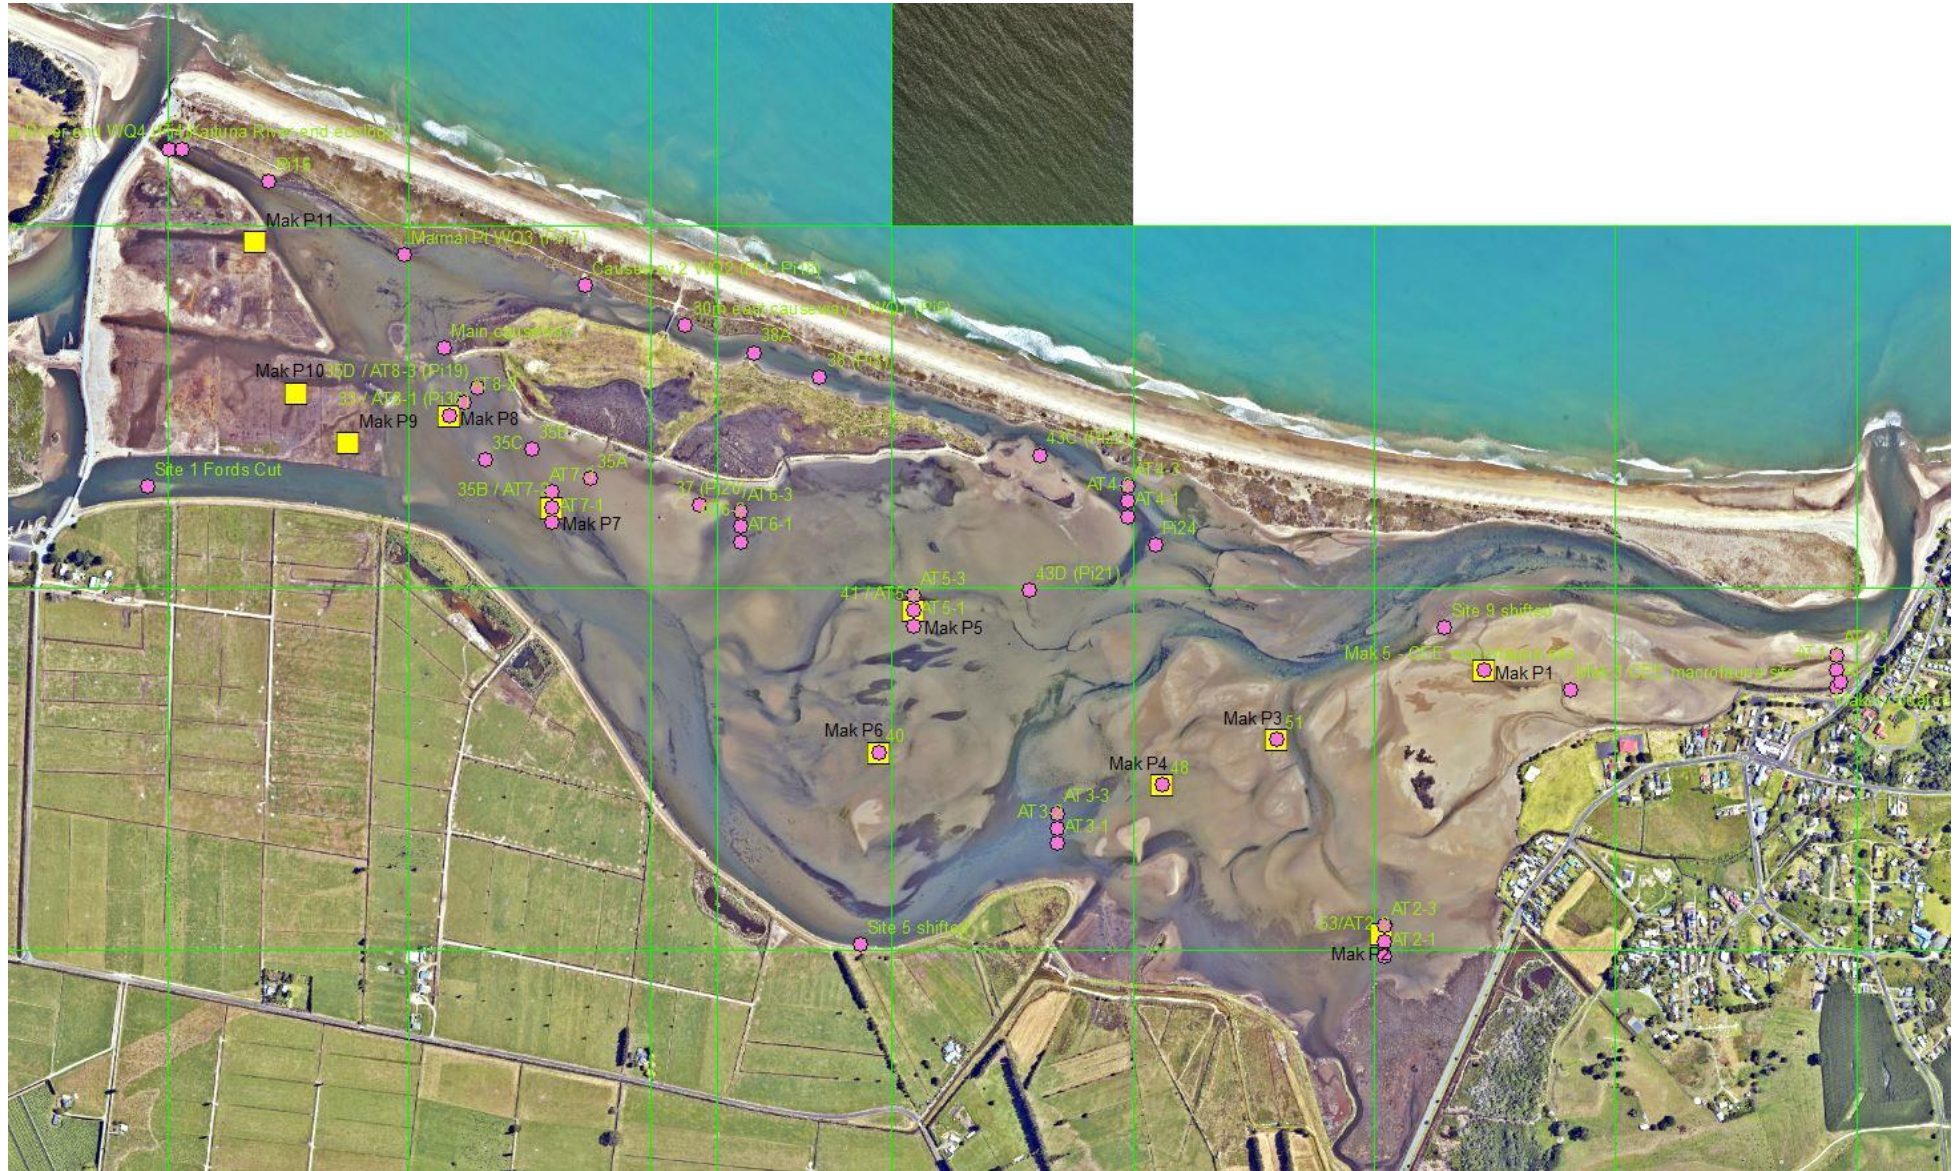
Figure 13 Location of ecological (pink circles) and sediment sites (yellow squares) throughout Maketu Estuary

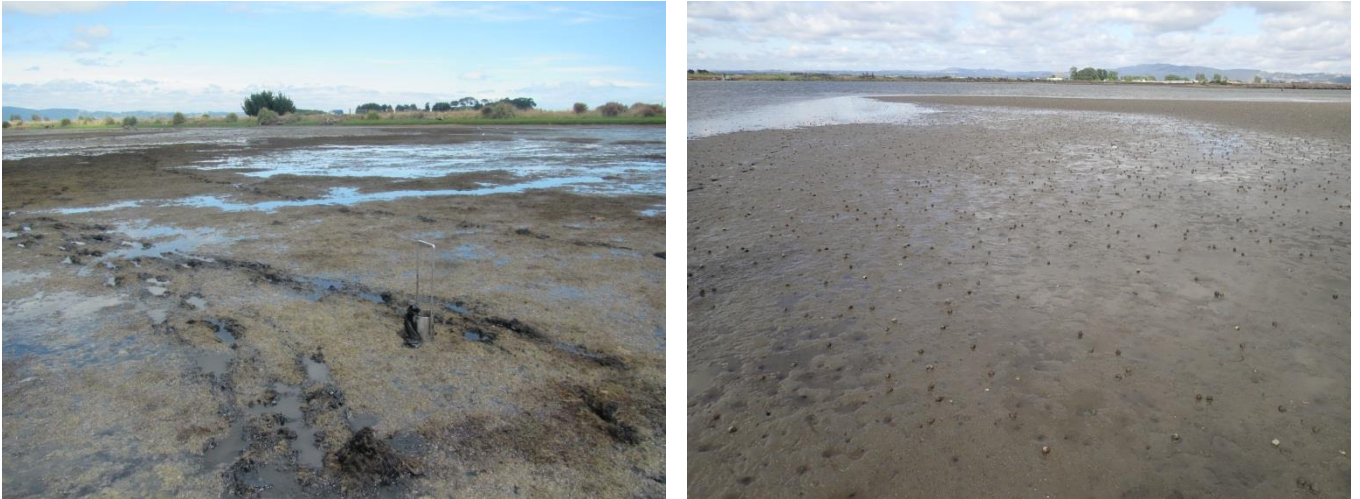
Figure 15 Photographs of site AT-8 in the upper estuary in January 2018 (left) with macroalgal and cyanobacterial cover and in 2020 with no macroalgae or cyanobacteria and titiko (mud snails) present.

Several sites around the estuary have for a number of years had consistently high cover and biomass of macroalgae. Transect AT-2 is in the southern most region of the estuary and has, as shown in Figure 14, had a very high cover of macroalgae from 2011 up to 2018. Since 2018 this site has largely cleared of macroalgae allowing improvement of sediment conditions and recovery of macrofaunal diversity. A similar trend has been observed at AT-8 which is the western most transect in the upper estuary. This site had a very high biomass of *Gracilaria chilensis* with patches of cyanobacteria which in the 2020 monitoring had cleared to near zero cover. The change in condition of this site between 2018 and 2020 is shown in the photos below (Figure 15) with abundant titiko present in 2020.

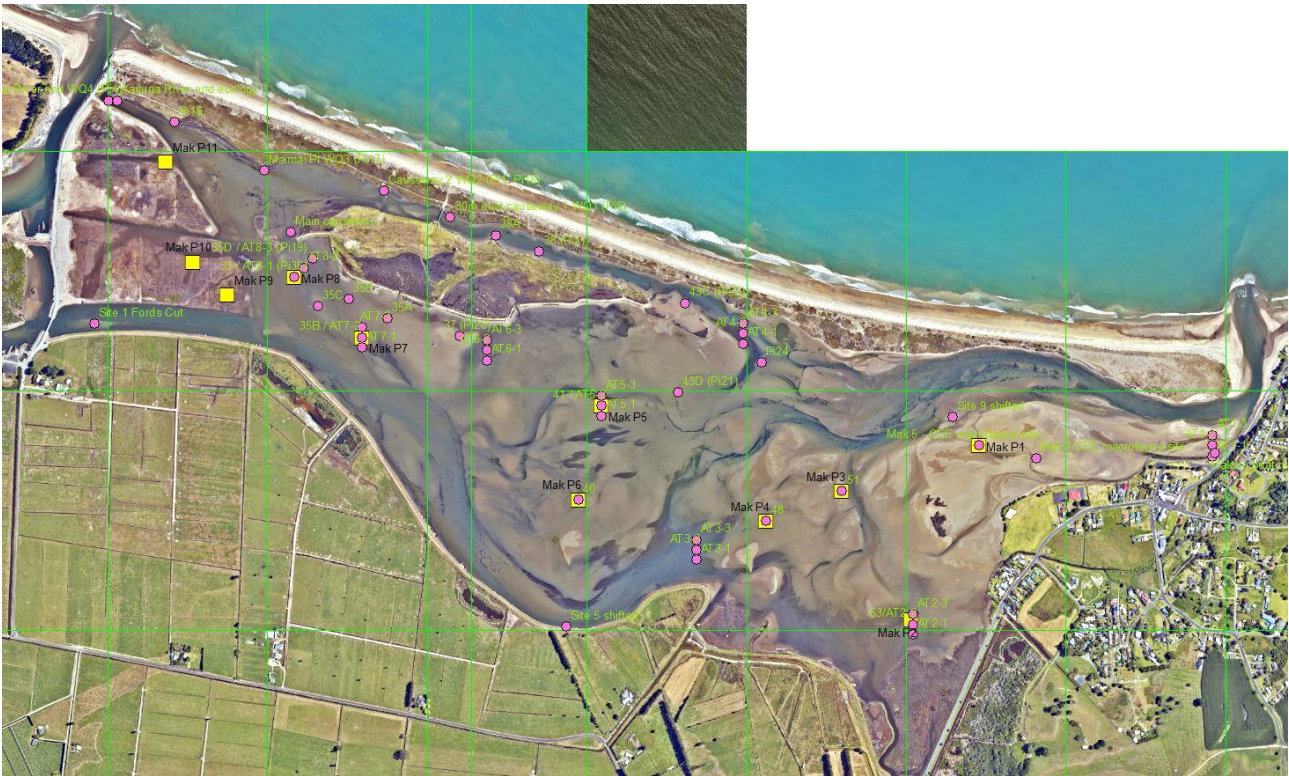
Figure 1, location of monitoring sites in Maketū Estuary (pink circles). Yellow squares are sites measuring sediment accumulation rate.

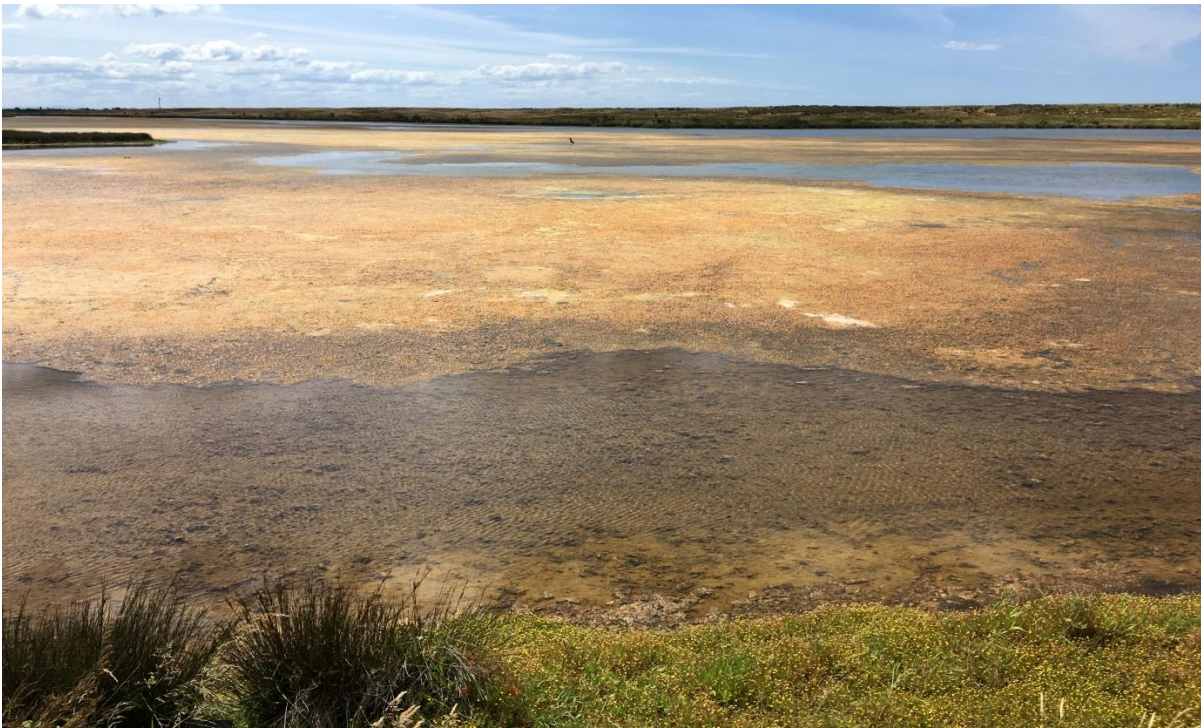
Figure 2, looking west from Papahikahawai Island (December 2016) showing former Kaituna River inflow channels in Maketū Estuary.

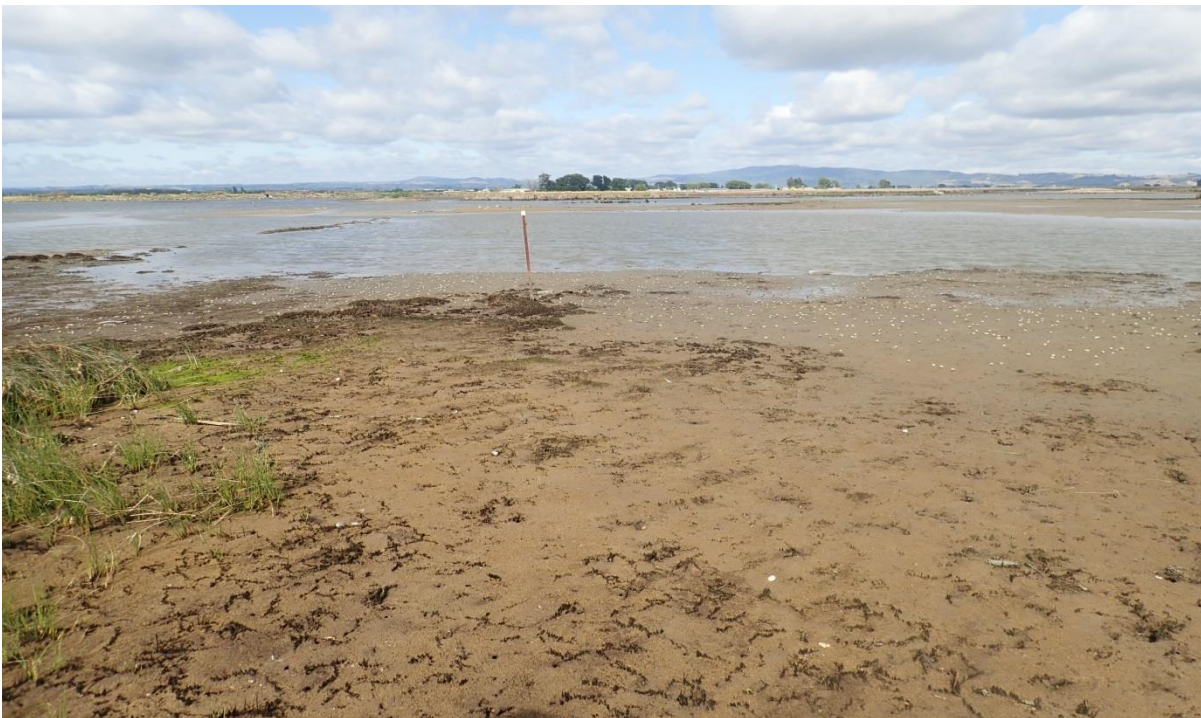
Figure 3, looking west from Papahikahawai Island (January 2020) showing former Kaituna River inflow channels in Maketū Estuary after June 2017 return of tidal flows.

Following the restoration of tidal flows to the Papahikahawai Creek area in June 2017 recovery of the area has progressed well. As shown in Figure 3, the cover of algae has substantially reduced now that tidal flows occur. The following sections present some of the key representative results from the various sites that have been monitored in this area.

Some sites such as the Main Causeway have also shown good recruitment of titiko (mud snails) with density at this site having reached average numbers around 25 per square meter since the June 2017 restoration of tidal flows. In Figure 3 which is a photo overlooking this monitoring site, the numerous small white dots further out on the flats towards the water are titiko.

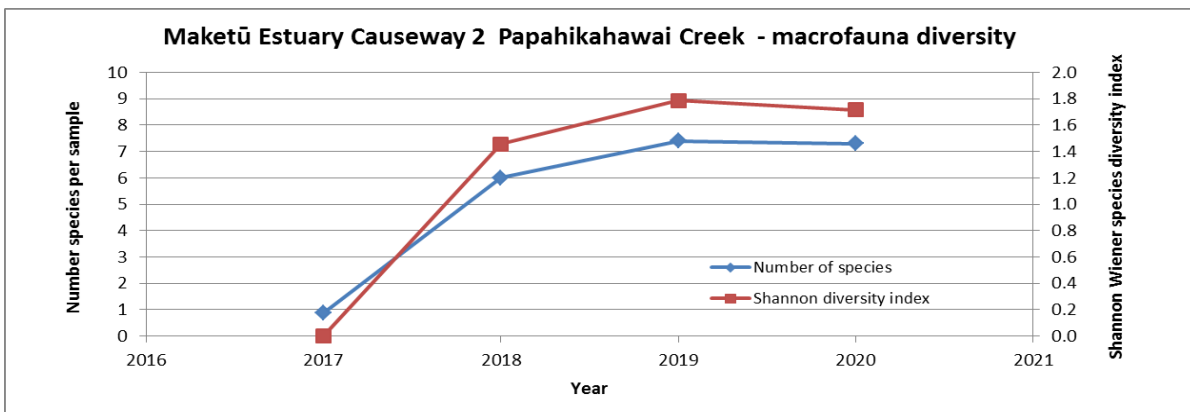
Figure 7, Mean number of species and Shannon diversity index for the Causeway 2 site in the Papahikahawai Creek area from 2017 to 2020.

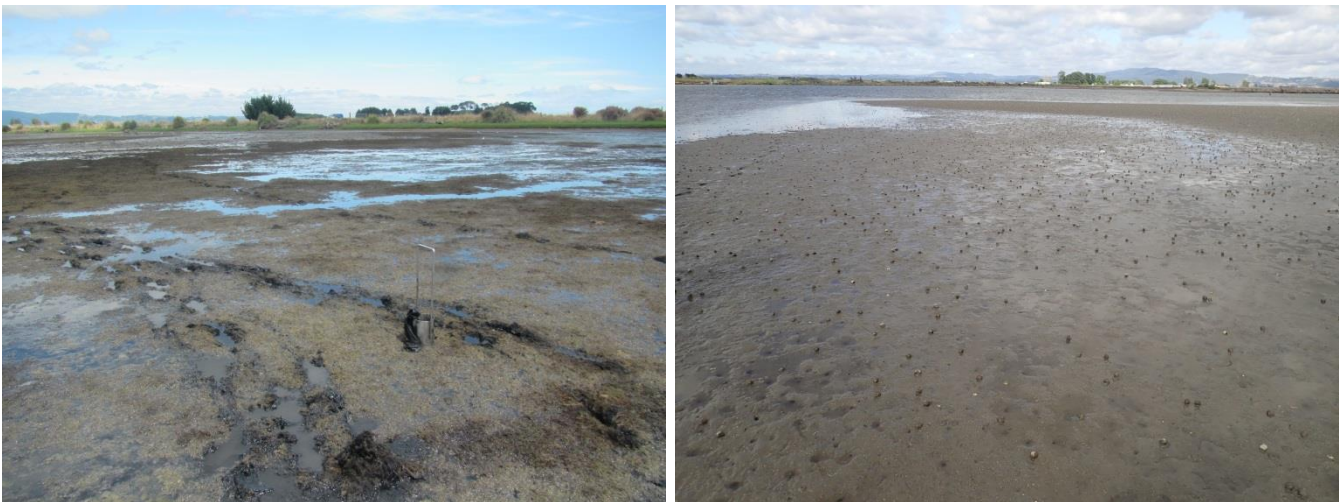
Figure 13, Photographs of site AT8 in the upper estuary in January 2018 (left) with macroalgal and cyanobacterial cover and in 2020 with no macroalgae or cyanobacteria and titiko present.

Several sites around the estuary have for a number of years had consistently high cover and biomass of macroalgae. Transect AT2 is in the southern most region of the estuary and has, as shown in Figure 11, had a very high cover of macroalgae from 2011 up to 2018. Since 2018 this sites has largely cleared of macroalgae allowing improvement of sediment conditions and recovery of macrofaunal diversity (see Figure 12 below). A similar trend has been observed at AT8 which is the western most transect in the upper estuary. This site had a very high biomass of *Gracilaria chilensis* with patches of cyanobacteria which in the 2020 monitoring had cleared to near zero cover. The change in condition of this site between 2018 and 2020 is shown in the photos below (Figure 13) with abundant titiko present in 2020.

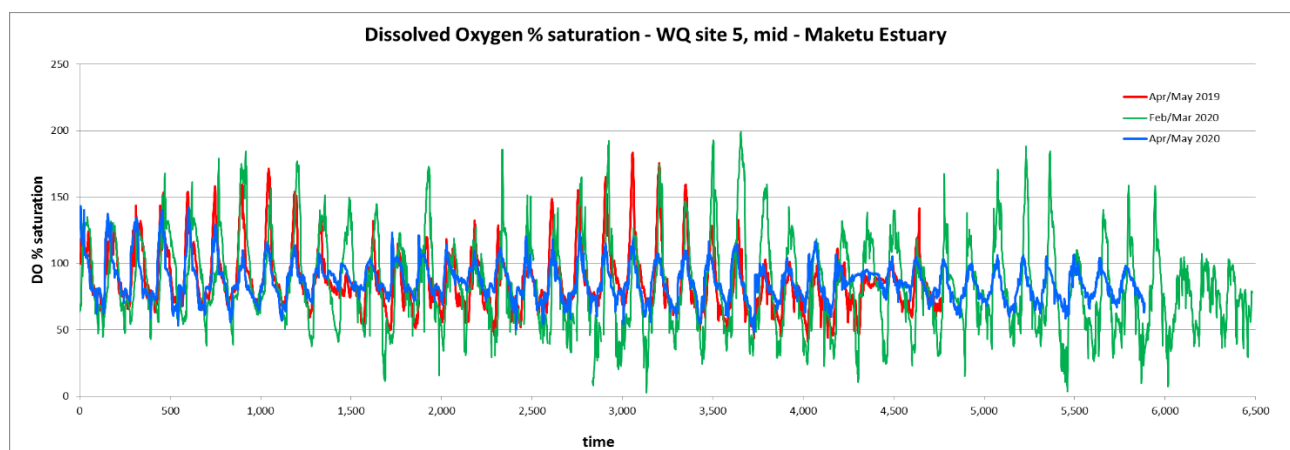
Figure 17, Dissolved oxygen levels (% saturation) recorded for short periods at the WQ 5 site in the upper mid area of Maketū Estuary in 2019 and 2020.

In Figure 17 below, results are shown for dissolved oxygen levels measured in the water column at the mid-estuary WQ 5 site. As with the Causeway 2 site results in Papahikahawai Creek, there is an apparent drop in DO minimums observed after the increase in river flow on the 12th February 2020. There was also some concern that the sensor had been placed too close to the bottom in the February deployment and suffered from smothering by drifting algae. The data that clearly showed such effects has been removed from the data set. Then a re-deployment at this site in April 2020 at a slightly higher level above the bottom resulted in far less variable levels of oxygen than the earlier February measurements and show improvement in conditions compared to the exact same time of year in 2019.
