**Active Fault Mapping for
Western Bay of Plenty Growth Areas**

GNS Science Consultancy Report 2017/97
July 2017

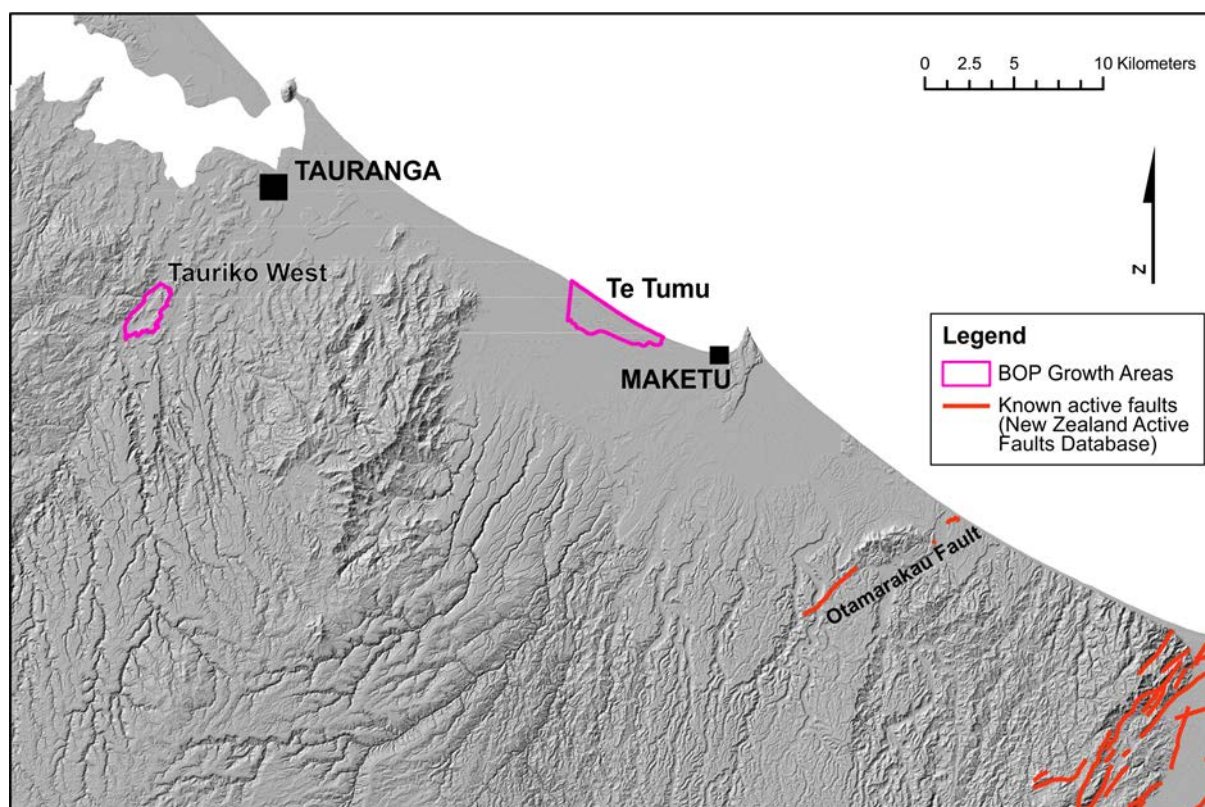
Figure 1.1 The Tauriko West and Te Tumu growth areas in the Bay of Plenty, shown on a hillshade LiDAR digital elevation model with the location of previously identified nearby active faults (Langridge et al. 2016).

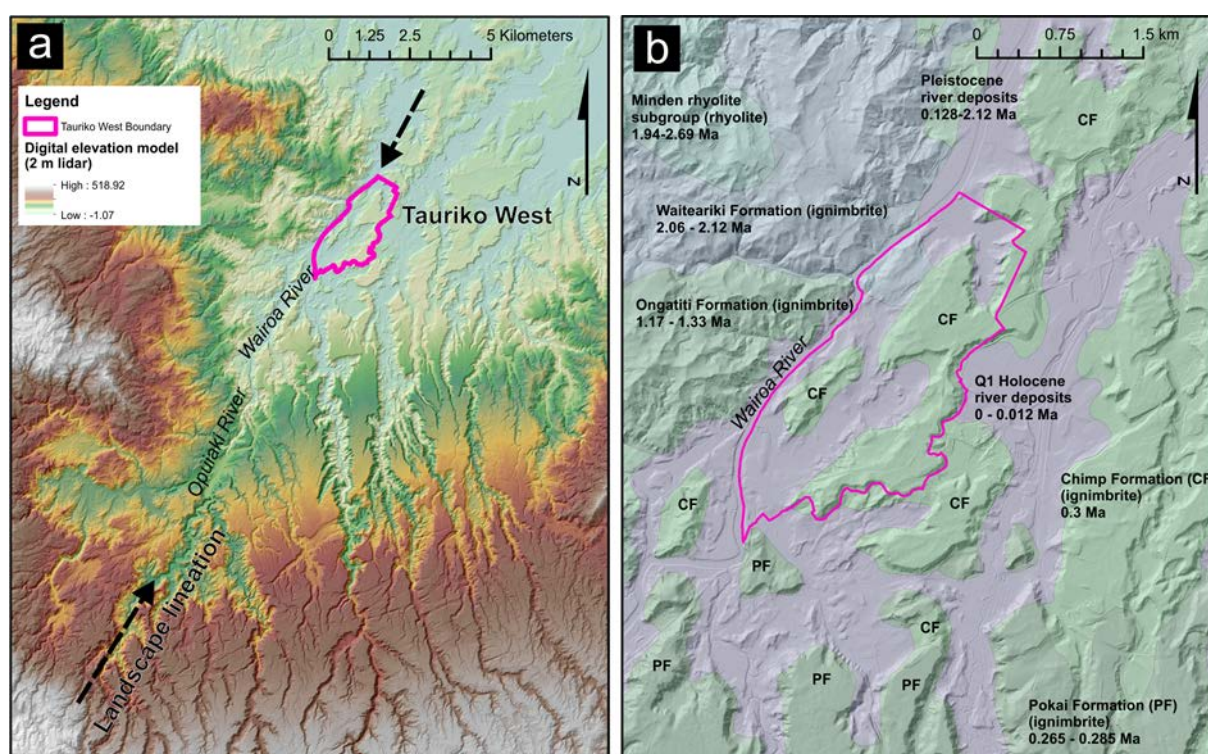
Figure 2.1 (a) A digital elevation and hillshade LiDAR DEM of the topography of the region surrounding the Tauriko West area. The black arrows point out the large-scale landscape lineation that may represent a fault line. (b) The geology and landform ages of the Tauriko West area, from Leonard et al. (2010).

The geomorphology of the Tauriko West area consists of elevated, near-flat terrace surfaces, steep terrace risers, and a low, flat area of infilled floodplain deposits (Figure 2.1 and Figure 2.2). The landscape features at Tauriko West were formed at different times. The main terrace surface (T1) is formed of ignimbrite (Chimp Formation, 0.3 million years old: (Leonard et al. 2010), a massive and thick volcanic deposit that usually covers and fills the whole landscape as it flows, during eruption, along the river network. It is expressed in the landscape as an extensive geomorphic surface, and forms the broad plateau that dominates the region from Mamaku to the Bay of Plenty coastline. The study area of Tauriko West is located at the distal edge of this plateau. The ignimbrite surface has been incised by the Wairoa River to create a sequence of lower river terraces at 35-40 m (T2), and 15 m (T3) elevation above sea level. The risers separating these terraces are typically very steep (15 - 20°). The lower terraces and risers are <0.3 Ma in age. The lowest elevation river terrace surface (Fluvial 1), at ~5 m above sea level is formed of Holocene (<12,000 years) fluvial deposits (Figure 2.1b).

The Wairoa/Opuiaki Rivers flow along a SW-NE trending valley (Figure 2.1a); the straightness of these river valleys is somewhat anomalous for the region and one possible explanation for this “straightness” is that the rivers follow a fault line. Such a fault line does not necessarily have to be active (i.e., to have ruptured in the past 125,000 years); the river may just be exploiting a line of weakness in the basement rocks created by an old fault. Indeed, the location and strike of this possible fault, well to the northwest of the currently active faults of the Taupo Volcanic Zone (TVZ), suggests it could be one of the faults that bounded the old Taupo Rift, which was active between 2 and 0.35 million years ago (Villamor and Berryman 2006; Villamor et al. in prep). A fault at that location could have created a large fault scarp in the landscape in the past that could have been a barrier for the deposition the Chimp Formation Ignimbrite at 0.3 million years ago. The ignimbrite is not present on the west side of the lineament, suggesting that this could be the case. The juxtaposition of different rock formations of either side of the fault could have promoted river diversion along the fault, thus creating a lineament in the landscape that is controlled by old, inactive geological structures.

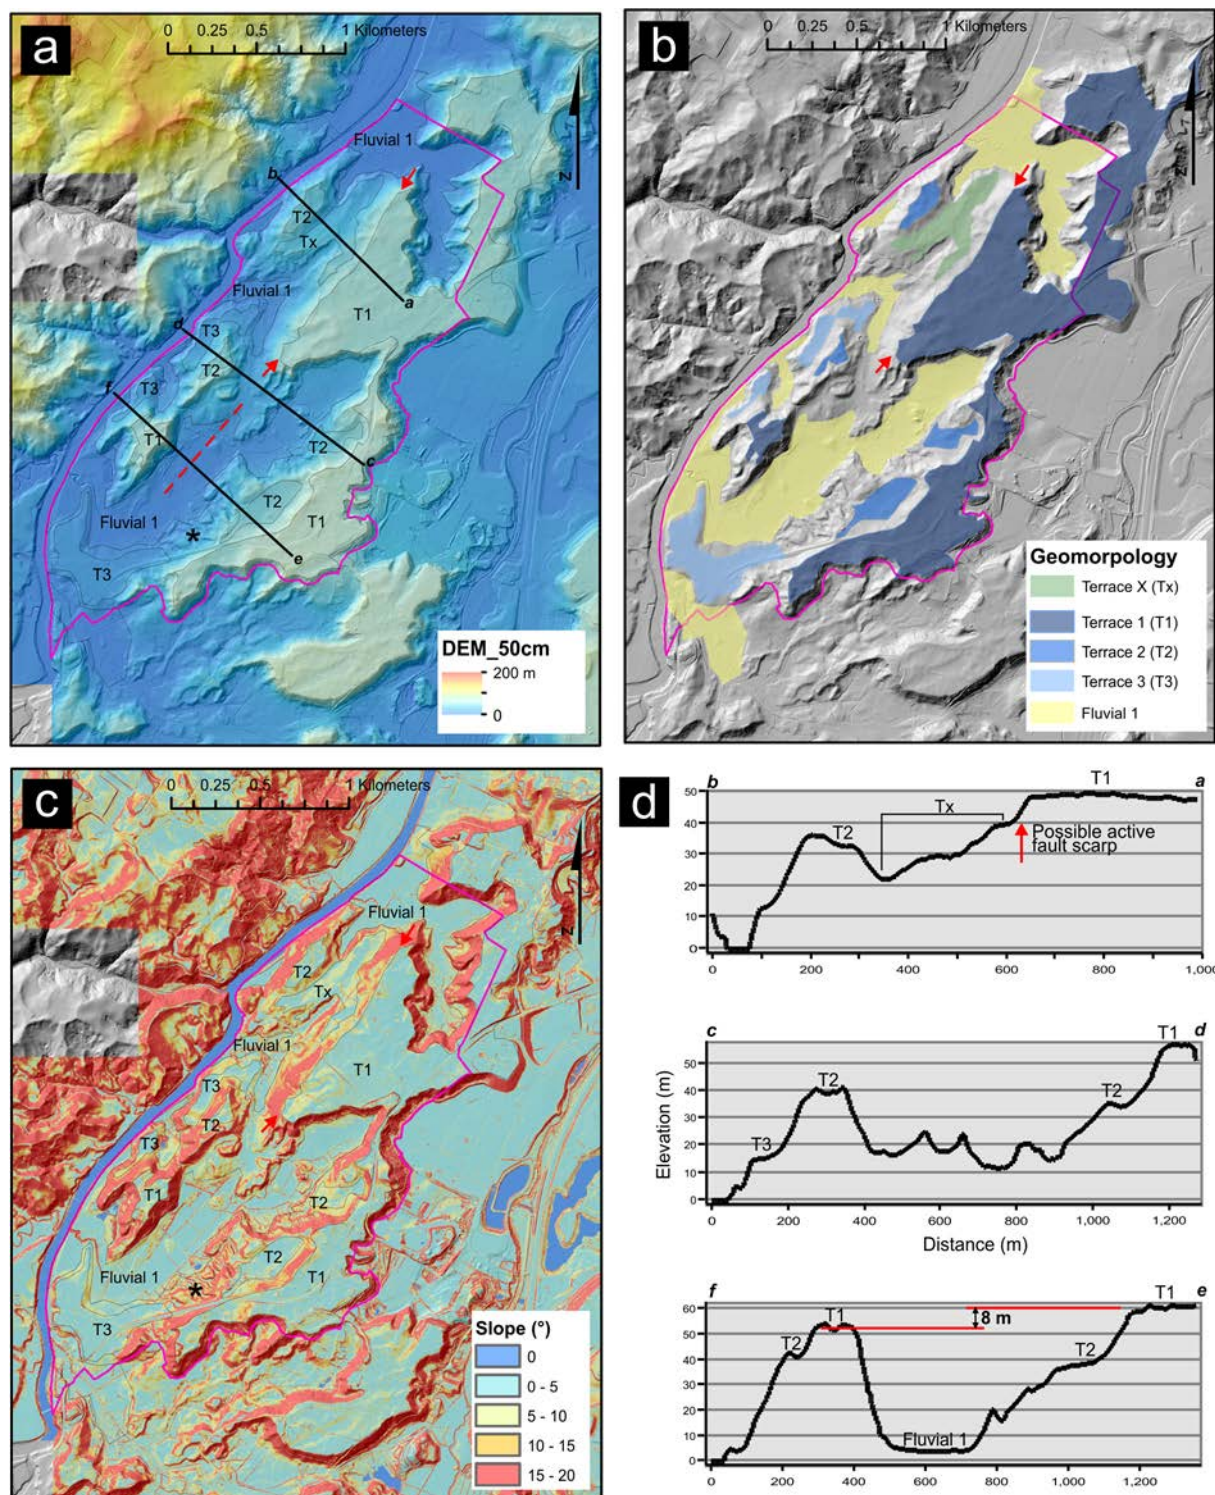
Figure 2.2 (a) Digital elevation and hillshade LiDAR DEM of the Tauriko West area. The location of the topographic lineation is shown by the red arrows. Red dashed line shows the along-strike projection of the lineation, * shows the location of landslide debris at the base of terrace risers and the black lines show the locations of the topographic profiles of figure (d). (b) Geomorphic map of the terrace surfaces (both volcanic and fluvial) in the area. (c) Slope DEM of the Tauriko West area. The river terrace risers, which are typically irregular and steep (15 – 20°) are shown well by this imagery. (d) Topographic profiles from across the possible active fault scarp and its along-strike projection. We show the possible faulted offset of surface T1 in profile e-f.

One topographic lineation, that may represent an active fault, has been identified in the Tauriko West area (Figure 2.2). The southwest-northeast trending topographic lineation may be a possible active fault for two reasons: (1) it aligns with a regional-scale landscape lineation that suggests the presence of a basement fault; and (2) the morphology of the topographic scarp, in terms of linearity and slope, is anomalous compared with nearby river-cut terrace risers. We expand on each of these points below.

We have undertaken geomorphic mapping of the Tauriko West area in order to identify the different terrace levels and the morphology of the terrace risers (Figure 2.2a-c). Most terraces are separated by risers that are relatively steep (15 - 20°) and have an irregular, sometimes scalloped-shape, morphology. These terrace risers are typical of fluvial systems where the terraces are cut by meandering fluvial channels. The topographic lineation that we discuss as a possible active fault is different from a typical terrace riser in two ways:

- The slope is less (10 - 15°) than typical for terrace risers (Figure 2.2c).
- It follows a more or less straight line for ~1 km, whereas most terrace risers have a more irregular shape (Figure 2.2a).

- The lesser slope of the scarp of the topographic lineation, compared to nearby terrace risers, could be due to slope movement or slumping of the riser. Indeed, evidence of past landslides at the base of terrace risers can be seen in other areas of Tauriko West (see * in Figure 2.2a and Figure 2.2c).

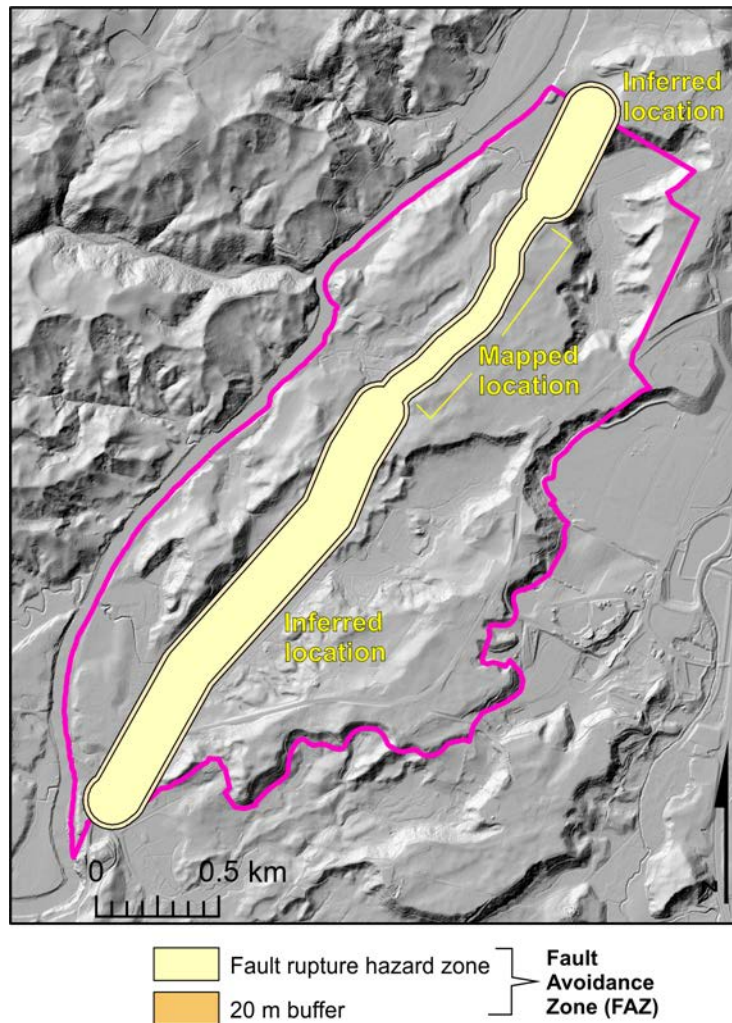
Figure 2.3 The FAZ for the possible active fault scarp in the Tauriko West area. Note that we can only map the possible fault scarp location across the higher T1 terrace; we infer the fault location across the low elevation floodplain and in this area there is a much higher locational uncertainty as the possible fault is concealed, resulting in a wider FAZ.

If we assume that the topographic lineation described above as a “possible fault” is, in fact, an active fault, then we have mapped the Fault Avoidance Zone (FAZ) for this feature in a GIS (Figure 2.3). The location has been defined as the lower edge of the topographic scarp, which is the typical location of a normal fault with respect to the scarp. The fault rupture hazard zone is ± 50 m wide either side of the fault (yellow area, Figure 2.3). This area comprises the uncertainty in the exact location where the fault plane would cut the surface (as it can be anywhere within the fault scarp, although observations of active fault ruptures suggest that it has a higher likelihood to be located at the base of the scarp) and also other secondary deformation that can occur in close proximity to the main fault trace.

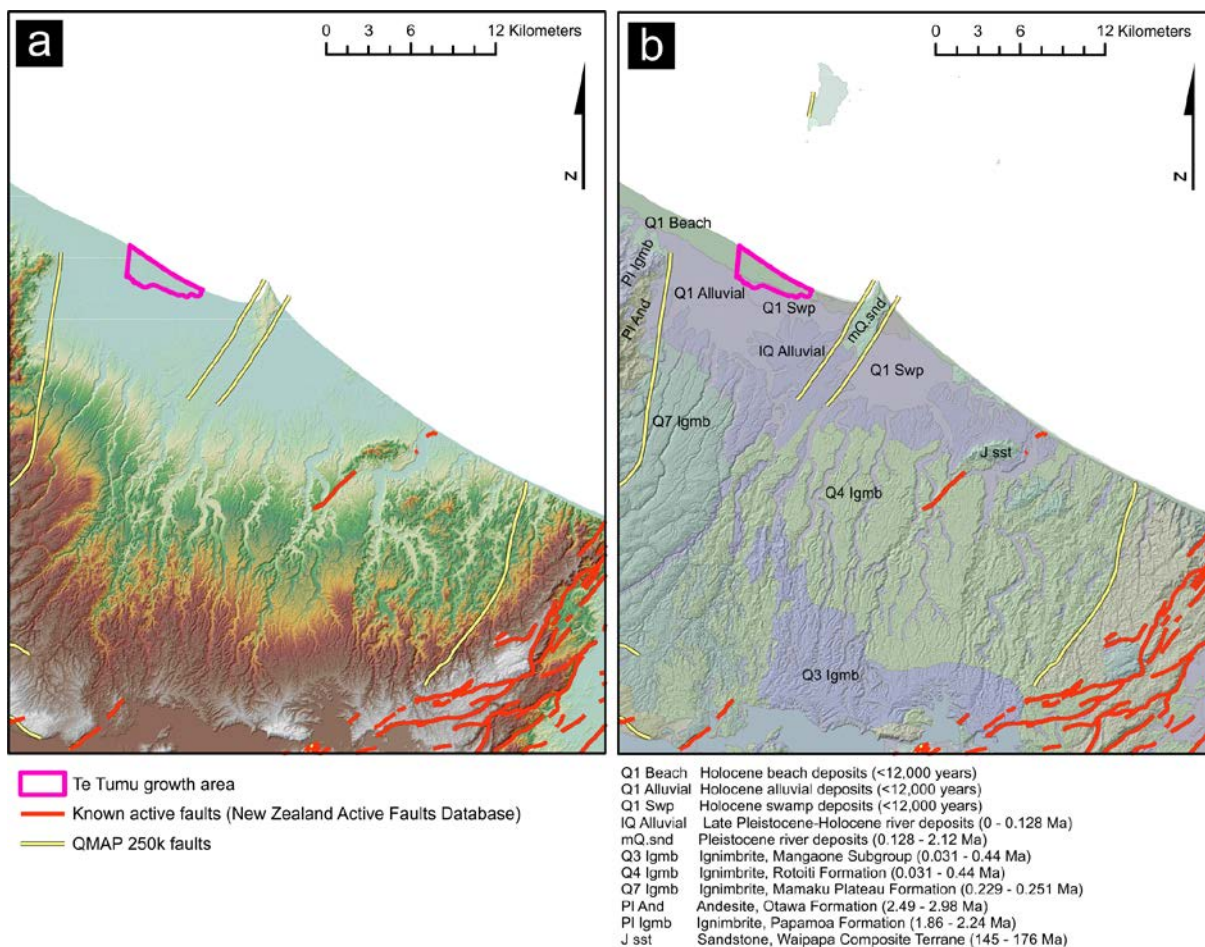
Figure 3.1 (a) A digital elevation and hillshade LiDAR DEM of the topography of the region surrounding Te Tumu. Onshore active faults from the NZ Active Faults database (Langridge et al. 2016), inactive faults from Leonard et al. (2010). (b) The geology and surface ages of the Te Tumu area, geological mapping from Leonard et al. (2010).

Several inactive faults have been mapped by Leonard et al. (2010) in the area near Te Tumu (yellow lines, Figure 3.1) and there are observations of Quaternary fault offsets in the coastal cliffs around Maketu. Unpublished data by P Villamor shows that ~322,000-240,000 year old formations exposed in the coastal cliffs around Maketu are offset by several normal faults, but overlying 240,000 year old ignimbrites and the last Interglacial (~125,000 years old) paleosol are not displaced, indicating that faulting had ceased before 240,000 years ago. For the purposes of this report, these are considered inactive faults.

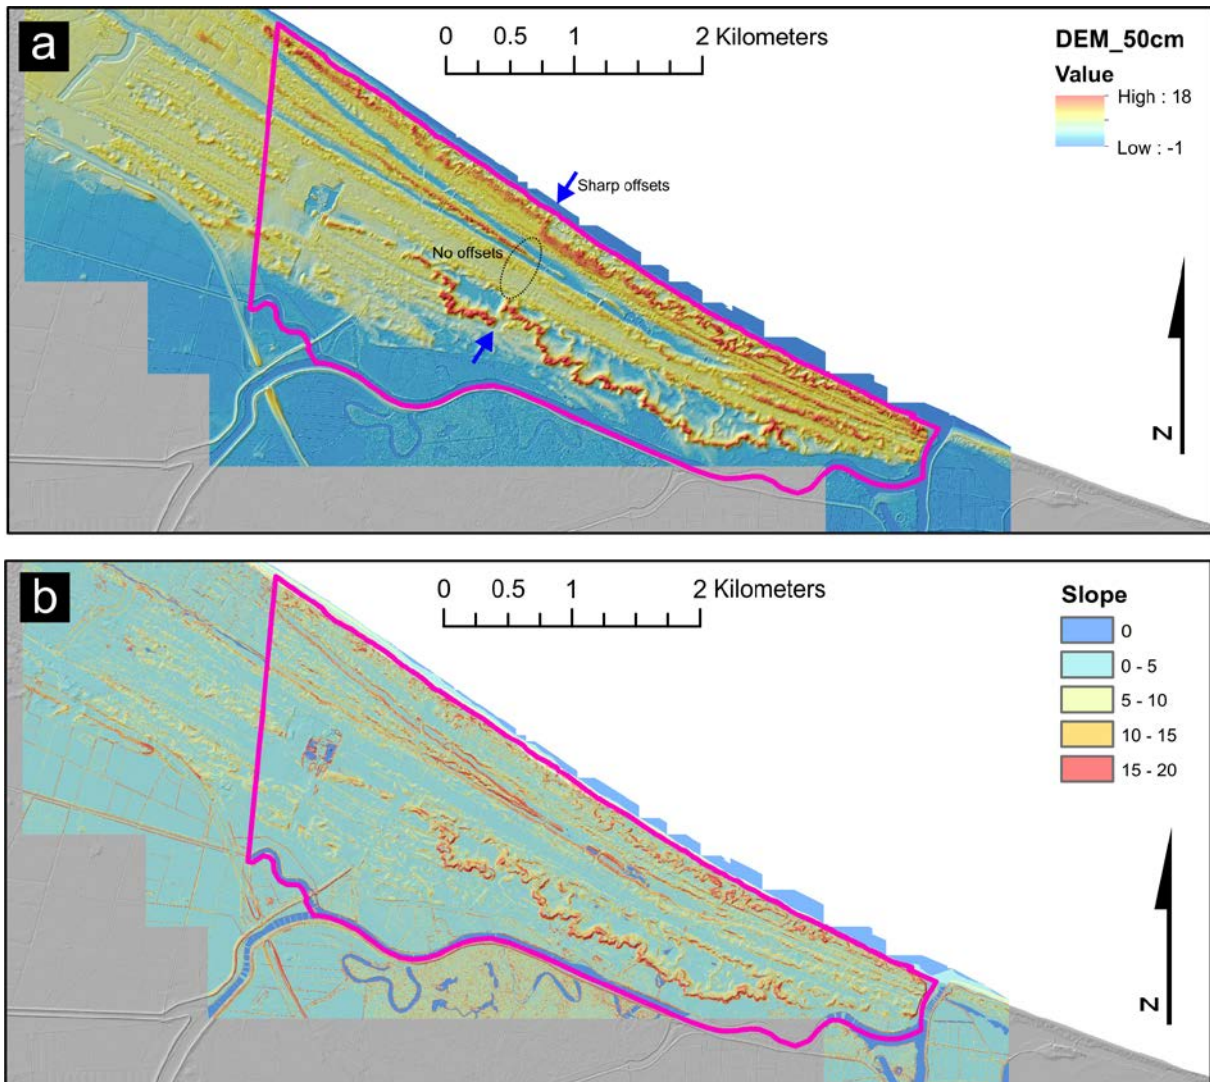
Figure 3.2 (a) Digital elevation and hillshade topographic LiDAR DEM of the Te Tumu area. The location of a lineation is shown by the blue arrows. (b) Slope DEM of the Te Tumu area. No scarp features compatible with active faults are seen.

A detailed examination of the topography and slope DEMs of the Te Tumu area was undertaken and no evidence of active faulting was seen (Figure 3.2). The geomorphology of the area is dominated by a sequence of shore-parallel low dune ridges (up to 15 m elevation above sea level) and inter-dune swales (1 – 2 m elevation above sea level). One lineation was seen near the middle of the Te Tumu area where two sharp changes in the location of the dune crests are seen (blue arrows, Figure 3.2a). However, not only are the coastal and inland dune crests offset in opposite directions (inconsistent with faulting which would offset features in the same direction) but the dune ridges in between show no evidence of an offset (circled area, Figure 3.2a). We conclude these sharp offsets in the dune crests are natural features that coincidentally occur in a lineation.

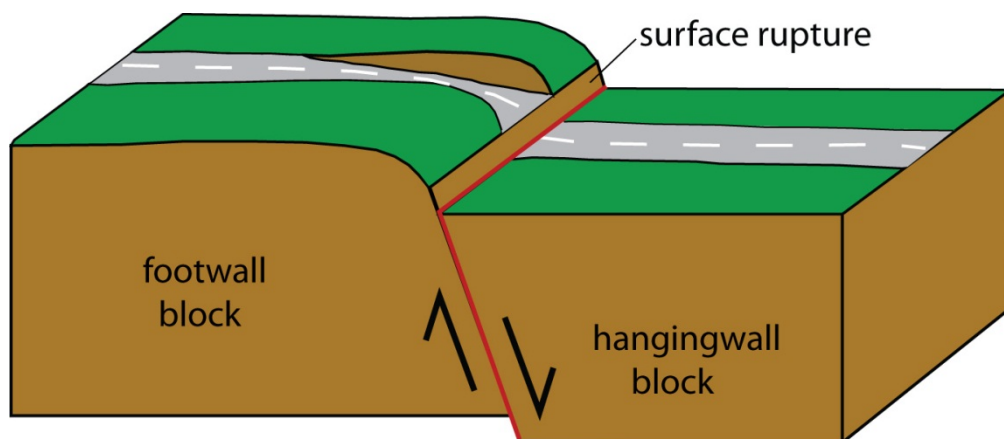
Figure A1.1 Block model of a normal dip-slip fault, typical of the TVZ faults. The relative movement of the blocks is vertical and in the dip direction of the fault plane. The hanging-wall block has dropped down, enhancing the height of the fault scarp.
