Bay of Plenty Regional Council Toi Moana
PO Box 364
Whakatāne 3158

Eastside Active Faults Study 2021 Update

1.0 INTRODUCTION

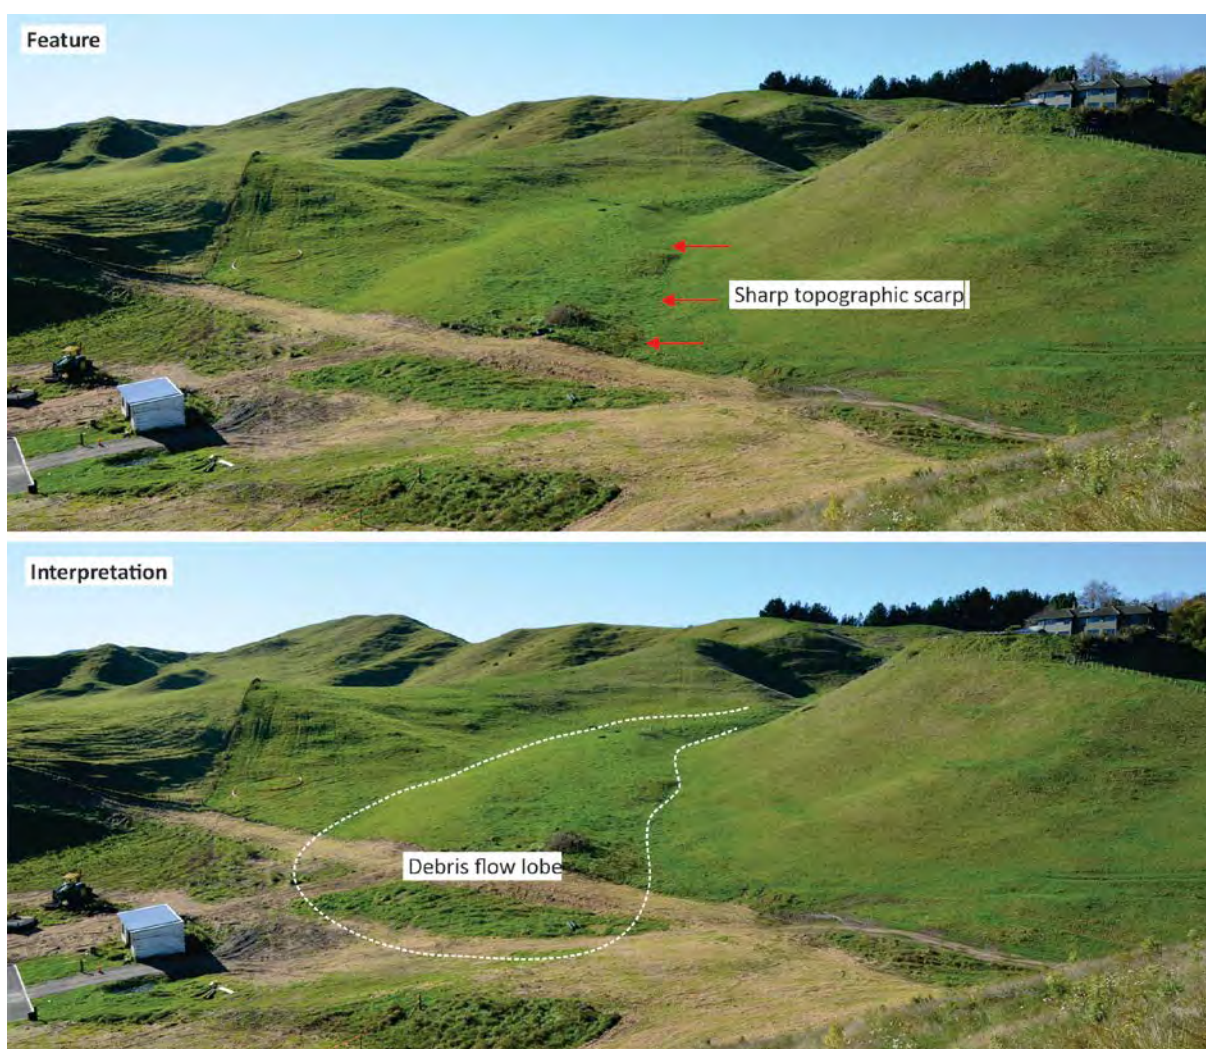
Figure 3.1 A photo looking along the strike of Fault 2a, the sharp topographic step is best explained as the edge of a debris flow rather than an active fault. Photo credit: Brad Scott, GNS Science VML254349. Location of photo shown in Figure 2.1.

A major objective for undertaking field work along Fault 2a was to check the small, sharp scarp at the eastern end of Fault 2a. This small, straight scarp was the main reason that Fault 2a was identified at this site, but we had concerns it could have been formed by human activities (e.g. an old driveway or farm race). In the field it became clear the scarp was natural but most likely marks the edge of a debris flow, rather than being a fault scarp (Figure 3.1). The debris flow forms a lobe within the valley and has quite straight sides. In this case the debris flow edges were along the strike of the other subtle fault scarps (Faults 2b and 2c, Figure 2.1). When we remove the debris flow edge scarp from consideration, there is no reason to keep a fault line in the location of Fault 2a. The western end of Fault 2a does follow a gully but there is little reason to consider this as a fault-controlled gully. As a result of the field investigation, we removed Fault 2a from the active faults map of the Eastside area.
