DETAILED SITE INVESTIGATION

297 TE PUNA STATION ROAD,
TE PUNA, TAURANGA

Prepared For: Momentum Planning and Design Limited

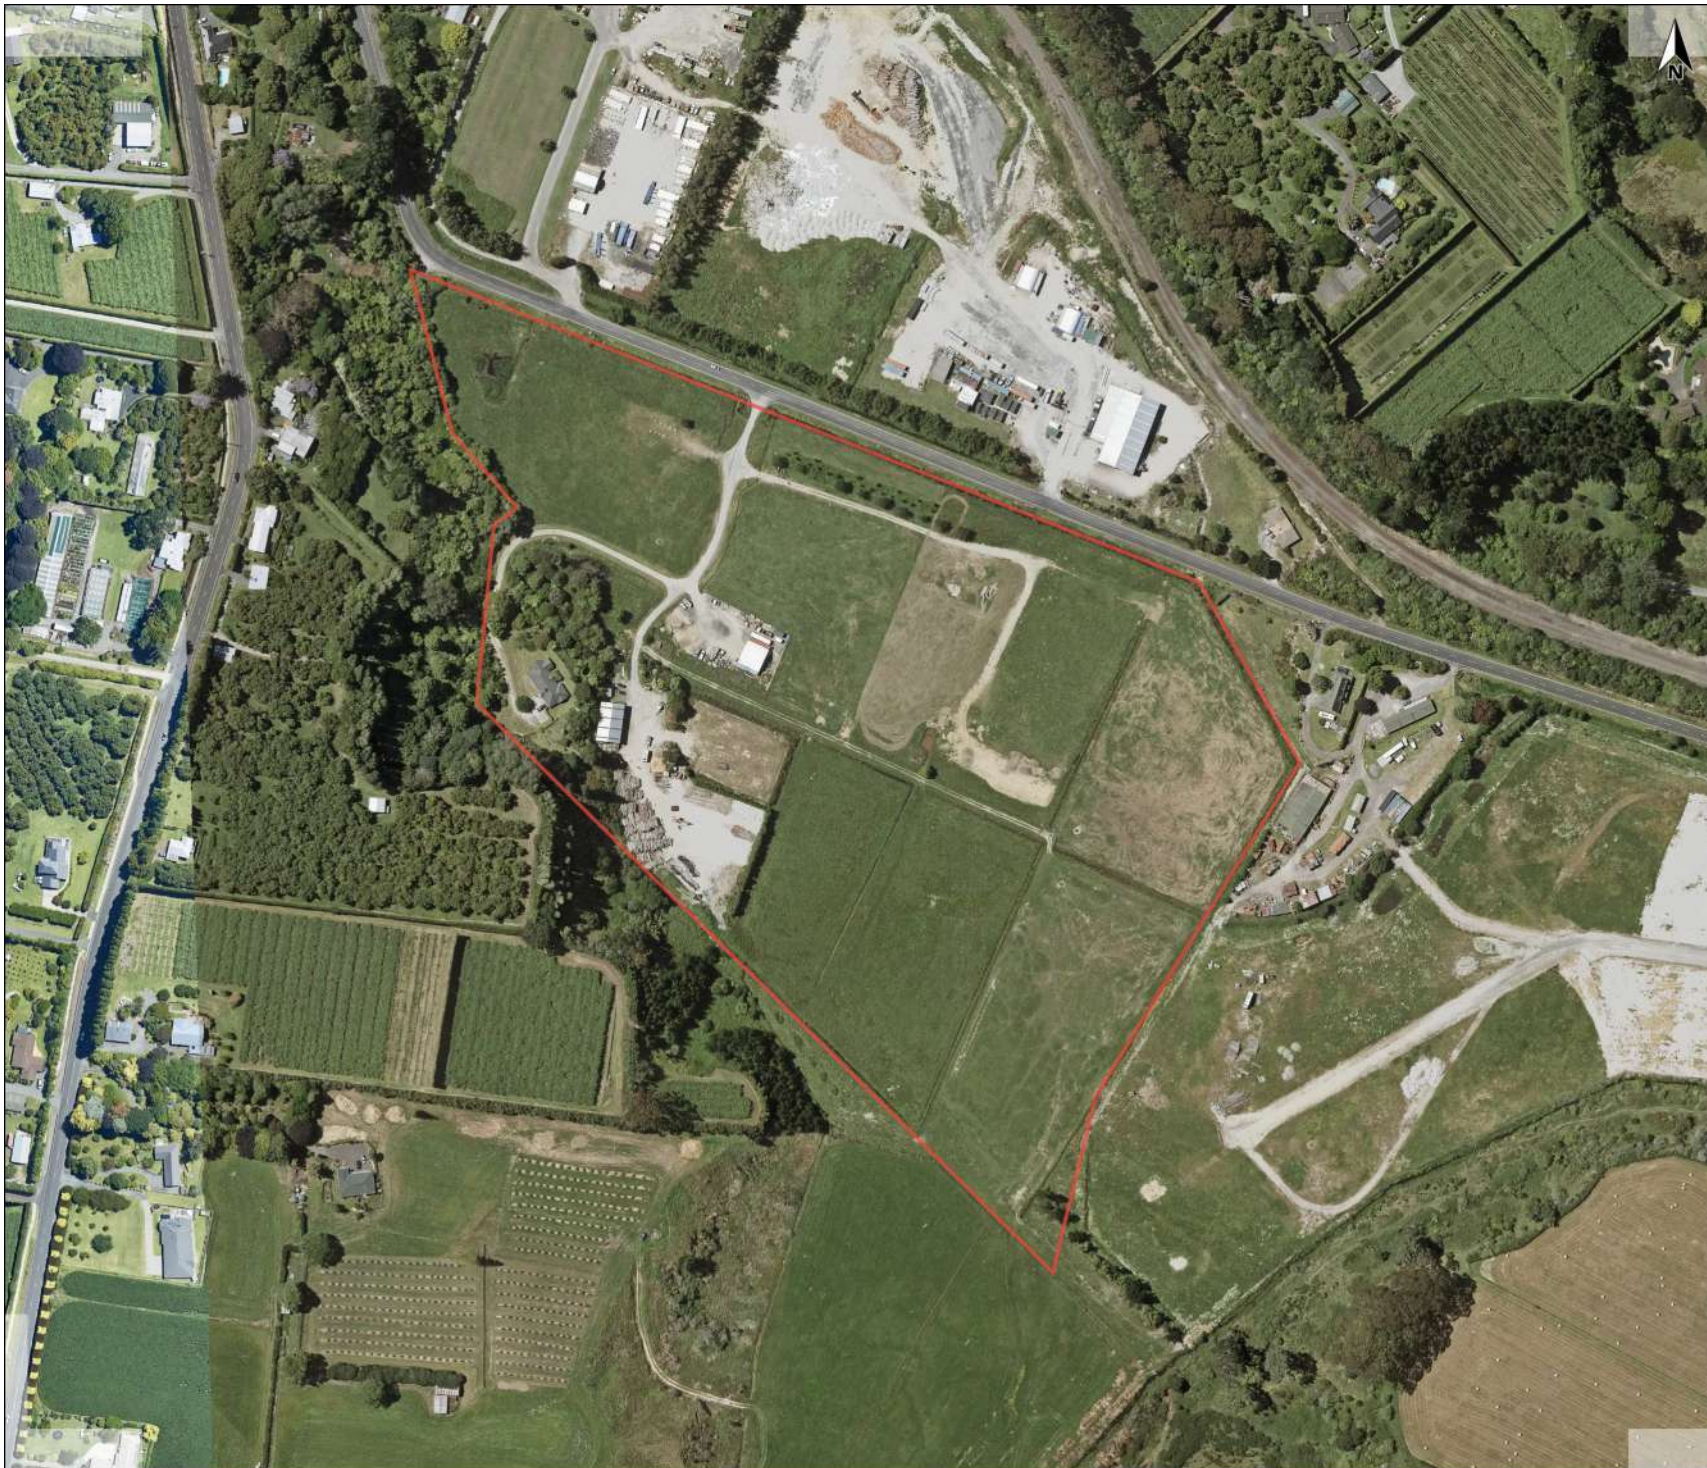
Title: Site Location		
Client: Momentum Planning and Design		Figure No: 1 Size: A4
Project: 297 Te Puna Station Rd	Drawn: EJ	
Date: 25-05-2022	Checked: EJ	
Proj No: 202201	Scale: 1:4000	Version: Final

The location and layout of the site is depicted in Figure 1.

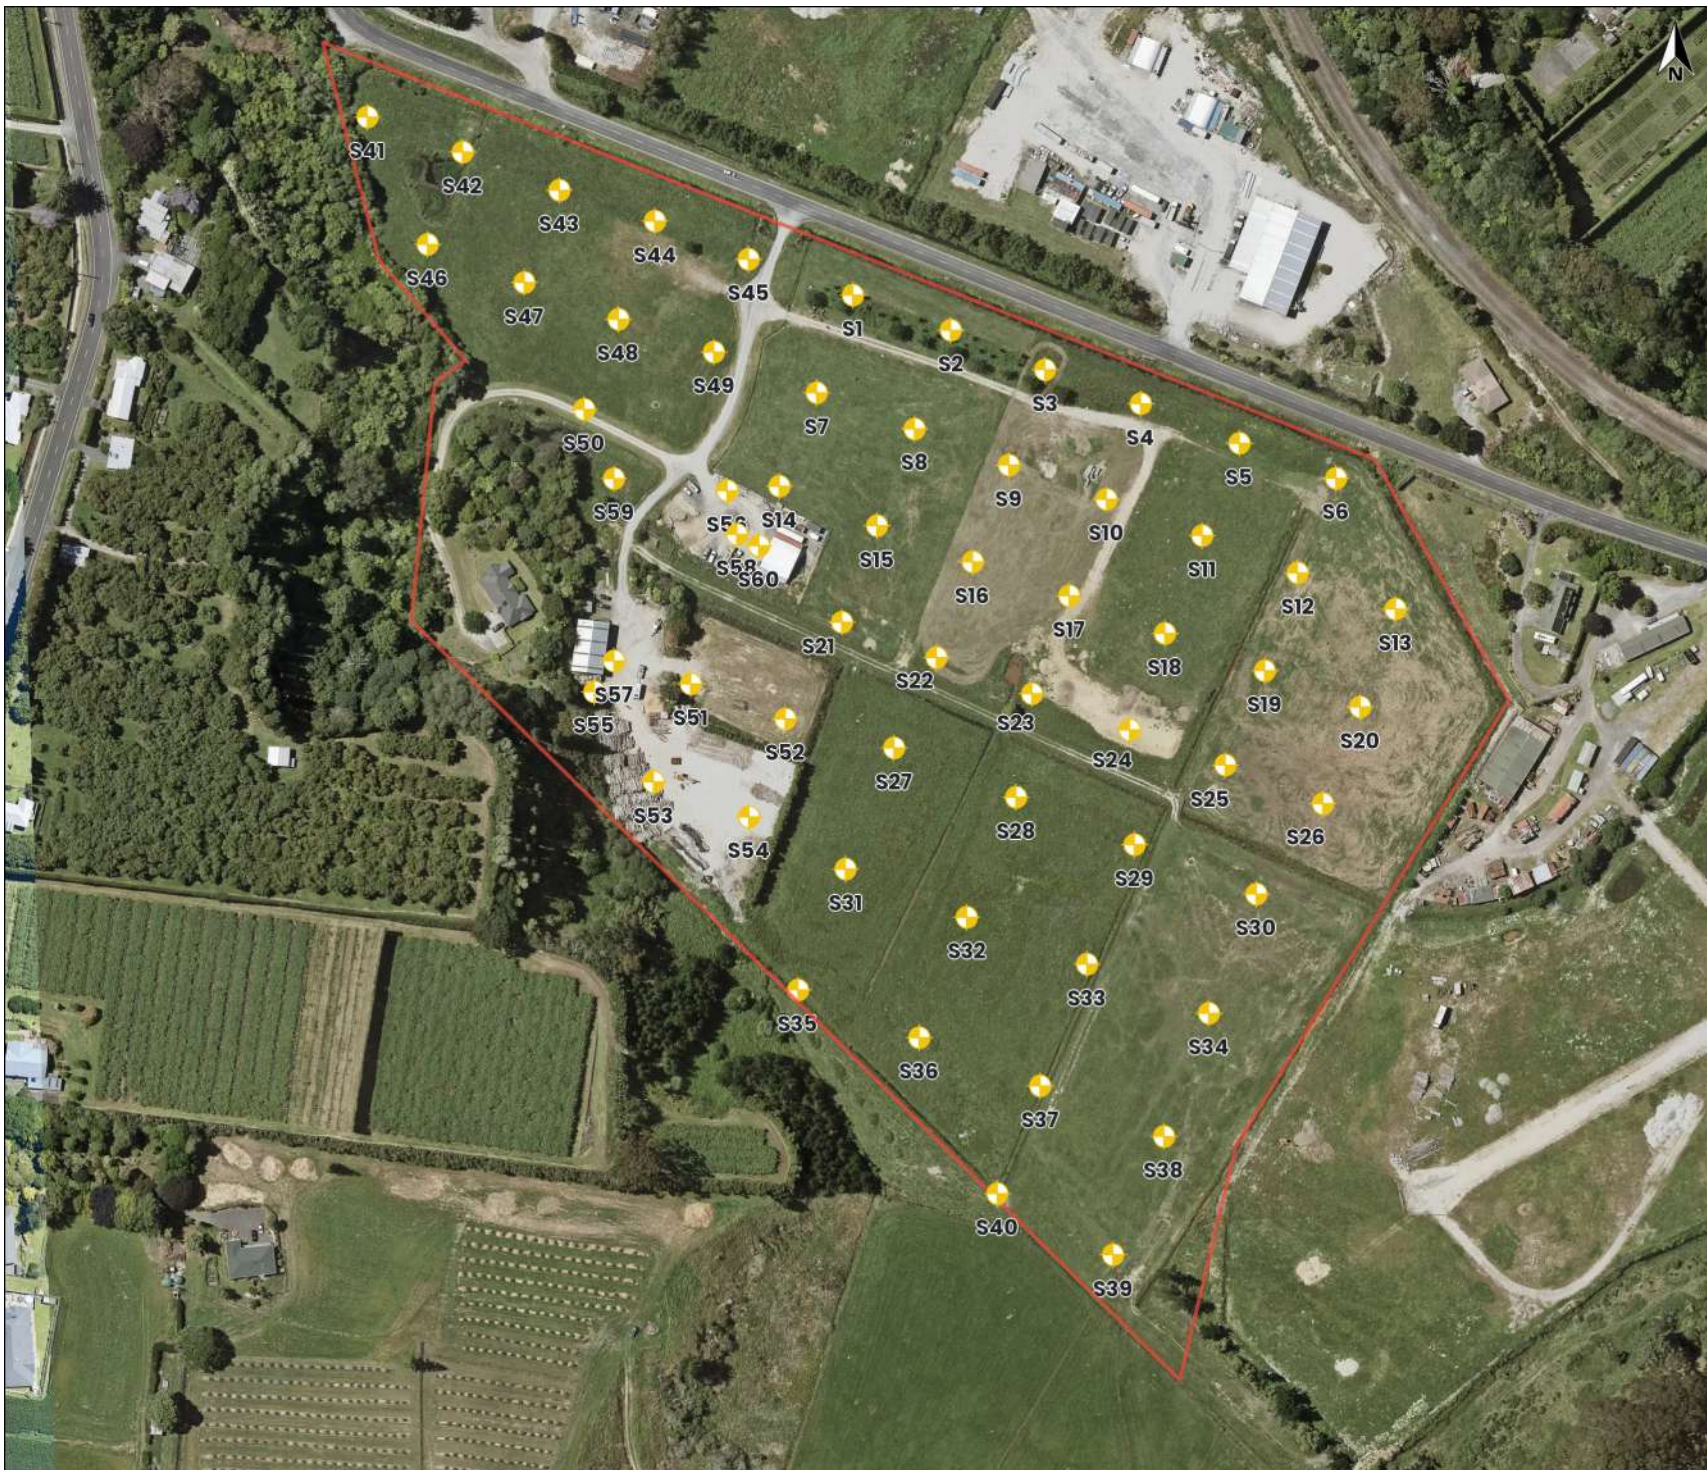
- Legend**
- Sample Locations
 - Site Boundary
 - Sample Locations

The fill material comprised a dark brown loam to 0.2 m bgl generally overlying a light brown/orange sandy clay to 0.9 m overlying brown/blue/green clay. Some locations contained grey sand from 0.4 m and a couple of locations contained gravel inclusions. No visual or olfactory signs of contamination were noted during the field investigation.

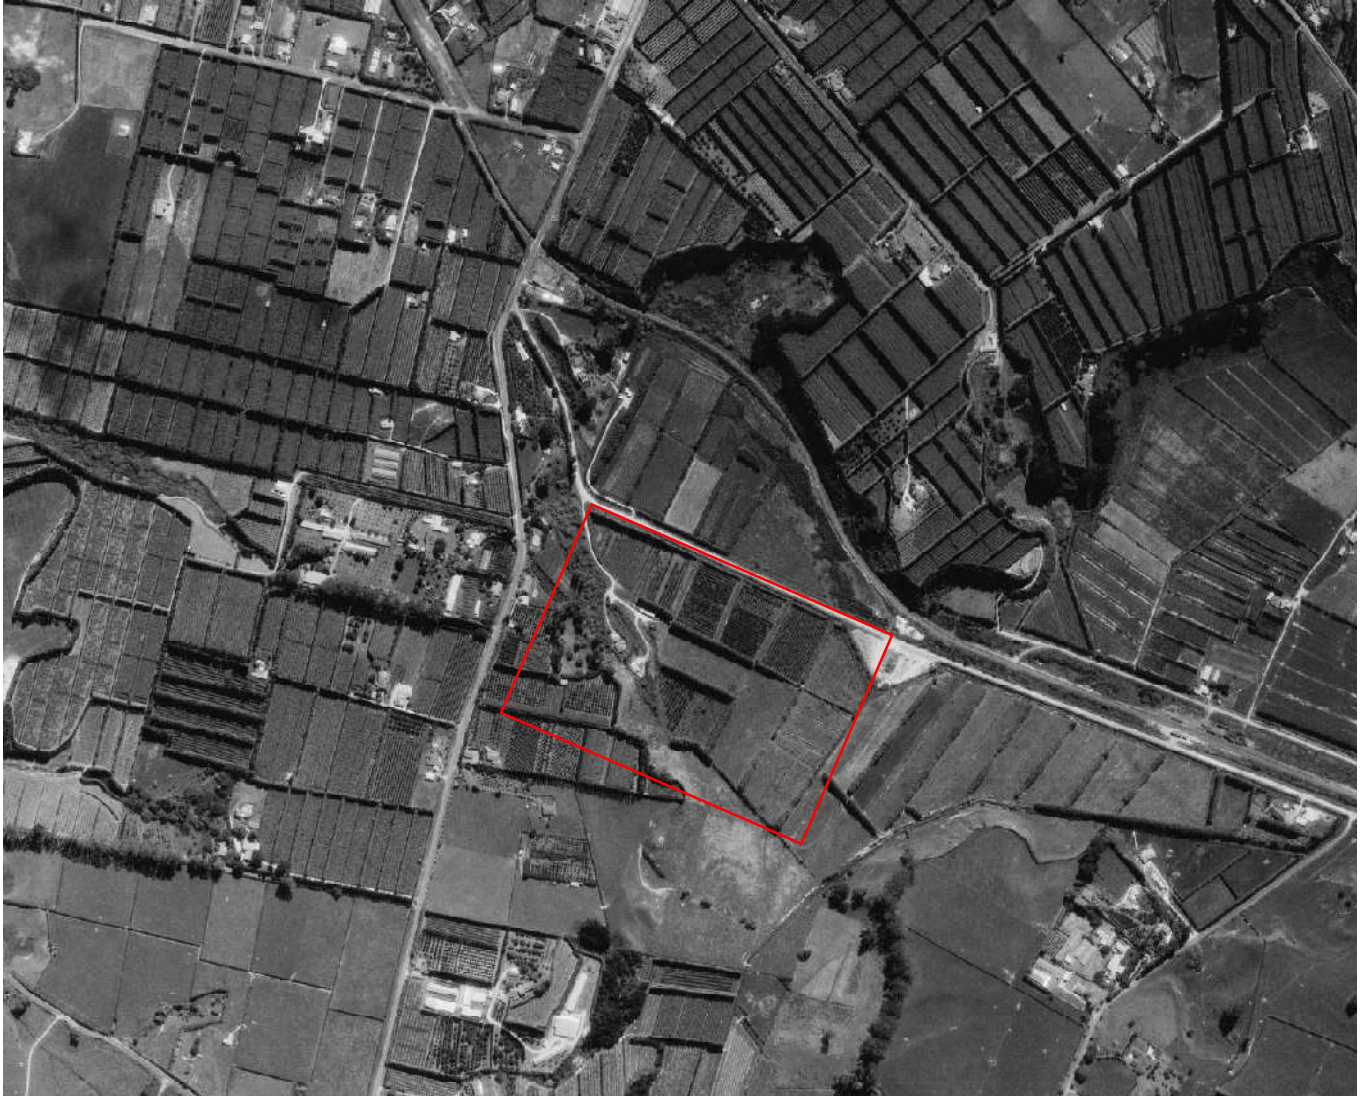
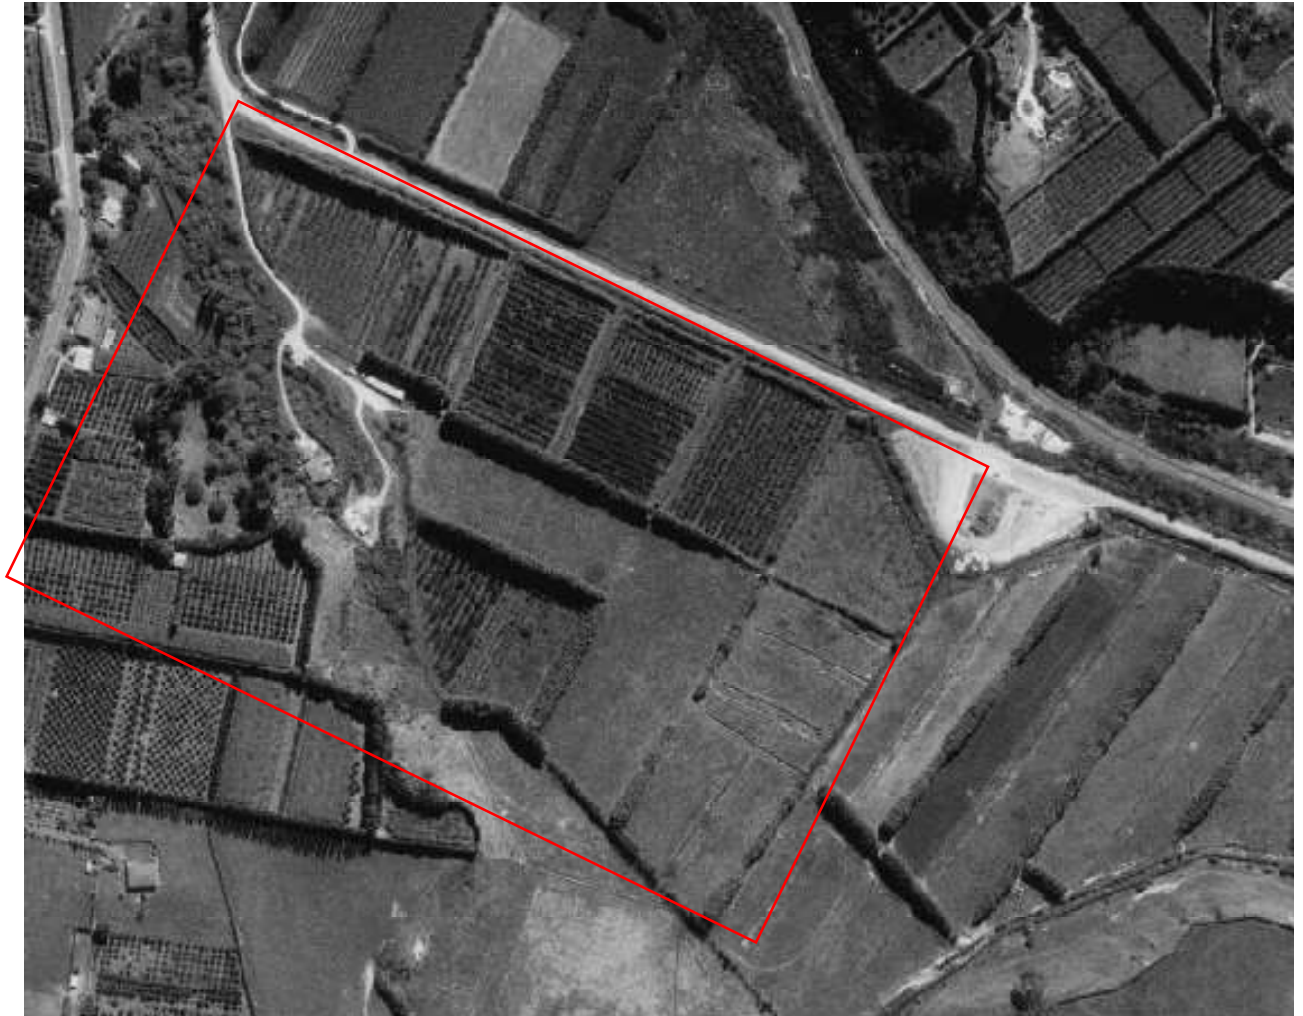
1986 (cropped)

1986	Approximately half of the property appears to be in orchards (northern paddocks and two southern paddocks). The remainder is in pasture land. Some of the pasture land appeared to have been converted back into pasture after having been planted out into orchards from what could be observed of the site in the 1981 photo. There are two additional areas that have been cleared on the site. One is at the location of the current house and is likely the site of the house that was relocated to the site in 1977. The other cleared area to the east of house site also appears to have a building sited there.	Surrounding area is largely in orchards. There is some pasture land remaining on the adjacent properties to the south and southeast of the site. The property directly north of the site has been put into orchard.
1992	Site looks unchanged	Surrounding area looks unchanged. The property to the north of the site, across the road appears to have been cleared of orchard and is being returned to pasture land.
