Rotorua and Tikitere geothermal surface features - monitoring sites surveying results

Bay of Plenty Regional Council Environmental Publication 2024/05

Prepared by: Mariana Zuquim, Geothermal Scientist

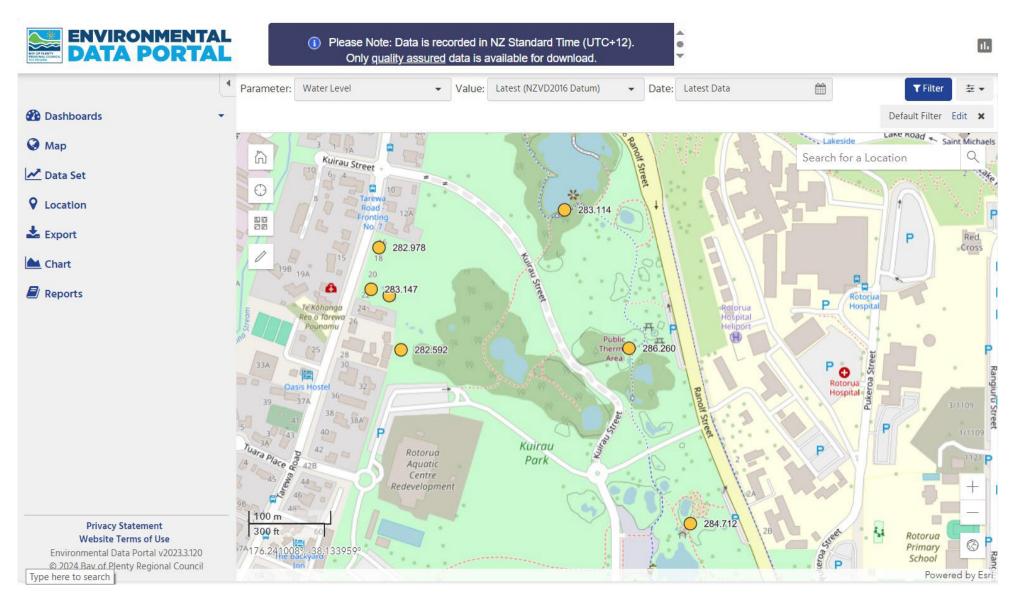
Figure 8 – Example of water level data (NZVD2016 datum) displayed in the BOPRC data portal. The time series can then be downloaded for each feature (Figure 9). Note that the geographic location has also been determined using this survey's results.

The survey yield quality level data with sufficient accuracy to enable the offset of water level historic data to a common datum. The process of offsetting the data has also been completed and the time-series are now published and available for download by internal and external stakeholders via BOPRC Data portal³ for externals (Figure 8) and Aquarius system (BOPRC data system available internally only; Figure 9) and this is considered a significant step forward to provide access to quality data, which is one of the BOPRC functions under Section 35 of the Resource Management Act (RMA).

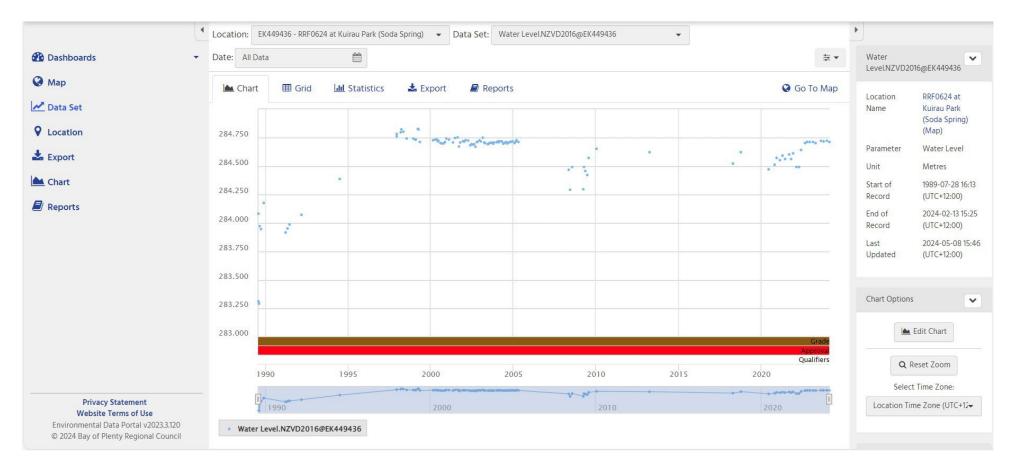
Figure 9 – Example of water level data (NZVD2016 datum) that can be downloaded from the BOPRC data portal. Data for RRF0624 – Soda Spring in Kuirau Park

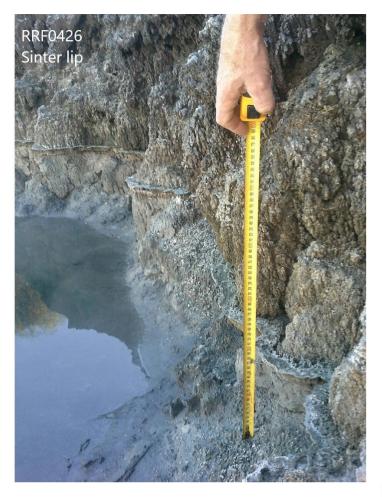
RRF0426 Unnamed feature old datum (sinter lip).

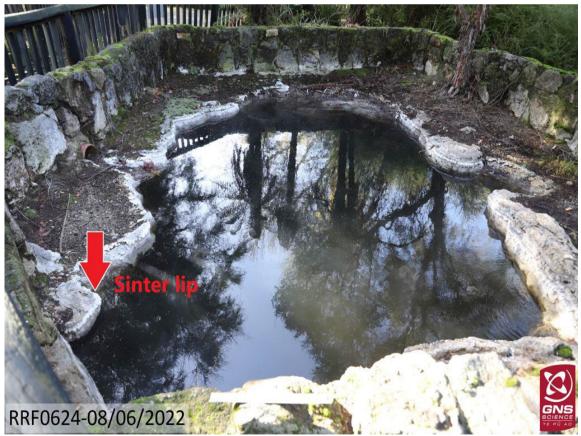
RRF0624 Soda Spring old datum (sinter lip)

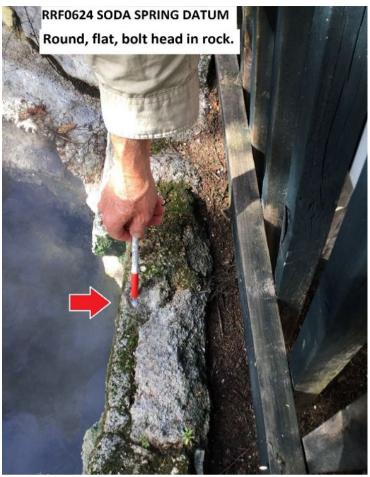
RRF0624 Soda Spring current datum (sinter lip)

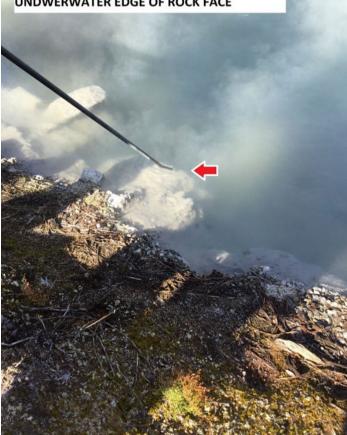
RRF0657 Waiariki Parekaumoana current datum

RRF0657 WAIARIKI PAREKAUMOANA DATUM UNDWERWATER EDGE OF ROCK FACE

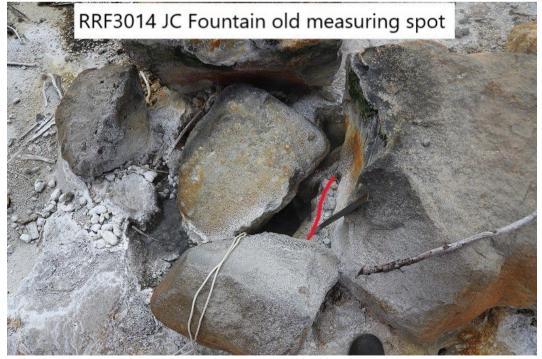
RRF3014 JC Fountain old datum (along the red line)

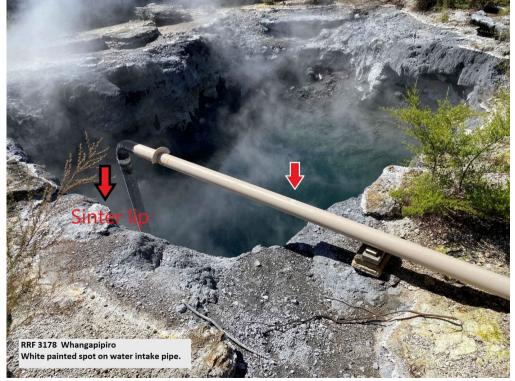
RRF3178 Whangapipiro / Rachel Spring old datum (sinter lip) and new datum (top of pipe).
