**Lake Rotorua groundwater study: results of the  
2004-2005 field programme**

**Confidential  
Client Report  
2005/66**

**July  
2005**

**ENVIRONMENT BAY OF PLENTY**

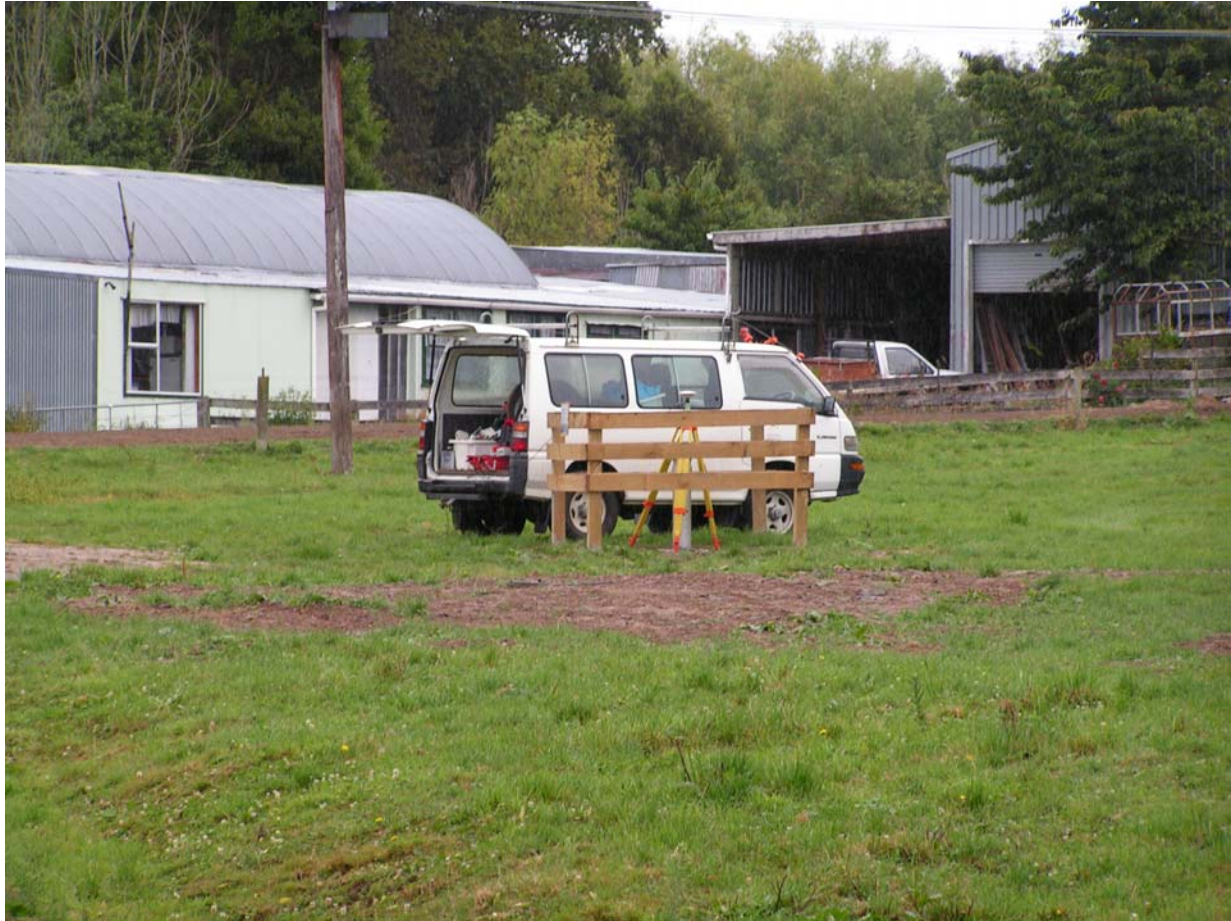
**Figure 2.1** Piezometer DP1. Piezometer under GPS tripod.

The location of the piezometer is in a farm paddock on the Dibley property at NZMG grid coordinates 2788703.8, 6346607.6 (Figure 2.1).

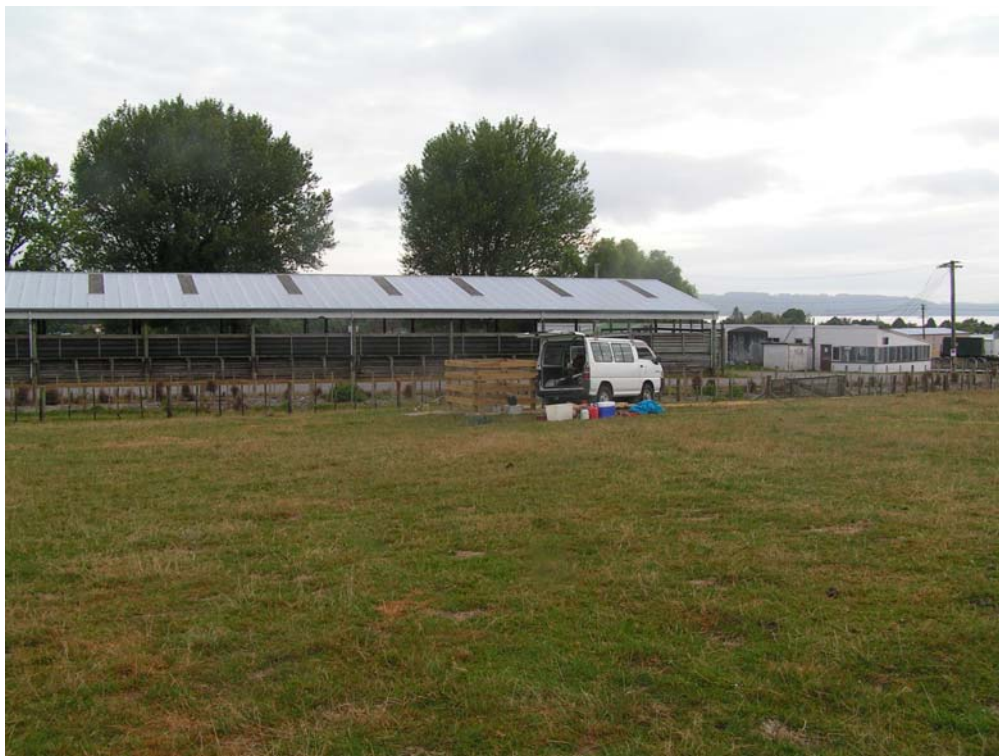
**Figure 2.4** Piezometer DP-2.

Permission was obtained for drilling the 2 bores at JMM Park from Rotorua District Council (RDC) prior to drilling (Street opening permit 10883). The permit states that holes should be “... finished flush with the ground so a mower can run over it”. Permission was obtained from RDC (Bob Brake, e-mail 15/12/2004) to finish piezometer DP-2 with an above ground finish. This was recommended to preserve the piezometer given:

- The piezometer is currently located in a grazing area and maybe subject to animal interference, and,
- RDC had suggested earthworks around the site may occur in the future. The possibility of the piezometer been buried is minimised with an ‘above ground’ finish.

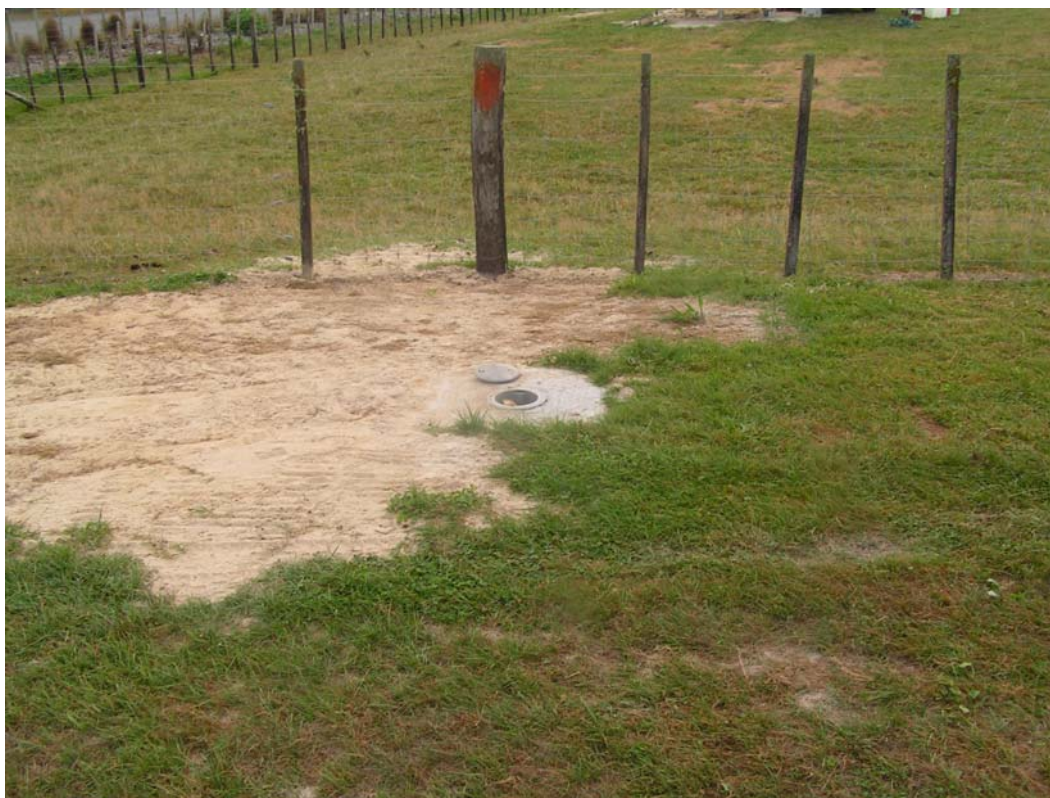
**Figure 2.6** Piezometer D3.

The location of the piezometers is at the northern end of Jessie Martin Memorial Park (JMM Park), owned by Rotorua District Council. The deep piezometer (DP-2, EBOP bore number 10967) is at NGMG grid co-ordinates 2791569.6, 6342323.5 (Figures 2.4 and 2.5) and the shallow piezometer (D3, EBOP bore number 10966) is at NGMG grid co-ordinates 2791541.2, 6342329.3 (Figures 2.5 and 2.6).

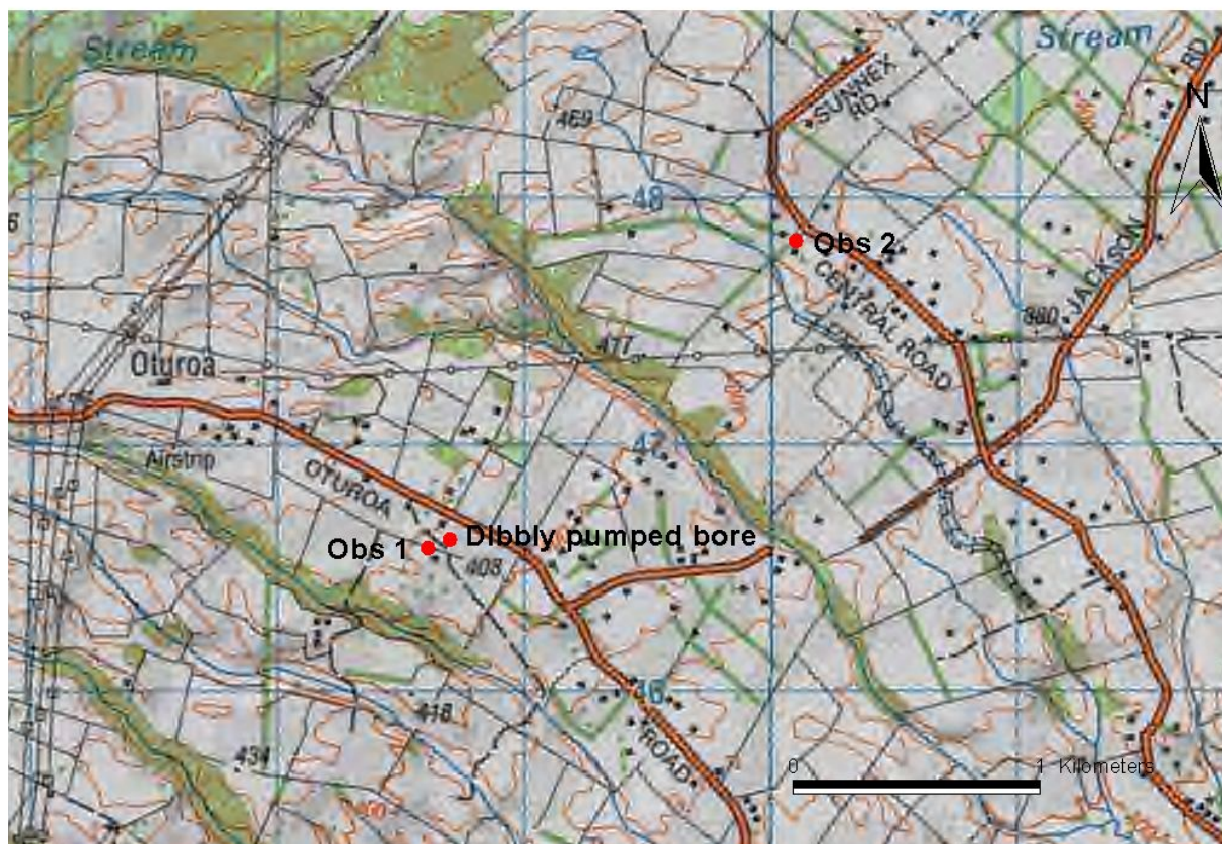
**Figure 3.1** Location map of DP-1 pump test bores.

A 24 hour pump test was undertaken on the Dibley bore on 13 and 14 December 2004. The purpose of the pump test was to provide aquifer transmissivity and storativity values of the Mamaku Ignimbrite aquifer for input into a groundwater flow model that is to be developed to assist with resource management of the Lake Rotorua groundwater catchment. The pump test was commissioned by Environment Bay of Plenty as part of a larger Lake Rotorua groundwater catchment study undertaken by GNS. The pump test was undertaken by Bayliss Bros. drilling from Hawke's Bay. The bore was pumped at a constant rate of 3 l/s. Groundwater levels were measured in three bores (Figure 3.1) by automatic recorder at minute interval during the pumping and recovery phase of the test.

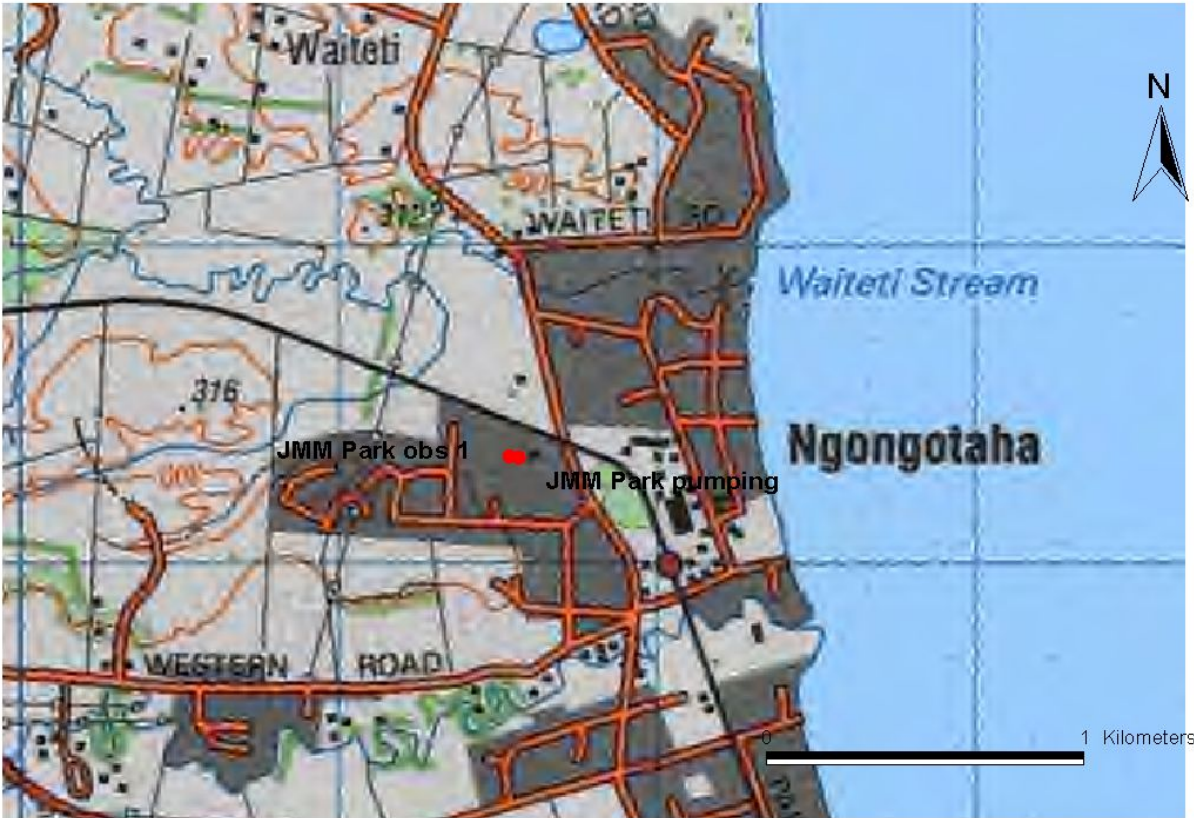
Figure 3.9 Location map of the DP-2 pump test bores.

A 12 hour pump test was undertaken on the JMM Park bore on 20 and 21 January 2005. The bore was pumped at a constant rate of 5 l/s. Groundwater levels were measured in two bores (Figure 3.9, Tables 3.4 and 3.5) by automatic recorder at minute intervals during the pumping and recovery phase of the test.

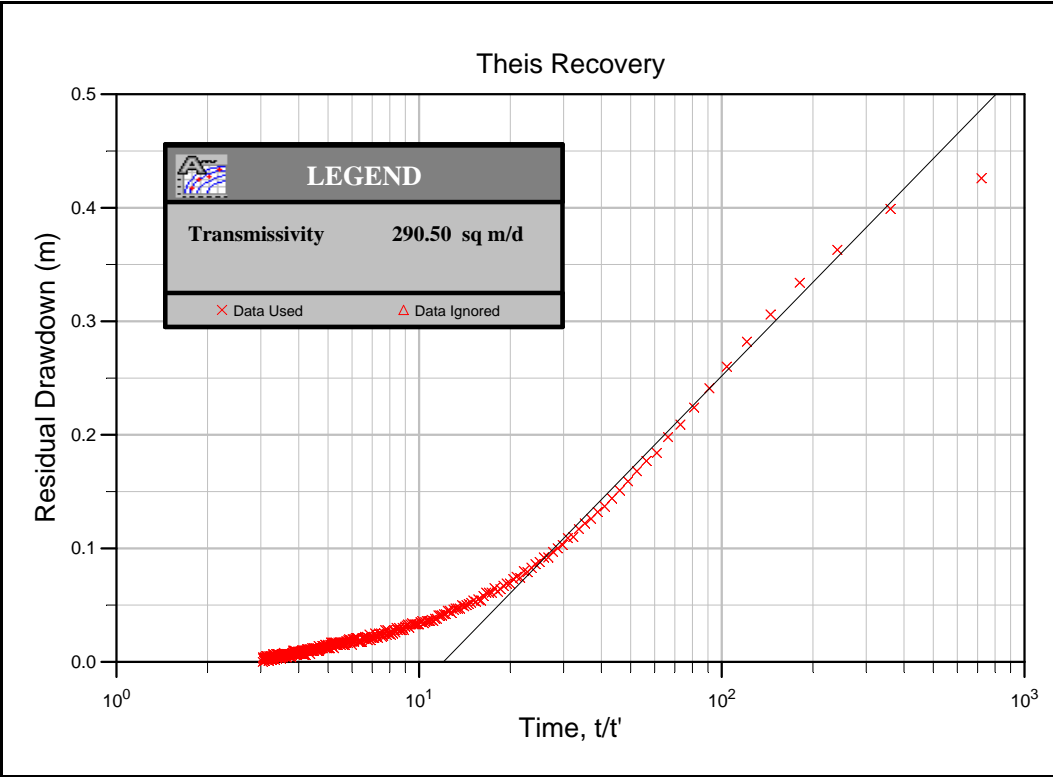
Figure 3.14 Obs 1 Theis recovery analysis.

The Hantush (1964) analyses for partial penetration of a leaky confined aquifer with  $r/B = 0.5$  and  $Kz/Kr = 0.04$  provided the best fit to Obs 1 drawdown data (Figure 3.14).

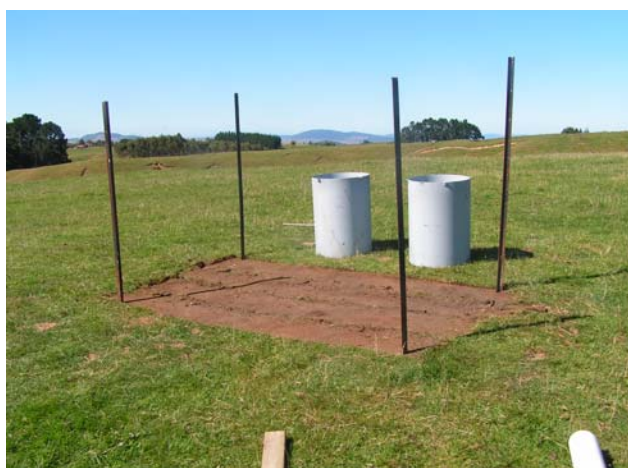
**Figure 6.5** Recharge site prior to driving casings.

The casings were driven into the ground with combination of weight from hydraulic digger and sledge hammer (Figures 6.5 and 6.6). The area around the casings was excavated as the casing was lowered to facilitate driving and decrease the risk of damaging the soil column (Figures 6.6 and 6.7). After the casing had been driven to a level approximately 5 cm below

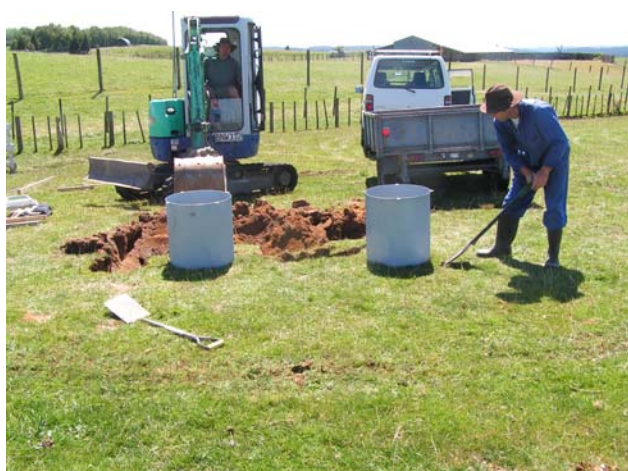
**Figure 6.6** Initial placing of casing.

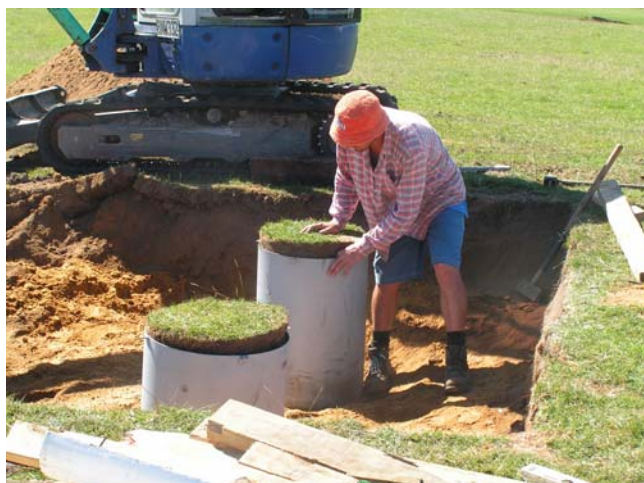
**Figure 6.7** Casing excavation.

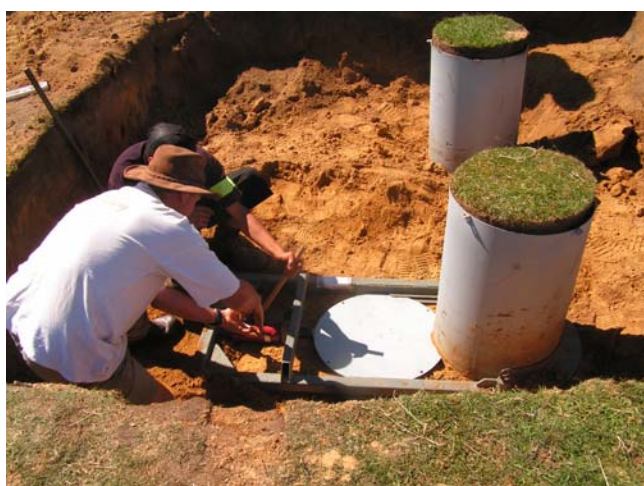
**Figure 6.8** Cutting plate.

the original ground surface, a cutting plate was inserted beneath the soil monolith (Figure 6.8). Long bolts with eyelets were fitted to lugs on the top of the casing to hold the cutting plate in place as the soil monolith was lifted out of the excavated pit (Figure 6.9). The cutting plate was then removed and the base of the monolith shaped with a spatula (Figure 6.10). A double layer of shade cloth was then laid on the base of the monolith and held in place by galvanised nails. A base plate with drainage hole was then bolted in place (Figure 6.11).

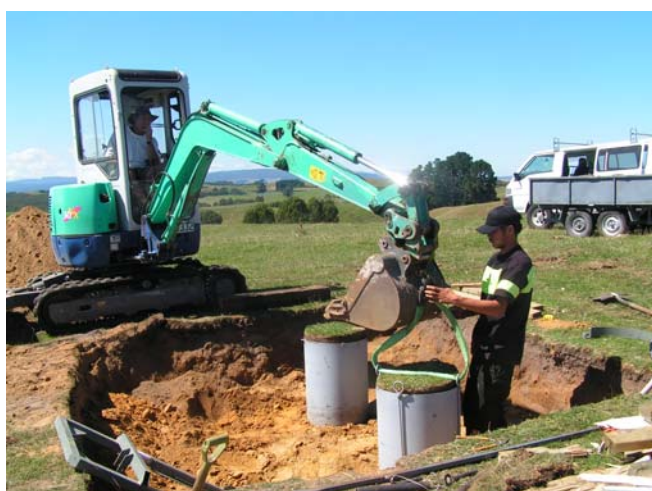
**Figure 6.9** Lifting the soil column.

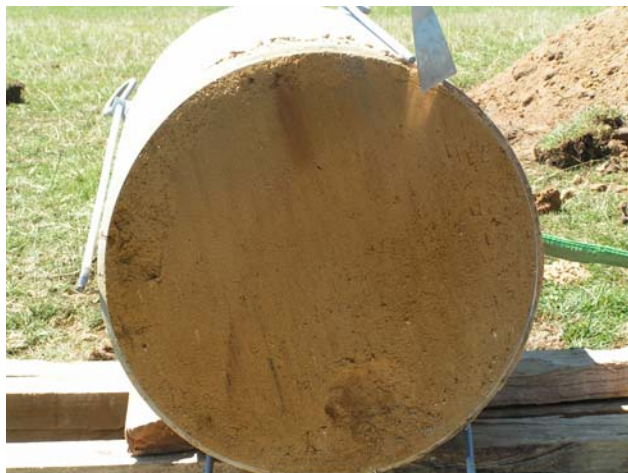
**Figure 6.10** Cutting plate removed.

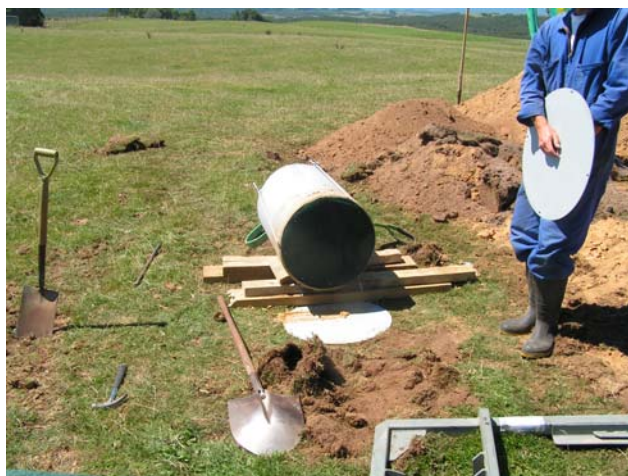
**Figure 6.11** Base preparation of the soil column.

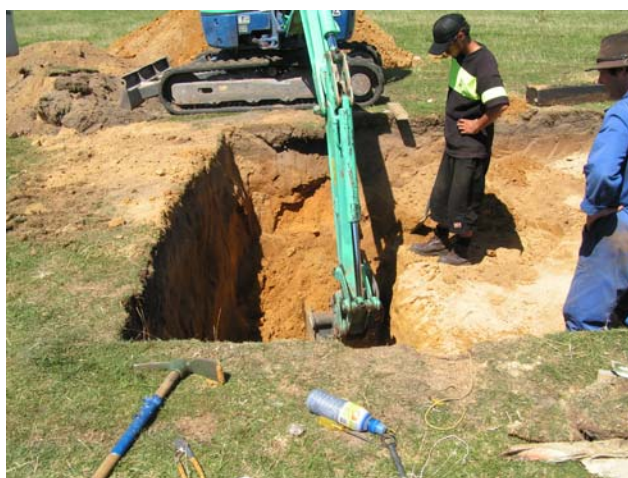
**Figure 6.12** Digging the box section.

The pit was then excavated for installation of a box section to house rain-gauges (Figure 6.12). When the box section was in place, the pit was backfilled to the level of the bottom of the soil monolith (Figure 6.13). An alkathene pipe was fitted to the base of the monolith with Hansen fittings. The alkathene pipe will conduit water that has infiltrated through the soil column, from the base of the monolith to a tipping bucket raingauge located in the box section area. A PVC pipe and concrete blocks were placed beneath the monolith to house the alkathene pipe and provide a stable platform for the monolith to rest (Figure 6.14). A hole was drilled in the box section wall to pass the alkathene pipe from the base of the monolith to the rain-gauge. Backfilling of the excavated pit was then completed (Figure 6.15) and the grass sod reinstated (Figure 6.16). An electric fence was installed around the site to protect the grass from stock while the grass re-established, and to protect the stock from falling into the open box section hole while cover grating was constructed and rainfall gauges installed.

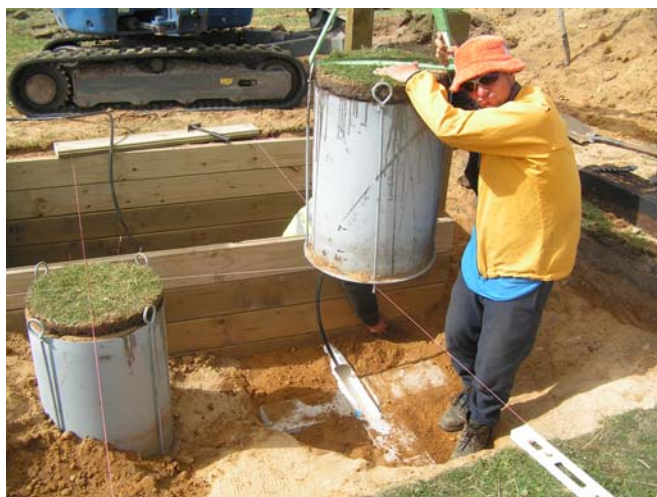
**Figure 6.13** Lysimeter installation.

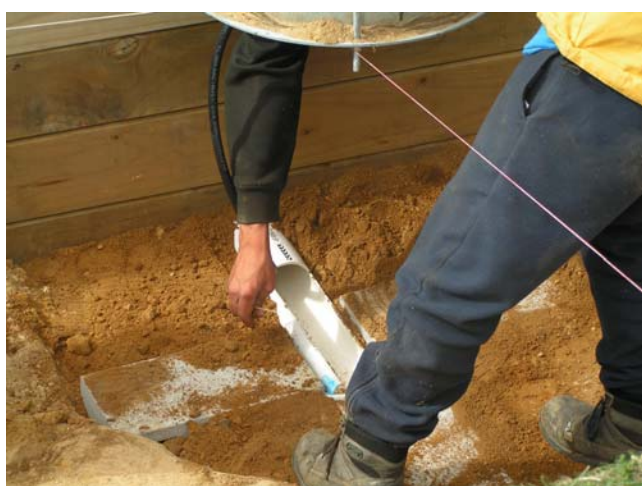
**Figure 6.14** Lysimeter outlet.

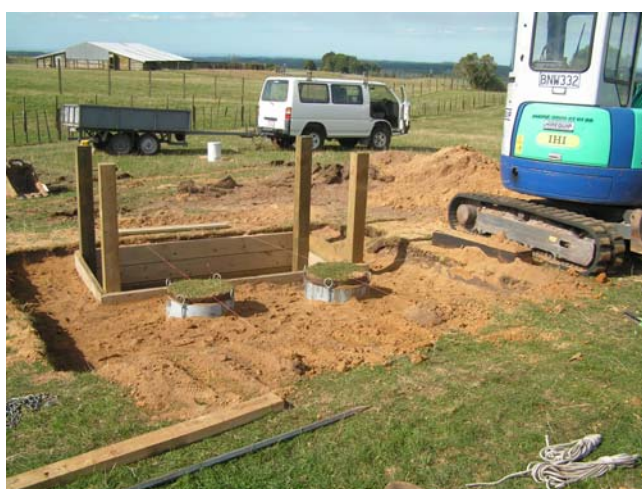
**Figure 6.15** Backfilling the pit.

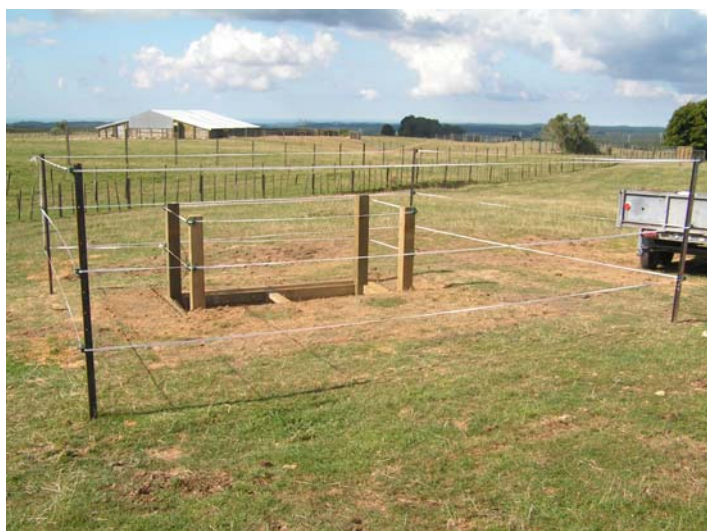
**Figure 6.16** Completed lysimeter installation.

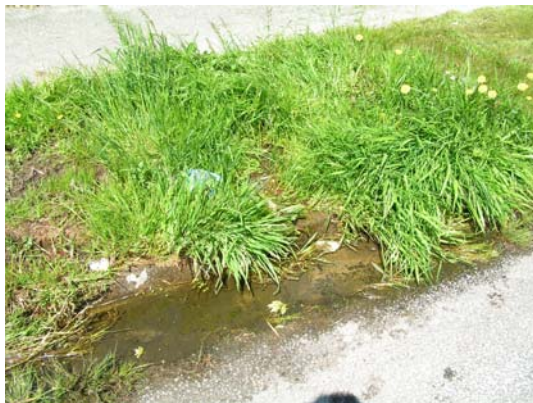
This seep is situated at the side of the road in front of 60 Pohutukawa Drive, on the south-eastern side of Lake Rotorua. The location of this site is 2799702, 6336862, using Garmin GPS, with an error of +/- 20m. The flow emerges from the grass by the footpath, and runs west for approximately 40 metres along the gutter to the drain. The driveway is also wet. The flow rate can possibly be measured in the trickle of water by the grass. Observed by Sally Grant, from Wairakei Geological and Nuclear Sciences, on 22 November 2004.

Figure 1.1. Seep in gutter outside 60 Pohutukawa Drive, Rotorua.

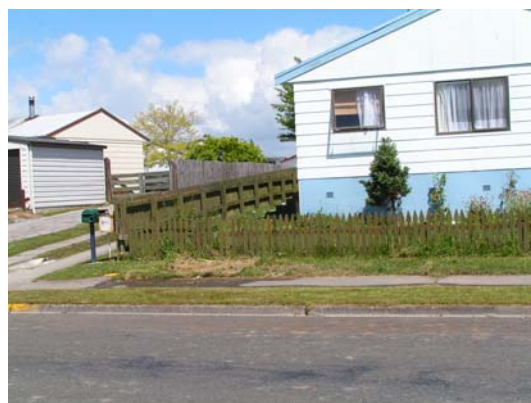
Seeps situated next to the footpath outside 54A Pohutukawa Drive, on the south-eastern side of Lake Rotorua. The location of this site is 2799733, 6336781, using the handheld Garmin GPS, with an error of +/- 20 m. This property is opposite the Pohutukawa Drive reserve, and the seep is approximately 2 m west of the letterbox. It covers an area of 2 m x 2 m, and wets the gutter on the side of the road towards the west. Flow rate is unlikely to be measurable due to the small amount of flow, and abundance of mud. Observed by Sally Grant, from Wairakei Geological and Nuclear Sciences, on 22 November 2004.

Figure 2.1. Seep outside 54A Pohutukawa Drive, Rotorua.

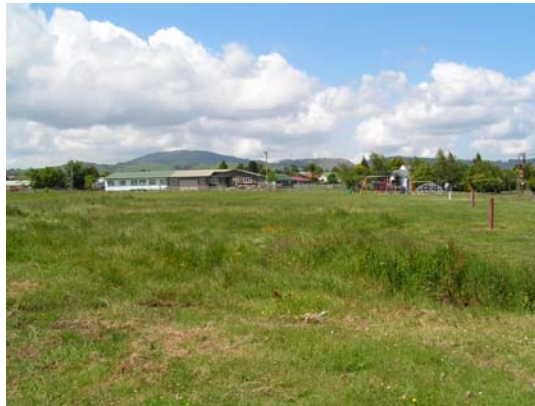
The wetland is located at south side of Pohutukawa Drive Reserve, approximately 15 m from the road, at the south-eastern side of Lake Rotorua. One point on the area's western edge is 2799773, 6336819, using the handheld Garmin GPS, with an error of +/- 20 m. The wetland covers an area of approximately 40m x 20m and can be seen as a patch of long grass. It is a boggy area, so it is unlikely that surface water flow rate could be easily measured. Observed by Sally Grant, from Wairakei Geological and Nuclear Sciences, on 22 November 2004.

Figure 3.1. Wetland area at south end of Pohutukawa Drive reserve.

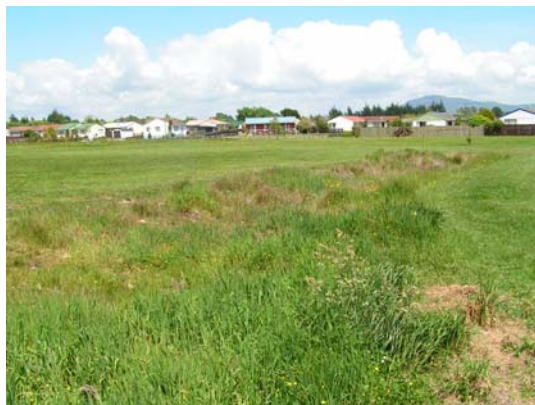
This wetland area is located at the north-eastern side of Pohutukawa Drive reserve, approximately 15 metres south of the stream, at the south-eastern part of Lake Rotorua. It is situated at 2799840, 6336842, using Garmin GPS, with an error of +/- 20 m. The area of wetland is roughly 30 m x 2 m, runs east, and is at right angles to another small boggy region or ditch. Due to the lack of flow and amount of mud, a surface water flow rate is unlikely to be able to be measured. Observed by Sally Grant, from Wairakei Geological and Nuclear Sciences, on 22 November 2004.

Figure 4.1. Wetland area at north-eastern end of Pohutukawa Drive reserve.

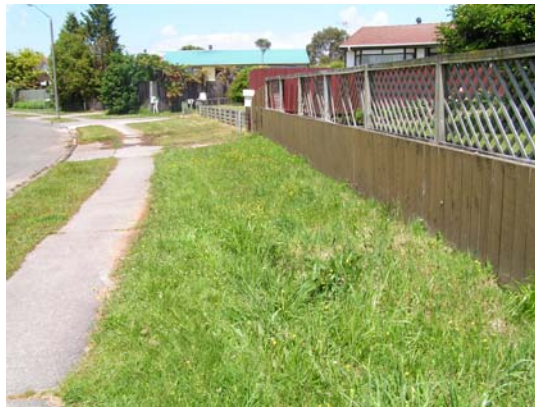
This seep is situated on and around the property of 48 Pohutukawa Drive, at the south-eastern part of Lake Rotorua. The location of this site is 2799711, 6336746, using the handheld Garmin GPS, with an error of +/- 20 m. The water has formed a muddy hole in the grass outside the house, and also boggy areas in front of the house next door (46 Pohutukawa Dr.), and house behind. The wet area covers approximately 30 m x 4 m on the front yard and road side of fence. The property owner stated that both the front yard and the back yard often flood, and the water is only about 5 cm below the ground surface. The front lawn drains into the road-side gutter, and the back lawn drains into the property behind. It would be difficult to obtain a surface flow measurement. Observed by Sally Grant, from Wairakei Geological and Nuclear Sciences, on 22 November 2004.

Figure 5.1. Seep in front of 48 Pohutukawa Drive, Rotorua.

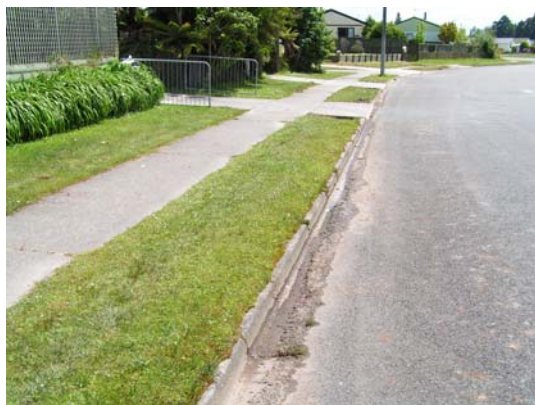
This seep is beside the footpath outside 38 Pohutukawa Drive, at the south-eastern side of Lake Rotorua. The location is 2799686, 6336687, using the handheld Garmin GPS, with an error of +/- 20 m. Both sides of the footpath are wet, and the water drains down the gutter for about 15 m. It is only a very small amount of water, so it is unlikely a flow rate would be able to be measured. Observed by Sally Grant, from Wairakei Geological and Nuclear Sciences, on 22 November 2004.

Figure 6.1. Seep outside 38 Pohutukawa Drive, Rotorua.

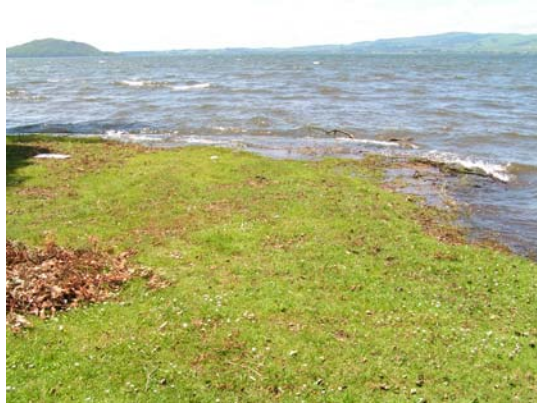
This area of seepage is at the south-east side of the Karenga Street Reserve, at the south-western side of Lake Rotorua. It has a location of 2794284, 6337242, using the Garmin GPS, with an error of +/- 20 m. The area is roughly 10m x 10m, and is wet, spongy grass to the lake edge. Water can be seen when the grass is pressed. The flow rate is unlikely to be able to be measured, as there is no obvious flow or outlet. Observed by Sally Grant, from Wairakei Geological and Nuclear Sciences, on 22 November 2004.

Figure 7.1. Area of seepage at South-east corner of Karenga Street Reserve.

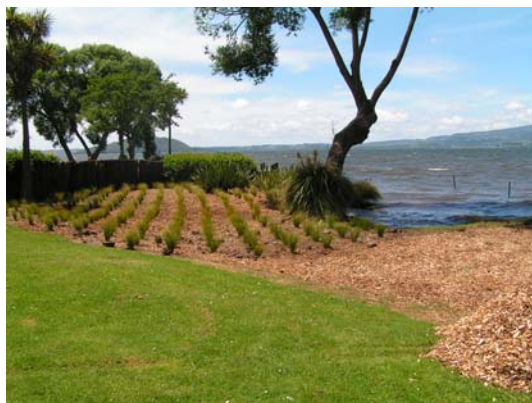
The area of seepage at site eight is located at the northern end of the Karenga Street Reserve, at the south-western side of Lake Rotorua. It is situated at 2794248, 6337322, using the Garmin GPS, with an error of +/- 20 m. This site is approximately 80 metres north of site seven, and has an area of 20 m x 15 m, and extends for another 20 metres along the lake edge to the south. It is wet, and nearby residents said the area used to be muddy, but has now been planted to stabilize the ground. Due to the lack of drainage channel, it is unlikely a flow rate could be measured. Observed by Sally Grant, from Wairakei Geological and Nuclear Sciences, on 22 November 2004.

Figure 8.1. Area of seepage at northern end of Karenga Street Reserve.

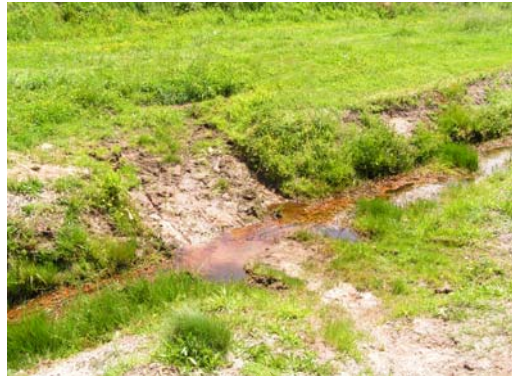
This small area of seepage is located approximately 30 metres north of 172 Parawai Rd, on the opposite side of the road to a wetland area, near Ngongotaha at the western side of Lake Rotorua. The location is 2792588, 6340520, using the Garmin GPS, with an error of +/- 20 m. The seep covers an area of 1 m x 1.5 m and drains into the ditch at the side of the road. As the small amount of water can be seen running into the drain, it may be possible to measure the flow rate. The stream in the ditch is not very close to the lake edge. Observed by Sally Grant, from Wairakei Geological and Nuclear Sciences, on 22 November 2004.

Figure 9.1. Seep draining into ditch on Parawai Road, Rotorua

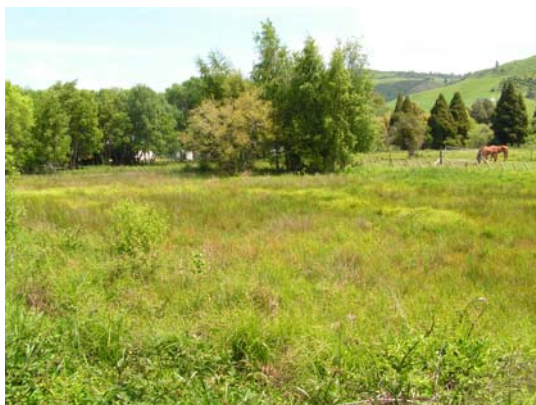
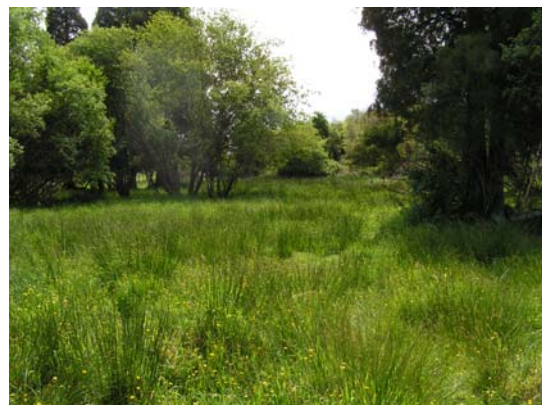
This wetland is situated next door to 172 Parawai Road in a north direction, at the western side of Lake Rotorua. The location of the wetland extends from 10m south of 2792770, 6340646 at its northern extremity, to a few metres northwest of 2792665, 6340522 at its western end, measured using Garmin GPS, which has an error of +/- 20 m. It is an 'L' shape, approximately 170 m x 120 m. A brown stream runs parallel with one arm, but no other drainage channel was observed, particularly due to the blackberry bushes which barred lake access. Therefore, flow rate measurements would be difficult, unless the brown stream was measured, but its source is unknown. Observed by Sally Grant, from Wairakei Geological and Nuclear Sciences, on 22 November 2004.

Figure 10.1. North end of wetland on Parawai Road, Rotorua, looking southwest.

Figure 10.2. Southwest end of wetland on Parawai Road, Rotorua, looking north.

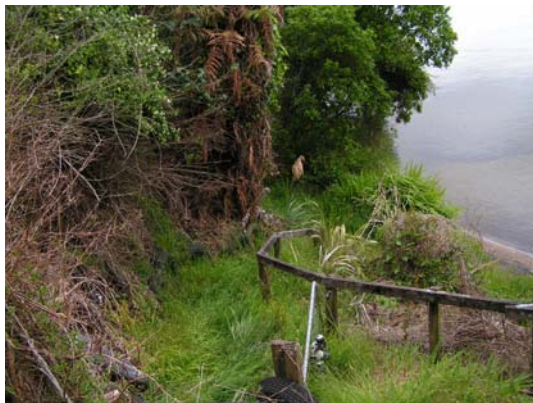
Access to the spring at site twelve is through the property at 89 Mokoia Road (RD2), owned by Douglas Black. The location is 2793032, 6340155 measured using Garmin GPS, which has an error of +/- 20 m. The spring can be seen on the bank by the path around the pongas. Water is piped down the hill and drains onto the grass at the base, where it is boggy. The spring is approximately 3 m west horizontally from the lake edge, and 10 m higher than lake level. Douglas Black reported that flow rate dramatically decreases during dry conditions, and increases during wet conditions. A flow rate measurement can be taken in the pipe to the left of the path when descending. Observed by Sally Grant and Rob Reeves from Wairakei Geological and Nuclear Sciences, on 29 November 2004.

Figure 12.1. Spring emerges at bank on the left, at 89 Mokoia Road, Rotorua.

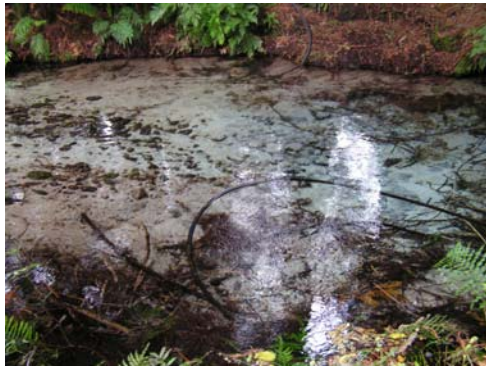
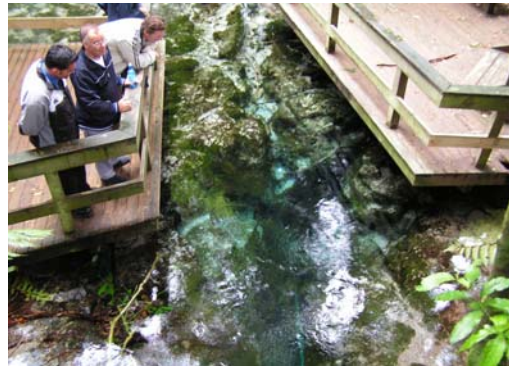
Hamurana Springs, just north of Hamurana Road at the northern end of Lake Rotorua, drains into Lake Rotorua as Hamurana Stream. There are several sources which form the springs, a couple of which are shown in the photographs. The springs are located at 2795789, 6347331 using Garmin GPS, which has an error of +/- 20 m. The spring to the east has a sign stating a flow rate of 4,500,000 litres per hour, a depth of 15 metres, and an elevation of 280 m above sea level. A flow rate can be obtained from the stream draining into the lake. Observed by Sally Grant, from Wairakei Geological and Nuclear Sciences, on 1 December 2004.

Figure 13.1. North-western spring at Hamurana Springs.

Figure 13.2. Large eastern spring at Hamurana Springs.

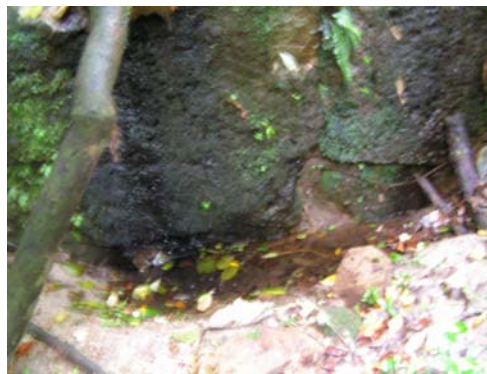
A possible seep exists approximately 70 metres west along a walking track from a small reserve at Mission Bay, at the north-eastern end of Lake Rotorua. The bank is 2 m north of the track, and was dripping into a small pool at its base. No drainage channel was observed, and the seep may be runoff from rainfall. Flow rate measurements may be difficult here. Observed by Sally Grant, from Wairakei Geological and Nuclear Sciences, on 1 December 2004.

Figure 14.1. Seep emerging from bank, Mission Bay, Rotorua.

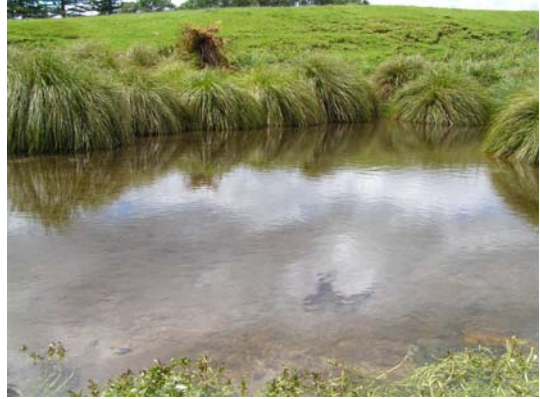
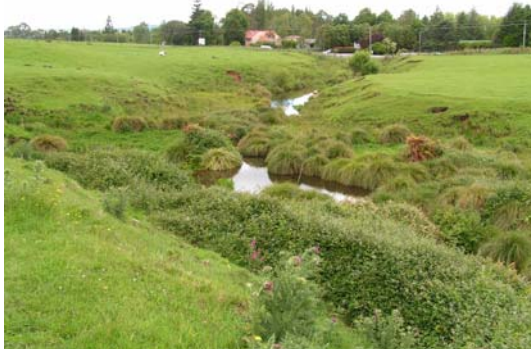
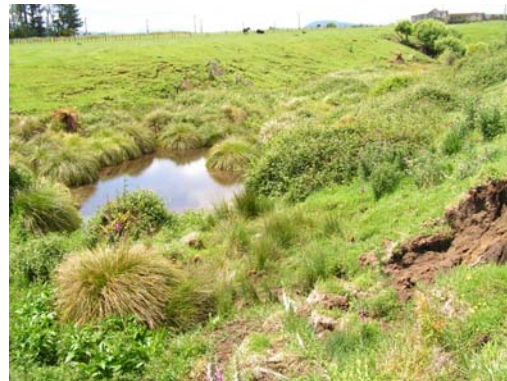
A spring emerges at a farm called the S6 block, on Ngongotaha Rd, on the western side of Lake Rotorua. The owners name is Alec Wilson, and he can be contacted on 027 4832974. All of the following GPS recordings used the handheld Garmin GPS which has an error of +/- 20 m. There are four springs that join to form Waikuta Stream, which crosses under Ngongotaha Road at 2792387, 6340111. This is the easiest place to measure the combined flow of the springs, at the western side of the road. The first spring is the main spring welling up in a pond at 2792324, 6340000, with an elevation of 283 m. The two banks to the west have a spring each, the southern most bank is at 2792308, 6340009, with the spring at the base of the bank, two metres below. The northern bank is 10 metres to the north, and has a larger flow. The older spring is 100 m south of the main pond, and used to be the main spring until an earthquake slowed flow (Wilson pers. comm.). The source was not observed due to vegetation. Observed by Sally Grant, from Wairakei Geological and Nuclear Sciences, on 6 December 2004.

Figure 15.1. Main spring at S6 Ngongotaha Rd, Rotorua.

Figure 15.2. Springs at S6 Ngongotaha Rd, Rotorua, looking north.

Figure 15.3. Springs at S6 Ngongotaha Rd, Rotorua, looking south. The south-western bank is on the right of the photo, and the main spring in the centre. The older spring is in the direction of the top right of the photo.

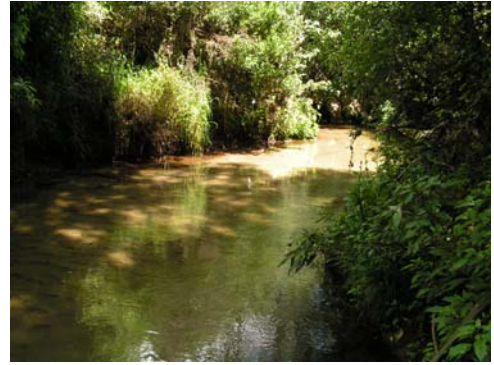
Taniwha Springs, north-western side of Lake Rotorua, off Hamurana Road, Awahau. The source of these large springs was not observed due to vegetation. A flow rate could be measured near the bridge. Observed by Sally Grant, from Wairakei Geological and Nuclear Sciences, on 6 December 2004.

Figure 16.1. Taniwha Springs stream, Awahau, Rotorua,

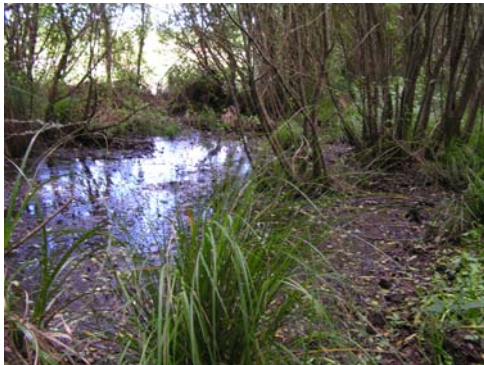
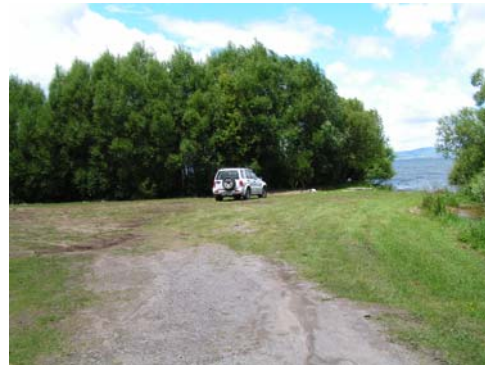
A small wetland area occurs at northern end of lake, west of Hamurana Springs. It runs approximately 100 m perpendicular to the lake edge, at 2793908, 6346435, at lake level elevation of 292 m. The only apparent drainage is two small streams at its eastern edge, and the flow rate could be measured from these, but the rest of the area is muddy and not flowing. Observed by Sally Grant, from Wairakei Geological and Nuclear Sciences, on 6 December 2004.

Figure 17.1. Wetland area at northern edge of lake, west of Hamurana.

Figure 17.2. Wetland area at northern edge of lake, west of Hamurana, wide view.

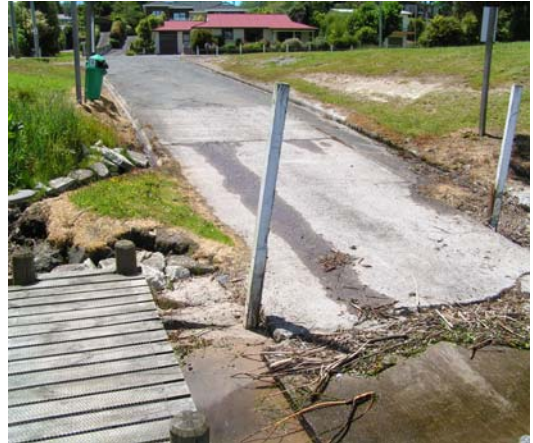
This seep emerges at a boat ramp, west of Hamurana, on the northern side of Lake Rotorua. It is located at 2794554, 6346665, at a 278 m elevation. Water is seeping out of the cracks of the boat ramp, and on both sides on the banks. Also, a concrete trough has flowing water from no apparent source, 5 m to the east of the ramp. The flow rate of the water can be measured on both sides of the ramp. Observed by Sally Grant, from Wairakei Geological and Nuclear Sciences, on 6 December 2004.

Figure 18.1. Seep emerging from boat ramp just west of Hamurana. Water is seeping out of cracks (centre) and both sides of ramp. Trough is to the east of the ramp.

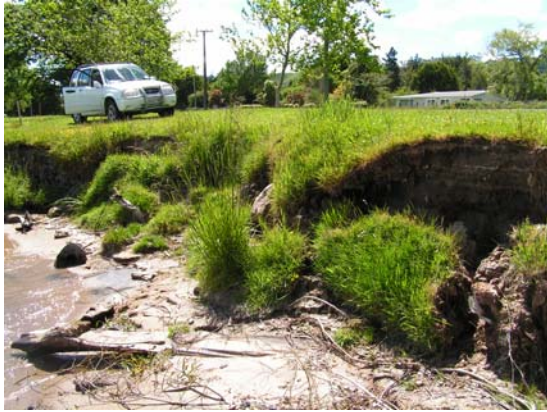
This seep is in a bank immediately west of the Hamurana reserve and occurs along 20 to 30 m of bank at 2795442, 6346823. Banks are directly above the edge of the lake, and are eroding. Some flow rates could be measured from the small flows at the base of the bank. Observed by Sally Grant, from Wairakei Geological and Nuclear Sciences, on 6 December 2004.

Figure 20.1. Wide view of seeping bank immediately west of Hamurana reserve.

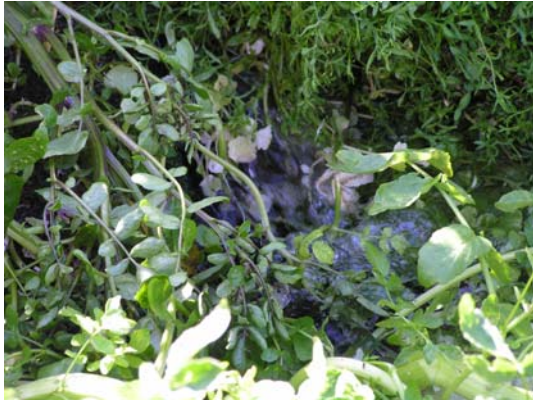
A spring on the eastern side of the lake, near the Rotorua airport, surfaces at 2801176, 6339385, at lake level. The spring flows into a pool 2 m x 1 m, which drains into the lake where a flow rate can be measured. Observed by Sally Grant, from Wairakei Geological and Nuclear Sciences, on 7 December 2004. Access is by boat.

Figure 21.1. Spring emerges from vegetation close to the lake edge, eastern side of Lake Rotorua.

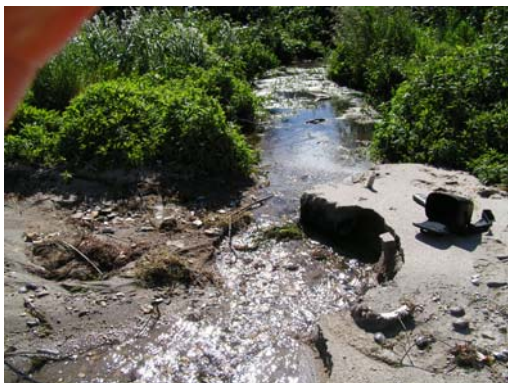
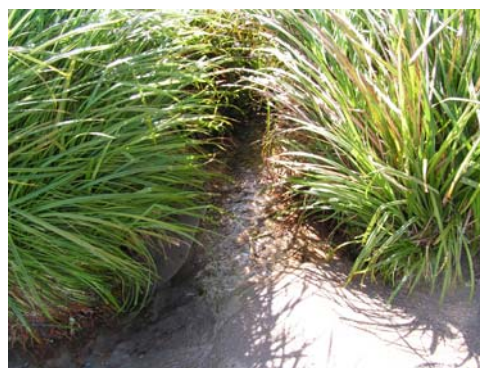
A stream drains from a wetland area, and flows into the lake at 2801556, 6340119, elevation 286 m. Flow rate could be measured from the stream. A second stream draining from the same wetland is 50 m north of this stream, and a third stream is 100 m north of this second stream. Further streams probably flow into the lake just south of these, but willow trees block visibility and access. Observed by Sally Grant, from Wairakei Geological and Nuclear Sciences, on 7 December 2004.

Figure 22.1. First drainage stream from wetland, eastern side of Lake Rotorua.

Figure 22.2. Second drainage stream from wetland, eastern side of Lake Rotorua.

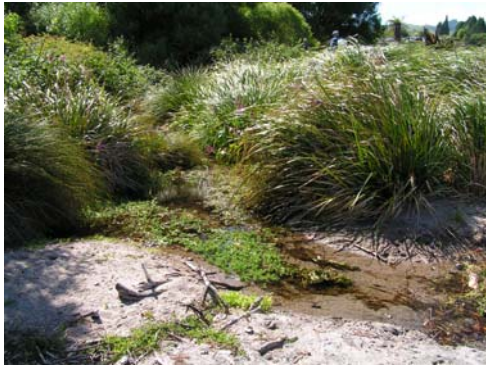
Figure 22.3. Third drainage channel from wetland, eastern side of Lake Rotorua.

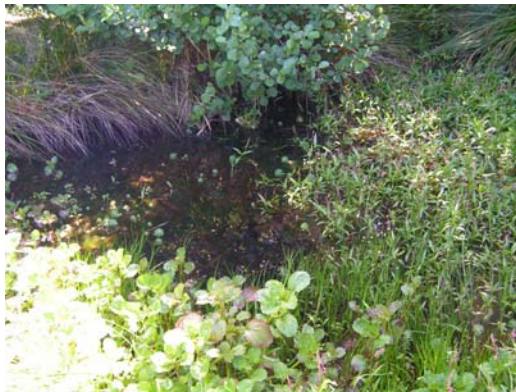
This channel is the outlet to swampy area at 2801666, 6340428, elevation 284 m. Another similar stream is 20 m north of this stream. Flow rates could be measured in the streams. Observed by Sally Grant, from Wairakei Geological and Nuclear Sciences, on 7 December 2004.

Figure 23.1. Swampy area, eastern side of Lake Rotorua.

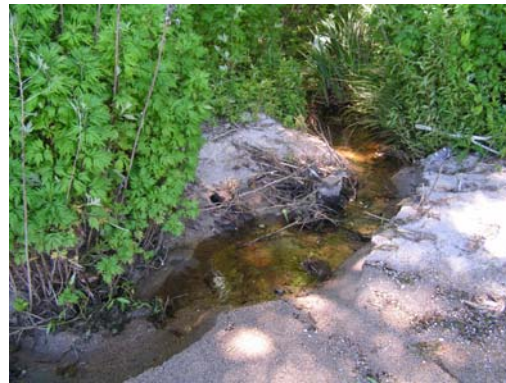
Figure 23.2. Outlet channel 20 m north of swampy area.

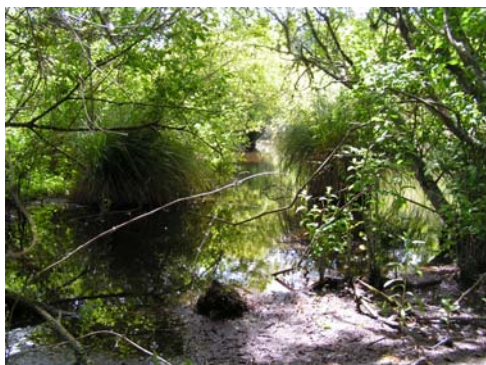
This wetland has a pond and a drainage outlet at 2801921, 6342478, at lake level elevation of 282 m. Flow rate could be measured from the outlet channel. Observed by Sally Grant, from Wairakei Geological and Nuclear Sciences, on 7 December 2004.

Figure 24.1. Wetlands pond, eastern side of Lake Rotorua.

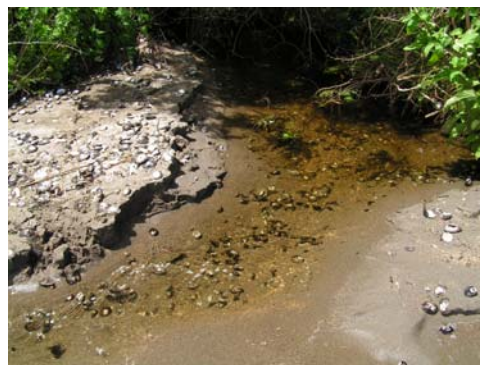
Figure 24.2. Drainage channel to wetlands area, eastern side of Lake Rotorua.

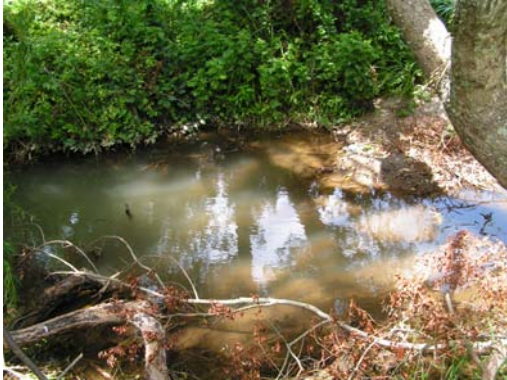
This feature appears to be road run-off to a pool that stops 3 m from the lake, and is not flowing. Is situated at 2801972, 6343040, 277 m elevation. Observed by Sally Grant, from Wairakei Geological and Nuclear Sciences, on 7 December 2004.

Figure 25.1. Pool of road run-off water, eastern side of Lake Rotorua.

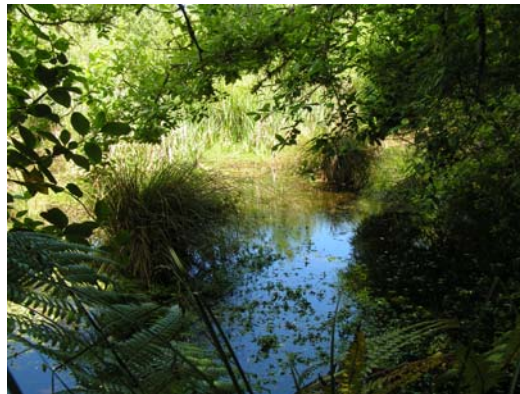
The wetland area is approximately 50 m x 10 m with no observed drainage channel at 2801840, 6344699, elevation 280 m. Water is not flowing. Observed by Sally Grant, from Wairakei Geological and Nuclear Sciences, on 7 December 2004.

Figure 26.1. Wetland area, eastern side of Lake Rotorua.

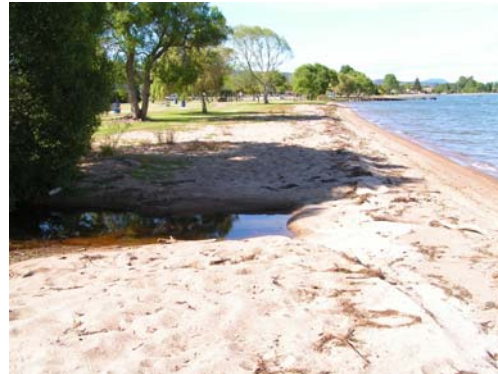
This wetland drainage channel stops 3m from lake edge and is not flowing. It is situated at 2800264, 6338133, by the Lee Rd boat ramp, eastern Lake Rotorua. Observed by Sally Grant, from Wairakei Geological and Nuclear Sciences, on 8 December 2004.

Figure 27.1. Wetland drainage pool, near Lee Road boat ramp, Rotorua.

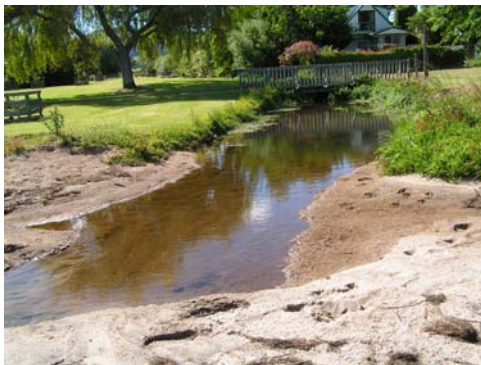
This stream flows into lake at 2800068, 6337836, elevation 261 m and is next to the playground by Lee Road, eastern Lake Rotorua. Flow rate could be measured in the stream. Observed by Sally Grant, from Wairakei Geological and Nuclear Sciences, on 8 December 2004.

Figure 28.1. Stream flows into lake near Lee Road playground.

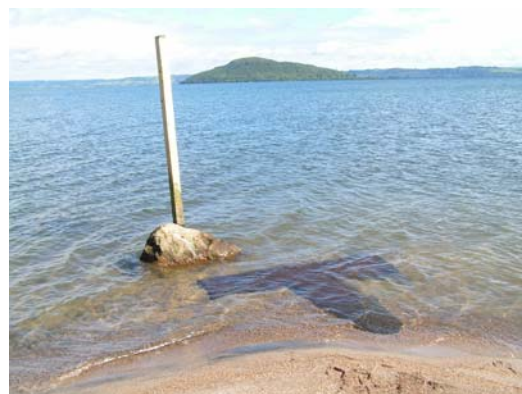
A concrete and steel drain has water flowing into the lake from the sides of the road at the Holden Bay reserve, eastern Lake Rotorua. The pipes end one metre offshore, at 2799917, 6337716, just below lake level. Flow rate could be measured in the holes in the pipe on the beach. Observed by Sally Grant, from Wairakei Geological and Nuclear Sciences, on 8 December 2004.

Figure 29.1. Steel pipes emerge offshore from Holdens Bay reserve.
