**Lake Rotorua groundwater study: results of the  
2004-2005 field programme**

**Confidential  
Client Report  
2005/66**

**July  
2005**

**ENVIRONMENT BAY OF PLENTY**

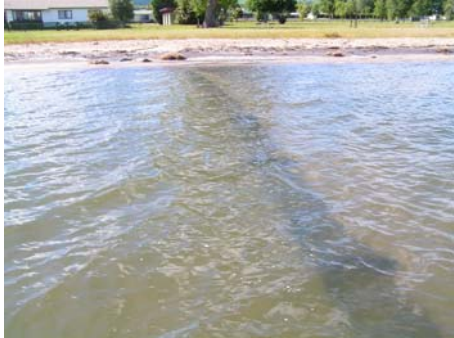
This drain runs along lake bed for 10m offshore at 2799778, 6337633, approximately one metre below lake level. Measuring the flow rate in this drain would probably be difficult. Observed by Sally Grant, from Wairakei Geological and Nuclear Sciences, on 8 December 2004.

Figure 30.1. Drain runs along lake bed for 10m offshore, eastern Lake Rotorua.

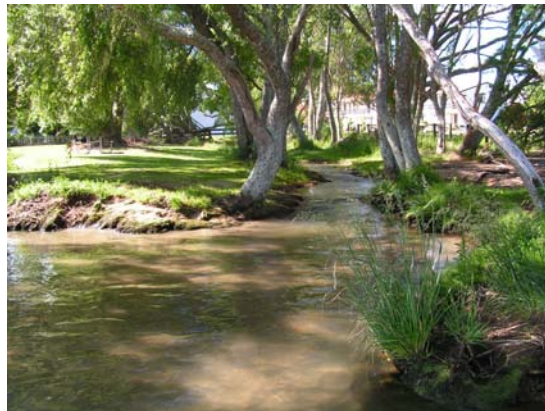
This stream flows into the lake under willow trees at 2799575, 6337528, elevation 284 m. Flow rate could be measured in stream. Observed by Sally Grant, from Wairakei Geological and Nuclear Sciences, on 8 December 2004.

Figure 31.1. Stream flows into lake under willow trees, eastern Lake Rotorua.

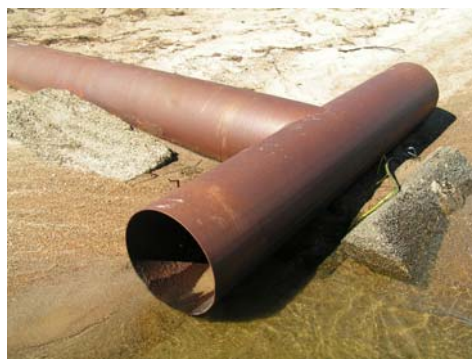
A small flow of water comes out of steel pipes at 2799368, 6337393, elevation 281 m. Flow rate could be measured at the end of the pipe. Observed by Sally Grant, from Wairakei Geological and Nuclear Sciences, on 8 December 2004.

Figure 32.1. Steel pipes emit flowing water, eastern side of Lake Rotorua.

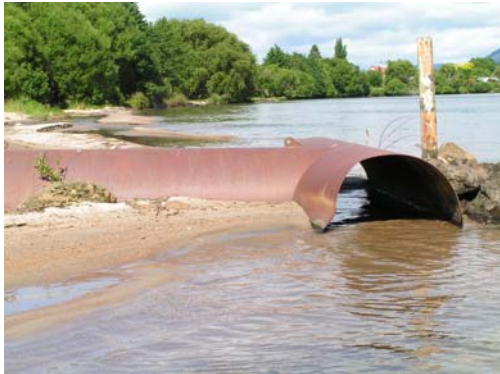
Flow from this steel pipe emerges at 2799251, 6337344, at lake level. Flow rate could be measured at the end of the pipe. Observed by Sally Grant, from Wairakei Geological and Nuclear Sciences, on 8 December 2004.

Figure 33.1. Large steel pipes have flowing water, eastern side of Lake Rotorua.

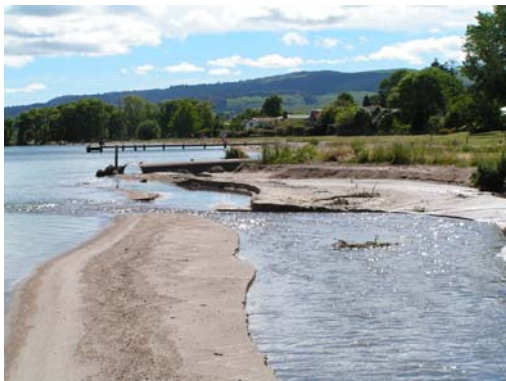
The Robinson Ave Floodway flows into the lake at 2799197, 6337322, elevation is lake level. The floodway is wide and the flow rate could be measured as it flows into the lake. Observed by Sally Grant, from Wairakei Geological and Nuclear Sciences, on 8 December 2004.

Figure 34.1. Outlet channel of Robinson Ave floodway, eastern Lake Rotorua.

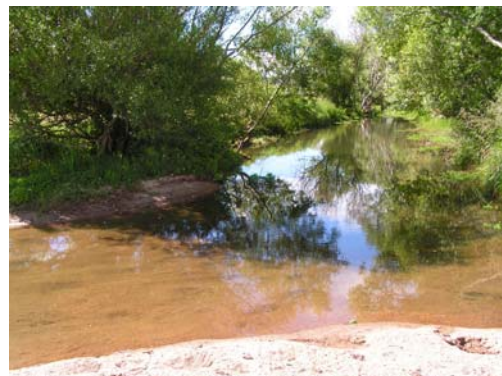
Figure 34.2. Robinson Ave floodway, eastern side of Lake Rotorua.

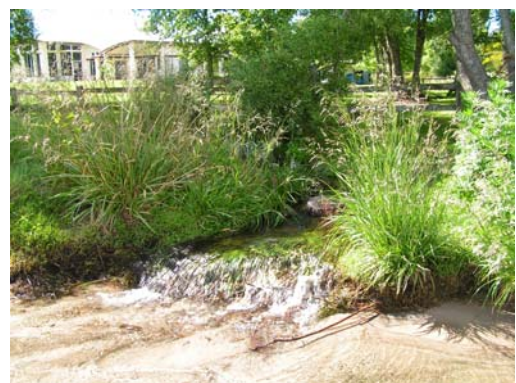
This stream reaches the eastern side of Lake Rotorua at 2799080, 6337297, just above lake level. It flows between houses, and the flow rate could be measured as it reaches the lake. Observed by Sally Grant, from Wairakei Geological and Nuclear Sciences, on 8 December 2004.

Figure 35.1. Stream flowing into Lake Rotorua.

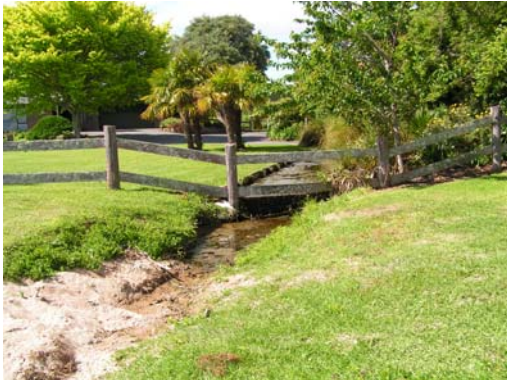
This drain stops 3 m from lake edge, and has no flow. Is situated at 2799023, 6337294, at 279 m elevation. Observed by Sally Grant, from Wairakei Geological and Nuclear Sciences, on 8 December 2004.

Figure 36.1. Drain with no water flowing, eastern Lake Rotorua.

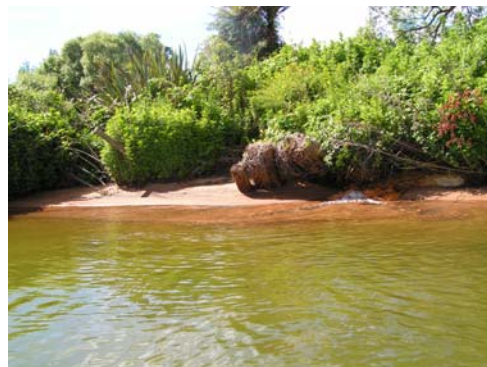
Figure 37.1. Wide view of first and northern most spring, eastern side of Lake Rotorua.

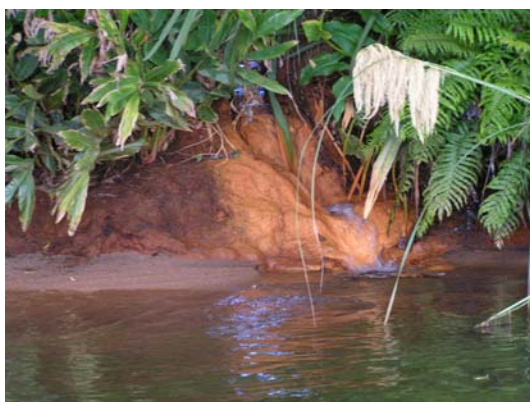
The second spring is approximately 0.8 m above lake level, and is at 2798852, 6337323.

Figure 37.2. The second geothermal spring, eastern side of Lake Rotorua.

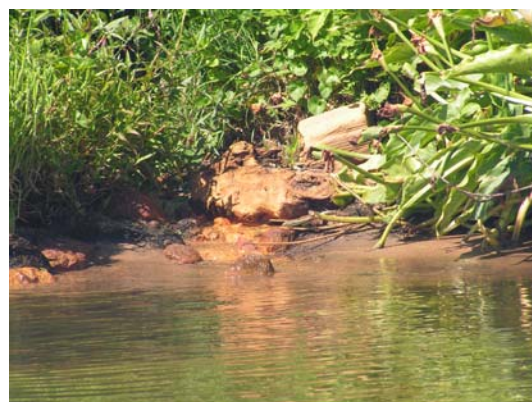
The third spring is 30 m south of the previous spring, under flax, and the fourth spring is 20 m south of the third spring. All flow rates could be measured.

Figure 37.3. The fourth and most southern geothermal spring, eastern Lake Rotorua.

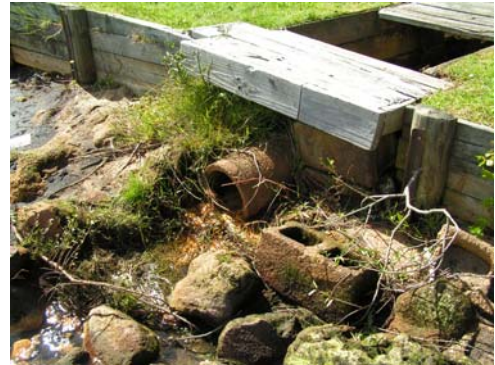
A drain flows into the lake, which has two sources, one behind the tree house, the other in the wooden drain. This drain possibly contains geothermal water (landowner pers. comm.). Located at 2798715, 6337353, 278 m elevation. Observed by Sally Grant, from Wairakei Geological and Nuclear Sciences, on 8 December 2004.

Figure 38.1. Drain flowing into lake, eastern Lake Rotorua.

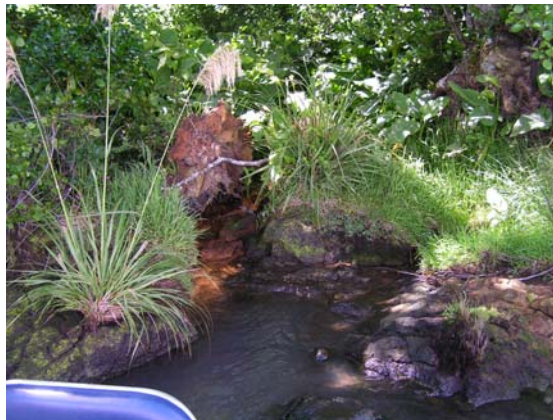
Flow reaches lake at 2798629, 6337291, running over an orange rock. Is possibly geothermal, and the flow rate can be measured. Observed by Sally Grant, from Wairakei Geological and Nuclear Sciences, on 8 December 2004.

Figure 39.1. Small flow runs into eastern side of Lake Rotorua.

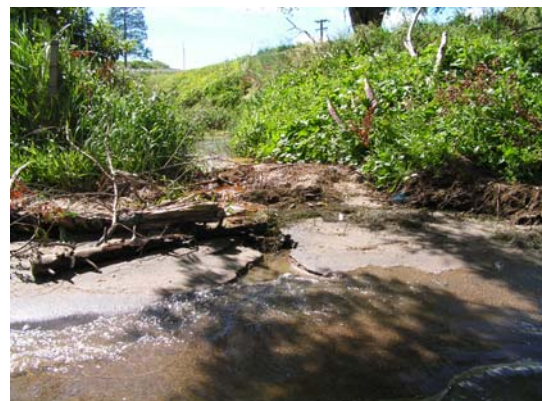
This drain possibly contains road run-off, at 2798484, 6337001, elevation 278 m. Flow rate could be measured. Observed by Sally Grant, from Wairakei Geological and Nuclear Sciences, on 8 December 2004.

Figure 40.1. Drain, eastern side of Lake Rotorua.

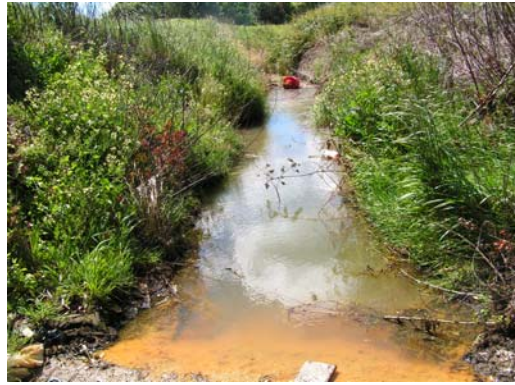
This drain has no apparent flow and stops 3 m from the lake edge. The drain is situated at 2798474, 6336961, 278 m elevation. Observed by Sally Grant, from Wairakei Geological and Nuclear Sciences, on 8 December 2004.

Figure 40.1. Drain with no flow, eastern side of Lake Rotorua.

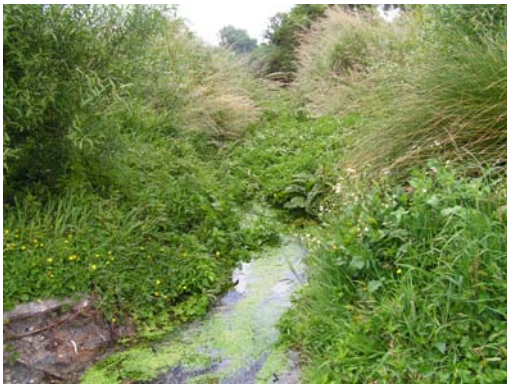
This stream flows into the lake at 2798321, 6336703 at lake level. No source was observed due to vegetation. Flow rate can be measured in stream. Observed by Sally Grant, from Wairakei Geological and Nuclear Sciences, on 8 December 2004.

Figure 42.1. Stream draining into lake from vegetation, eastern side of Lake Rotorua.

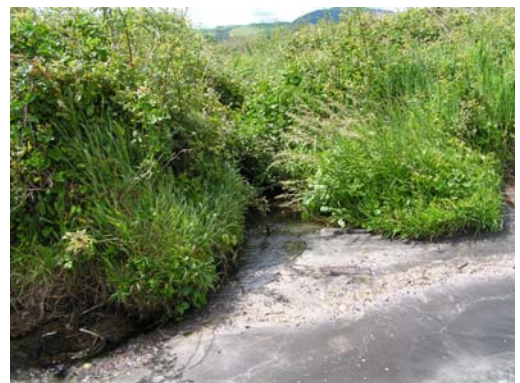
This stream flows through vegetation and joins the lake at 2798218, 6336620, at lake level. Flow rate can be measured in stream. Observed by Sally Grant, from Wairakei Geological and Nuclear Sciences, on 8 December 2004.

Figure 43.1. Stream emerges from vegetation, eastern Lake Rotorua.

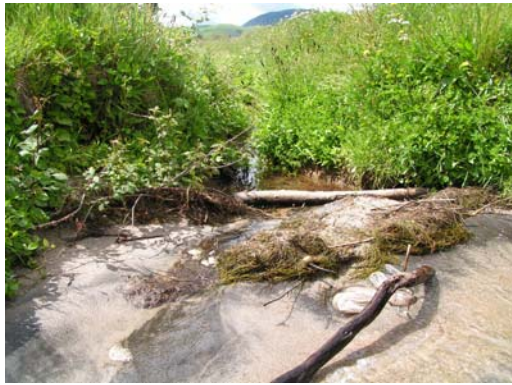
The stream drains through fields from unknown source and flows into lake at 2798129, 6336509, elevation 275 m. Flow rate could be measured in stream. Observed by Sally Grant, from Wairakei Geological and Nuclear Sciences, on 8 December 2004.

Figure 44.1. Stream drains through fields and flows into eastern Lake Rotorua.

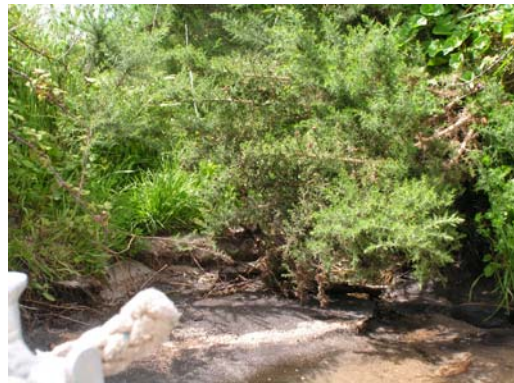
A small stream drains from fields and flows into Lake Rotorua at 2798102, 6336490, elevation 276 m. Flow rate could be measured from stream. Observed by Sally Grant, from Wairakei Geological and Nuclear Sciences, on 8 December 2004.

Figure 45.1. Stream drains through fields and flows into eastern Lake Rotorua.

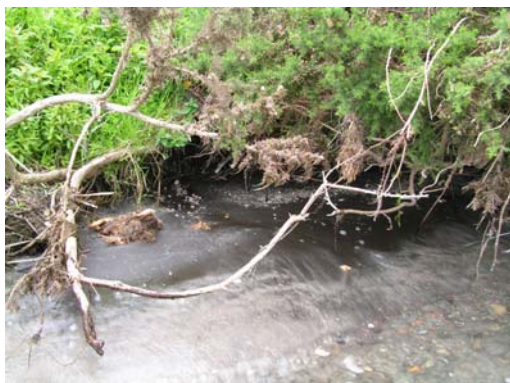
A small seepage from wetland emerges under gorse bush at 2797897, 6336310, 278 m elevation. The flow rate is quite low. Observed by Sally Grant, from Wairakei Geological and Nuclear Sciences, on 8 December 2004.

Figure 46.1. Wetland seepage emerges under gorse bush, eastern Lake Rotorua.

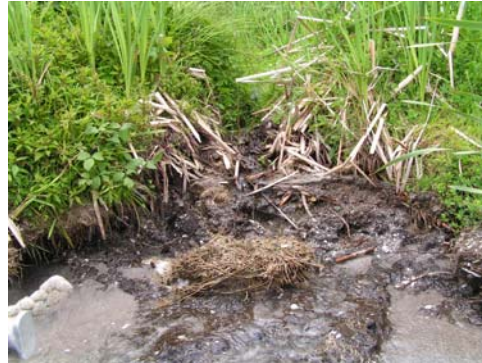
A small seepage issues from a wetland (site 46), located at 2797884, 6336291. The flow rate is quite low. Observed by Sally Grant, from Wairakei Geological and Nuclear Sciences, on 8 December 2004.

Figure 47.1. Wetland seep,  
eastern Lake Rotorua

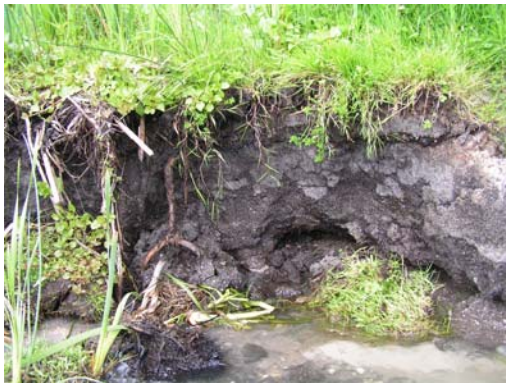
Seepage along a 0.5m high bank occurs from the same wetland as site 46. The flow rate is quite low. Located at 2797876, 6336291. Observed by Sally Grant, from Wairakei Geological and Nuclear Sciences, on 8 December 2004.

Figure 48.1. Seepage along bank  
from wetlands, eastern Lake  
Rotorua.

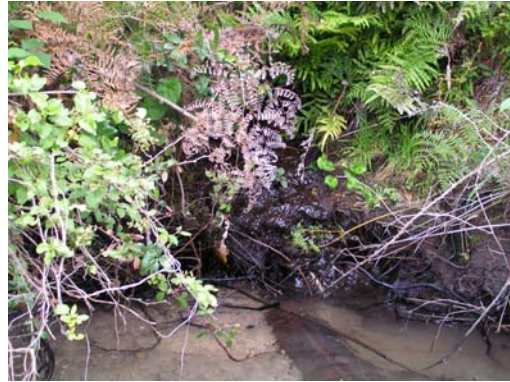
This seepage is from a wetland dripping off a small bank at 2797714, 6336171. The flow rate is low. Observed by Sally Grant, from Wairakei Geological and Nuclear Sciences, on 8 December 2004.

Figure 50.1. Wetland seepage dripping off bank, eastern Lake Rotorua.

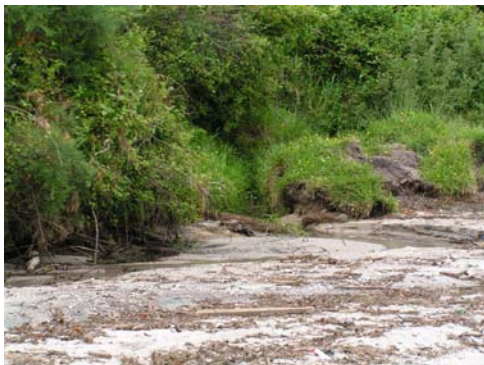
This stream is from wetland at 2797671, 6336111 and flows into lake. It can be measured for a flow rate. Observed by Sally Grant, from Wairakei Geological and Nuclear Sciences, on 8 December 2004.

Figure 51.1. Outlet stream from a wetland, eastern Lake Rotorua.

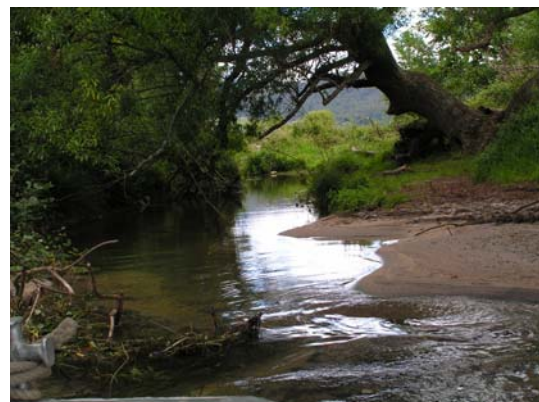
This wide stream flows into the lake at 2797476, 6335966. Flow rate could be measured. Observed by Sally Grant, from Wairakei Geological and Nuclear Sciences, on 8 December 2004.

Figure 52.1. Stream flowing into the eastern side of Lake Rotorua.

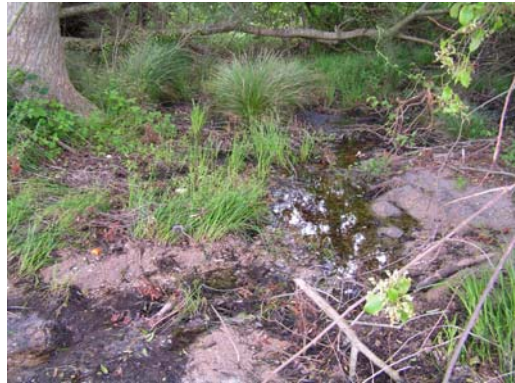
This seepage from a wetland is located at 2797166, 6335645, at lake level. There is no surface flow. Observed by Sally Grant, from Wairakei Geological and Nuclear Sciences, on 8 December 2004.

Figure 53.1. Wetland seepage with no flow, south-east side of Lake Rotorua.

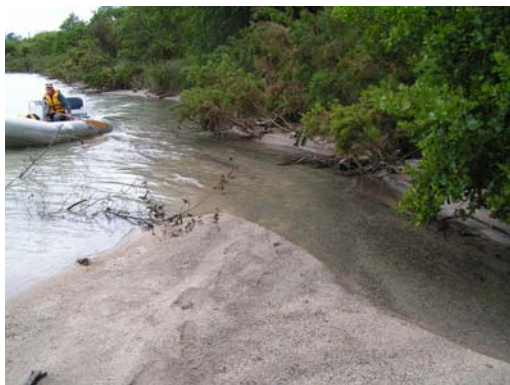
This stream flows into Lake Rotorua at 2796995, 6335256. Flow rate could be measured in the stream. Observed by Sally Grant, from Wairakei Geological and Nuclear Sciences, on 8 December 2004.

Figure 54.1. Outlet to stream, South-east Lake Rotorua.

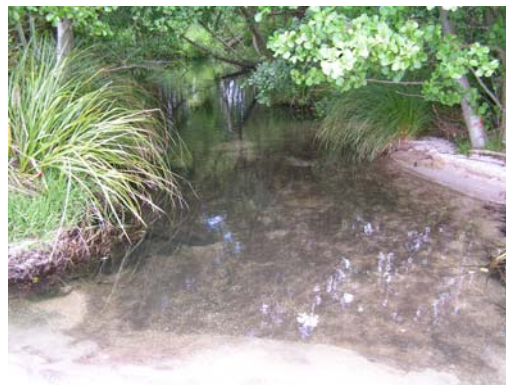
Figure 54.2. Stream, south-east Lake Rotorua.

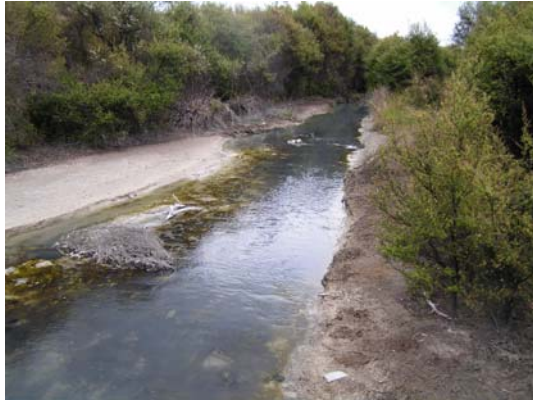
Swamp land (geothermal) southeast of Sulphur Point stops about 10m from lake edge, and has a stream which flows west, parallel to the lake. Flow rate could be measured in the stream. Observed by Sally Grant, from Wairakei Geological and Nuclear Sciences, on 8 December 2004.

Figure 55.1. Outlet stream to geothermal swamp, Southeast of Sulphur Point

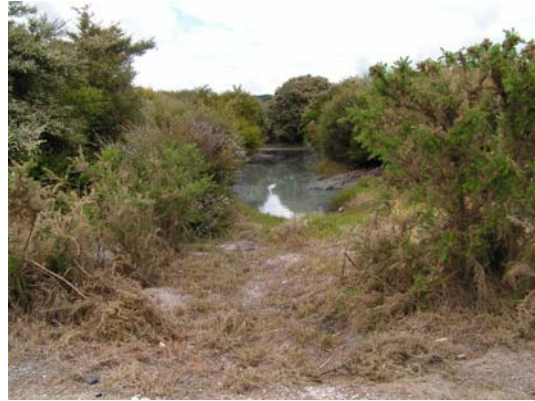
Figure 55.2. Geothermal swamp southeast of Sulphur Point.

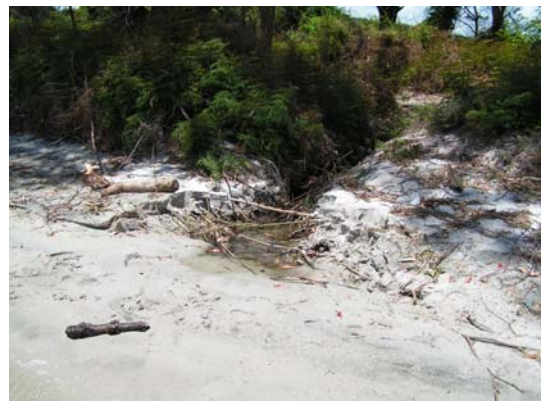
This drain stops one metre from the lake on Sulphur Point and is not flowing. The drain is located at 2795975, 6336112, at lake level. Observed by Sally Grant, from Wairakei Geological and Nuclear Sciences, on 8 December 2004.

Figure 56.1. Drain on Sulphur Point, not flowing.

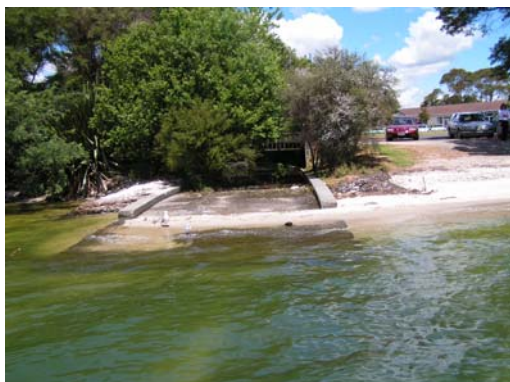
This is a manmade channel containing water; the water does not flow into the lake. Located at 2795694, 6336134. Observed by Sally Grant, from Wairakei Geological and Nuclear Sciences, on 8 December 2004.

Figure 57.1. Manmade channel on Sulphur Point, no water flowing.

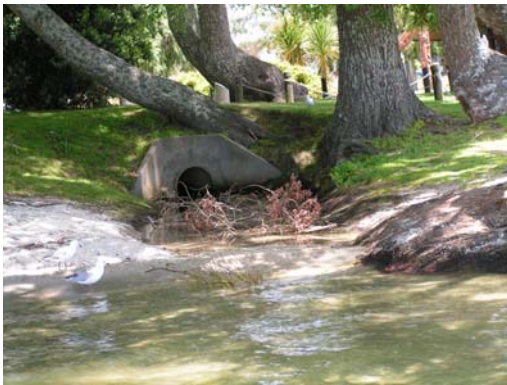
A stream occurs at 2795538, 6336166, near Rotorua's waterfront. The stream flows into sand. Observed by Sally Grant, from Wairakei Geological and Nuclear Sciences, on 8 December 2004.

Figure 59.1. Water does not reach lake edge due to sandbank, near Rotorua's waterfront.

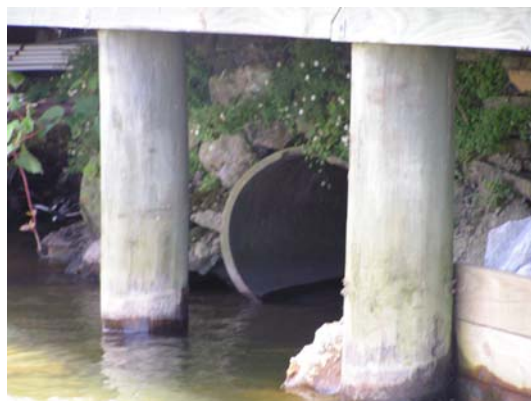
This large pipe is under a walkway by the cruise offices at Rotorua's waterfront, at 2795247, 6336318. Flow rate could be measured. Observed by Sally Grant, from Wairakei Geological and Nuclear Sciences, on 8 December 2004.

Figure 60.1. Large pipe at Rotorua's waterfront.

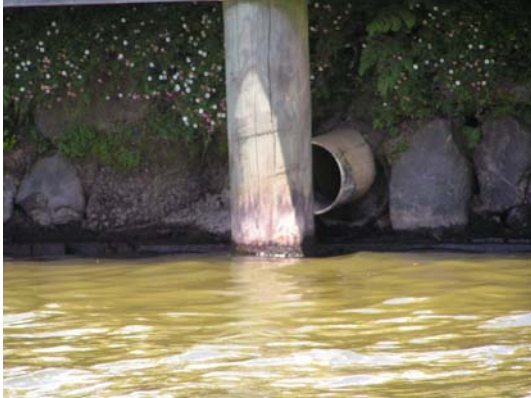
A pipe emerges under the walkway to Mokoia Island cruises on the lake front at 2795168, 6336355.

Figure 60.2. Drainage pipe at Rotorua Lakefront.

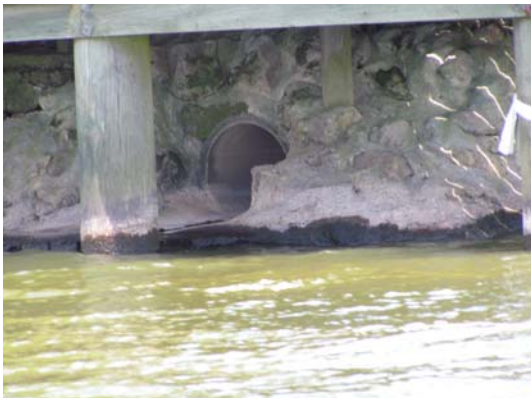
A drain is located 20 m west of Site 60B and there is a big pipe emerging at the lake front at 2795130, 6336385.

Figure 60.3. Big pipe at Rotorua Lakefront

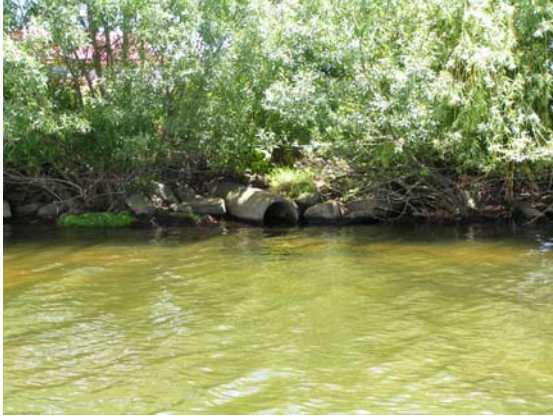
A concrete pipe is situated at 2795016, 6336511, at the south end of Lake Rotorua. Flow rate could be measured in the drain. Observed by Sally Grant, from Wairakei Geological and Nuclear Sciences, on 8 December 2004.

Figure 62.1. Drain at south end of Lake Rotorua.

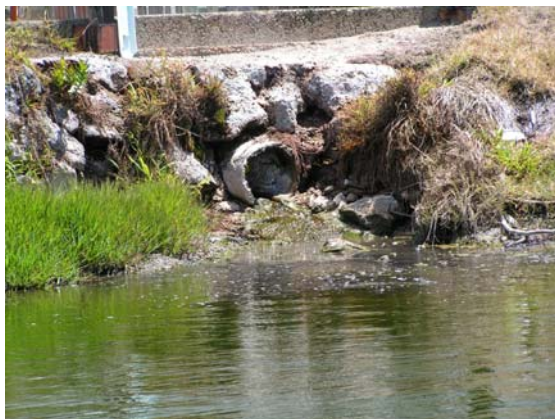
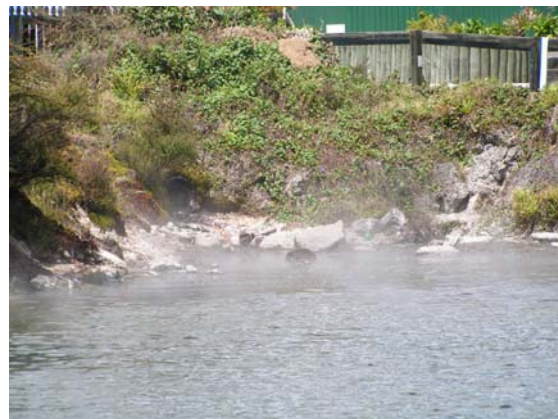
An inlet at the south of Lake Rotorua, at Ohinemutu, has four geothermal hot water drains flowing into it. The most western pipe is located at 2794792, 6336519. The second pipe is 20 m east of the previous pipe, and the third and fourth are at the eastern end of the inlet. Flow rate measurements should be possible. Observed by Sally Grant, from Wairakei Geological and Nuclear Sciences, on 8 December 2004.

Figure 63.1. Western hot water pipe at Ohinemutu inlet, Lake Rotorua.

Another small pipe is dripping hot water in from a marae at the side of the inlet, at 2794825, 6336575.

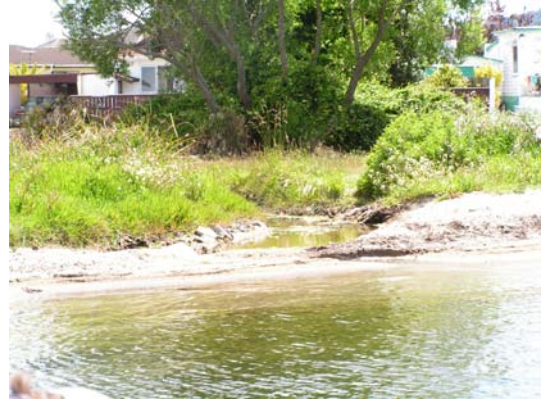
This drain (or stream) is located at 2794768, 6336649. Flow rate measurements could be made in the stream. Observed by Sally Grant, from Wairakei Geological and Nuclear Sciences, on 8 December 2004.

Figure 64.1. Drain (or stream) near Ohinemutu, Lake Rotorua.

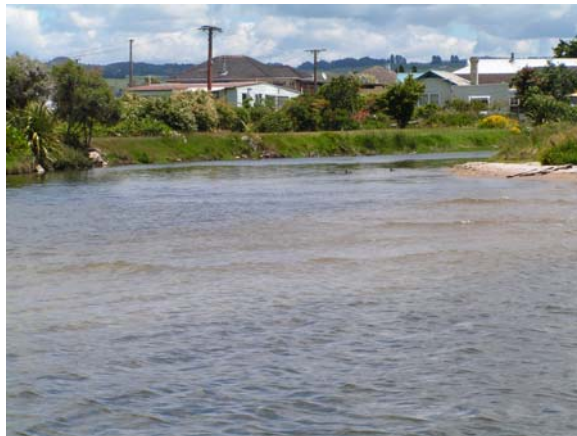
Utuhina Stream flows into the south end of Lake Rotorua at 2794783, 6336822. Flow rate could be measured in the stream. Observed by Sally Grant, from Wairakei Geological and Nuclear Sciences, on 8 December 2004.

Figure 65.1. Utuhina Stream flowing into the south end of Lake Rotorua

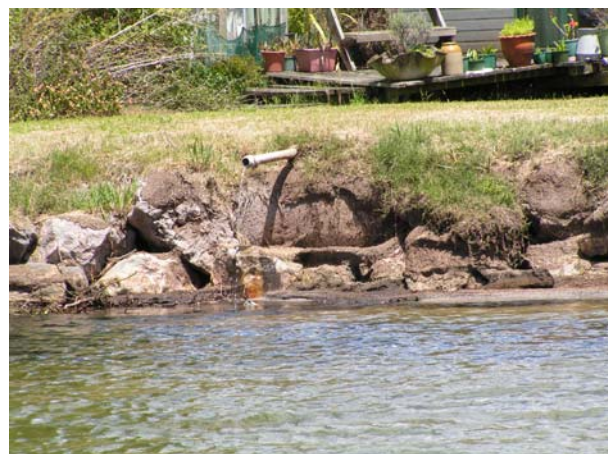
A small pipe one metre high has water flowing into the lake at 2794542, 6336918, and there is a similar pipe 50 m west of these coordinates. A flow rate measurement is possible. Observed by Sally Grant, from Wairakei Geological and Nuclear Sciences, on 8 December 2004.

Figure 66.1. Small pipe with water flowing into lake, south side of Lake Rotorua.

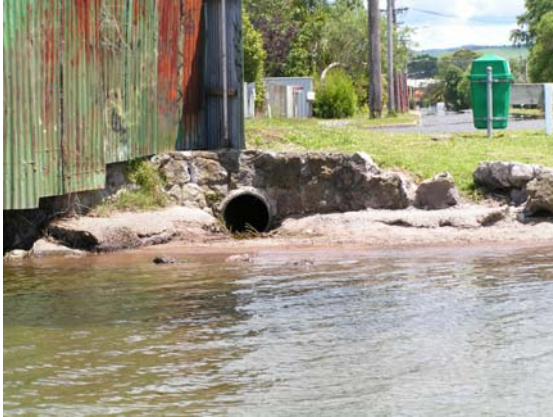
At the end of a road, two concrete pipes drain roadside water into the south end of Lake Rotorua. Flow rates could be measured from these pipes. Observed by Sally Grant, from Wairakei Geological and Nuclear Sciences, on 8 December 2004.

Figure 67.1. Roadside runoff drains through pipes into lake.

Houses 30 m west of this location have drains that discharge into the lake.

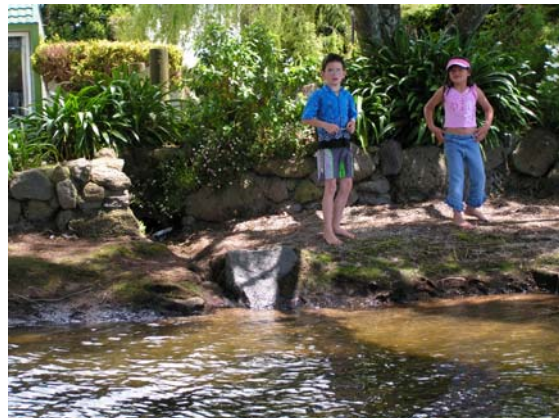
A drain in the camping ground carries flowing water into the south end of Lake Rotorua at 2794427, 6336998, at lake level, near the wharf. A flow rate measurement is possible. Observed by Sally Grant, from Wairakei Geological and Nuclear Sciences, on 8 December 2004.

Figure 68.1. Camping ground drain

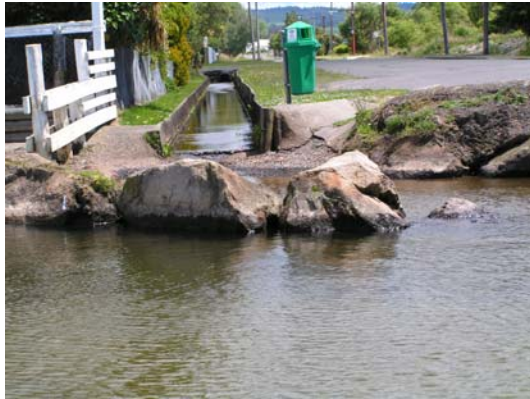
Road runoff drains into the lake from both sides of the road at 2794315, 6337115, at lake level. Flow rate measurements can be made in the drains. Observed by Sally Grant, from Wairakei Geological and Nuclear Sciences, on 8 December 2004.

Figure 69.1. Eastern side of the road, water drains into Lake Rotorua.

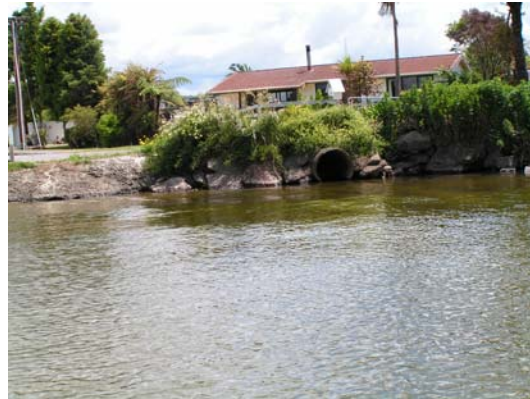
Figure 69.2. Western side of road, water drains into Lake Rotorua.

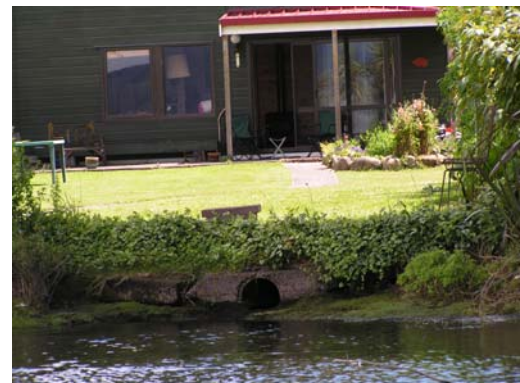
A drain occurs at 2794322, 6337171 and flow rates could be measured. Observed by Sally Grant, from Wairakei Geological and Nuclear Sciences, on 8 December 2004.

Figure 70.1. Drain by houses, southwest Lake Rotorua.

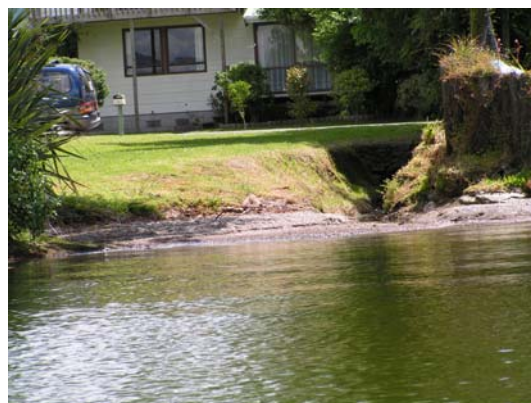
A road drain occurs beside a reserve at 2794213, 6337623, southwest Lake Rotorua. Flow rate could be measured in the pipe. Observed by Sally Grant, from Wairakei Geological and Nuclear Sciences, on 8 December 2004.

Figure 71.1. Drain by reserve, southwest Lake Rotorua.

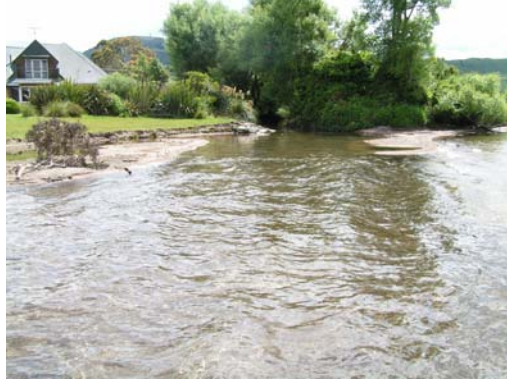
Waiowhiro stream at the end of Aquarius Drive, western Lake Rotorua, located at 2794211, 6339256. Flow rate can easily be measured in stream. Observed by Sally Grant, from Wairakei Geological and Nuclear Sciences, on 8 December 2004.

Figure 72.1. Waiowhiro Stream,  
western Lake Rotorua.
