Report on exotic forest debris management related to storm events in the Bay of Plenty

Bay of Plenty Regional Council
Operations Publication 2011/03

July 2011

Prepared by John Douglas, Simon Stokes, and Waiora
Soil Conservation Ltd.

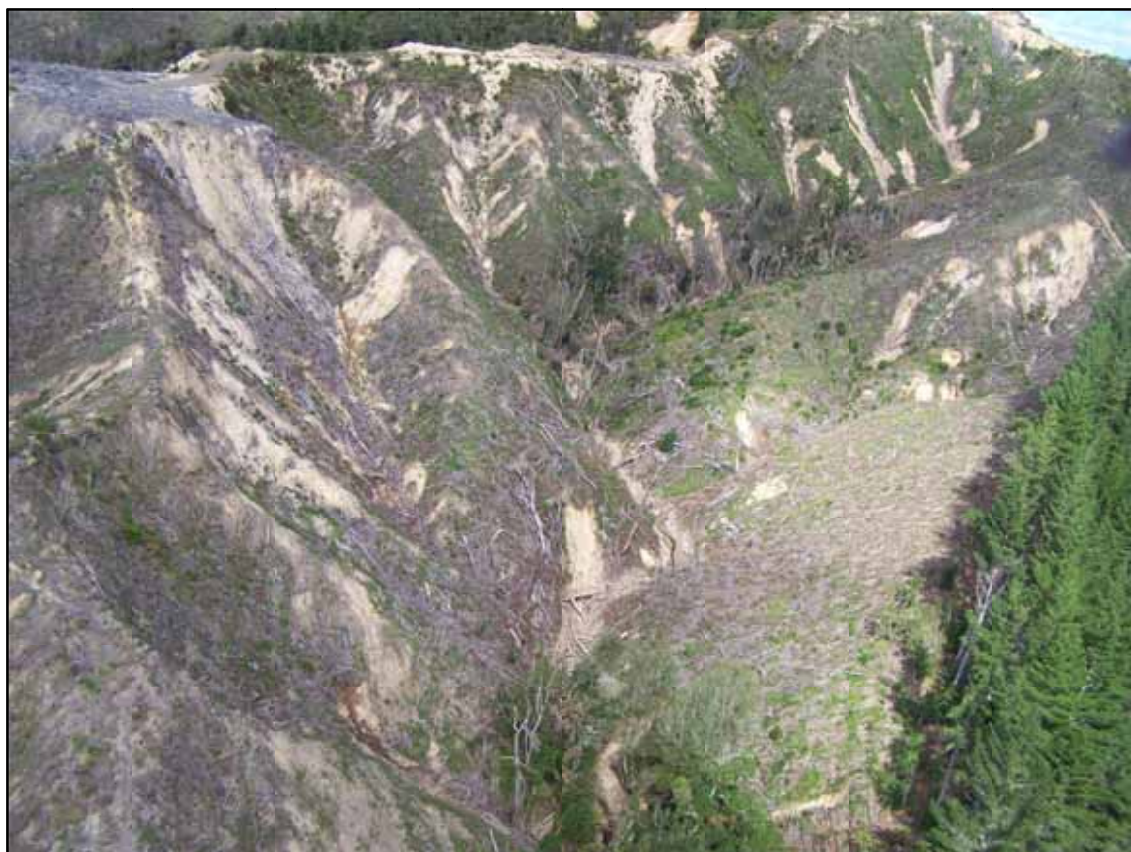
Photo 1: Typical mid slope failure in the lower Whakatane catchment which has light volcanic soils known as Kaharoa ash over lapilli.

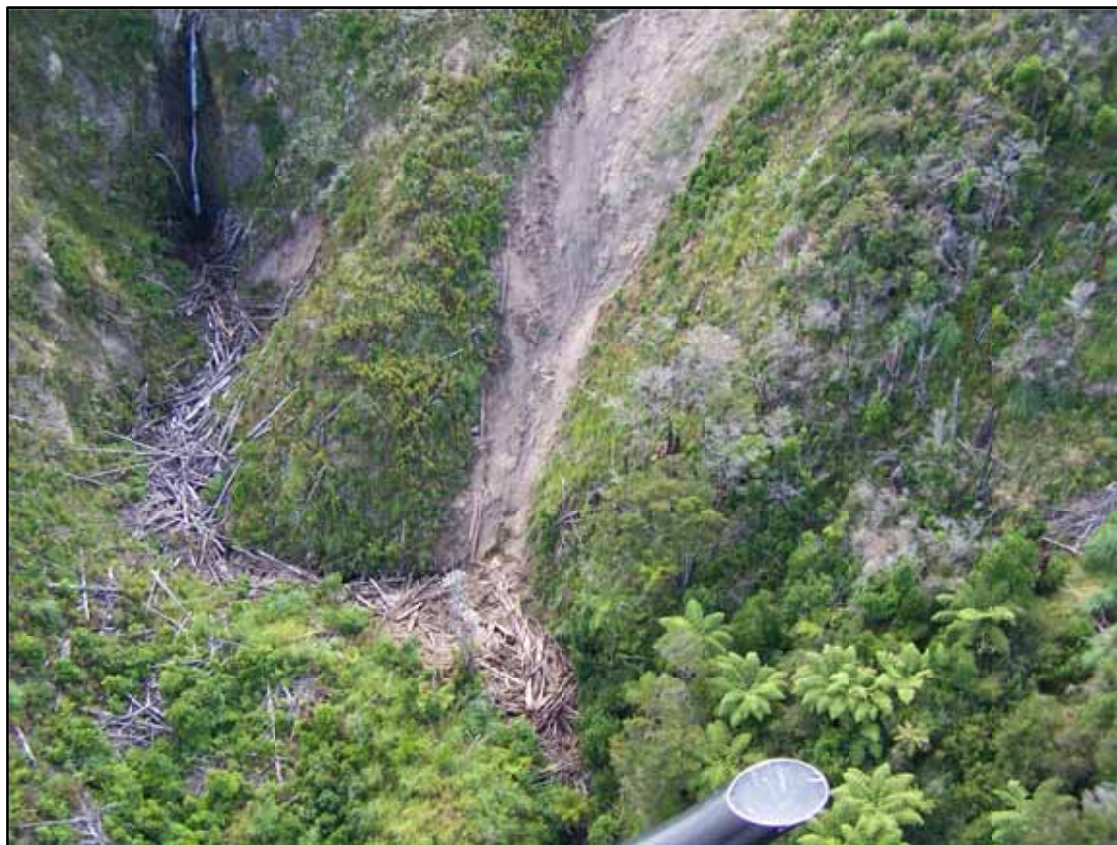
Photo 2 The upper catchment of the Taneatua forest with logging debris washed down from steep slopes into flowing waterways

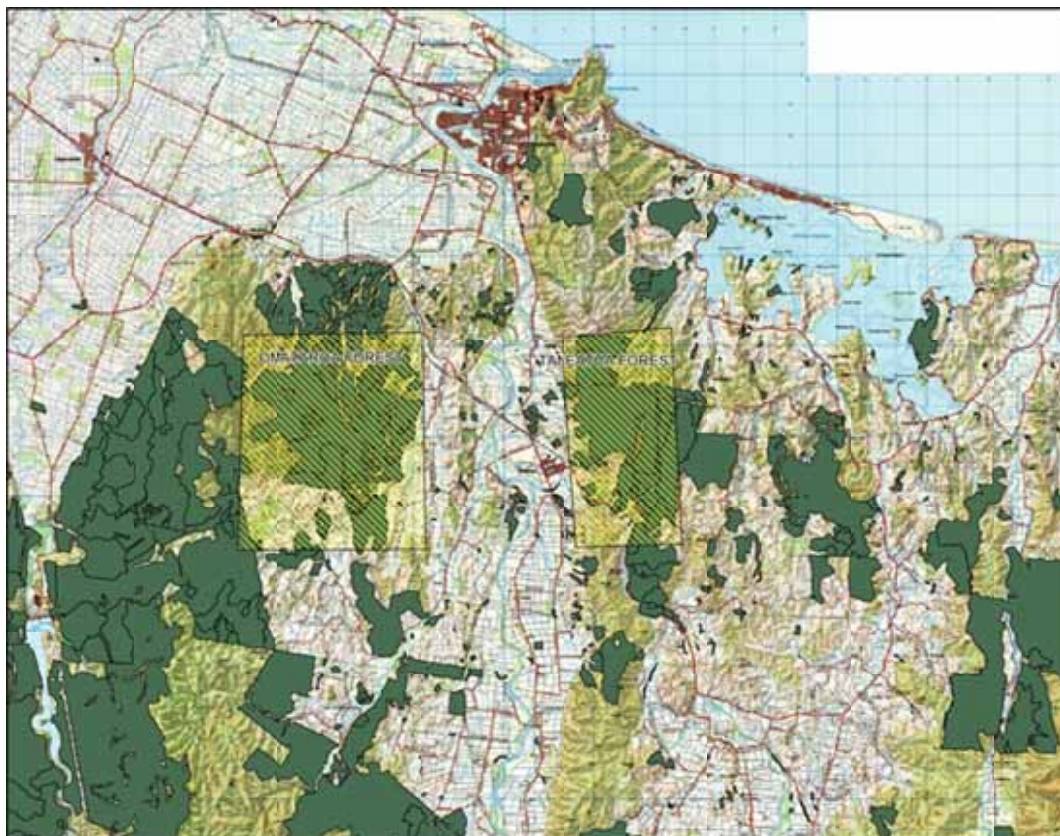
Figure 2 Forest areas affected by the January 2011 event Taneatua and Omataroa.

The two areas most affected by the storm event were both located in the lower reaches of the Whakatāne River. The catchment to the east was in Omataroa forest and the other was to the west and was in the steeper areas of the Taneatua forest - see Figure 2.

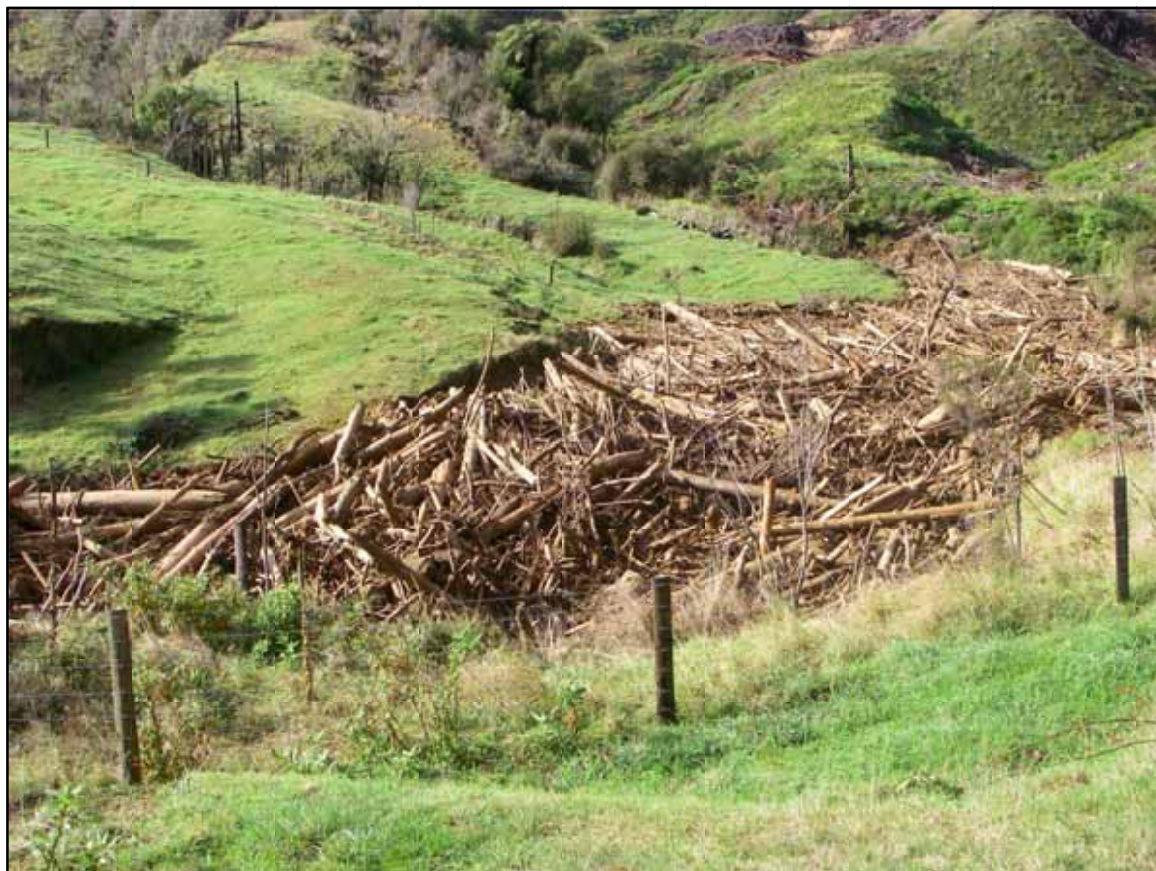
Photo 3 Significant erosion which carried logging slash downstream in the Waiootahi area.

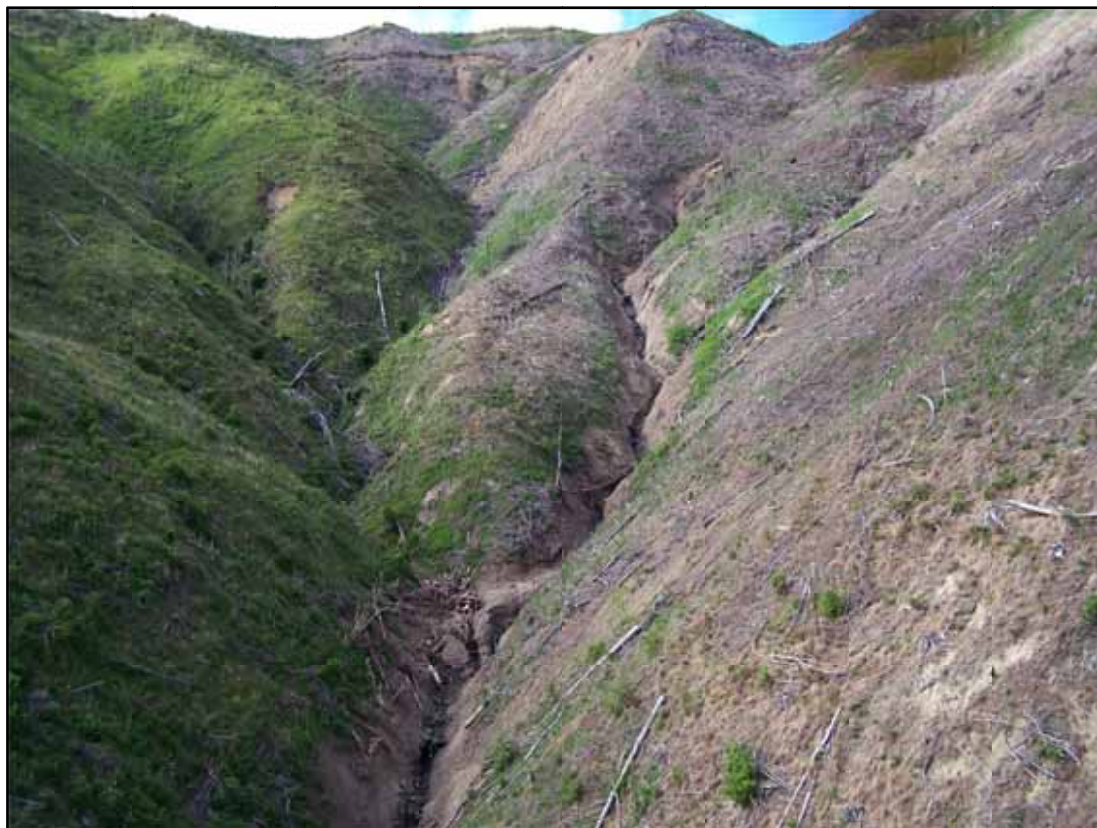
Photo 4 Gully erosion which carried logging slash downstream.

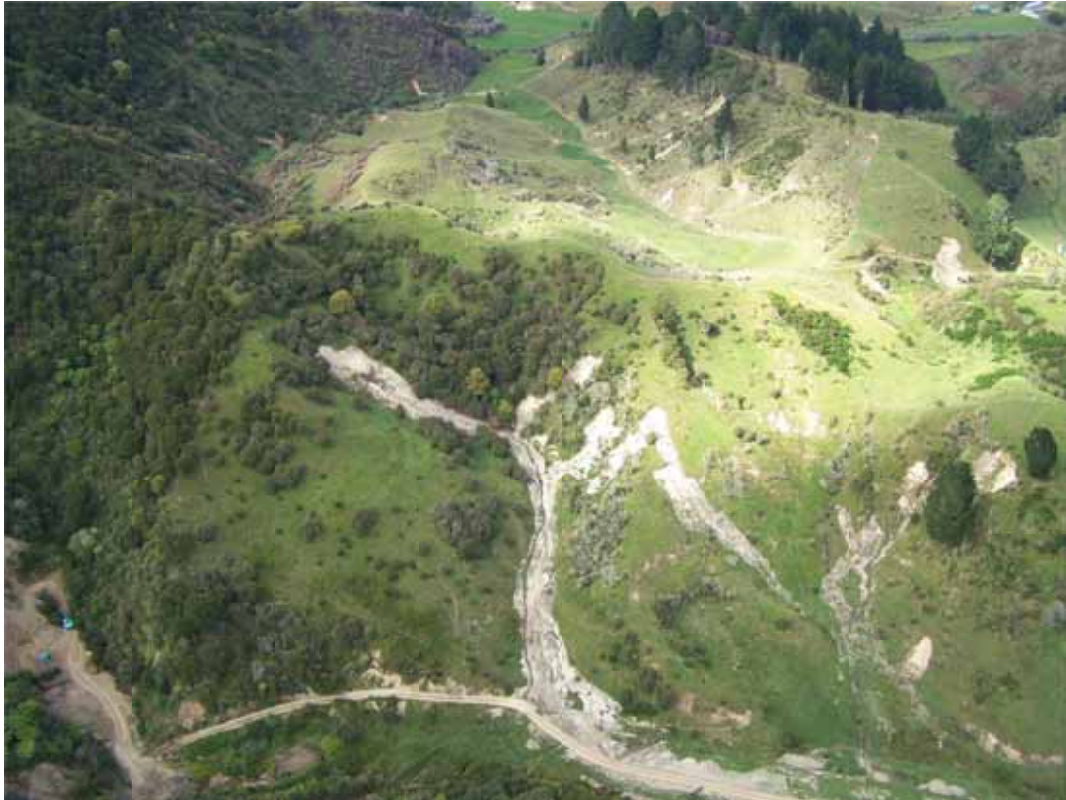
Photo 5 Pasture adjacent to forests also suffered significant erosion.

The natural loss of the soil from the slopes as a result of erosion has affected many aquatic ecosystems through deposition into once pristine ecological areas. It must be noted however that this mid slope failure has been attributed to extremely heavy rainfall and similar soil loss was more serious in adjoining pastoral areas with similar soil types and slopes where extreme rainfall events had occurred – see Photo 5.

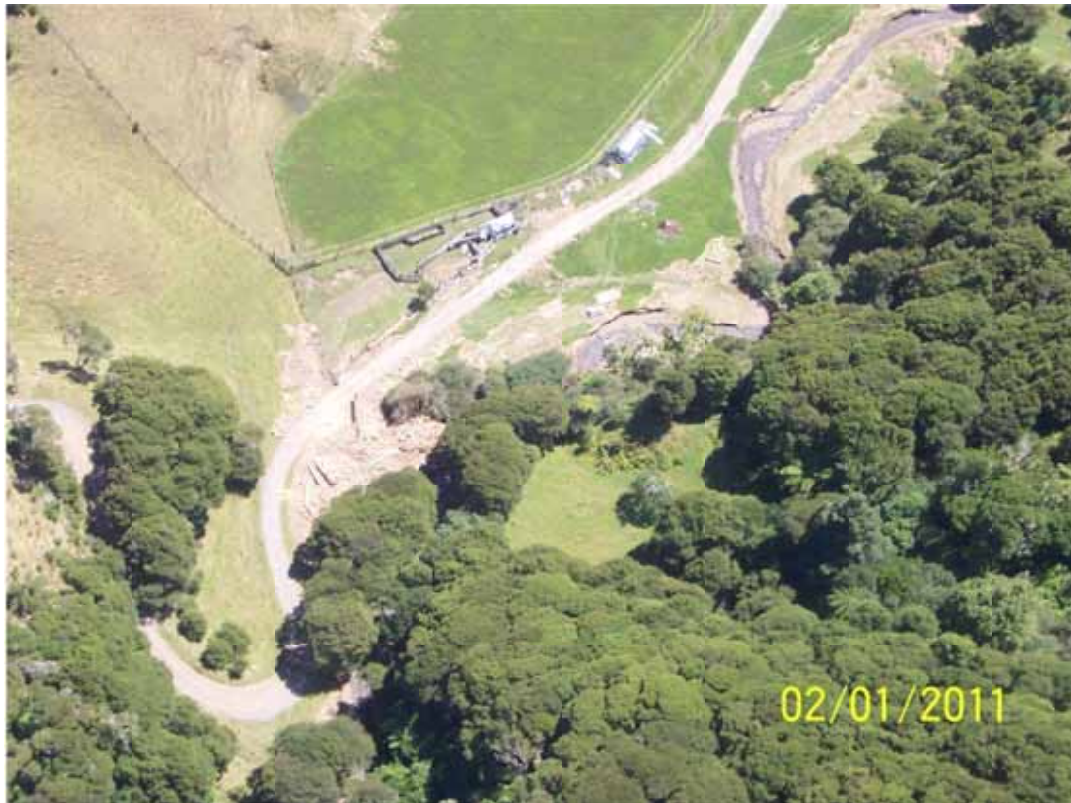
Photo 6: An alluvial fan which would be suitable for the construction of a slash rack.

Slash racks located on alluvial fans where the problem is likely to occur is another mitigation option. These will require heavy machine access so that the slash racks can be easily cleared when build-up of slash occurs. The slash racks are usually constructed using railway irons and wire rope driven into a floodway area where slash can accumulate. The slash racks should not be placed across gullies or in streams.

Standing managed forest trees on alluvial fans can also be used to contain woody debris during extreme rainfall events. A structure would have to be constructed in the floodway to guide the woody debris into the trees when the stream was in full flood.
