# State of the Rotorua/Te Arawa Lakes 2009-2010

An update on the current state of the Rotorua/Te Arawa Lakes  
and what actions are being taken to protect and restore them

Protection and Restoration Action Programme

A Bay of Plenty Regional Council, Rotorua District Council and Te Arawa Lakes Trust joint project

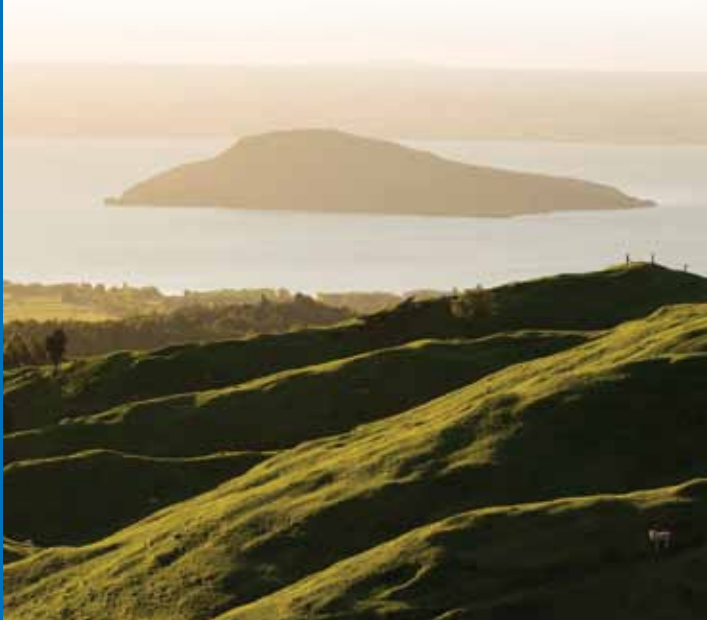
Seasonal differences in temperature, light, plant growth and nutrient availability may result in stratification of lake waters.

When lake stratification occurs, oxygen in bottom waters is not replenished adequately because atmospheric inputs are cut off and there is insufficient light for photosynthesis. In low-oxygen conditions, nutrients such as phosphorus can be released from the lake sediments. Remixing of the waters in autumn can bring these nutrients to the surface where they can stimulate algal blooms. Increased algal growth in the surface waters results in further deposition of algae on the lake bed, further fuelling the cycle.

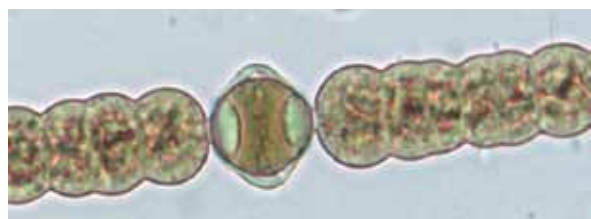
Photo of *Anabaena planktonica*, one of the blue-green algae responsible for past algal blooms in Lake Rotoiti (magnified x 400 times). The clear cell in the middle of the filament is a heterocyst, a specialised cell used for nitrogen fixation. Photo by Barry O'Brien.

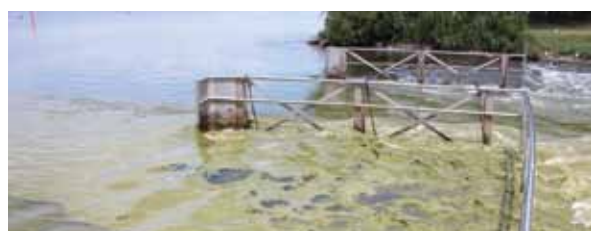
Bloom of blue-green algae at entrance to Ohau Channel, Lake Rotorua (January 2006)

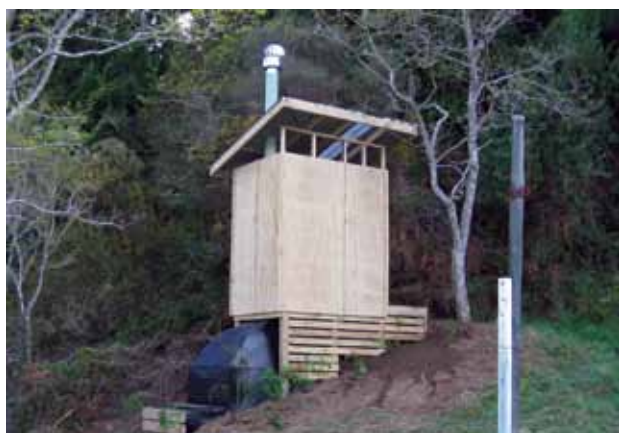
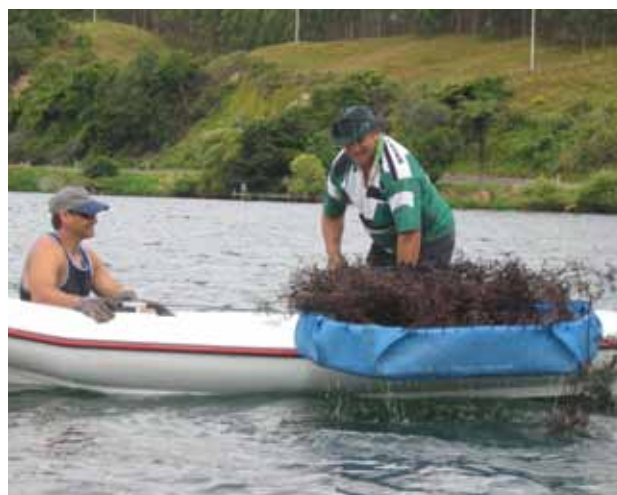
**"Tau Koura" - Traditional fishing method used as a monitoring tool.** Photo taken by Dr Chris Hickey, NIWA

"With the assistance of Ngati Pikiao, traditional methods of collecting kōura using submerged bracken fern bundles are being used in Lake Rotoiti to monitor the possible effects of the new diversion wall on kōura populations. Early results indicate that the wall has not affected the size or quantity of kōura when comparing the different sample sites."

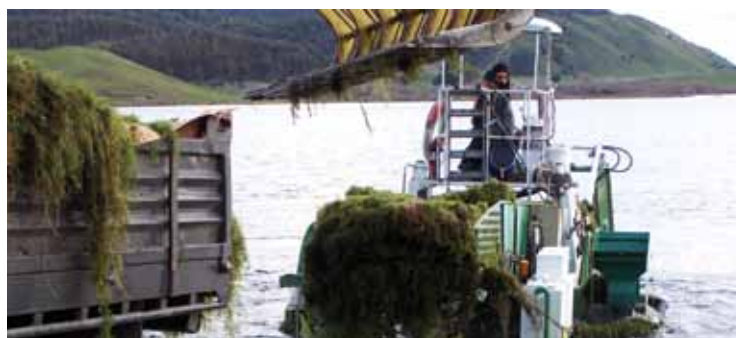
Hornwort harvesting is carried out on Lake Rotoehu as part of the lake nutrient management plan. Harvesting is budgeted to be carried out each season over ten years. Nutrient removed in this way is dependent on the lake weed growth available for harvesting each season. In 2009, more than 3000 tonnes of hornwort was removed, equating to eight tonnes of nitrogen from the catchment.

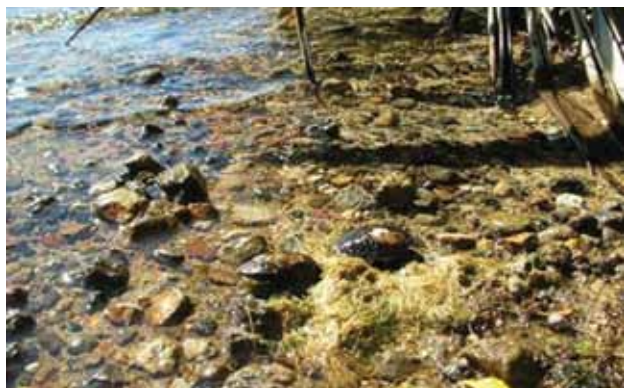
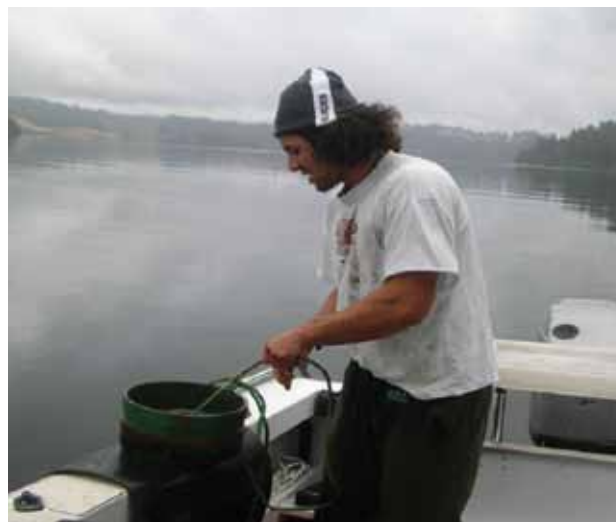
Joe Butterworth surveying the kakahi *Echyridella menziesii* population in Lake Rotokakahi. A University of Waikato M.Sc. research study looking at lake water quality trends and key environmental determinants of the kakahi or freshwater mussel.

The thermocline (water layer that prevents mixing of oxygen rich surface waters with oxygen depleted bottom waters during summer) corresponds to the lower distributional limit of the kakahi. In lakes that stratify the thermocline could be a major limiting factor for kakahi colonising deeper areas. Of particular concern is the ability of kakahi to survive prolonged periods of depleted oxygen in lakes with degrading water quality.
