# Monitoring the impacts of on-site wastewater treatment systems, Bay of Plenty

Bay of Plenty Regional Council  
Environmental Publication 2018/01  
February 2018

Prepared by Paul Scholes (Science Team Leader - Water Quality)

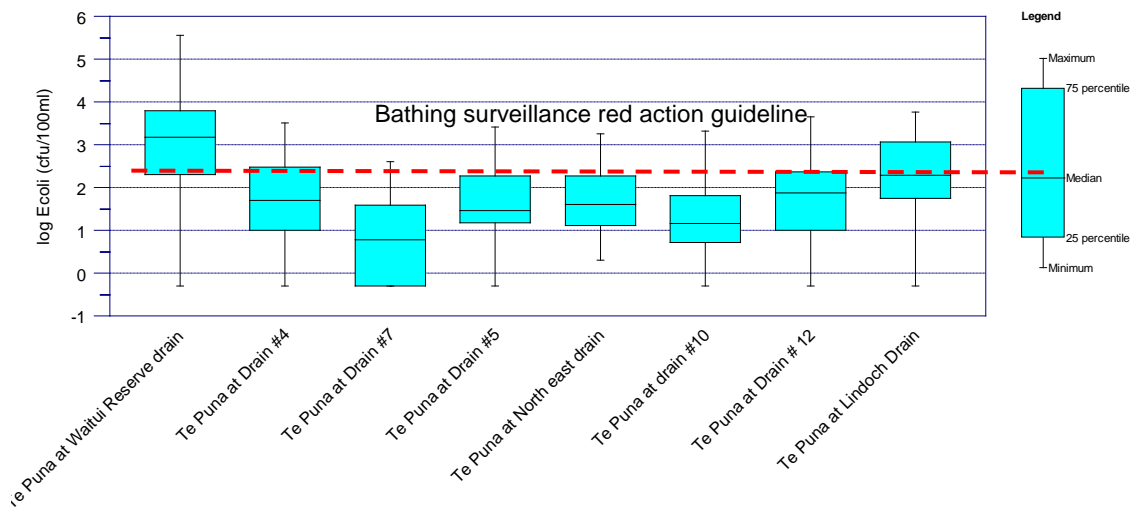
Several drains show high bacterial contamination (Figure 3.7.2, 3.7.6) typical of poorly treated septic tank effluent. The highest bacterial contamination occurs on the western side of Te Puna where a number of dwellings are located on flat low lying land. Median *E. coli* levels above the microbiological water quality guideline (red action mode) occurred in one drain on the west side in data from 2010 to 2017. All drains have periodic results above the red action mode guideline with the exception of drain #10 and drain #7.

Figure 3.7.2 Box-whisker plots of *E.coli* concentrations, Te Puna drains, 2010 to 2017.

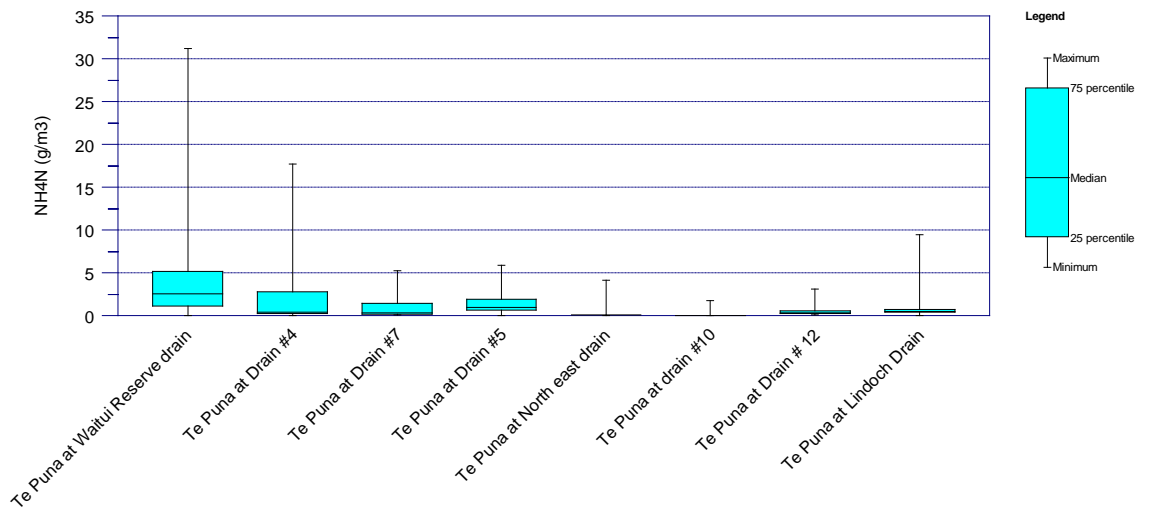
Several of these west side drains have elevated ammoniacal-nitrogen ( $\text{NH}_4\text{-N}$ ) concentrations, indicating septage contamination. Drains on the eastern side have lower ammoniacal-nitrogen concentrations. Two drains on the eastern side have higher NNN concentrations than their western counterparts. This could be a result of nutrient renovation of septic tank effluent as well as rural land use impacts. High NNN concentrations at the two western drains also indicate influence of septic tanks. Elevated phosphorus levels on the eastern side also indicate some potential effluent influence (Figure 3.7.5).

Figure 3.7.3 Box-whisker plots of  $\text{NH}_4\text{-N}$  concentrations, Te Puna drains, 2010 to 2017.

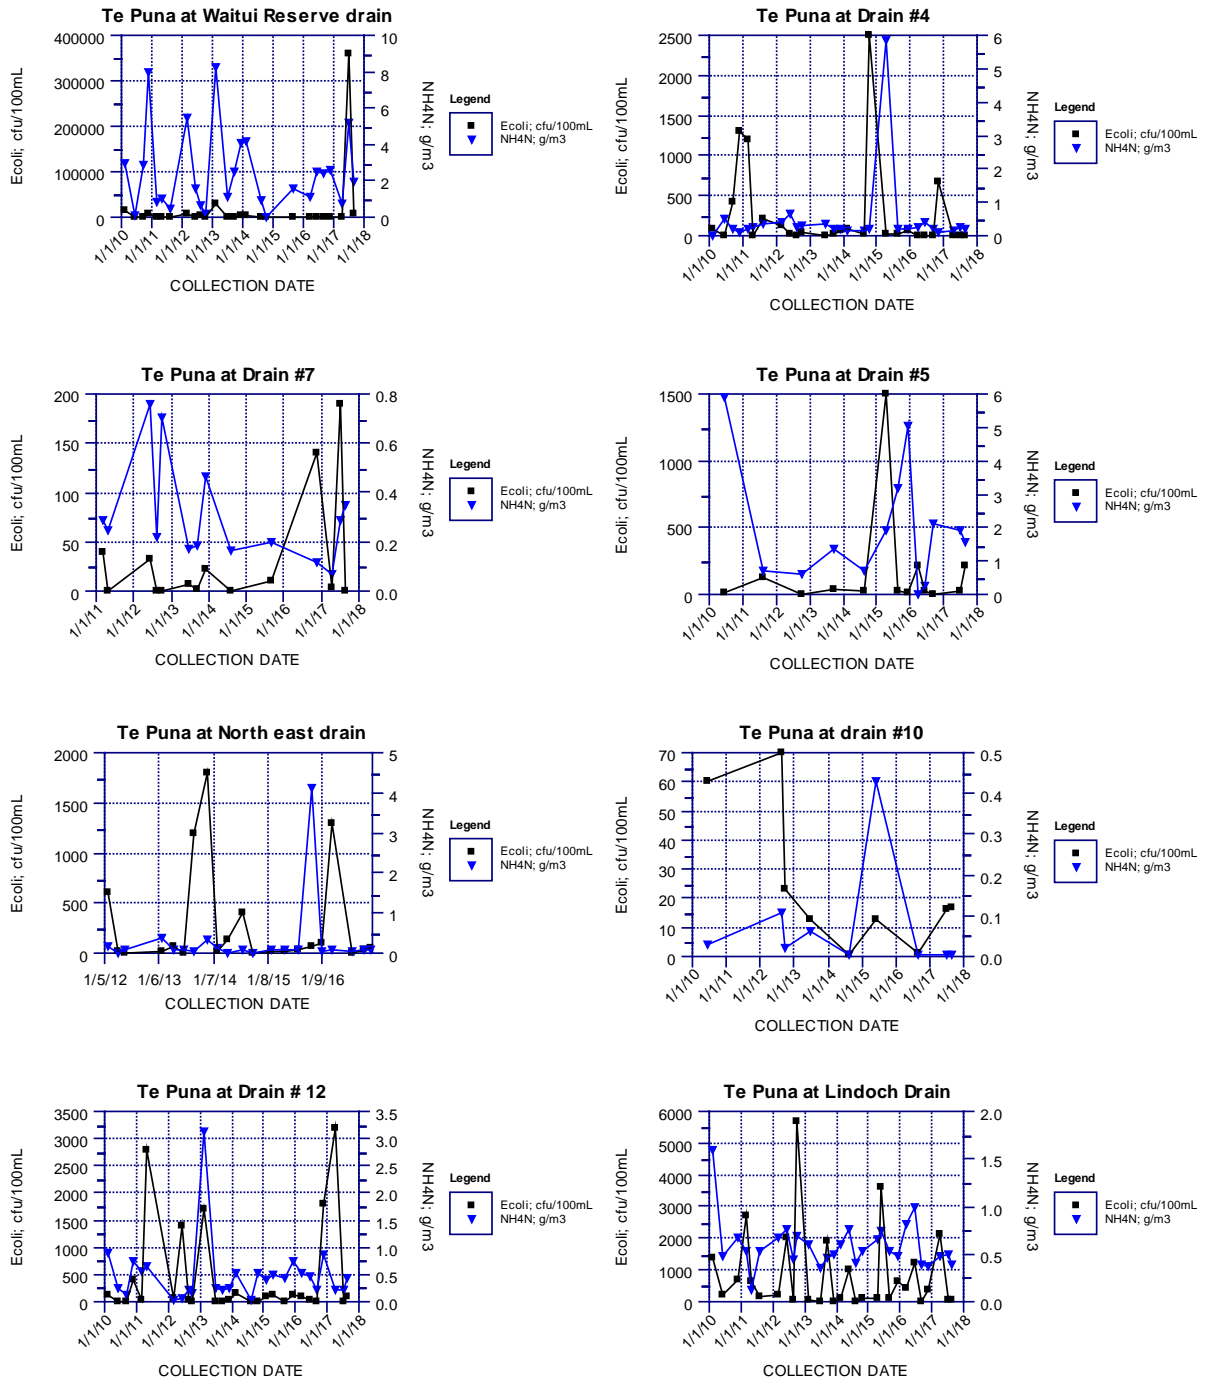
Figure 3.7.6 Te Puna Drain E.coli and NH<sub>4</sub>-N concentrations, 2010 to 2017.

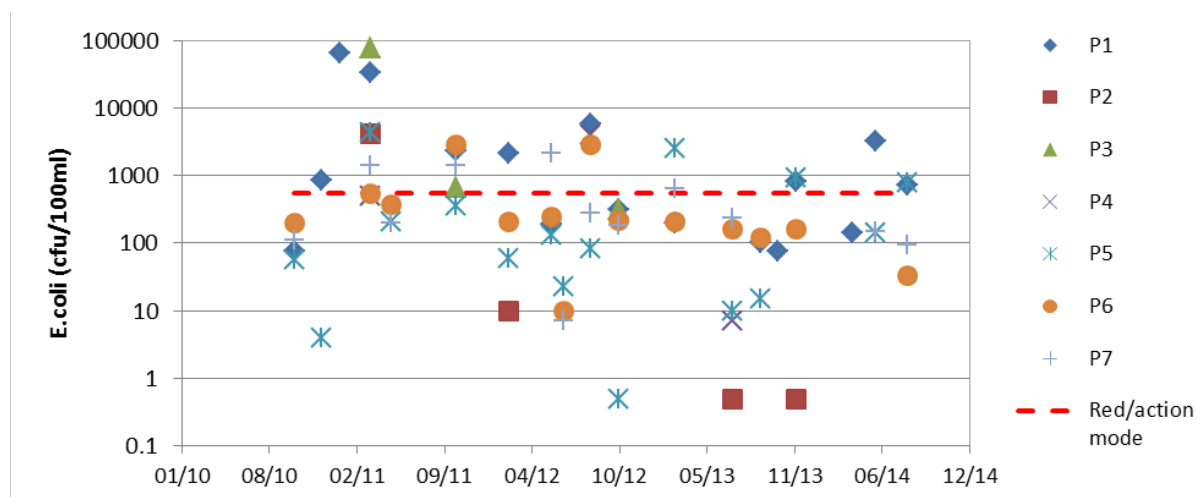
*E.coli* results above the Ministry of Health's and Ministry of the Environment's recreation guideline red action have, for the most part, been sporadic for most sites with the exception of site P1 which has shown consistent elevated *E.coli* levels. The seepage at site P7 has previously also had elevated *E.coli* levels, but in the last two years, these have been below recreation guidelines. Sites P5 and P7 show a weak correlation between *E.coli* and ammonium ( $\text{NH}_4\text{-N}$ ), indicating septic tank effluent as a probable source of contamination. Elevated ammonium has been most prevalent at sites P1 and P7 again the most likely source at these levels is septic tank effluent (Figure 3.8.3).

Figure 3.8.2 *E.coli* concentrations from seeps and drains, Pukehina.

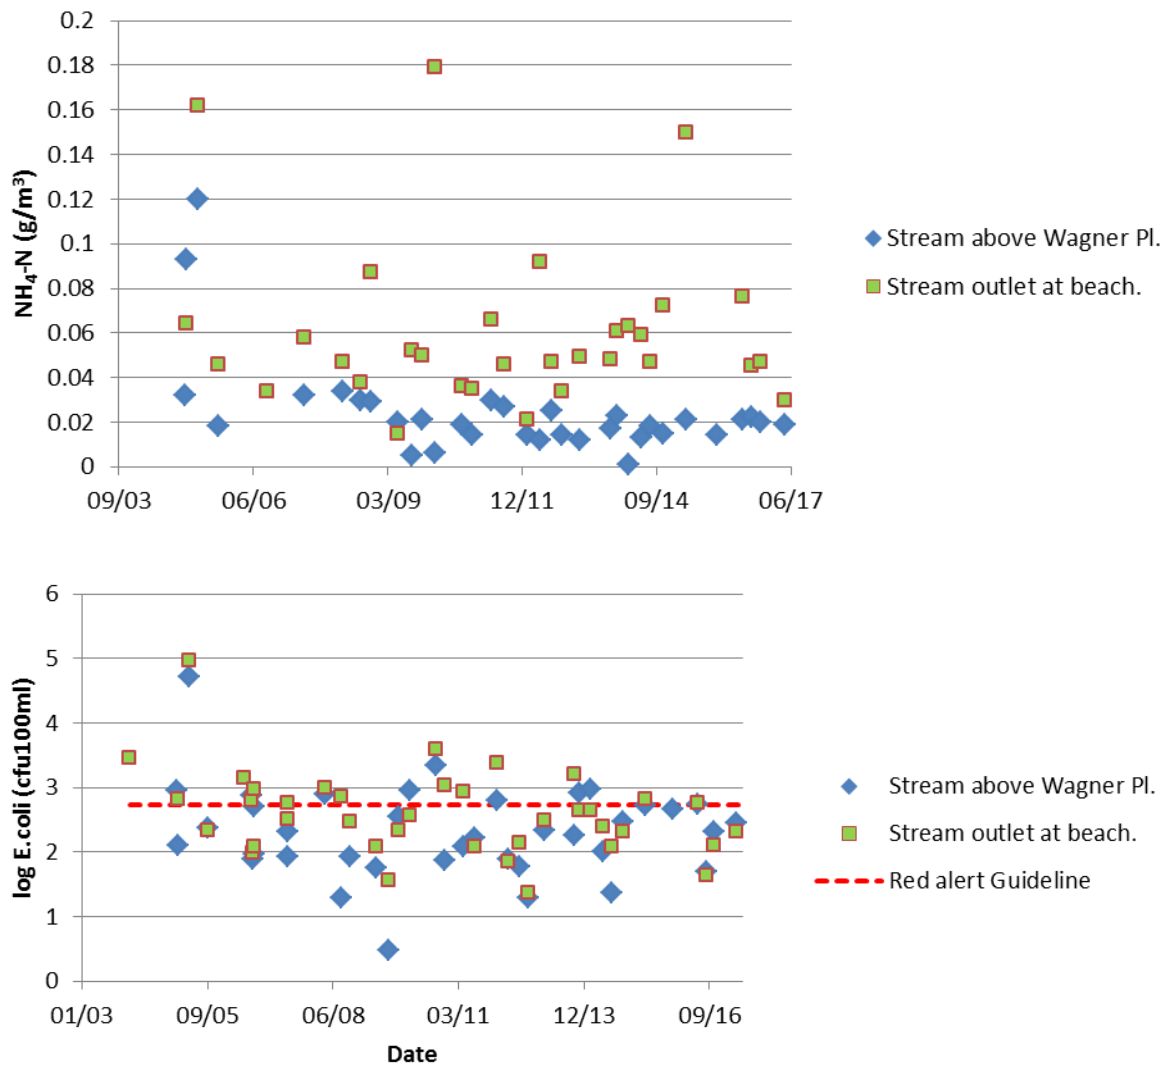
Comparison of upstream and downstream results of the stream show nutrient and indicator bacteria water quality parameters are higher downstream than upstream (Figures 3.10.2 and 3.10.3). Ammoniacal-nitrogen is notably elevated downstream in comparison to upstream of residential area. As ammoniacal-nitrogen is in high concentrations in septic tank effluent and generally adsorbs onto soil particles, except when contaminant sources overwhelm soil adsorption properties, it is a good marker of septic tank contamination. Together with elevated *E.coli* concentrations downstream, it can be concluded that septic tank effluent continues to reach the small stream.

Figure 3.11.2 Ammoniacal-nitrogen and *E.coli* concentrations from stream sites, 2003 to 2017, Bryans Beach.

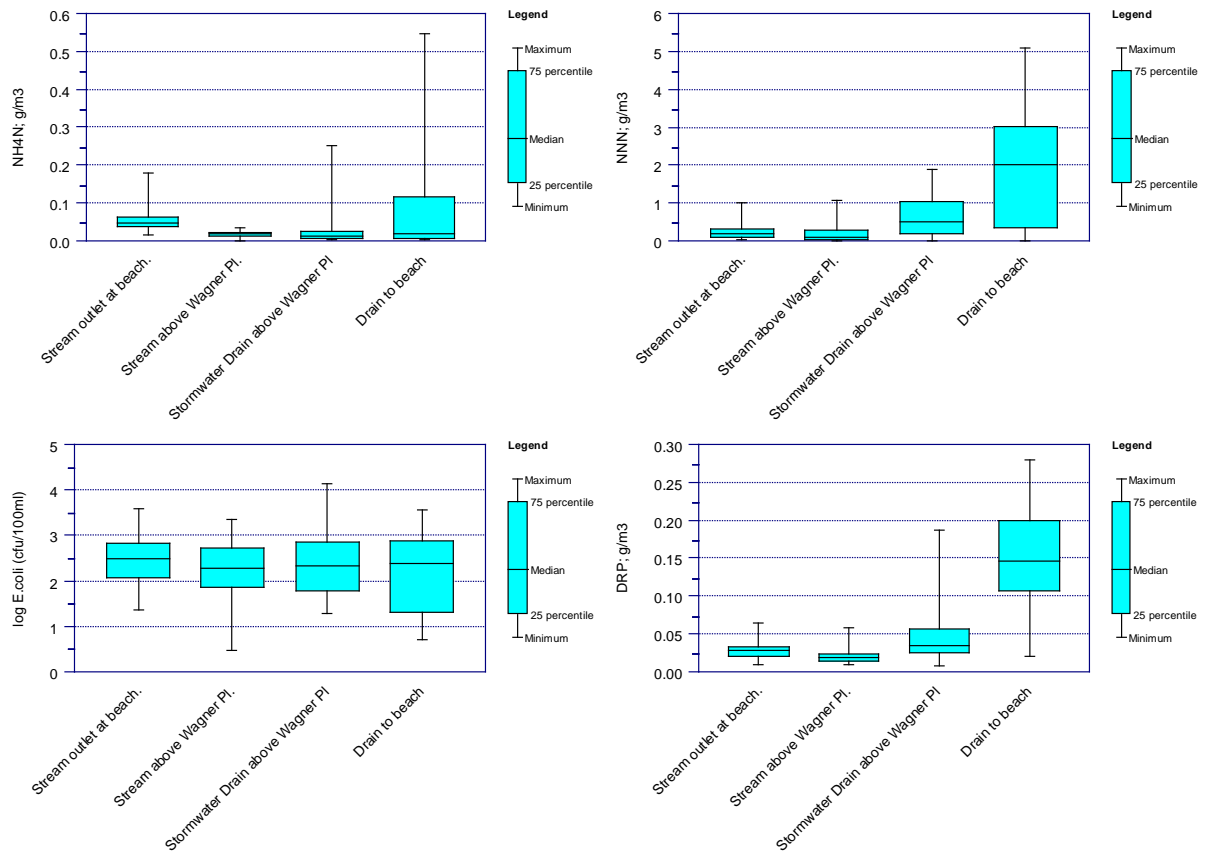
Figure 3.10.3 Box whisker plots of nutrient and *E.coli* concentrations from stream and drains, 2007 to 2017, Bryans Beach.

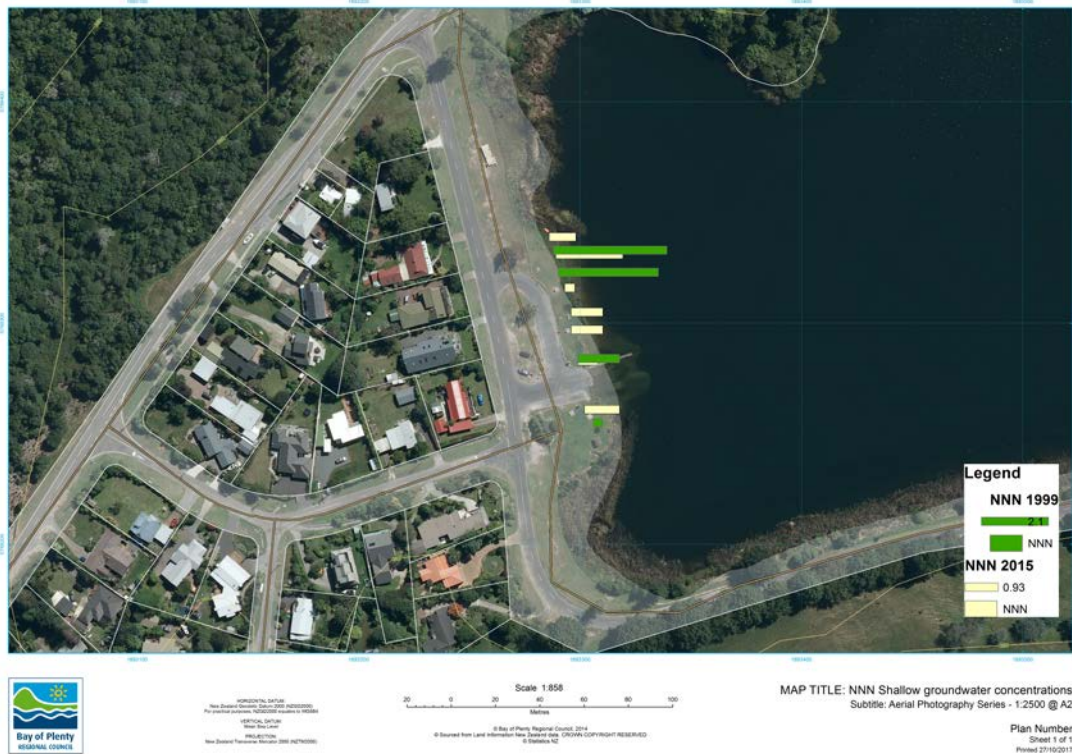
Nitrate-nitrogen results from the 1999 NIWA study overall show higher concentrations from the sites sampled in the residential areas. Reduction of nitrate-nitrogen concentrations is likely to a direct result of removal of septic tank effluent discharges. There still remains the question of how much nitrogen has built up in the local soils over the years and how long it takes for this source to be utilised by soil microbes and plants or leached into the water table. The Boyles Beach area which is not residential returned low nitrate-nitrogen concentrations in both 1999 and 2015, with the exception of one result returning nitrate-nitrogen around 1.5 ppm (Figure 4.1.3).

Figure 4.1.1 Shallow groundwater nitrate-nitrogen concentrations, Acacia Road. Green bars are from NIWA study 1999, yellow bars are from 2015.

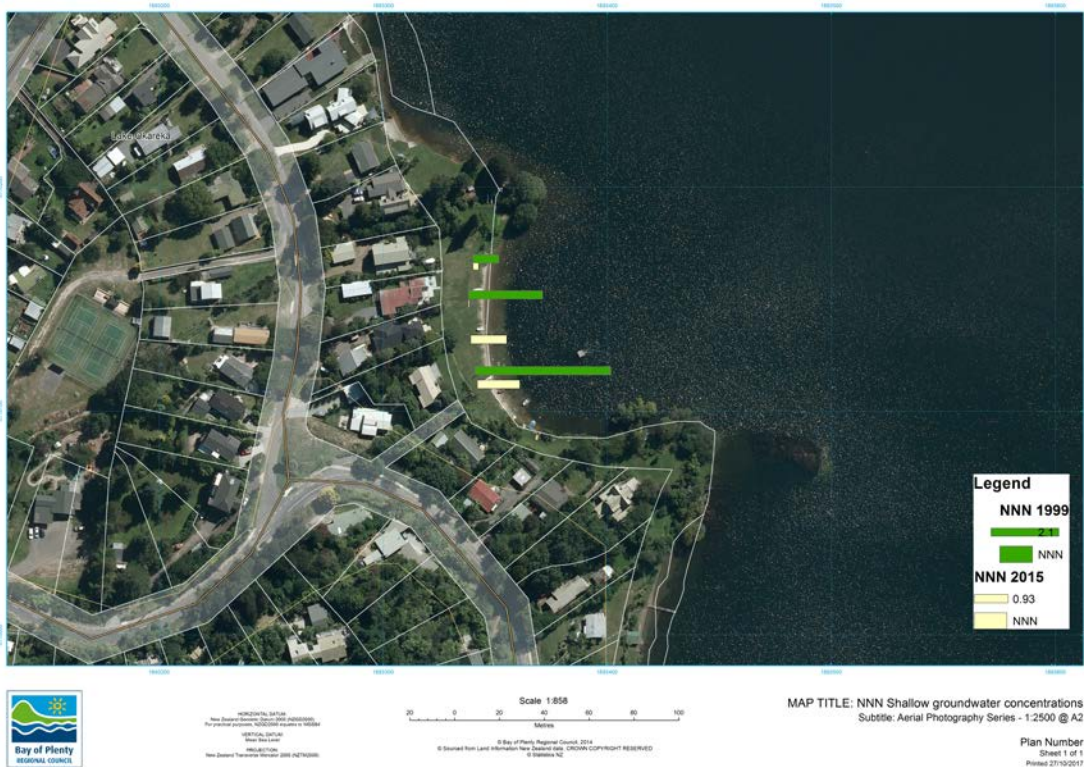
Figure 4.1.2 Shallow groundwater nitrate-nitrogen concentrations, Steep Street beach. Green bars are from NIWA study 1999, yellow bars are from 2015.

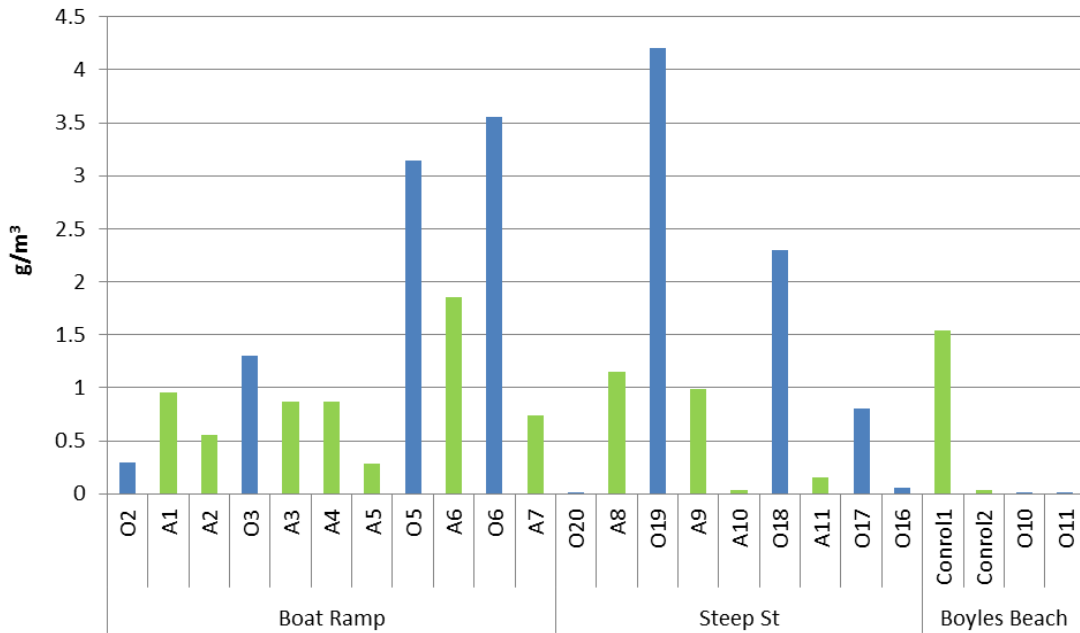
Figure 4.1.3 Shallow groundwater nitrate-nitrogen concentrations, Lake Okareka. Blue bars ('O' sites) are from NIWA study 1999, green bars ('A' sites) are from 2015.

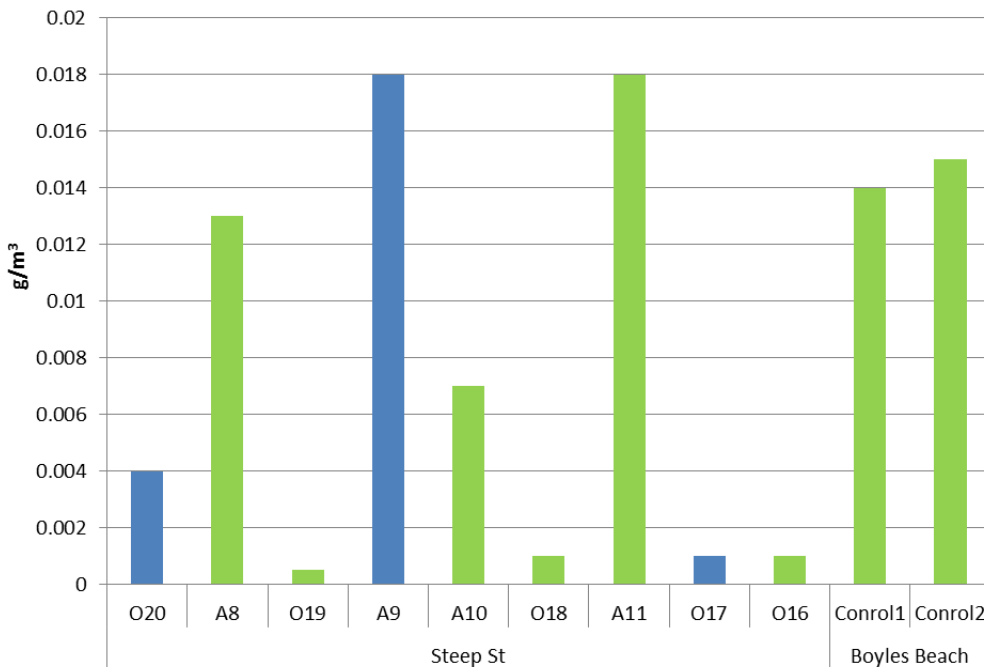
Figure 4.1.4 Shallow groundwater nitrate-nitrogen concentrations, Lake Okareka. Blue bars ('O' sites) are from NIWA study 1999, green bars ('A' sites) are from 2015.

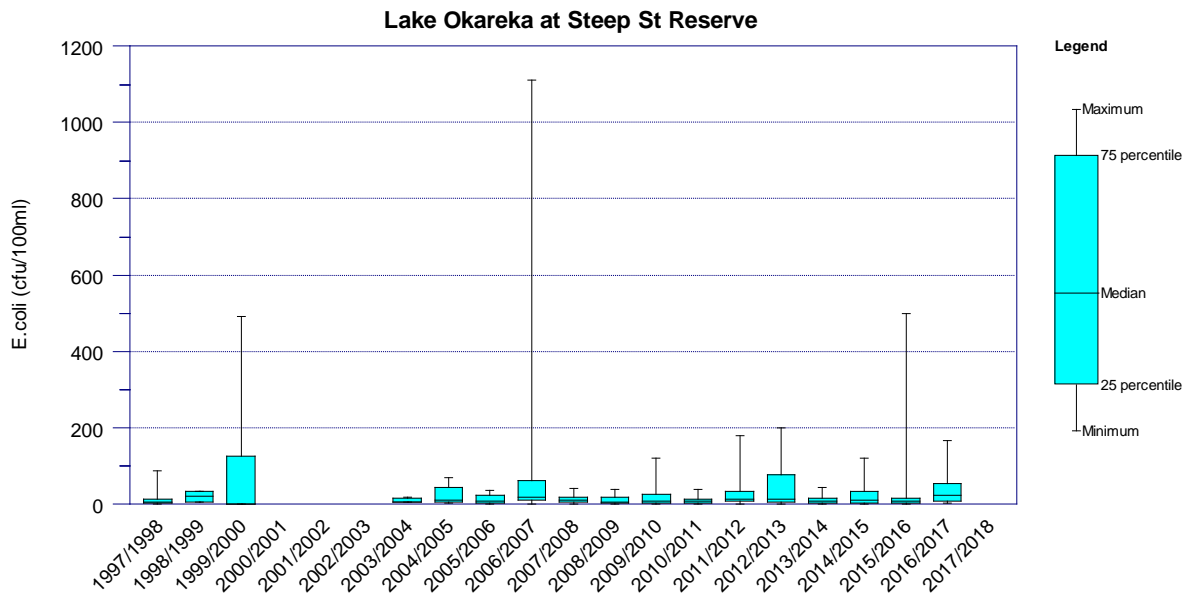
Figure 4.1.5 Box whisker plot of annual *E.coli* concentrations, Lake Ōkāreka at Steep Street Reserve.

Recreational surveillance monitoring undertaken at Steep Street Reserve and from the jetty in Acacia Road indicates changes in near shore *E.coli* concentration over the past 20 years (Figures 4.1.5 and 4.1.6). No appreciable change in *E.coli* concentrations have been observed at the Steep Street Reserve site, compared to the more highly populated area around Acacia Road jetty, in which has had a strong trend of declining *E.coli* concentrations.

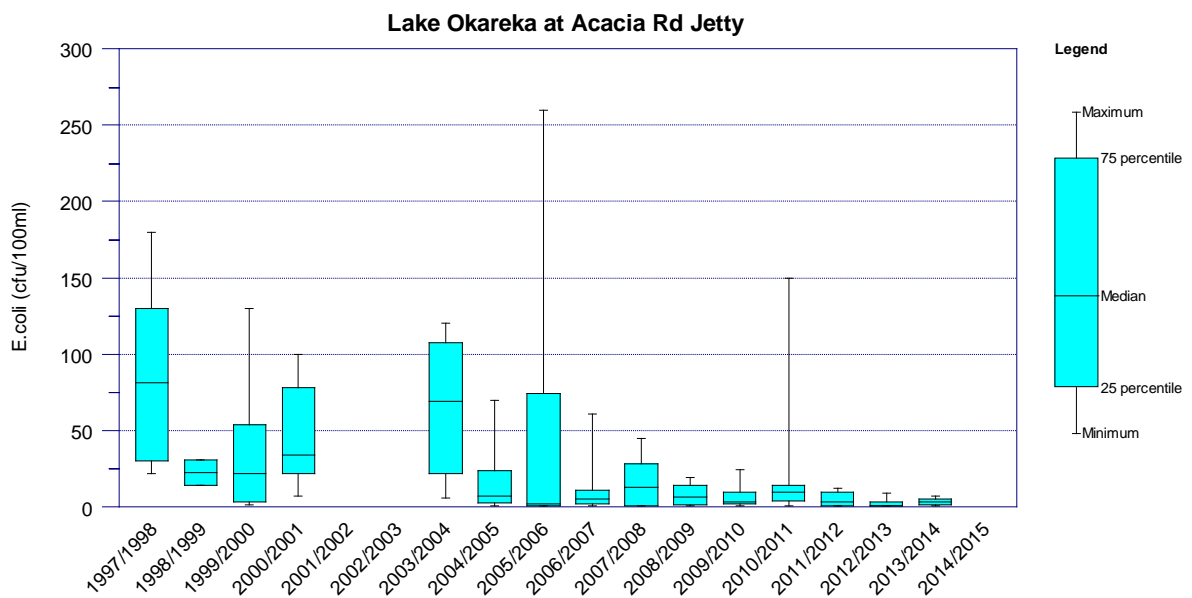
Figure 4.1.6 Box whisker plot of annual *E.coli* concentrations, Lake Ōkāreka at Acacia Road Jetty.

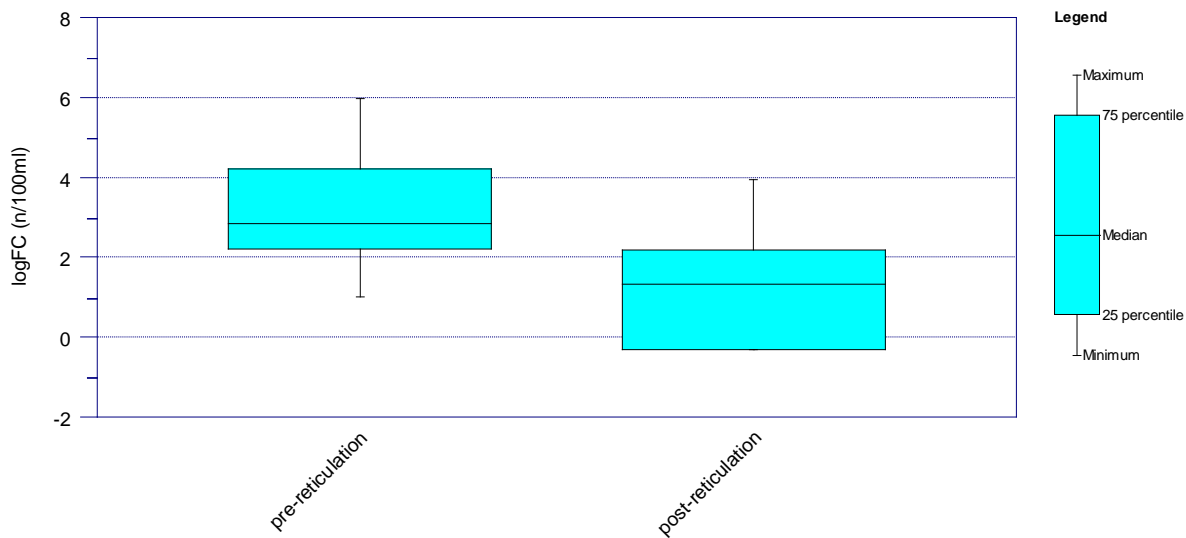
Drains and seeps show an overall improvement in indicator bacteria concentrations since reticulation. The most dramatic improvements appear in the faecal coliform results (Figure 4.4.2). The highly contaminated drains (Domain and Esplanade #1) have shown around a 3 log order reduction (1,000 to 10,000-fold) in faecal coliform levels, with the exception of one high result in July 2017 after heavy rain. Other drains and seeps are displaying a two or one log (10 to 100-fold) reduction, but these were generally not as highly contaminated as the Domain and Esplanade #1 drains.

Figure 4.2.2 Faecal coliform concentrations from drains and seeps, pre (1997-2003) and post-reticulation (2008-2017), Omokoroa. Note; the log scale in the graphs de-emphasises the significant reductions that occurred post-reticulation.

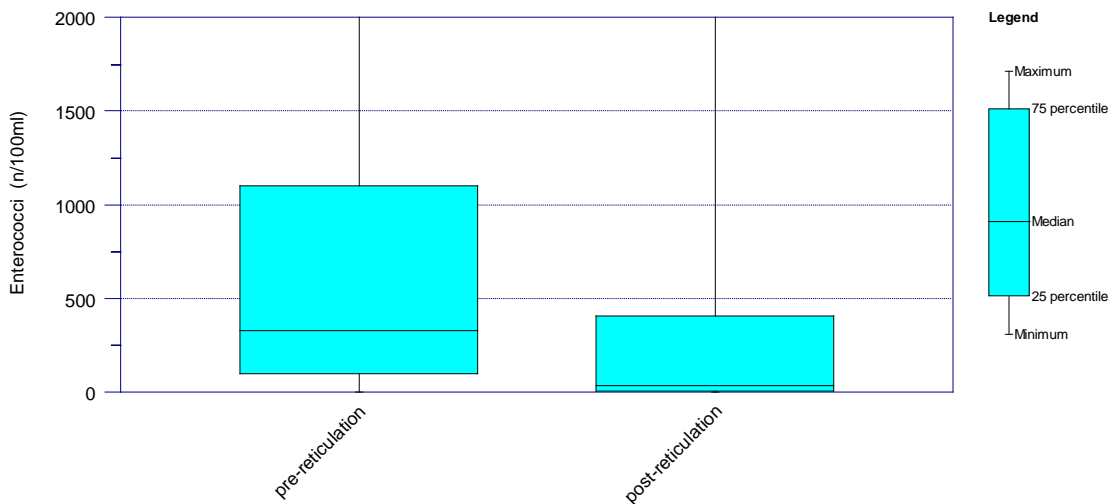
Figure 4.2.3 Enterococci concentrations from drains and seeps, pre (1997-2003) and post-reticulation (2008-2010), Omokoroa.

The enterococci results are not as conclusive as the faecal coliform results, with a one to two log order improvement in concentrations in the Domain and Espanade #1 drains. However, results from other communities tend to show faecal coliform or *E.coli* as the better indicator of contamination from on-site wastewater treatment sources (see Scholes, 2007). Enterococcus species also come from a variety of vegetative sources and may not be exclusively from a faecal source.

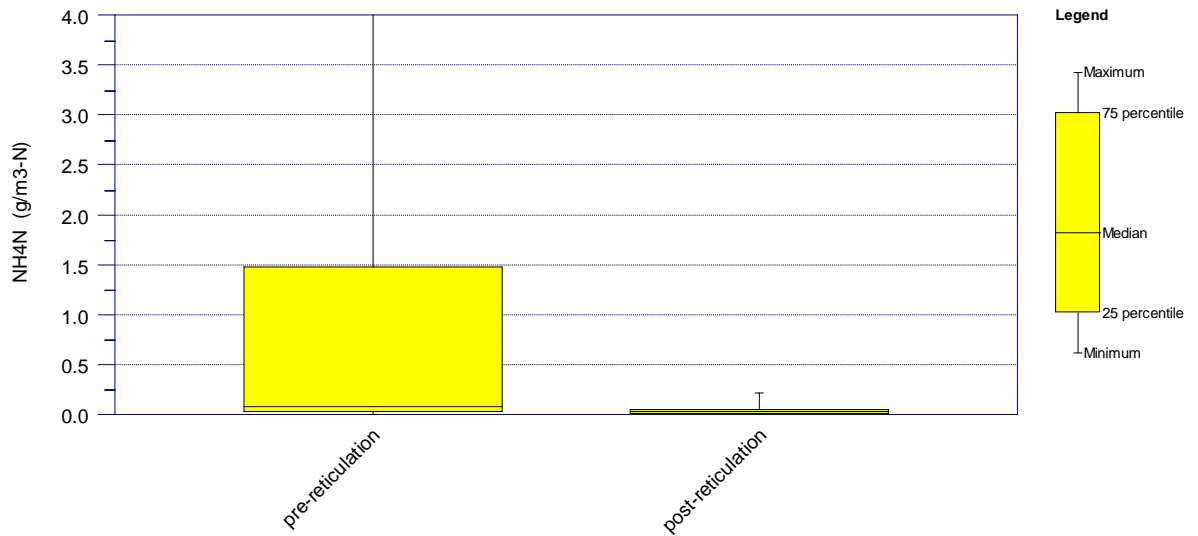
The nutrient results indicate an improvement in ammoniacal-nitrogen ( $\text{NH}_4\text{-N}$ ) and DRP concentrations in discharges to the foreshore. Nitrate-nitrite-nitrogen (NNN) show little change since reticulation (Figure 4.2.5) indicating a pool of organic nitrogen that is continuing to oxidise and leach into groundwater. These concentrations may also be due to high background concentrations and/or slow leakage of existing on-site wastewater treatment tanks through anaerobic soils.

Figure 4.2.4  $\text{NH}_4\text{-N}$  concentrations from drains and seeps, pre (1997-2003) and post-reticulation (2008-2017), Omokoroa.

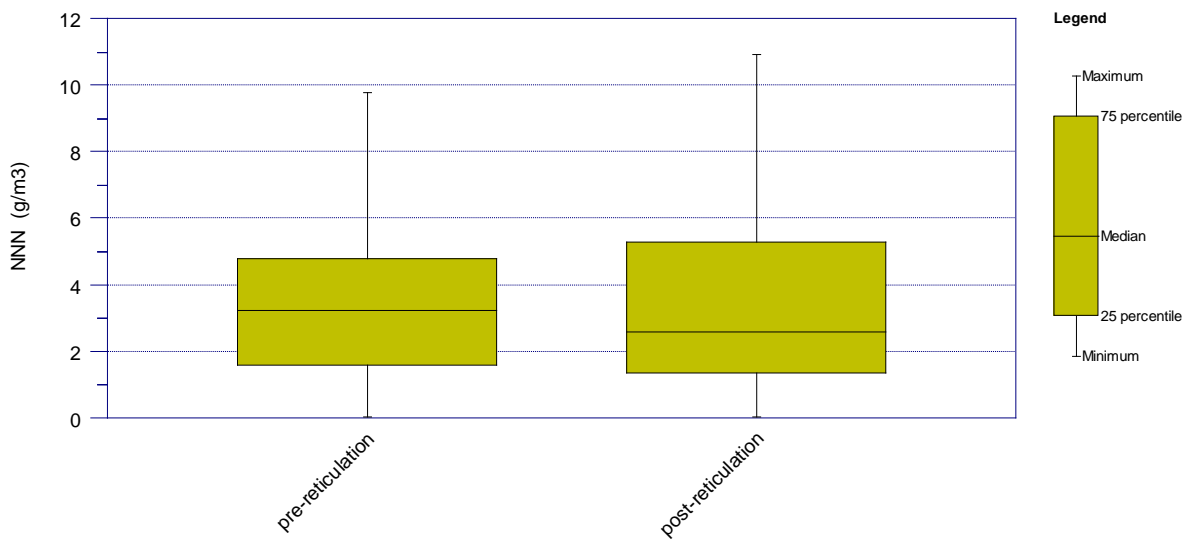
Figure 4.2.5 *NNN concentrations from drains and seeps, pre (1997-2003) and post-reticulation (2008-2017), Omokoroa.*

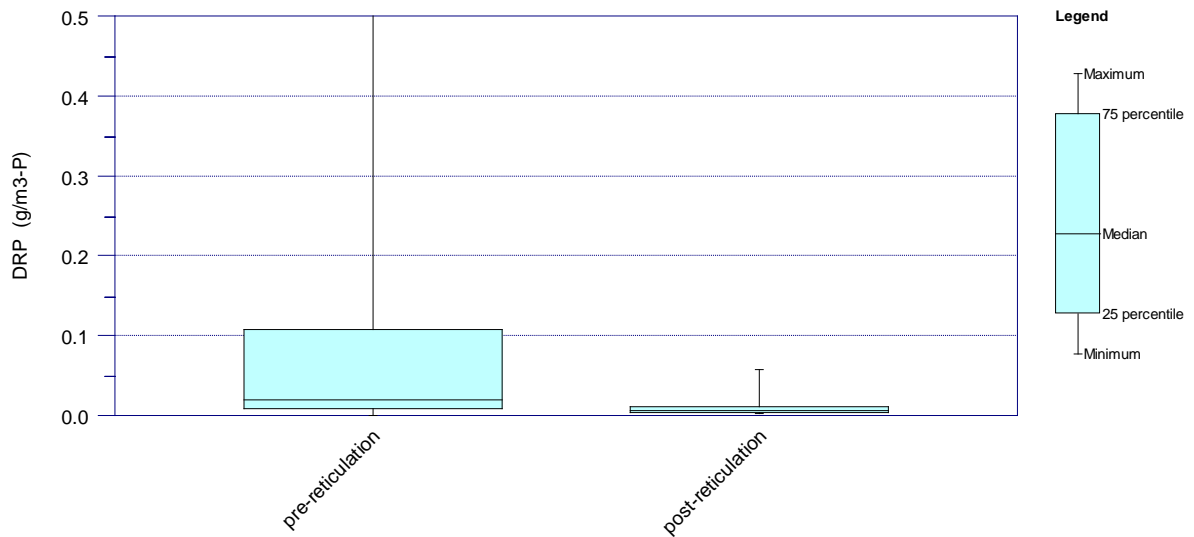
Figure 4.2.6 *Dissolved Reactive Phosphorous concentrations from drains and seeps, pre (1997-2003) and post-reticulation (2008-2017), Omokoroa.*
