Mamaku On-Site Effluent Treatment System Study

Bay of Plenty Regional Council

September 2019

Ormiston Associates Ltd.

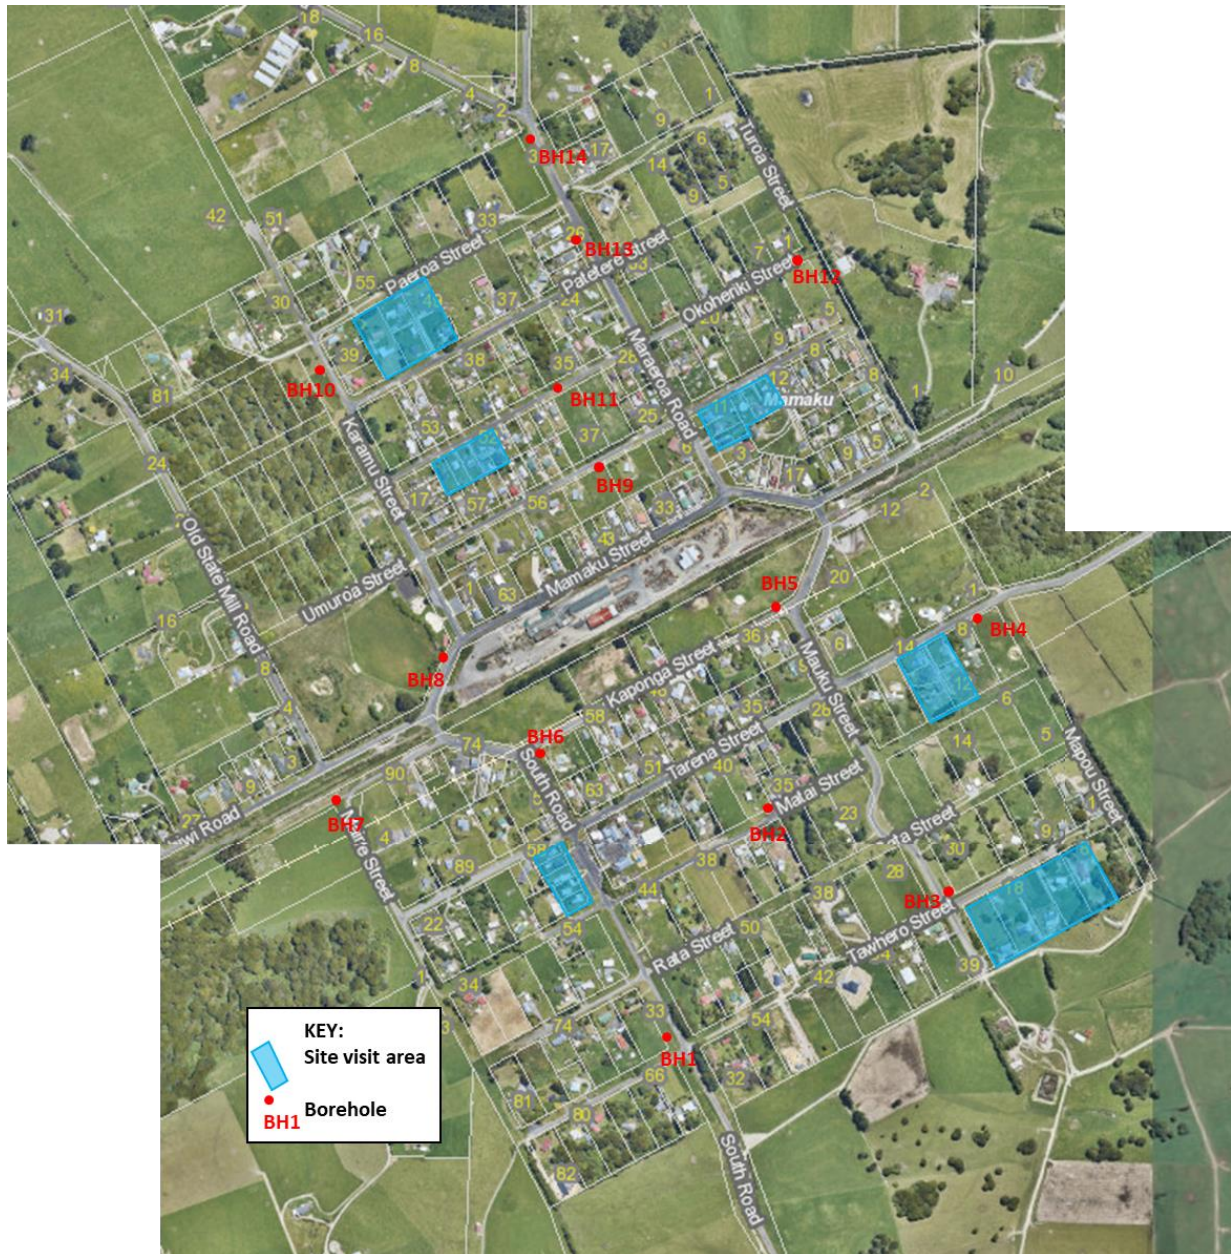
Figure 3: Borehole and site visit locations

1. Drilling of 14 hand auger boreholes across Mamaku, within the road reserve, to describe the soil profile, determine the depth to groundwater and the depth to the impermeable layer. Borehole locations are shown in Figure 3.

Fourteen boreholes were drilled within the settlement at locations as shown in Figure 3. The soil texture was described and categorised in accordance with AS/NZS 1547:2012¹ by an engineering geologist experienced in soil assessment. Photographs of the soil columns are included in Appendix 1.

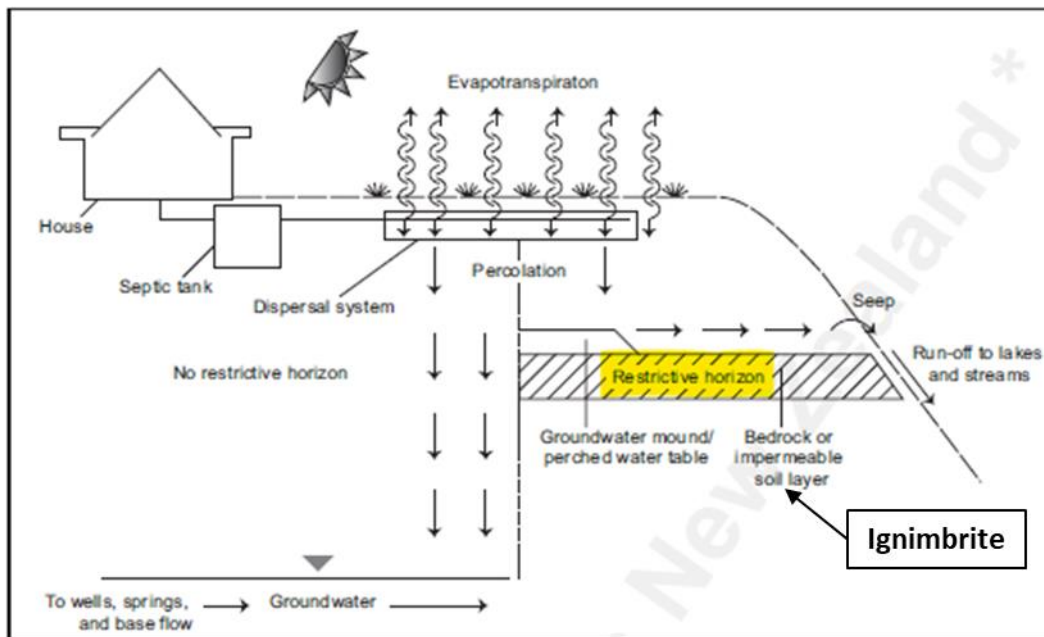
Figure 4: Figure R2 AS/NZS1547:2012

The geological sequence has implications regarding the effectiveness and sustainability of OSET systems operation in Mamaku. The main concern is the presence of the unweathered ignimbrite at around 2 metres depth across the village. This unit will impede the progress of discharged wastewater into the ground, as it will not be able to soak through the rock layer and perch on this low permeability surface. The orange gravelly silt/ash layer overlying ignimbrite was always noted as wet, even after a long dry summer season. This confirms that water in the soil, both natural groundwater and wastewater, perches on the top of the low permeability ignimbrite potentially saturating overlying soils and resulting in surface breakout.

As winter groundwater levels rise towards the ground surface, this limits the thickness of dry soil available to provide further treatment of pathogens and removal of nutrients such as phosphorus, which binds to clay particles and nitrate which is highly mobile in water. When these contaminants enter groundwater, there is the potential for adverse effects to occur when the groundwater surfaces as springs, streams or lakes, or is intercepted by a water bore.

This is shown pictorially in Figure 4, from AS/NZS 1547:2012. The Standard also notes in Table R1, that the vertical setback distance between a land application system and a hardpan or bedrock should be 0.5 to 1.5m.

- To utilise conventional soakage trenches or beds, the depth of these (500mm) would require that they were constructed within the Red-brown Ash unit, which is category 5, however this unit had weak structure, and hence this is not an acceptable design solution (see Figure 4).
