Investigation into the role of jet boating on bank erosion in the Kaituna River

Prepared for Bay of Plenty Regional Council

February 2012

NIWA Client Report No: CHC2011-088
Report date: February 2012
NIWA Project: EBP10501

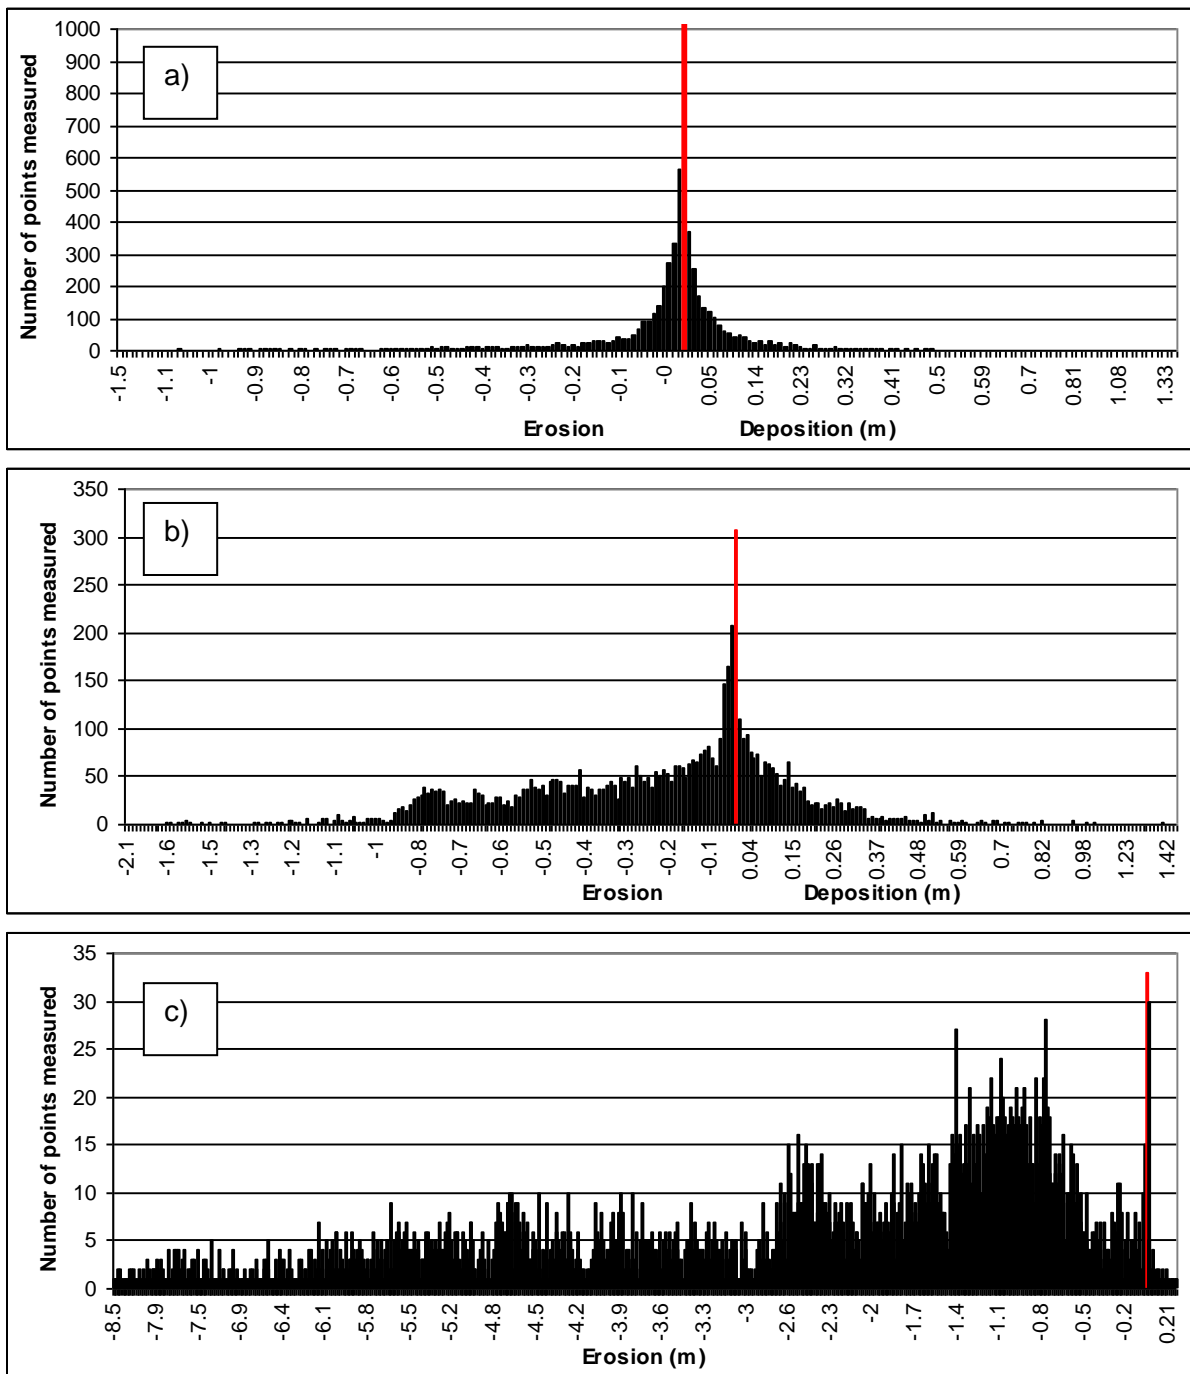
The DEM of difference images for this site are presented in Figure 3-2 and the histograms are presented in Figure 3-3. Mean change over the full area scanned between the first two scans was 3 cm of erosion. Between Scan 1 and Scan 3 the mean change over the area scanned was 20 cm of erosion. Between the first and last scan mean change over the area scanned was 2.62 m of erosion. Figure 3-2 shows that changes prior to Scan 3 were focused along the toe of the bank, whereas later changes occur over the full area of bank scanned.

Figure 3-3: Histograms of the DEMs of difference for Site 1. a) between scan 1 (December 2009) and scan 2 (March 2010); b) between scan 1 and scan 3 (December 2010); c) between scan 1 and scan 4 (May 2011).

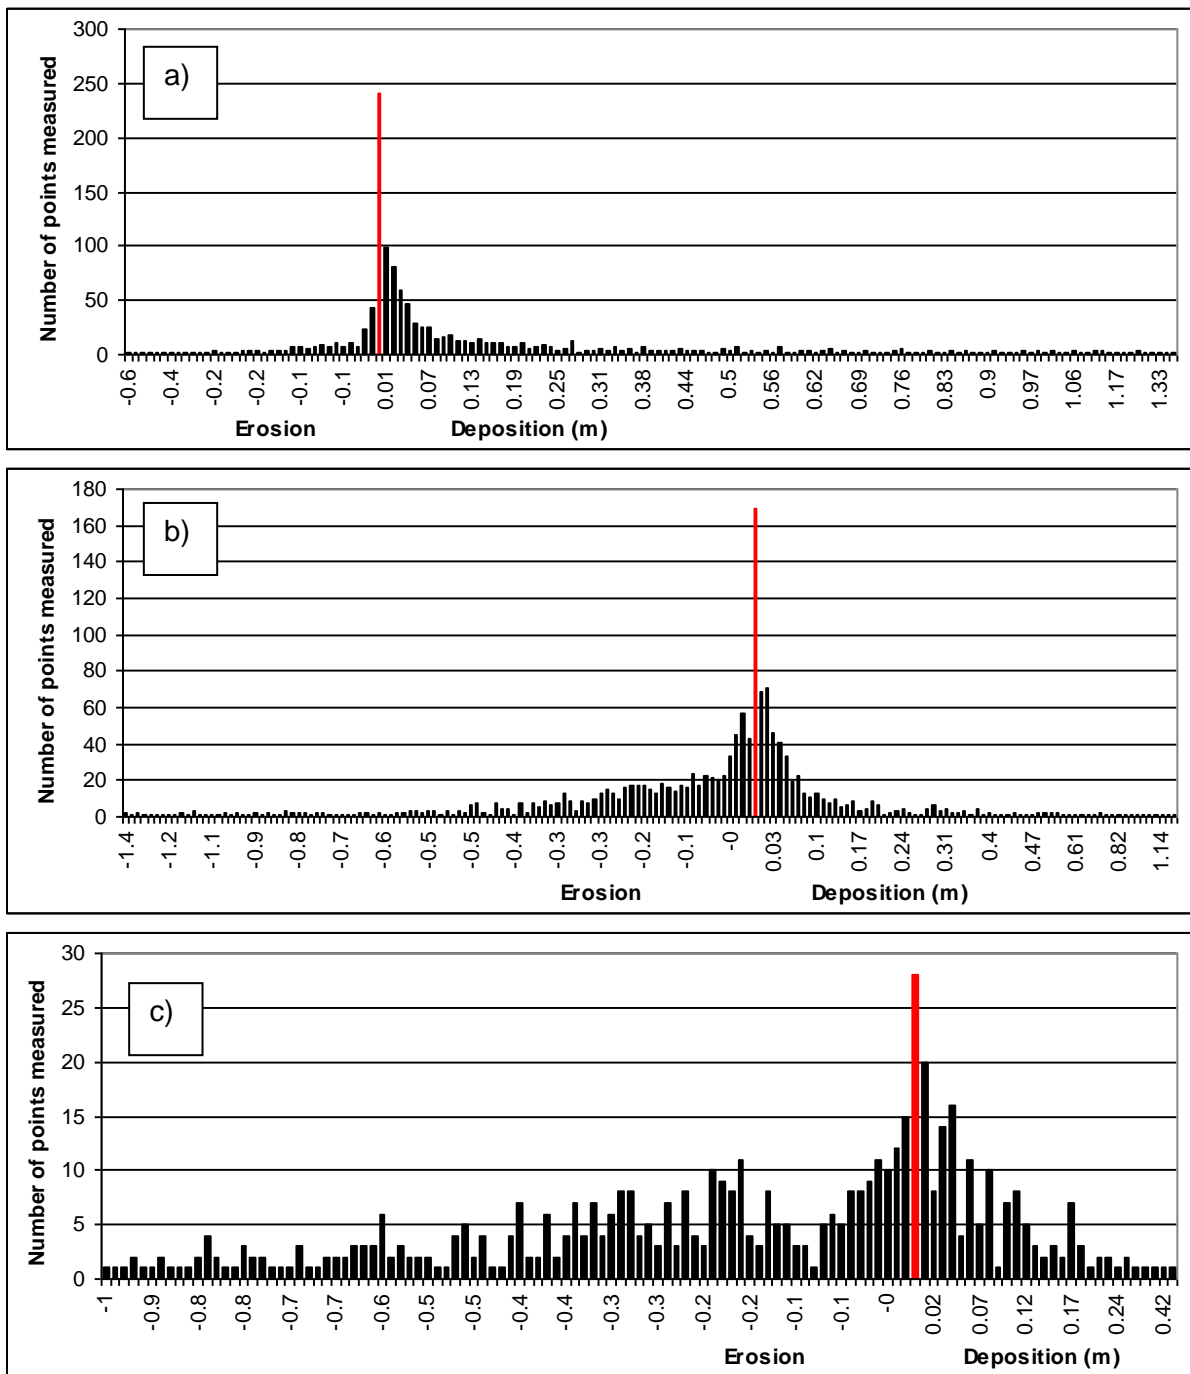
The DEM of difference images for Site 2 are presented in Figure 3-4 and the histograms are presented in Figure 3-5. Mean change over the full area scanned between the first two scans was 14 cm of deposition. This change is more likely vegetation growth than accretion, as a significant increase in vegetation cover was noted at the time of the second scan. Between Scans 1 and 3 the mean change over the area scanned was 8 cm of erosion. Figure 3-4 b) shows that much of this occurred along the toe of the bank. Areas of the previous vegetation growth, particularly at the upstream end of the scan area, clearly remained at the time of the third scan. Between the first and last scan mean change over the area scanned was 19 cm of erosion. The height of bank that was able to be captured during Scan 4 was less than the previous scans, as water level was higher at this time. As a result, the DEM of difference shown in Figure 3-4 c) is a narrower strip of bank. This also means that any further changes along the toe of the bank are obscured.

Figure 3-5: Histograms of the DEMs of difference for Site 2. a) between scan 1 (December 2009) and scan 2 (March 2010); b) between scan 1 and scan 3 (December 2010); c) between scan 1 and scan 4 (May 2011).

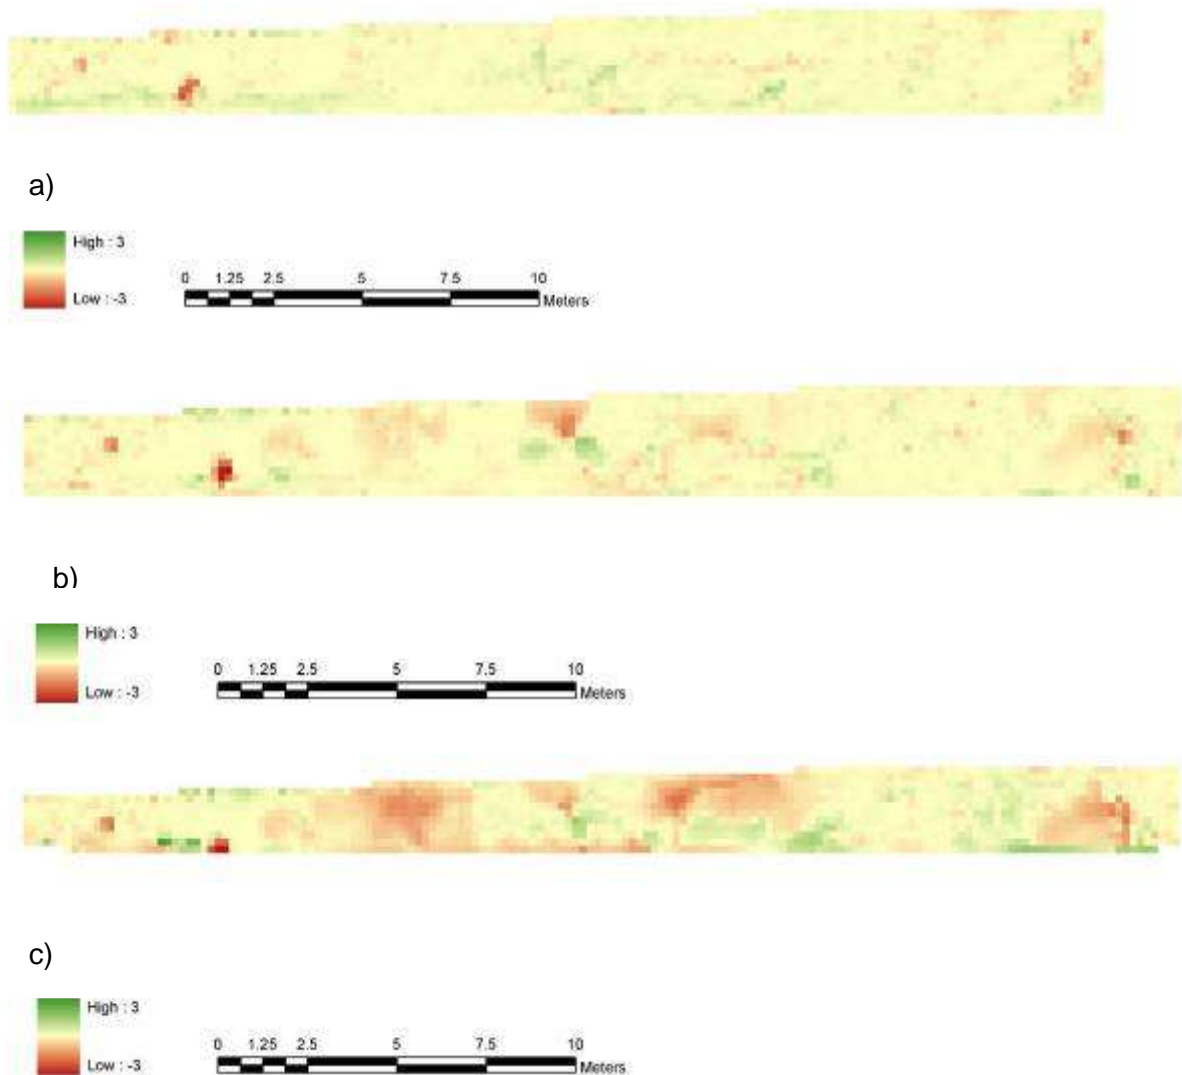
The DEM of difference images for Site 3 are presented in Figure 3-6 and the histograms are presented in Figure 3-7. Mean change over the full bank between the first two scans was 3 cm of deposition (more likely vegetation growth). Between Scans 2 and 3 the mean change over the area scanned was 6 cm of erosion. Between the first and last scan mean change over the area scanned was 15 cm of erosion. The changes over the first three scans can generally be considered negligible as this is a relatively vegetated bank. However, change before Scan 4 is clear in part c) of both figures.

Figure 3-6: DEM of difference images for Site 3. a) between scan 1 (December 2009) and scan 2 (March 2010); b) between scan 1 and scan 3 (December 2010); c) between scan 1 and scan 4 (May 2011). Note flow is from right to left.

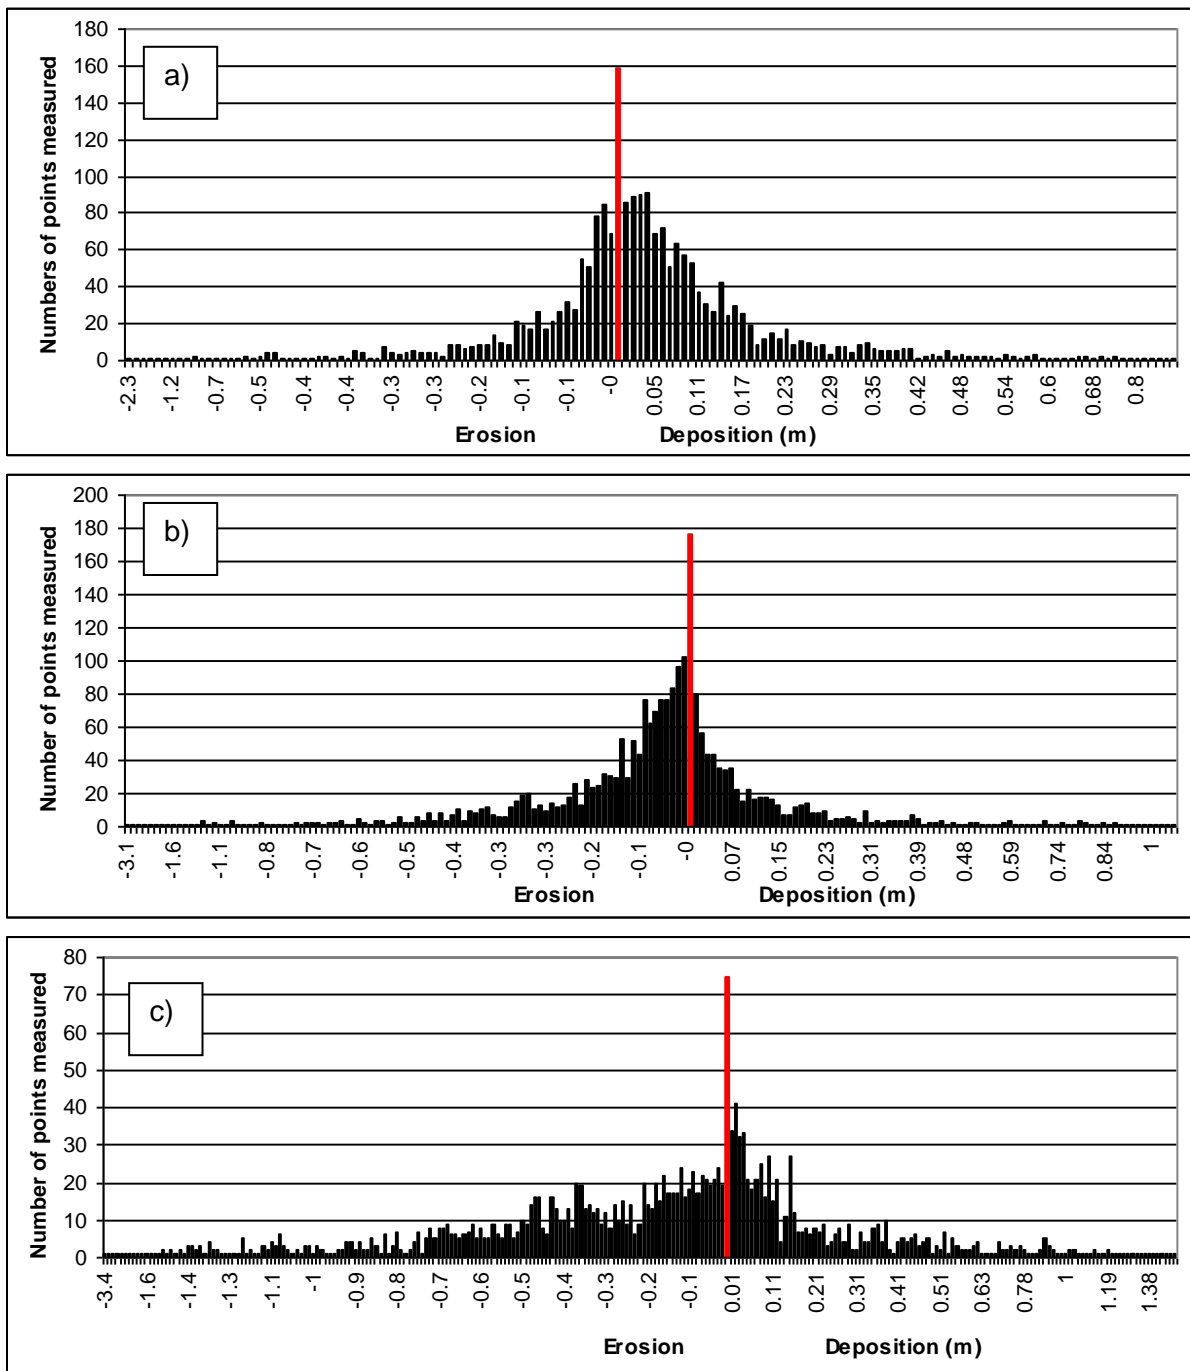
Figure 3-7: Histograms of the DEMs of difference for Site 3. a) between scan 1 (December 2009) and scan 2 (March 2010); b) between scan 1 and scan 3 (December 2010); c) between scan 1 and scan 4 (May 2011).

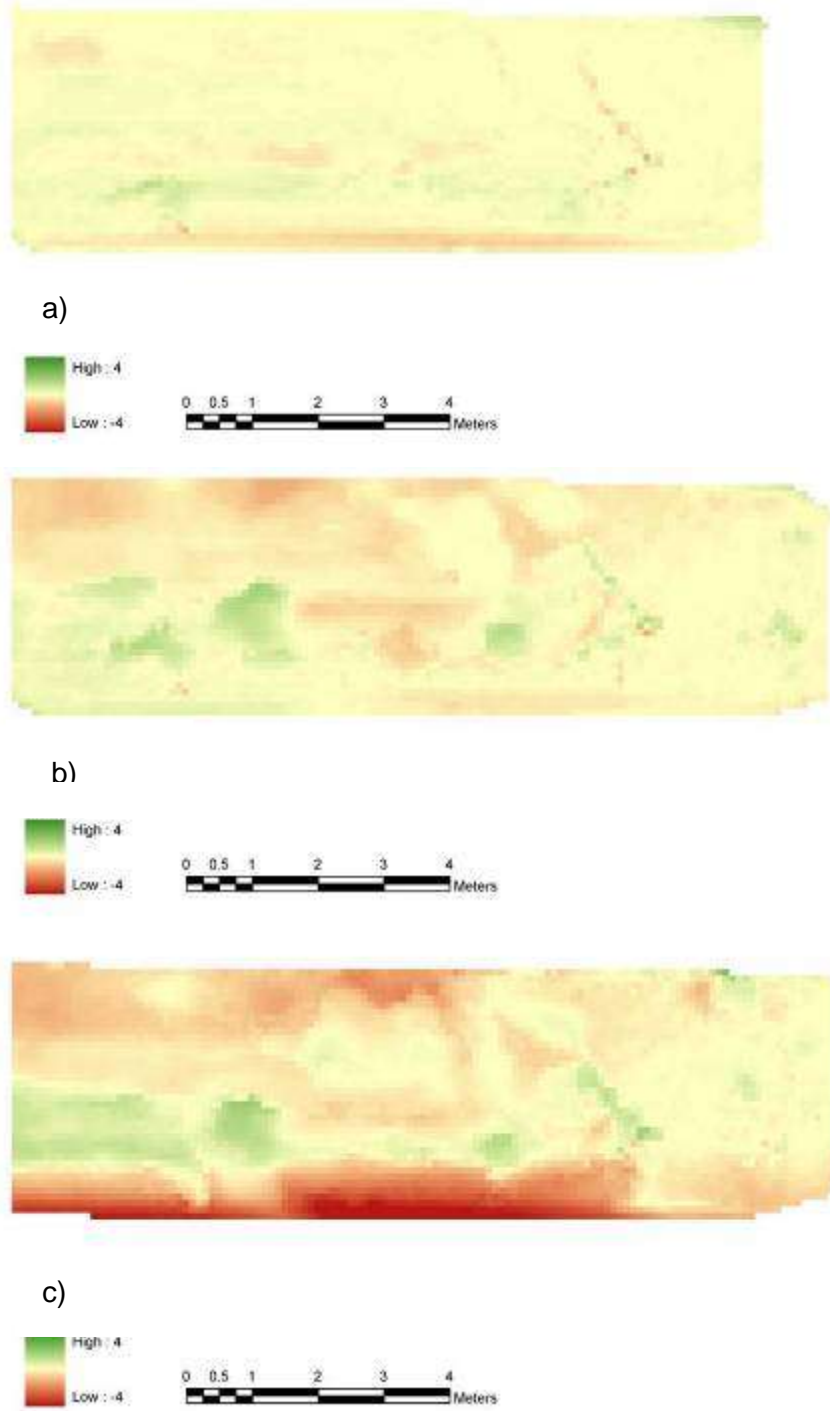
The DEM of difference images for Site 4 are presented in Figure 3-8 and the histograms are presented in Figure 3-9. Overall, change between Scans 1 and 2 at this site is generally negligible with a mean change over the area scanned of 1 cm of erosion. However, Figure 3-8 a) clearly indicates a strip of erosion along the toe of the bank. Mean change between Scans 1 and 3 was 9 cm of erosion. While this mean indicates a net loss of material, Figure 3-8 also indicates that some slumping has occurred, with material removed from the top of

the bank but deposited at the bottom of the bank. The same feature is apparent to a greater degree in part c) of Figure 3-8 but much of the slumped material has been eroded from the top of the bank. Mean change over the area scanned between the first and last scan was 49 cm of erosion.

Figure 3-8: DEM of difference images for Site 4. a) between scan 1 (December 2009) and scan 2 (March 2010); b) between scan 1 and scan 3 (December 2010); c) between scan 1 and scan 4 (May 2011). Flow is from right to left.

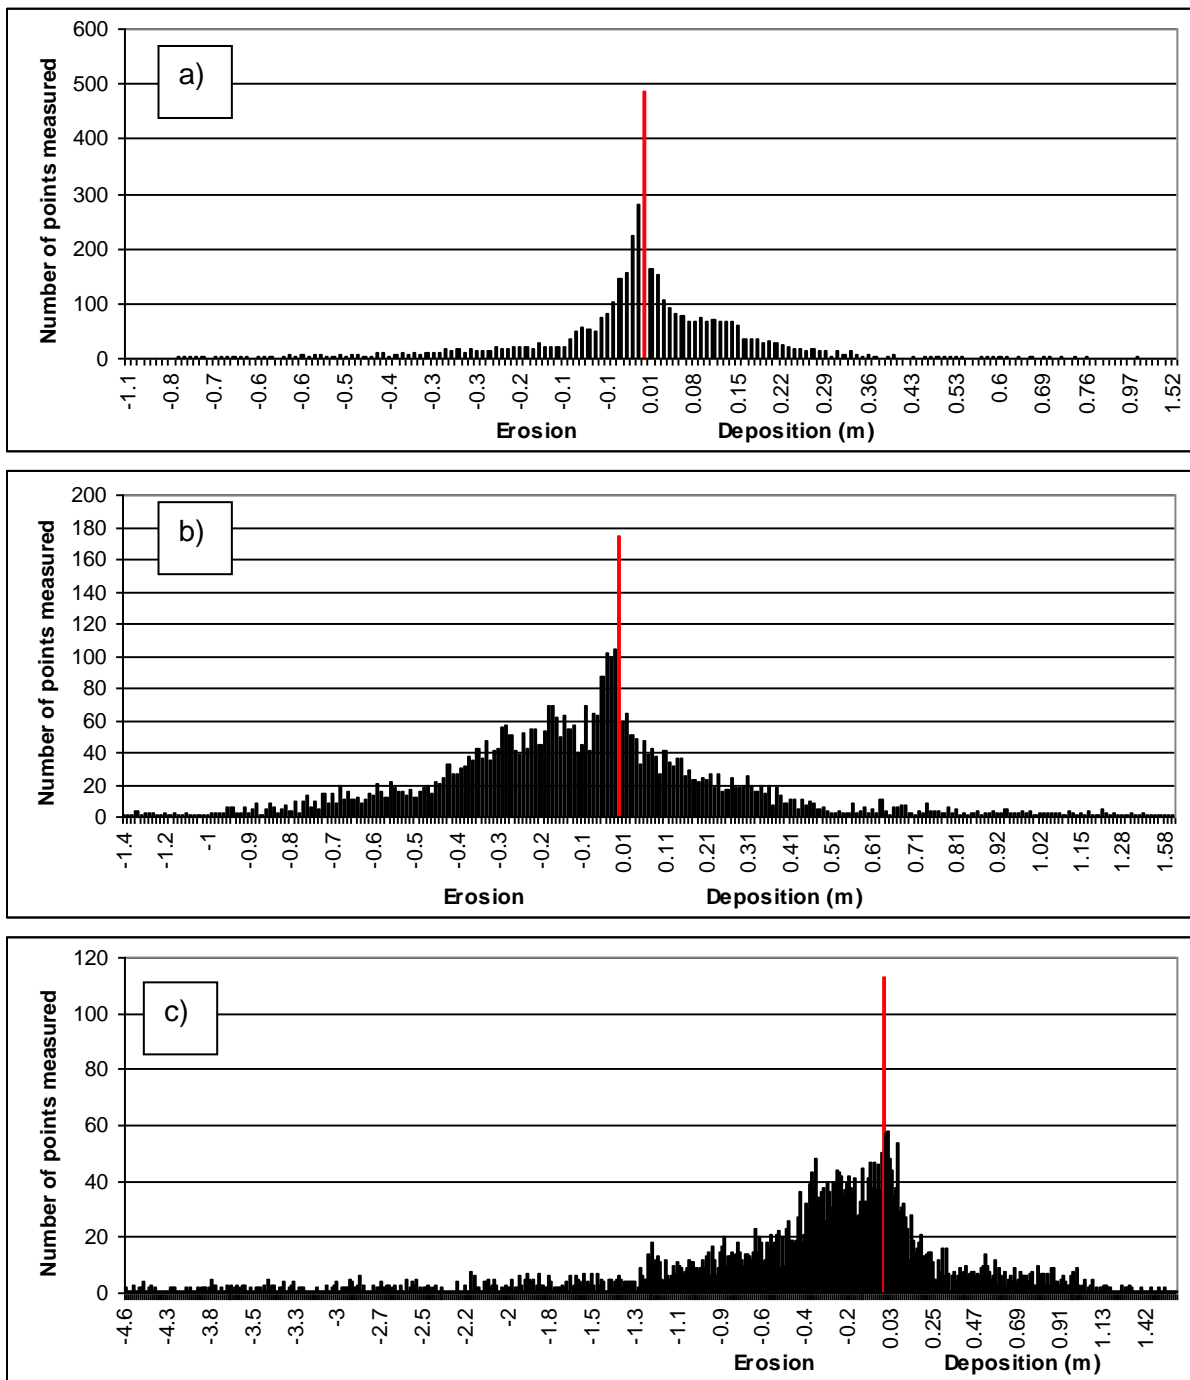
Figure 3-9: Histograms of the DEMs of difference for Site 4. a) between scan 1 (December 2009) and scan 2 (March 2010); b) between scan 1 and scan 3 (December 2010); c) between scan 1 and scan 4 (May 2011).

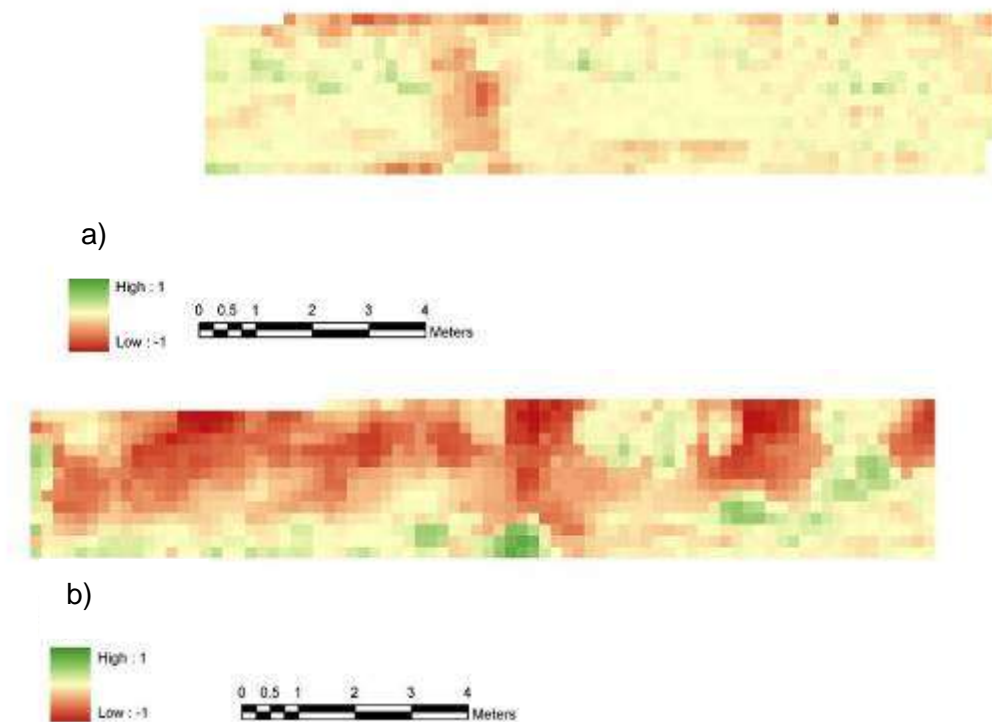
Only three scans could be compared at Site 5, as several of the TLS orientation pegs moved after the third scan. The DEM of difference images for this site are presented in Figure 3-10 and the histograms are presented in Figure 3-11. Between the first and second scans mean change over the full area of scanned bank was 5 cm of erosion, however, most of the change can be seen to have occurred in one particular area (Figure 3-10 a). This differs from the change between Scans 1 and 3 where erosion is clear on Figure 3-10 b) across the full length and particularly the upper part of the bank. Mean change between the Scans 1 and 3 was 26 cm of erosion.

Figure 3-10:DEM of difference images for Site 5. a) between scan 1 (December 2009) and scan 2 (March 2010); b) between scan 1 and scan 3 (December 2010). Note flow is from right to left.

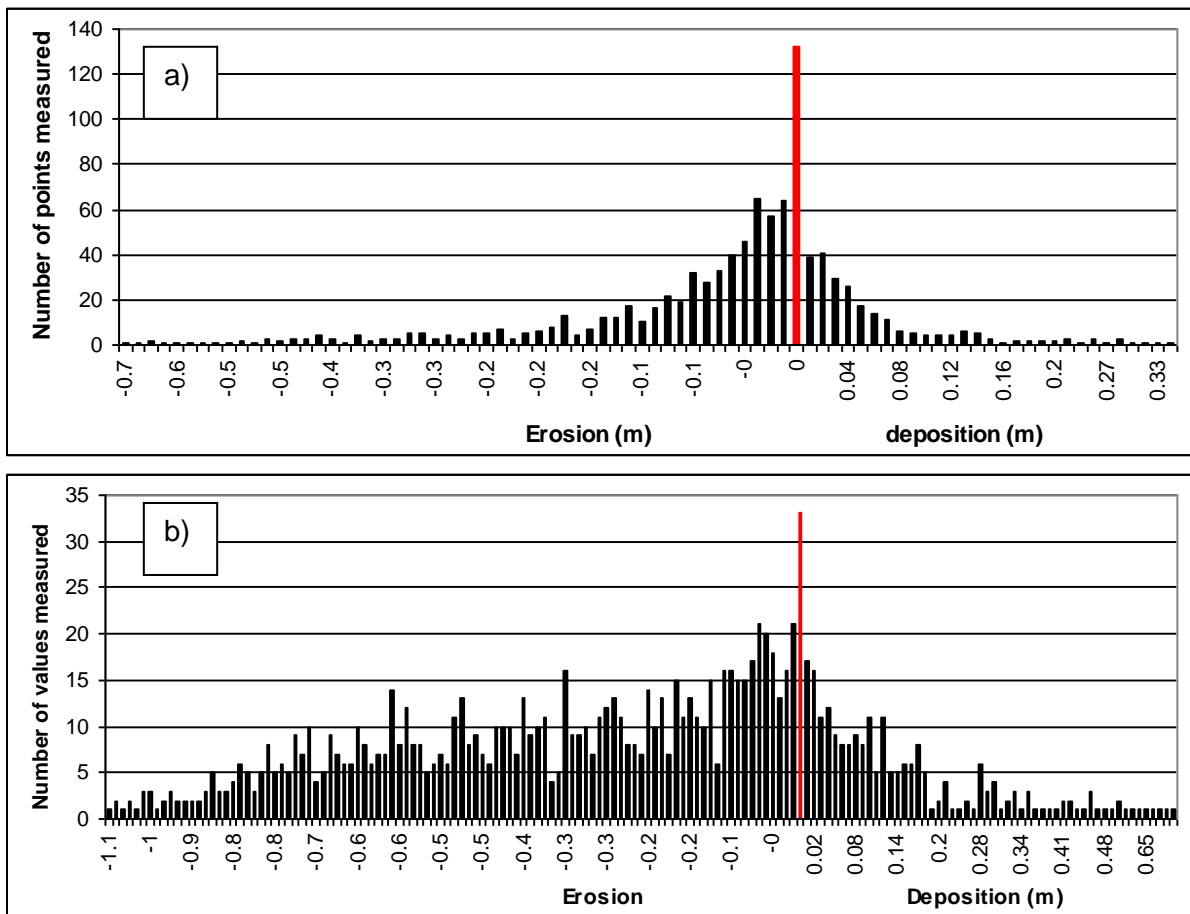
Figure 3-11: Histograms of the DEMs of difference for Site 5. a) between scan 1 (December 2009) and scan 2 (March 2010); b) between scan 1 and scan 3 (December 2010).

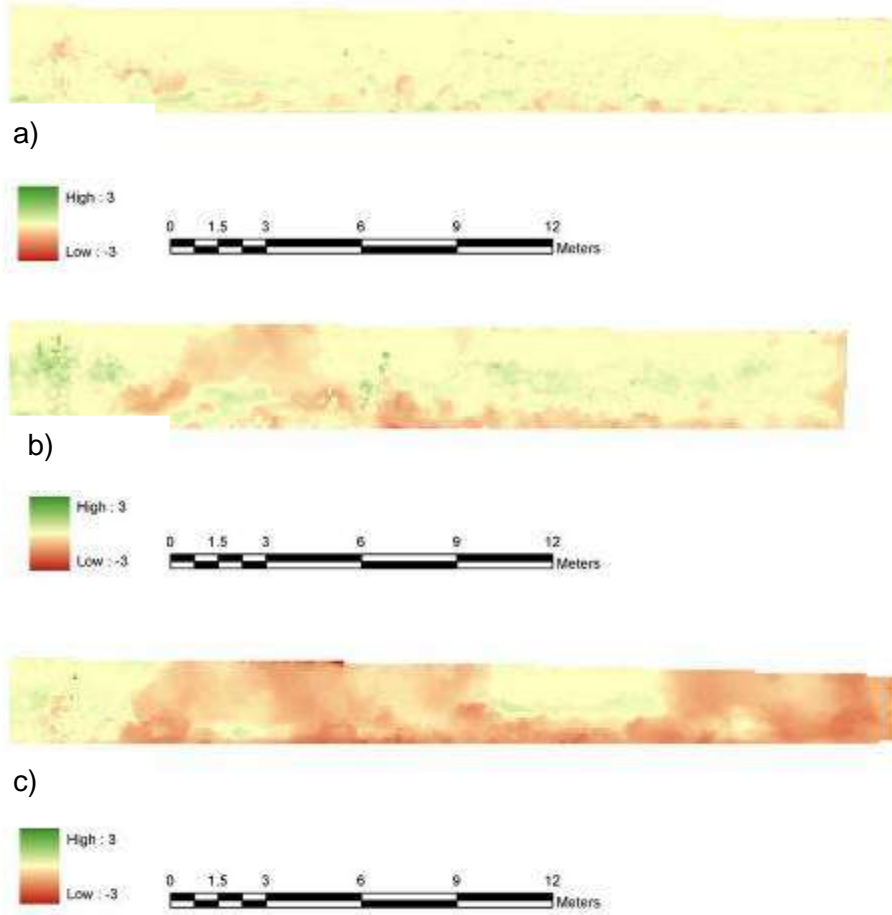
The DEM of difference images for Site 6 are presented in Figure 3-12 and the histograms are presented in Figure 3-13. Change between the first and second scans is negligible with a mean over the area scanned of 1 cm of erosion. Change between the first and third scans is clearer with a patch of vegetation growth at the upstream end, a slip about a third of the way along the bank and erosion at the toe along the downstream half of the bank (Figure 3-12 b). Mean change over the area scanned for this period was 8 cm of erosion. Erosion between the first and last scans increases considerably. It is generally focussed in the same areas of the bank but there is a new area of erosion at the downstream end. Mean change over the area scanned for this period was 58 cm of erosion.

Figure 3-12:DEM of difference images for Site 6. a) between scan 1 (December 2009) and scan 2 (March 2010); b) between scan 1 and scan 3 (December 2010); c) between scan 1 and scan 4 (May 2011). Note flow is from left to right.

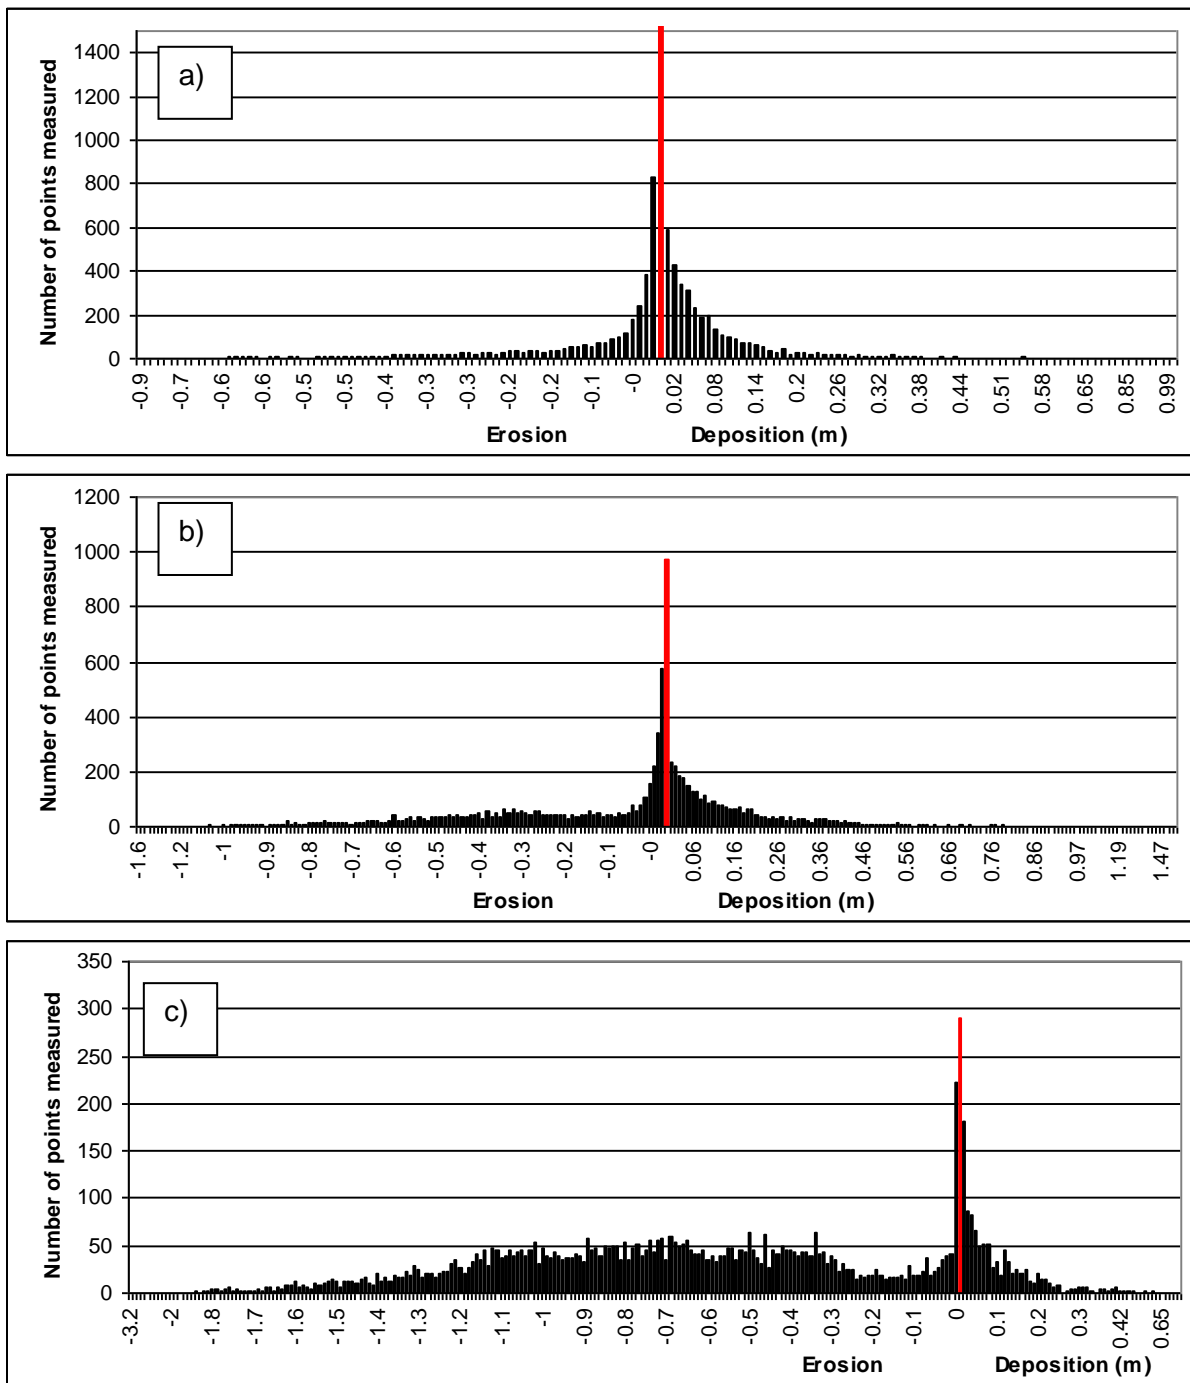
Figure 3-13: Histograms of the DEMs of difference for Site 6. a) between scan 1 (December 2009) and scan 2 (March 2010); b) between scan 1 and scan 3 (December 2010); c) between scan 1 and scan 4 (May 2011).

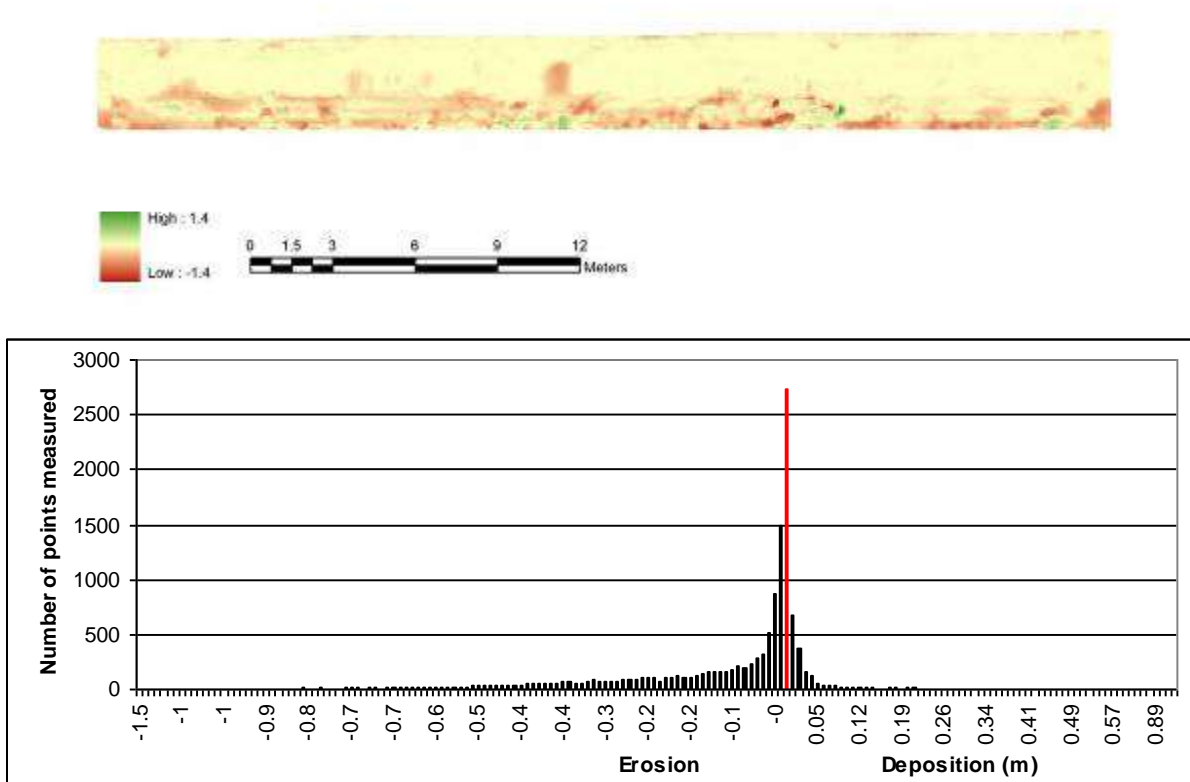
Only two scans could be compared at Site 7, as several of the TLS orientation pegs were removed when the bank engineering works were carried out in April 2010. The DEM of difference image is presented with the histogram in Figure 3-14. As the third and fourth scans could not be used, changes after the second scan cannot be quantified. However, photographs taken during Scan 3 and during the final inventory of bank erosion along the full reach clearly show that significant erosion occurred after Scan 2. These photographs are presented in the following section where they can be compared with surveillance photos.

Mean change over the area scanned between the first and second scan was 9 cm of erosion. This was a period of relatively low flow and the erosion occurred along the toe of the bank. The DEM of difference image in Figure 3-14 shows an area around the middle of the bank where a block of material higher up the bank has collapsed and registers as deposition (green) at the toe of the bank.

Figure 3-14: DEM of difference and the associated histogram for Site 7. For the period between scan 1 (December 2009) and scan 2 (March 2010). Note flow is from right to left.

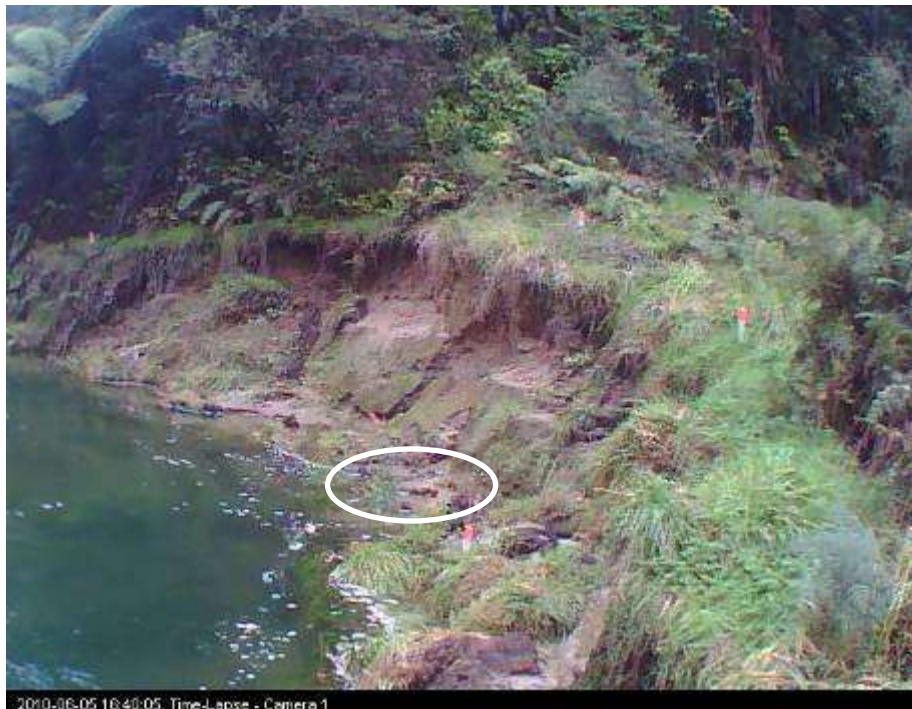
Figure 3-18: Active erosion at waters edge at Site 1 on 5/6/10. See following figure for site 10 mins later.

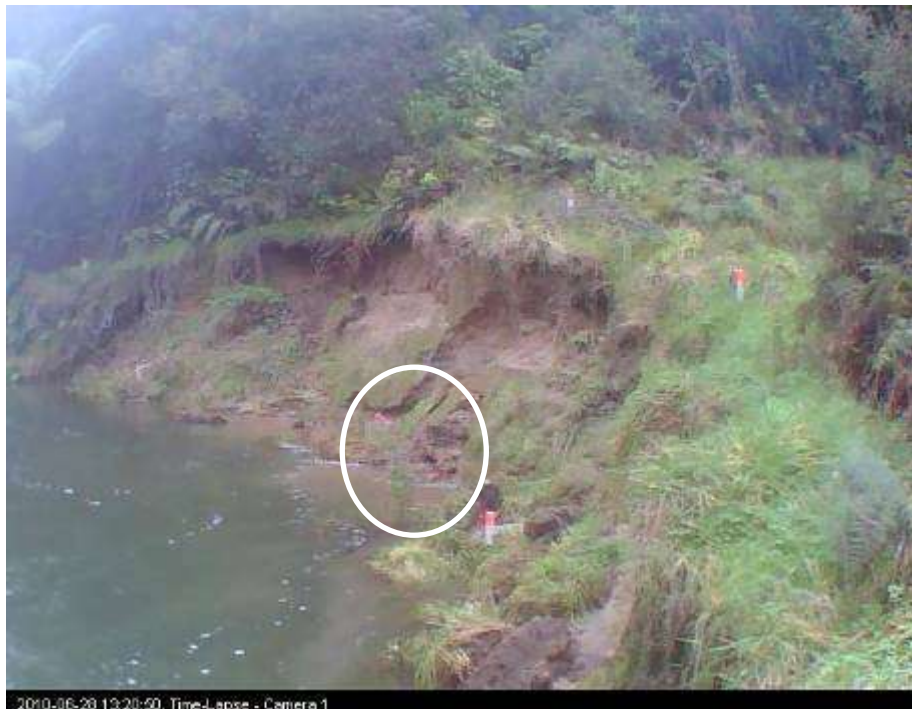
Figures 3-21 and 3-22 are taken 2 hours apart and show a section of bank in the middle of the site slumping into the river. The water at the toe of the bank is also discoloured on Figure 3-22, showing that sediment is being mobilised. This slump may have been caused by jet boating and/or by bank saturation, as this period was preceded by rain. Figure 3-23 shows a wave hitting the toe of the bank and spilling over the vegetation in the foreground. This wave is clearly viewed on the time-lapse movie and is believed to be from a jet boat wake. The following figure (Figure 3-24) is taken 5 minutes later and shows no apparent change. However, Figure 3-25 is taken 25 minutes later and clearly shows that the water is discoloured. During the remaining part of this day, the water cleared and became murky again. This is believed to be the result of a jet boat passing up and down the river. Figures 3-26 and 3-27 show further slumping in the middle part of the bank on 8 August 2010. This corresponds with a flow peak apparent on the hydrograph in Figure 3-15.

Figure 3-22:Area of erosion at waters edge at Site 1 on 28/6/10. 2 hours after previous photo. Note water discolouration.

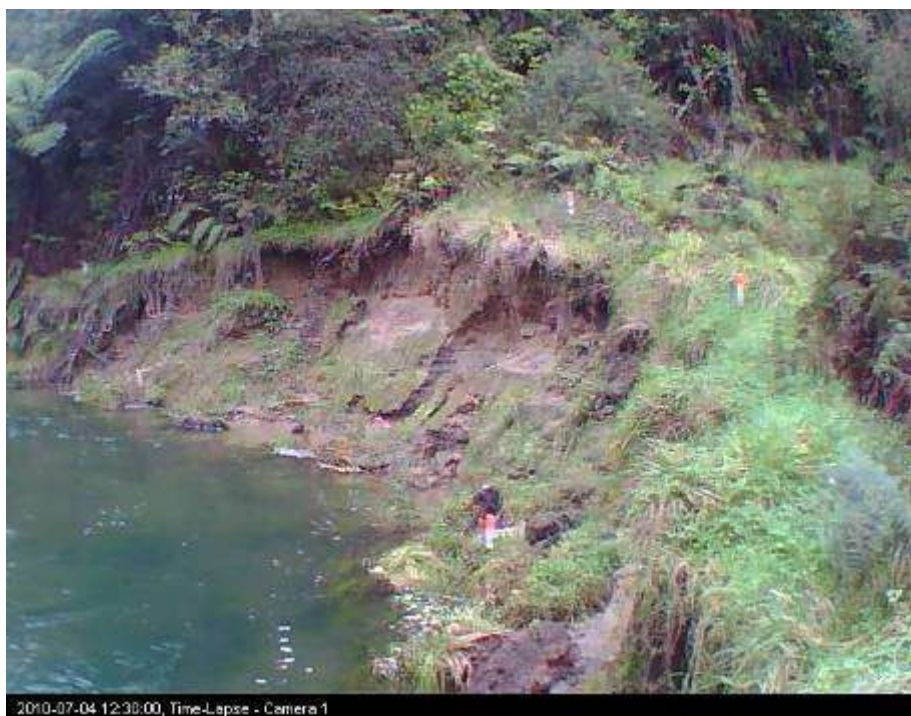
Figure 3-24:Site 1 on 4/7/10 at 12:30. 5 minutes after the previous photo.

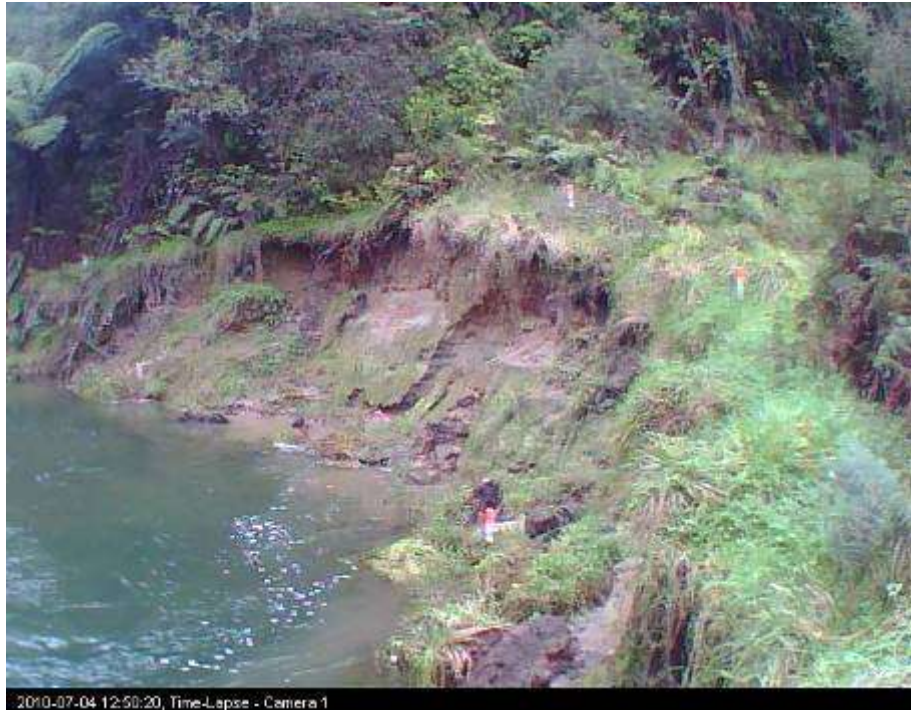
Figure 3-25: Site 1 on 4/7/10 at 12:50, 25 minutes after the small wave hit the bank. Note the murky water. The water goes murky at this site on the same day at 13:56, 14:26 and 16:03

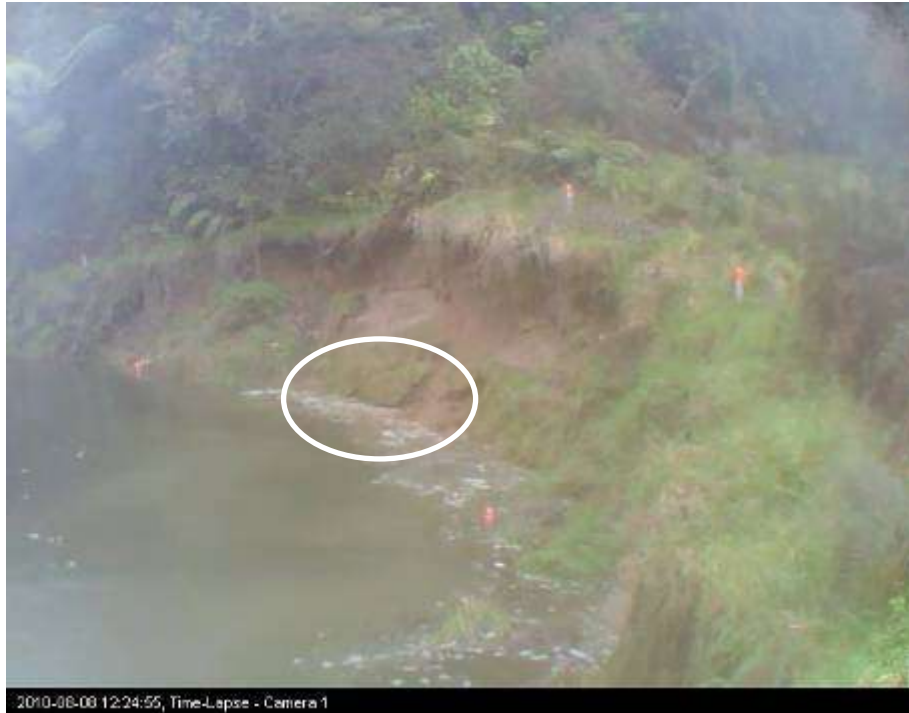
Figure 3-27:Active erosion at waters edge at Site 1 on 8/8/10 12:25. 5 mins after the previous photo. Note the peg in the circled area has disappeared.

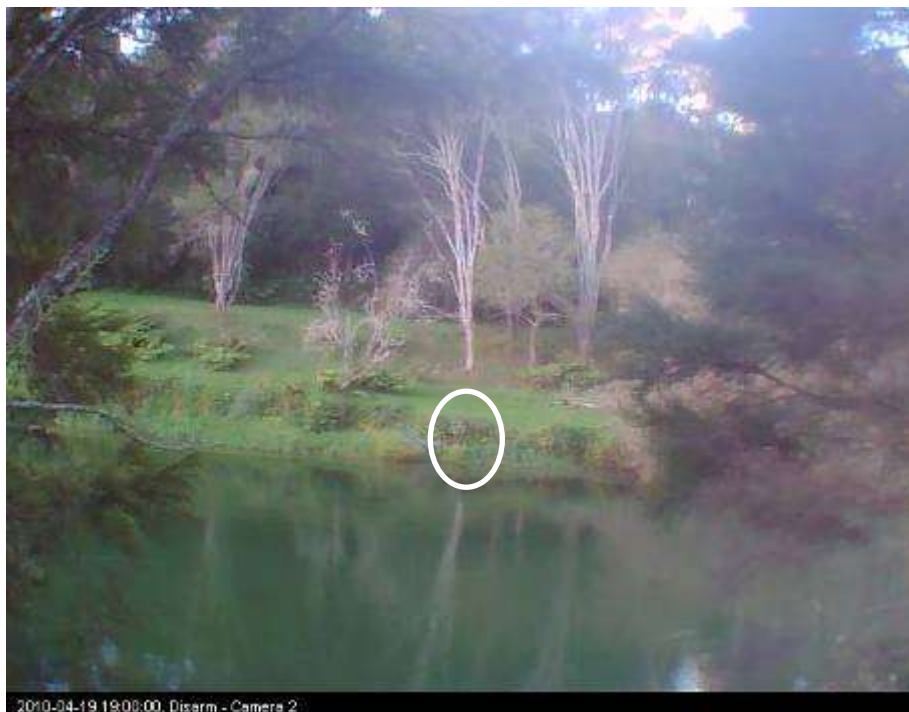
Figure 3-29:The last photo taken of Site 2 before nightfall on 19/4/2010. The area circled is the site of erosion that occurs overnight.

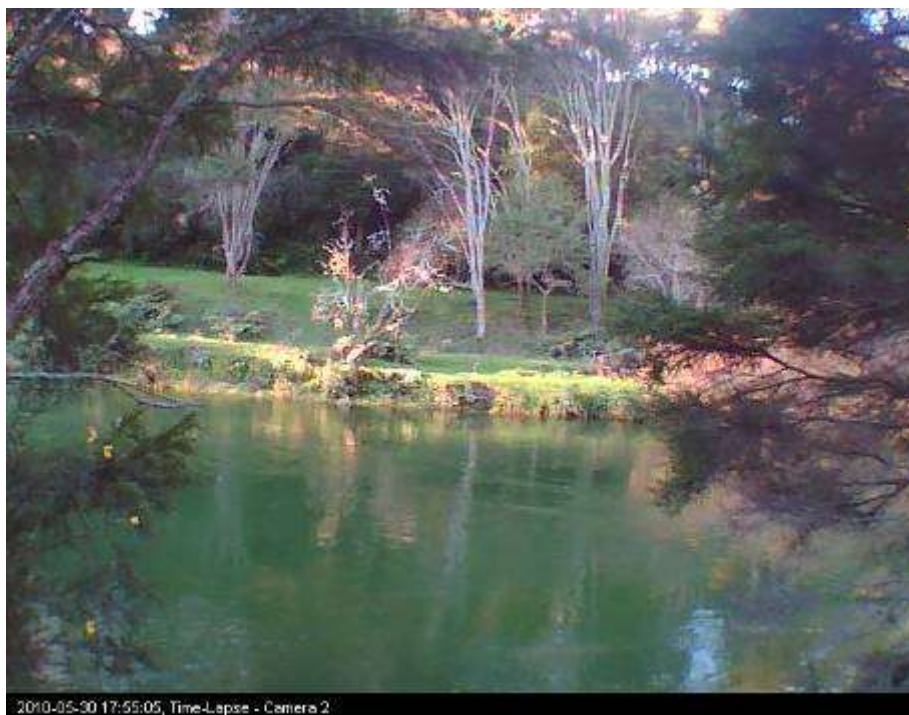
Figure 3-33:The first clear photograph of Site 2 after water level had dropped (30/5/10). Note no apparent new erosion.

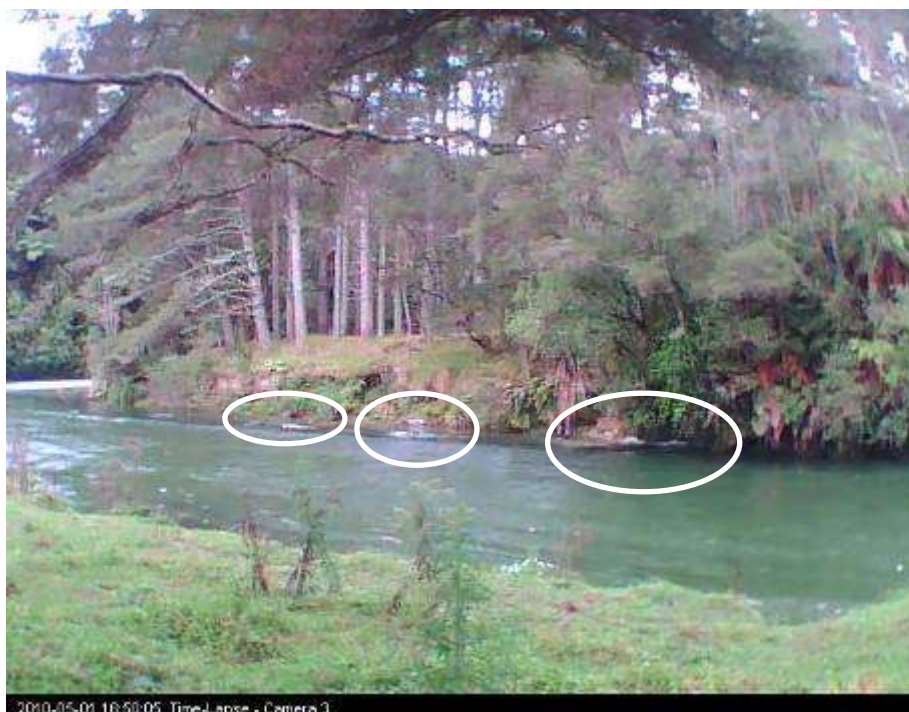
Figure 3-40: Jet boat wake hitting Site 3 on 1/5/10 at 16:50. Waves hitting the bank are circled.

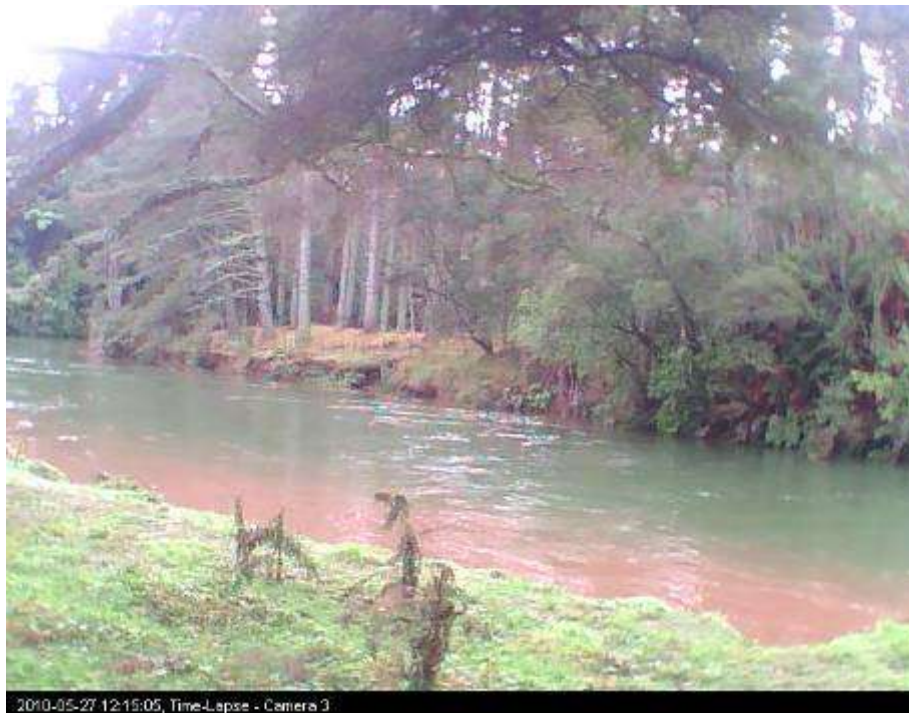
Figure 3-43: Photograph taken on 27/5/10 at 12:15 clearing showing a high degree of suspended sediment along the edge of the near bank opposite Site 3.

The main question to be answered in this report is what role jet boating is playing on the bank erosion in this reach, and whether or not it is significant. The surveillance photos (particularly Figures 3-42 to 3-45) clearly show that jet boat activity is contributing to bank erosion, and also to reduced water clarity, but quantifying its effect is less simple.
