Investigation into the role of jet boating on bank erosion in the Kaituna River

Prepared for Bay of Plenty Regional Council

February 2012

NIWA Client Report No: CHC2011-088
Report date: February 2012
NIWA Project: EBP10501

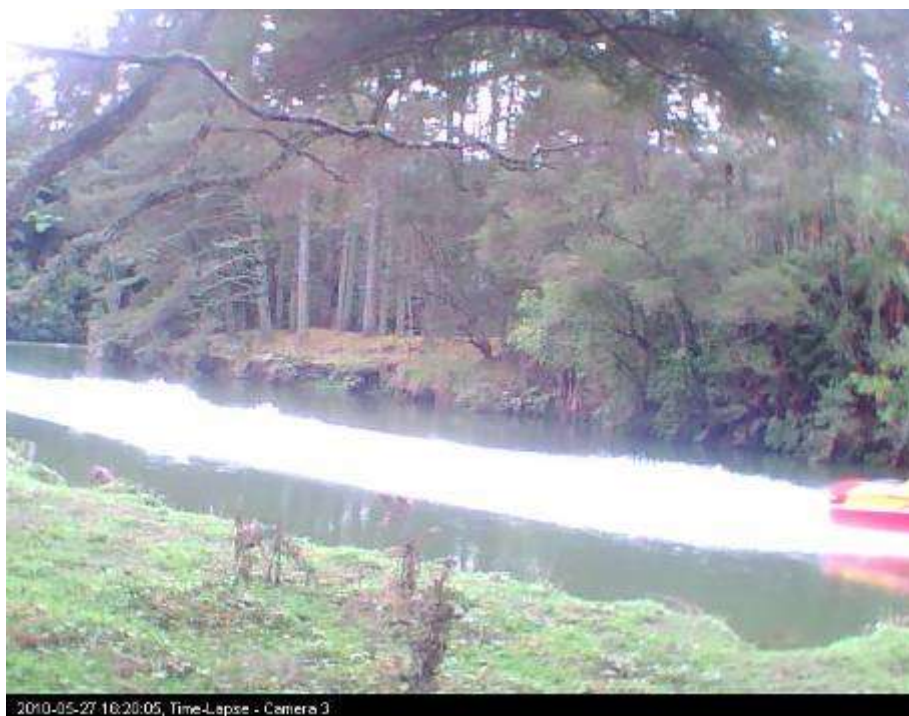
Figure 3-44: Photograph of Site 3 later on 27/5/10 (16:20) showing that the commercial jet boat was operating on this day.

The main question to be answered in this report is what role jet boating is playing on the bank erosion in this reach, and whether or not it is significant. The surveillance photos (particularly Figures 3-42 to 3-45) clearly show that jet boat activity is contributing to bank erosion, and also to reduced water clarity, but quantifying its effect is less simple.

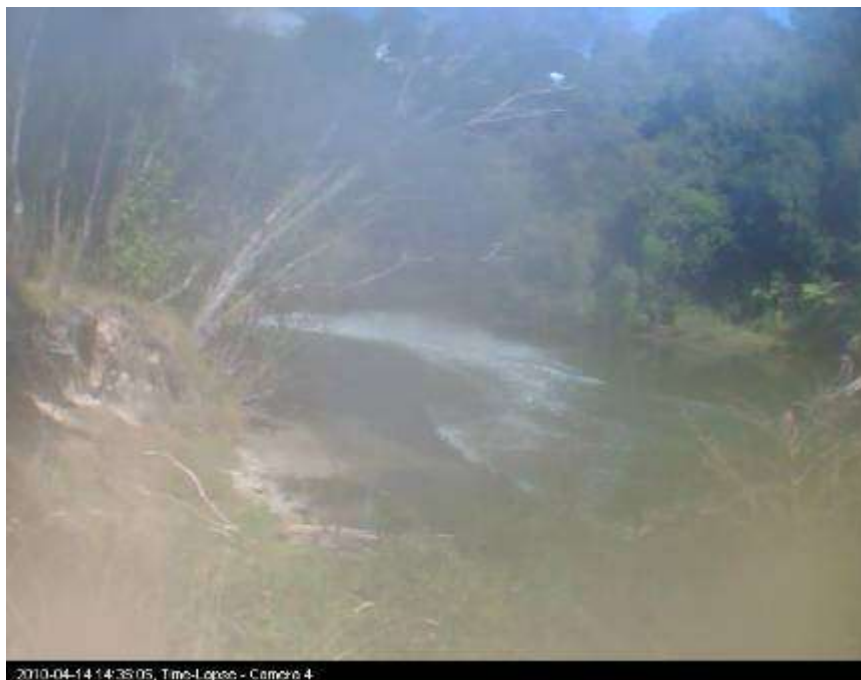
Figure 3-48:Jet boat wake at Site 4 on 14/4/10.

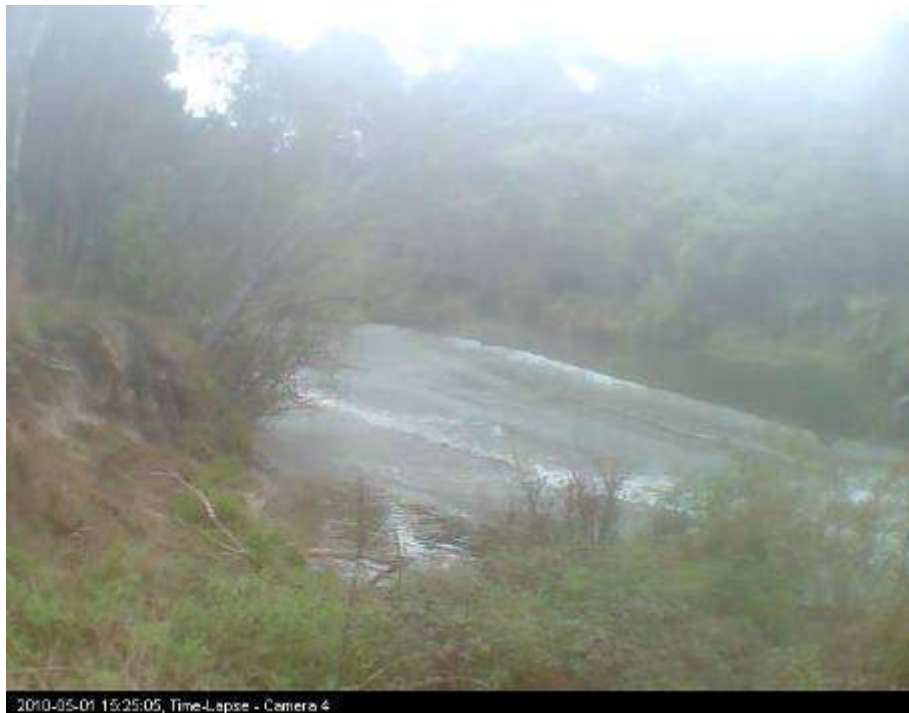
Figure 3-49: Jet boat wake at Site 4 on 1/5/10.

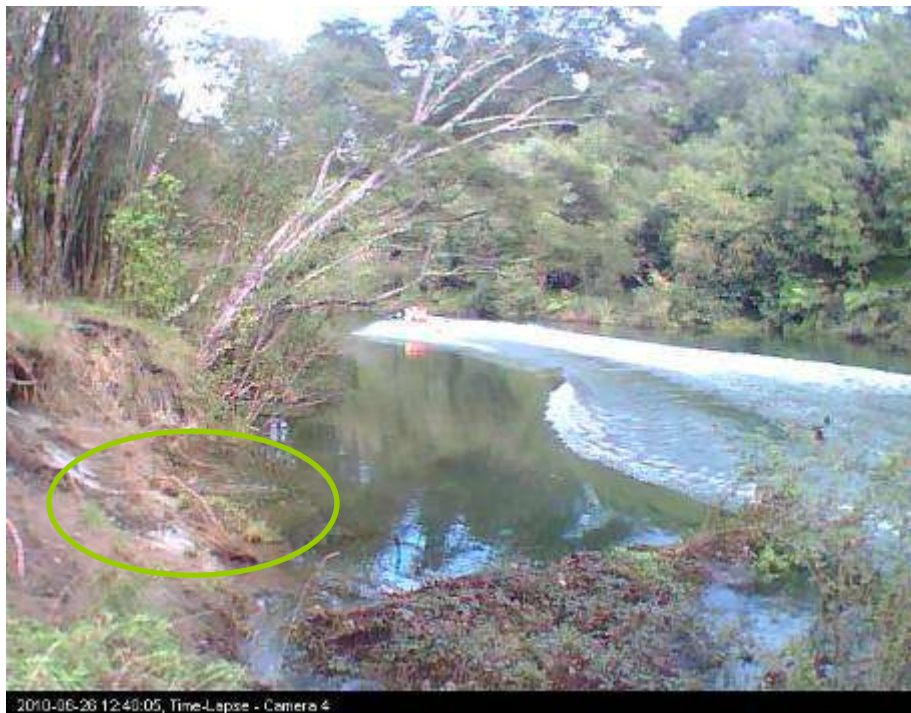
Figure 3-54: Jet boat passing Site 4 on 26/6/10. Note this is 1 month after the previous photo and grass is regrowing on the bank.

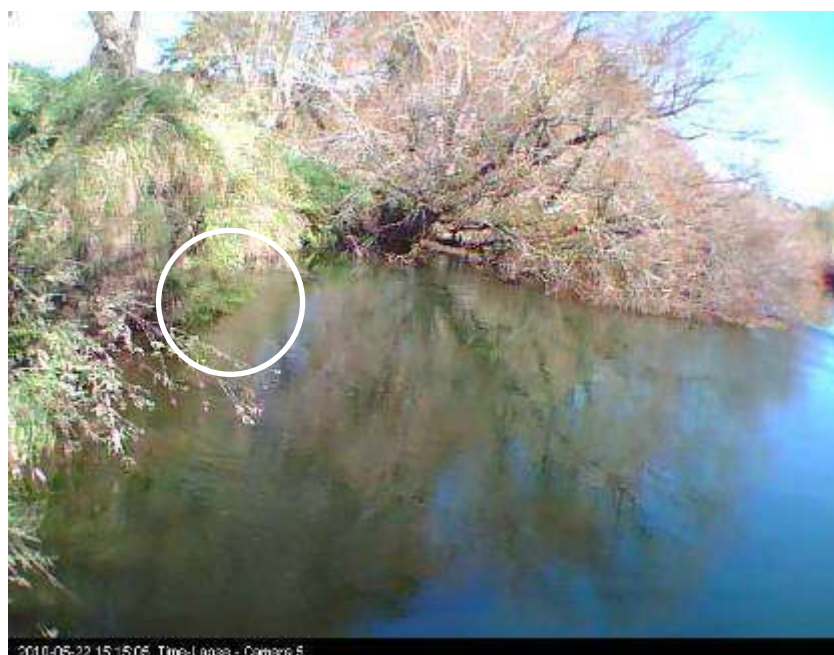
Figure 3-56:Site 5 on 22/5/10 just prior to the flood of 25/5/10. Some of the vegetation circled is removed during the following flood – see photo taken 30/5/10

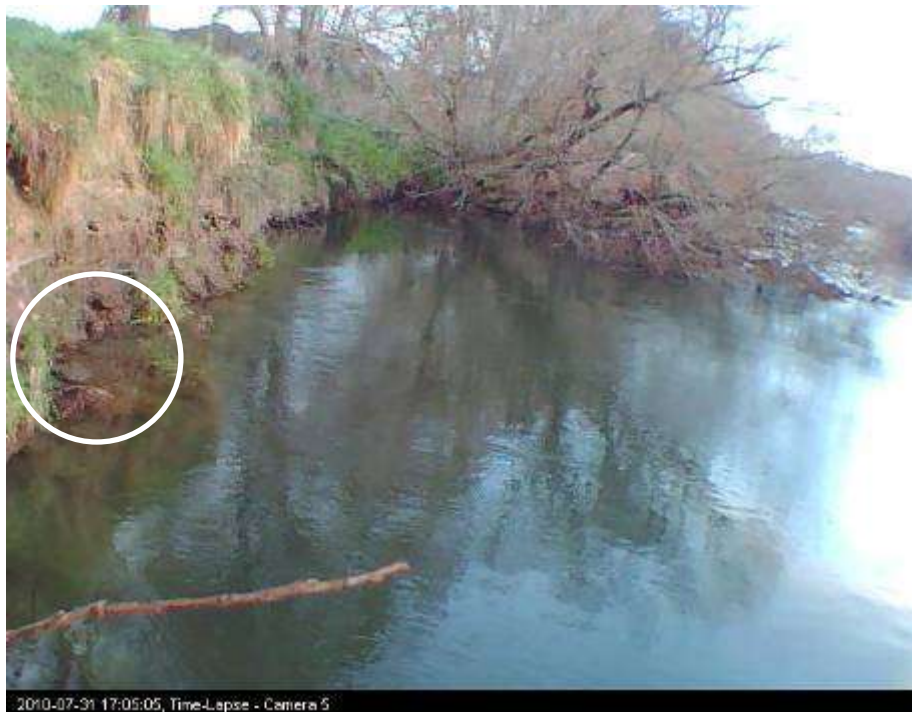
Figure 3-60:Erosion at waters edge of Site 5 on 31/7/10. Compare with previous photo.

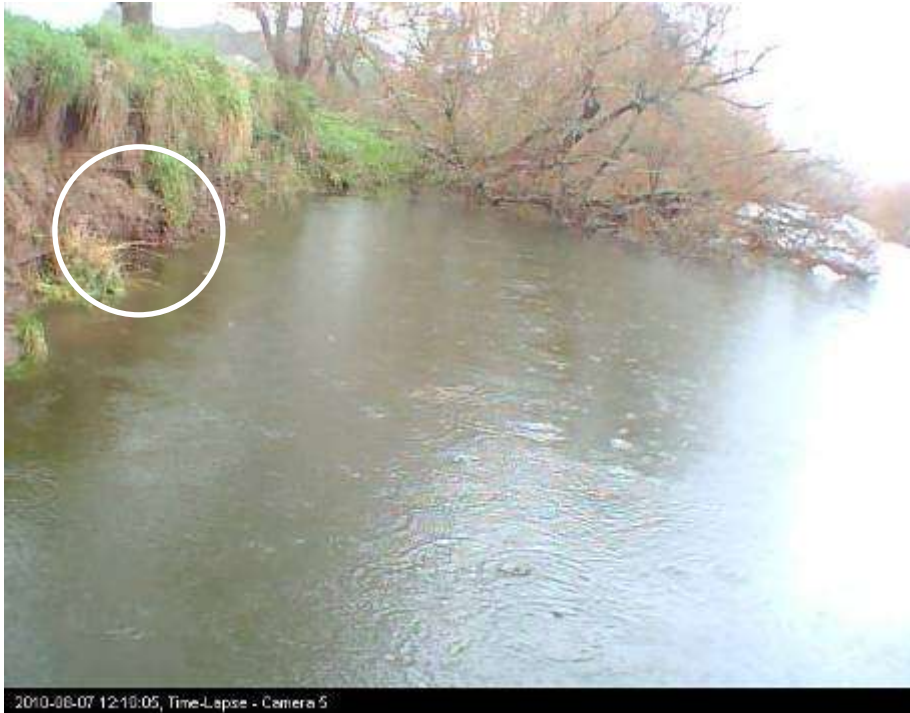
Figure 3-61:Erosion at waters edge of Site 5 on 7/8/10. Compare with following photo.

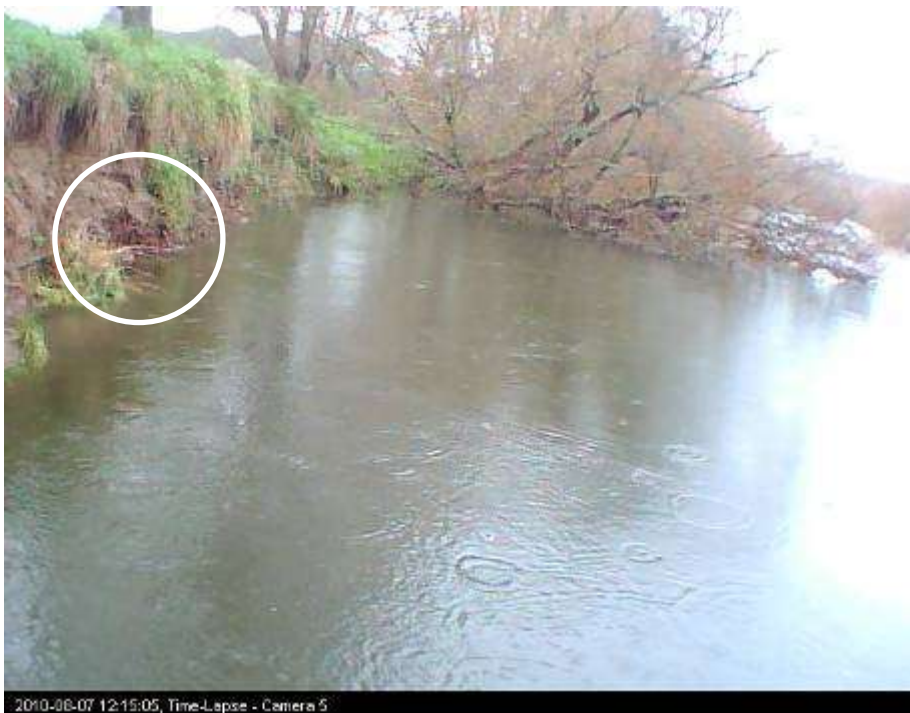
Figure 3-62:Erosion at waters edge of Site 5 on 7/8/10. Compare with previous photo, taken 5 mins earlier.

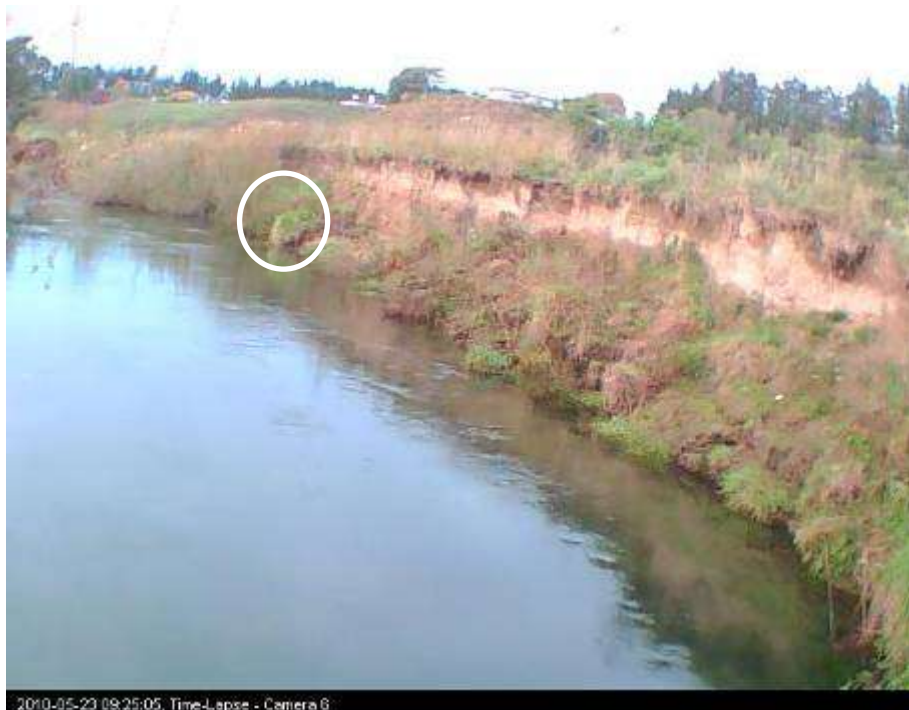
Figure 3-65:Site 6 on 23/5/10 prior to flood of 25/5/10. Circled feature to be compared with photo following flood.

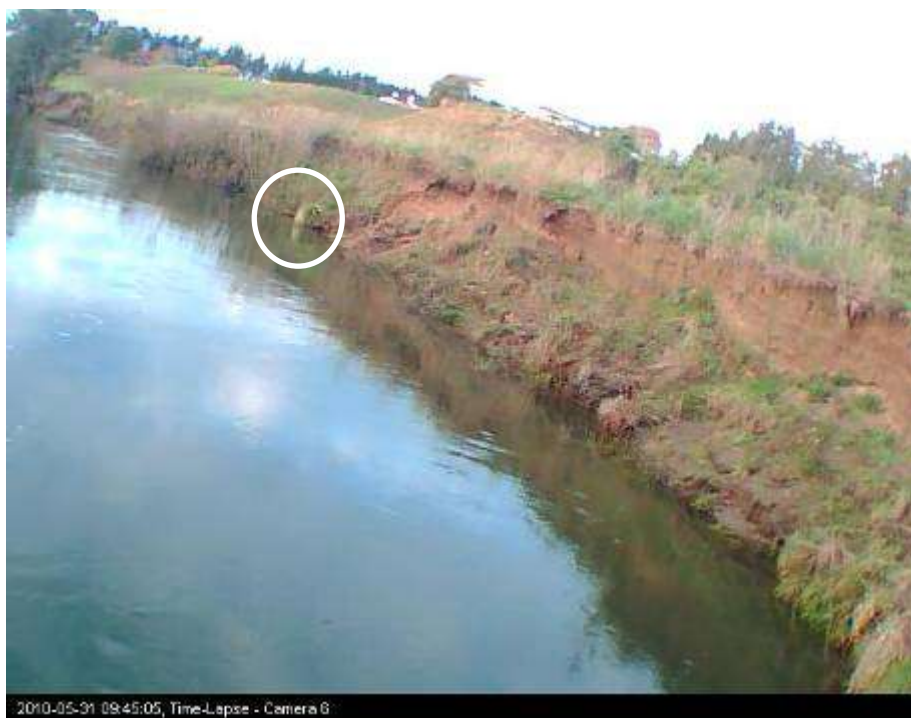
Figure 3-67:Site 6 after floodwaters had receded on 31/5/10. Circled feature to be compared with photo prior to flood.

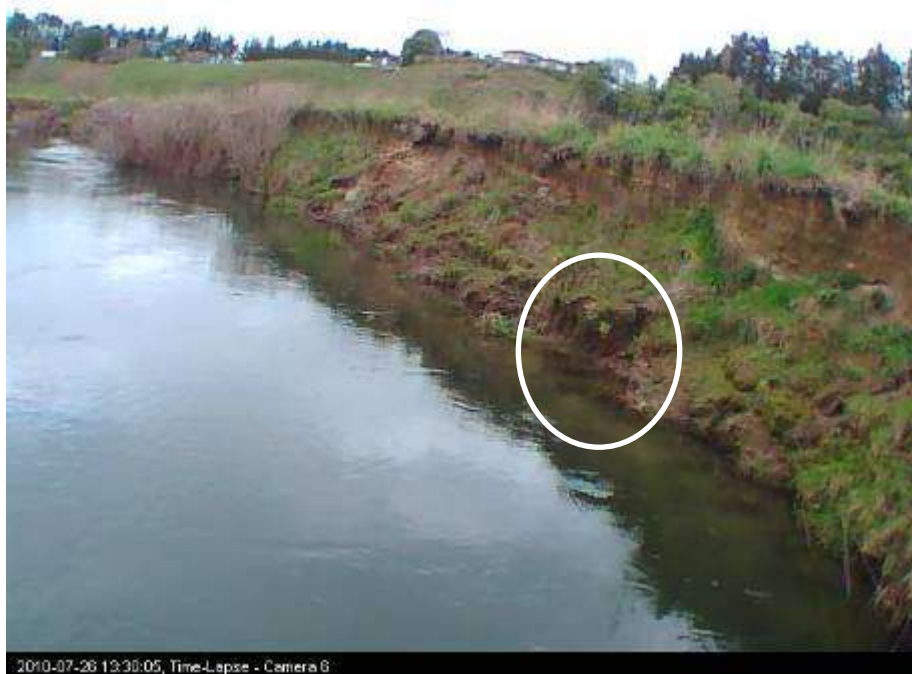
Figure 3-69:Final photograph at Site 6 taken on 26/7/10. The area circled highlights an area of bank erosion since the start of surveillance.

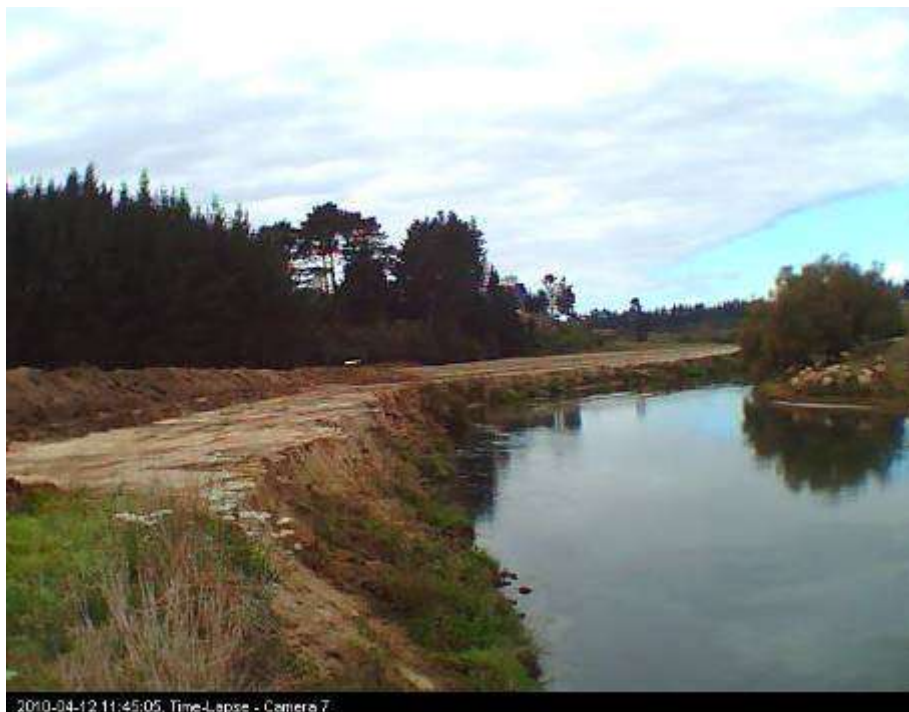
A series of surveillance photographs from Site 7 are presented in Figures 3-70 to 3-73. An additional photograph taken after the surveillance camera was removed is presented in Figure 3-74. This surveillance camera was set up at the downstream end of Site 7 so flow is towards the viewer. The first photograph is at the start of the surveillance period just after the second TLS scan. Figures 3-71 and 3-72 show stock access on the opposite bank and the latter figure also shows the engineering works underway at Site 7. Figure 3-73 shows the engineering works completed and is the final photo taken at this site from the surveillance camera before it was removed from the site. As these engineering works removed some of the TLS orientation pegs, further comparison of TLS scans was also no longer possible. However, the site was photographed at the time of the third TLS scan (6 December 2010) and considerable erosion at this site was evident (Figure 3-74). Note that this photograph was taken before the large floods of January 2011. This photograph also provides an interesting comparison with Figure 2-7, taken in October 2009.

Figure 3-72:Site 7 part way through battering of the bank on 12/4/10. Note cows on opposite bank.

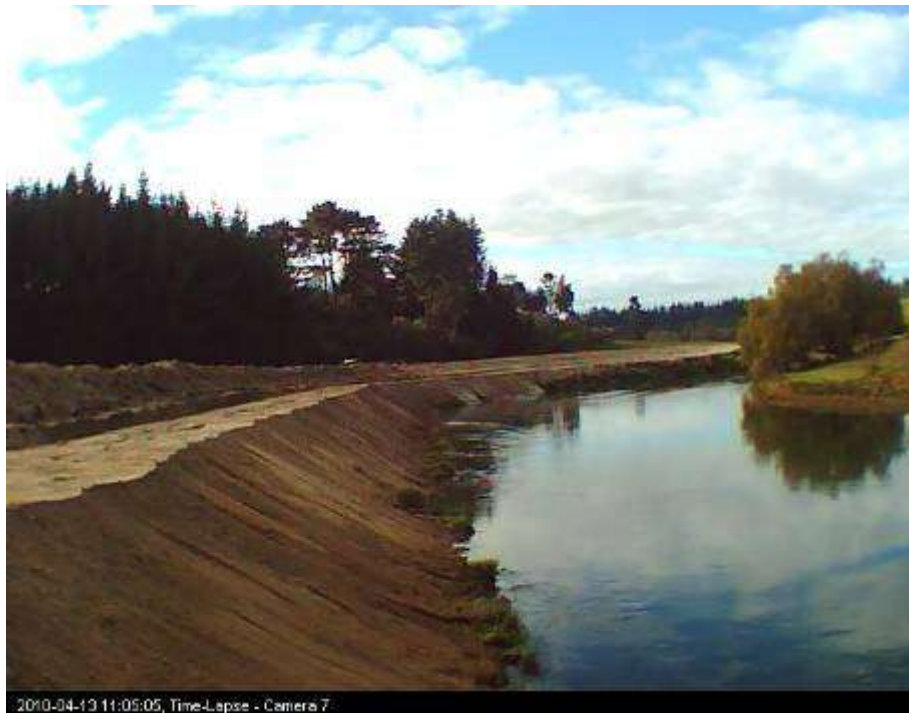
Figure 3-73:Final photograph of Site 7 after engineering works were completed on 13/4/10.

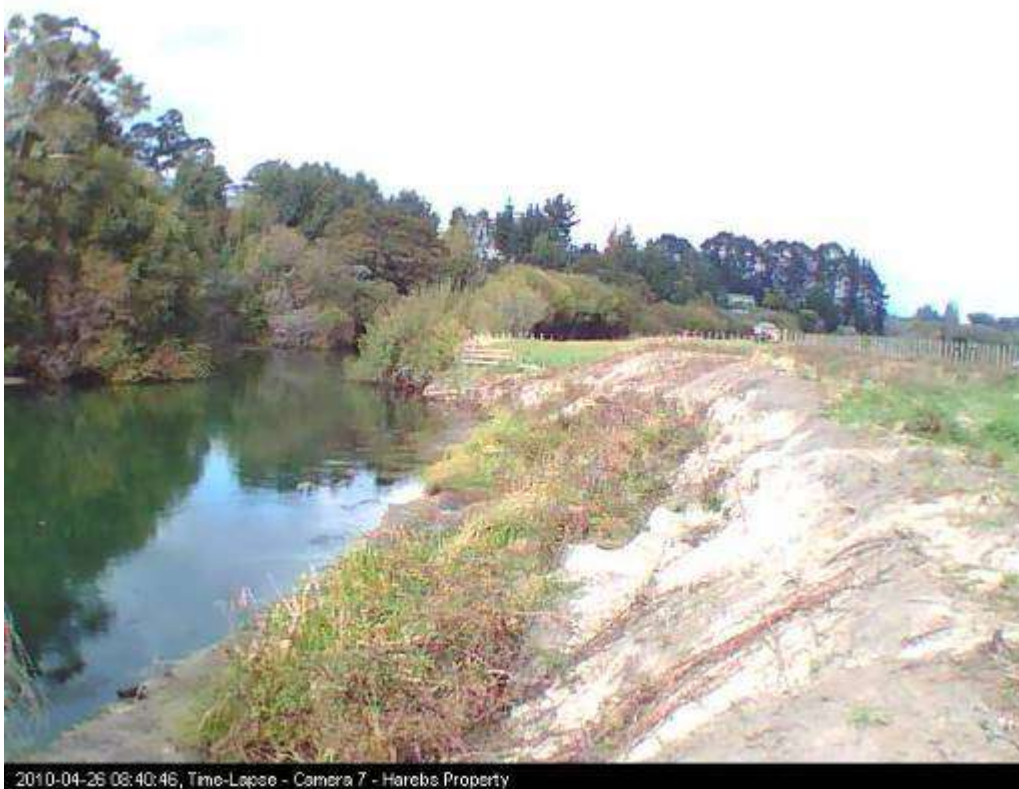
As the Site 7 surveillance camera had to be removed, it was relocated to a site on the Hareb's property. TLS was not carried out at the Hareb's site as instrument set up was not possible on the opposite bank. A series of surveillance photographs taken from this site are presented in Figures 3-75 to 3-81. This camera was positioned facing upstream so flow is towards the viewer. The first photograph is at the start of the surveillance period in April 2010. Figure 3-76 shows a jet boat passing this site on 1 May 2010. This site is well vegetated at water level and no change in bank erosion was detectable over the following 5 days. On the 6th of May this camera stopped working for no apparent reason. It was restarted on 23 June but two days later the camera moved so that it was pointing at the sky. The camera failed to capture anything of interest to this study in the following days, other than a horses head (Figure 3-78) indicating that stock have access to this site. The camera was repositioned on the 30 June 2010 and no change in the bank is apparent from the time the camera was pointed away. Figure 3-80 shows another jet boat wake at this site and Figure 3-81 is the final photo downloaded before this camera went missing.

Figure 3-75:Initial photo of Hareb's Site on 26/4/10. To compare with future photos.

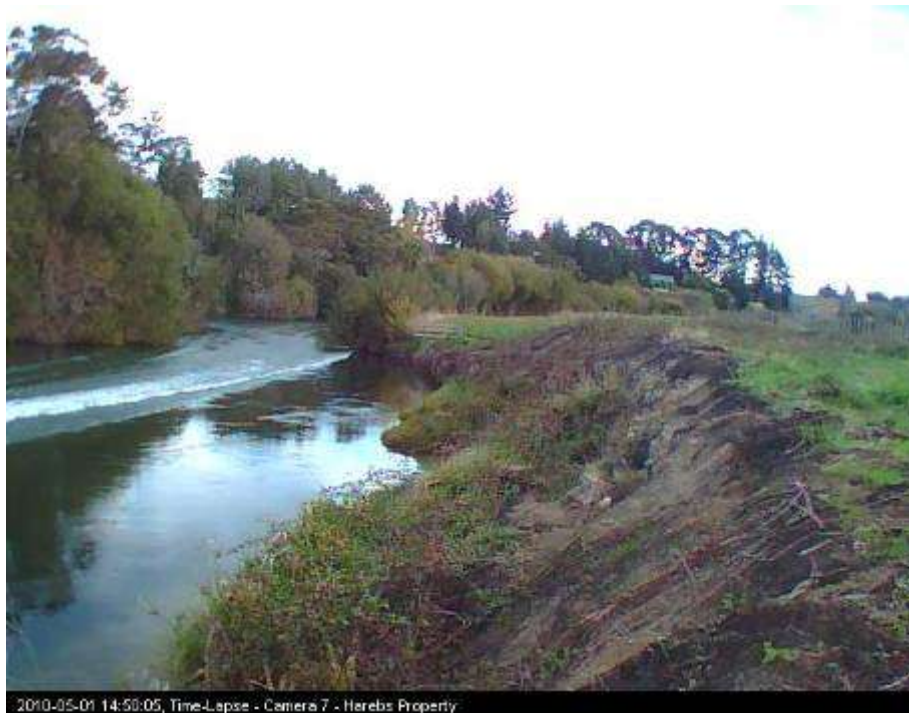
Figure 3-76: Jet boat passing Hareb's site on 1/5/10. The camera unexpectedly stopped working at this site on the 6/5/10 but was restarted on the 23/6/10

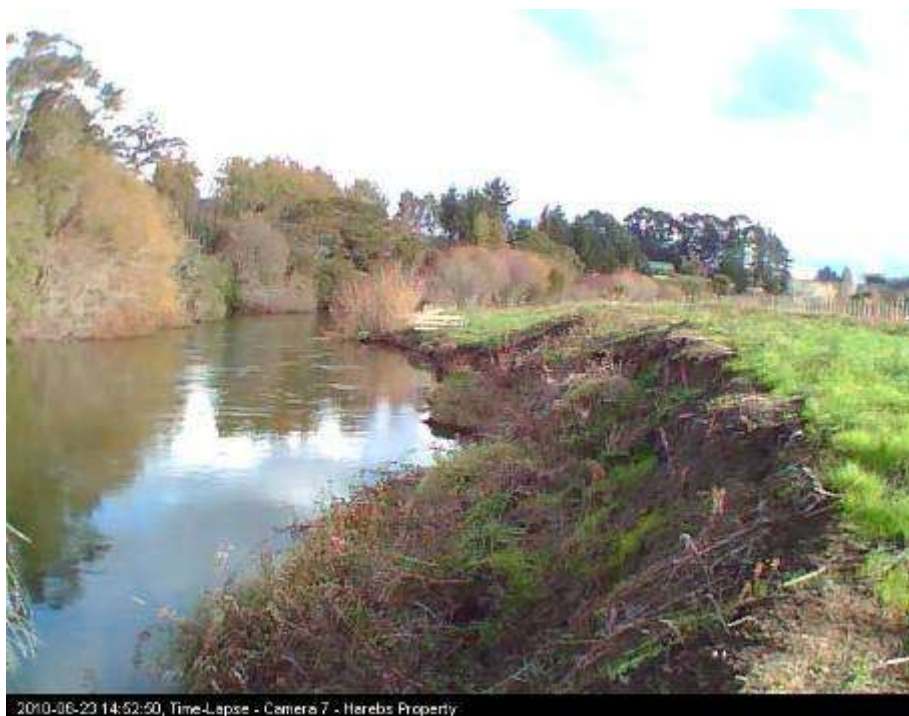
Figure 3-77: Photograph of Hareb's site after the camera was restarted on the 23/6/10. Two days later the camera suddenly moved to be pointing at the sky.

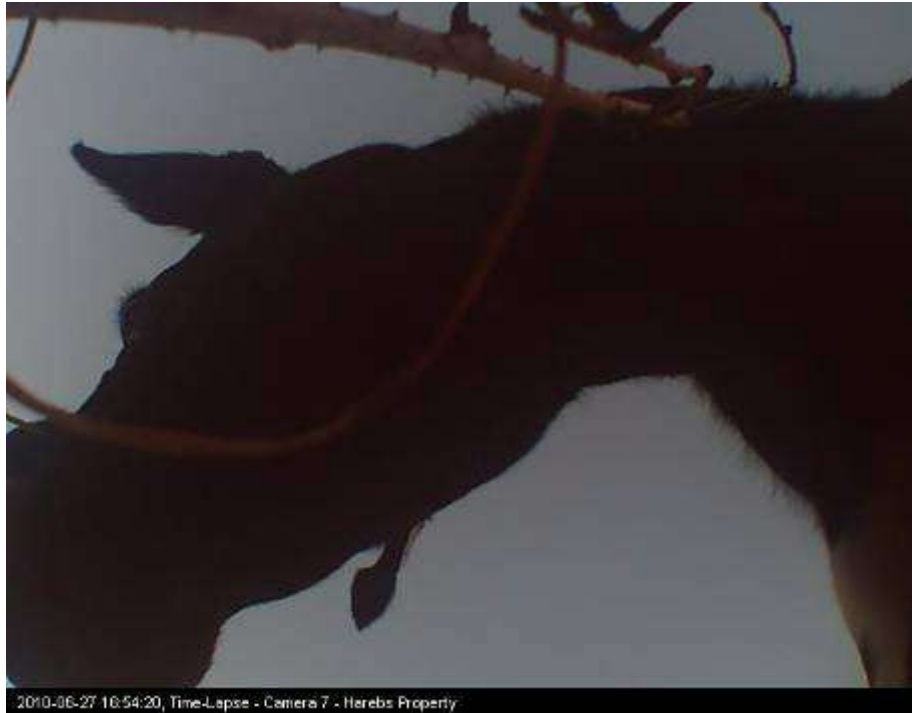
Figure 3-78:A horse head captured on camera on 27/6/10. The apparent cause of camera movement at the Hareb's site

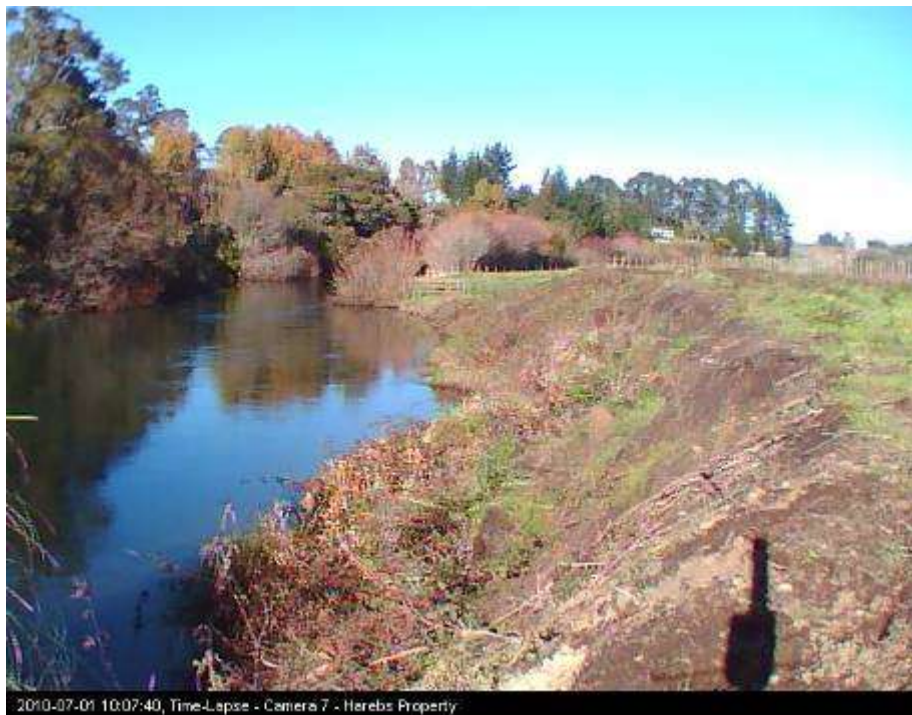
Figure 3-79:The camera was repositioned on the 30/6/10 and this photo shows the bank at Hareb's site the following day.

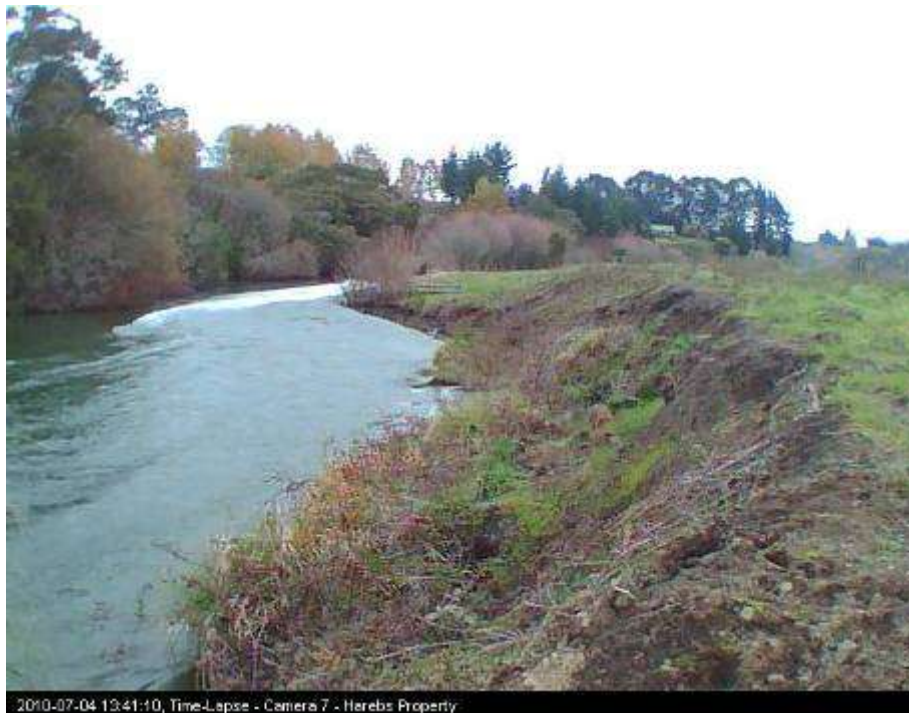
2010-07-04 13:41:10, Time-Lapse - Camera 7 - Hareb's Property
Figure 3-80:A jet boat wake at Hareb's site on 4/7/10.

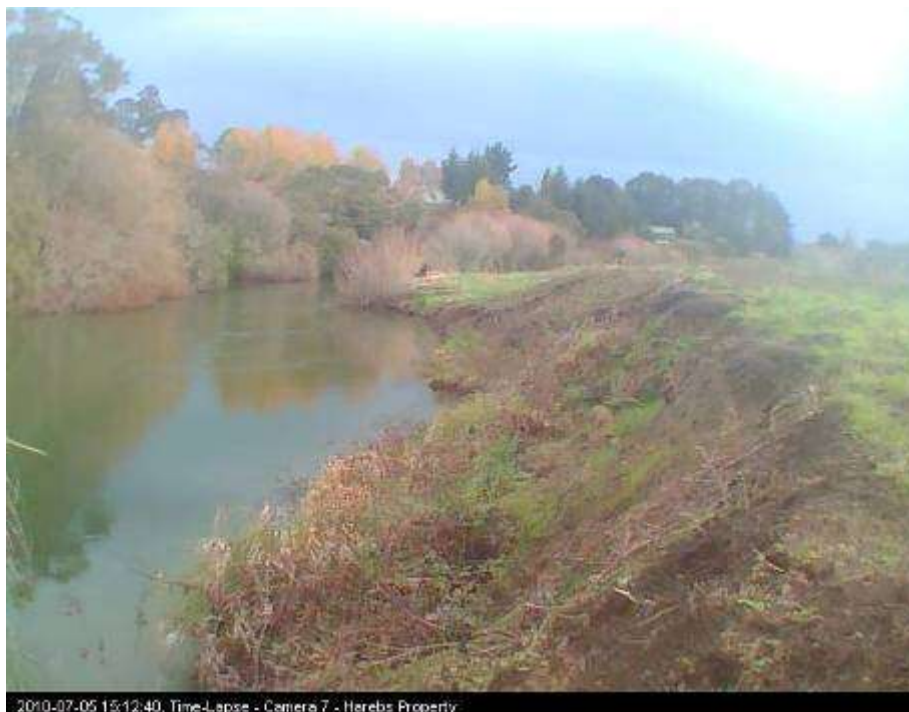
2010-07-05 15:12:40, Time-Lapse - Camera 7 - Hareb's Property
Figure 3-81:Final photograph downloaded from Hareb's site, taken on 5/7/10. When this site was next visited for photo downloading the camera was missing, apparently stolen.

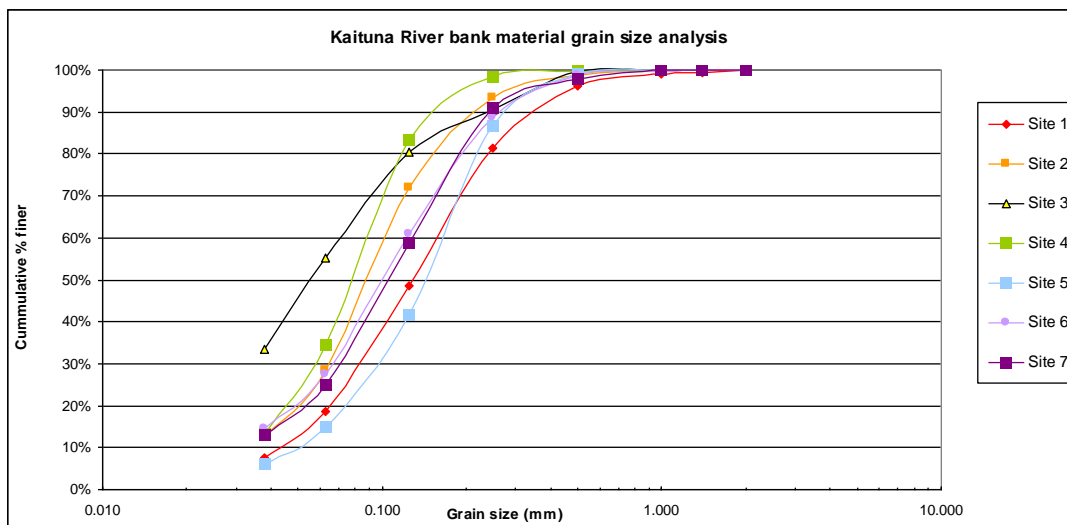
Figure 3-82 presents the results of the grain size analysis of bank material samples collected at the seven bank erosion sites. Sites 1-4 are in the jet boat reach and Sites 5-7 are in the control reach. Results show that the bank material in each case is dominantly composed of fine sand, making it naturally prone to erosion. However, material at site 3 may contain up to 30% silt and clay sized material (<64 μm), as the samples were only sieved down to 38μm. Material with a higher proportion of clay may be expected to be more cohesive and less prone to bank erosion. Sites 5 and 1 comprise the coarsest material. Overall the results indicate that there is as much variability between individual sites as between the two reaches and, therefore, the reaches may be considered comparable in terms of bank material.

Figure 3-82: Grain size analysis of bank material samples taken from the 7 bank erosion sites.

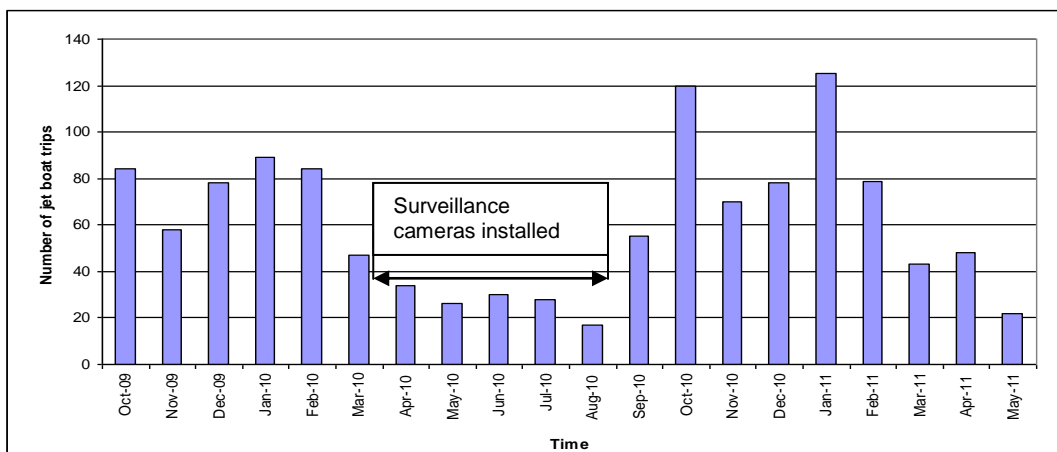
Spring Loaded supplied NIWA with summary statistics outlining the total number of trips taken by their jet boats each month and the number of hours a jet boat was on the river each month. These data are presented as a histogram in Figure 3-83 and supplied in Table 3-2.

Figure 3-83: Histogram of jet boat activity over the study period. Period in which the surveillance cameras were installed is indicated.

The average number of trips per month is 57, but the number of trips clearly peaks over the summer period. In summary, there is typically at one trip (two passages) per day in autumn/winter (36 trips per month on average) and two to three trips per day (four to six passages) in spring/summer (83 trips per month on average).

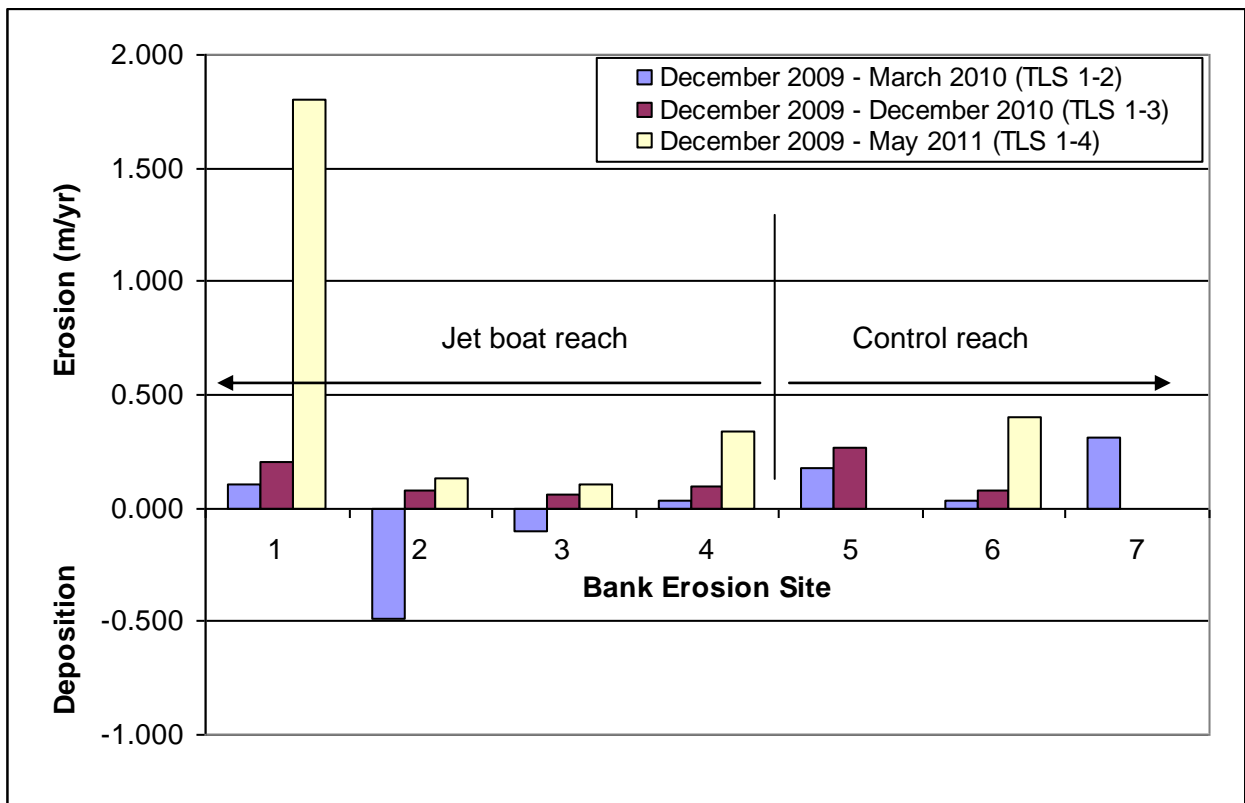
The TLS work enables us to quantify rates of erosion at particular locations and how these rates have changed over the period of this study. These data are presented in Figure 4-1. The rates of erosion measured over the longest period possible for each site are highlighted in Table 4-1 in bold. While the total erosion measured over the study period at each site is generally the result of multiple causes, the majority of the erosion was caused by the large floods of January 2011 (Period C, indicated in pink on Figure 4-2). However, as the dominance of flooding varies in each of the periods between the TLS scans (Figure 4-2), the relative contribution of jet boating may be examined by investigating the timing of changes in Periods A and B.

Figure 4-1: Rates of bank erosion measured by TLS.

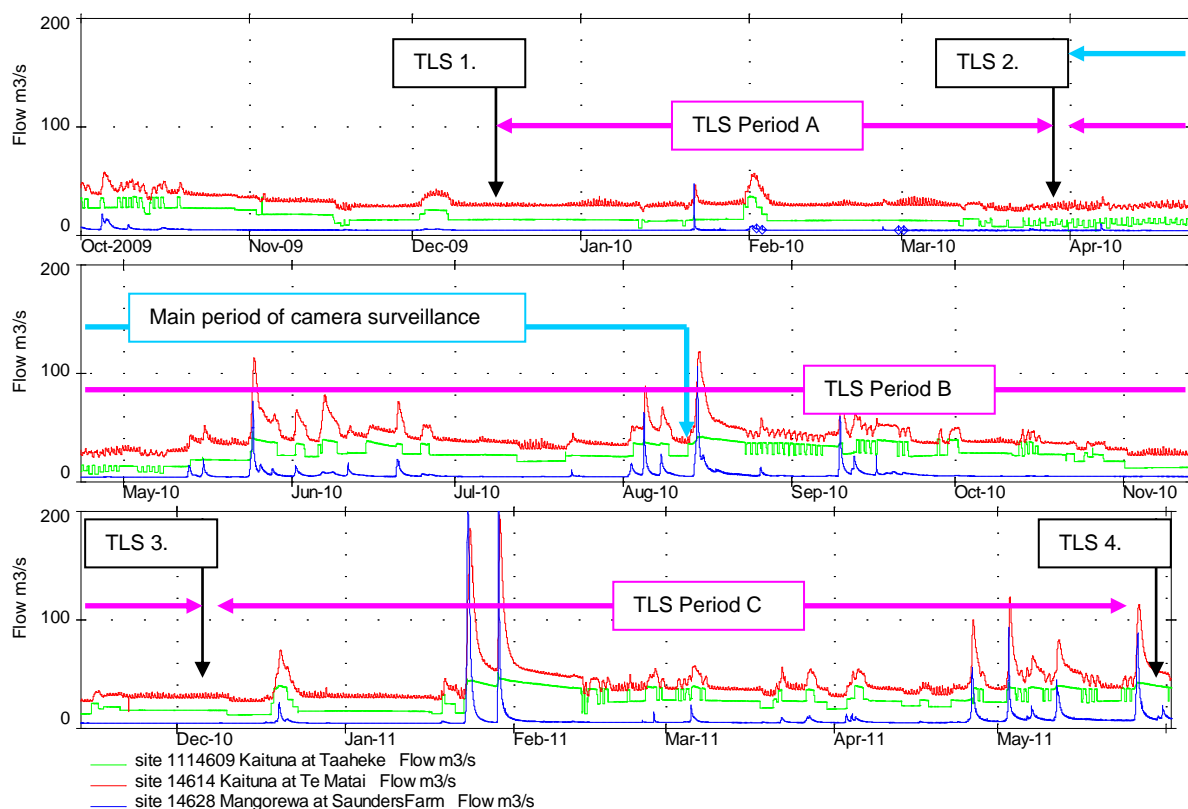
Period A (between the first and second TLS scans) was one of relatively low river flow, with only one small flood in early February, and there was little fluctuation in water level caused by the Okere Gates (Figure 4-2). This is also a period of increased jet boat activity (summer) with around 260 trips during this period (Table 3-2, half of the December trips are assumed to have occurred after the 15th of December). Therefore, rates of erosion at Sites 1-4 during Period A may largely be attributed to jet boating. While erosion did occur at Sites 2 and 3, the net change during Period A at these two sites was vegetation growth (observed on surveillance photos).

Figure 4-2: Timing of floods relative to TLS scan periods (pink) and surveillance period (blue).

Period B (between the second and third scans) included several moderate sized floods as well as 380 jet boat trips (Figure 4-2 and Table 3-2). The only way of separating out the effects of jet boating from flooding during Period B is through observation of changes on the surveillance photos, which were only taken over part of Period B (indicated in blue on Figure 4-2). Erosion directly resulting from the moderate flood of 25 May 2010 was observed on the surveillance photos at Sites 1, 4, 5 and 6. Erosion directly resulting from jet boat boating during the surveillance period was observed at Sites 1 and 3 (on opposite bank). The erosion from jet boating at Site 1 during the surveillance period was of the same order of magnitude as that from the 25 May 2010 flood (a 2 year return period event, Surman, 2005). Only 135 of total 380 trips in Period B occurred during the surveillance period, so it's likely that jet boating contributed to more erosion in Period B than just that observed on the surveillance photos.

It is estimated that the effect of all jet boating on bank erosion during Period B is approximately equivalent to the total amount of flooding that occurred during the same period. Rates of erosion in the control reach were greater than those in the jet boat reach during Period B, however, the flood magnitudes were also greater in the control reach than the jet boat reach, because a significant proportion of the flow was sourced from the Mangorewa confluence (Figure 4-2).
