1 Introduction

A breach occurred in the Rangitiaki River stopbank adjacent to Hydro Road, just upstream of Edgecumbe, at approximately 10am on Sunday 18th July 2004. The river was flowing very high at the time and water poured through the breach causing serious flooding of farmland, the railway, roads, and buildings downstream. The breach in the stopbank widened to about 100m and water flowed through for several days. Photograph 1 shows the breach from the air and Figure 1, prepared by Environment Bay of Plenty (EBOP), shows the extent of the flooding which resulted. As the breach occurred on Sullivan's farm it is referred to as Sullivan's Breach.

Ice Geo and Civil has been commissioned by EBOP to investigate the causes of Sullivan's Breach. This report discusses the following:

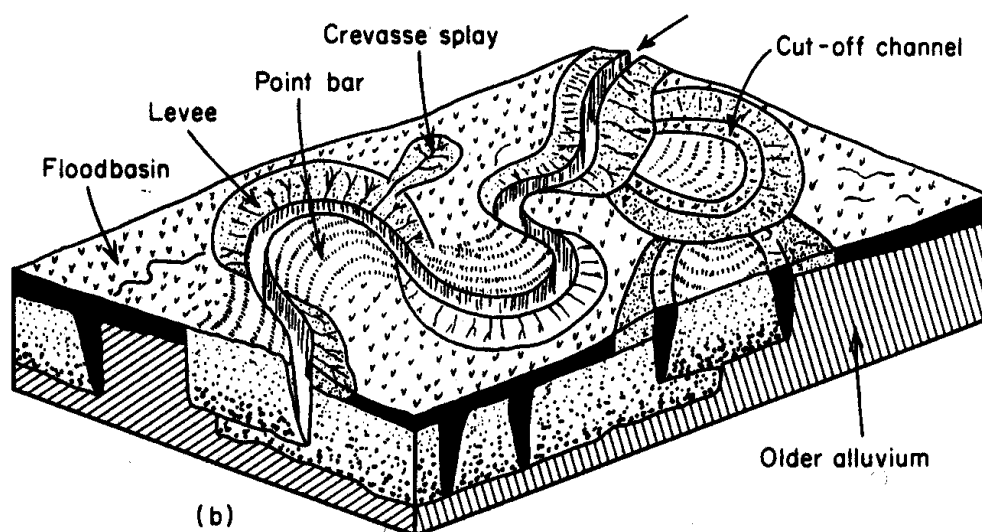
Figure 5: The floodplain environment of meandering rivers
(Figure 4.2 Freeze & Cherry (1979) Reference 5)

The plains have been built up by over-bank alluvial deposits from meandering rivers in flood, wind blown sand, airfall ash deposits and peat formation in depressions. The active volcanism of the upper Rangitaiki River catchment and the high erodibility of the volcanic tephra result in a large source of sediment which can be deposited on the plains. The outcome of the plain formation processes is a wide and unpredictable variety of soil types and grain sizes within small horizontal and vertical distances. Figure 5 (Reference 5) illustrates the floodplain environment of a meandering river with bank erosion and cut-off channels.

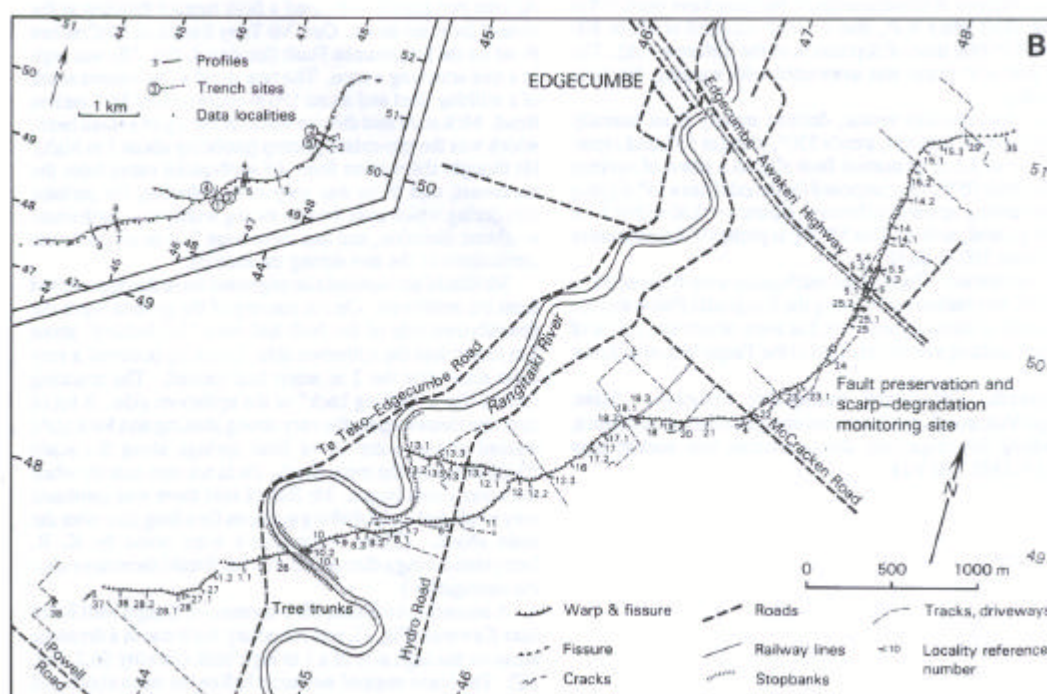
Figure7: Edgecumbe Fault location (Beanland et al., 1989)

The earthquake caused reactivation of the Edgecumbe, Onepu and Rotoitipakau Faults and several new surface ruptures ranging in length from 0.5 to 7.0km (Reference 7). Typically the north-western side of the rupture dropped relative to the south-eastern. The largest displacement was near the centre of the Edgecumbe Fault rupture which is as close as 700m to the Sullivan's Breach site. This displacement was up to 2.5m vertically and 1.8m horizontally (Figure 7). The rupture crossed the Rangitaiki River about 3km upstream from the breach site.
