**ENVIRONMENT BAY OF PLENTY  
REGIONAL COUNCIL AND WHAKATANE DISTRICT  
COUNCIL**

**EASTERN BAY OF PLENTY HARBOURS  
NAVIGATIONAL RISK ASSESSMENT**

Prepared For : Environment Bay of Plenty Regional Council and  
Whakatane District Council  
Report Number : 06NZ123  
Issue : Issue 1  
: July 2006

**MARICO MARINE NZ LIMITED**

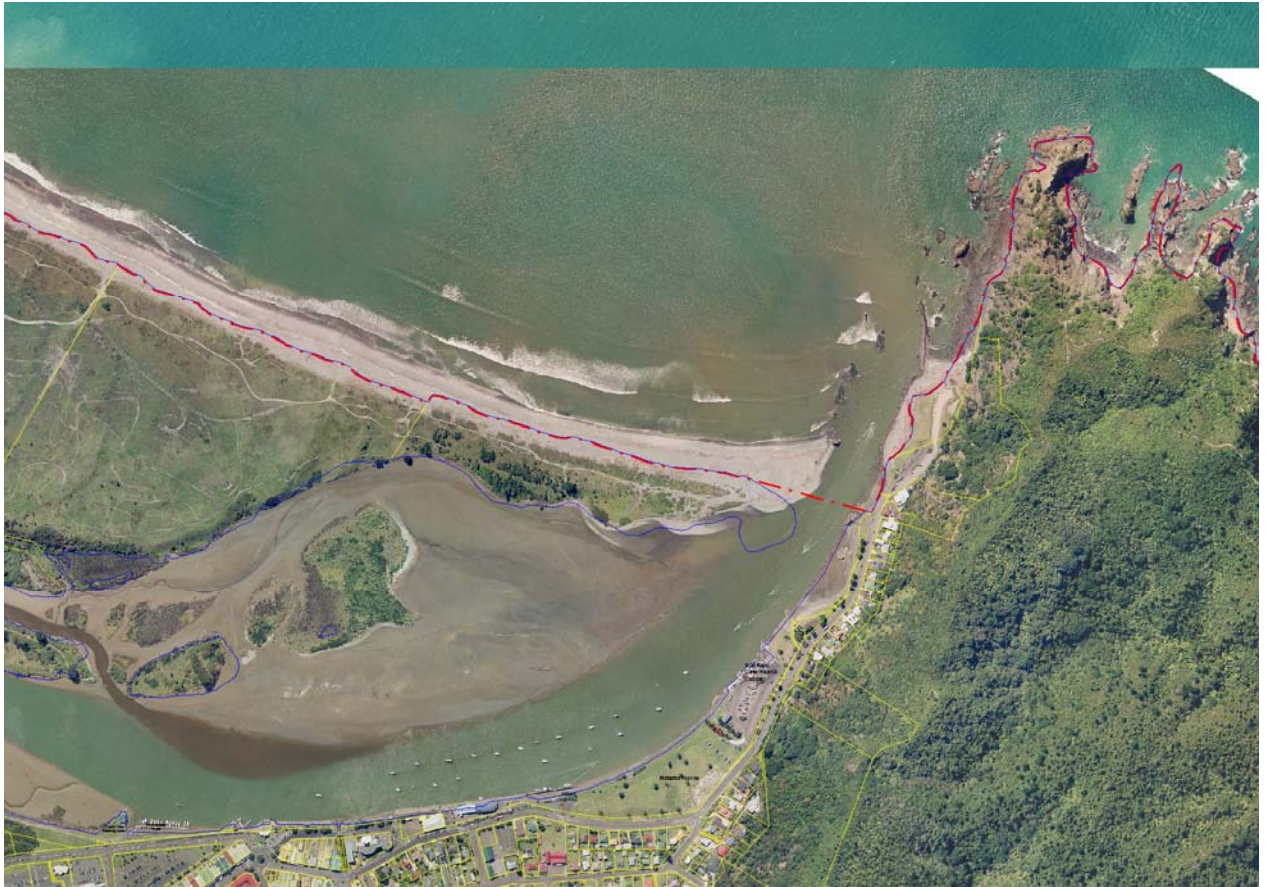
**Figure 7:-** Overview of Whakatane River Mouth. The location of the Bar can be appreciated from the discoloured water at the harbour entrance.

Mussel Rock lies adjacent to the Whakatane Bar and lies almost at chart datum, but can emerge during heavy swells. It is located just north-east of the entrance beacon. It is exposed at low water springs (breaks surface) and is visible at other times in the normal swell at the Bar. The rock lies in line with nos. 2 and 4 beacon. Its approximate location can be appreciated from **Figure 7**.

Mussel Rock is reported by stakeholders to be even more of a hazard to outbound vessels or craft as on clearing the entrance, a tendency to take a short cut exists before clearing the line of the leads.

There are a large number of craft that end up on Mussel Rock each year, but most of the reports are anecdotal in nature. Damage to hulls and running gear is reported to range from minor embarrassment for the skipper to significant damage to both hull and running gear. As a large number of events are minor, they are not formally reported. However Mussel Rock appears to stand out as the most struck object in all of the Bar harbours considered by this risk assessment. This type of event certainly occurs more than once each year<sup>9</sup>. This is more likely to occur when the Bar is shallow, which has the effect of skippers taking a course more to the east, as the western side of the entrance is shallower (skippers seeking clearest water path through the Bar).

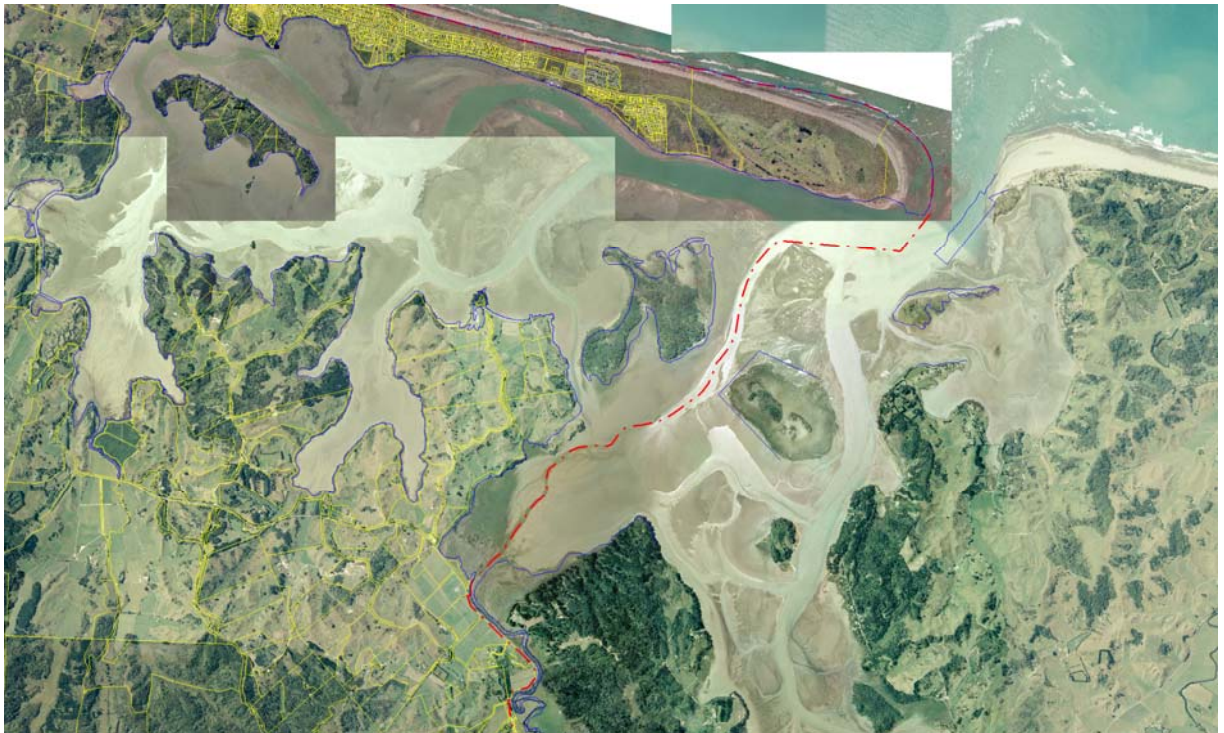
The entrance channel lies between two spits, which also form the harbour – the Ohope spit to the west and the Ohiwa spit to the east. The Ohope Spit has been growing in recent years. This can be appreciated from **Figure 8**, which is an aerial view of Ohiwa harbour.

**Figure 8:** Aerial view of the extent of Ohiwa Harbour

There are a number of commercial marine farms operating in the area (Oysters). Pipis, cockles, scallops and mussels occur naturally throughout the harbour. The harbour would have low tolerance to an oil spill event. Ohiwa was declared un-navigable in 1981 by the Marine Division of the Ministry of Transport (pre-runner to MNZ) due to ongoing accretion.

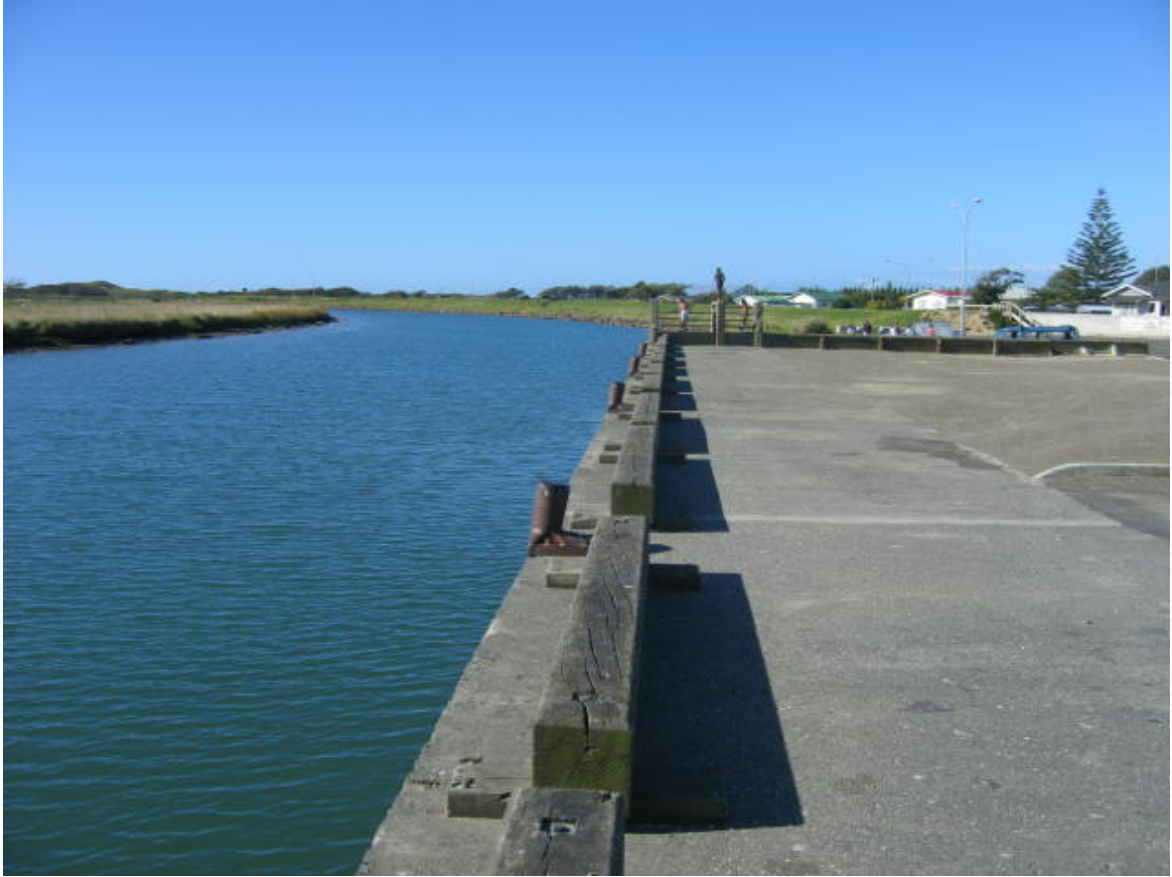
A piled wharf exists adjacent to the ramp and although this is in a state of disrepair, it is reported to be structurally suitable for refurbishment to facilitate harbour development. Opotiki District Council has plans to develop a commercial port in the harbour, serving potential offshore marine farms<sup>12</sup>. These plans have been in place for some time. A view of the Wharf Apron is shown in **Figure 9**.

**Figure 9:** A view of the Old Wharf Apron at Opotiki, looking up the Otara River. The launching ramp is located at the far end of the Wharf Apron.

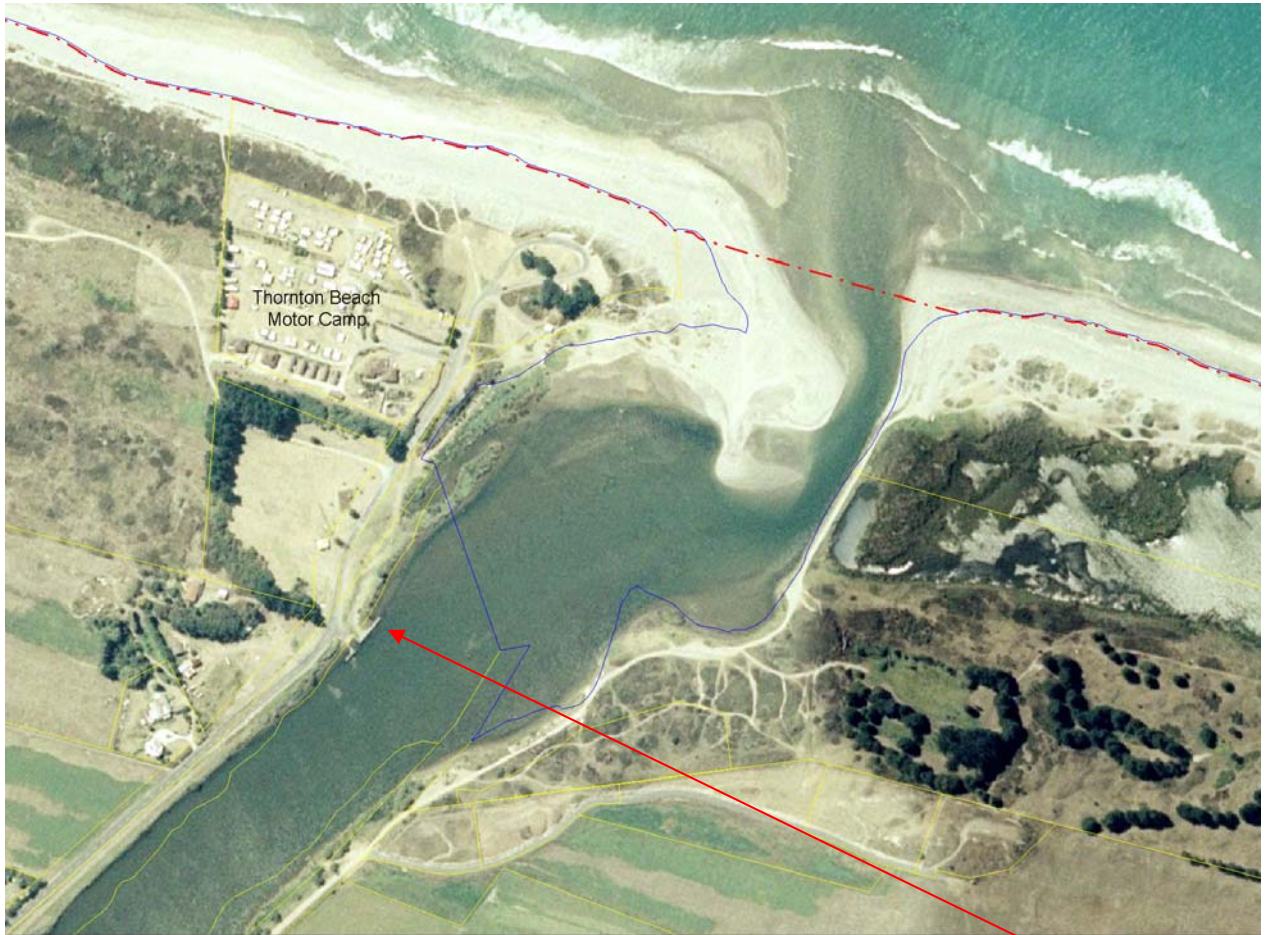
**Figure 11 Aerial view of Thornton Bar and the Rangitaiki River Mouth. The Location of Launching Ramps is shown by an Arrow. The Bar formation can be seen at the top of the view**

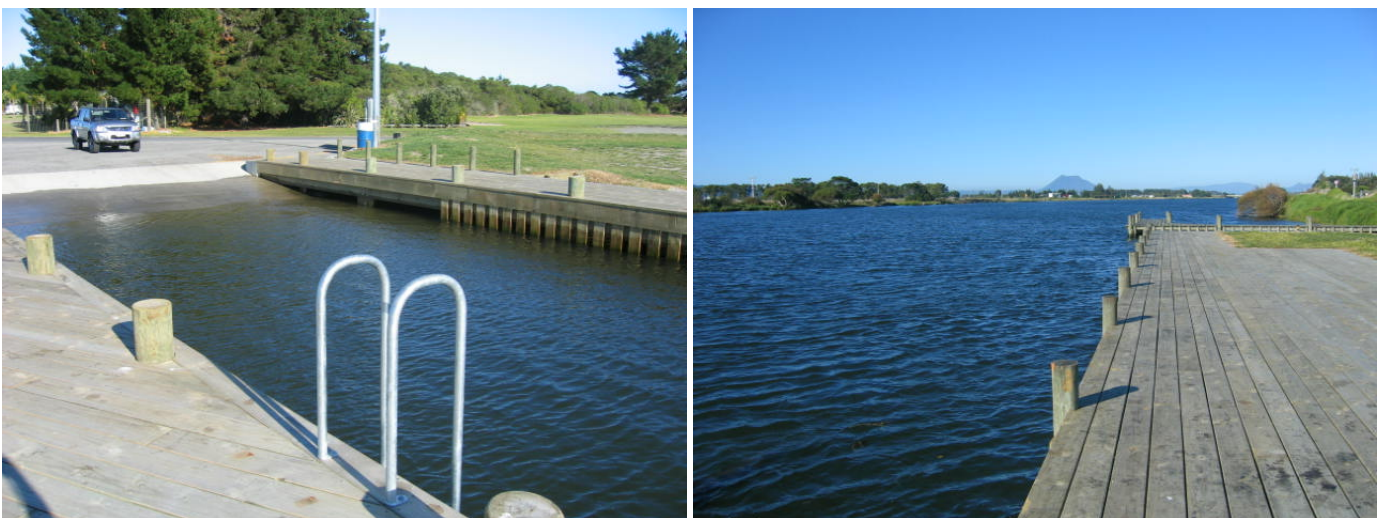
The Thornton launching ramp is well designed and exits into a wide area of relatively safe water, formed by the spit at the river mouth. Accordingly it is an attraction to swimmers, with the ramp providing a convenient platform for diving. Reports of conflict with swimmers and craft attempting to use the ramp were provided by stakeholders, this being a common problem reported at all launching sites in the Eastern Bay of Plenty Harbours. Similar reference to swimming and craft conflict was made in Tauranga by vessels or craft using Salisbury Wharf.

**Figure 12:** Two views of the launching ramp at Thornton and a view up the Rangitaiki River
