# Onsite Effluent Disposal in the Bay of Plenty 2006

Prepared by Paul Scholes, Environmental Scientist

Environment Bay of Plenty  
Environmental Publication 2007/01  
January 2007

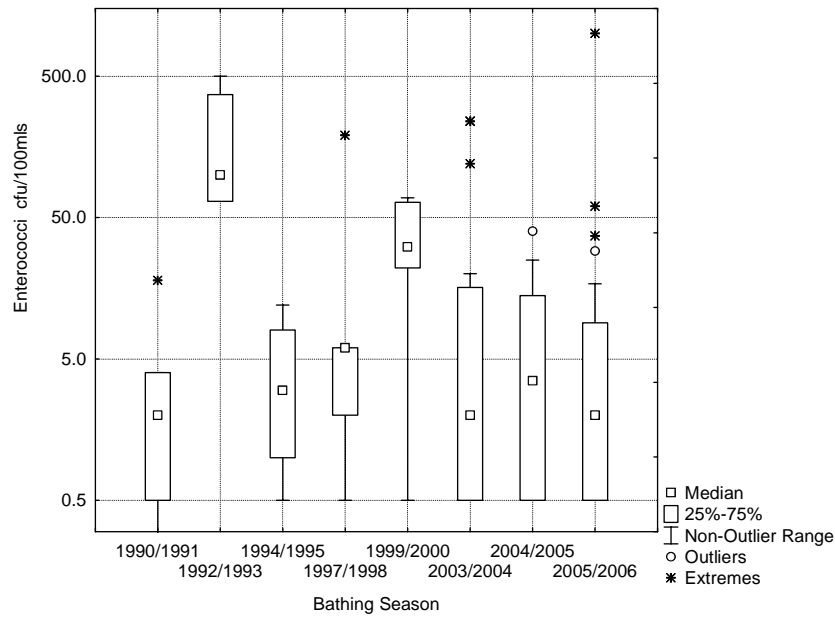
Figure 7.5 Bathing monitoring results from 1990 to 2006, Ongare Point.

Bathing beach monitoring over the past two seasons has generally been good with only a two results having reached amber alert mode of the 2003 Microbiological Water Quality Guidelines (Figure 7.5).

Using the bathing beach grading system, a risk based assessment procedure, has resulted in the beach having a microbiological assessment category (MAC) grade “B” (hazen percentile = 71) and a sanitary assessment grade (SIC) of “very high”. This gives an overall suitability for recreation class (SFRG) of “follow up”, indicating a small risk of contamination, particularly after rainfall.

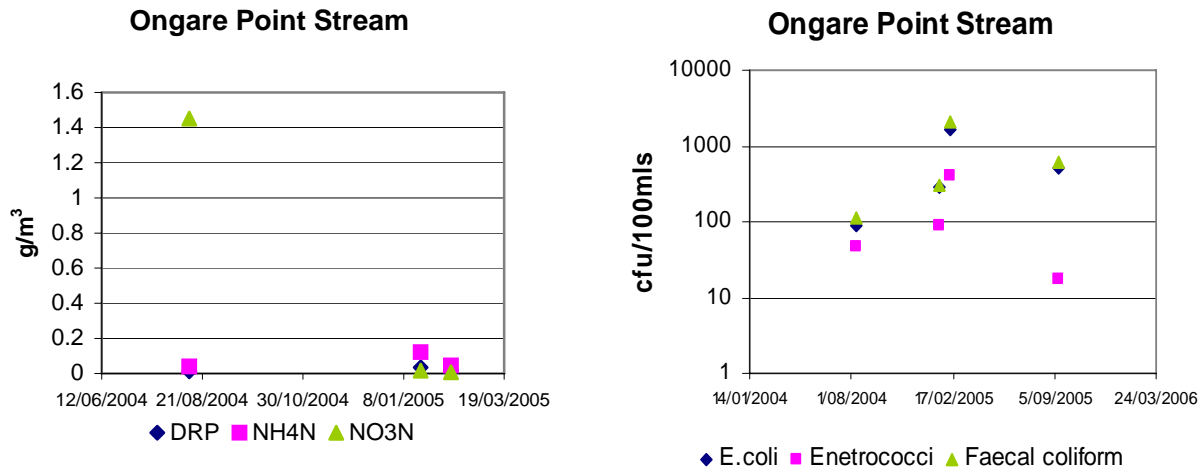
Figure 7.6 Monitoring results, Ongare Point Stream.

One stream dominates the freshwater inflows entering the area near the Ongare Point community (Figure 7.1). Recent monitoring (Figure 7.6) shows low levels of nutrients in the stream with the exception of one high nitrate-nitrogen sample. Bacteria levels are moderately elevated, but are typical of streams connected to pastoral farms with livestock agriculture. On one out of the three sampling occasions the *E.coli* concentration has been above the microbiological water quality guidelines. There appears to be no correlation of data with rainfall.

In 1992 an ammonium-nitrogen concentration of 8.84 g/m<sup>3</sup> was recorded. This was likely to have been a result of direct faecal contamination, unfortunately no bacterial sampling occurred on this occasion to confirm this. A piggery was located in the catchment at this time and this or similar livestock venture may be the cause of this high monitoring result, and may also be the cause of higher bacterial levels monitored in the bathing survey (Figure 7.5).

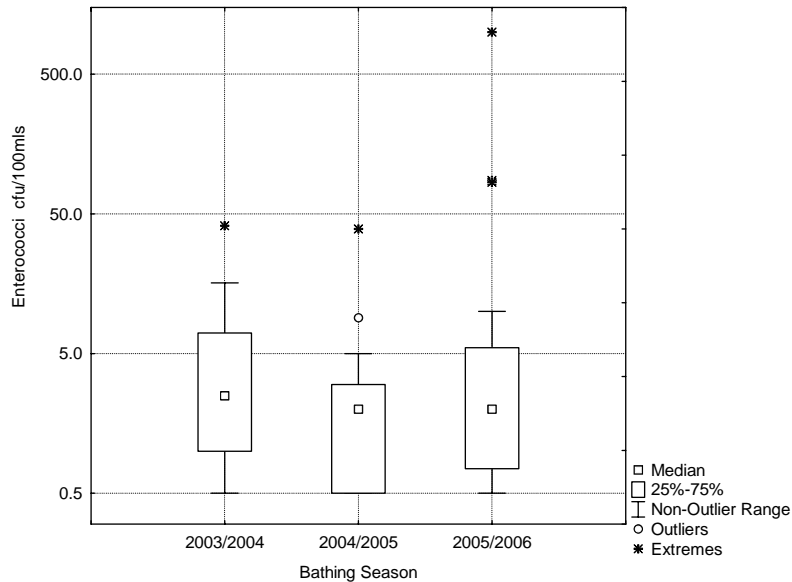
Figure 8.3 Bathing monitoring results from 2003 to 2006, Omokoroa.

Bathing suitability surveys undertaken since the early 1990's have shown water quality around the Omokoroa Peninsula to be very good. The latest bathing suitability results are displayed in Figure 8.3. These also indicate that bathing water quality remains very good, with only one result in the past three seasons exceeding recommended bathing water quality guidelines.

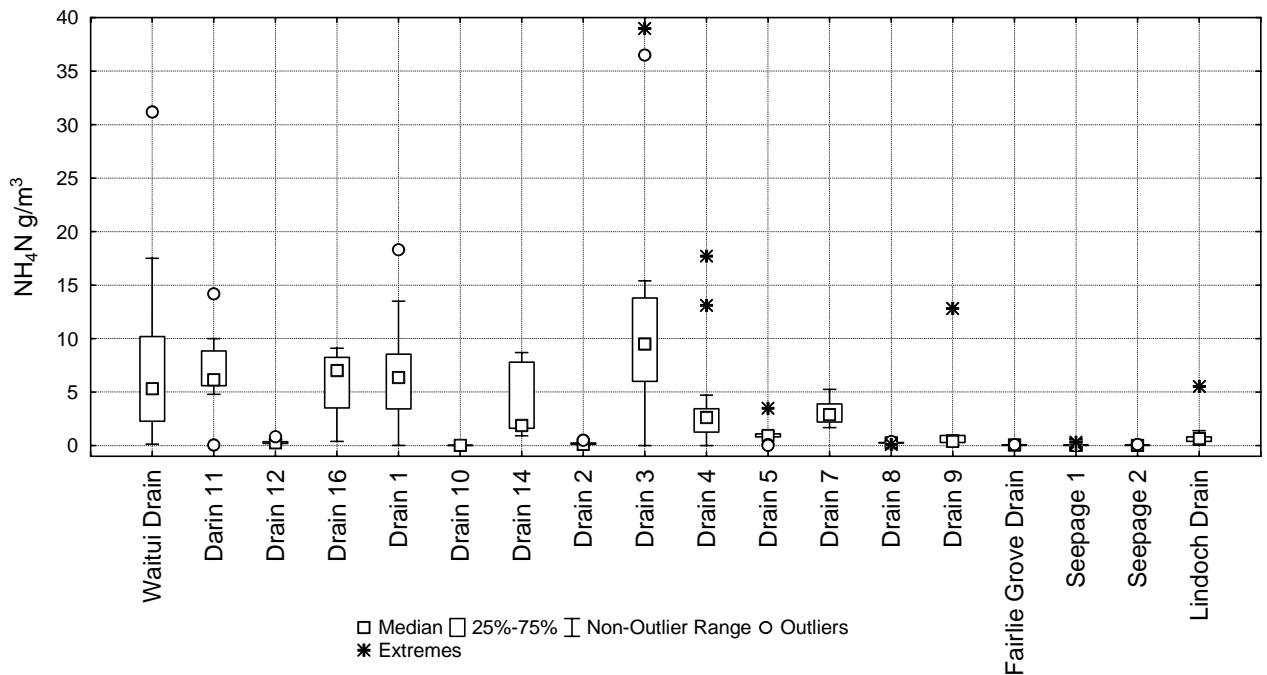
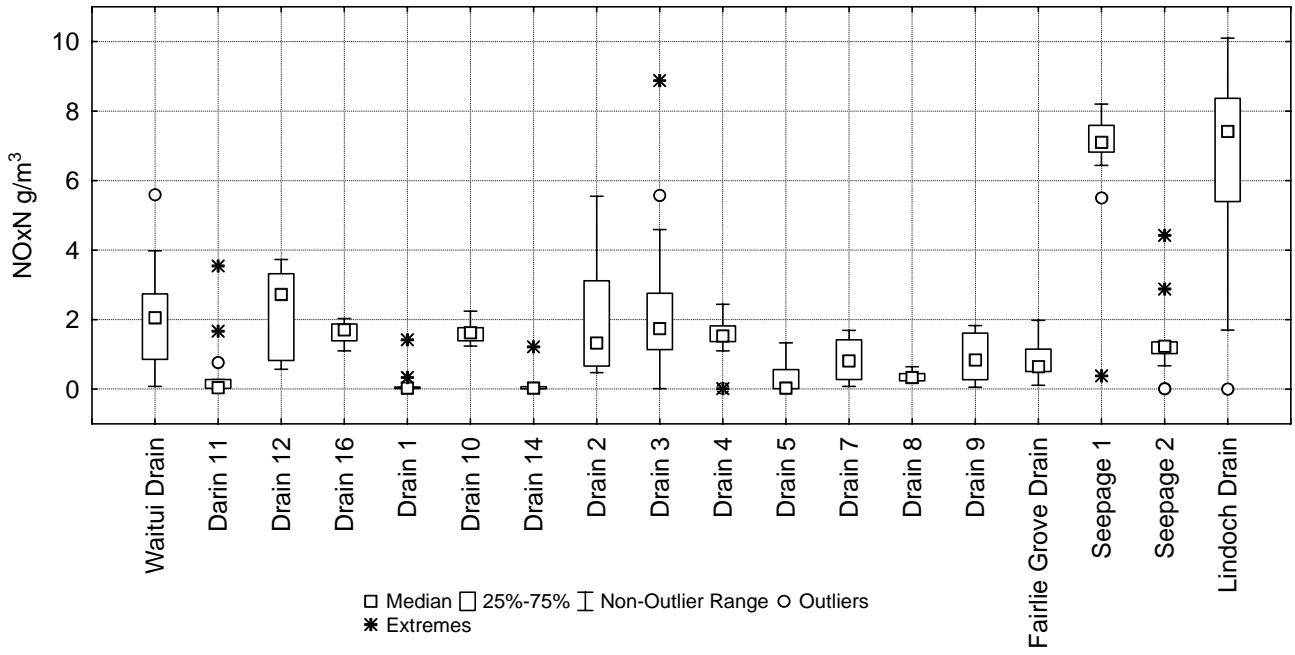
Figure 9.2 Box-whisker plots for  $NH_4N$  and  $NO_3-N$ , data monitored from Te Puna drains and seepages, 2002 to 2005.

Several of these west side drains as well as a couple of the drains on the north side of the Waitui Reserve have elevated ammonium-nitrogen concentrations. Five of these drains have median ammonium-nitrogen concentrations above 5 g/m<sup>3</sup> (Figure 9.2). Such concentrations are indicative of poorly treated septage and/or a high water table.

A range of drains display increased nitrate-nitrogen concentrations. Notably, the Lindoch stormwater drain and a seepage near Fairlie Road have median nitrate levels exceeding 5 g/m<sup>3</sup>. It is possible that Lindoch Stormwater Drain and Drains 10 and 12, all located on the north-eastern side of the Peninsula, are influenced by groundwater nitrate levels from the agricultural sector. No agricultural groundwater has been sampled in this area, but surveys at Omokoroa which has a similar geology and land use found nitrate results from 0.914-4.8 g/m<sup>3</sup> (McIntosh, 1992).

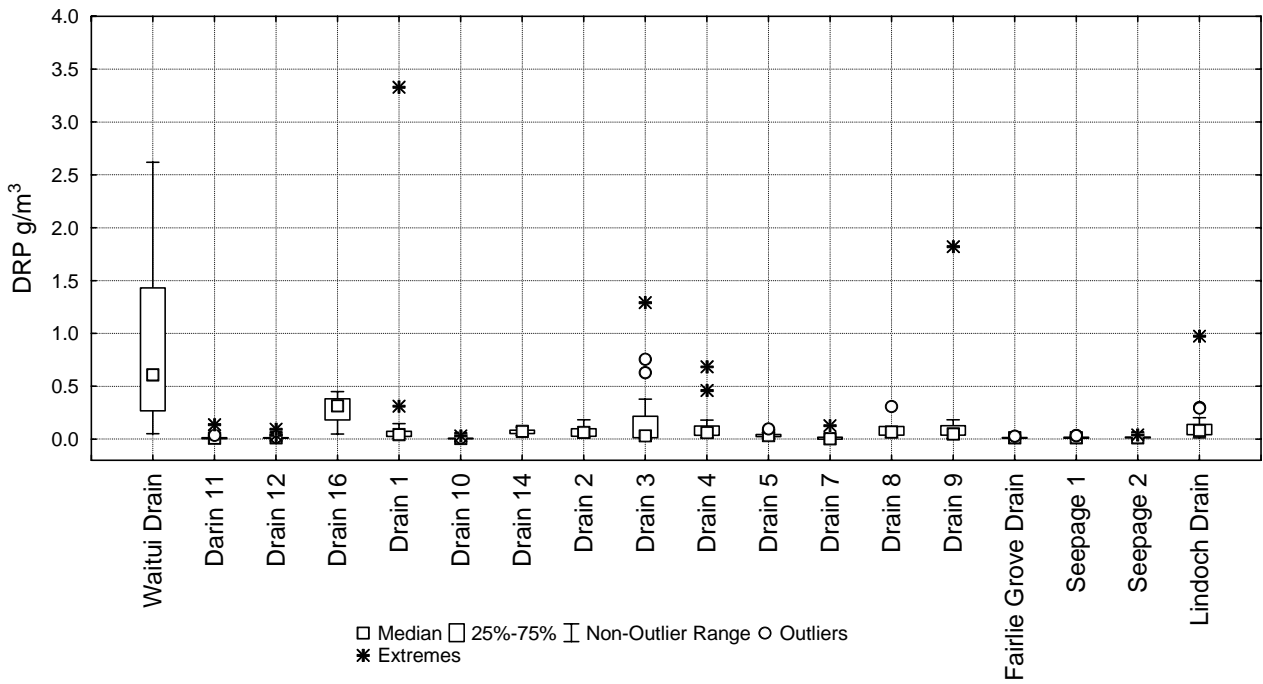
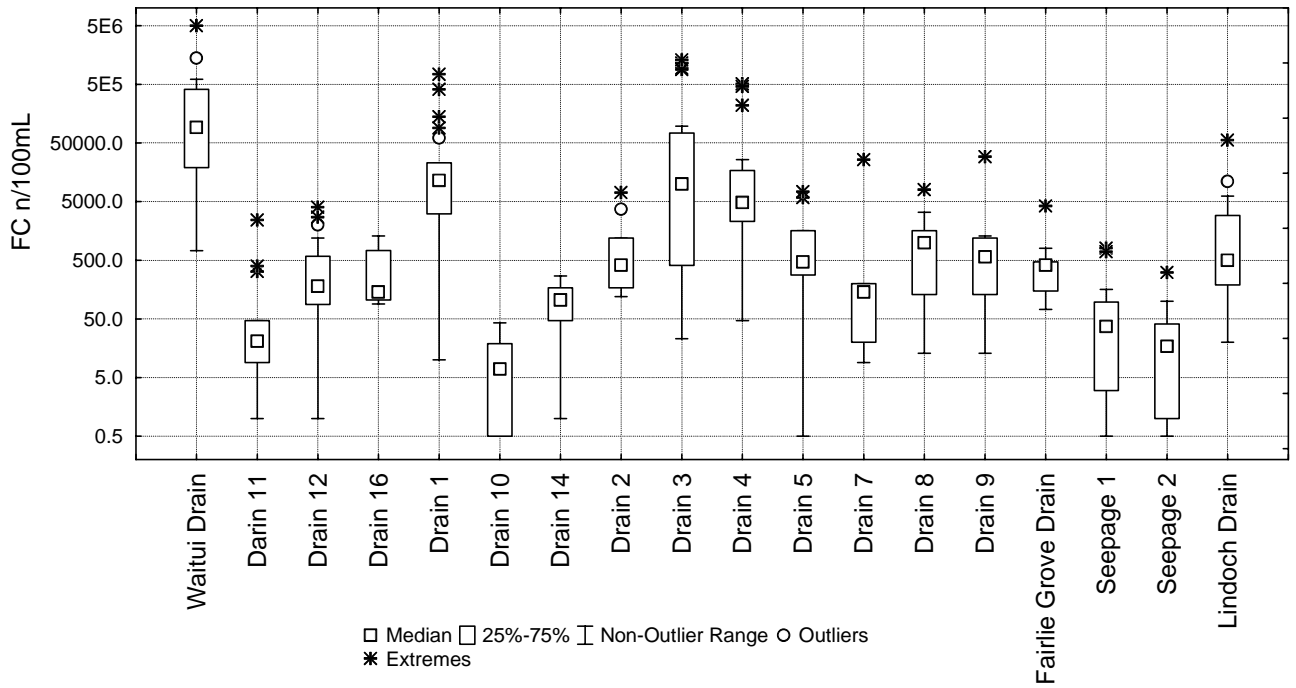
Figure 9.3 Box-whisker plots for DRP and faecal coliforms, data monitored from Te Puna drains and seepages, 2002 to 2005.

Monitoring has predominantly centred around the drains and seepages that exit the Te Puna Peninsula at the foreshore (Figure 9.1). Four drains show high bacterial contamination (Figure 9.3) that might be typical of poorly treated or at times almost raw septic tank effluent. All four drains are located on the western side of Te Puna where a number of dwellings are located on flat low lying land. The main stormwater drain, the Waitui drain, has not only high indicator bacterial levels but also elevated nutrient levels, indicating that contamination is coming from two or more sources.

Correlations of the water quality parameters of the four drains with the highest faecal coliform concentrations revealed only Drain 1 to have a relationship between ammonium-nitrogen and faecal coliform concentrations ( $r=0.88$ ,  $p<0.05$ ,  $n=16$ ). Other drains generally showed good correlations between phosphorus concentrations and ammonium-nitrogen, as does the Lindoch Stormwater Drain ( $NH_4-N:DRP$   $r=0.98$ ,  $p<0.05$ ,  $n=19$ ). However, at low concentrations, as found in Lindoch Drain, such a relationship is typical of urban stormwater and may not represent contamination in a drain characterised by elevated nitrate. Only the Waitui Drain and Drain 3 have elevated DRP concentrations (Figure 9.3) that are likely to be a sign of contamination from septic tank effluent.

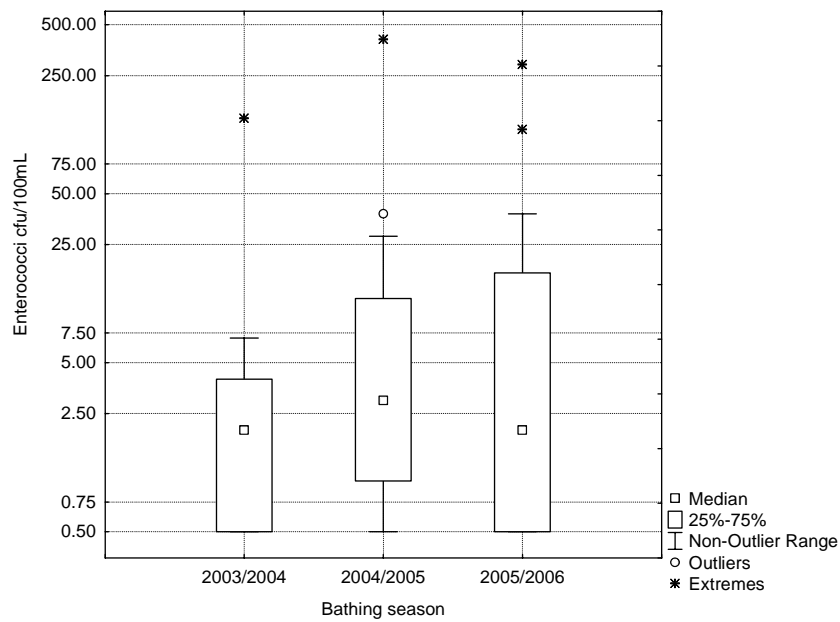
Figure 9.4 Bathing monitoring results from 2003 to 2006, Te Puna.

Contact recreation water quality at Te Puna is good, with only the two samples in the last two seasons being above the red alert microbiological water quality guideline (Figure 9.4). Oysters are abundant in the Te Puna estuary growing on mangroves and structures such as the rail bridge. Figure 9.5 displays the faecal coliform levels found in these shellfish. Two of these samples were at concentrations unacceptable for human consumption. Only low level of *Clostridium perfringens* (1-10 cfu/g) were found in the oyster samples suggesting that contamination may be rurally derived rather than from any septage.

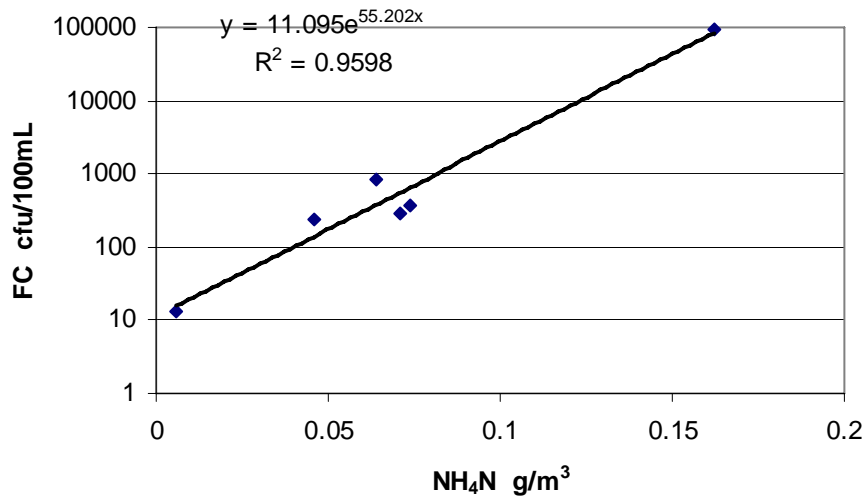
Figure 10.3  $NH_4$ -N versus FC, Wagner Street stream at beach outlet.

Nutrient indicators in the stream and drains alike are generally low (Figure 10.2). Only the Wagner Street stormwater drain displayed elevated nitrate-nitrogen and ammonium-nitrogen concentrations after one rainfall event. Ammonium-nitrogen and faecal coliform results at the stream outlet to beach do show a good relationship (Figure 10.3). Such a relationship may indicate that a poorly treated effluent and/or other raw faecal source(s) are contributing the faecal loading in the stream. However, neither site upstream of the outlet has such a strong relationship between these two parameters, although data is limited.
