Tauranga Harbour Sediment Source Survey

Report prepared by Matthew Surman, Design Engineer
Richard Clarke, Student - Lincoln University
Meredith Carter, Student - Waikato University

Environment B·O·P
Quay Street
P O Box 364
Whakatane
NEW ZEALAND

The report provides an order of magnitude estimate of sediment transported from stream bank erosion into Tauranga Harbour from the harbour catchments. The report describes and costs possible stream improvement works and estimates the reduction of sediment yields such works may achieve.

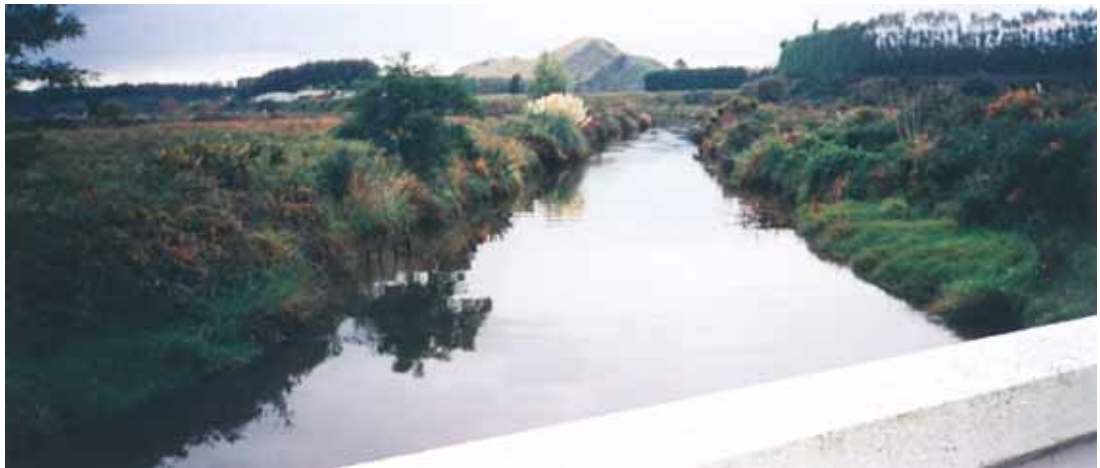
Figure 3.3 Ground vegetation of banks is dominant in the last 600m to the estuary

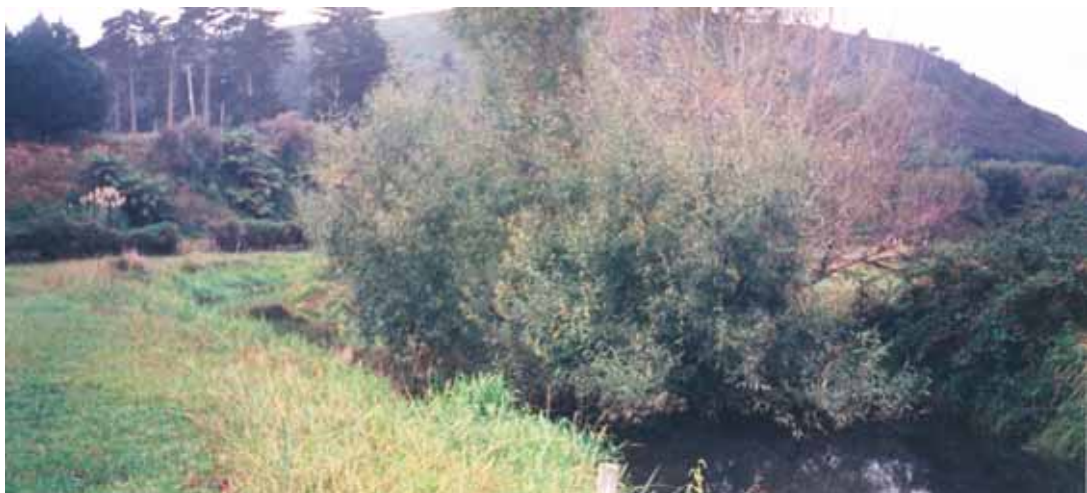
Figure 3.4 A willow growing in the stream 900m from the estuary.

Maintenance of the waterway, in particular the clearing of willows likely to cause blockages, is vital in reducing the flood risk and erosion of banks of the lower stream area. To reduce future problems associated with overgrown willows, alternative plantings could be investigated. In particular, an area of manuka appeared to hold the bank together sufficiently without creating significant debris problems. A preferred cross-section probably includes a fenced area that may include willows and shrubs, but not with the willows right on the bank edge or in the stream. Because of their easily reproduced nature, willows may not be particularly appropriate for this catchment.

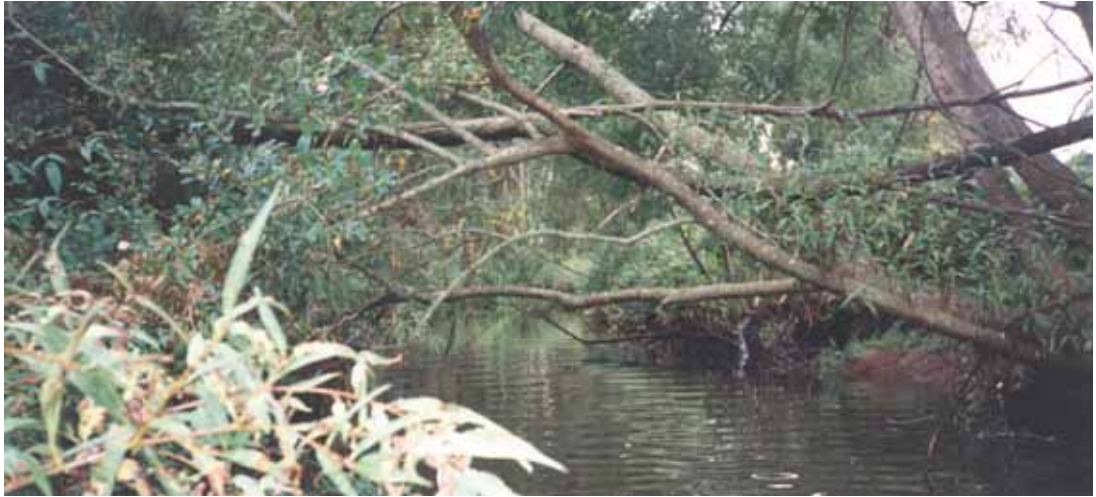
Figure 3.5 Overhanging may collapse into the stream in future

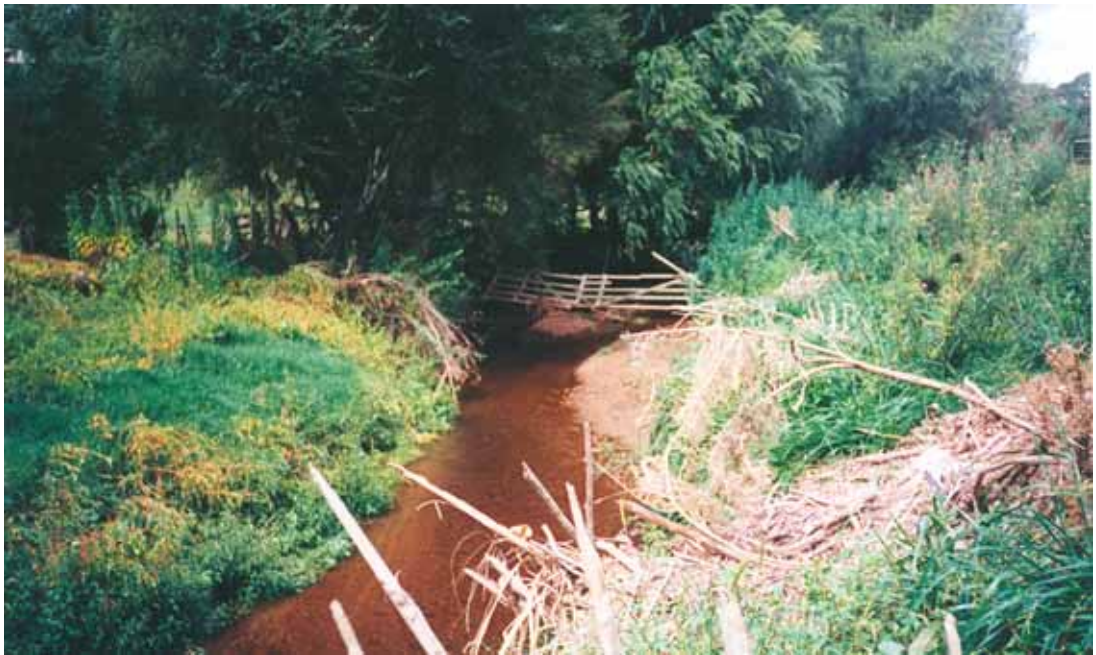
Figure 3.6 Potential for stream blockage on fence

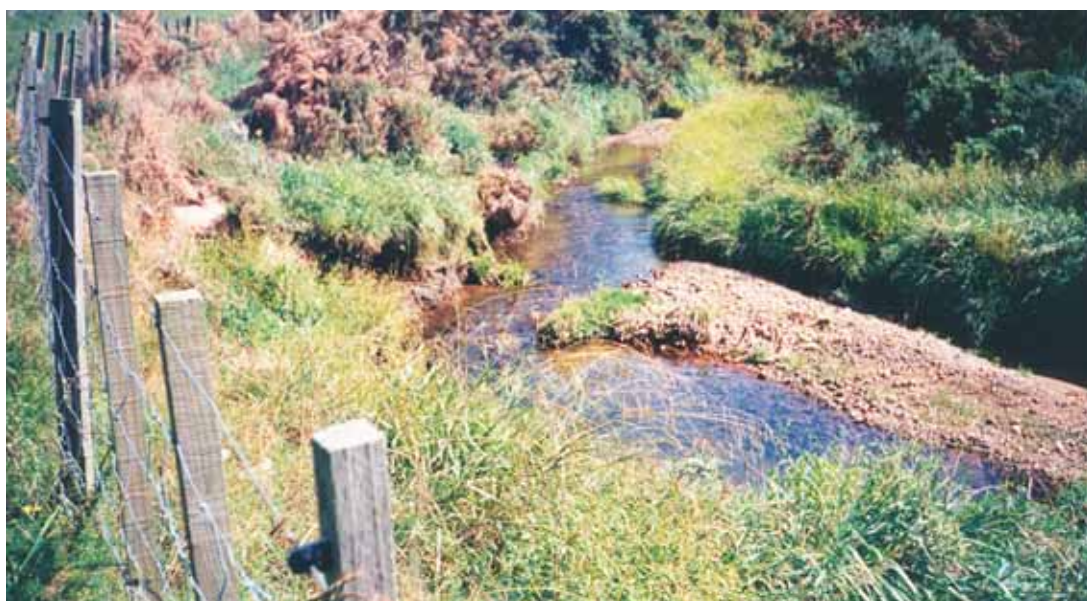
Figure 3.8 Sediments from erosion may be deposited and stored until larger flows transport them further.

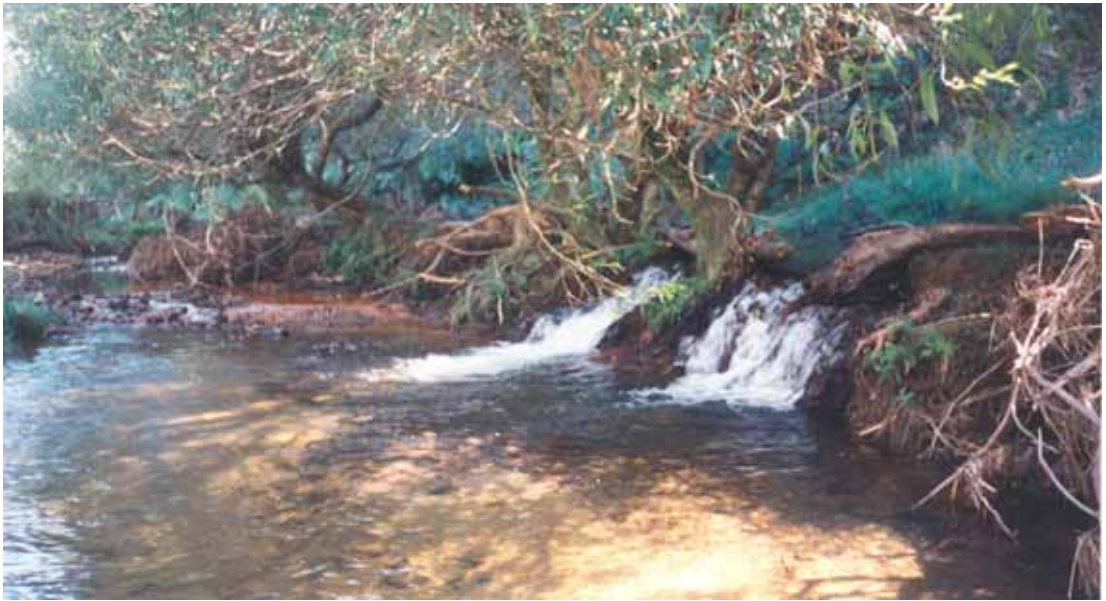
Figure 3.9 The upper reaches may have obstructions, but little damage is caused here as flood waters have plenty of room to spread and the banks are vegetated.

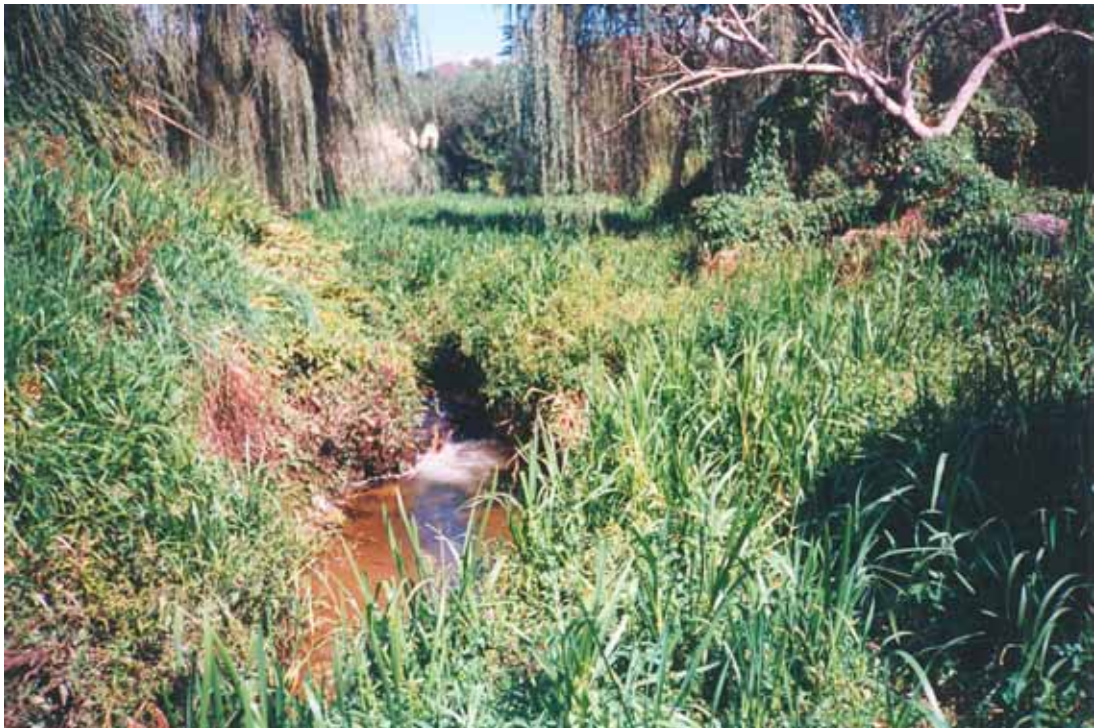
Figure 5.1 The floodplains of the lower reaches are currently mostly vegetated in *Glyceria Maxima* with a few dispersed willows.

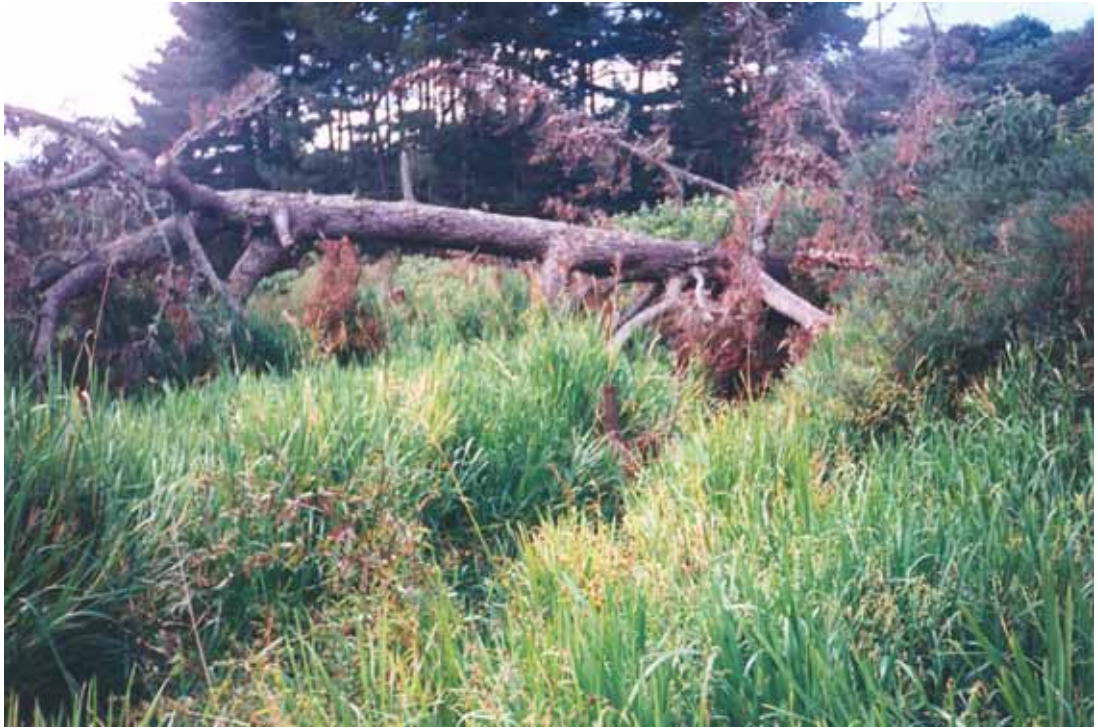
There is one willow growing in the channel and one large pine tree has fallen across (above) the stream. Debris was observed about 1.2m above the ground level in some willow trees in the floodway. Some gorse, blackberry, shrubs on right bank.

Figure 5.3 Fallen pine tree at 1.2km lies above the stream.

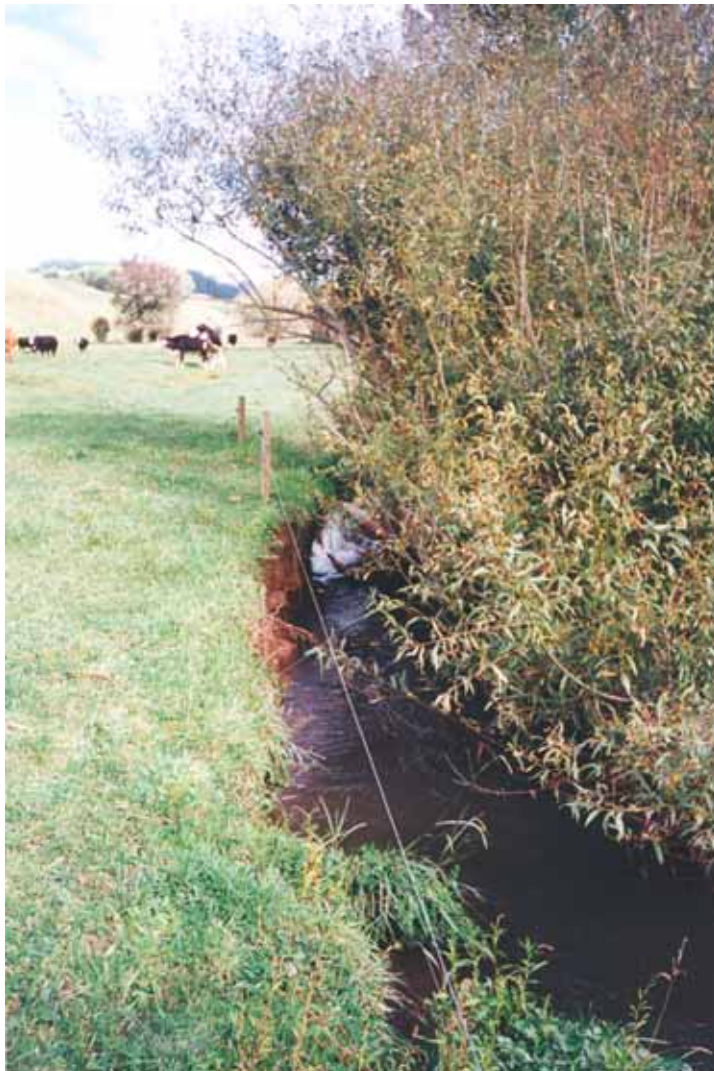
Figure 6.4 Erosion at 2.2km

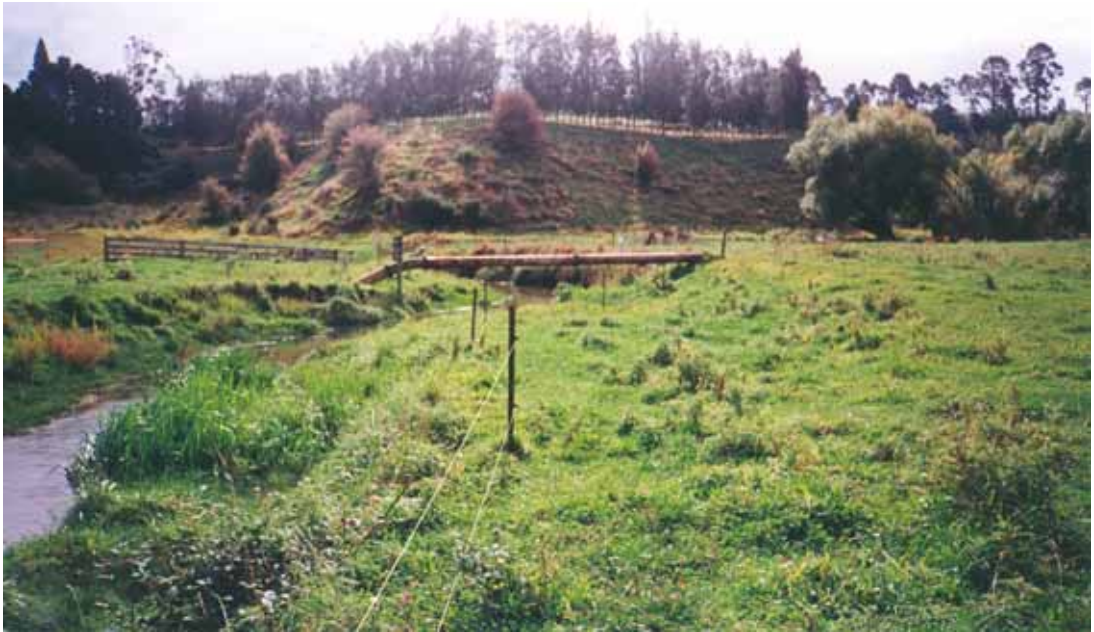
Figure 6.5 Downstream view at 2.4km, open flood plain with grasses to waters edge, some slumping of banks.

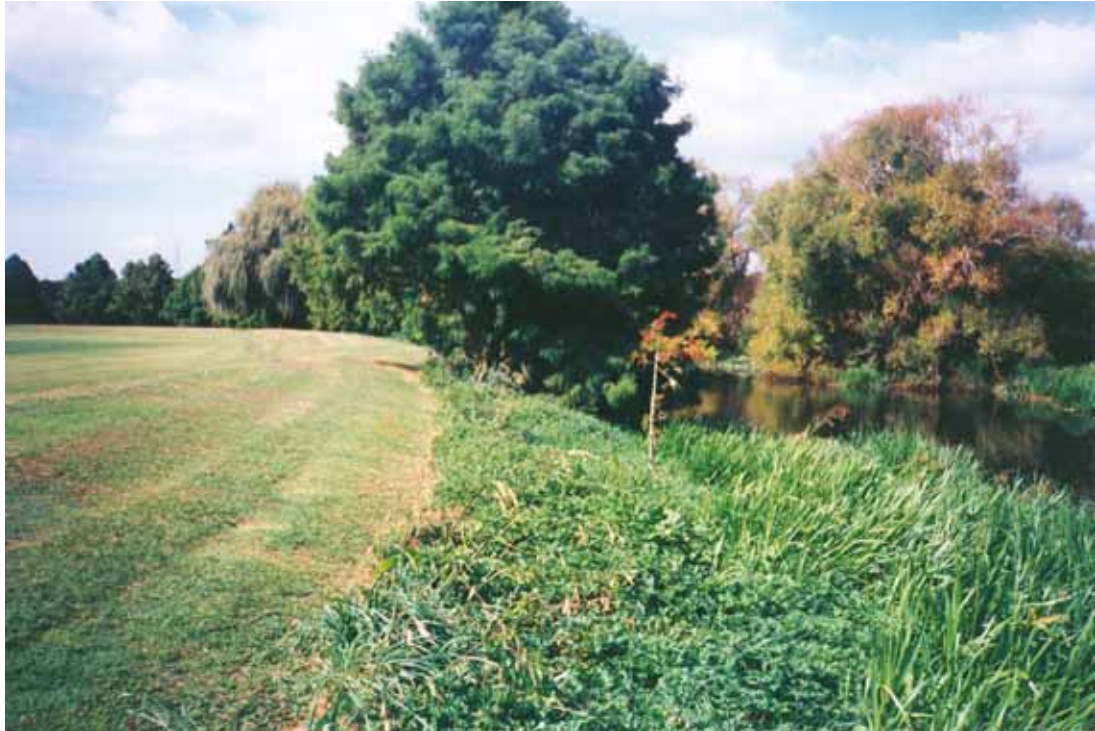
Figure 6.7 Stopbanking around the playing fields appears to be in excellent condition. Here, the stream is very wide (35m at the footbridge by the grounds) and slow-flowing.

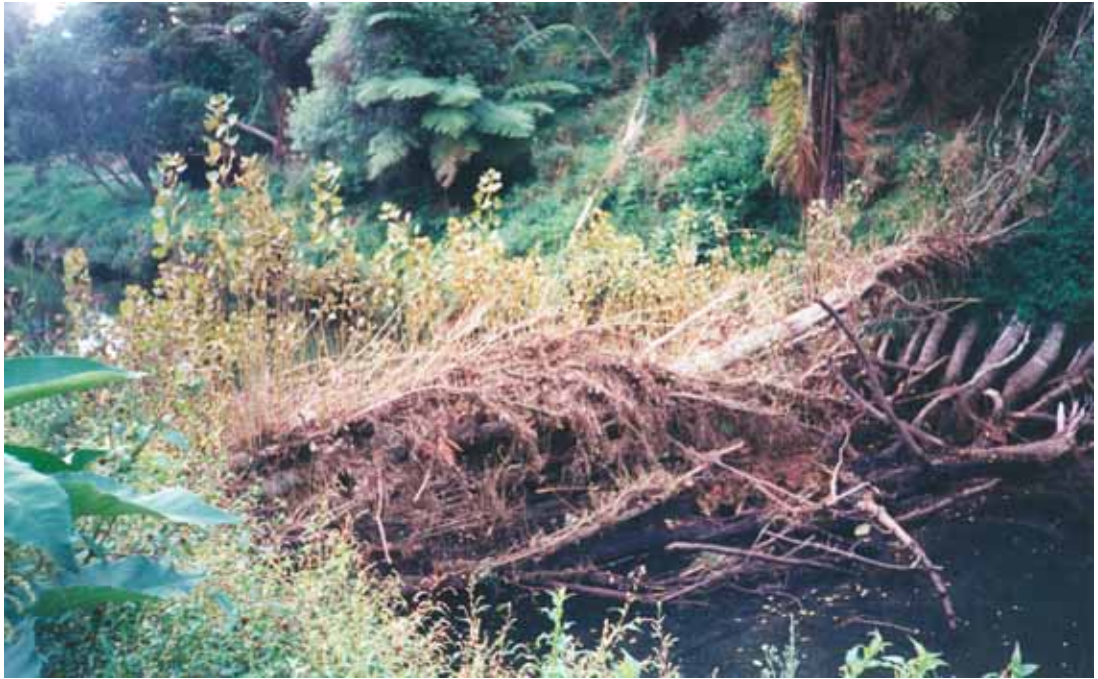
There are two partial blockages and two overhanging willows just downstream of the SH29 bridge (2.3km). Between the SH29 bridge and the Pukemapu Rd bridge, there are many large willows overhanging and/or partially blocking the stream (especially 2.4km to 2.8km, refer Figure 6.8), six full blockages and eight partial blockages (mostly from 3.2 to 3.6km, refer Figure 6.9). The stream is about 10m wide here.

Figure 6.9 Vegetation debris can thoroughly dam the channel.

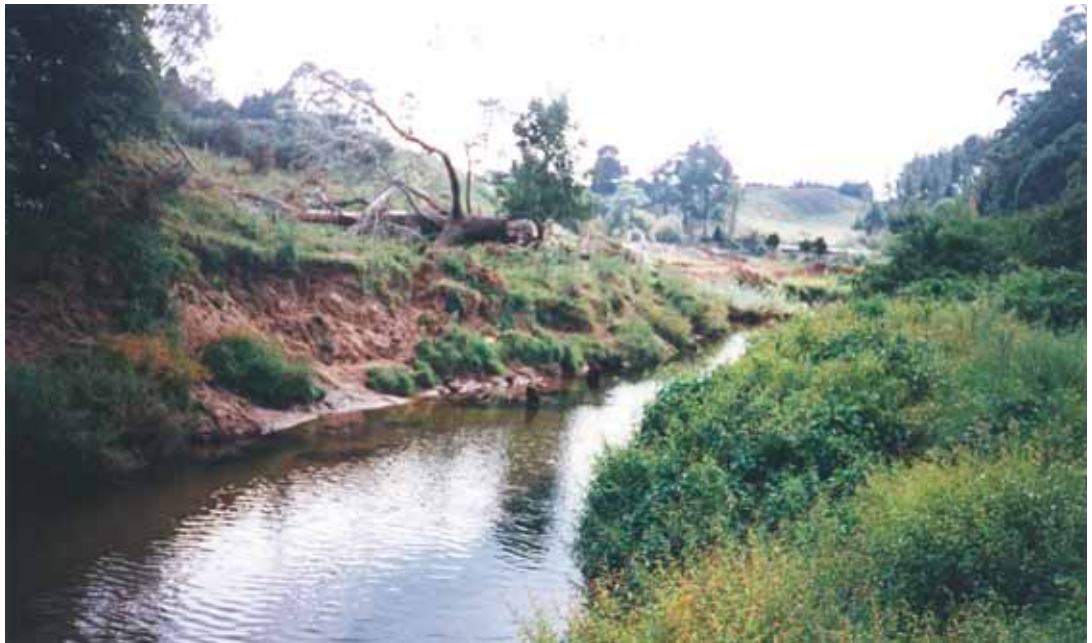
Figure 6.10 Sediment at 4.1km resulting from bank erosion and fill dumping as seen in the background.

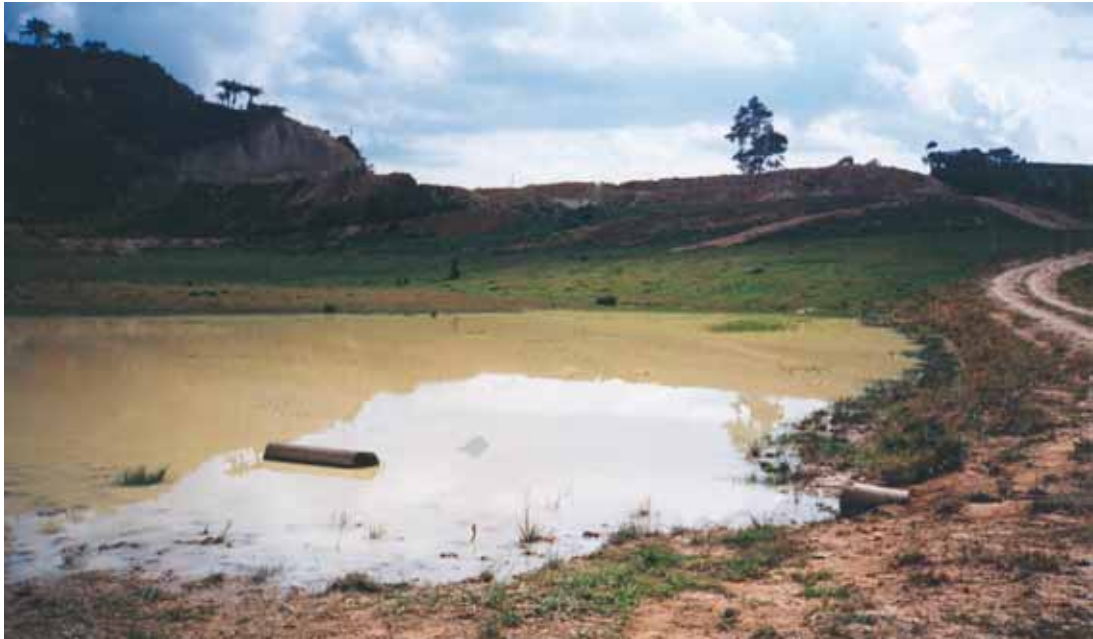
No problems are apparent in the stretch from 5.3 to 7.5km except for bank erosion on a sharp bend at the outlet of a quarry sediment pond (refer Figure 6.13).

Figure 6.13 High suspended sediment levels in pond at 6.1km, due to quarry activities.

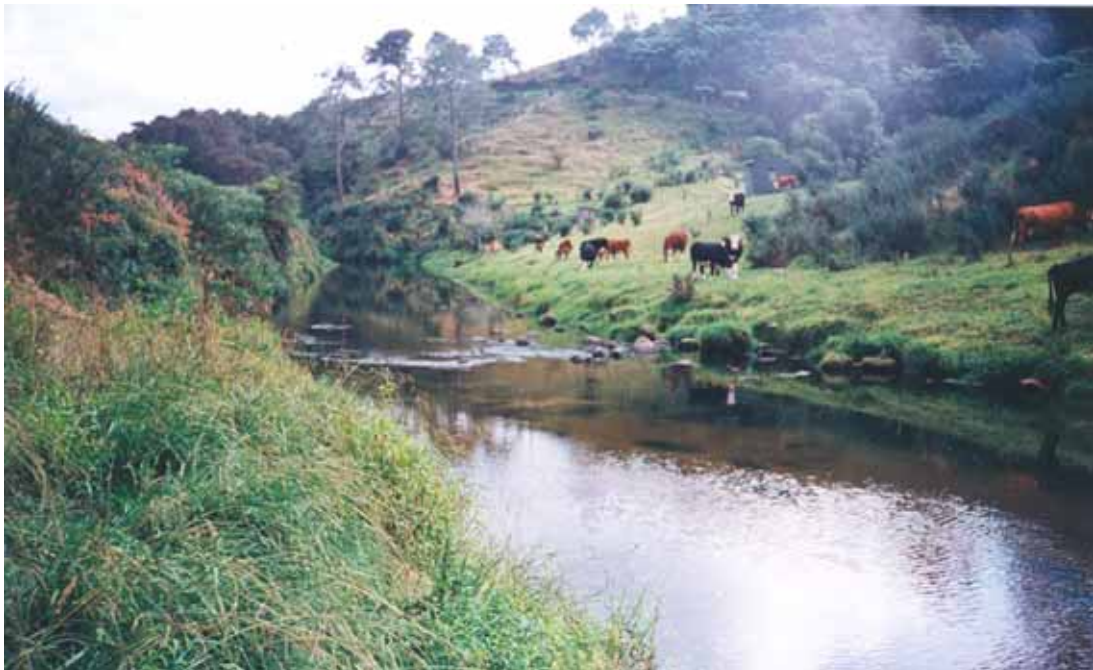
Where there are berms, the stream banks are 2-3m high. Stock grazing was evident down to the waters edge along with indications of past erosion.

Figure 6.14 Some very steep banks have been fenced off, but most of the banks are grazed.

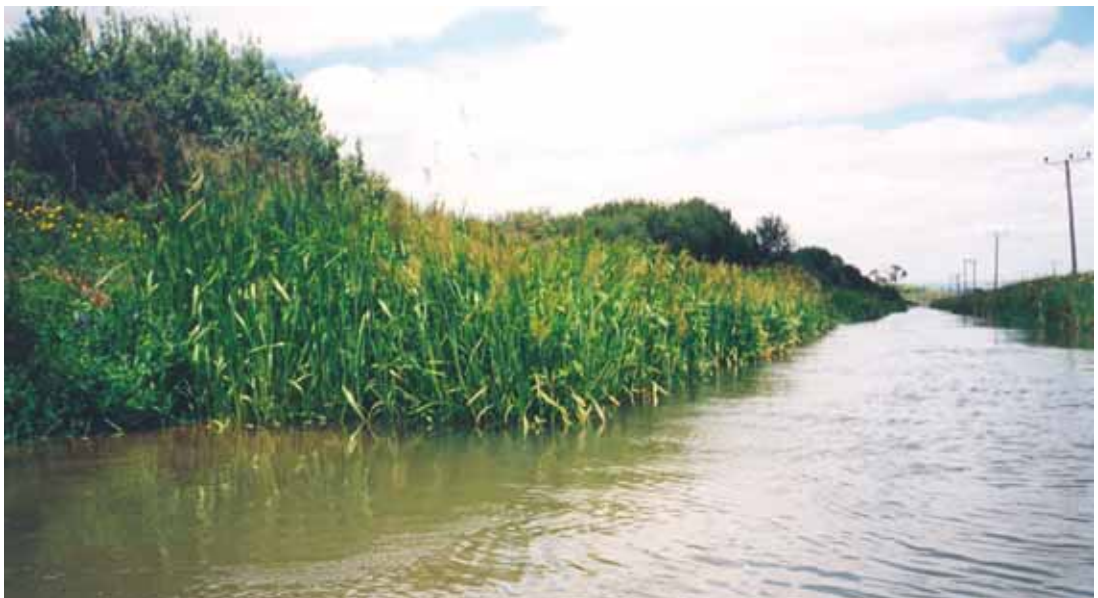
At the end of the industrial area, banks continue at around 0.5m in height, increasing to 1m within a couple of hundreds of meters. *Glyceria maxima* then appears in the channel to about 3km (refer Figure 7.2), growing out from the banks between 1 and 3m, effectively narrowing the stream width to around 4m in places.

Figure 7.2 *Glyceria Maxima* reduces the effective width of the stream.

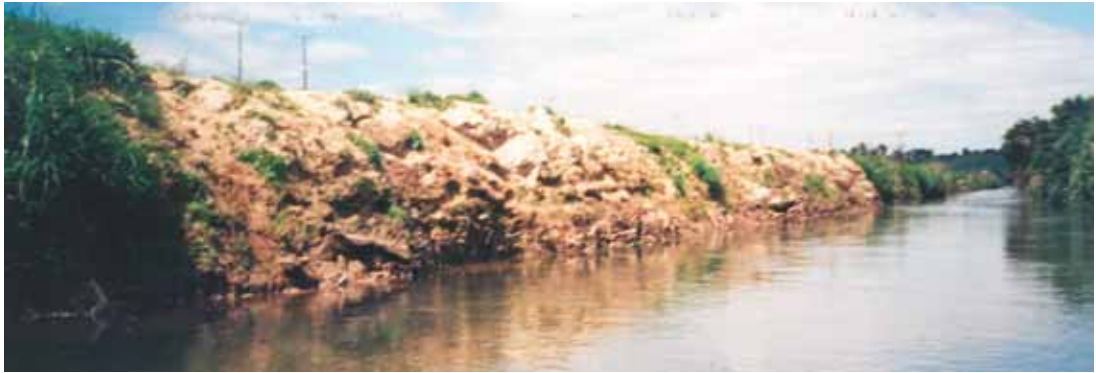
From 3 to 4km, it appears that dumped fill material constitutes the right bank over several lengths of up to 50m (refer Figure 7.3). There is steady erosion on the left bank, probably due to tidal variation. From approximately 3km to the SH29 bridge (6km), there were five localities in which a stock path to the water's edge existed. The banks in this area were often partially supported by old tree trunks embedded in them - it is possible this is a product of previous tree clearings works. Water clarity was improved compared to near the mouth. Between 4 and 6km, the banks are well vegetated with occasional erosion. Only a few trees are present, commonly draping up to 2m into the main flow. Logs in several places are jammed across the streambed, often 10 to 20cm of water flows over these, resulting in localised swift currents.

Figure 7.3 Dumped fill adjacent to stream has not yet been tested by flood flows.

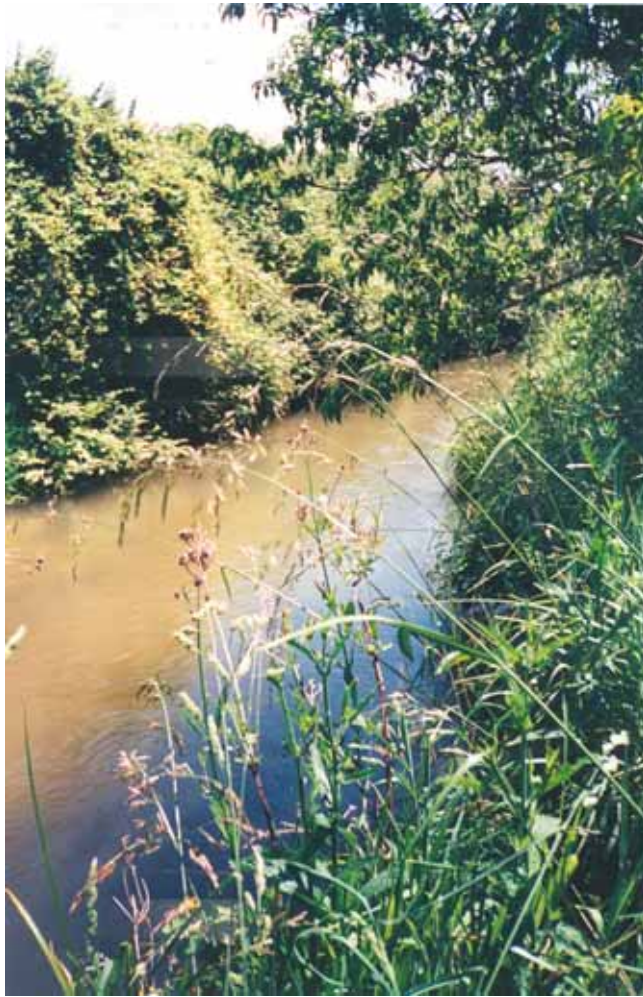
*Figure 7.5
Thick vegetation cover
stabilises the bank*

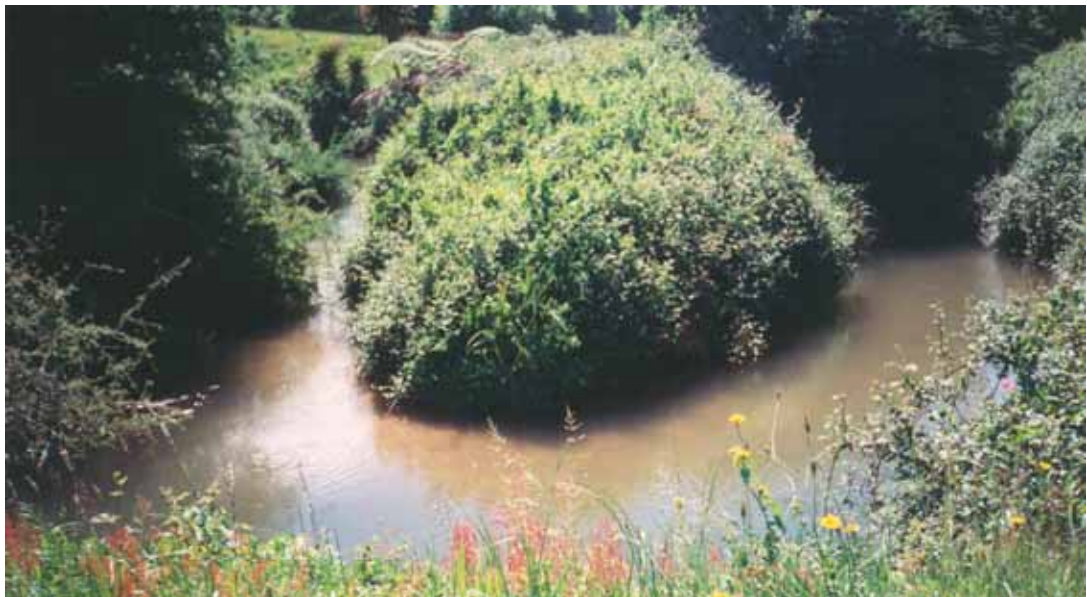
Figure 7.8 Vegetation can protect the banks but has potential to impede the flow. Tight meanders increase the length of the river, reducing flood capacity and putting pressure on the outside of bends.

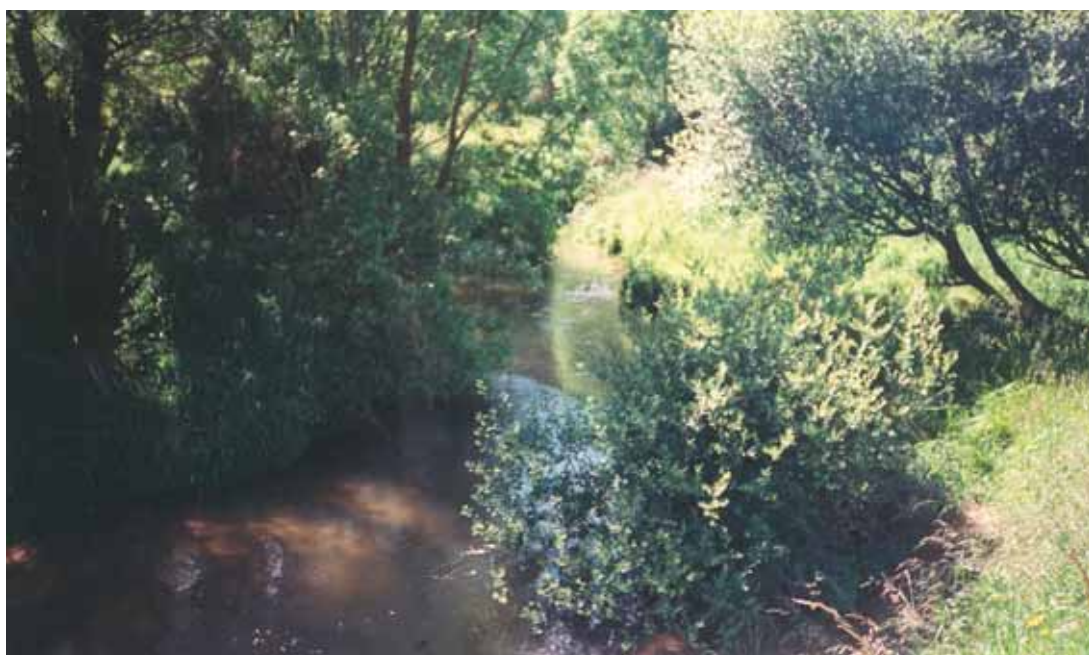
Between this heavily vegetated section and the confluence with the Tautau stream (5.6km above the SH29 bridge), the tree density is halved, refer Figure 7.10.

Figure 7.10 Below the Tautau confluence, in-stream trees do not significantly congest the channel, banks are in good state.

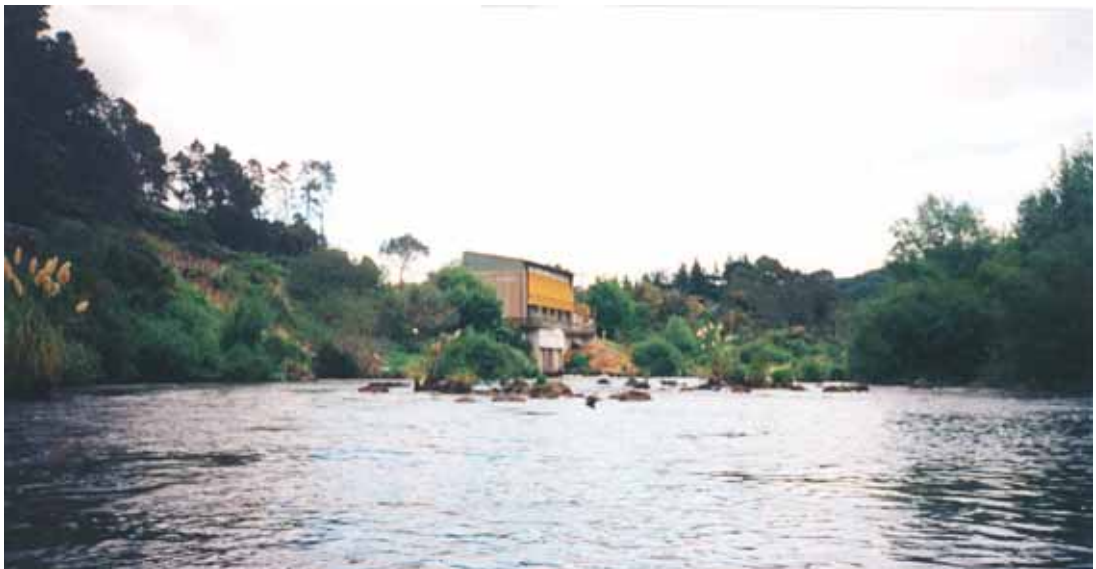
Water appears tainted slightly orange/brown below the Ruahihi power house, yet this is also evident above the hydro-schemes, hence is suspected to be related to ground water and run off flows. A 0.5 to 1m deep rocky bed (refer Figure 8.3) is bounded by 10m high banks around 50m apart; previous flooding is evident to 4m. Grass grows down to the water's edge, with trees generally set back a little. The river is clear of trees and debris, and there is some tidal influence here. 12km upstream of the railway bridge, there is a stretch of erosion 20m long and over 4 to 5m high. The right bank is mainly grass to the water's edge; farmland extends for most of the river. At 10.4km, a distinct change to a sandy bed is apparent, which dominates the remainder of the river.

Figure 8.3 Shallow rocky bed at the Ruahihi power house.

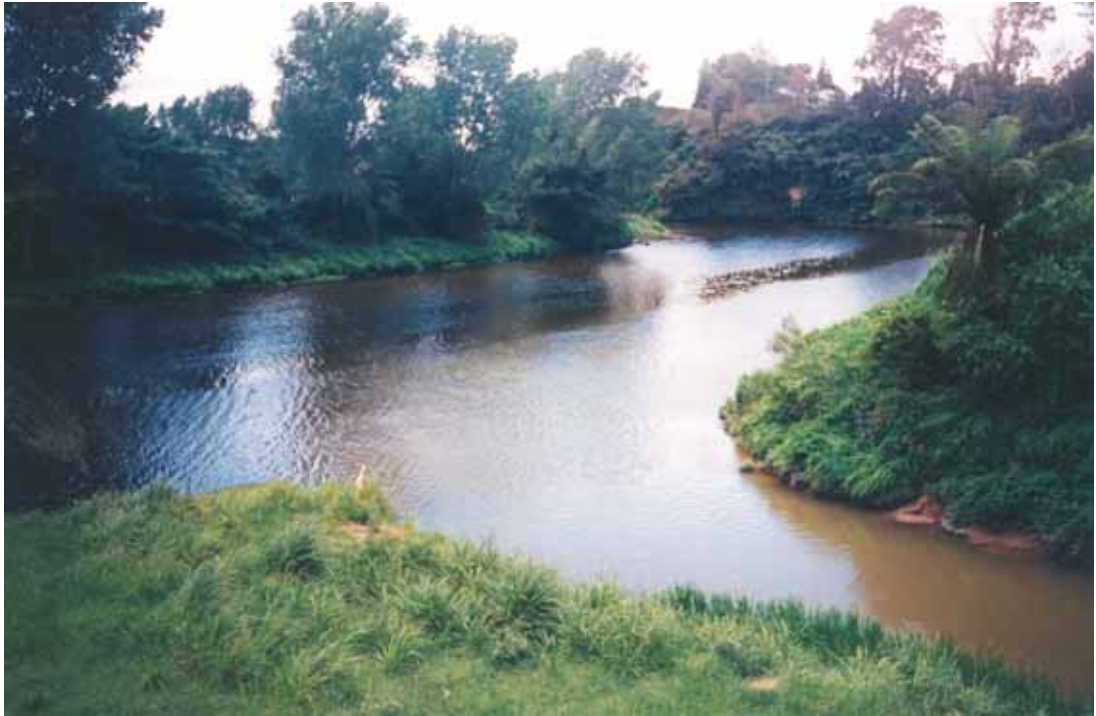
At 9.5km Omanawa River joins the Wairoa; the Omanawa was observed as cloudy and takes some distance downstream of the confluence to mix laterally. Waireia stream (at 8km) while also considered murky, has a small flow rate; fallen trees lie across this stream. Forestry lines the left bank of the Wairoa until the Ohourere

Figure 8.4 Confluence of the Wairoa and the Omanawa rivers.

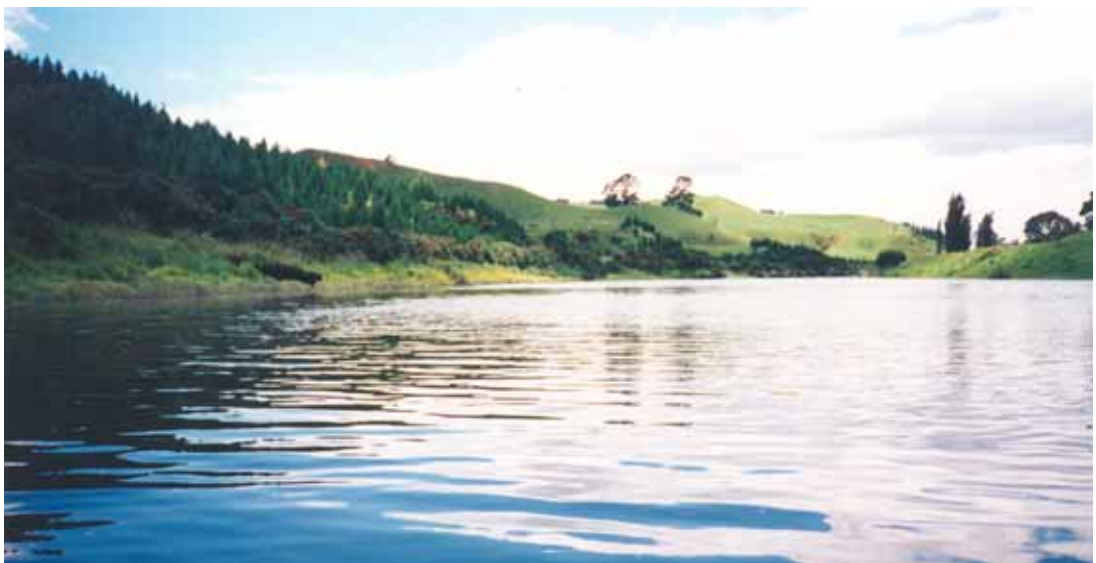
Lower banks ($2\text{m} \pm 1\text{m}$) start from around 6km on both sides. At 4km, several trees overhang the river (refer Figure 8.5) and two dead trees lie in the water, however the width of the river has increased to 80m so that the proportion remains small. The banks within the normal tidal range are unvegetated (at least 0.6m in some places).

Figure 8.5 Downstream view, recontoured right bank, and cattle to waters edge.

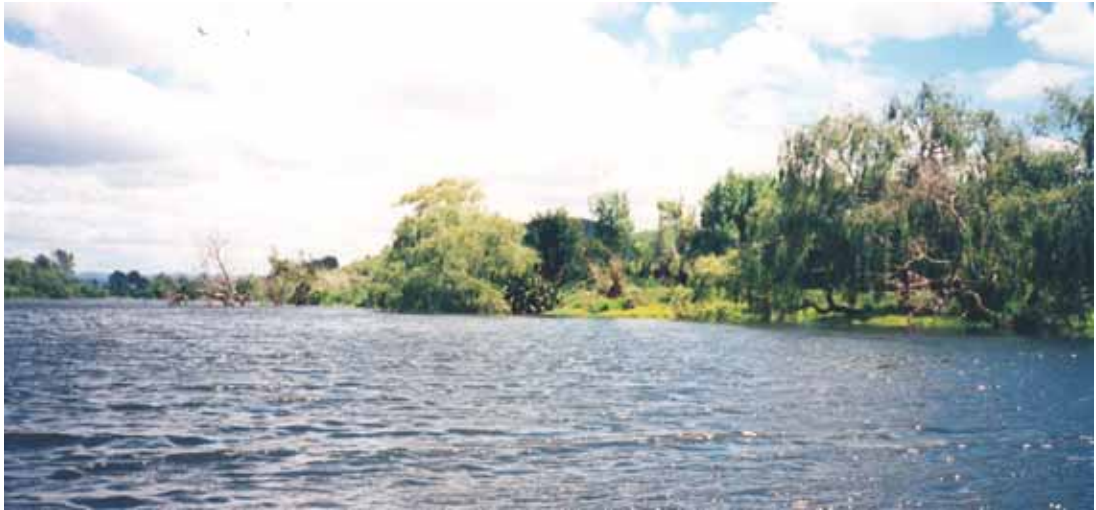
Figure 8.6 Large trees in the river, (living or dead), have only a small impact once the river widens.

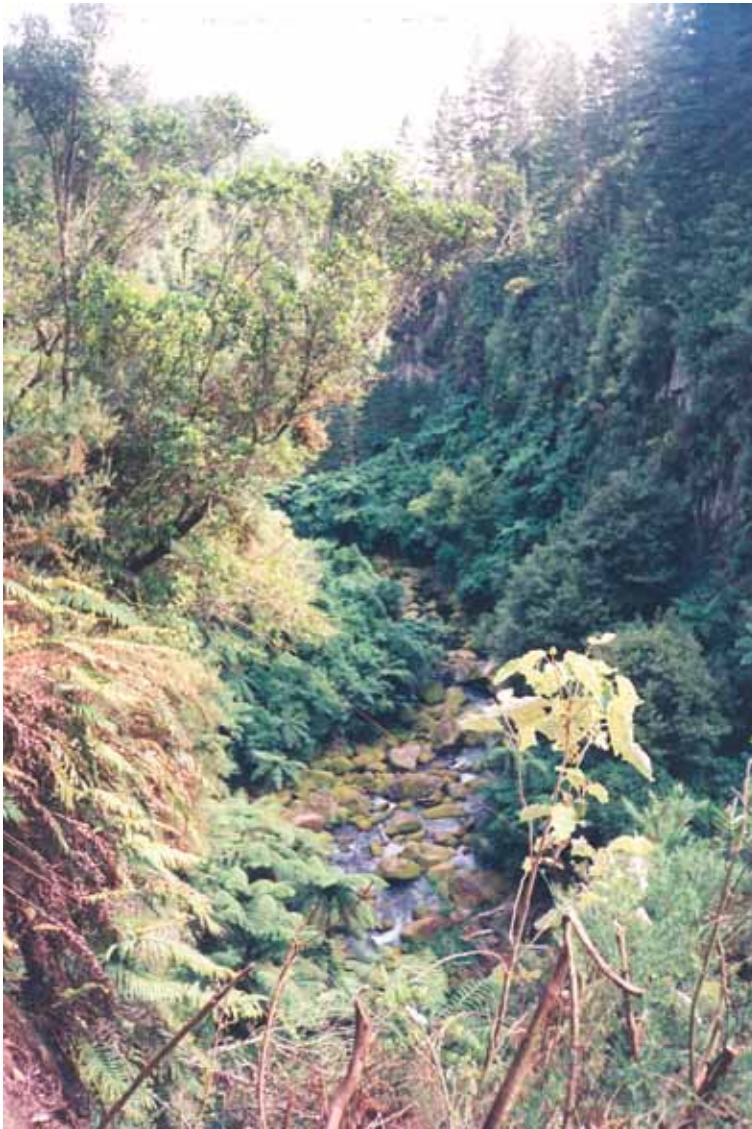
*Figure 9.1
Omanawa gorge
high in the
catchment
(approximately 7km
above the beginning
of the survey).
Rocky bed and cliffs
contain the river
flow.*

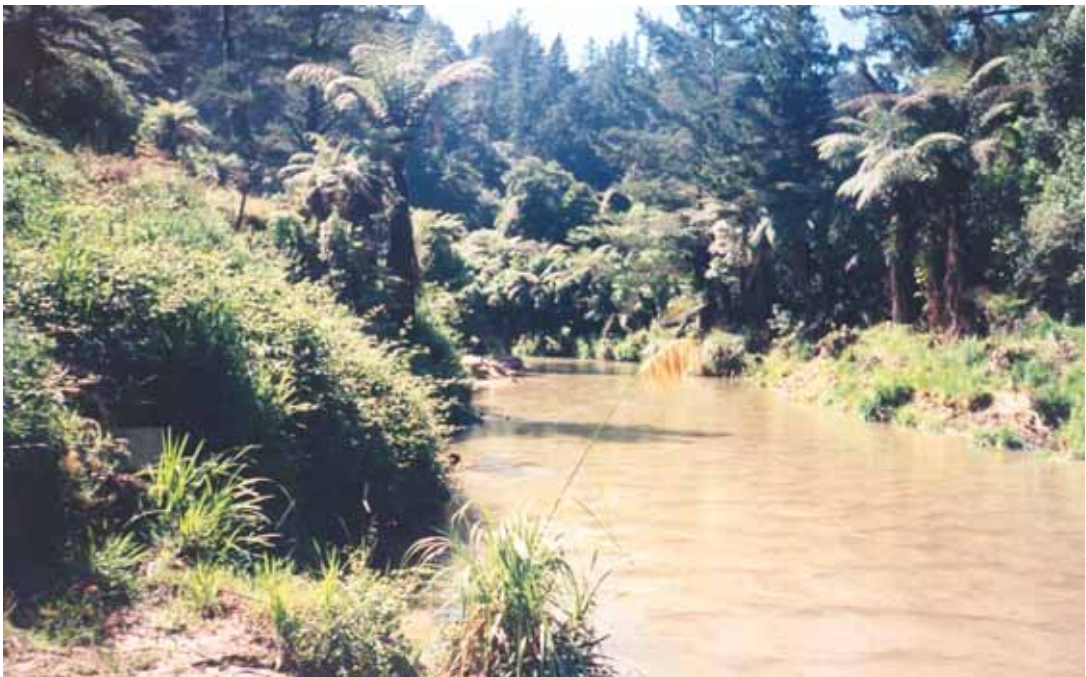
Preceded by the bush covered gorge of around 100m height shown in Figure 9.1, the Omanawa river first contacts farmland on one bank, 6km above its confluence with the Wairoa River. Here the channel is 15m wide while only 0.3 - 0.4m deep (refer Figure 9.2). The sandy bed is rippled and sediment of up to 1.5cm diameter is seen moving as bed-load between ripples. Scattered erosion, approximately 0.3m in height, is evident.

Figure 9.2 Clear and shallow water - easily visible bed ripples.

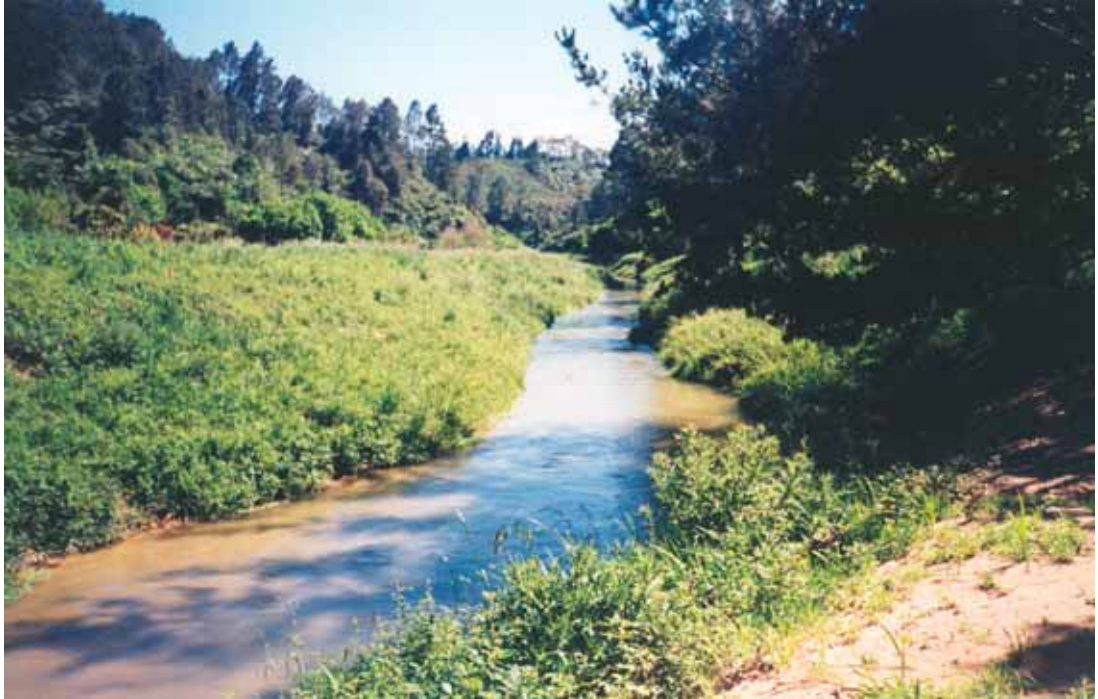
A grassed flood plain up to 100m wide occurs inside the 4 to 5km section. Tighter meanders within the plain are well bounded by a bush covered gorge (refer Figure 9.3). Outside banks are commonly eroded over entire height (i.e. $\approx 4\text{m}$) whereas the inside banks (lower) are covered in sand deposits.

Figure 9.3 Grasses cover the flood plains 5km above the Wairoa confluence.

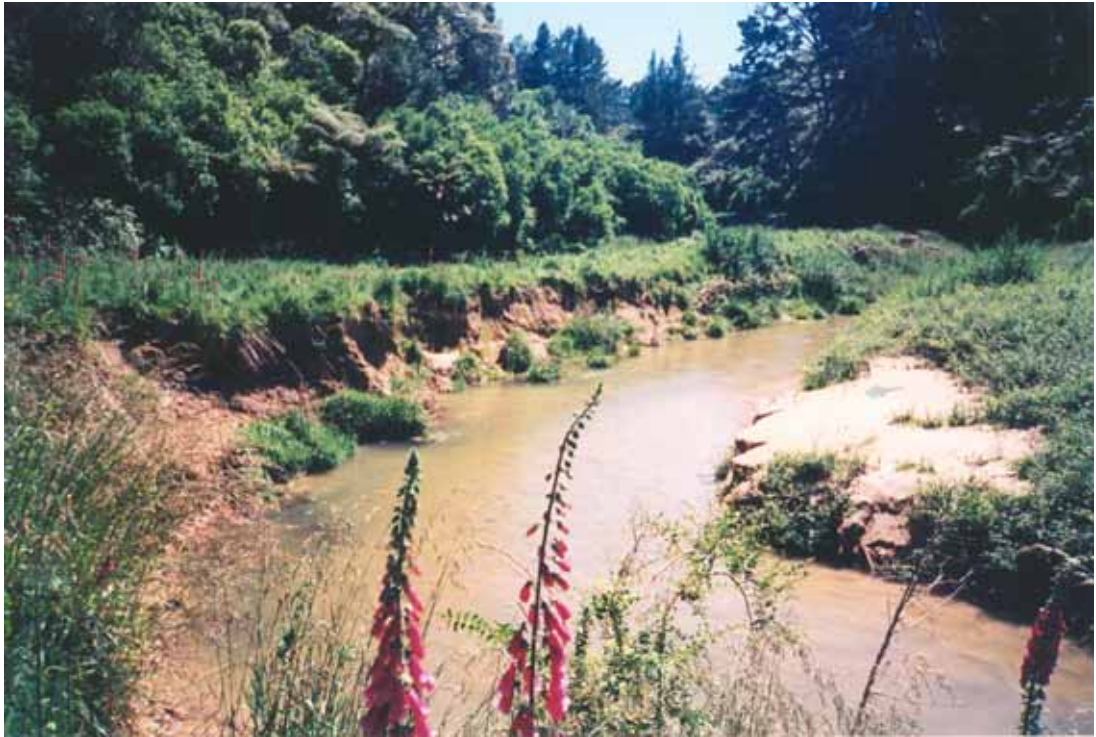
Figure 9.4 Erosion and deposition on the outer and inner banks respectively.

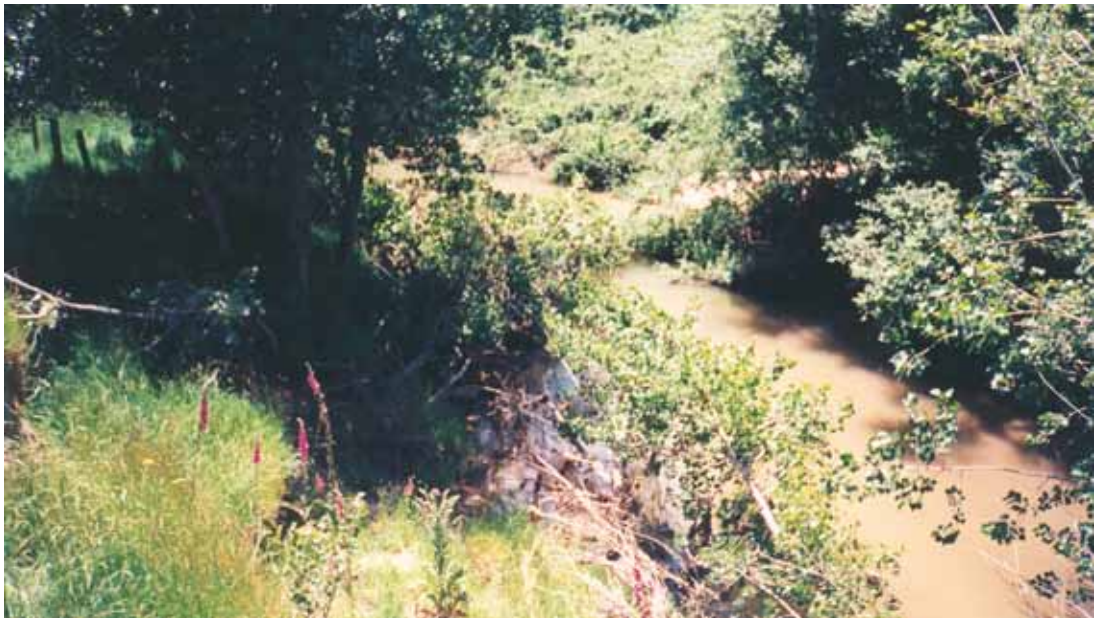
Figure 9.5 Trees have been flattened into the stream by floodwaters.

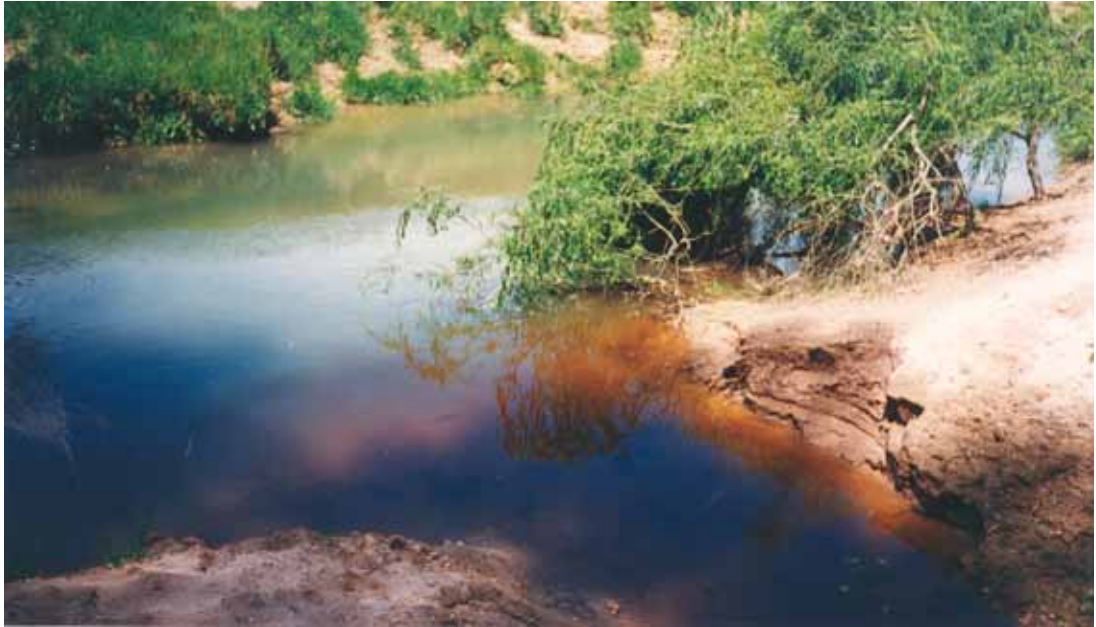
The first trees *in* the channel were noticed 2km above the Wairoa confluence (refer Figure 9.6), and bank erosion was evident. From 0.8 to 1.5km, the left bank land is planted in crops and agricultural use of the right bank begins; trees follow the river's path, some blockages are encountered. Drainage works were being carried out at the time of the survey; a small quantity of very muddy water entered the river here.

Figure 9.6 Discoloured stream (around 0.4m width) enters.
