Tauranga Harbour Sediment Source Survey

Report prepared by Matthew Surman, Design Engineer
Richard Clarke, Student - Lincoln University
Meredith Carter, Student - Waikato University

Environment B·O·P
Quay Street
P O Box 364
Whakatane
NEW ZEALAND

The report provides an order of magnitude estimate of sediment transported from stream bank erosion into Tauranga Harbour from the harbour catchments. The report describes and costs possible stream improvement works and estimates the reduction of sediment yields such works may achieve.

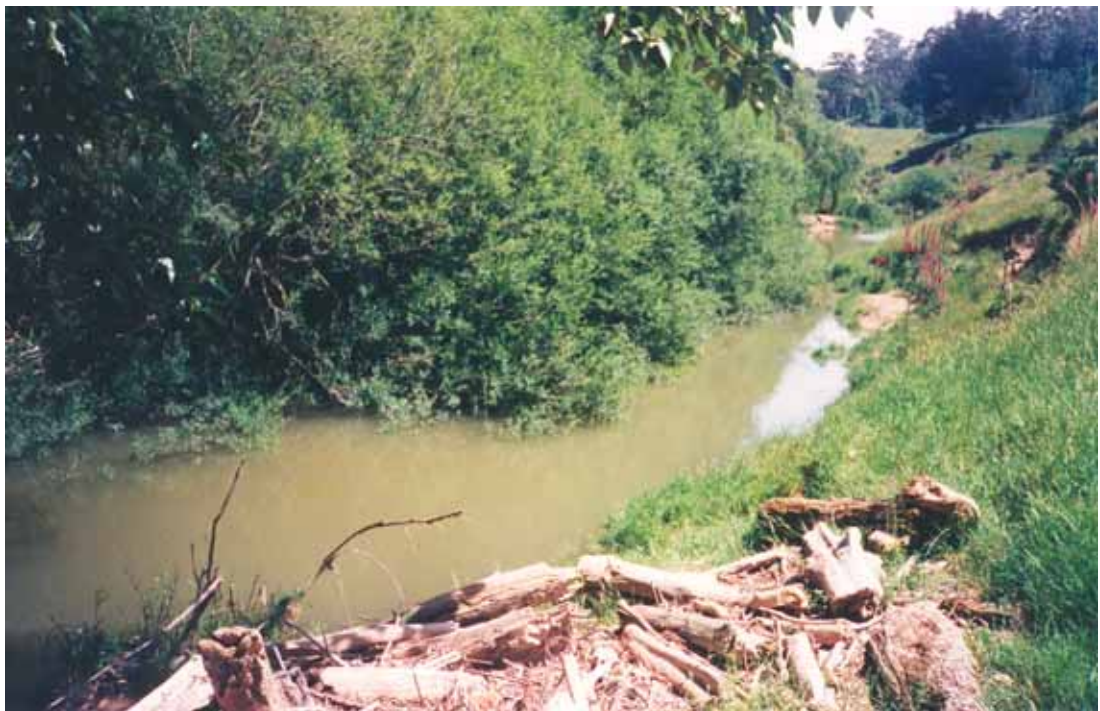
Figure 9.7 Within the final 200m willows straddle almost the entire river so that at one point only 0.5m can freely flow past.

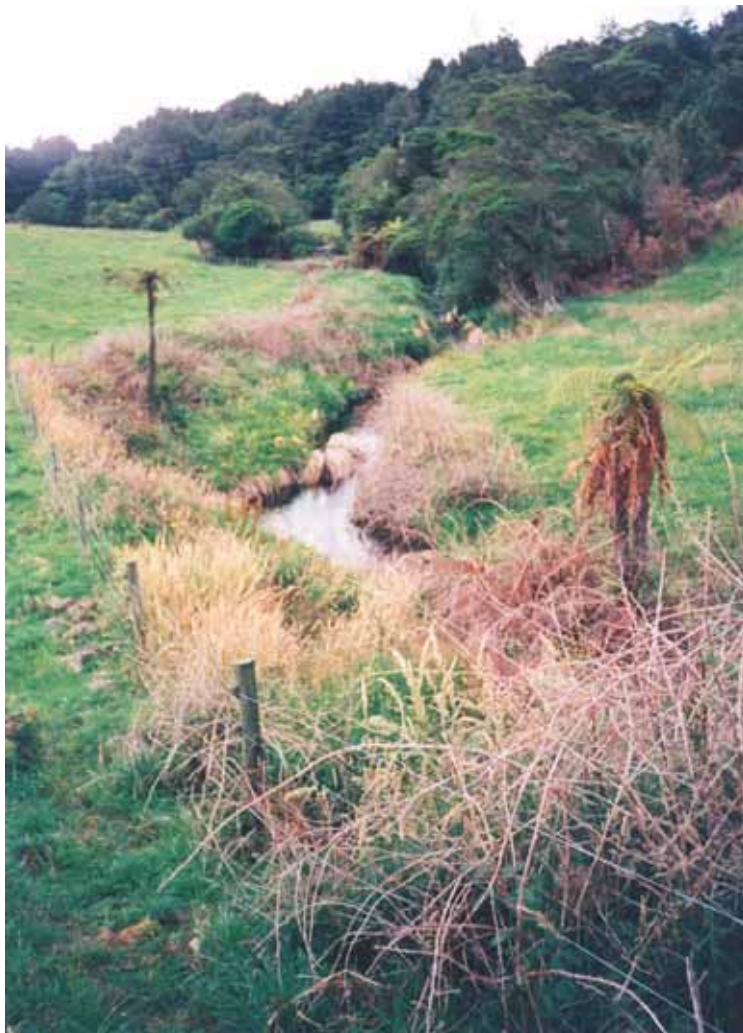
*Figure 11.1
As the bush decreases, it is replaced by blackberry (that has been killed off by spraying), with some dragging in the stream. Grass patches line the 1.5m high bank, generally farmed hills rise on either side of a 50 to 100m of floodplain.*

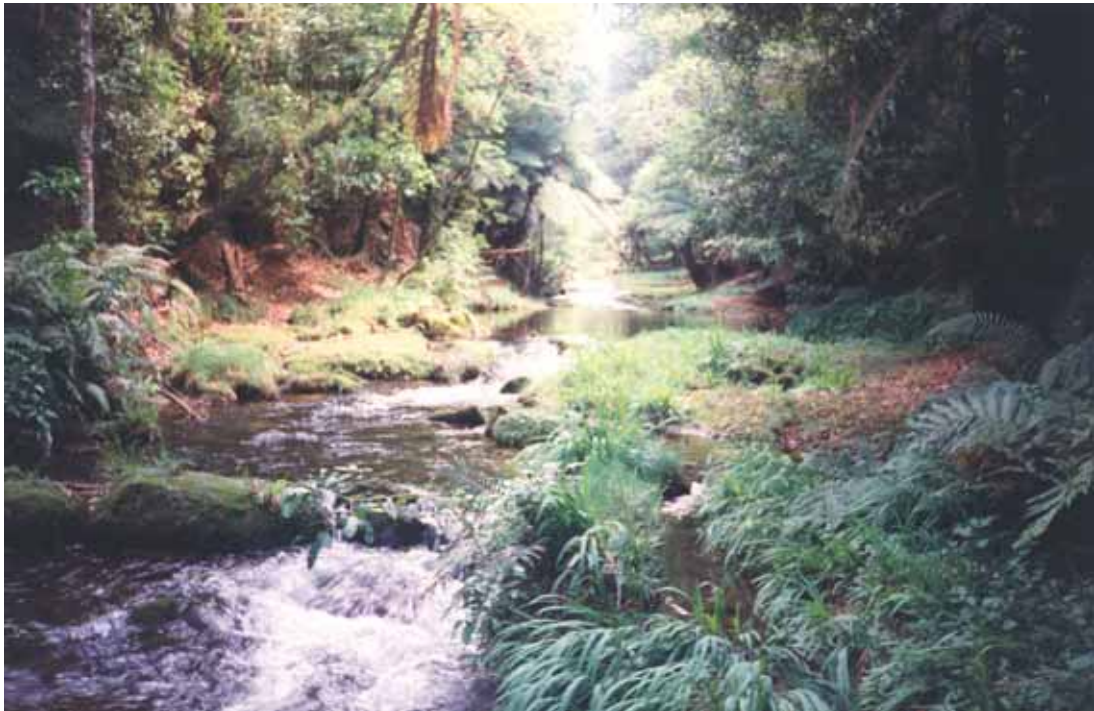
The first substantial drop sees water falling around 7m over a rock shelf. The land level does not follow these dramatic changes in bed level and a gorge develops with bush extending to farmed land making access to water level more difficult. At each visible section of water it appears there is a substantial drop, from a topographical map it is estimated that the stream gradient in the top portion (i.e. down to around 2.5km above SH2) has at least 30m per 1km. There is little erosion because the rock base (Waiteariki ignimbrite) extends up the banks; the very steep and high banks are stable. Vegetation is on ledges and lower gradient banks where possible. A small moss covered area 2m either side of the 3 to 4m wide channel is available as a flood plain through some of the flatter sections (refer Figure 11.2).

Figure 11.2 Within the gorge there is a few metres floodable area to either side of the channel.

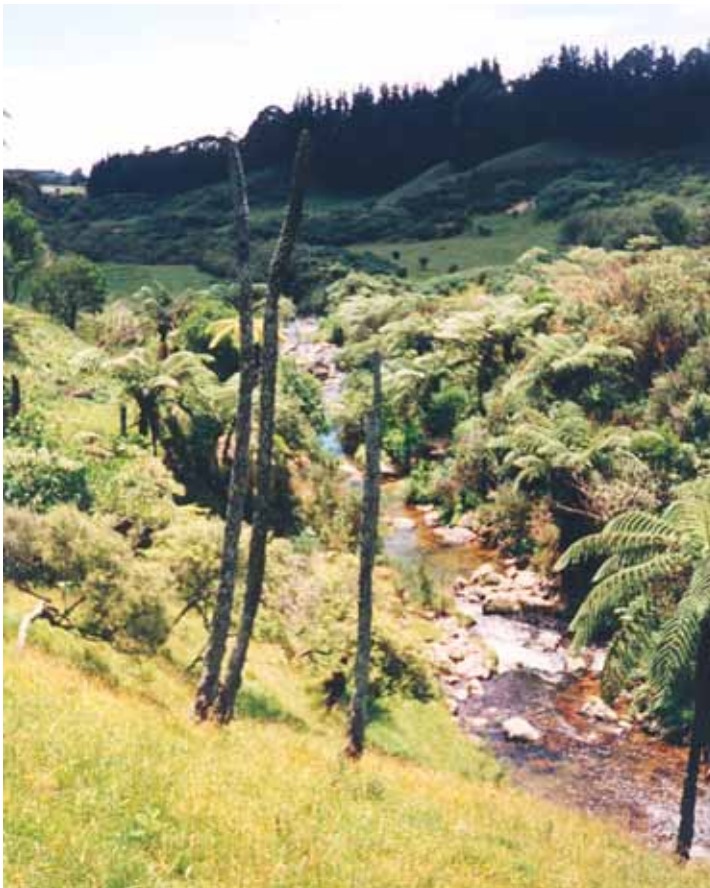
The bed now contains many loose rocks which form short bouldery rapids (refer Figure 11.4) each 50 – 100m in length over the following 1km. In this section, the stream meanders within the plains. Animals are generally fenced off from the river.

*Figure 11.4
At 1.8km above SH2, the steep gradient decreases.*

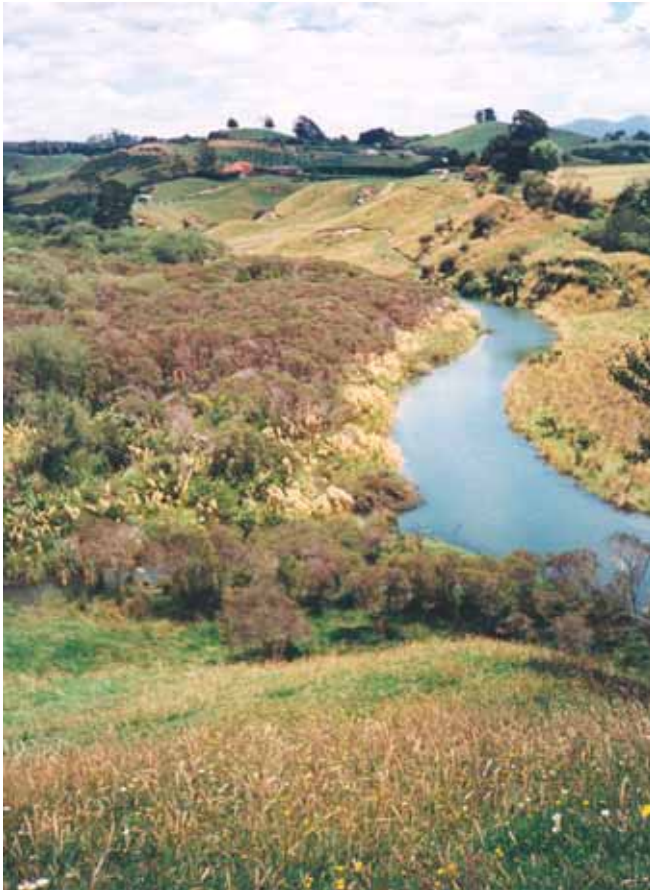
Figure 11.5 From 200m above SH2, viewing upstream, adjacent land is swampy. The water is noticeably discoloured as it mixes with tidal harbour waters.

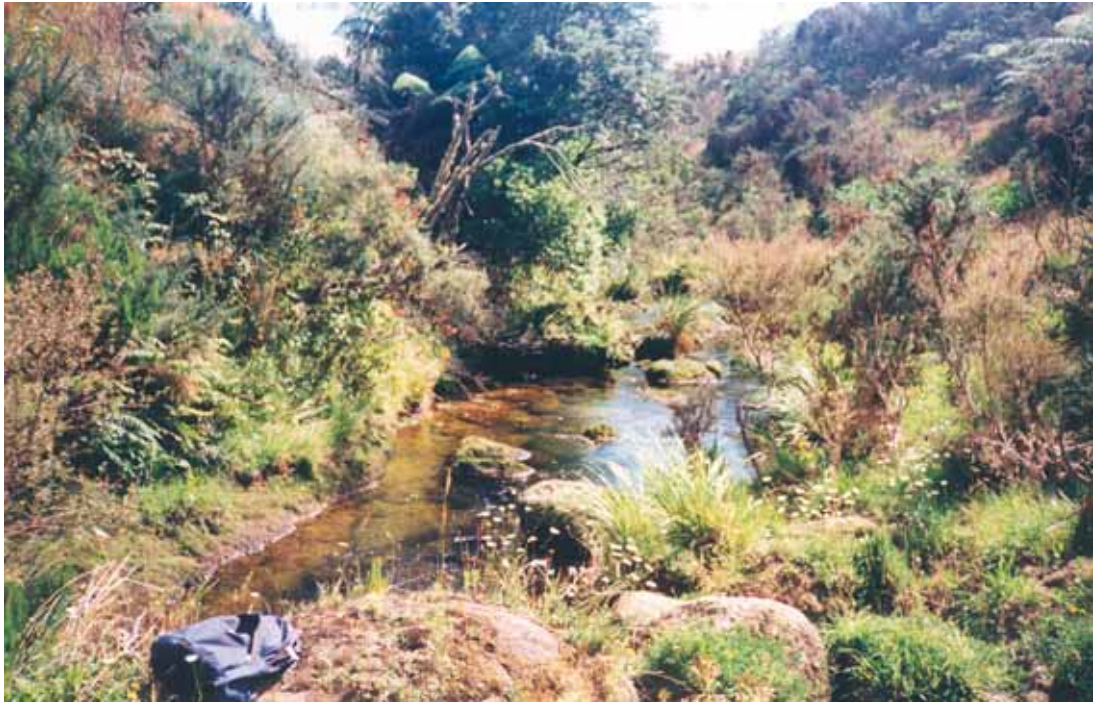
Figure 12.1 Here the water is clear, the banks are well vegetated 0.3m above the water line, below which is a thick covering of moss.

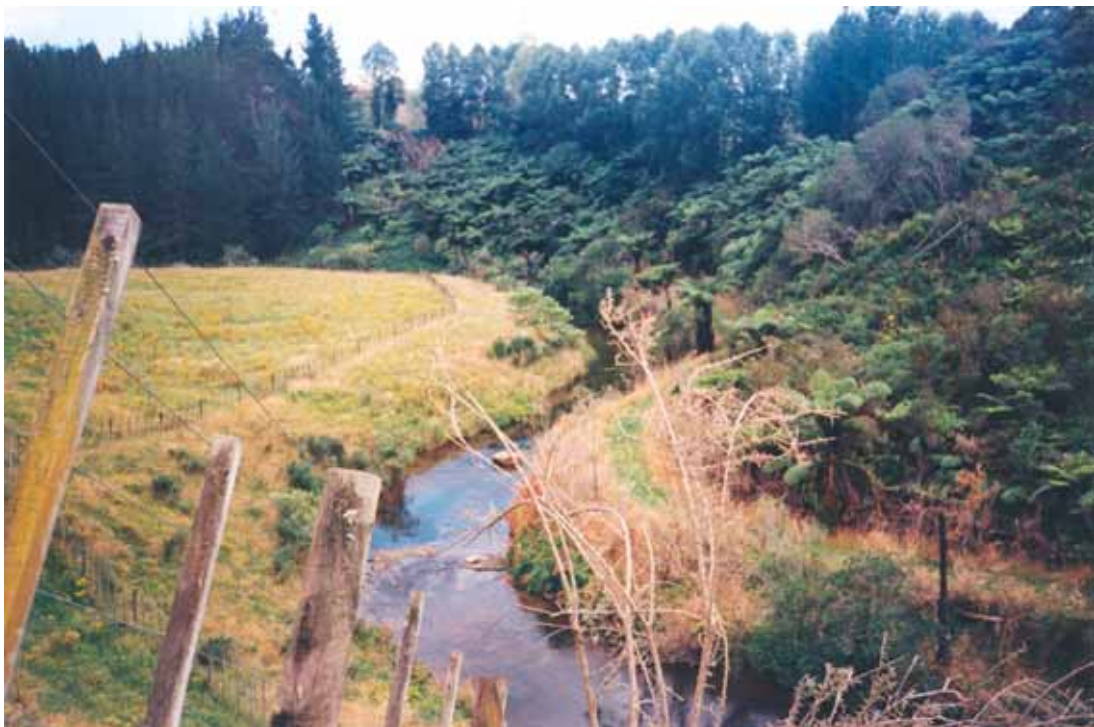
Figure 12.2 From 2.8 till 2.2km above SH2 the river is flat, erosion is minimal; some tree debris is evident in patches.

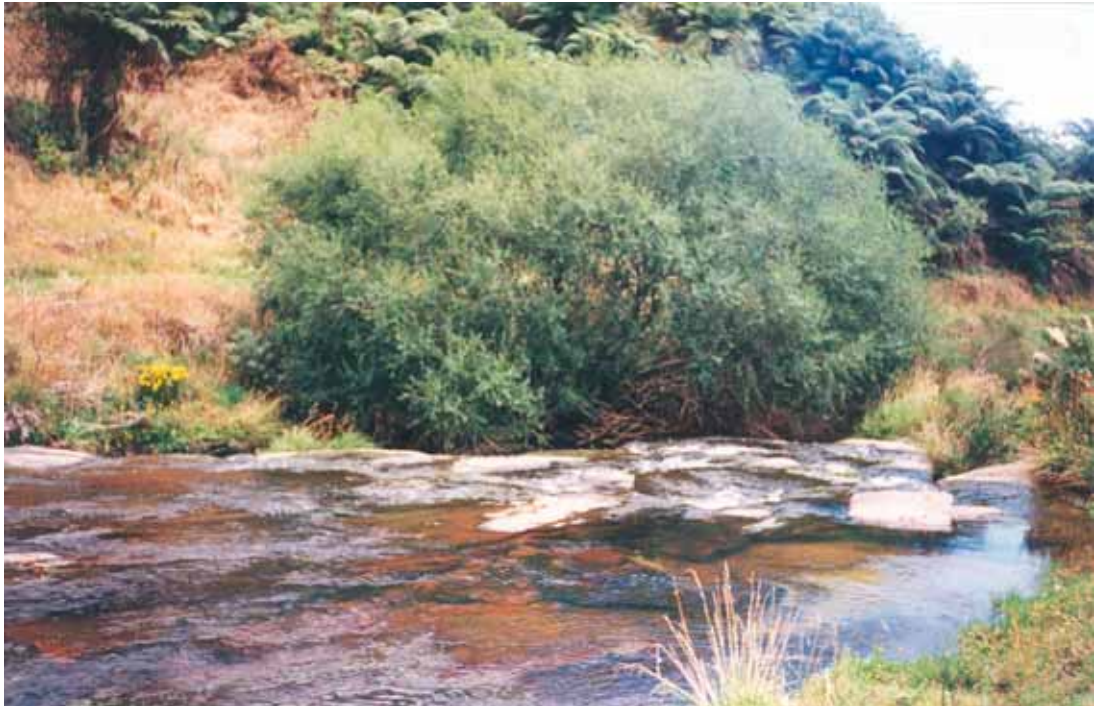
The first significant obstruction occurs at 1.9km above SH2 where a willow restricts the stream (refer Figure 12.3). Erosion (10m by 1.5m) follows shortly after. The surrounding land starts to open out.

Figure 12.3 The river drops over a 1m shelf and is restricted by a willow that is rooted on the left bank.

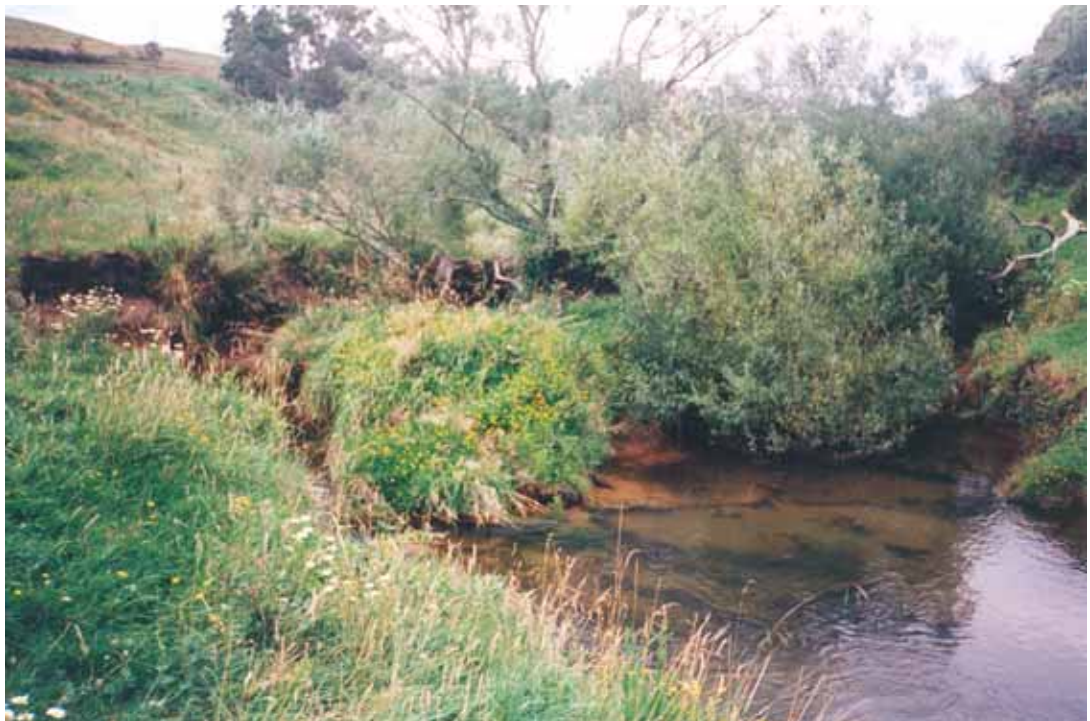
Figure 12.4 At approximately 1.4km above SH2 the river has previously been fully blocked by debris. A new route has eroded its path sharply to the true right leaving a 3m bare bank (shown on the left of this upstream view).

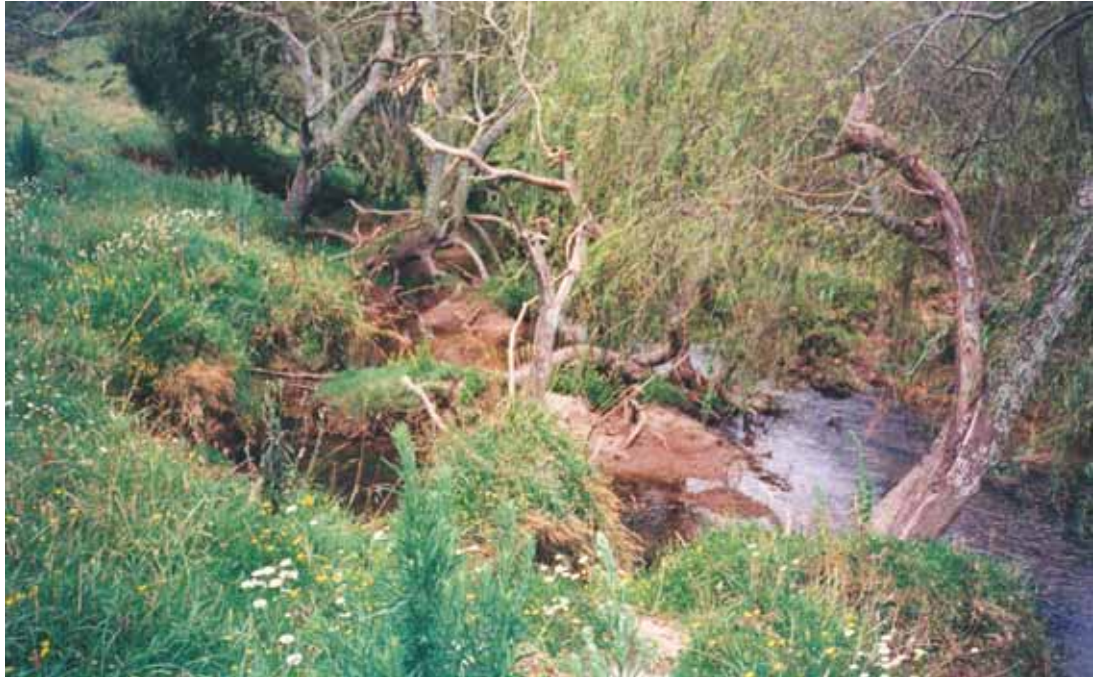
Further downstream (until 1km) is a series of similar blockages, but which are not so advanced. Islands within the river divide the flow and can trap sediments behind them creating an obstruction (refer Figure 12.5).

Figure 12.5 At 1.2km, growth of in-stream willows encourages sediment deposition. The consequential islands redirect flow, causing erosion.

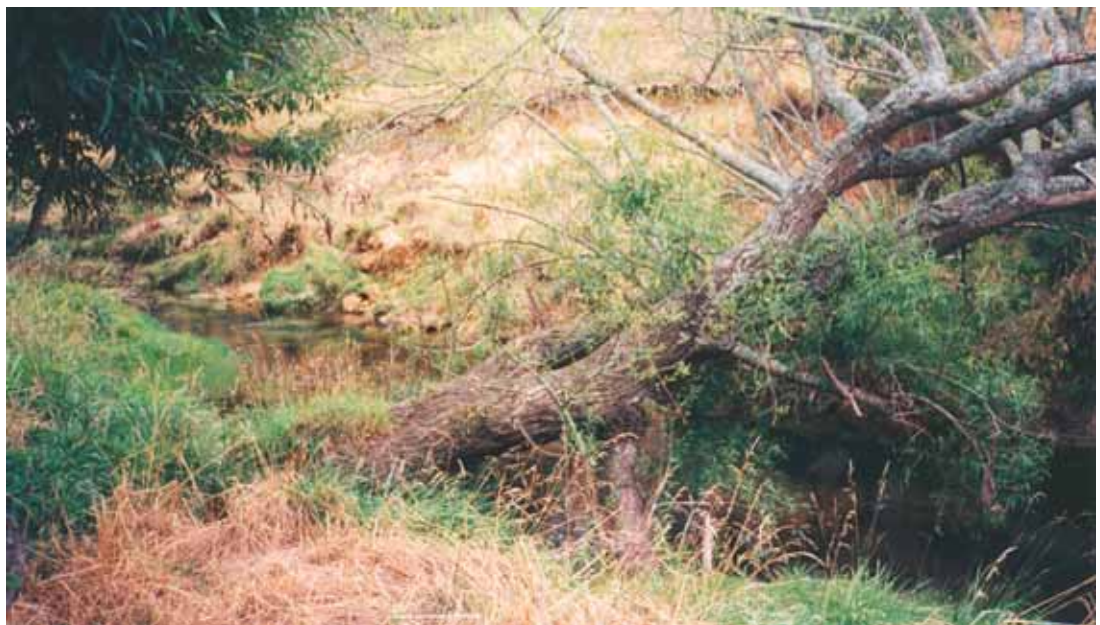
There are several overhanging willows which are potential contributors to blockages (refer Figure 12.6). Erosion on the left bank at 1.3km is of substantial length and is also very close to an unsealed farm road, with the possibility of undermining it if the erosion continues. At 1km there is a 100m section of erosion.

Figure 12.6 Typical potential tree blockage at 1km above SH2, while extensive erosion is evident in the background.

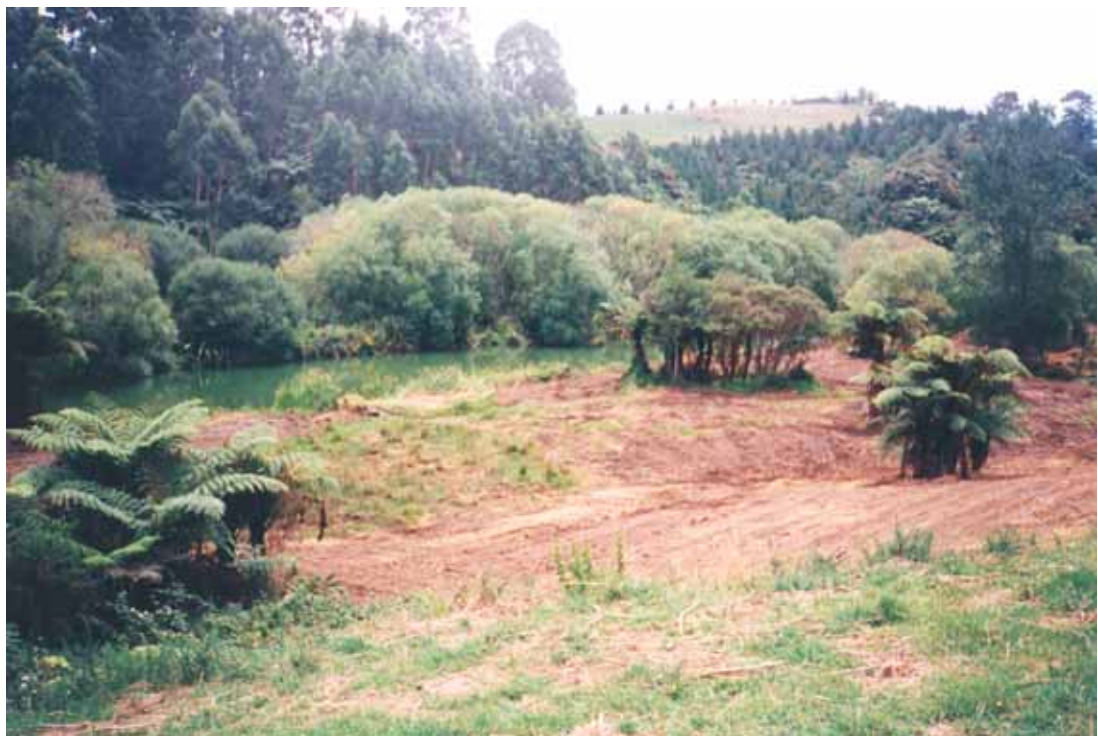
At SH2, there is a final drop in the river, which on the day of the survey the tide did not over top. The water lost much of its clarity at this point indicating the harbour's influence. Around 2km of river exist before transition to the harbour via the Waipapa estuary. Some low-lying land adjacent to the river is being cleared for grazing of stock; much of the land has little freeboard above the river level (refer Figure 12.7).

Figure 12.7 Flats beside river at 400m below SH2 are cleared for grazing of stock. For the first 800m below SH2 the left bank is lined with willows.

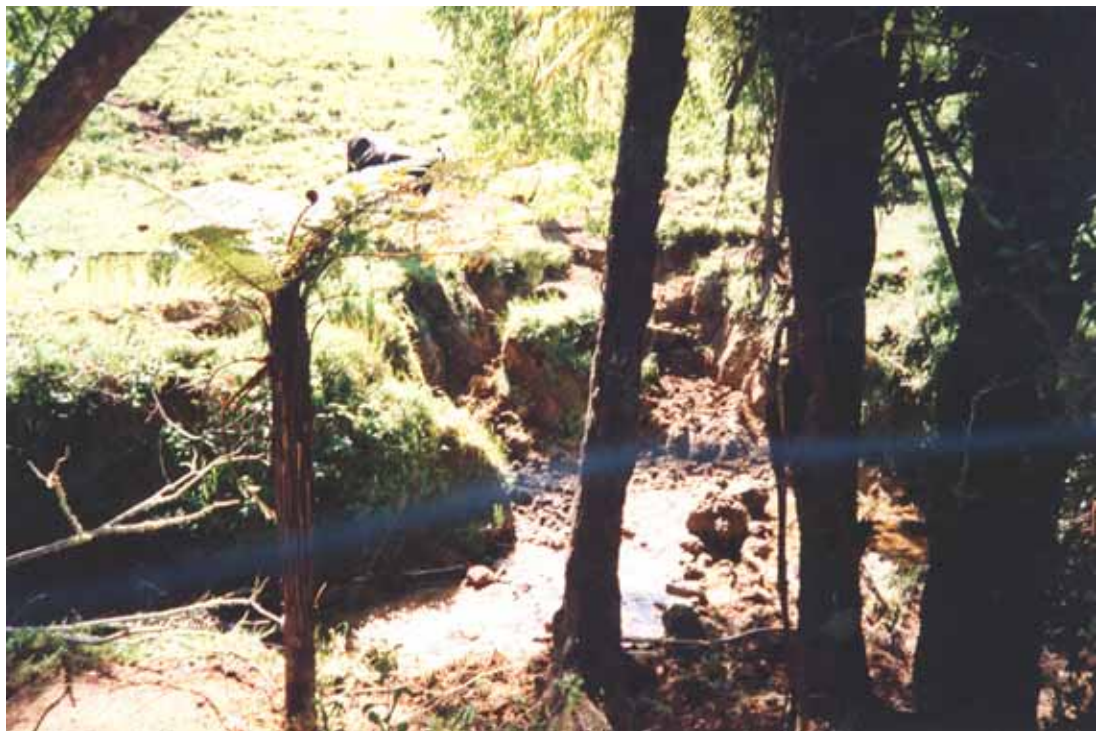
Initially a small flow is bordered by trees with a moderate amount of debris on the bed. The 1 – 2m high banks are mainly well vegetated with grasses extending up to farmed hills. The banks are generally fenced but stock access at 5.0km has resulted in minor bank erosion and slumping (refer Figure 13.1). Fencing is absent on the left bank, only occasional sign of stock being visible at the waters edge.

Figure 13.1 Slumping of the right bank at 5.0km.

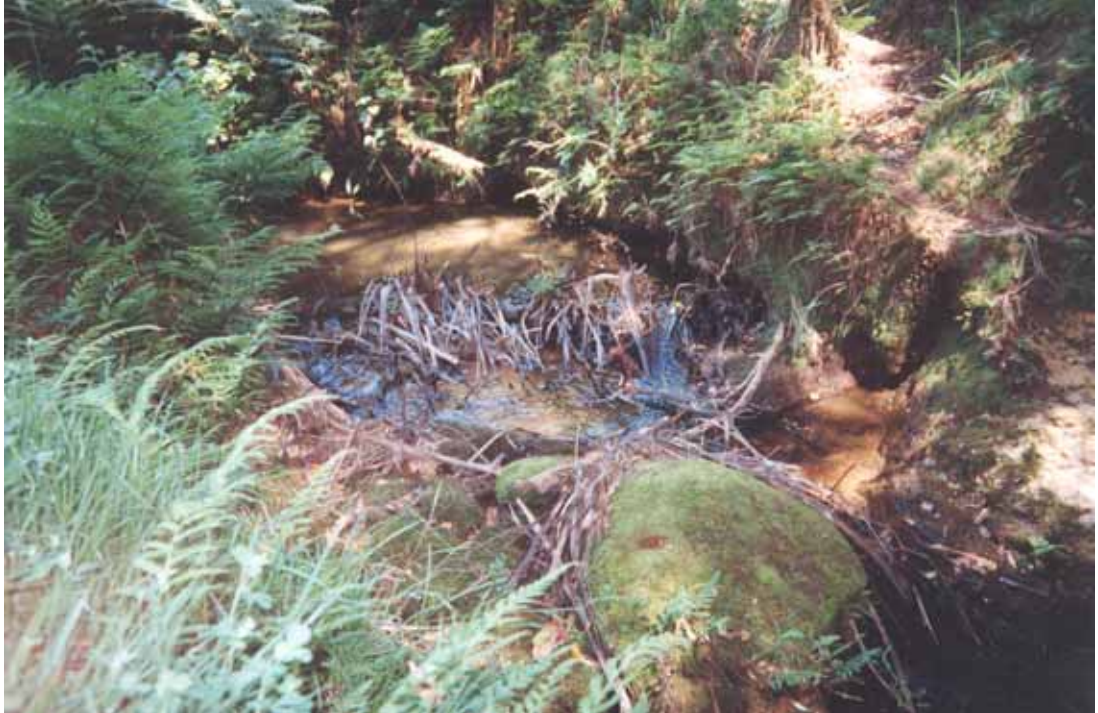
Figure 13.2 The water is clear, the banks are well vegetated, with debris collecting on rocks and branches.

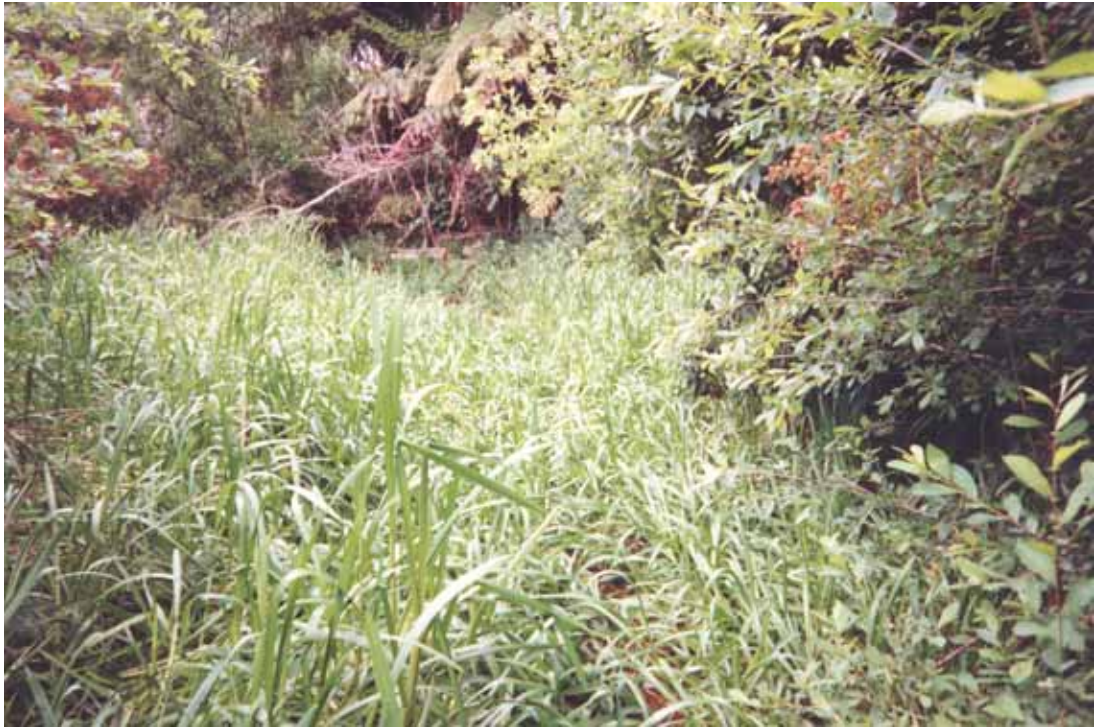
Figure 13.6 *Glyceria Maxima* grows in the channel, reducing the width. The banks are well vegetated.

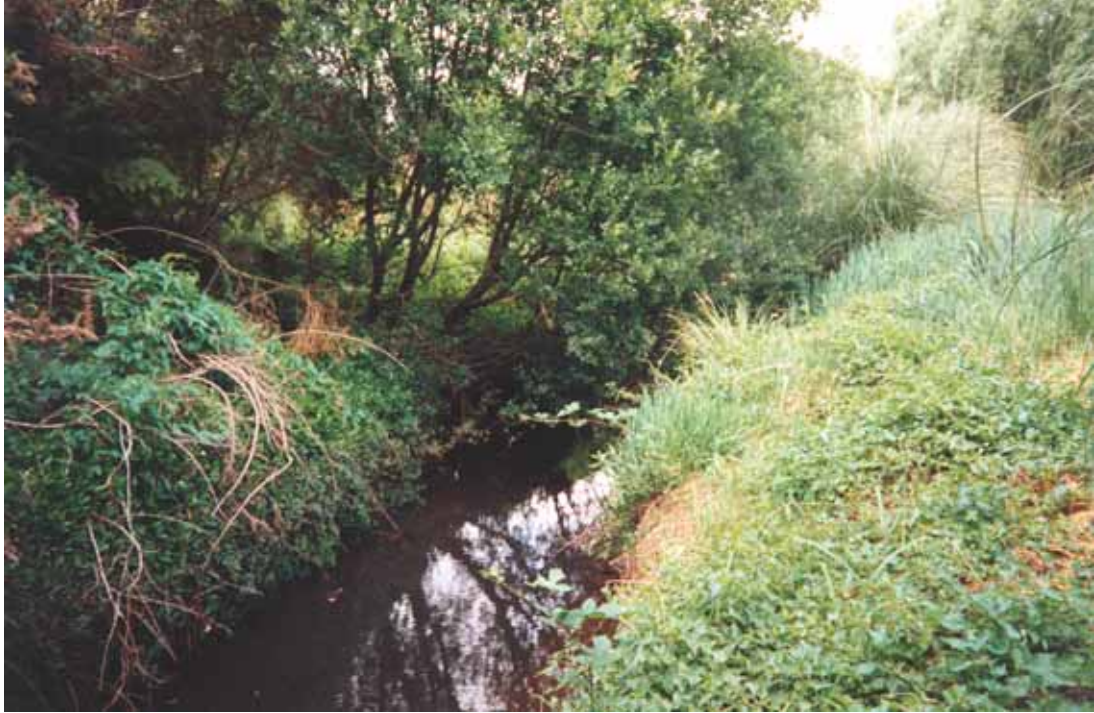
Figure 13.8 A lone tree overhangs the stream at 700m above SH2, banks have good vegetation cover.

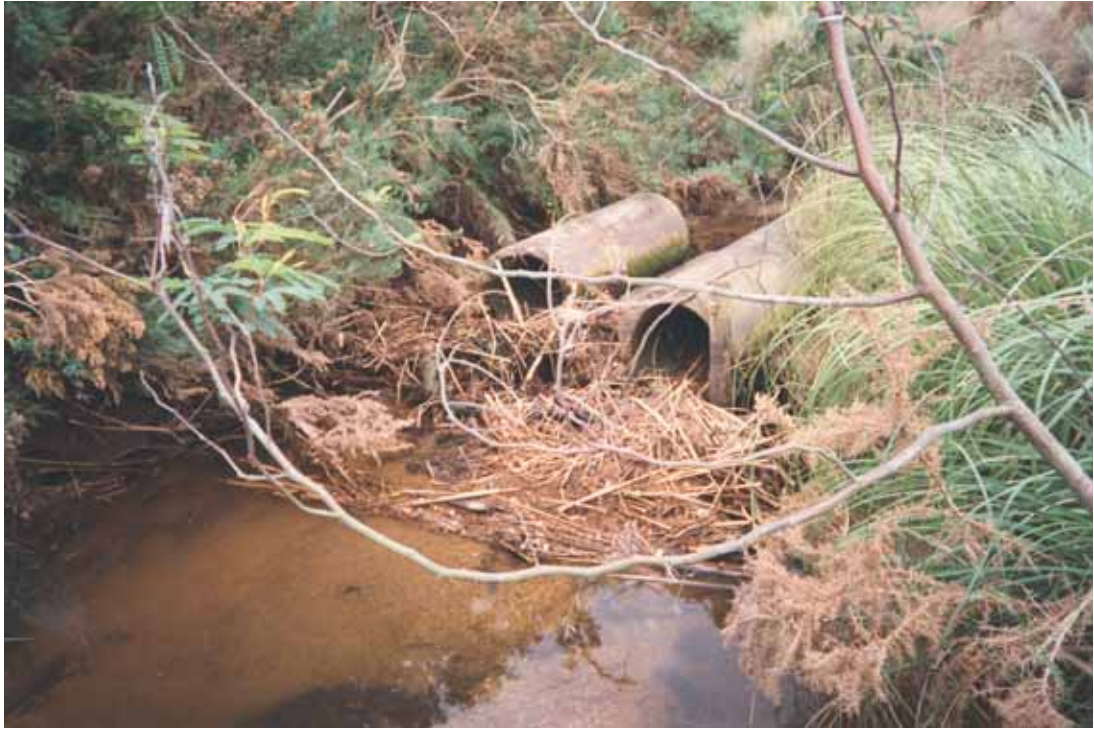
550m above SH2 a floodgated culvert is present. Below this the water loses much of its clarity, and the stream widens to 5m. 250m downstream (refer Figure 13.9) a debris blocked culvert crossing consisting of four pipes diverts flow either side. The culverts do not appear to be serving a purpose, though they once may have acted as a bridge or a walkway.

Figure 13.9 Culverts collect debris, and partially block the flow.

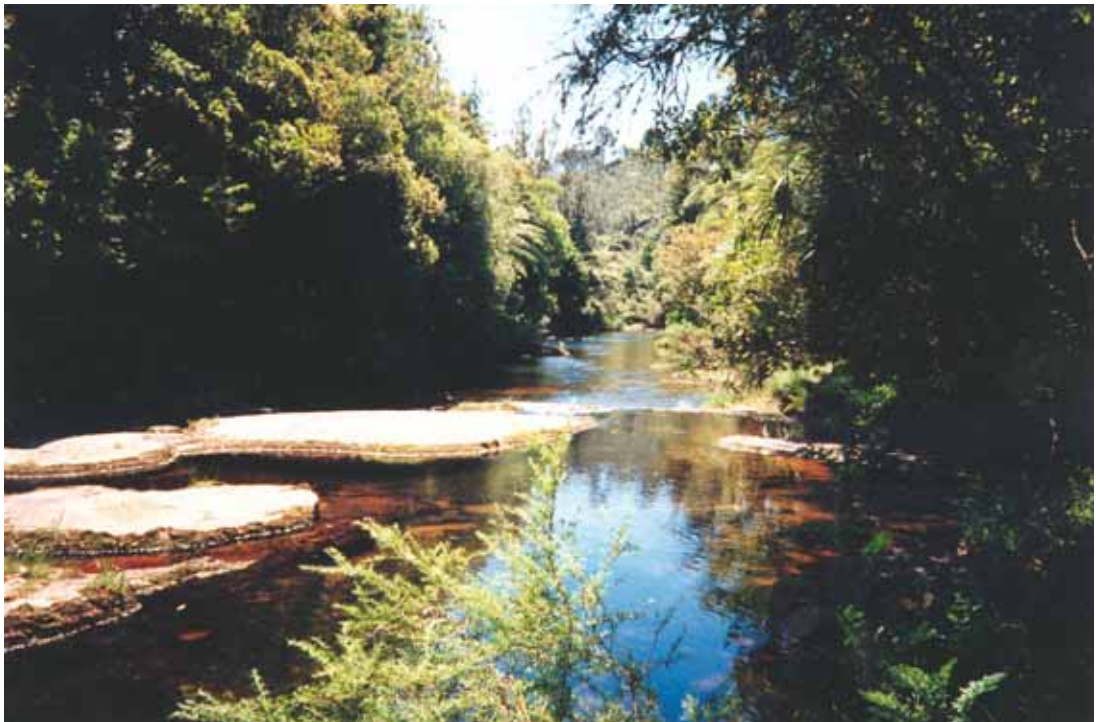
Figure 14.1 Looking downstream at 4.5km, the river is bordered by bush, the banks are stable and well vegetated.

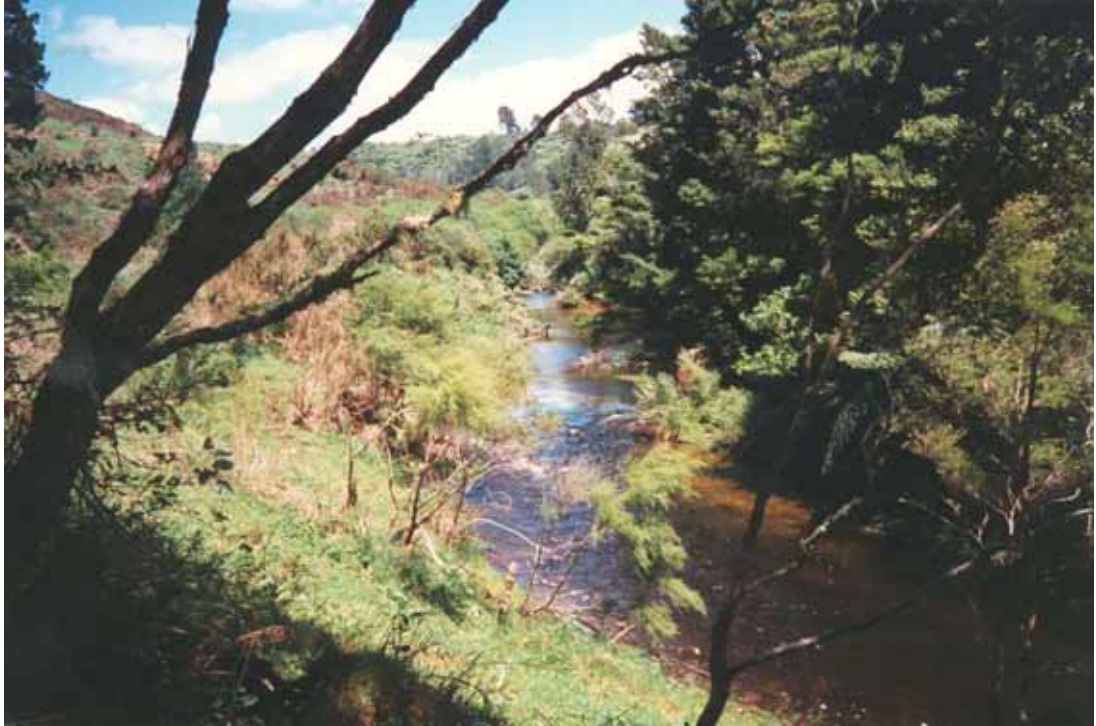
Figure 14.2 At 3.7km above SH2, the steep gradient decreases. Minor amounts of debris lie on the streambed.

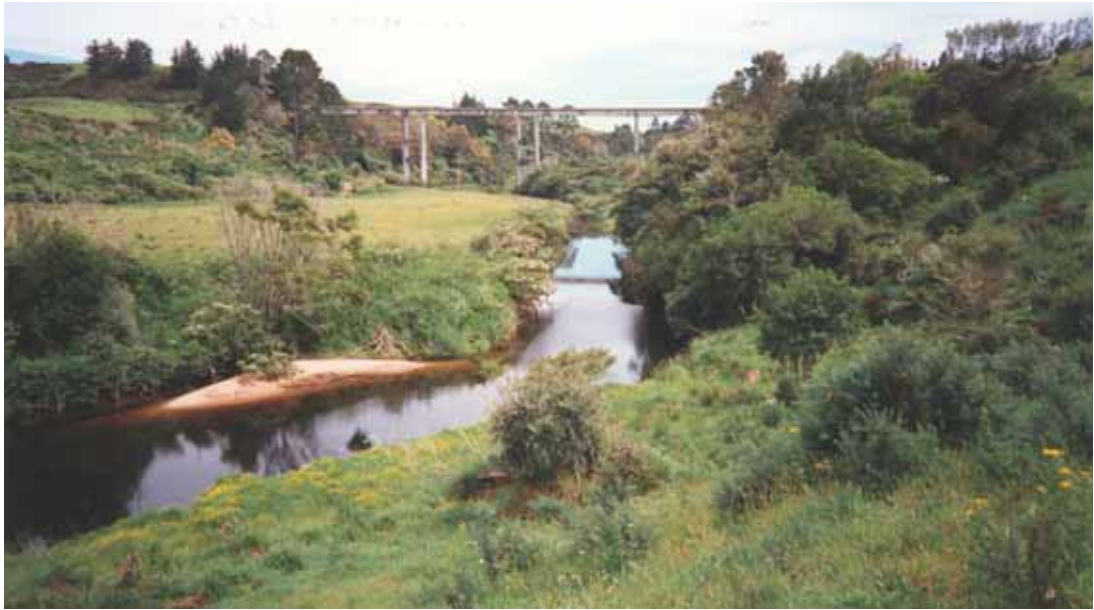
Figure 14.3 Viewing downstream areas of adjacent land are swampy and the river is noticeably discoloured.

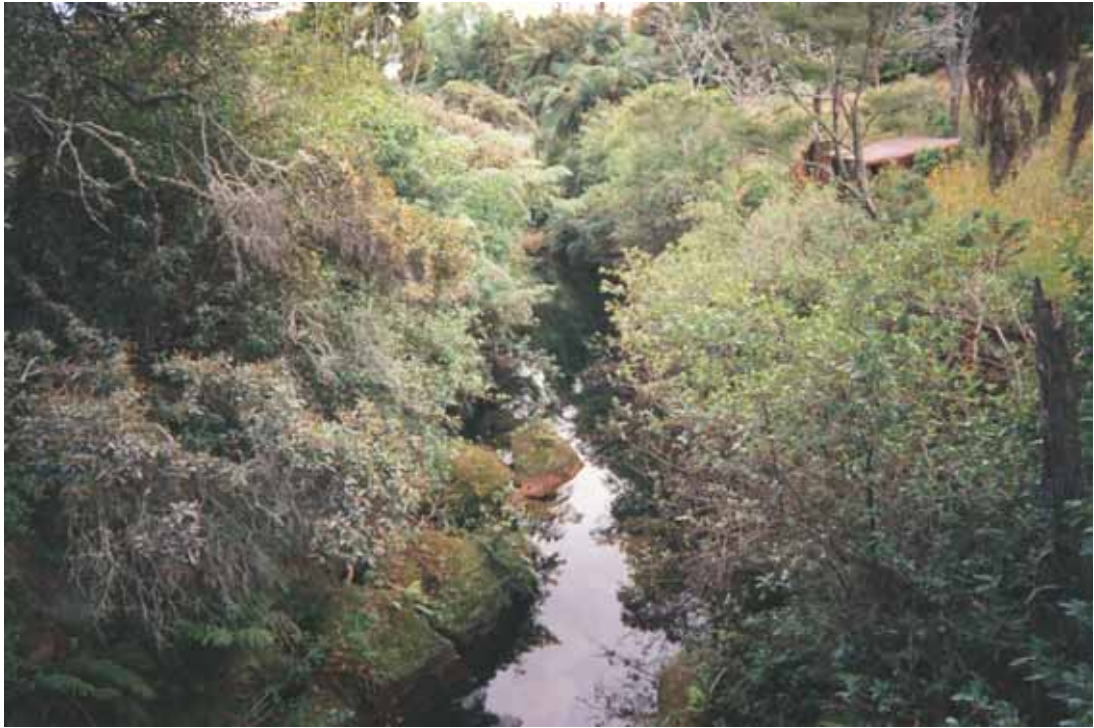
Figure 15.1 Looking downstream from Upland Road bridge. Banks have a thick vegetation cover, and erosion is minimal.

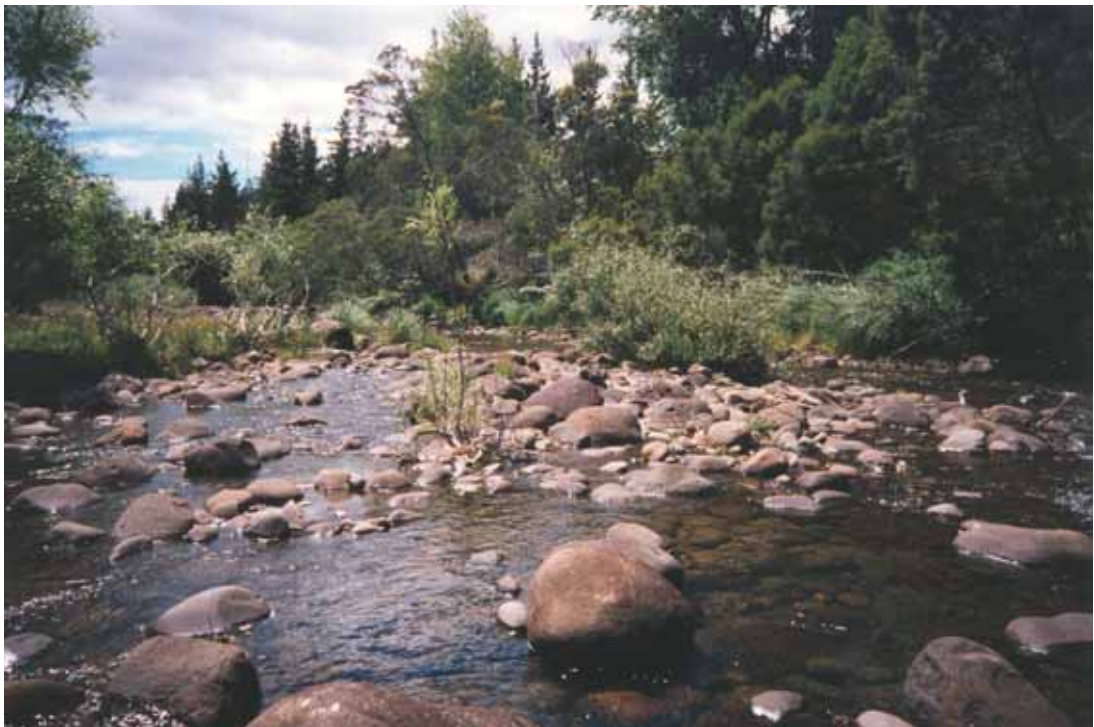
Figure 15.2 Young willows growing on rock beds have been flattened by high flows.

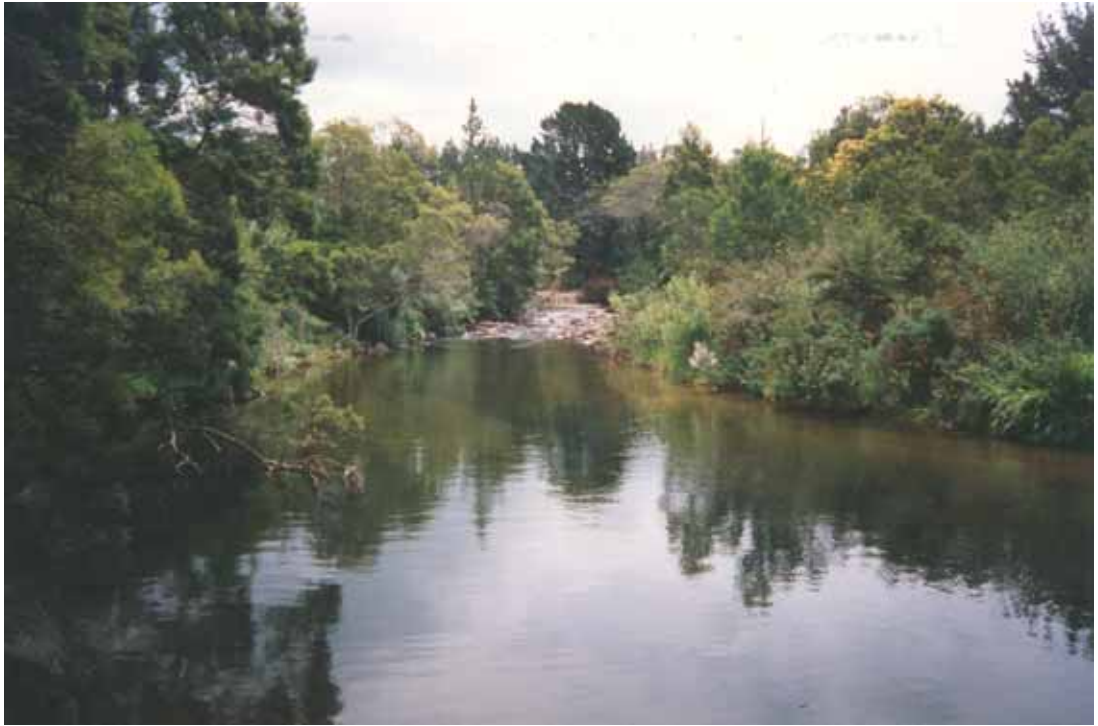
The banks continue to be well vegetated, with trees bordering the stream. Minor bank erosion on a bend at 3.3km (at quarry).

Figure 15.3 Looking upstream, banks are well vegetated, except for minor erosion on the bend.

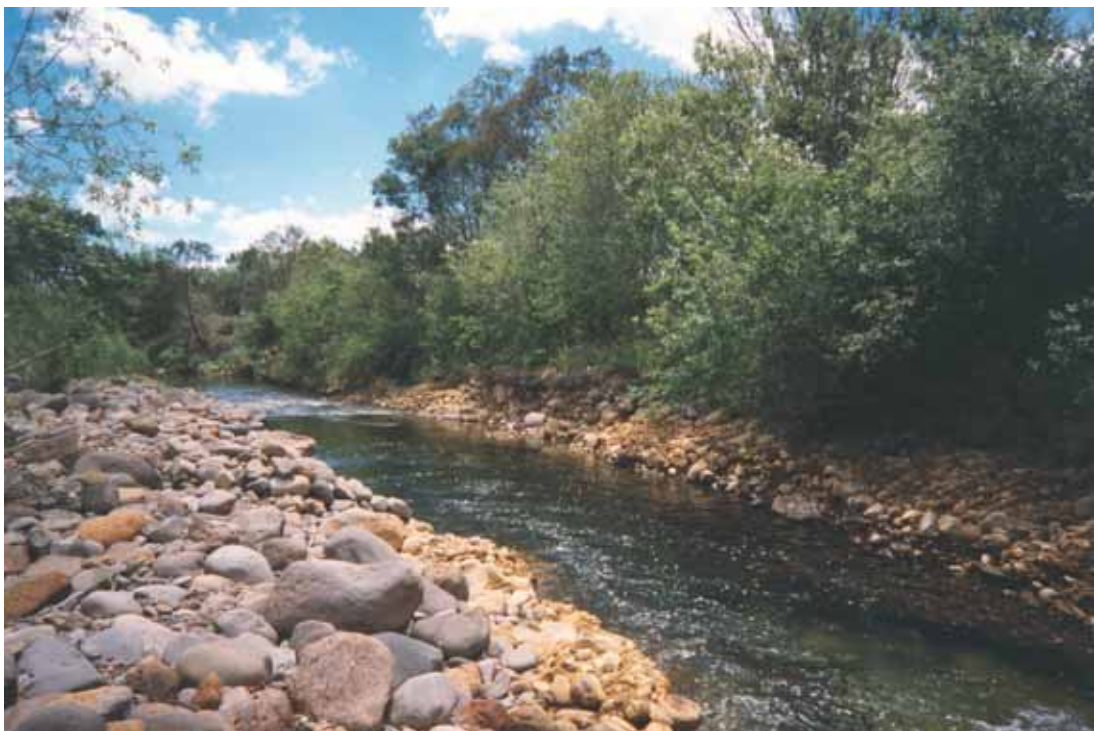
Figure 15.4 Looking downstream at 1.9km, large rocks cover the banks.

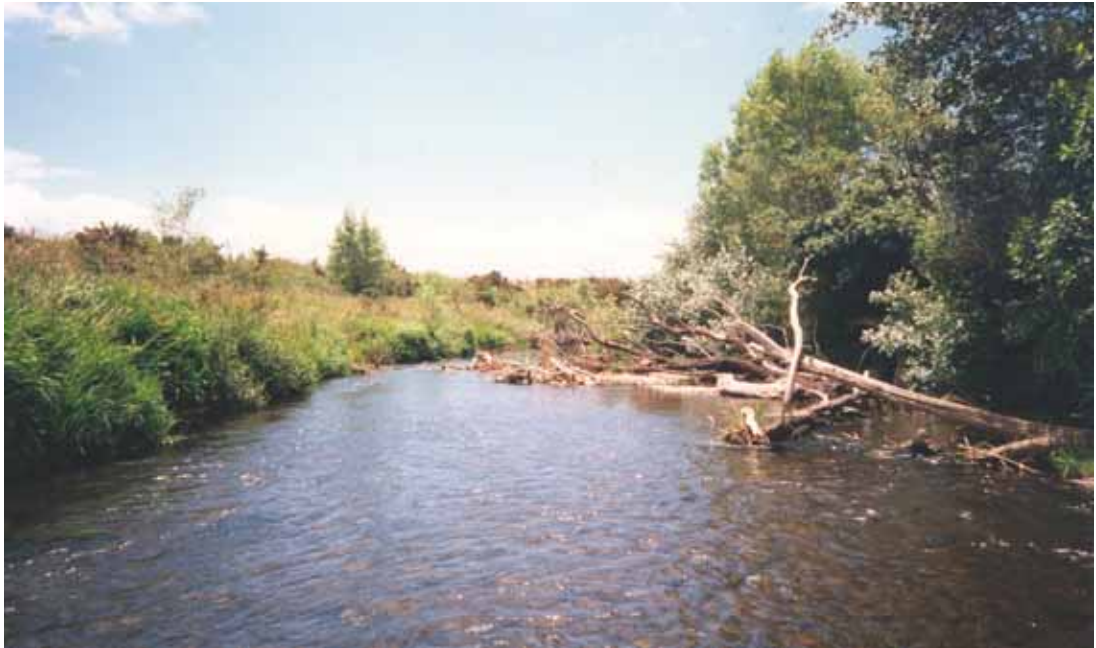
Figure 15.6 Willows continue to overhang the stream in this open area, some debris on the channel bed at 300m above SH2.

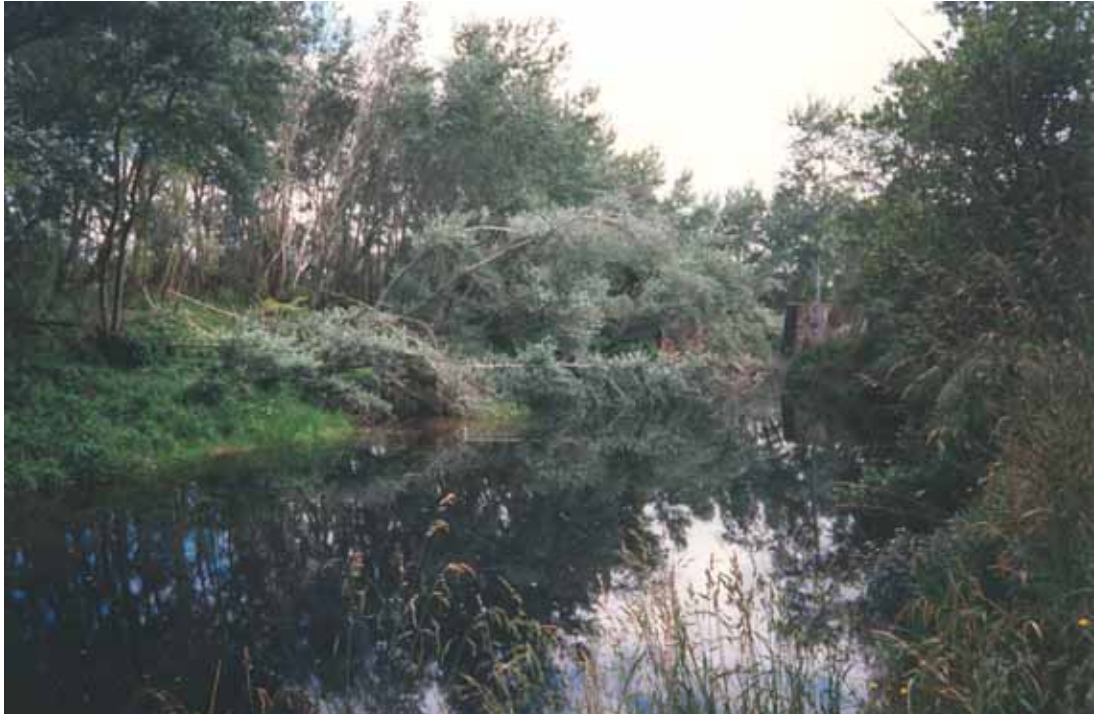
At the SH2 bridge, willows grow on the bank. 50m downstream of SH2 a large tree has fallen across the river and partially blocks the flow (refer Figure 15.7). Several metres downstream, more trees lean over the river and may be potential contributors to the blockage.

Figure 15.7 Partial blockage 50m below SH2.

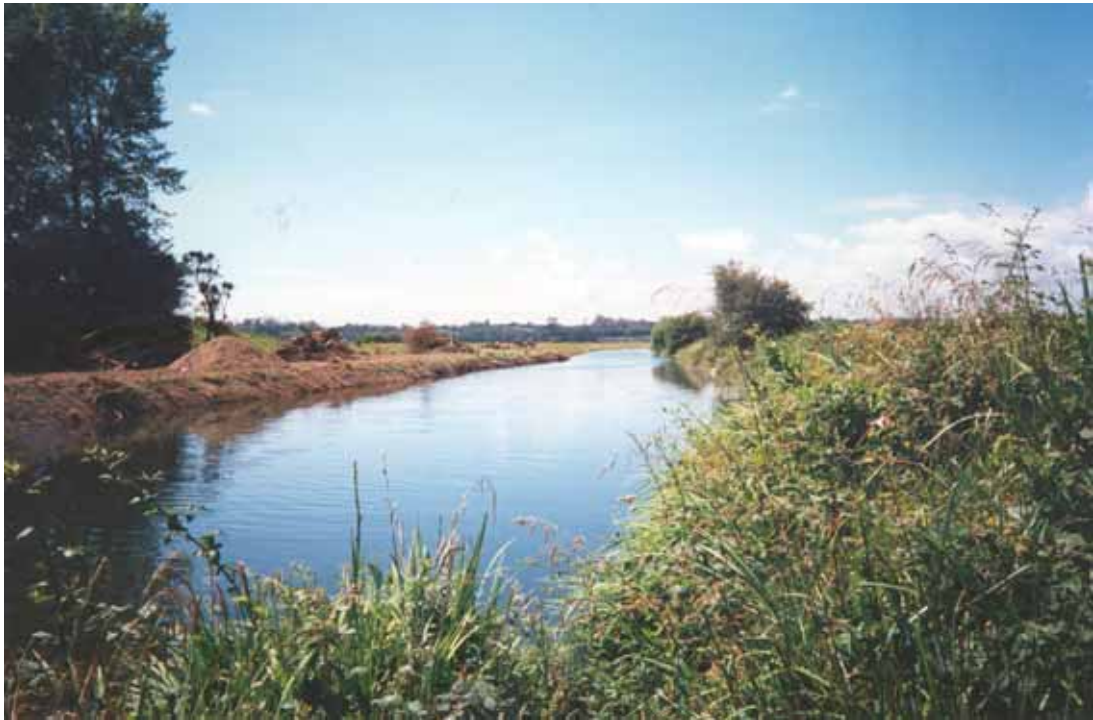
The river then becomes surrounded by dense vegetation (some willow clearing has occurred), till 300m downstream, where the surrounding area opens out and the banks become well vegetated with an established riparian strip. Six hundred metres below SH2 the left bank has recently been cleared of vegetation for a stretch of 100m

(refer Figure 15.8). The right bank is well vegetated, except for two small areas of erosion 20m apart. The river is still and loses much of its water clarity at this point.

Figure 15.8 Recent clearing of vegetation leaves the bank exposed. Downstream of this, a stopbank situated 10m from the left bank follows the river to the estuary.
