Tauranga Harbour Sediment Source Survey

Report prepared by Matthew Surman, Design Engineer
Richard Clarke, Student - Lincoln University
Meredith Carter, Student - Waikato University

Environment B·O·P
Quay Street
P O Box 364
Whakatane
NEW ZEALAND

The report provides an order of magnitude estimate of sediment transported from stream bank erosion into Tauranga Harbour from the harbour catchments. The report describes and costs possible stream improvement works and estimates the reduction of sediment yields such works may achieve.

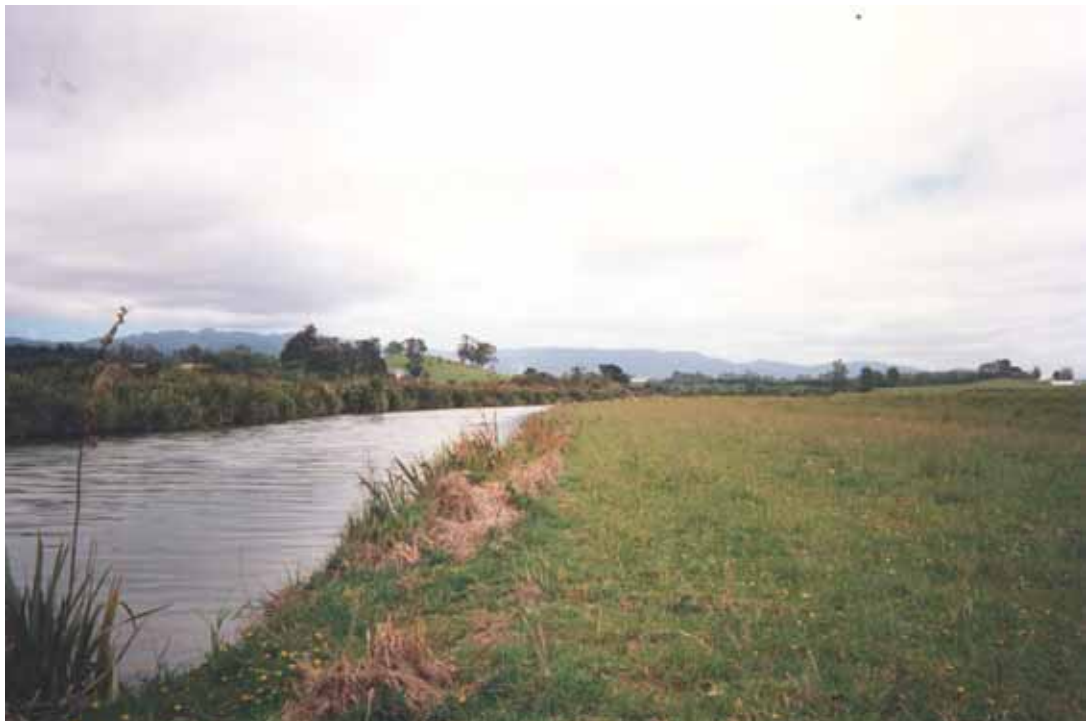
Figure 15.9 Looking upstream the true right bank is well vegetated, while frequent slumping of the left bank is evident.

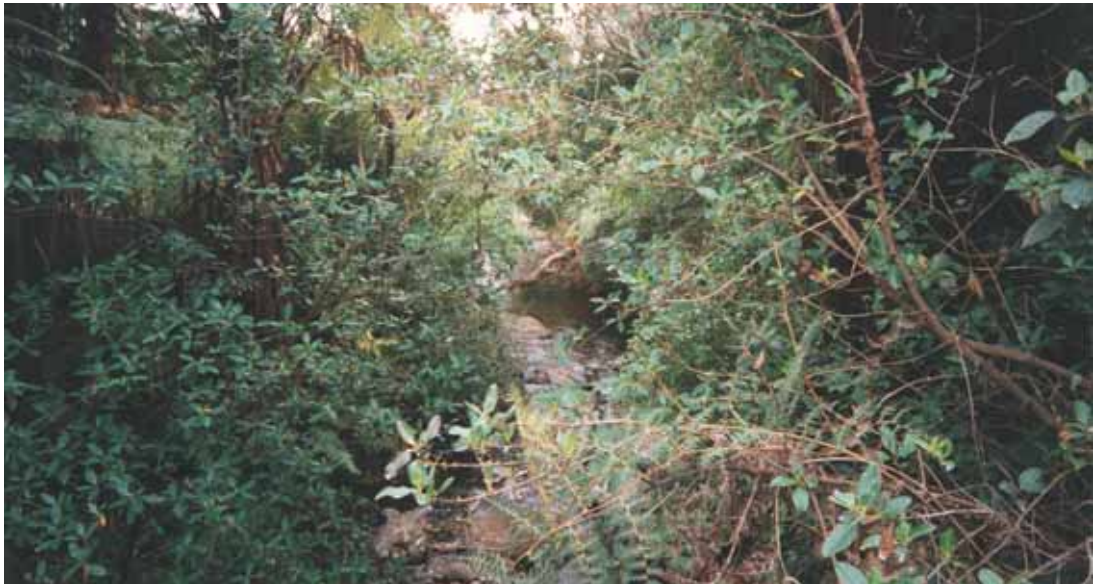
Figure 16.1 Looking downstream from Hume Road Bridge, the water is clear and banks are well vegetated. In places vegetation over hangs in the stream.

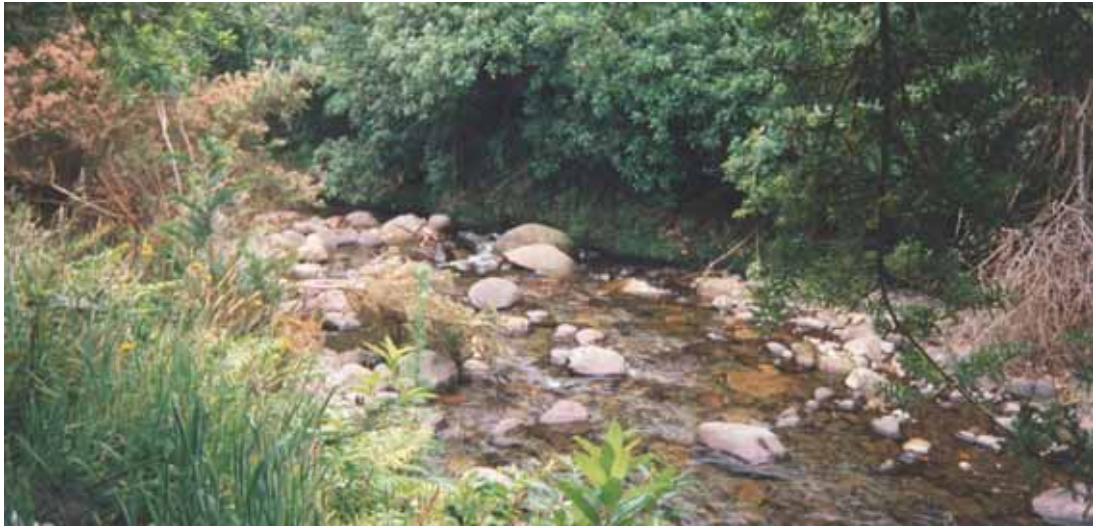
Figure 16.2 Farmland surrounds the stream, but banks continue to have good vegetation cover.

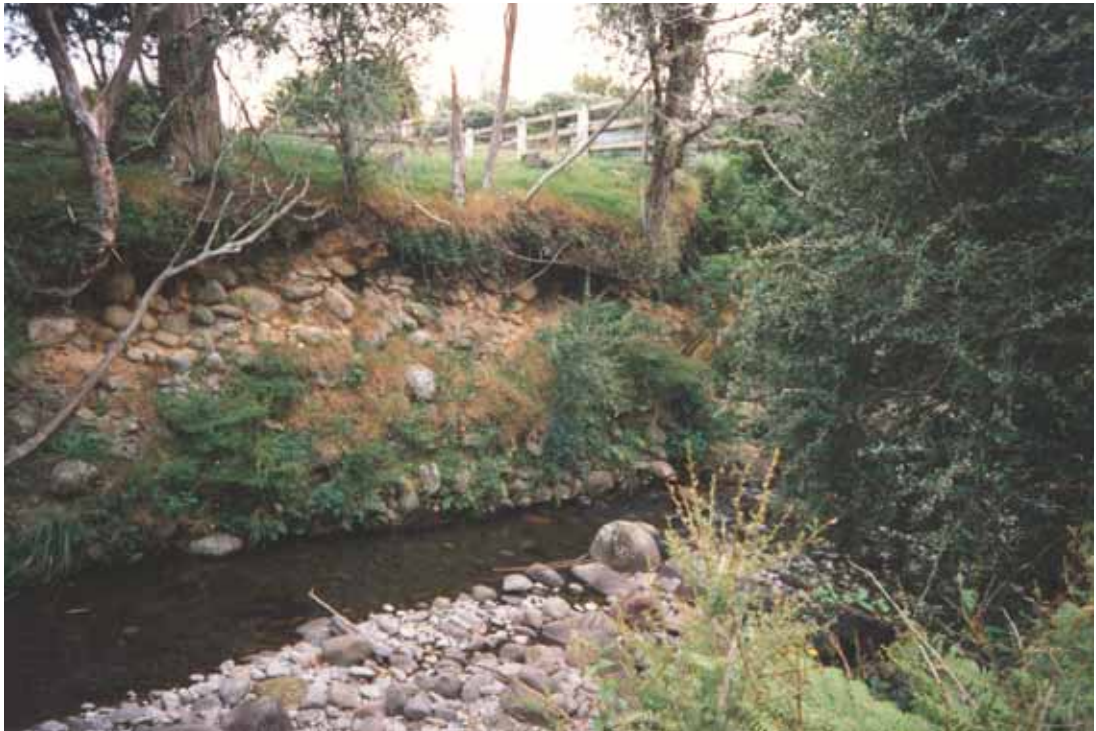
Figure 16.3 Previous undermining of the right bank exposes tree roots. The lower bank remains well vegetated.

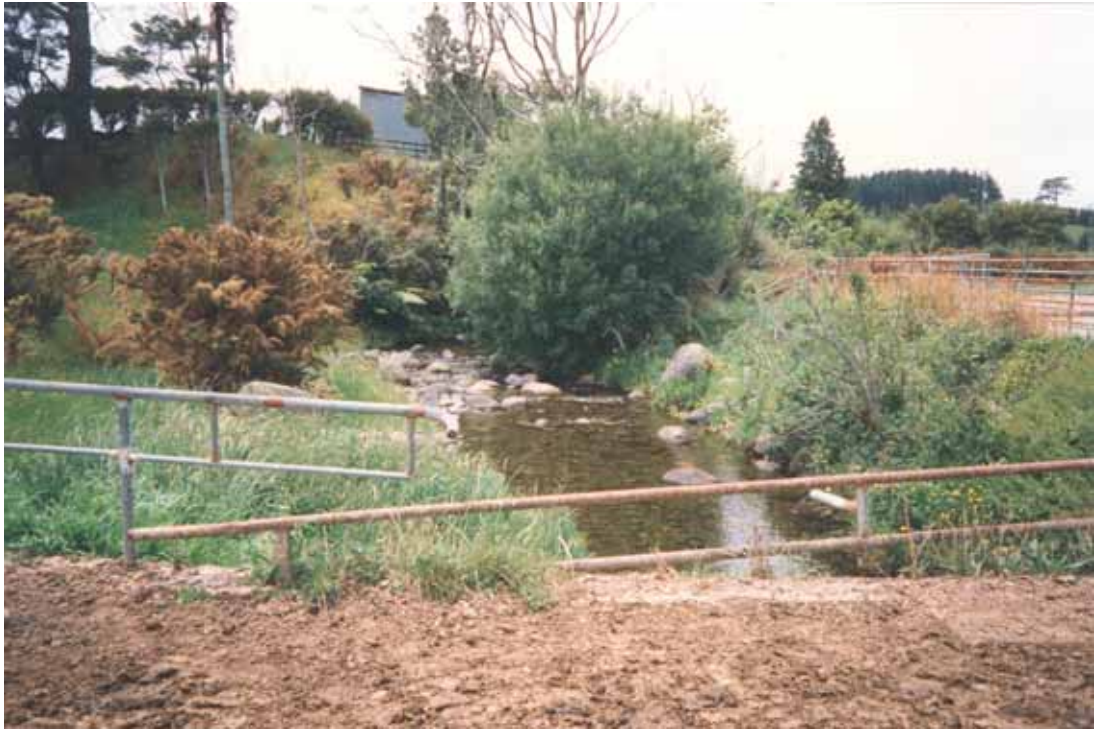
Figure 16.4 400m below Hume Rd bridge a lone willow does restrict the flow.

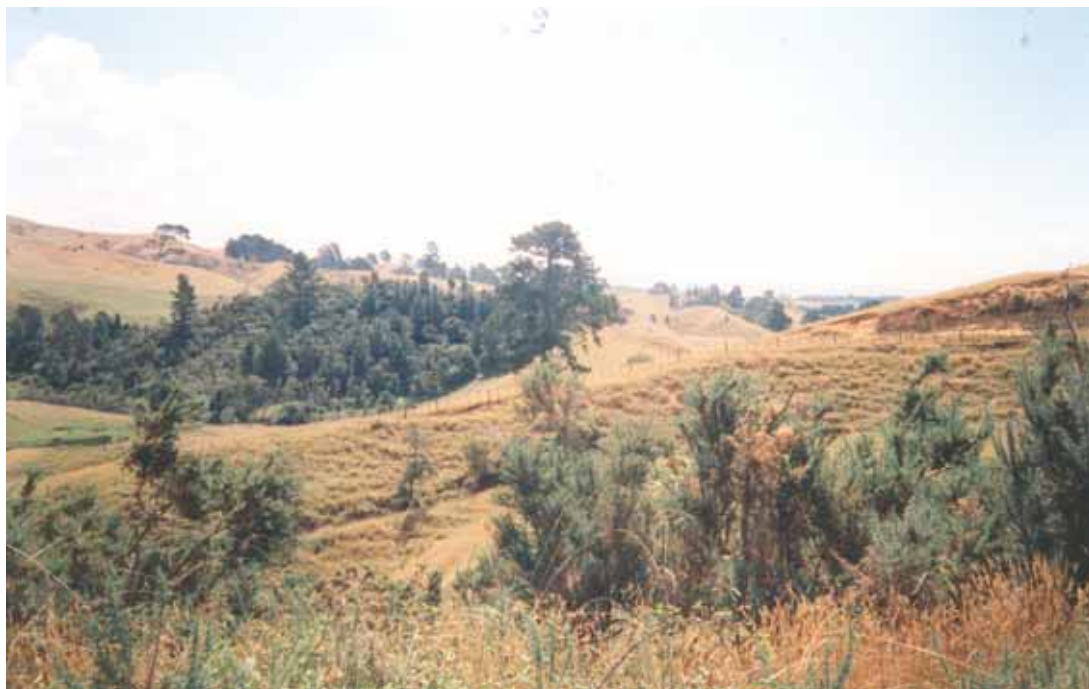
Figure 17.1 The upper Whatakao Stream catchment.

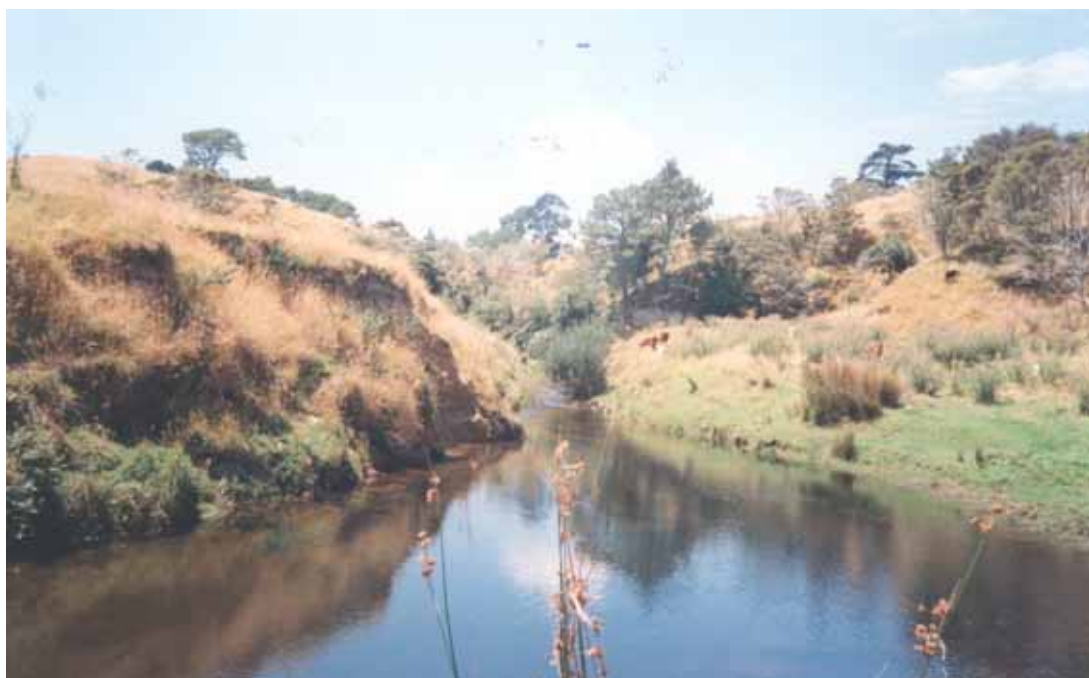
Figure 17.2 A floodplain of 10-20m becomes available. Grass covered banks are more susceptible to erosion.

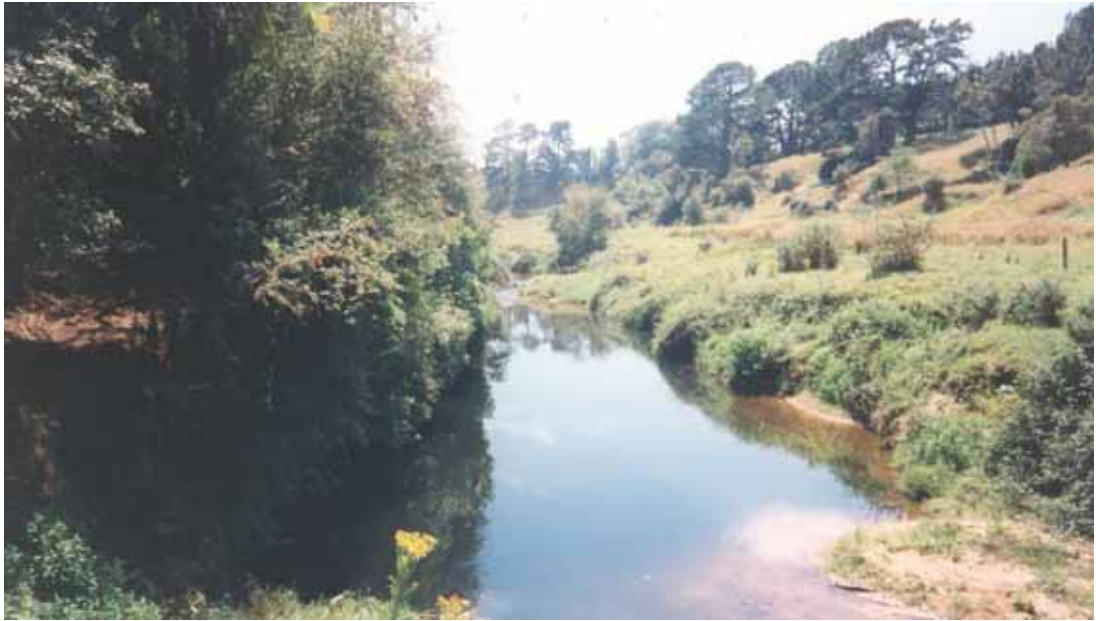
Figure 17.3 Banks are stable and well vegetated with bush.

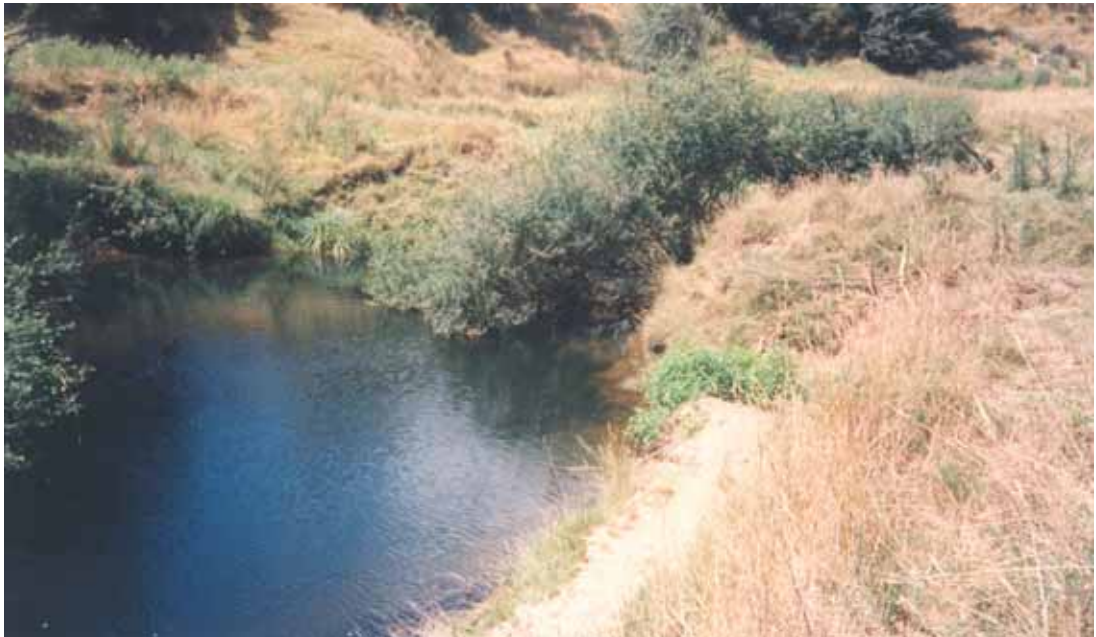
Figure 17.4 The first partial tree blockage occurs at 4.9km. Here stock tracks expose the banks and make them more susceptible to erosion.

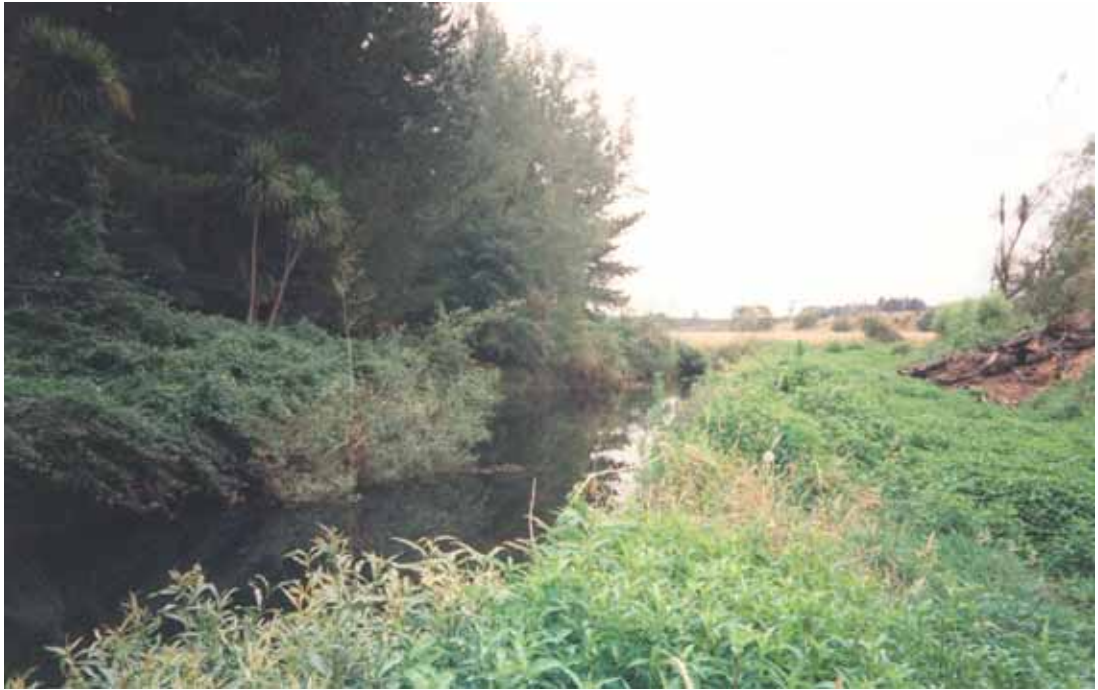
Downstream of this, clearing of vegetation has recently occurred. Stockpiles of burnt wood are situated next to the stream. The stopbank on the right of the stream appears to deteriorate somewhat, especially where stockpiled vegetation have been burnt, often exposing the stopbank.

Figure 17.8 Banks become well vegetated with little erosion. Stockpiled cleared vegetation have been burnt (seen to the right of the stream) often exposing the stopbank.

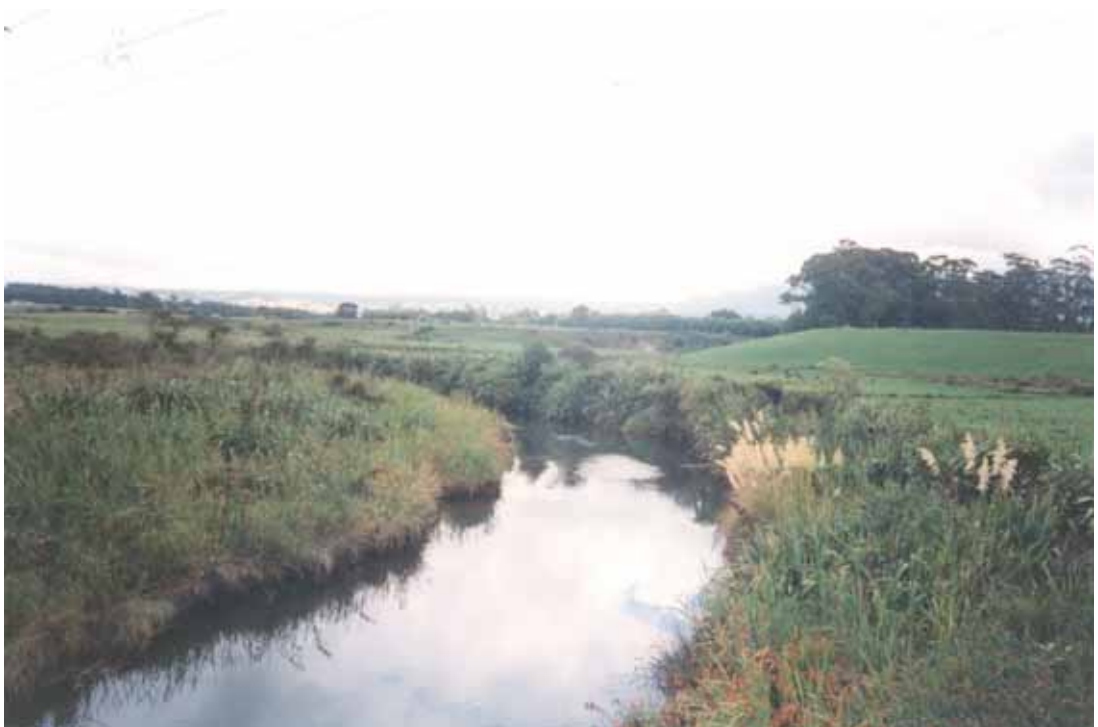
Figure 17.9 For the first 3km above SH2 the banks have good vegetation cover, with little erosion. A wide grassy floodplain extends up to small hills.

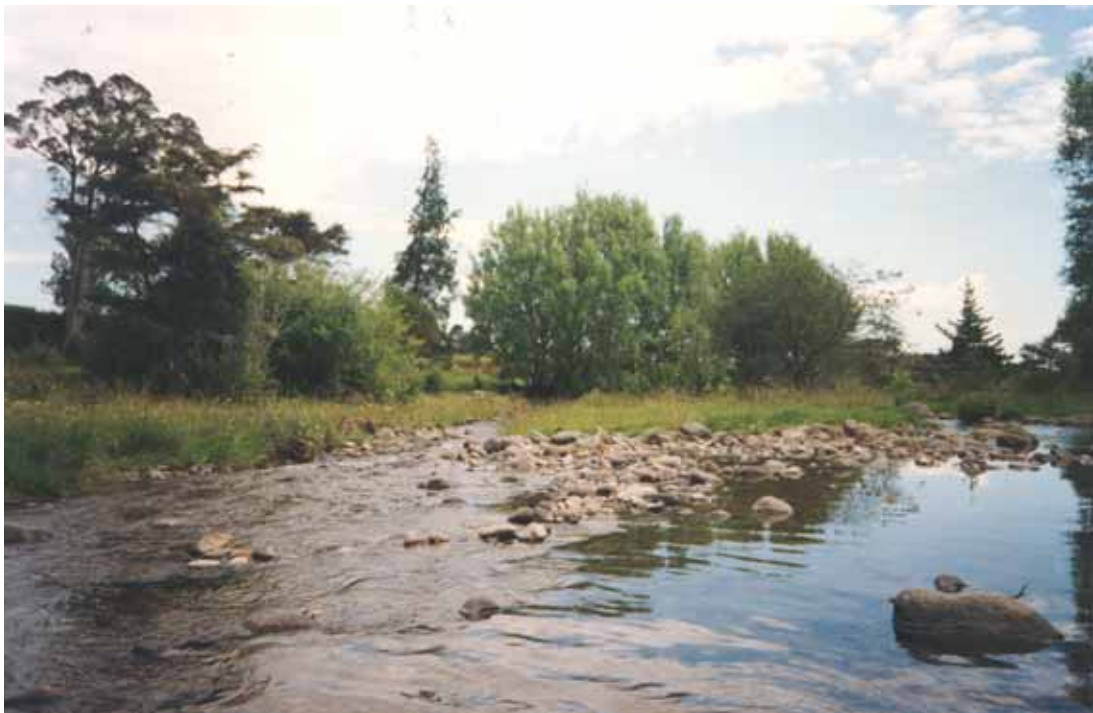
Figure 18.2 Bank vegetation consists mainly of grasses. An island divides the flow at 1.45km.

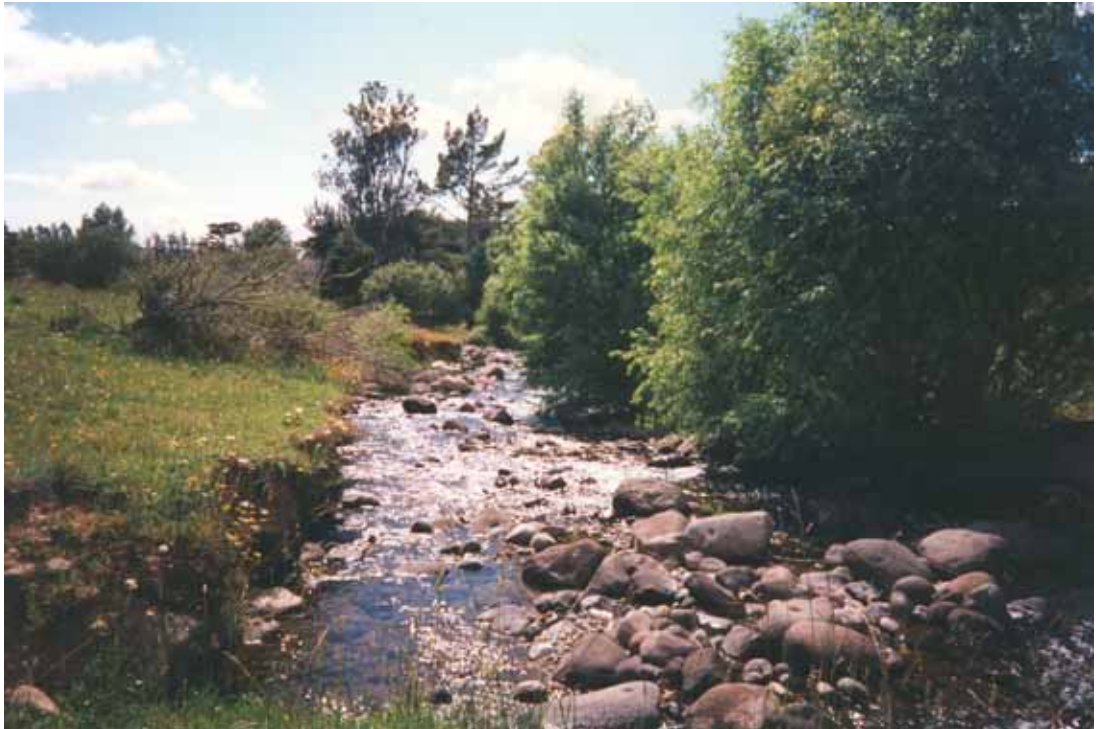
Figure 18.3 At 800m, willows overhang the stream. Minor bank erosion.

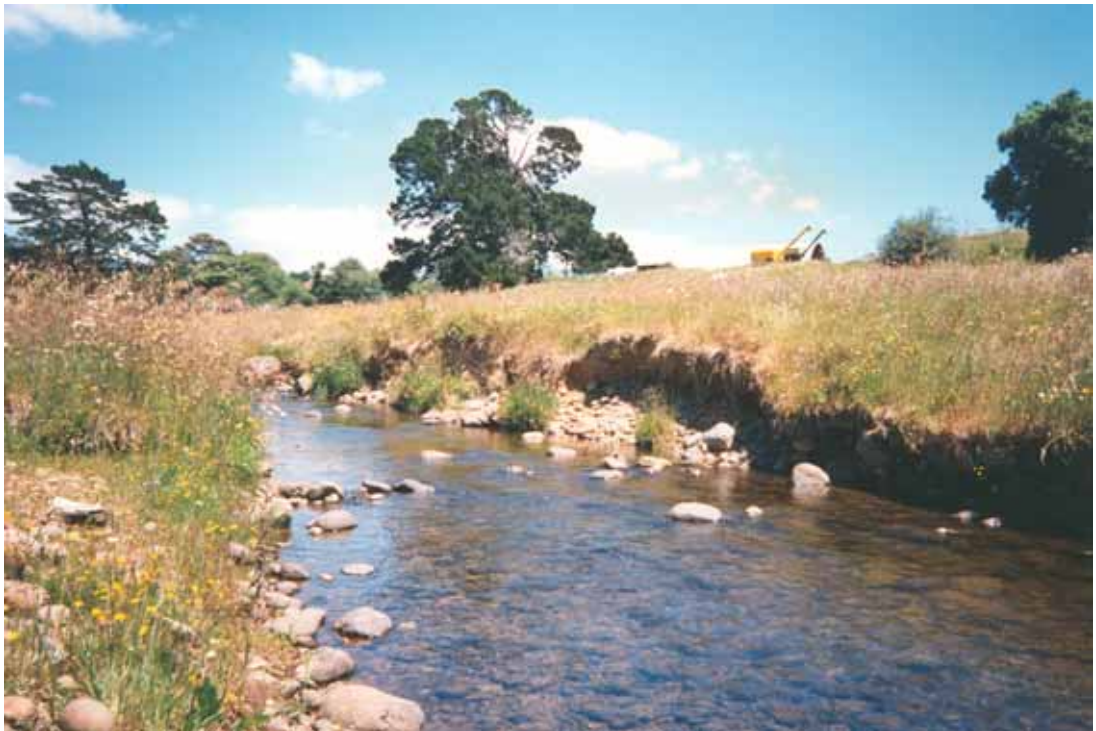
Figure 18.4 The banks become eroded at 300m above SH2.

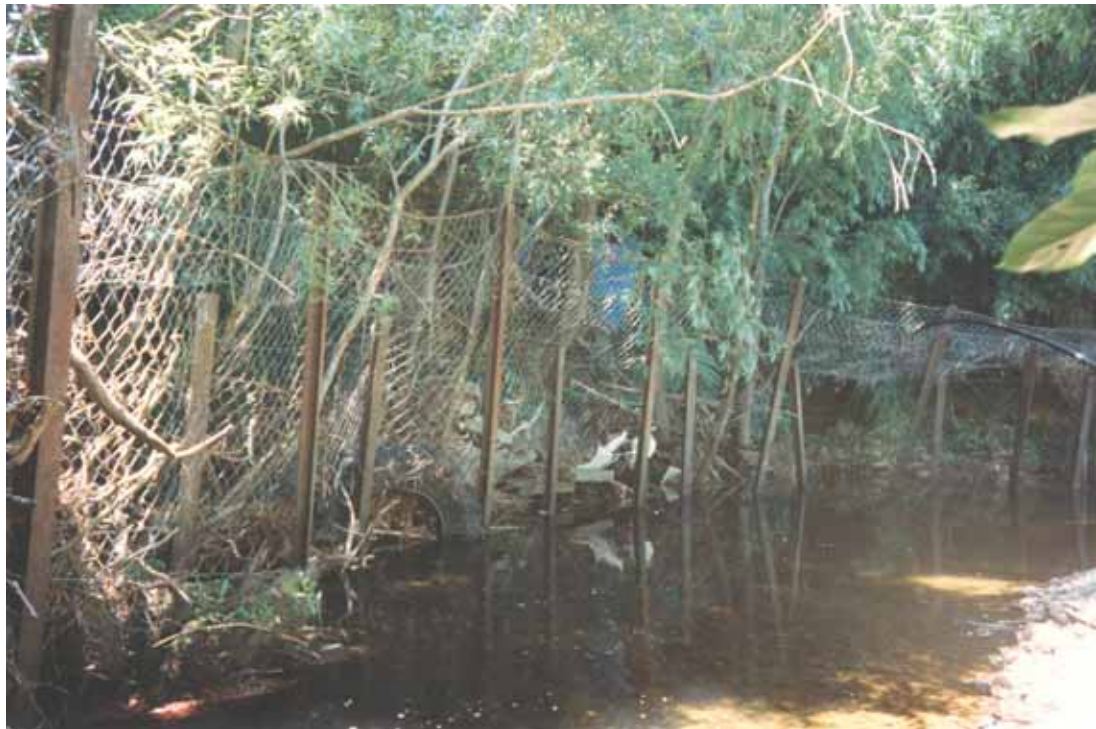
50m below the SH2 Bridge two willows partially block the flow. 50m downstream of this, as the stream bends around, wire fencing extends for 10m along the 3m high left bank. The fence holds back loose rocks, trees, branches and debris. The body of a car has washed into the stream, while another car body is lodged between trees up on the bank. Tyres, concrete and other debris were seen behind the fence which appears to be deteriorating slightly in condition. The stream is still and has deepened (refer Figure 18.5).

Figure 18.5 Fencing along the left bank holds back trees, rubbish and other debris.

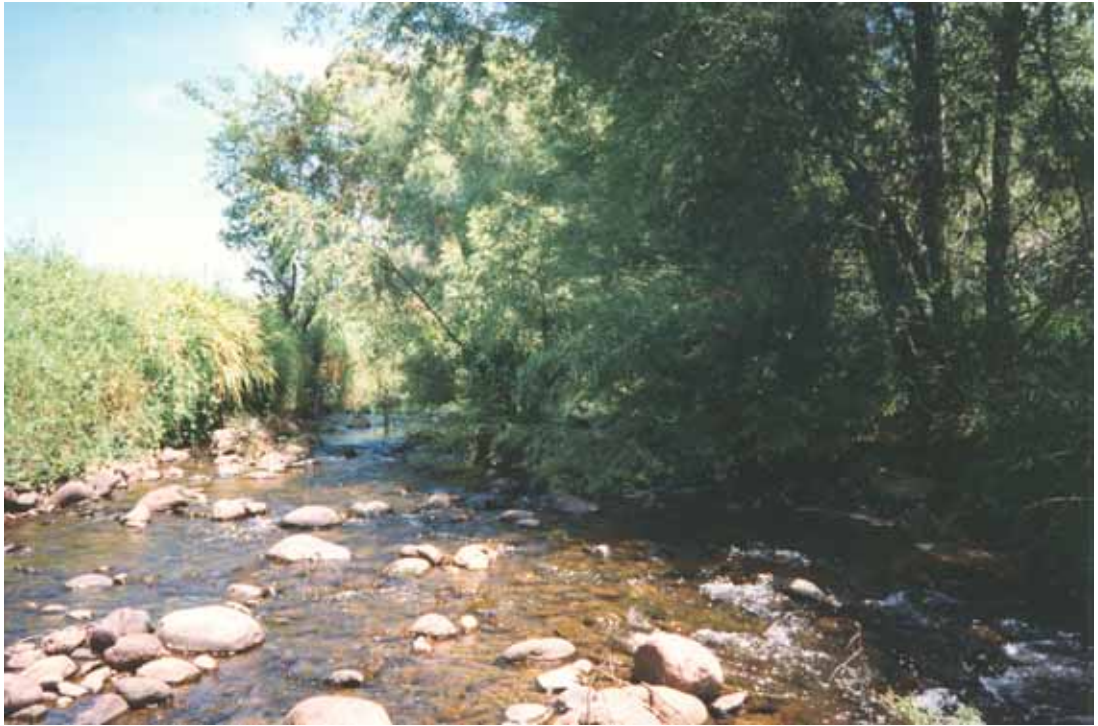
Figure 18.6 A willow overhangs the stream at 400m below SH2.

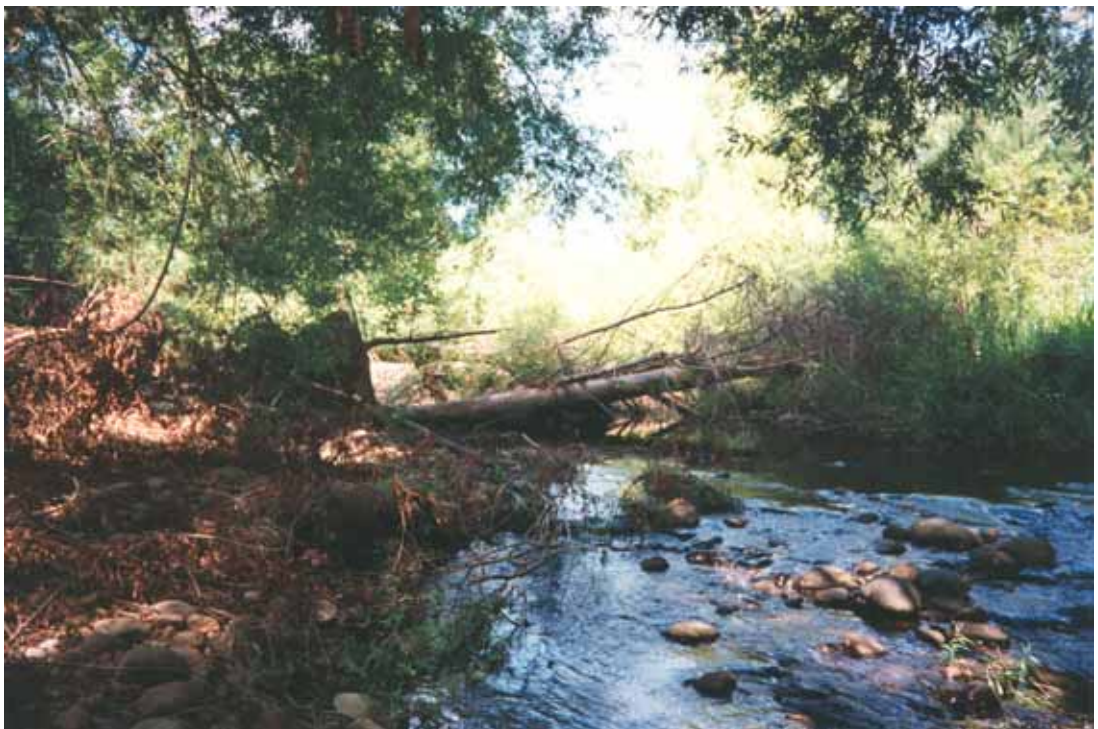
Figure 18.7 Vegetation debris partially blocks the stream flow.

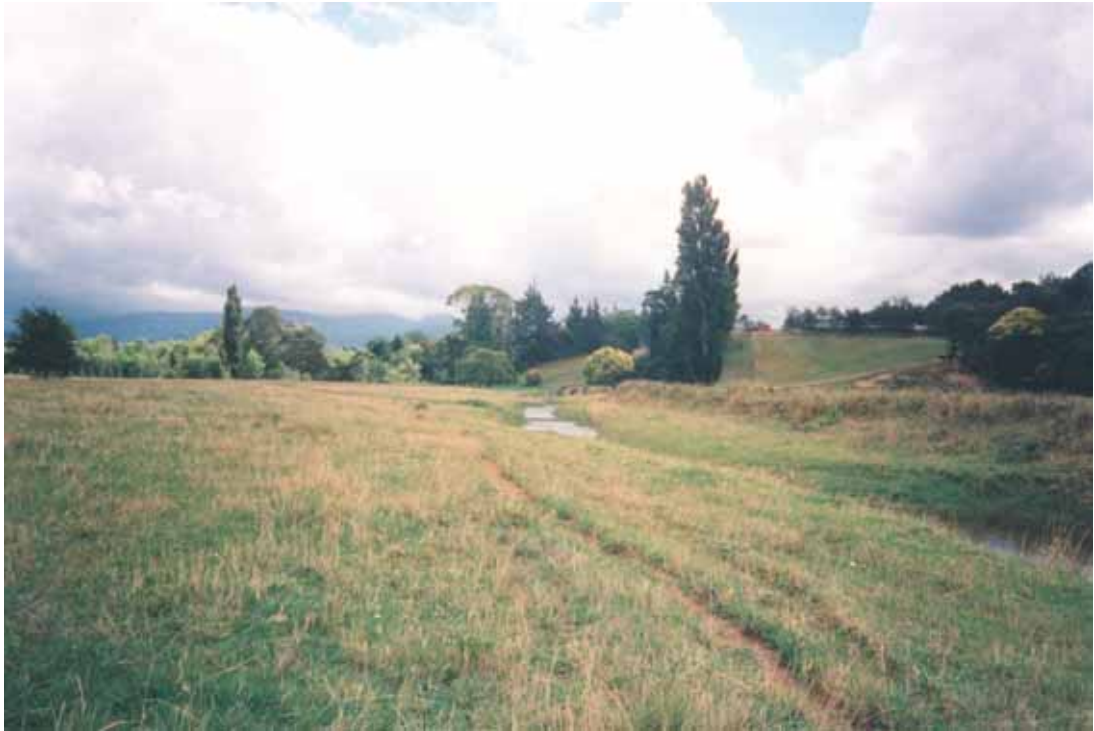
Between 600m and 1.2km below SH2 farmed land extends to the streams edge. Minor slumping and erosion has occurred where stock have entered the stream (refer Figure 18.8).

Figure 18.8 Upstream view at 800m of an open floodplain with grasses to the waters edge. The stopbank on the true left is in good condition.

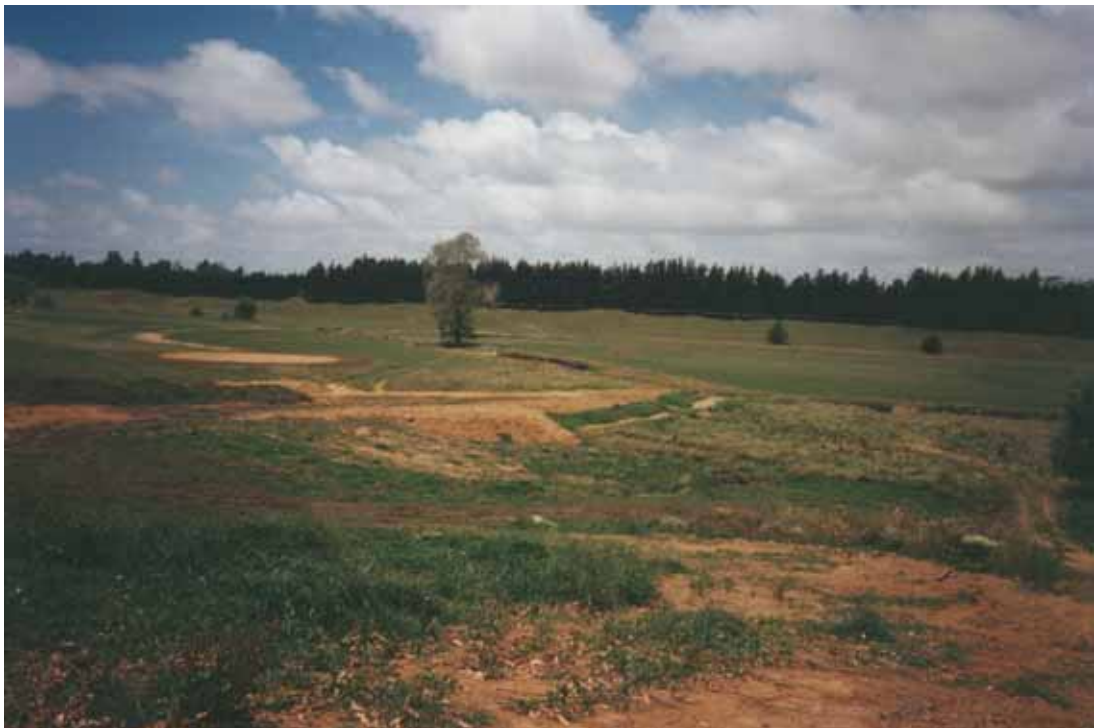
The next part of the stream is an open section with a floodplain of 100m extending up to hills. The adjacent flat area to the left of the stream is under construction to become an extension of the golf course (refer Figure 18.9).

Figure 18.9 Construction work is underway at 1.3km. Heavy vehicle tracks are present down to the streams edge.

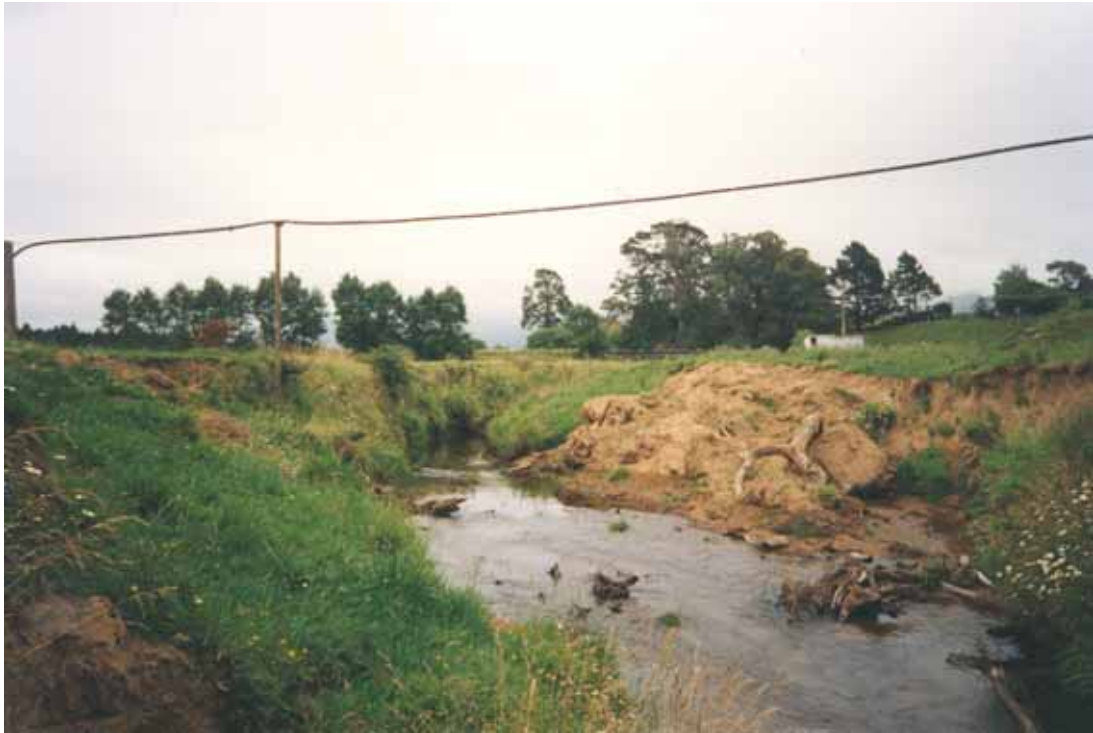
From 2.1km to the harbour farmland extends to the streams edge (stock generally have access). Within the first 500m, the 2m high banks become eroded, and slumping occurs frequently. Clearing of bank vegetation has taken place in two small areas (refer Figure 18.11). Two small, isolated willows partially block the flow at 2.2km below SH2, and several instances of logs partially blocking the flow (minor).

Figure 18.11 Small area of clearing here at 2.4km.

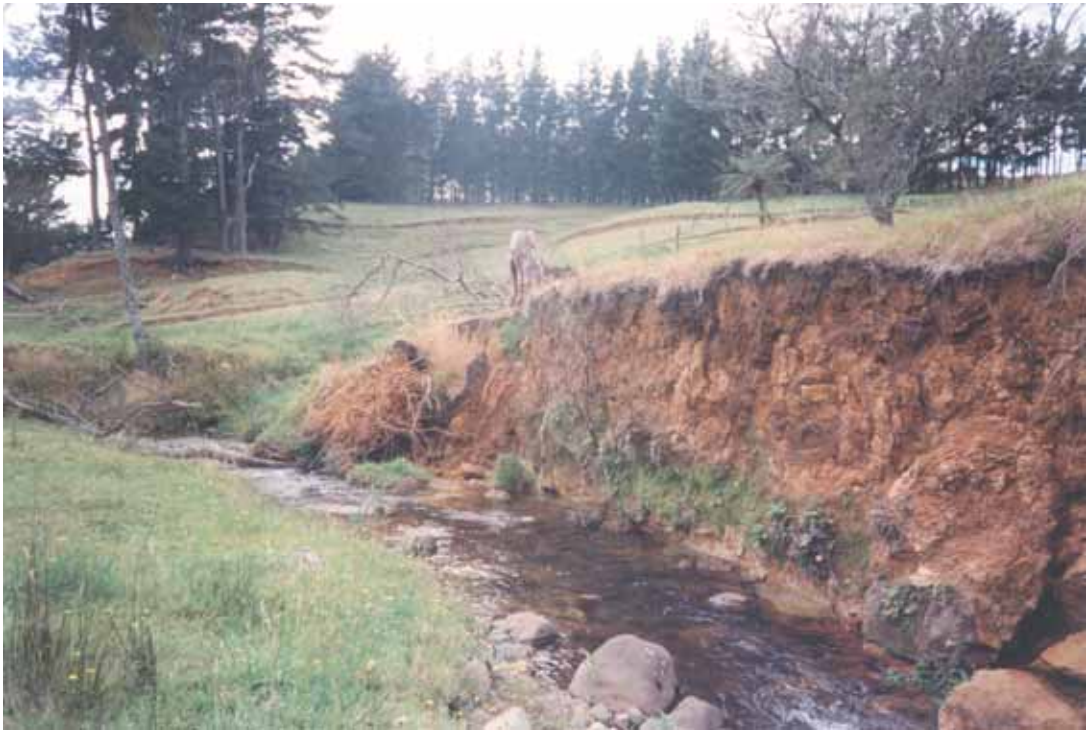
Figure 19.2 Exposed right bank at 4.15km.

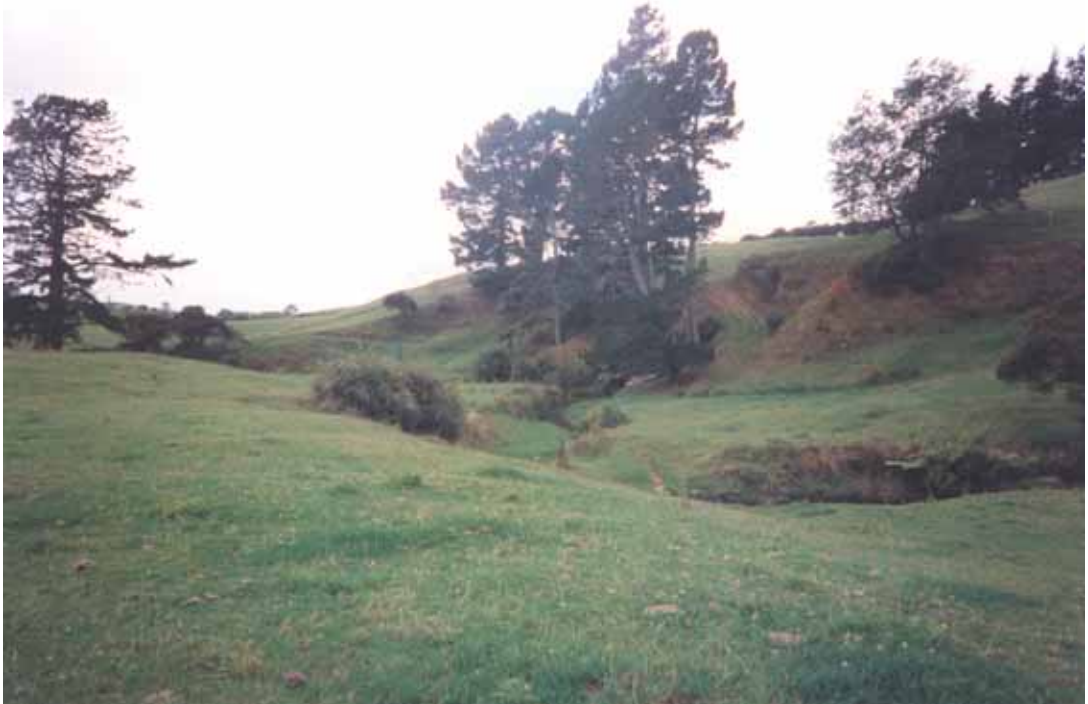
Figure 19.3 Downstream view at 3.8km of an open section with grasses to the waters edge.

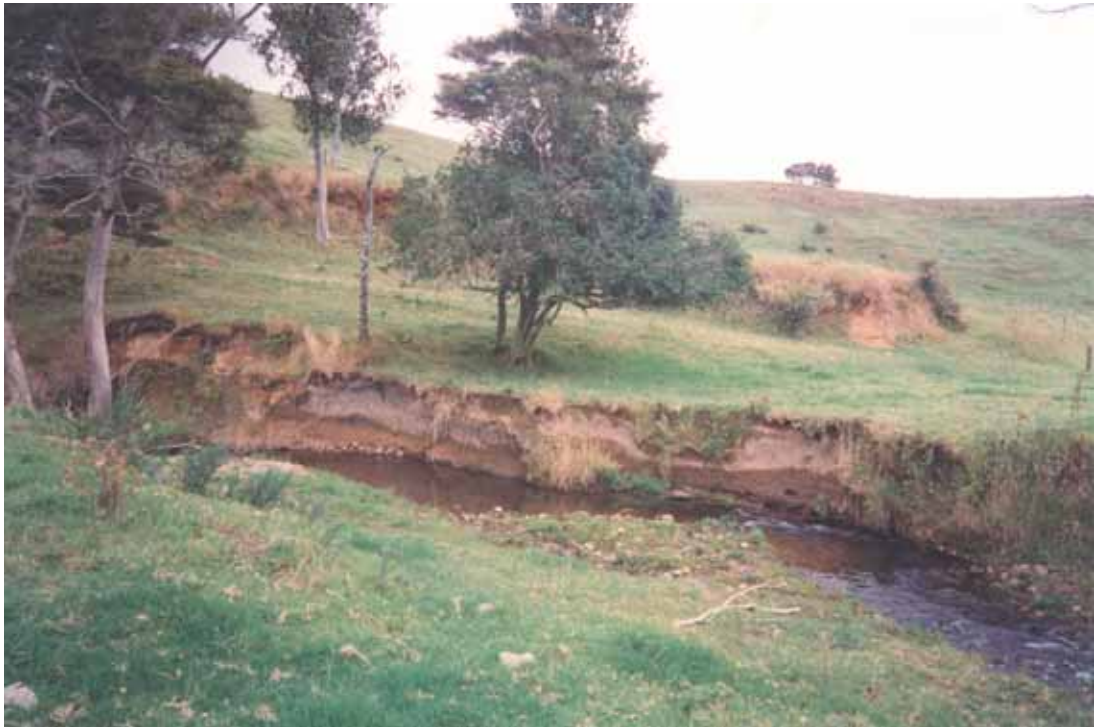
Figure 19.4 The grassy left bank becomes eroded at 2.6km above SH2.

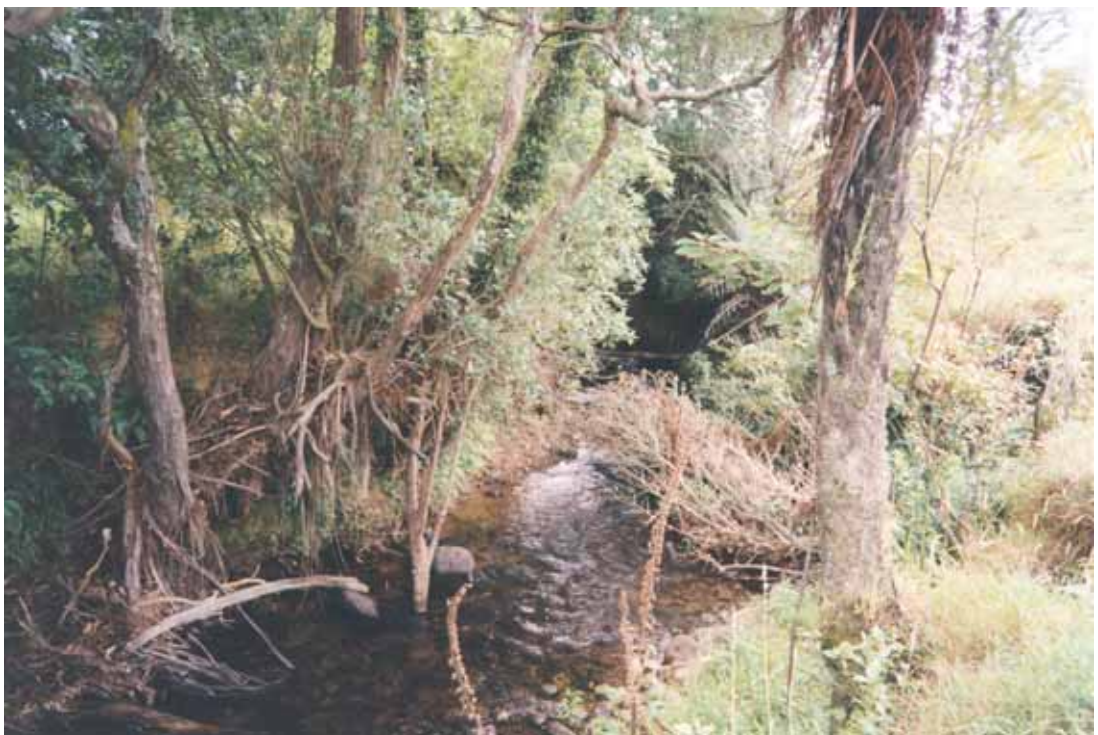
Figure 19.5 Debris is caught on vegetation above the normal flow. The 1-2m high banks are stable in these well vegetated areas.

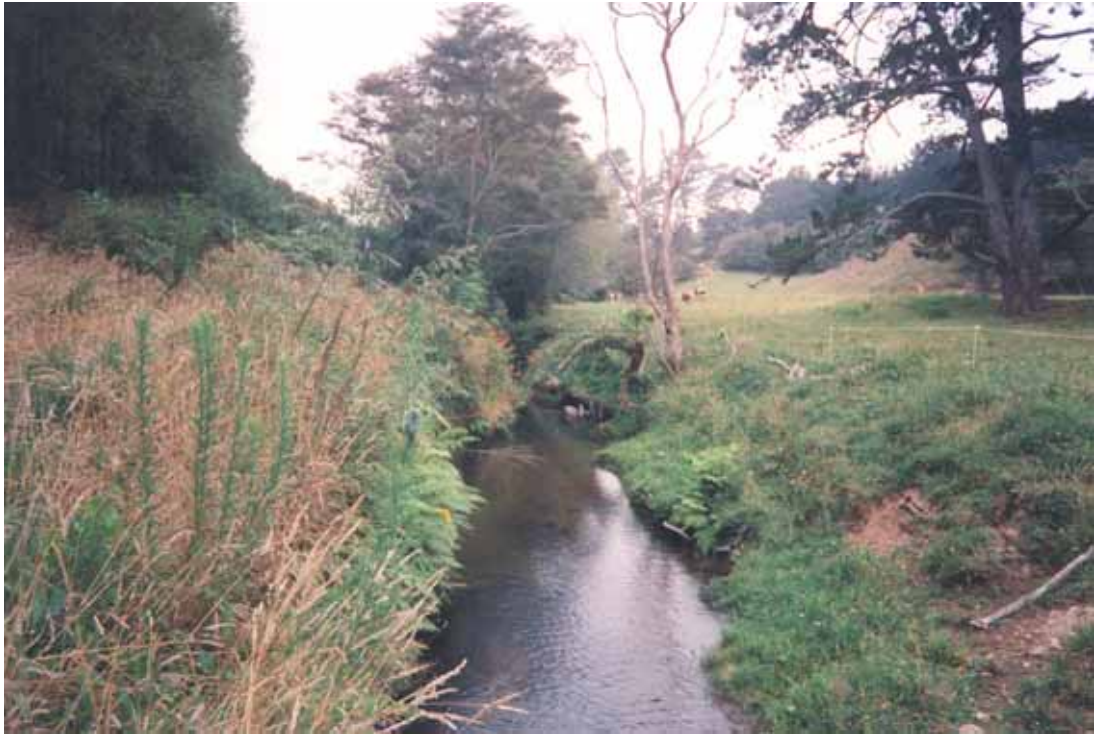
Figure 19.6 Minor erosion of the grassy banks occur at 1.55km.

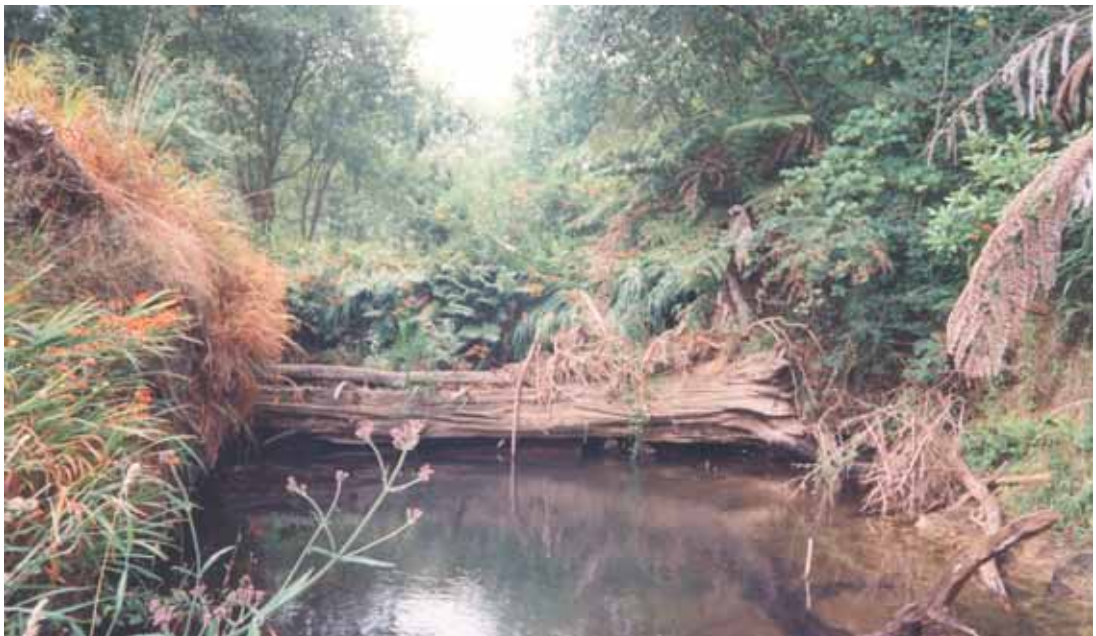
At 900m, banks have a good vegetation cover, increasing in height to 2-3m. Debris is commonly seen on the streambed. At 800m branches and debris collect to the side of the stream partially blocking the stream flow. Downstream of this, two trees lie in the channel within 5m of each other. The first of the trees, fully blocks the stream (refer Figure 19.7), while the second partially blocks the stream.

Figure 19.7 A fallen tree fully blocks the flow at 750m.

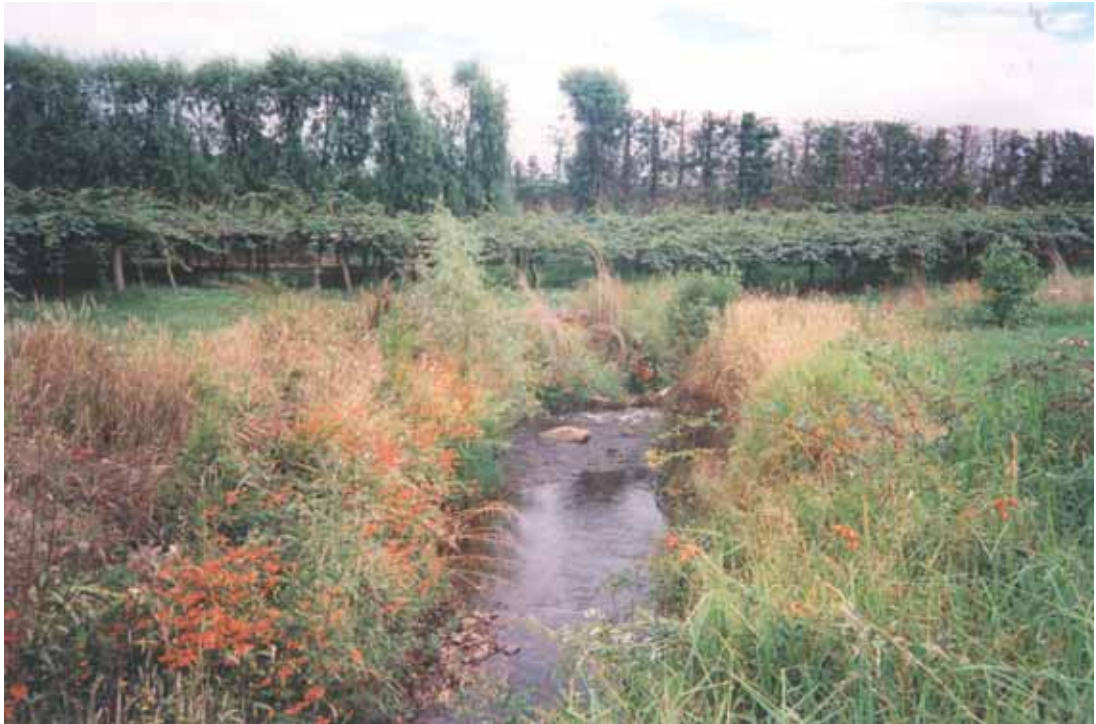
Figure 19.8 Banks have good vegetation cover, with several small willows overhanging the stream.

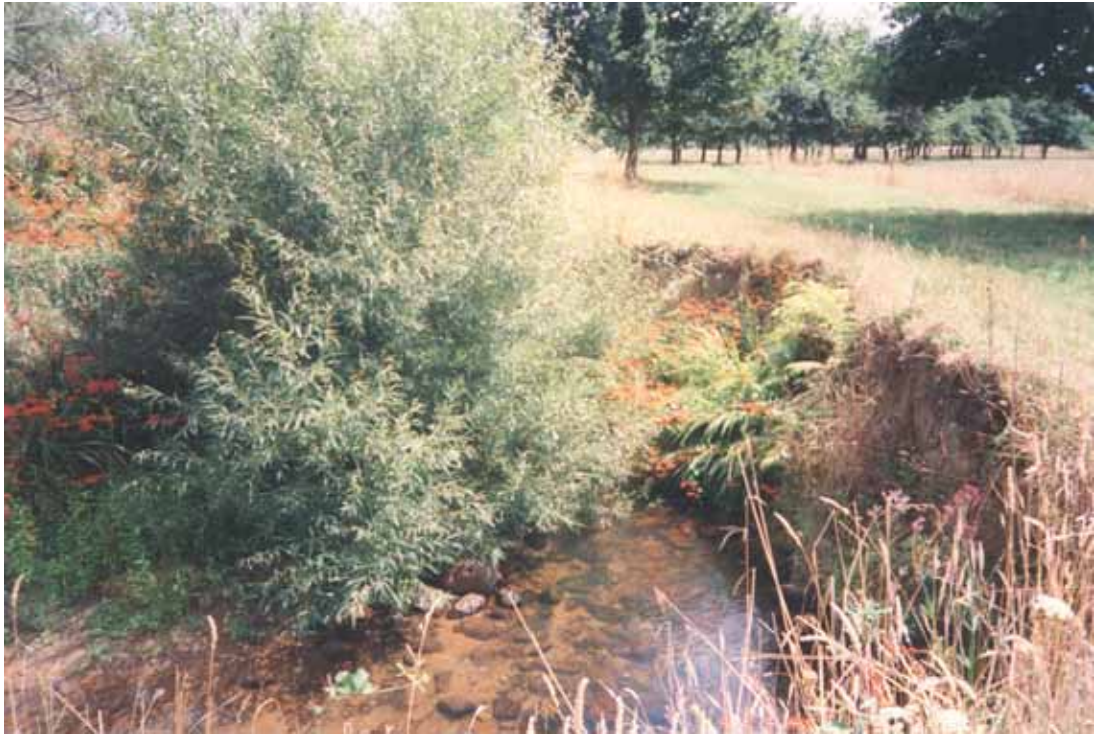
Downstream of SH2 to its confluence with the Waitekohe Stream, a wide grassy floodplain is present, with farmland to the stream's edge. A willow blockage occurs 40m below SH2. Patches of willows continue to congest the channel to 300m, occasionally completely blocking the stream flow. The banks are mostly well vegetated, but patches of erosion are seen where thick bank vegetation is absent.

Figure 19.9 A typical willow blockage at 70m below SH2.
