Tauranga Harbour Sediment Source Survey

Report prepared by Matthew Surman, Design Engineer
Richard Clarke, Student - Lincoln University
Meredith Carter, Student - Waikato University

Environment B·O·P
Quay Street
P O Box 364
Whakatane
NEW ZEALAND

The report provides an order of magnitude estimate of sediment transported from stream bank erosion into Tauranga Harbour from the harbour catchments. The report describes and costs possible stream improvement works and estimates the reduction of sediment yields such works may achieve.

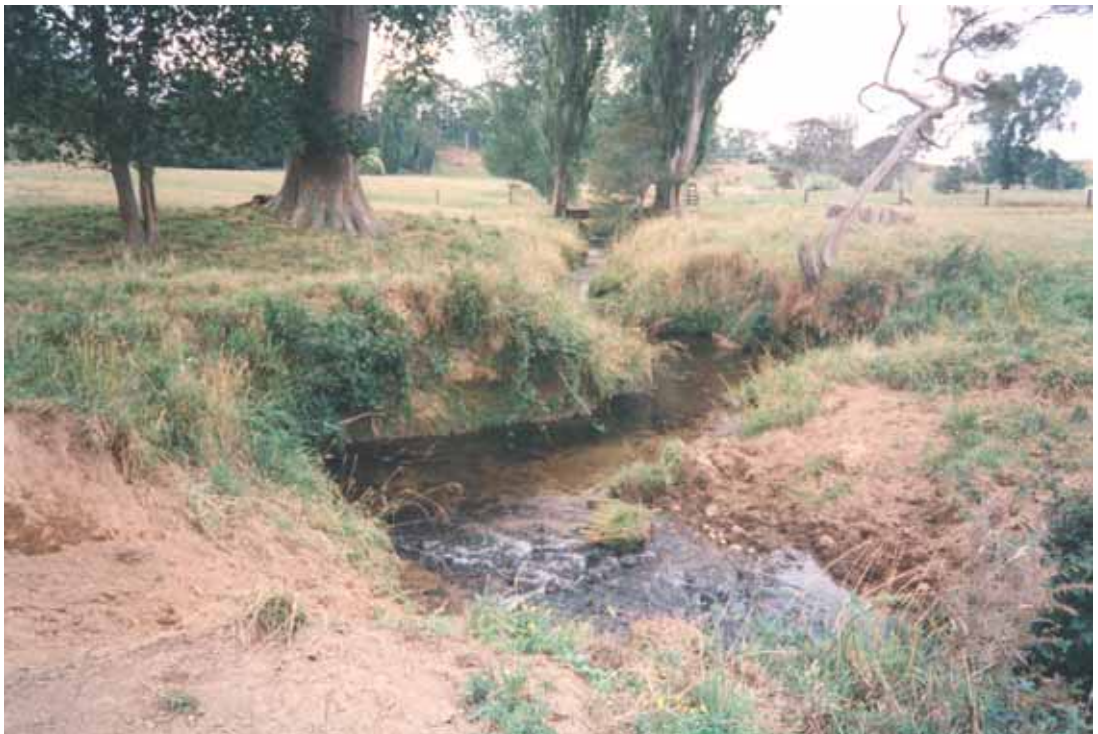
At 400m below SH2 stock tracks have exposed the banks (refer Figure 19.10). Bank vegetation consists mainly of grasses and further small erosion and slumping occurs downstream.

Figure 19.10 An exposed grassy bank at 400m below SH2.

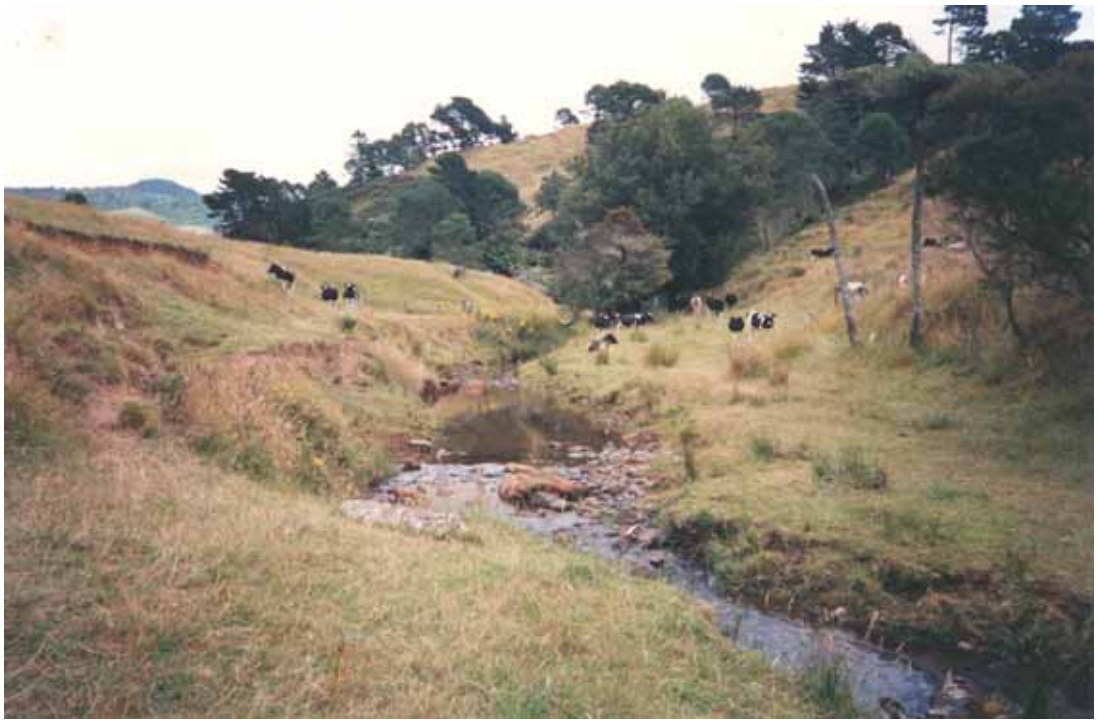
300m downstream, the area opens out partially, with farmland to the streams edge. A small floodplain 2–5m wide is available for floodwaters. Stock have access, very minor slumping and erosion has occurred (refer Figure 20.1).

Figure 20.1 At 4.3km, bush subsides with farmland to the streams edge.

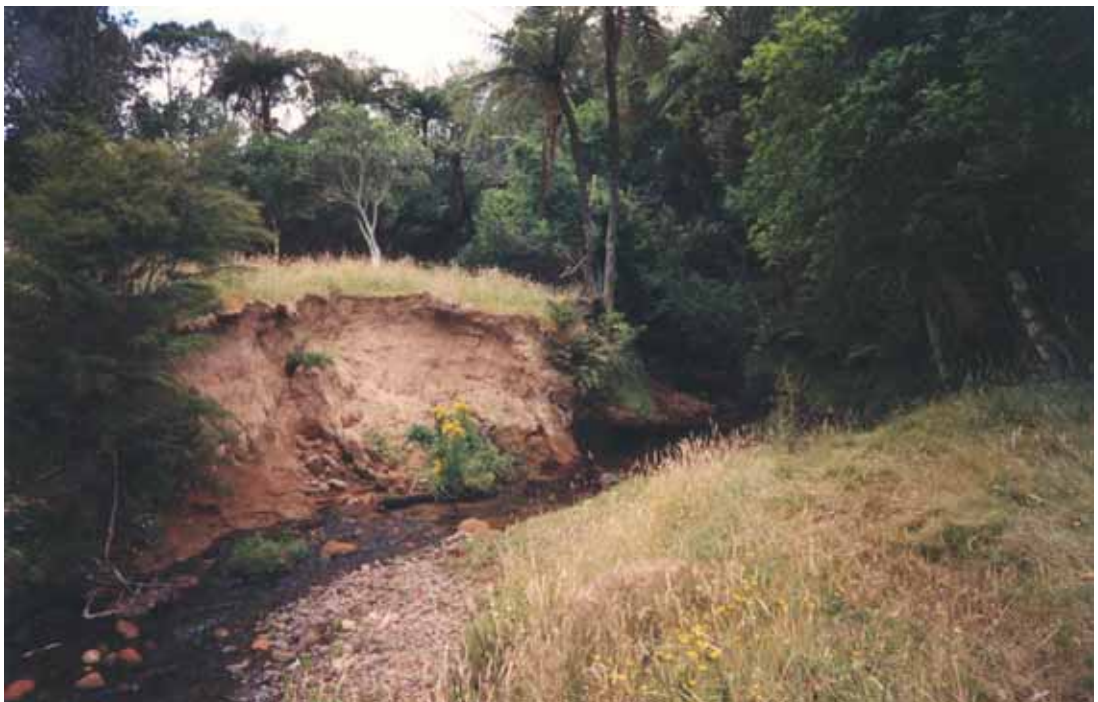
Downstream of this, bank erosion occurs at several sites (approximately 5m lengths) where thick bank vegetation is absent (refer Figure 20.2). A reasonable amount of tree debris is seen on the channel bed.

Figure 20.2 Erosion of the left bank at 4km above SH2. Downstream of this banks continue to erode in approximately 5m lengths in the open areas.

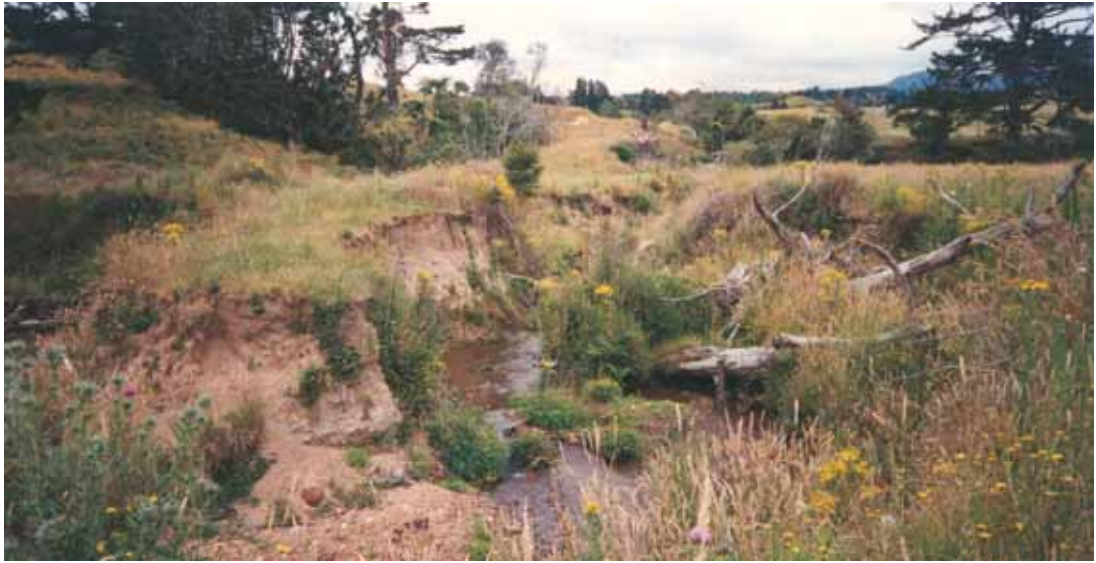
Figure 20.3 Bank erosion at 3.55km. Dead wood has collected on four occasions in this area, all of which partially block the flow.

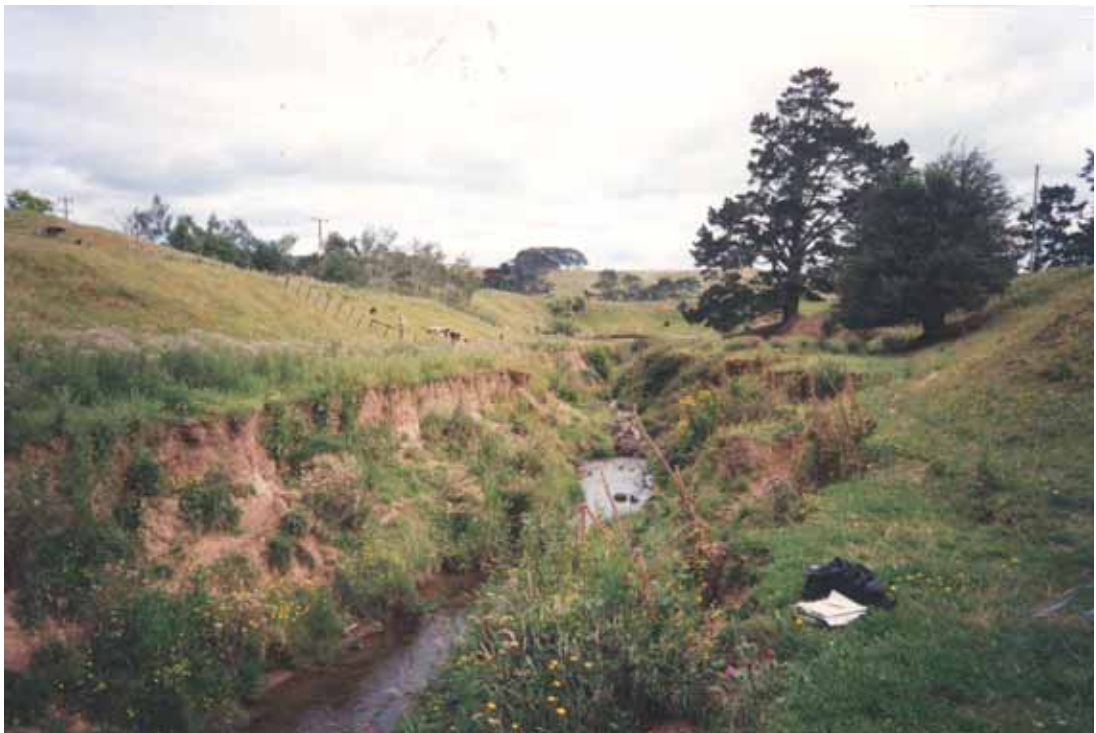
Figure 20.4 Erosion of the 2m high banks at 3.2km.

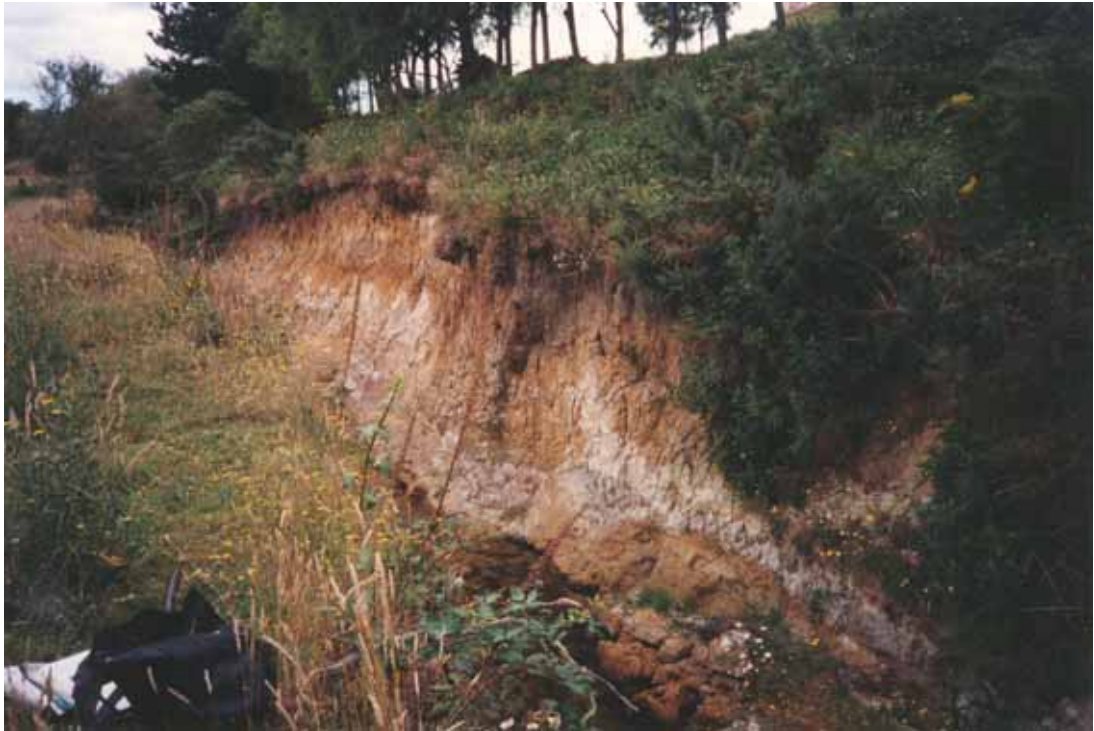
Figure 20.5 The banks become exposed at 2.9km.

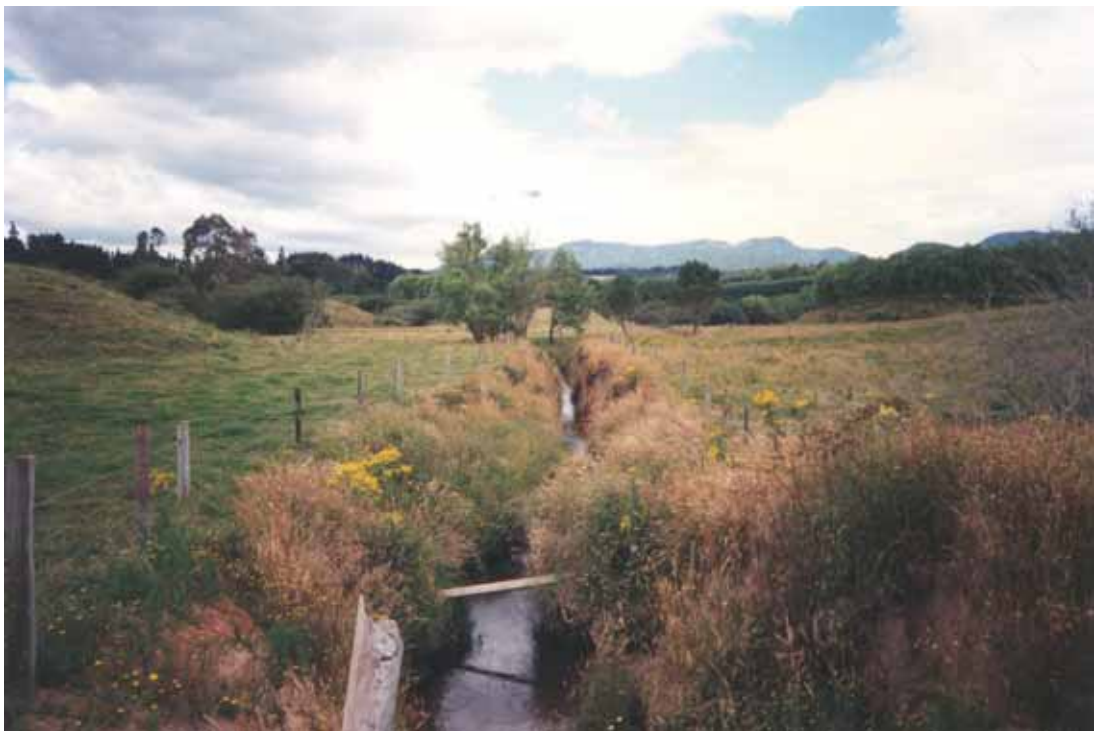
Downstream of this a fence which borders the stream begins and concludes 1.7km. Bank vegetation consists mainly of grasses with erosion occurring periodically down the length of the stream (refer Figure 20.6). This area appears to have been diverted and modified, due to its straightened course and often exposed steep banks.

Figure 20.6 Bank vegetation consists mainly of grasses in this section. The 1-2m high banks are often exposed.

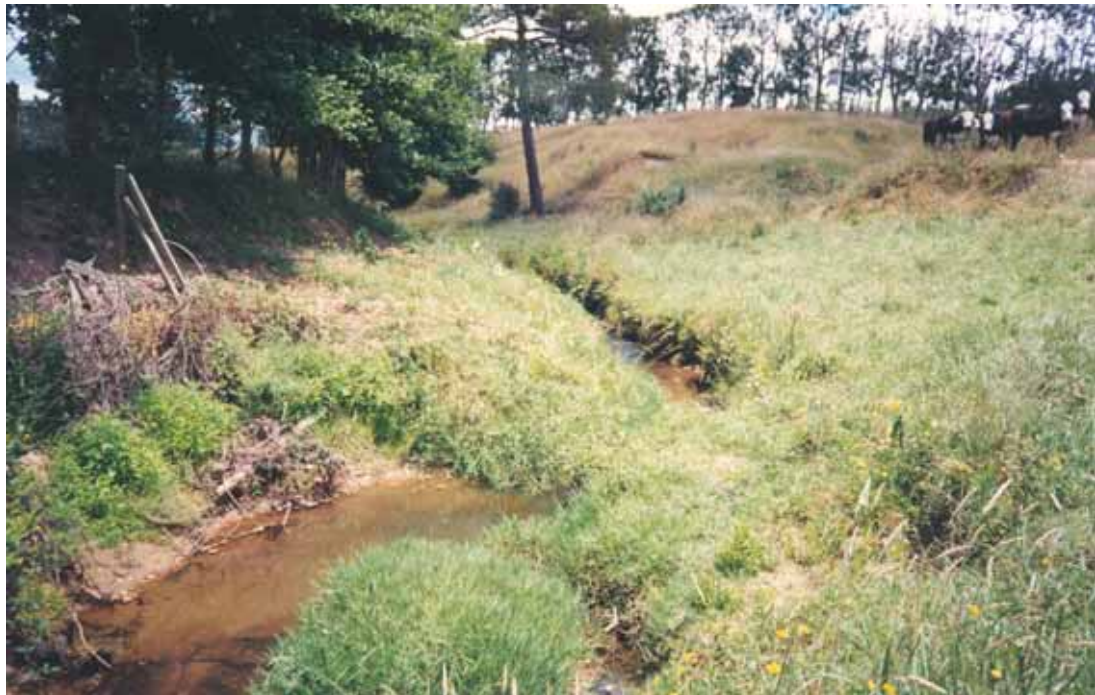
Figure 20.7 At 950m above SH2, banks are mostly well vegetated with little erosion. Small amounts of debris on the channel bed.

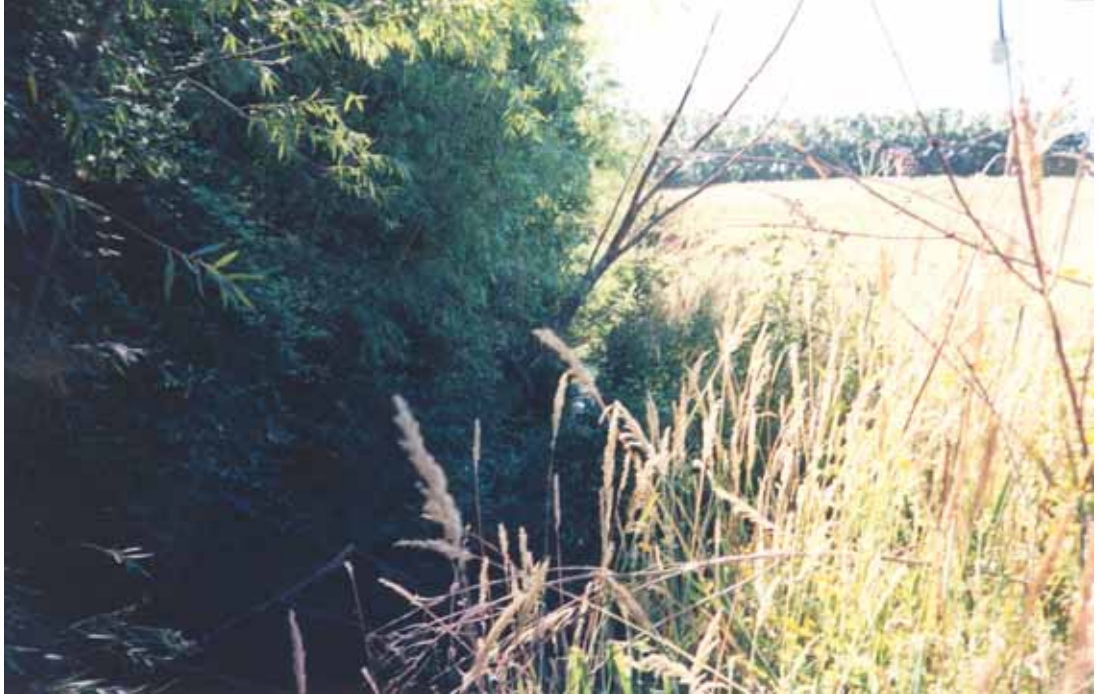
Below SH2 banks have a thick vegetation cover, often overhanging the stream. A sawmill is situated on the left of the stream, while farmland on the right is fenced from stock with an established riparian strip. Debris is commonly seen on the channel bed, and on several occasions has collected causing partial debris dams. Three incidences were noted, where sawn logs have collected in the stream along with debris and branches (refer Figure 20.10). The stream is murky in this area.

Figure 20.10 Thick bank vegetation below SH2, often overhangs the stream.

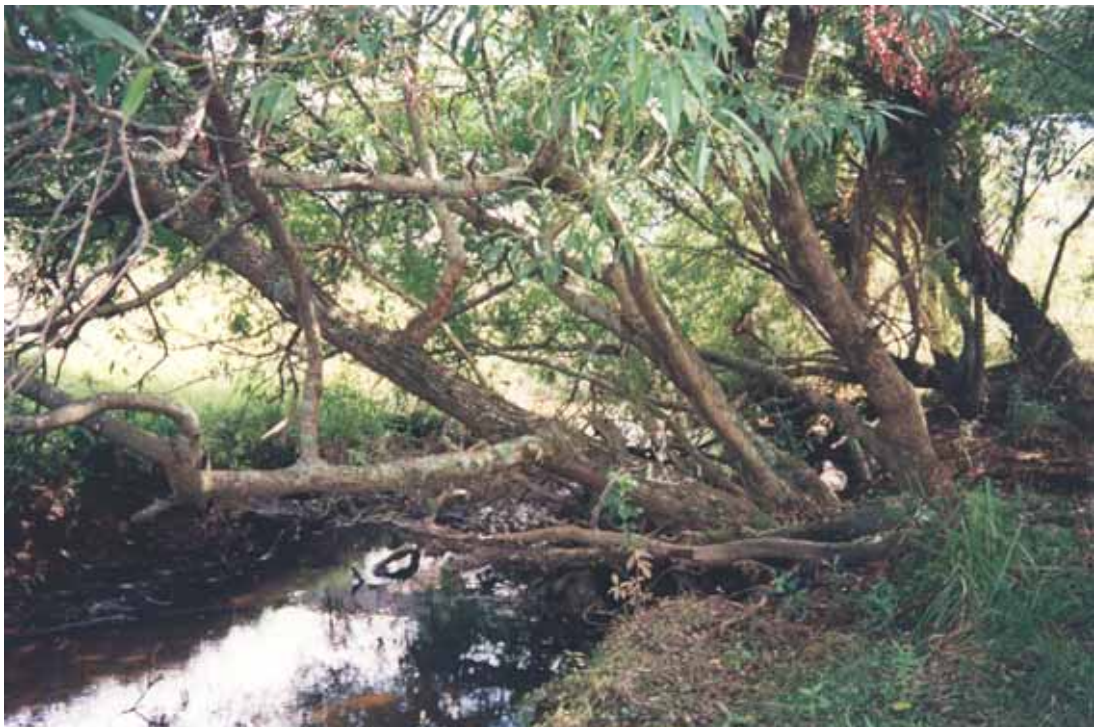
Figure 20.13 Overhanging willows are potential blockages.

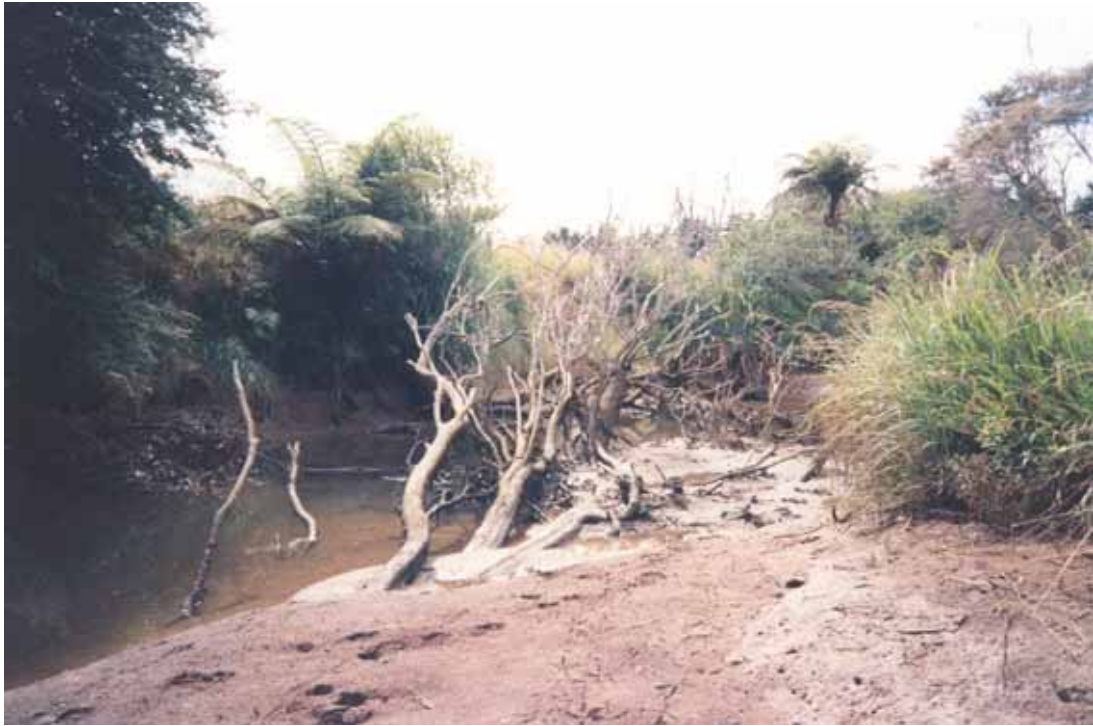
Figure 20.14 Debris situated on the channel bed at 1.8km below SH2.

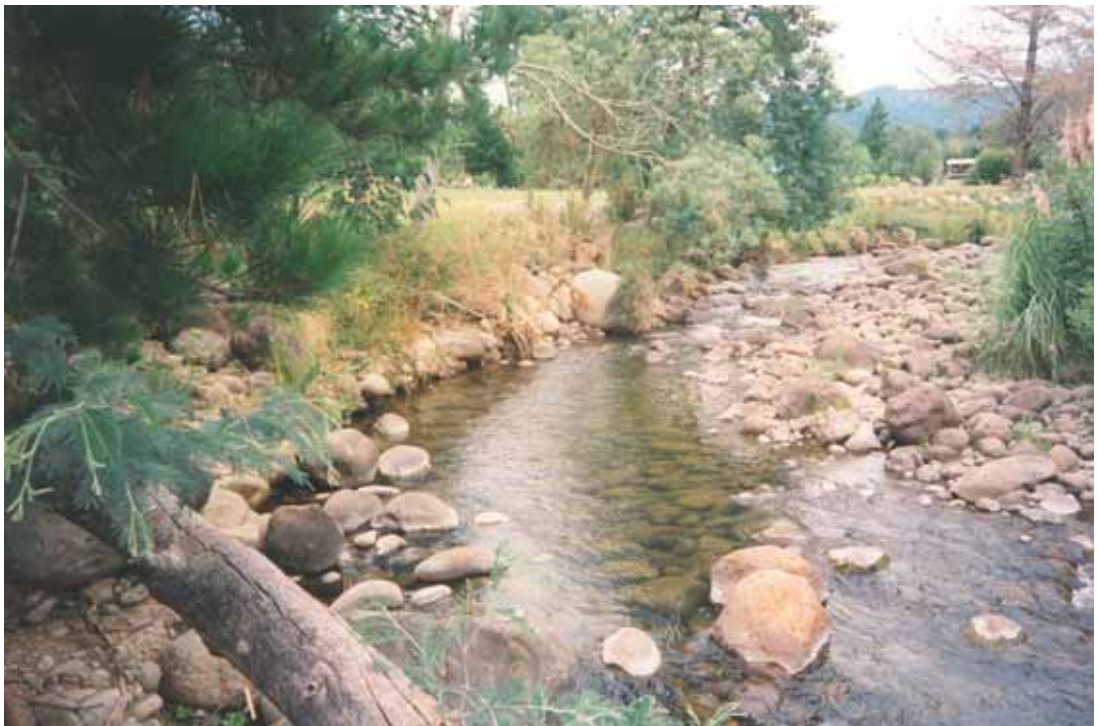
4.8km above SH2, the right bank becomes less vegetated and in small areas the bank becomes exposed. Rocks situated along the bank appear to protect it from further erosion (refer Figure 21.3).

Figure 21.3 The right bank is generally clear of trees, with small areas of exposed bank.

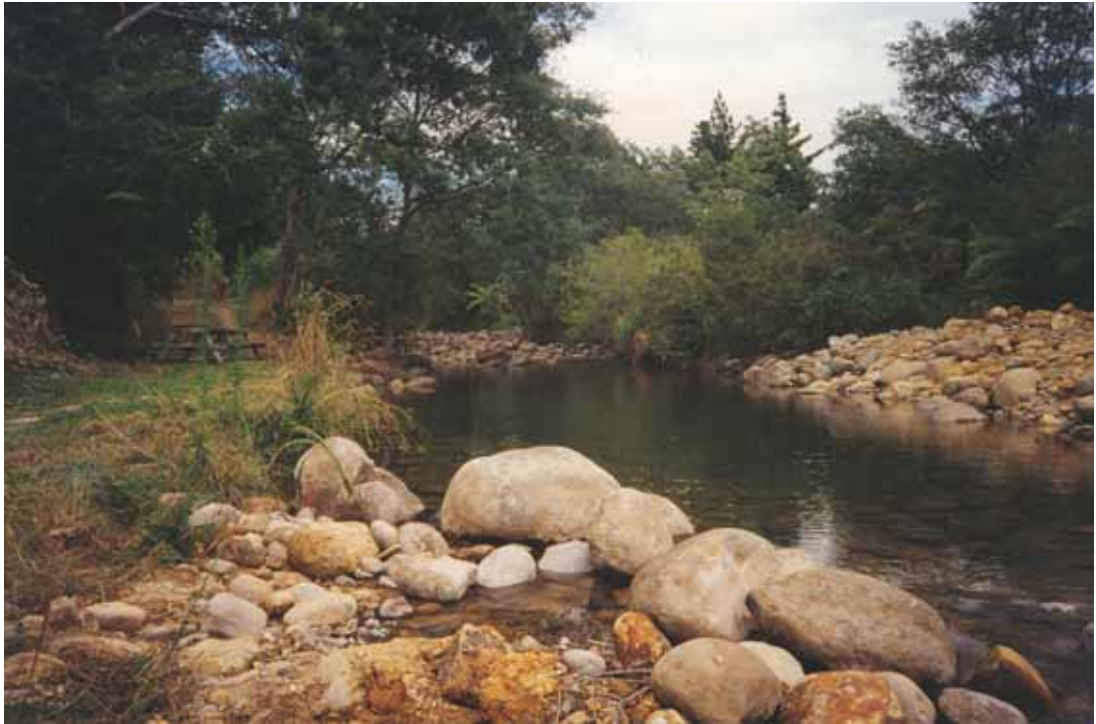
Figure 21.4 Gravel and rocks situated along the true left bank at 4.2km.

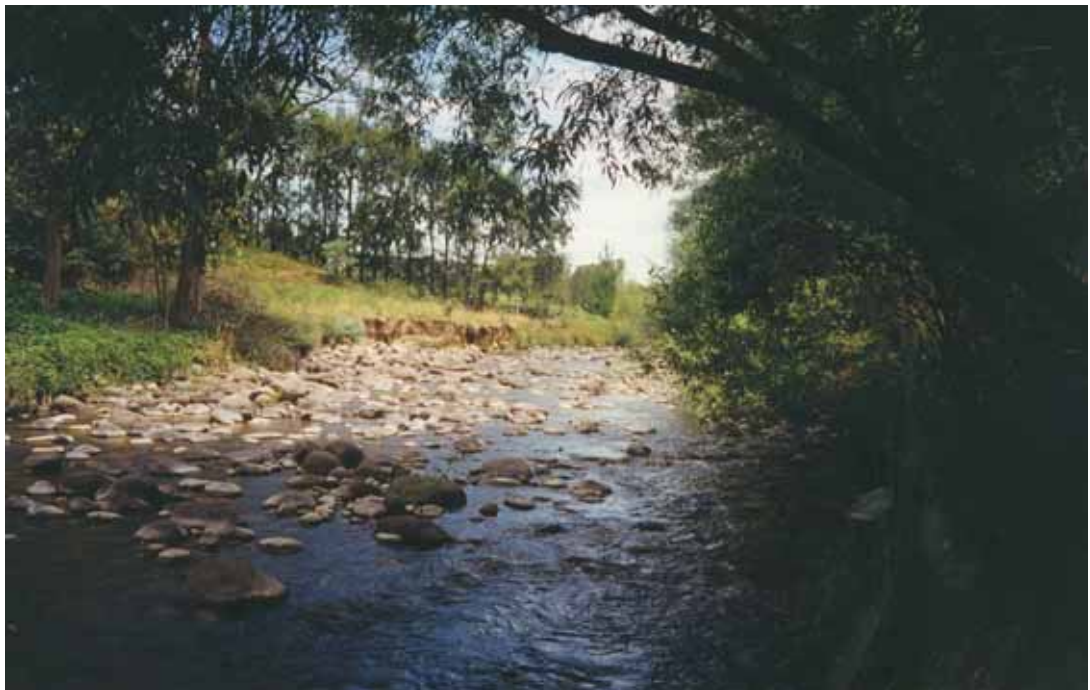
Between 3.9km and the Wharawhara Road Bridge the banks have good vegetation cover except for a 10m length of isolated erosion at 3.5km (refer Figure 21.5). Willows become more frequent and often overhang the stream (none at present block the stream channel) (refer Figure 21.6).

Figure 21.5 Isolated erosion of the true right bank. The bank is vegetated by grasses.

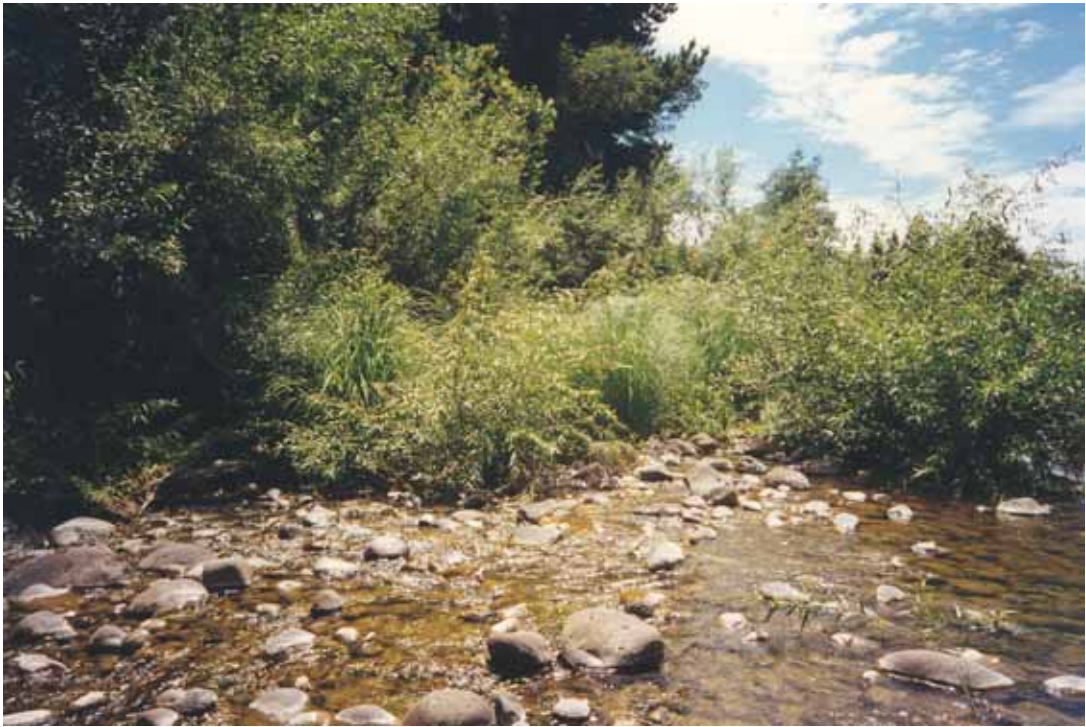
Figure 21.6 Willows growing on a rock bed, overhang the stream at 3.25km.

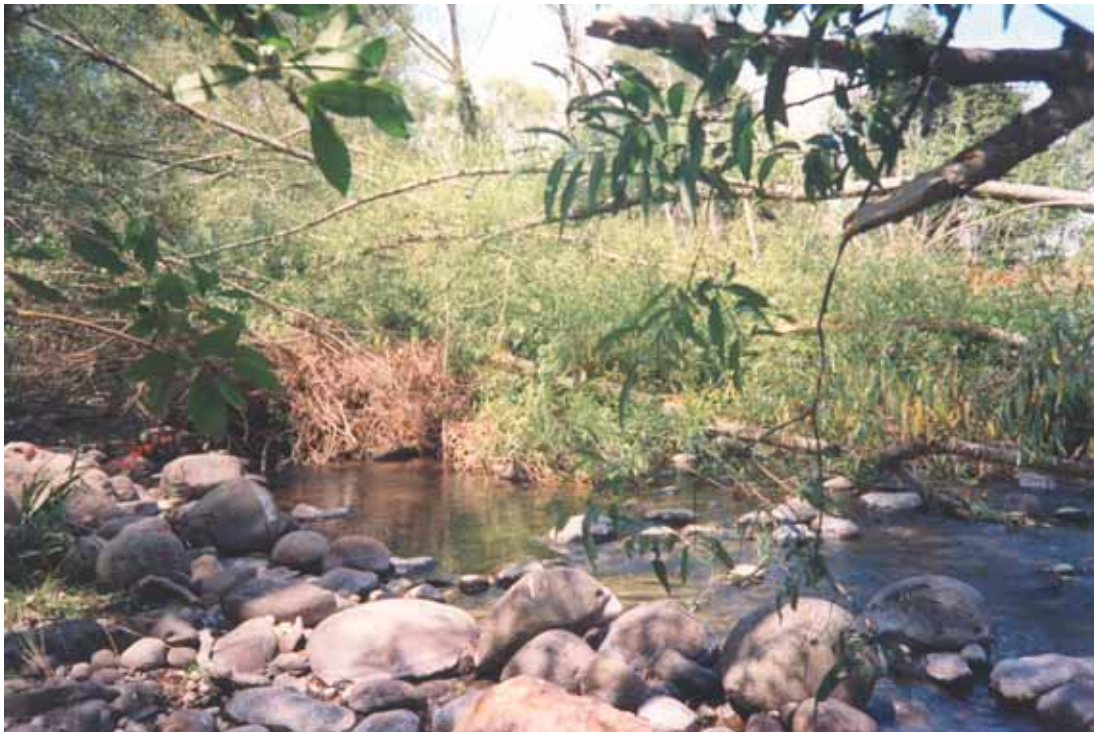
Below the Wharawhara Road Bridge there are many willows overhanging the stream, especially between 2.6km and 2.3km. In this section several willows have fallen into the stream and partially block the flow (refer Figure 21.7).

Figure 21.7 This blockage collects a large quantity of willow debris.

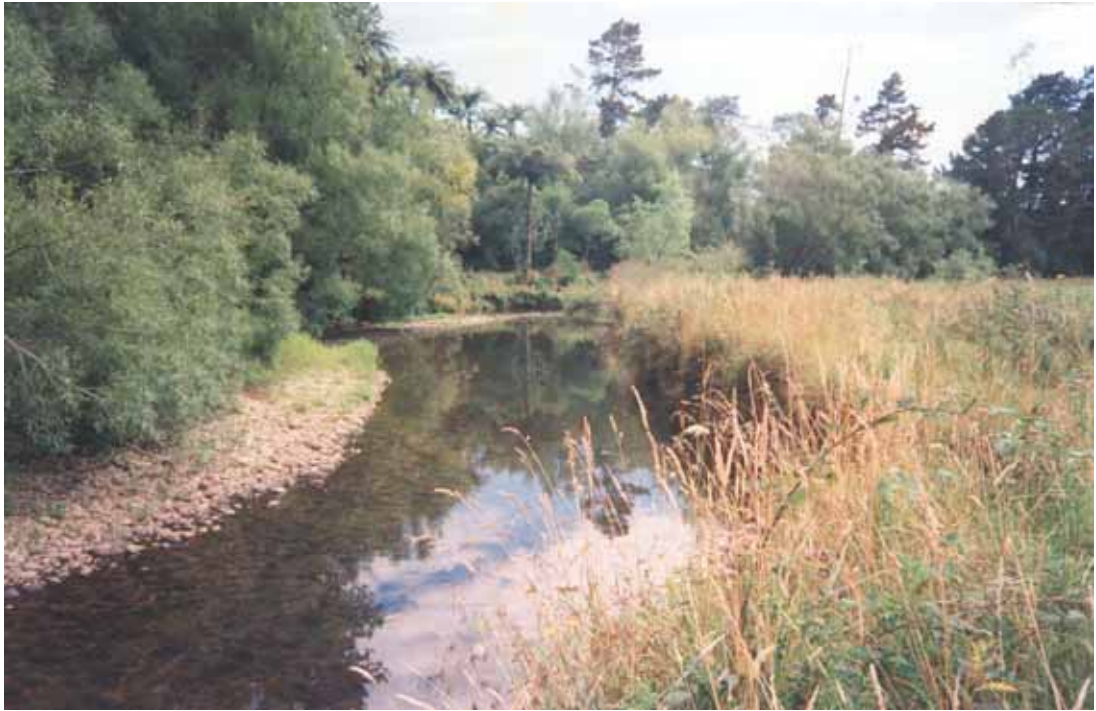
Between 2.2km and the Henry Road ford several willows overhang the stream. At 2.0km a fallen willow partially blocks the flow. 200m downstream of this, the right bank is eroded and fencing which borders the stream has slumped (refer Figure 21.8).

Figure 21.8 At 1.8km, the right bank is eroded for a length of 15m.

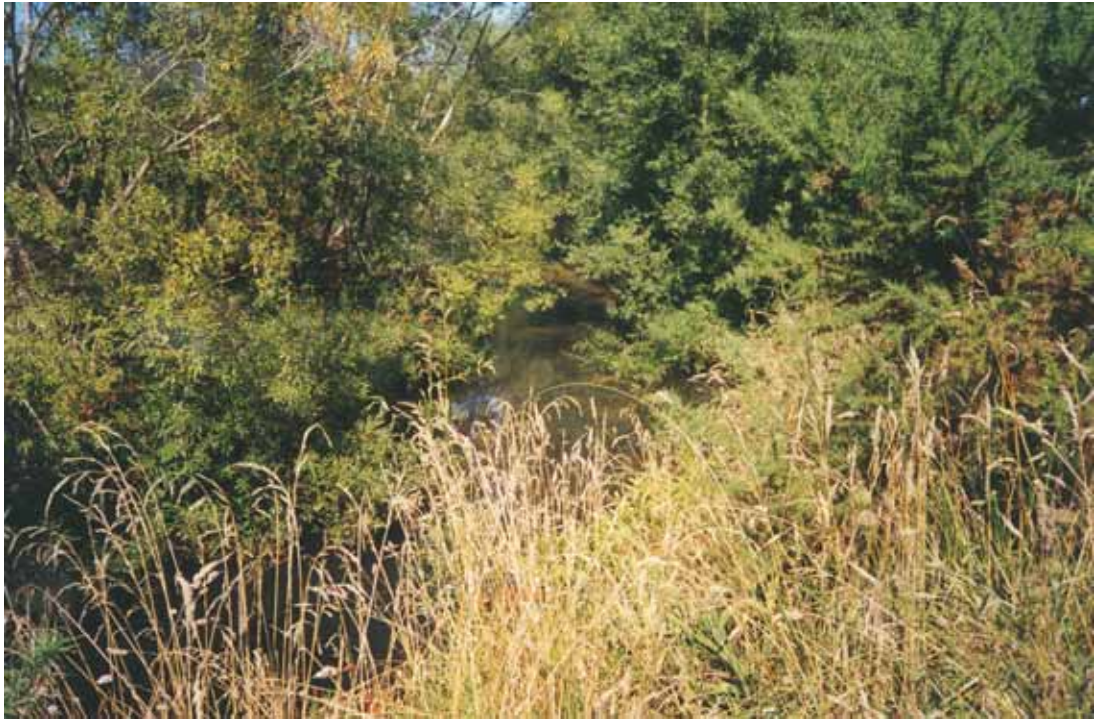
Figure 21.9 Willows commonly overhang the stream in this section.

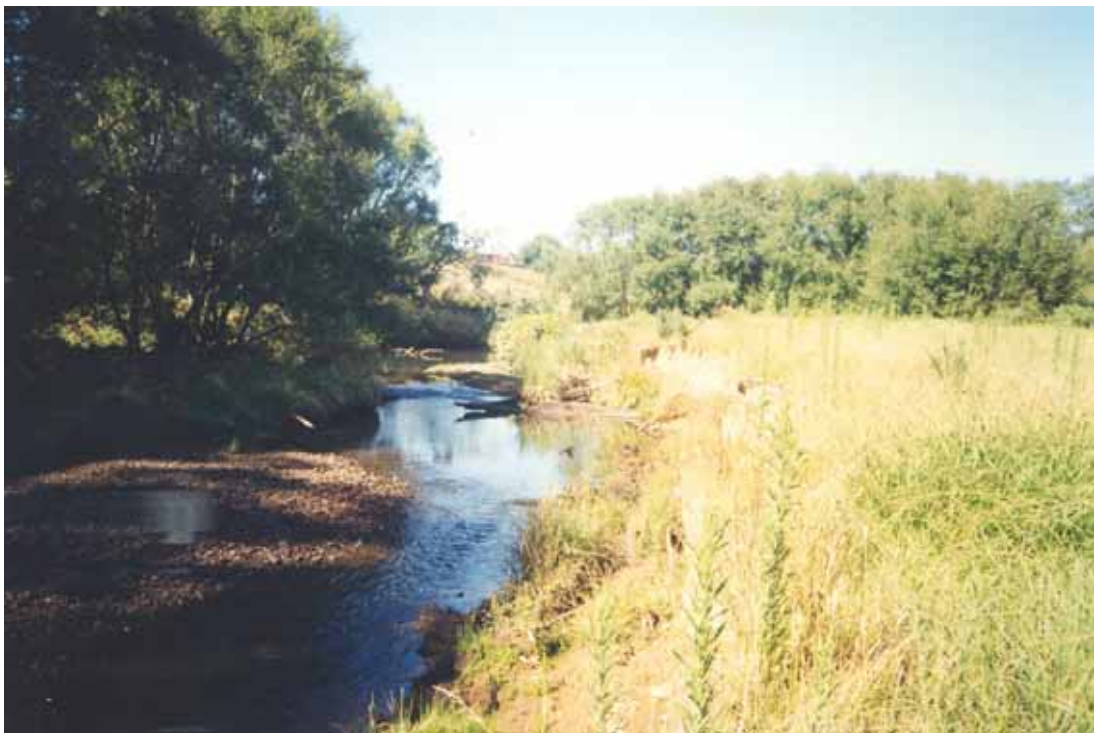
Figure 21.10 Looking upstream at 750m the left bank has opened out, with some erosion .

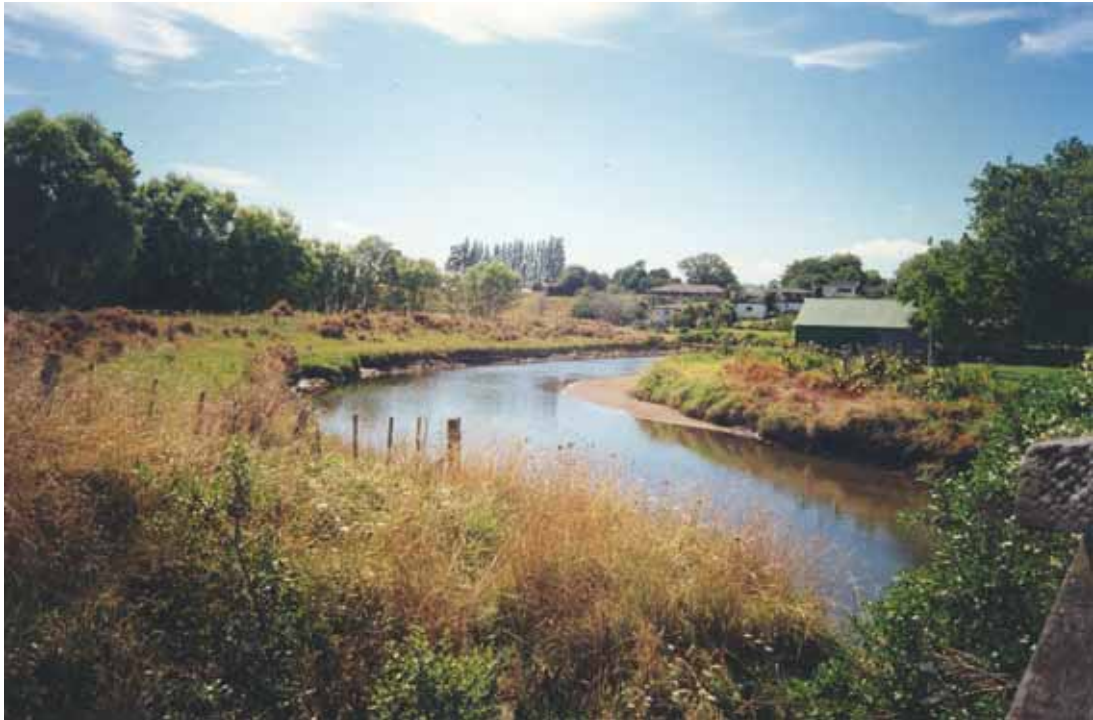
Below the SH2 bridge the 1m high banks are generally exposed and appear susceptible to erosion.

Figure 21.11 Looking downstream from the SH2 bridge the 1m high banks are frequently exposed.

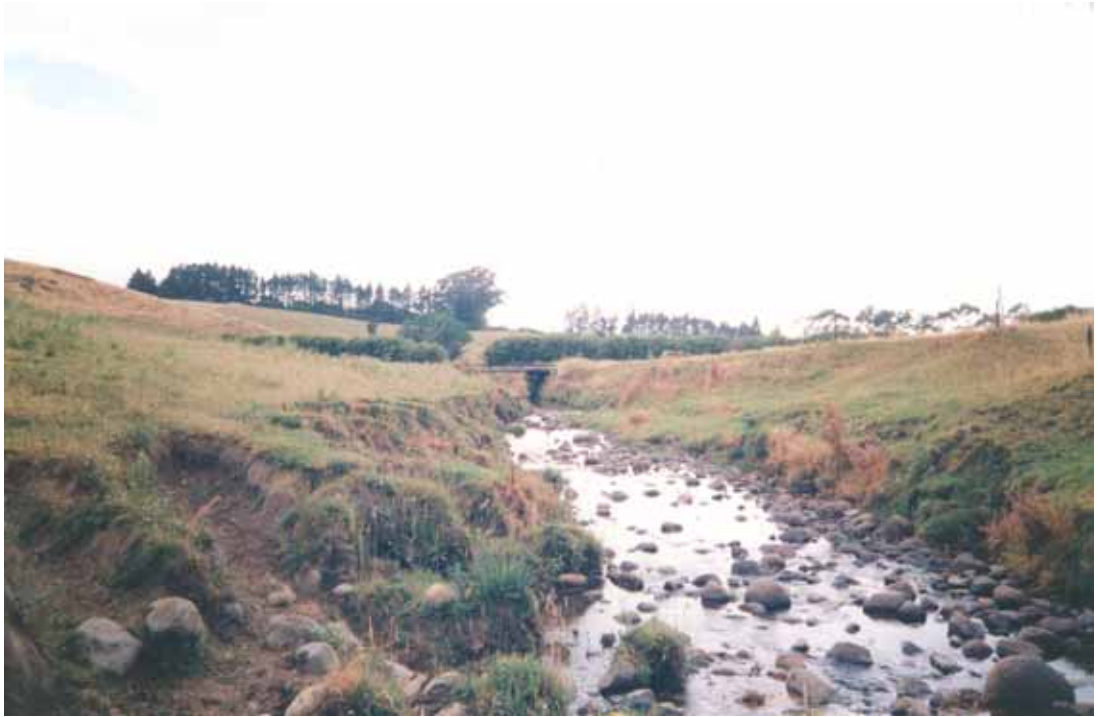
The next section of the stream is open, with farmland to the waters edge. Bank vegetation consists mainly of grasses, where frequent stock tracks to the stream edge expose the banks making them more susceptible to erosion (refer Figure 22.2).

Figure 22.3 Tracks down to the stream expose the banks at 3.6km.

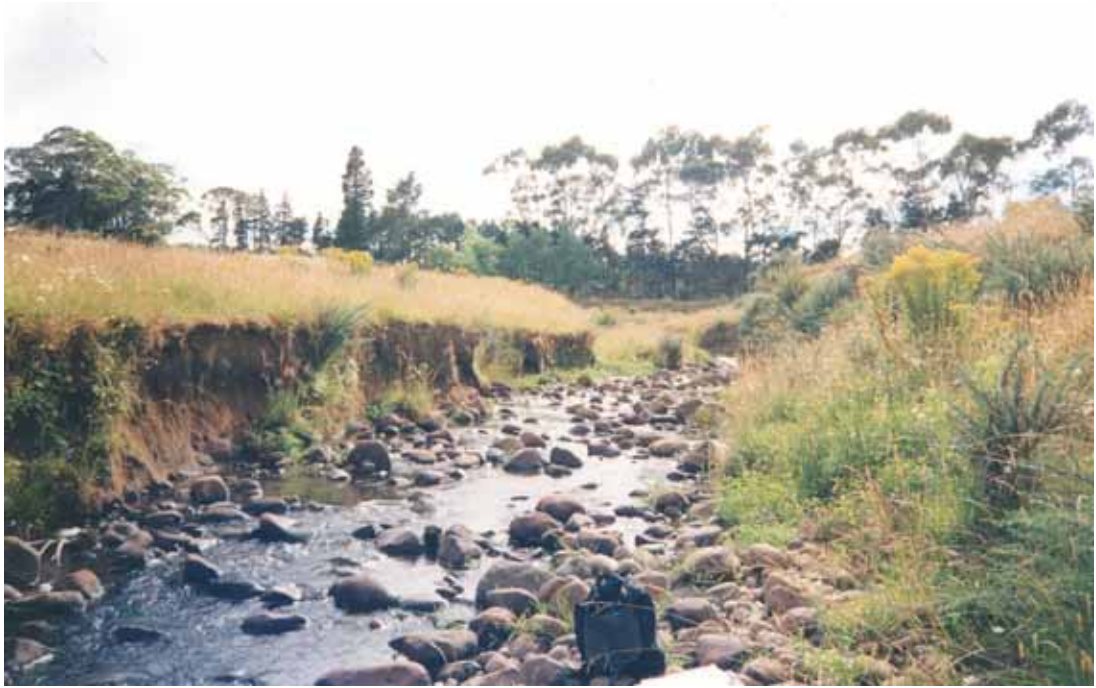
Figure 22.5 Typical bank erosion at 2.75km.

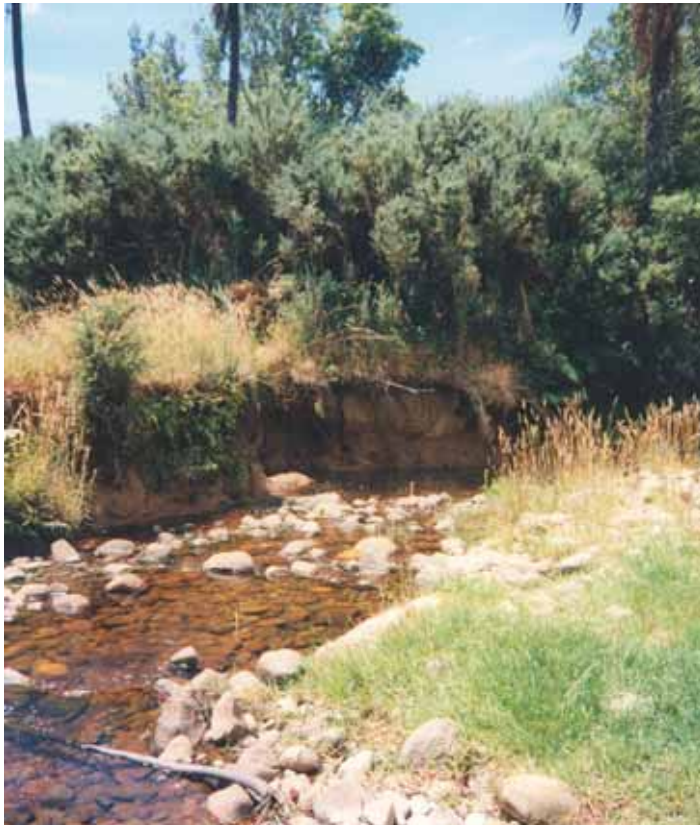
*Figure 22.7
The left bank is
eroded at 1.2km.*

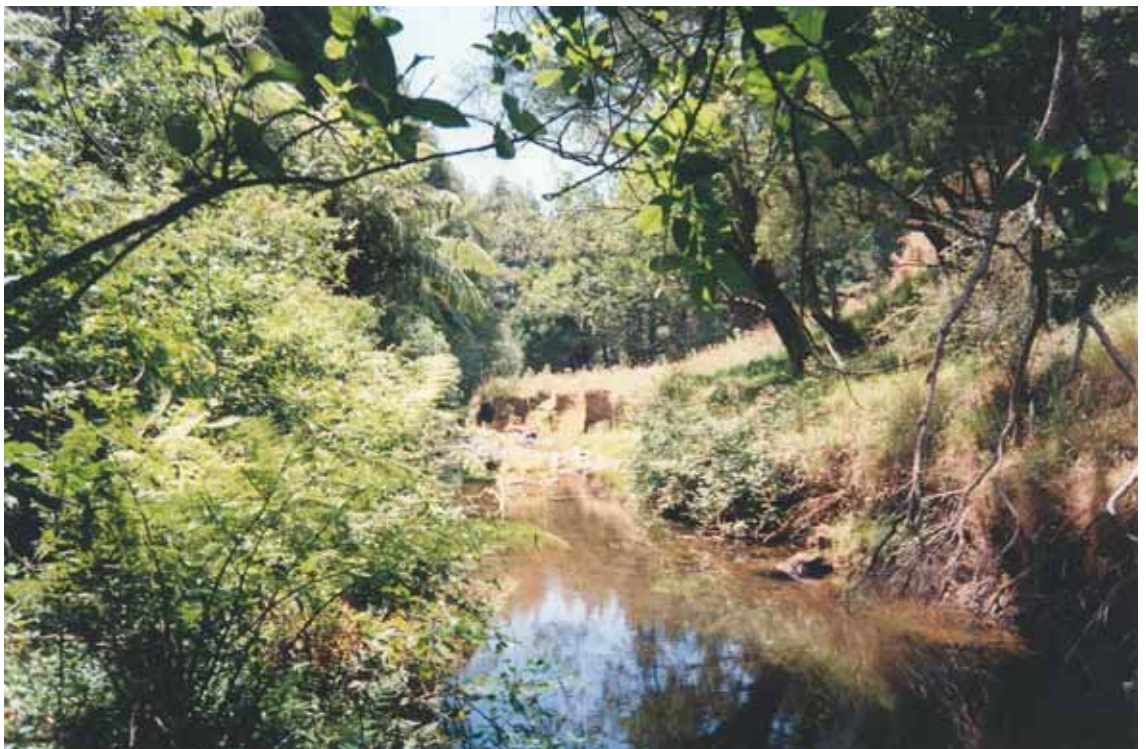
Figure 22.8 Erosion of the right bank where thick bank vegetation is absent.

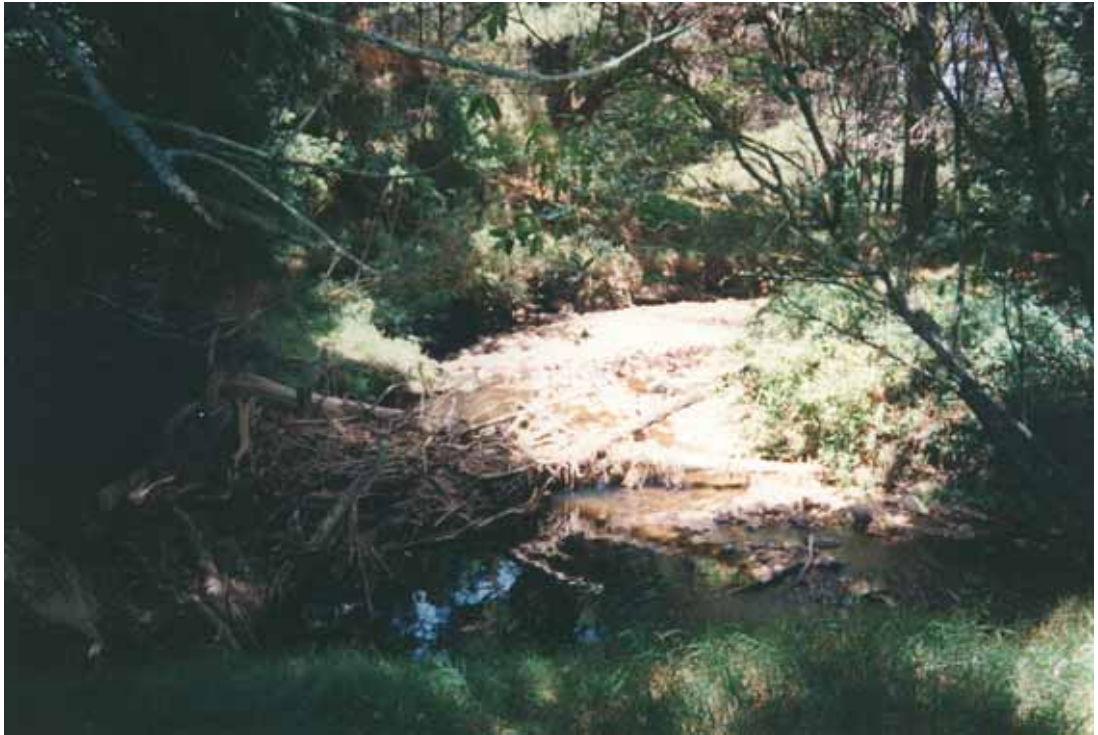
Figure 22.9 Debris collects in the stream at 550m and partially blocks the stream flow. Downstream of this the right bank is eroded for a length of 10m.

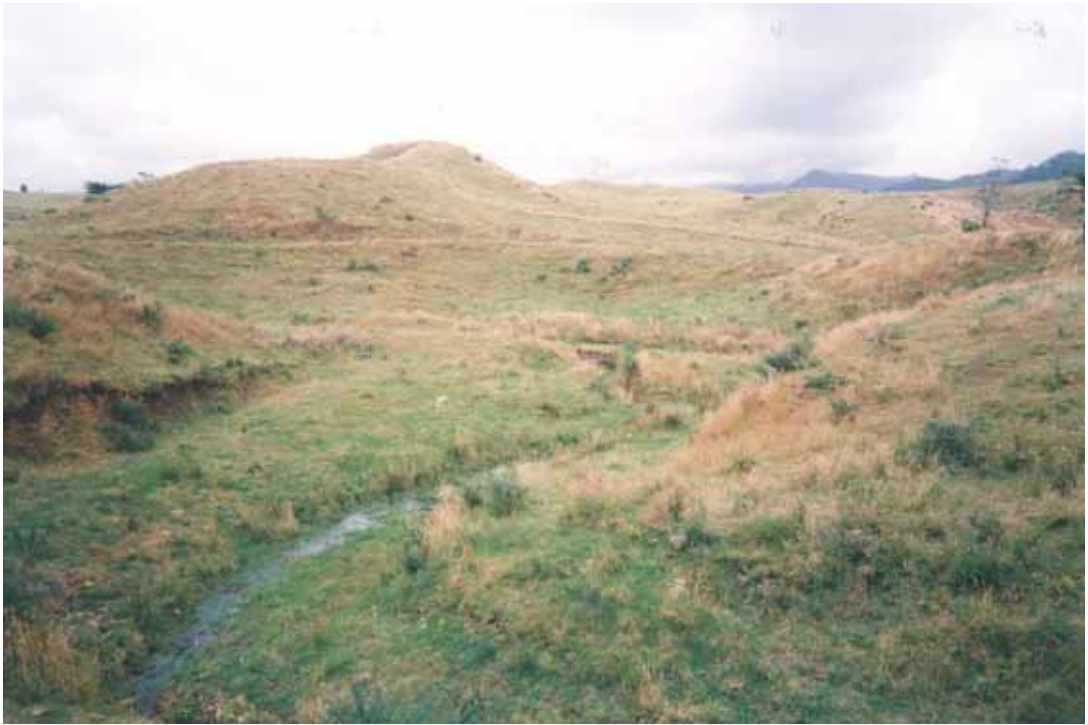
Figure 23.2 Weed growth commonly reduces the width of the stream flow.

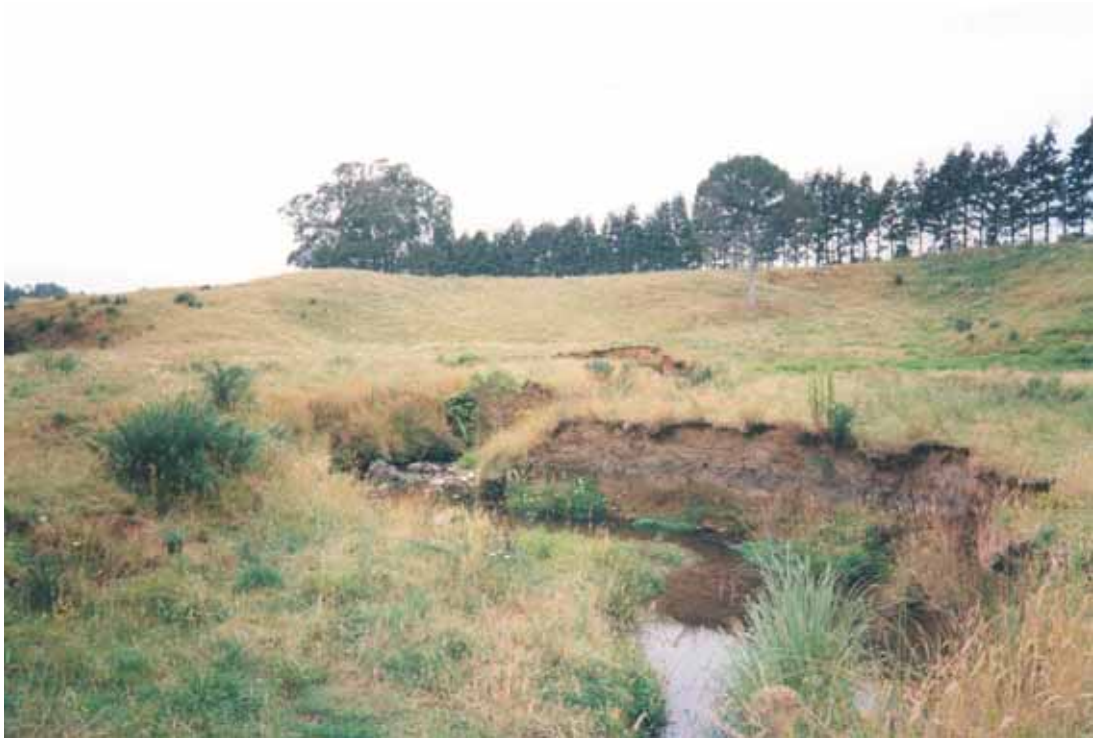
Farmland then continues to border the stream, with frequent bank erosion and slumping, occurring commonly in 5–10m lengths.

Figure 23.4 The 1–2m high banks become eroded at 2.4km.
