Tauranga Harbour Sediment Source Survey

Report prepared by Matthew Surman, Design Engineer
Richard Clarke, Student - Lincoln University
Meredith Carter, Student - Waikato University

Environment B·O·P
Quay Street
P O Box 364
Whakatane
NEW ZEALAND

The report provides an order of magnitude estimate of sediment transported from stream bank erosion into Tauranga Harbour from the harbour catchments. The report describes and costs possible stream improvement works and estimates the reduction of sediment yields such works may achieve.

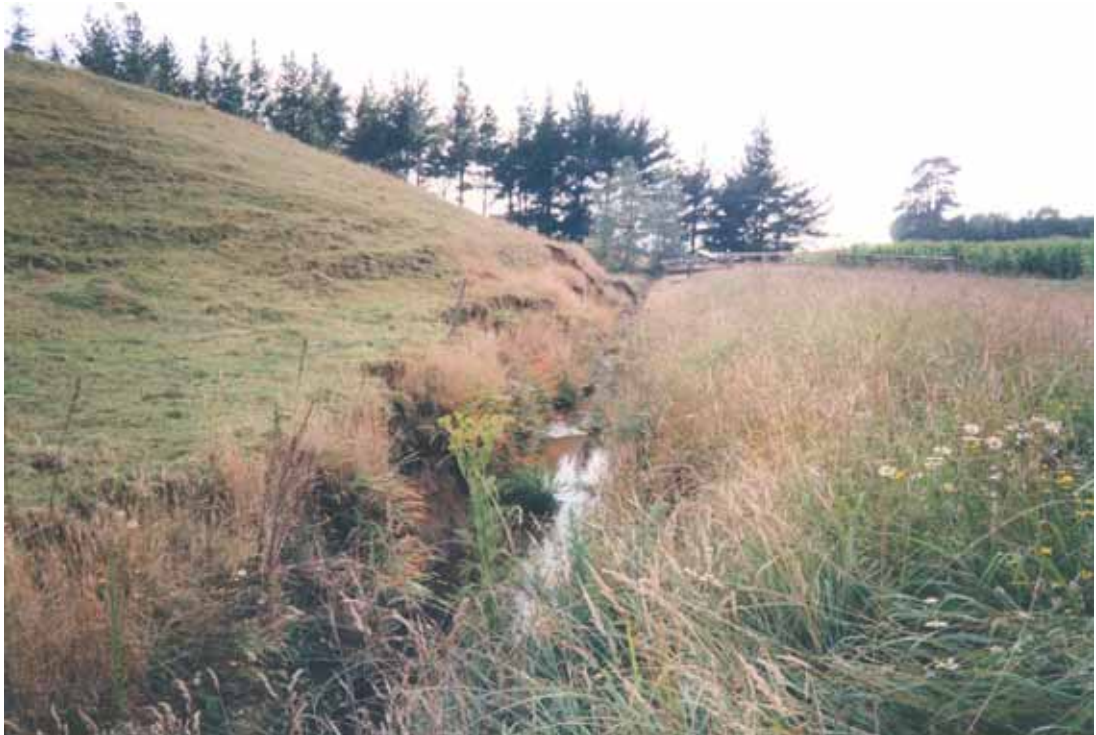
Figure 23.6 Bank erosion at 1.3km.

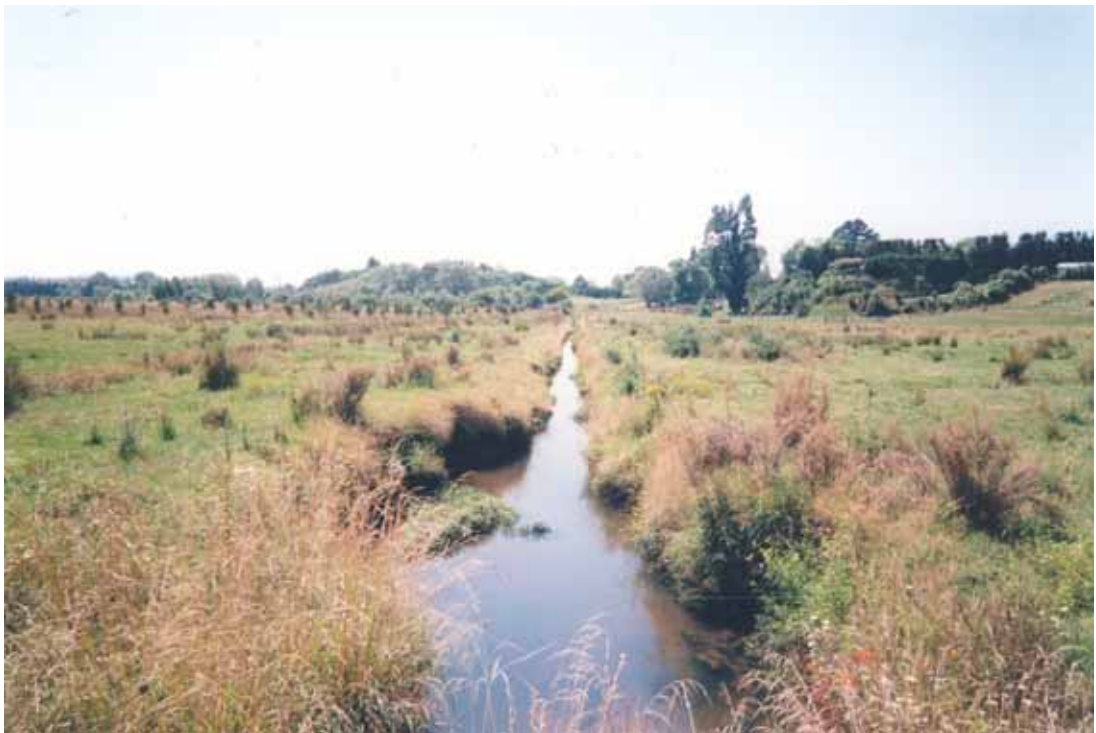
300m above SH2 the bank height decreases to 1m with slumping occurring on several occasions. The channel is 1m wide and very straight. Some growth in the stream (refer Figure 23.7).

Figure 23.7 The channel here is very straight, with slumping of the banks.

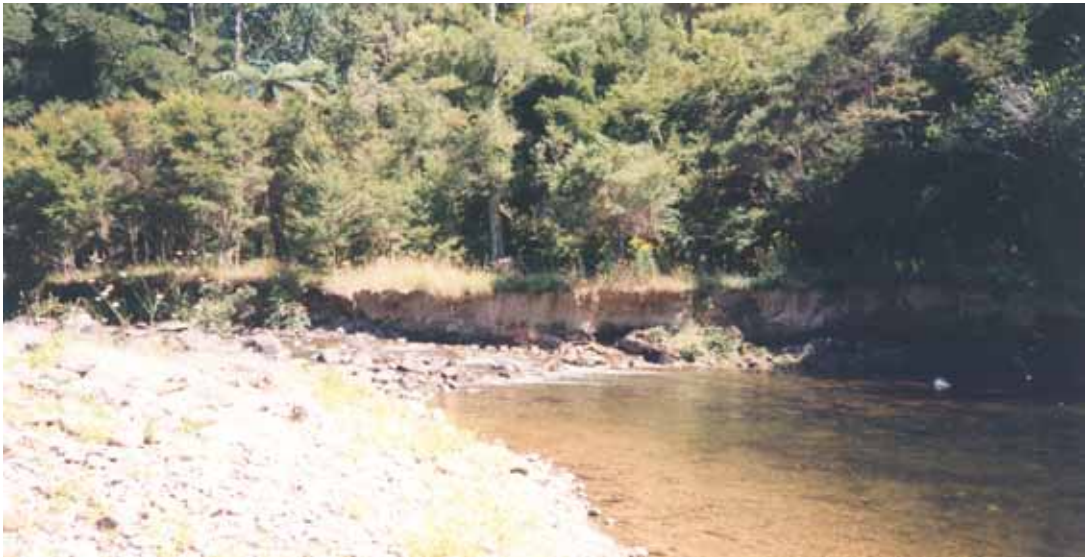
At 6.8km above SH2 dense bush again surrounds the left bank. The bank is stable and well vegetated, except for a 15m length of erosion on a stream bend (refer Figure 24.3). At this point the bank is grassy.

Figure 24.3 Erosion of the true left bank.

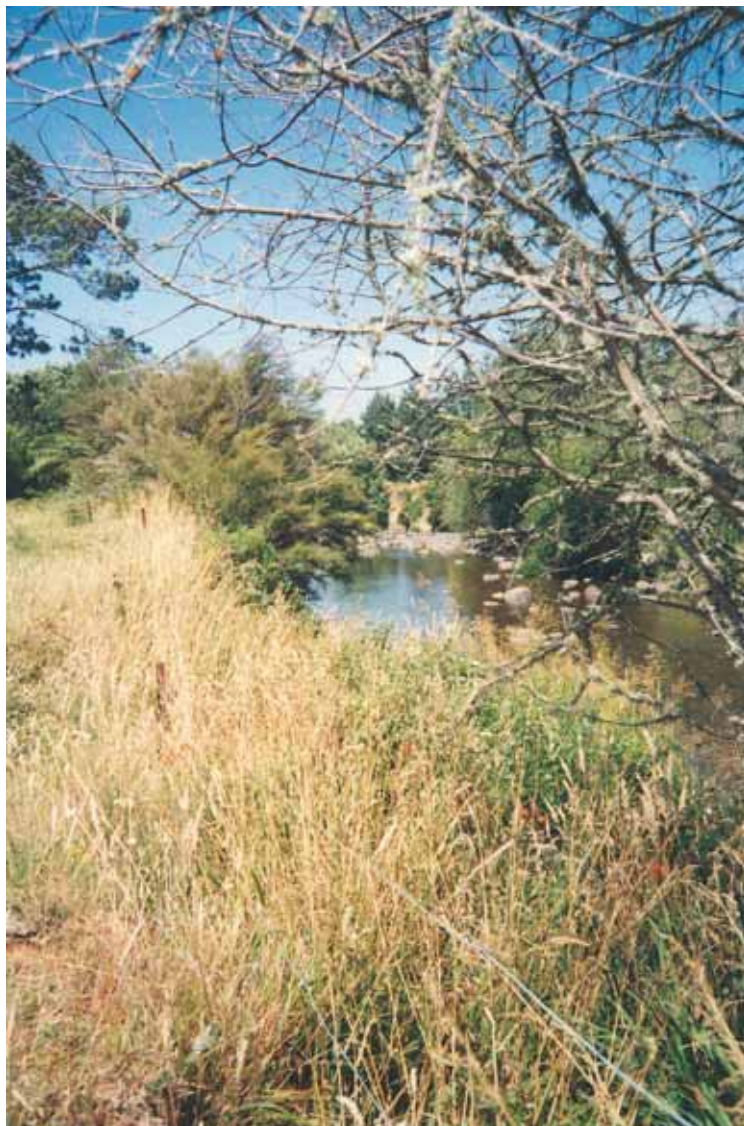
Farmed hills extend on either side of the stream to 3.7km above SH2. The 2–3m high banks are well vegetated, fencing borders the stream. A few trees overhang the stream, but do not presently restrict the flow. The right bank becomes exposed and eroded at 3.8km above SH2, where thick bank vegetation is absent (refer Figure 24.6). Another small patch of erosion occurs downstream of this. At this point a few trees overhang the stream.

Figure 24.6 Fencing and vegetation borders the stream in this farmed area. Erosion of the right bank occurs where thick bank vegetation is absent.

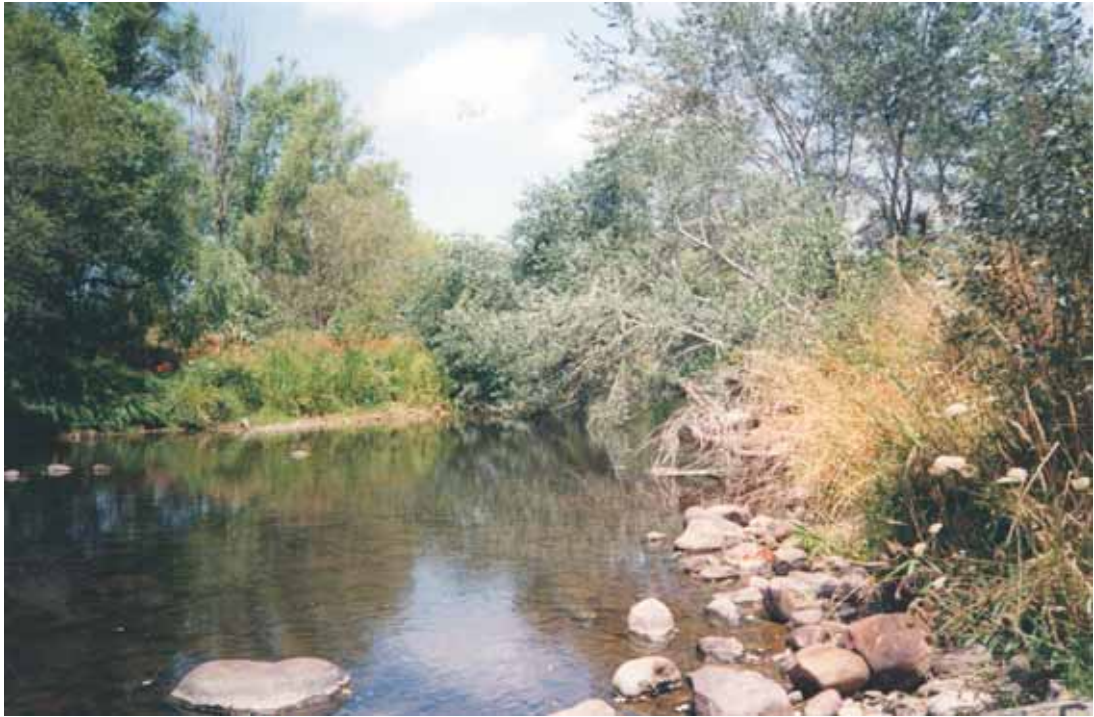
Figure 24.7 Trees overhang in the stream at 3.0km.

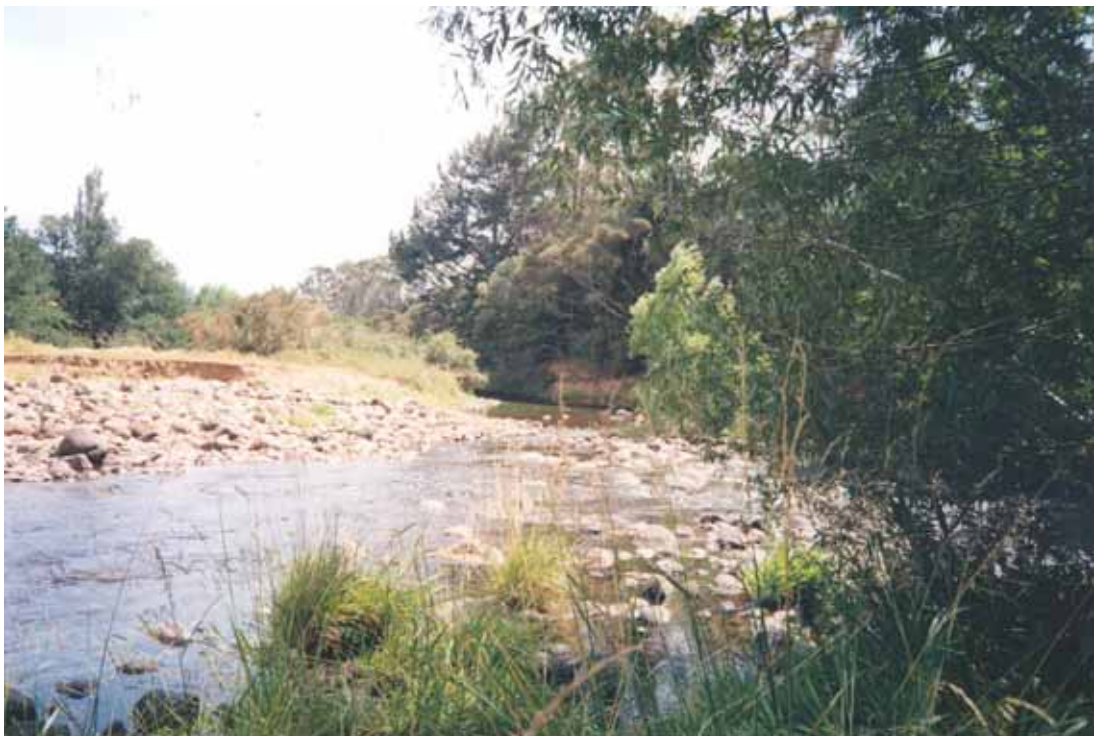
Figure 24.8 Minor erosion of the left bank at 2.6km.

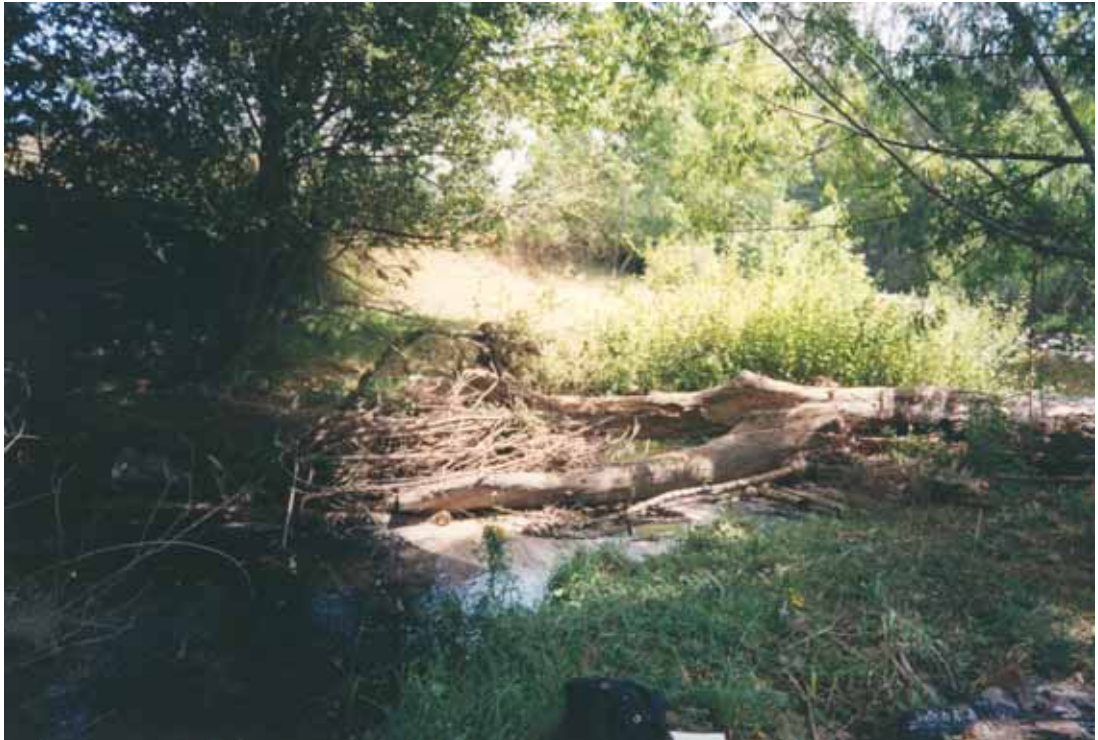
2.5km above SH2 an island divides the stream flow. On the true left bank two relatively large trees have fallen in, 10m apart. The second of the fallen trees partially blocks the stream, with a small area of erosion on the right bank. The first significant obstruction occurs 5m downstream, where two trees fully block the stream (refer Figure 24.9).

Figure 24.9 A dam catches a large quantity of debris and fully blocks the stream flow.

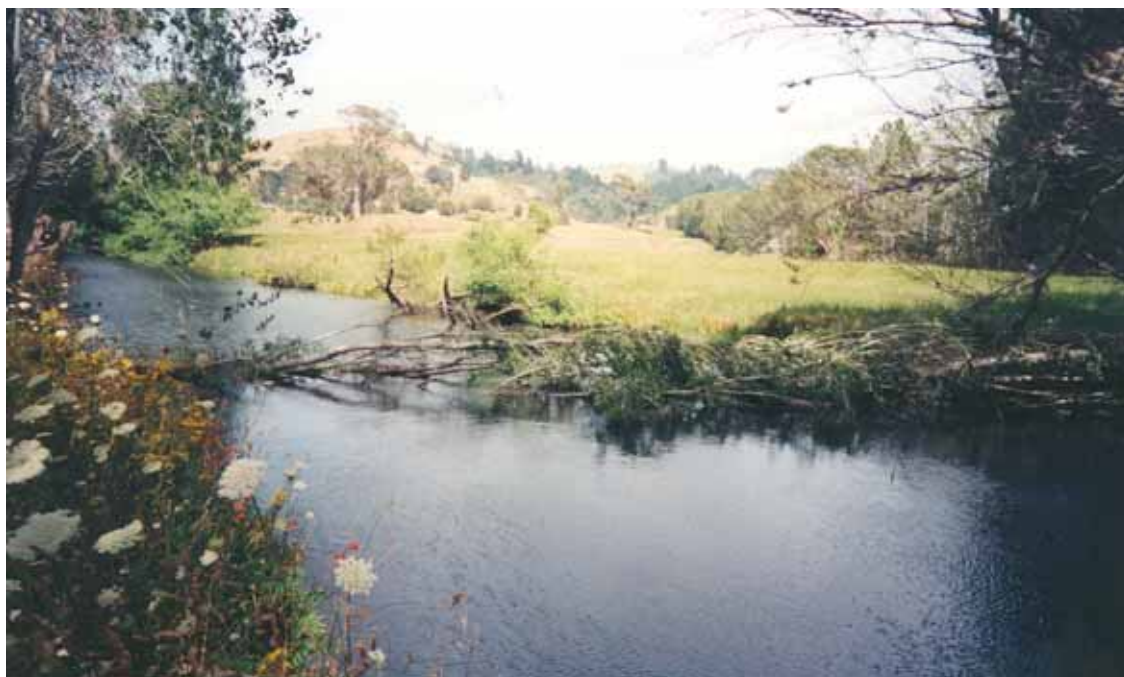
Downstream, a large poplar tree has been uprooted and lies across the stream blocking the flow (refer Figure 24.12). From here to the SH2 bridge, the banks are well vegetated, except for a small area of exposed bank immediately upstream of the SH2 bridge.

Figure 24.12 At 400m, a large poplar blocks the flow.
